October 28, 2022

**RE: Issued for Construction Drawings Submission – 2022/2023 Tote Road Culvert Upgrades  
Mary River Project - Type 'A' Water Licence 2AM-MRY1325 - Amend. No. 1 –  
Expedited NWB Review**

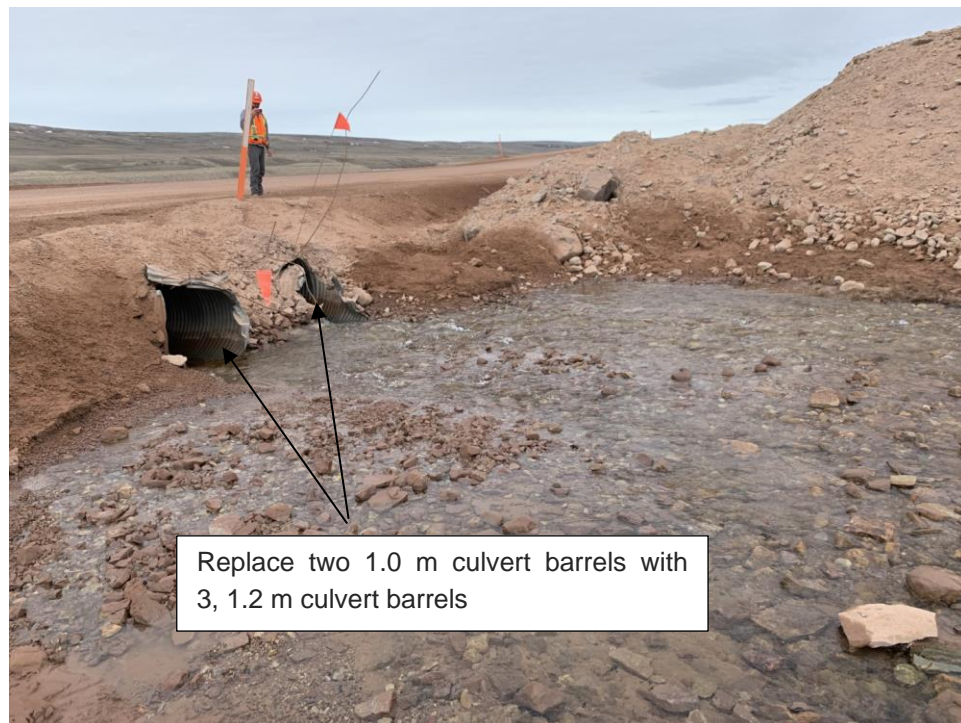
- Damaged Culverts - The culvert barrels appear to be damaged (Photo B1.1).
- Erosion of Slopes - The embankment slopes are steep, lack armouring and contain fines leading to erosion of the embankment slopes (Photos B1.1 and B1.2).
- Adequate Cover - Loading over culvert pipes should be in accordance with the design criteria with the minimum cover for culverts being 600 mm, or as required by the differing specific design vehicle (Hatch, 2018) (Photo B1.1).
- Perched Culverts - The culvert barrels are perched above the stream (Photo B1.2).

The existing water crossing at CV-114 was rated high risk and was identified as a barrier for 88 mm Arctic Char fish passage (Appendix C).

**Photo B1.1 CV-114 Culvert Inlet**

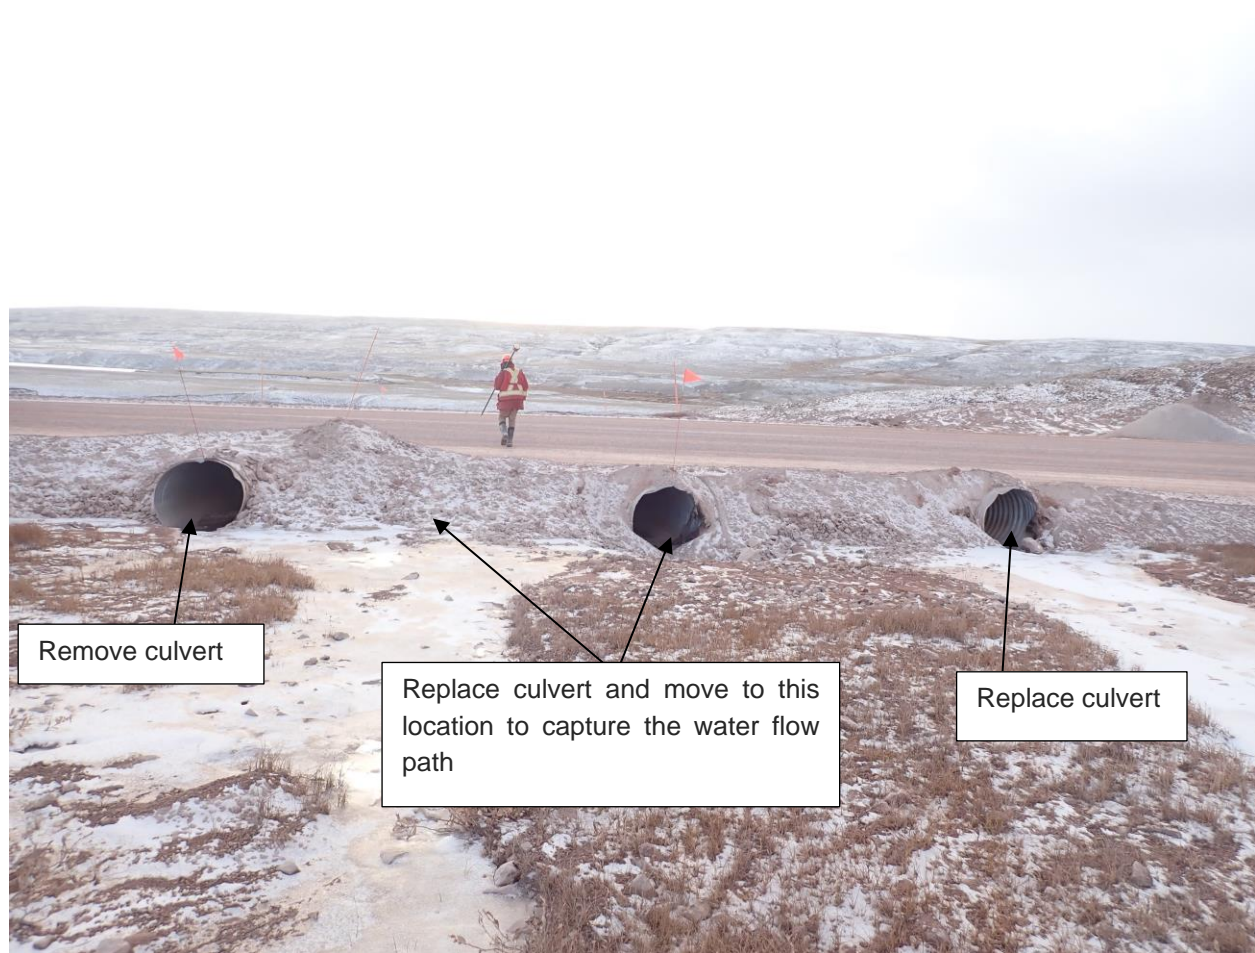
- Damaged Culverts - The culvert barrels appear to be damaged (Photos B2.1 and B2.2).
- Erosion of Slopes - The embankment slope is steep and contains fines leading to erosion of the embankment slope (Photos B2.1 and B2.2).
- Perched Culvert - The culvert barrel is slightly perched above the stream (Photo B2.2).

**Photo B2.1 CV-112 Culvert Inlet**

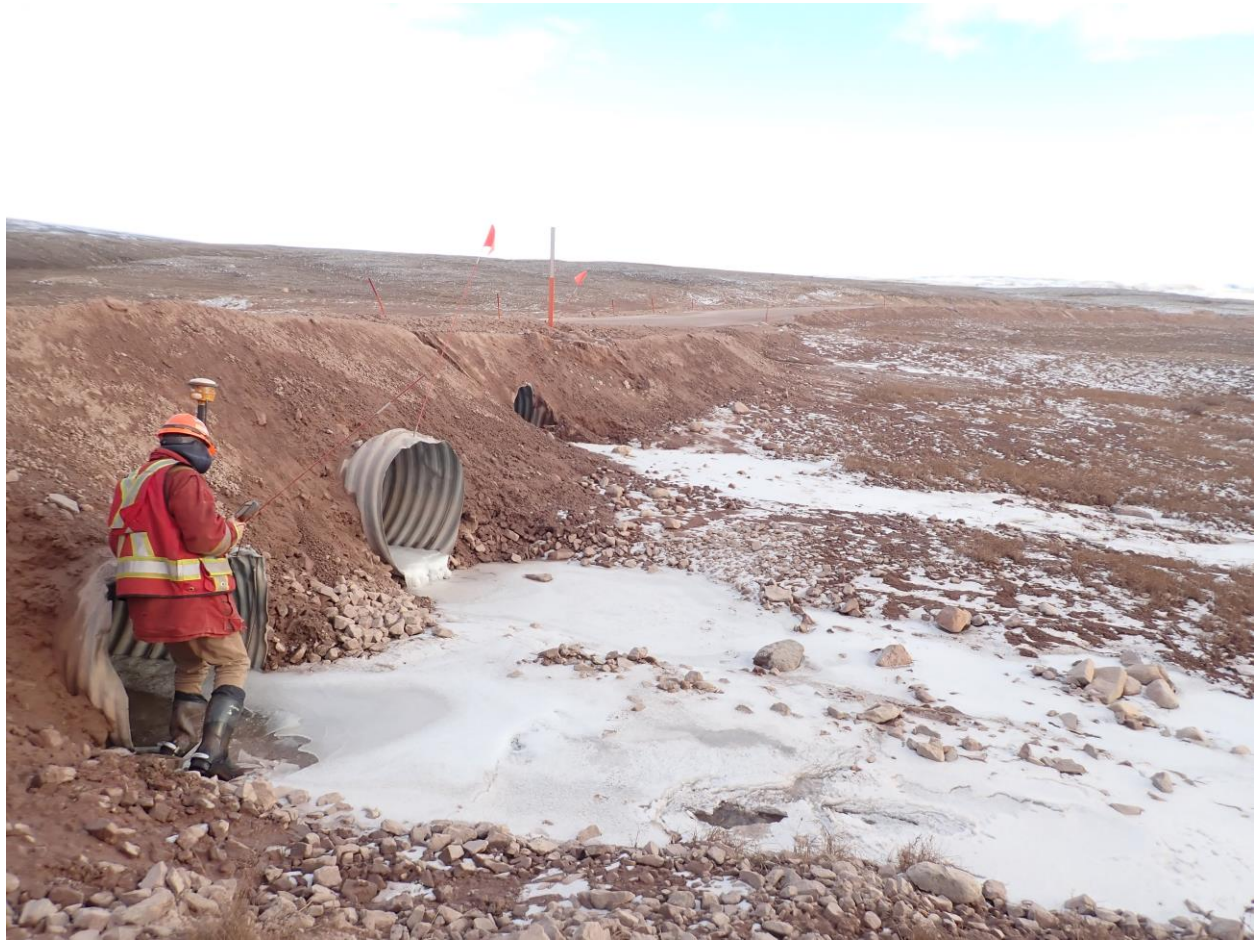
The existing water crossing at CV-112 was rated high risk for fish passage (Appendix C).

**Photo B2.2 CV-112 Culvert Outlet**

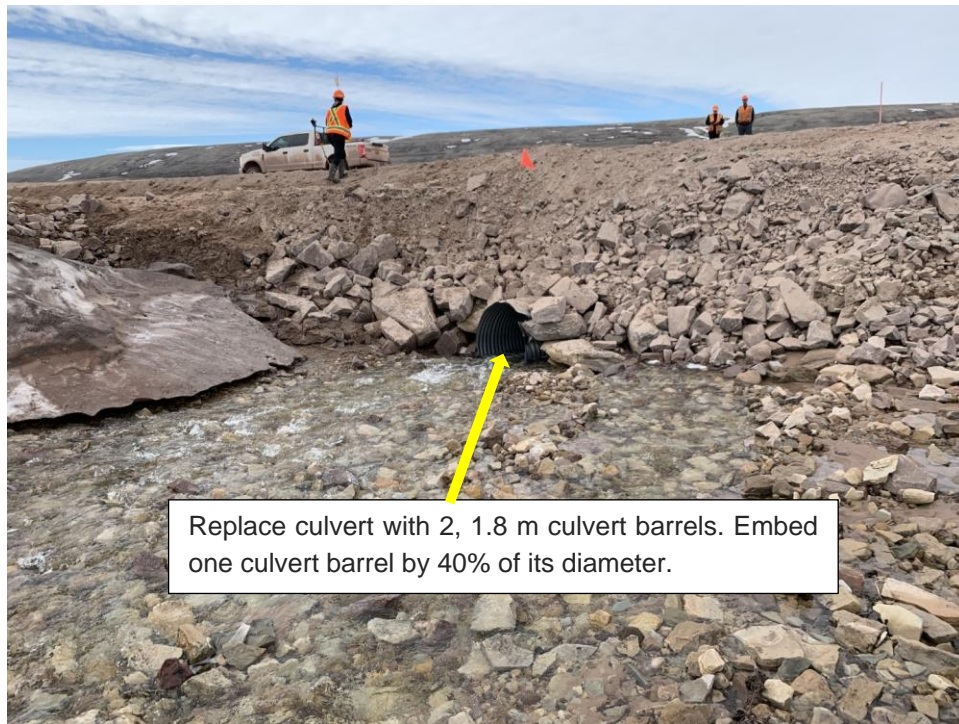
- Erosion of Slopes - The embankment slopes are steep and contain fines leading to erosion of the embankment slopes (Photos B3.1 and B3.2)
- Damaged and Perched Culvert - The culvert barrel is damaged and perched above the stream (Photo B3.2)

The existing water crossing was rated high risk and was identified as a barrier for 88 mm Arctic Char passage (Appendix C).

**Photo B3.1 CV-111 Culvert Inlet**

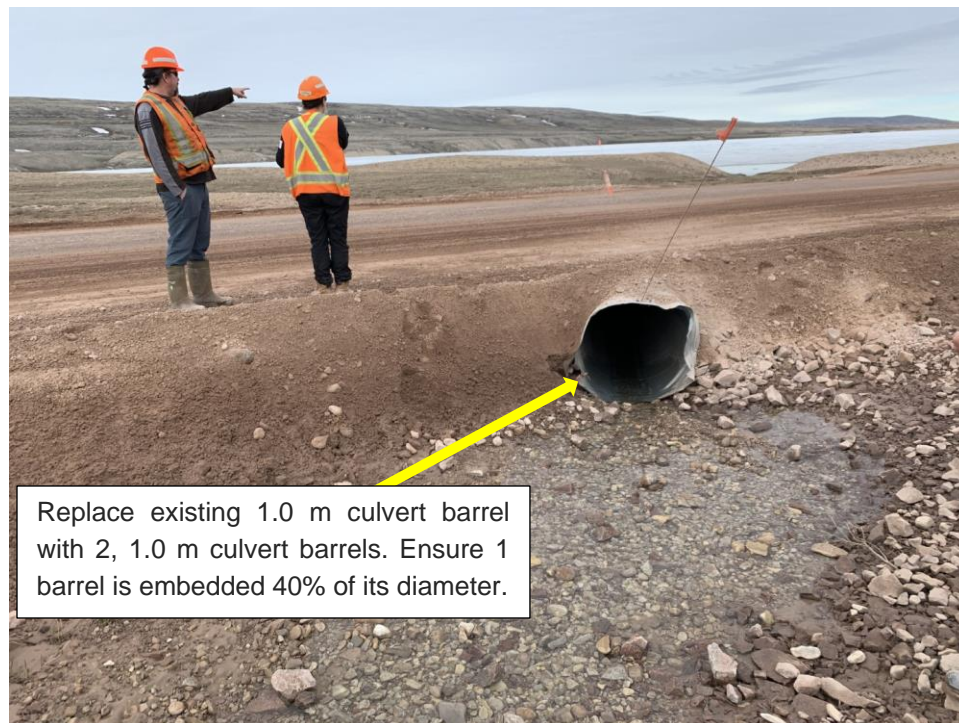
The existing water crossing was rated high risk result as a barrier for fish passage (Appendix C).

**Photo B4.1 CV-106 Culvert Inlet**

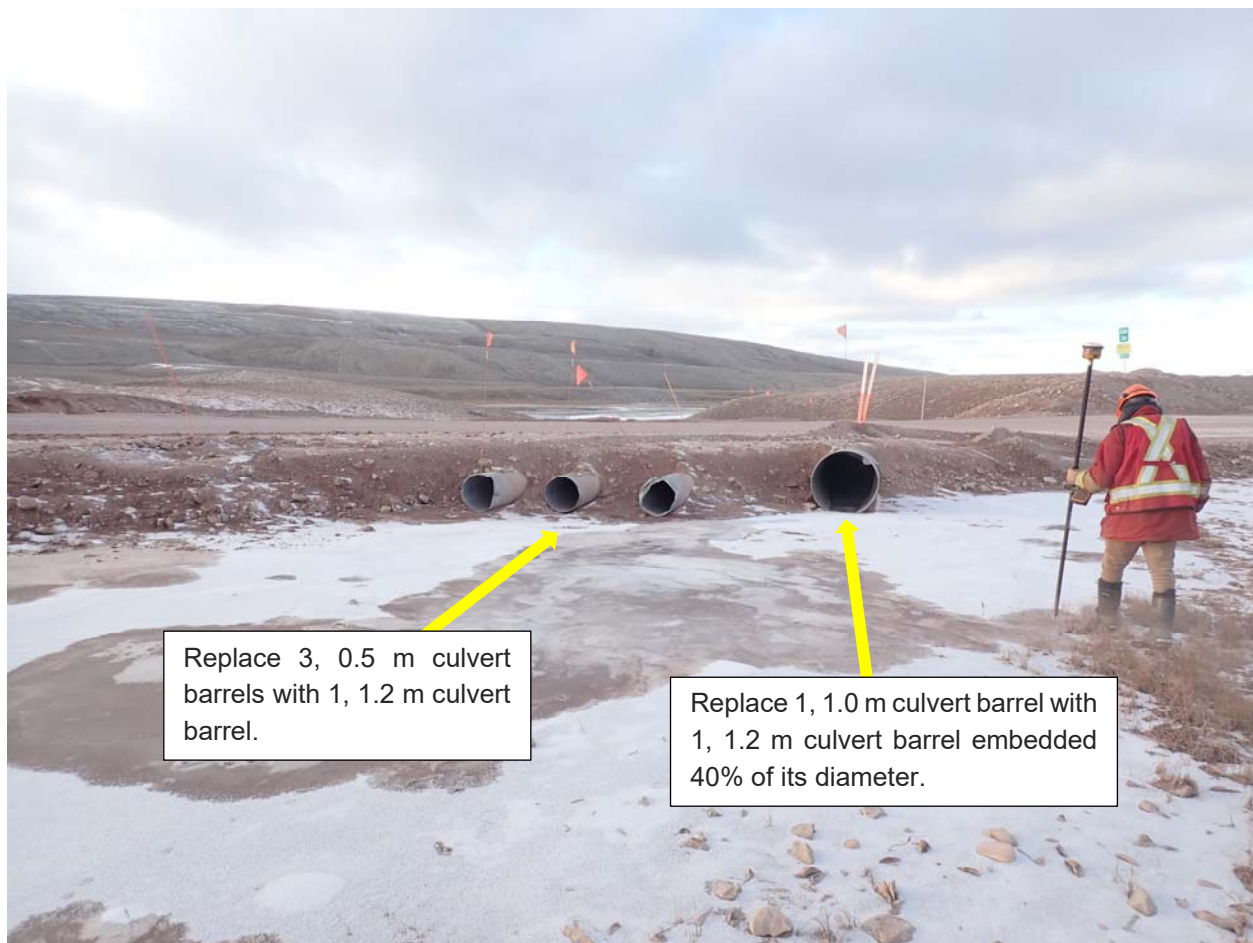
The existing water crossing at CV-102 was rated high risk for the potential to be a barrier to fish movement (Appendix C).

**Photo B5.1 CV-102 Culvert Inlet**

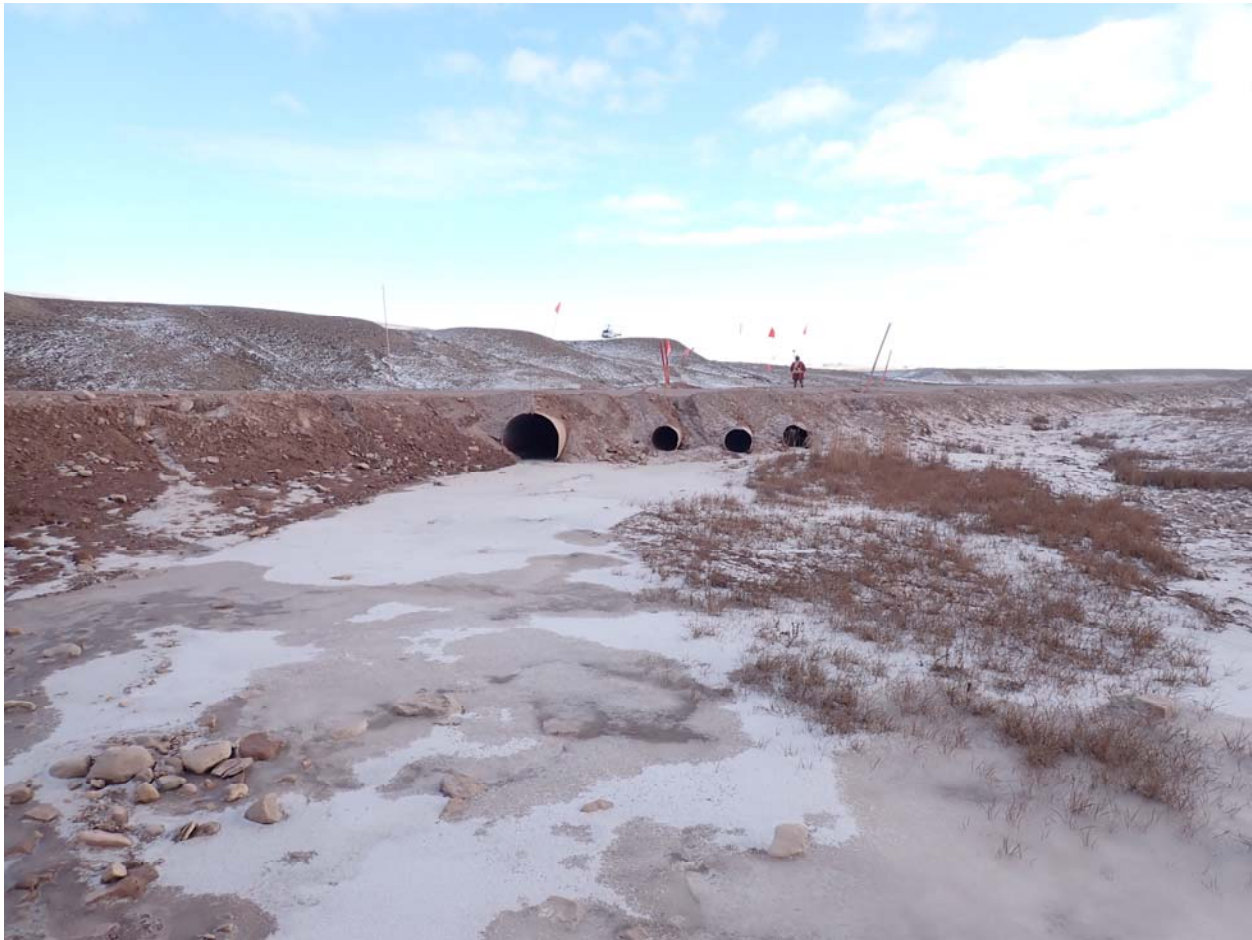
**Photo B5.2 CV-102 Culvert Outlet**

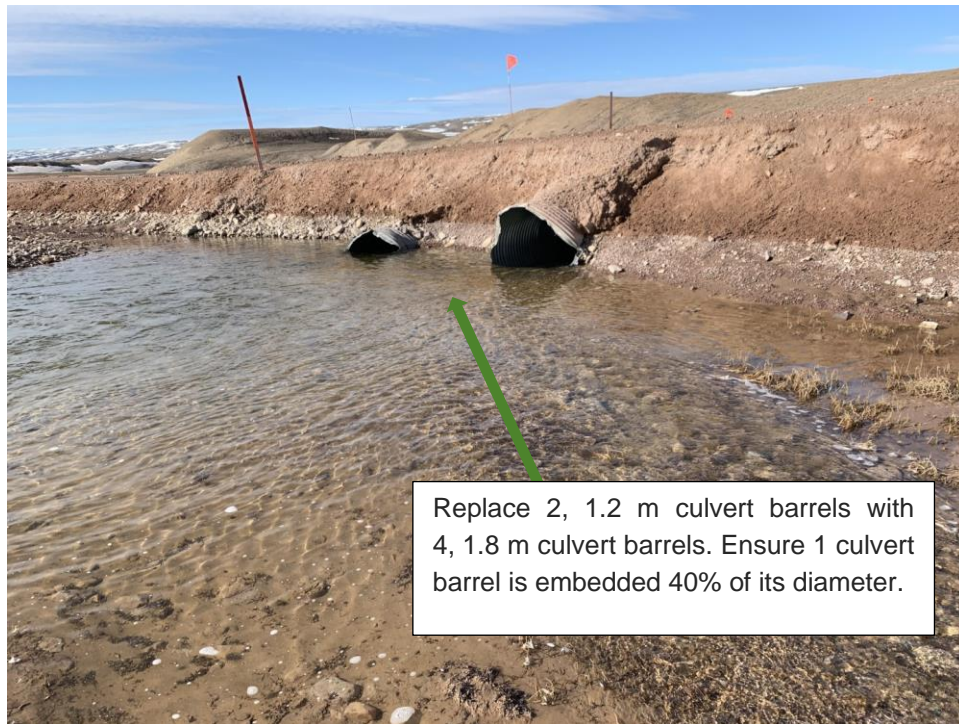
The existing water crossing was rated high risk and identified as a barrier to 88 mm Arctic Char passage (Appendix C).

**Photo B6.1 CV-079 Culvert Inlet**

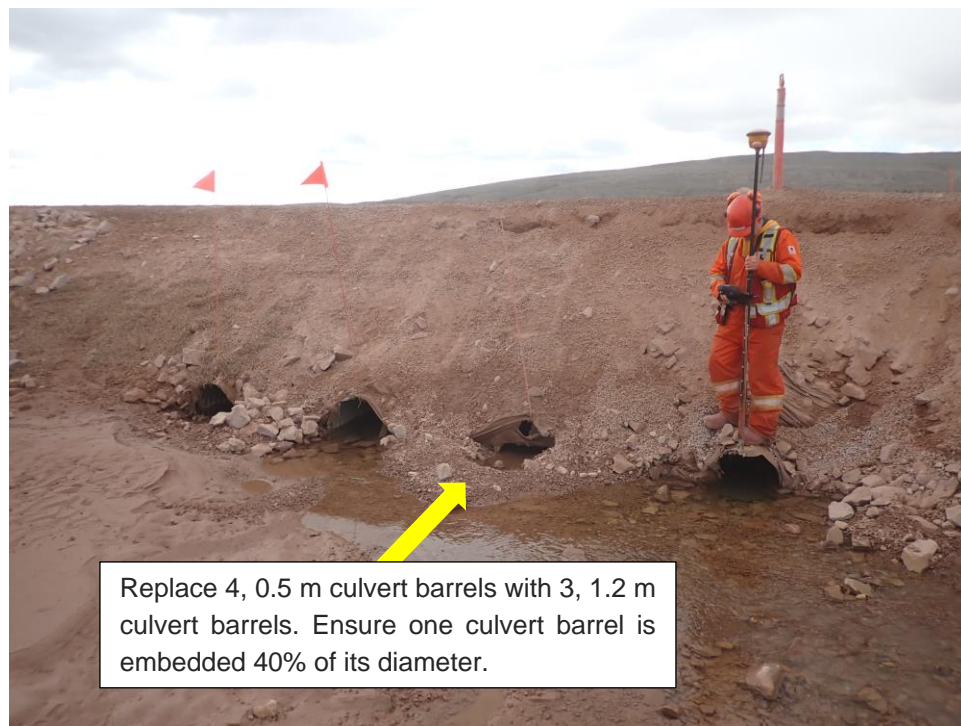
The existing water crossing was rated high risk result as a barrier for fish passage (Appendix C).

**Photo B8.1 CV-059 Culvert Inlet**

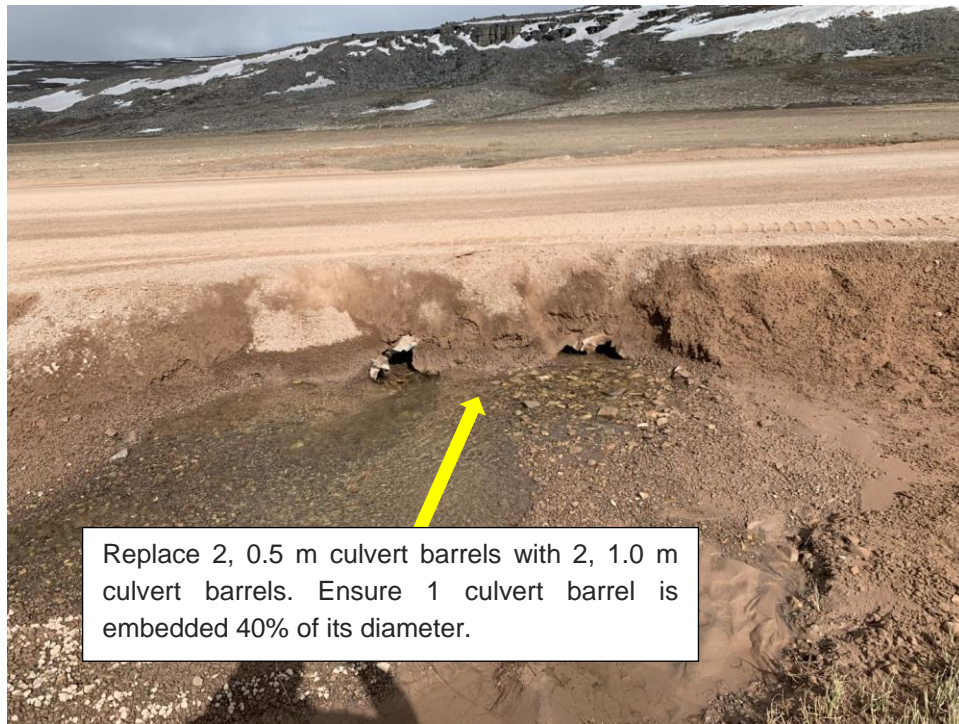
The existing water crossing was rated high risk as a barrier for fish passage (Appendix C).

**Photo B9.1 CV-057 Culvert Inlet**

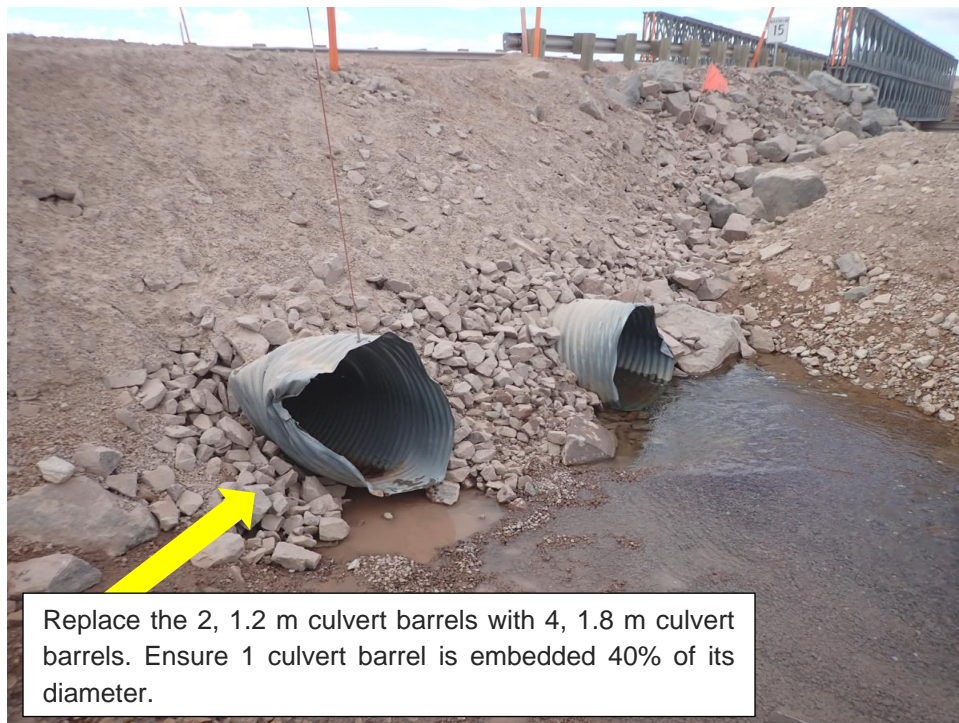
The existing water crossing was rated high risk as a barrier for fish passage (Appendix C).

**Photo B10.1 BG-50 Culvert Inlet**

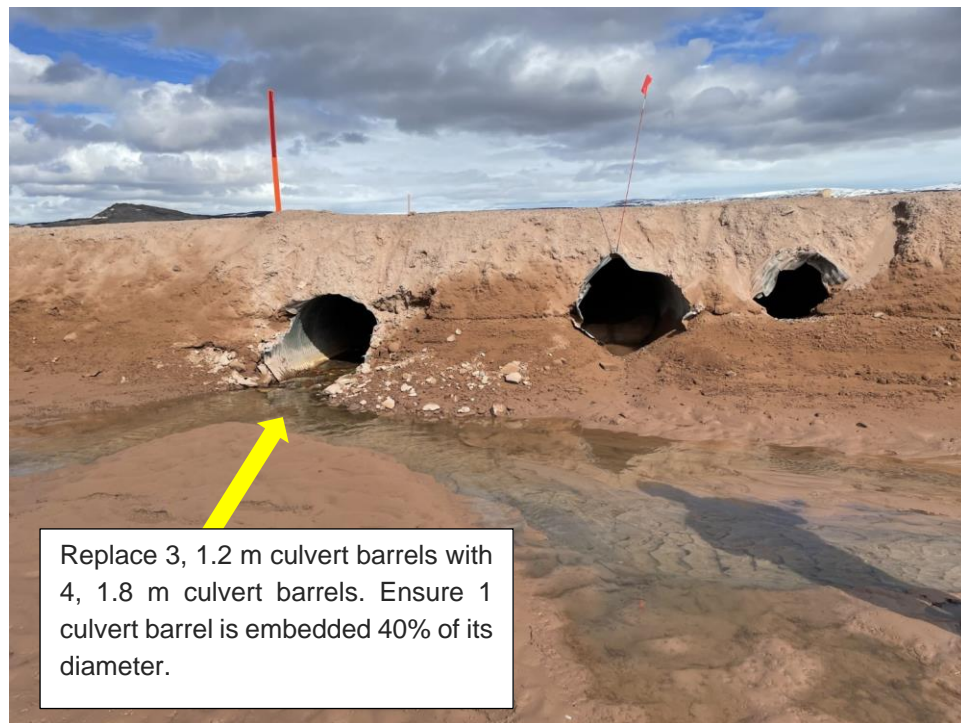
The existing water crossing was rated high risk result and was identified as a barrier to 88 mm Arctic Char passage. (Appendix C).

**Photo B11.1 CV-216 Culvert Inlet**

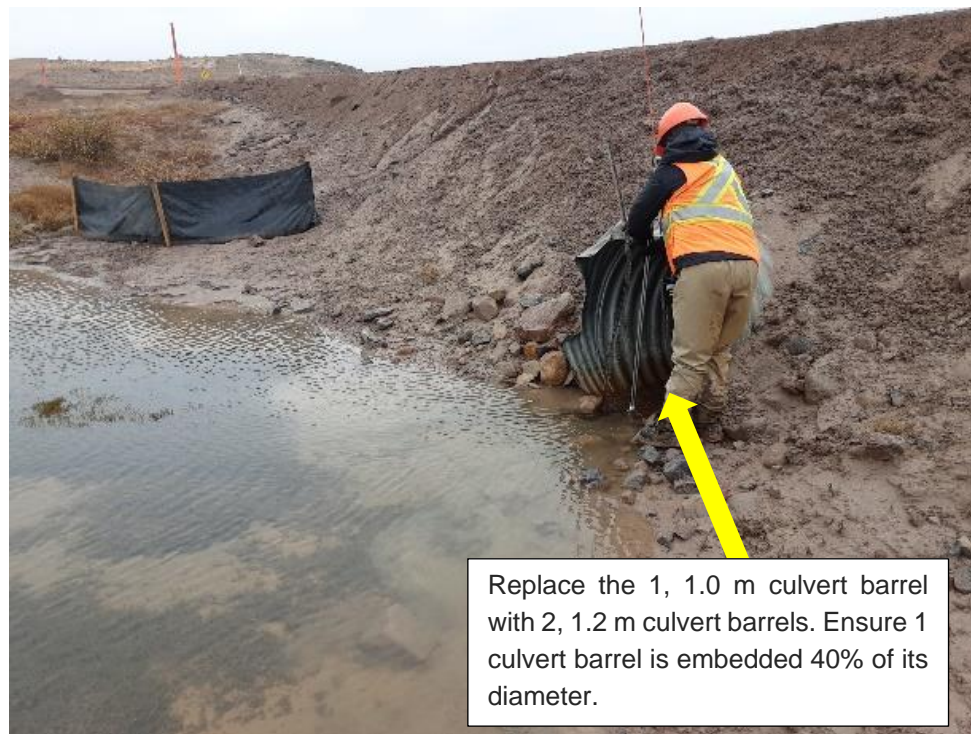
The existing water crossing was rated high risk for potential to be a barrier to fish movement (Appendix C).

**Photo B12.1 BG-30 Culvert Inlet**

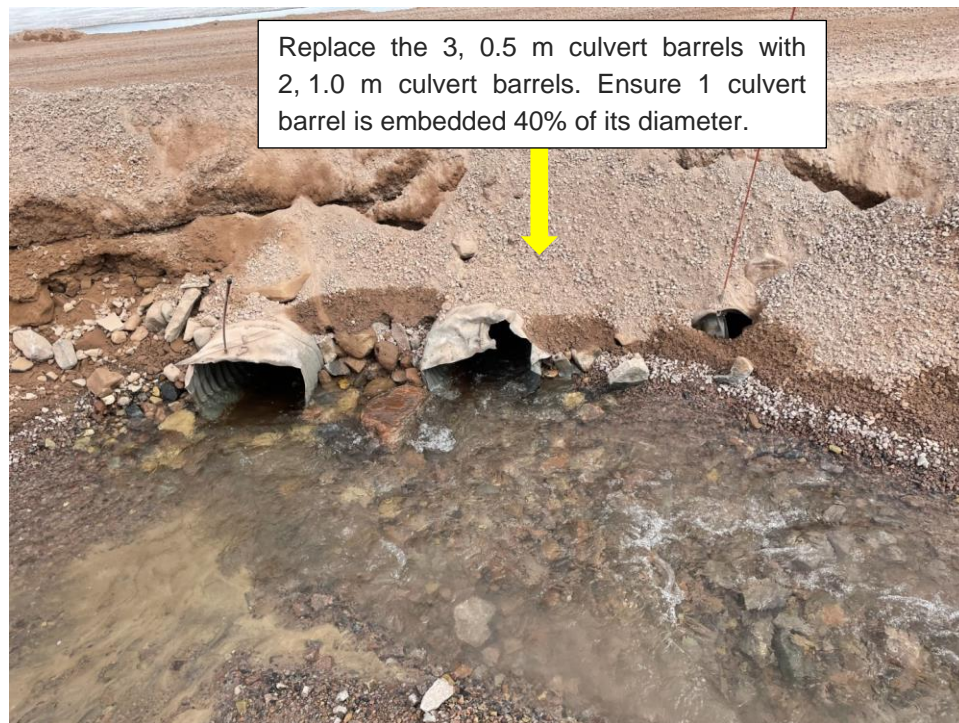
The existing water crossing was rate high risk result as a barrier for fish passage (Appendix C).

**Photo B13.1 BG-27 Culvert Inlet**

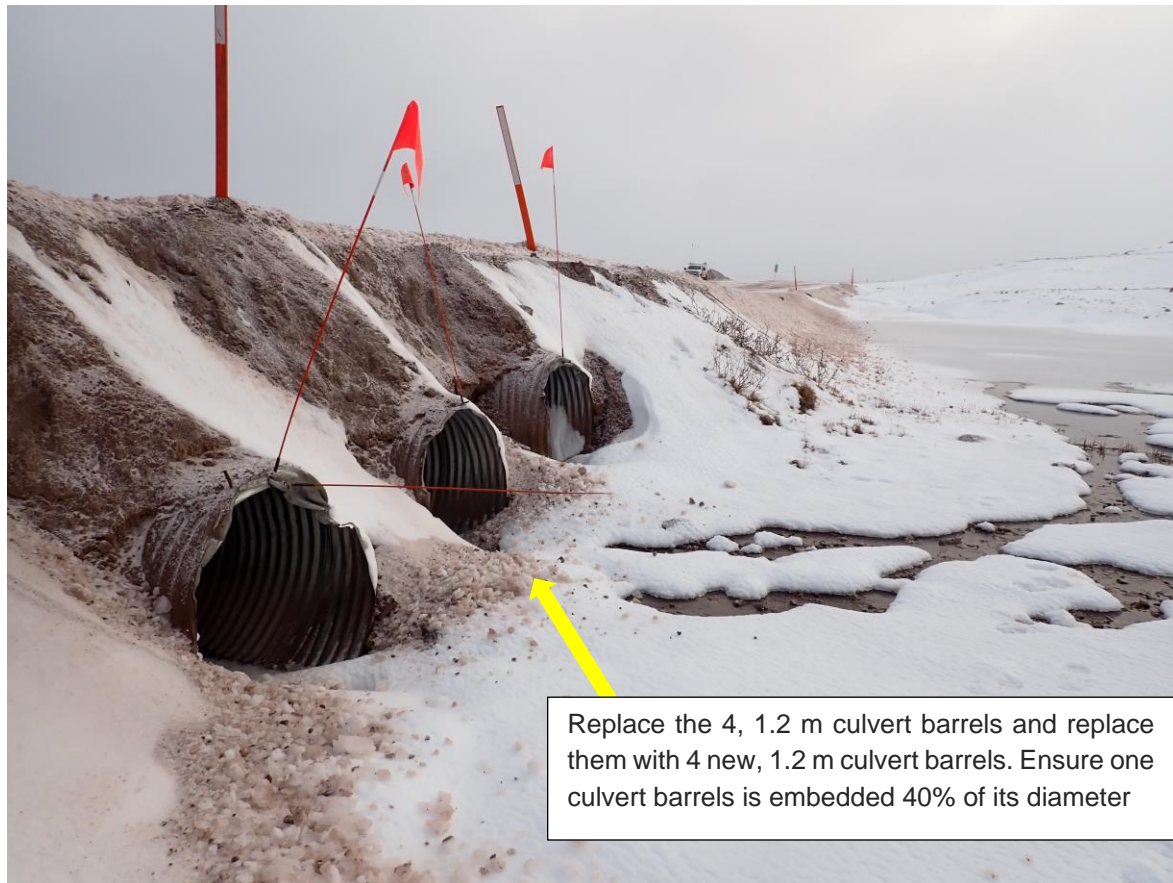
The existing water crossing at BG-24 was rated high risk as a potential barrier for fish movement (Appendix C).

**Photo B14.1 BG-24 Culvert Inlet**

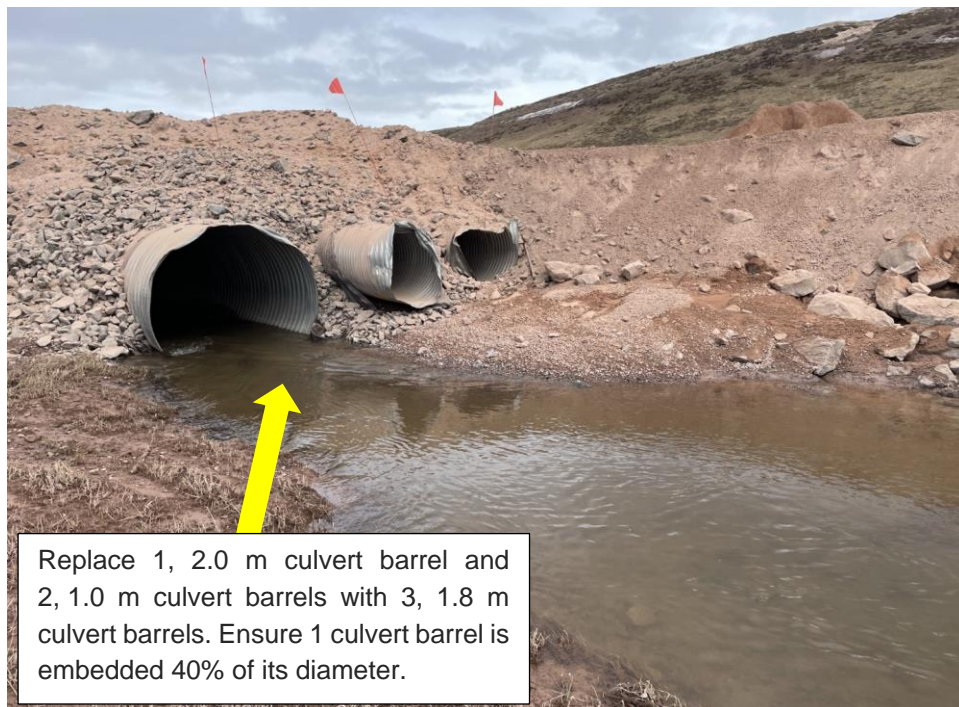
The water crossing at BG-17 was rated high risk as a barrier for fish passage (Appendix C).

**Photo B15.1 BG-17 Culvert Inlet**

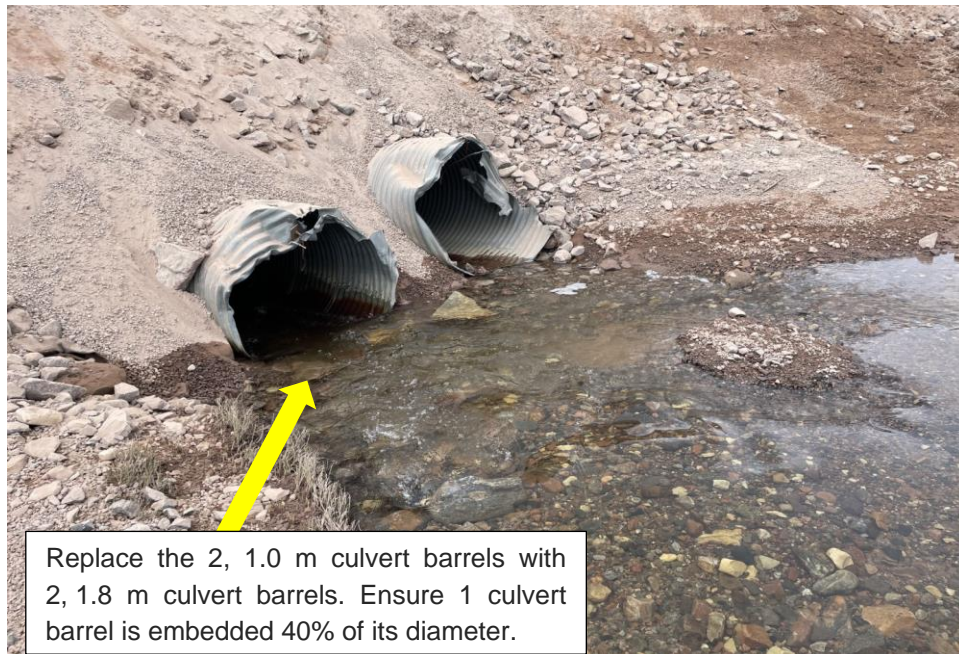
The existing water crossing was rated high risk as a barrier for fish passage (Appendix C).

**Photo B16.1 BG-04 Culvert Inlet**

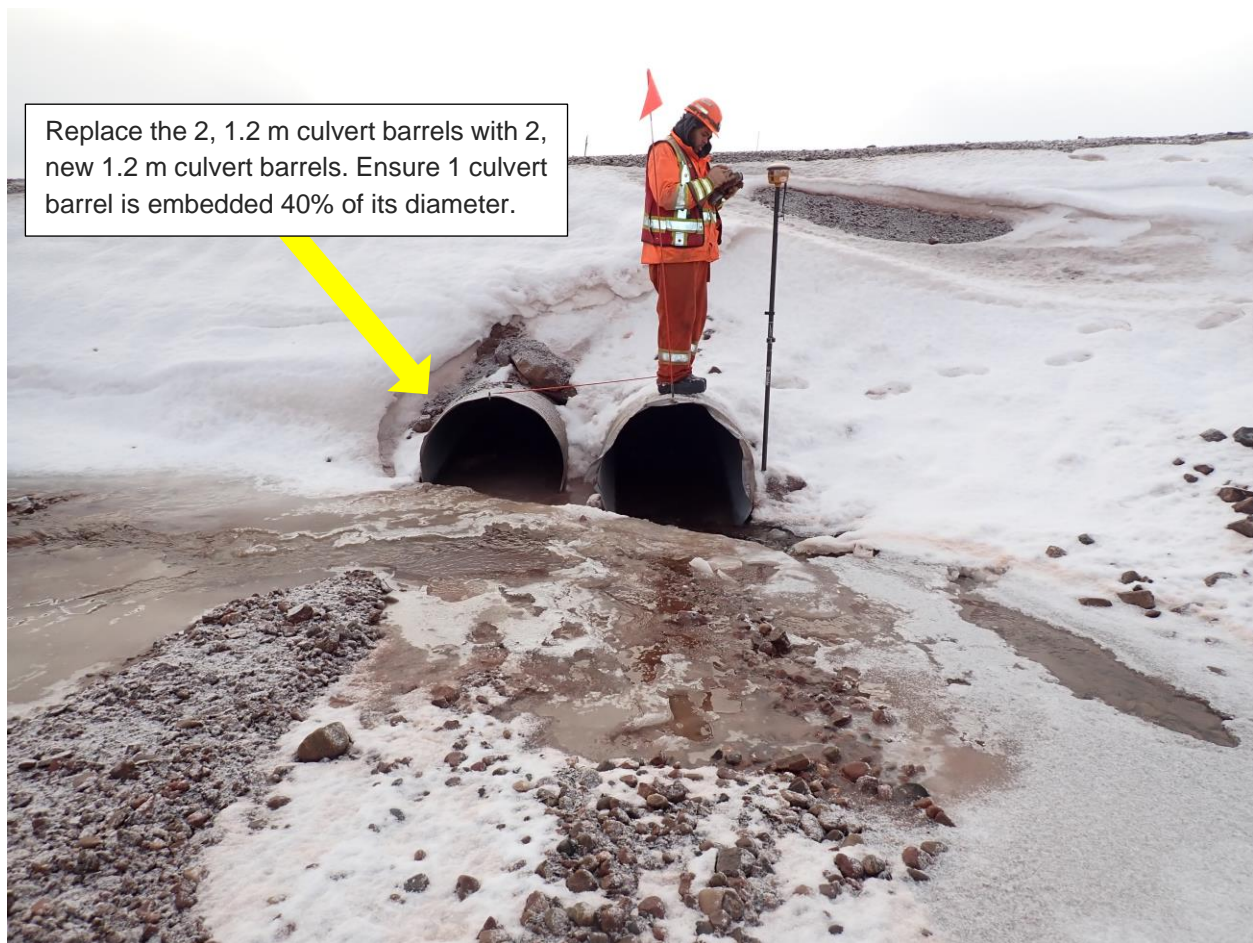
The existing water crossing at CV-224 was rated high risk for potential to be a barrier to fish movement (Appendix C).

**Photo B18.1 CV-224 Culvert Inlet**

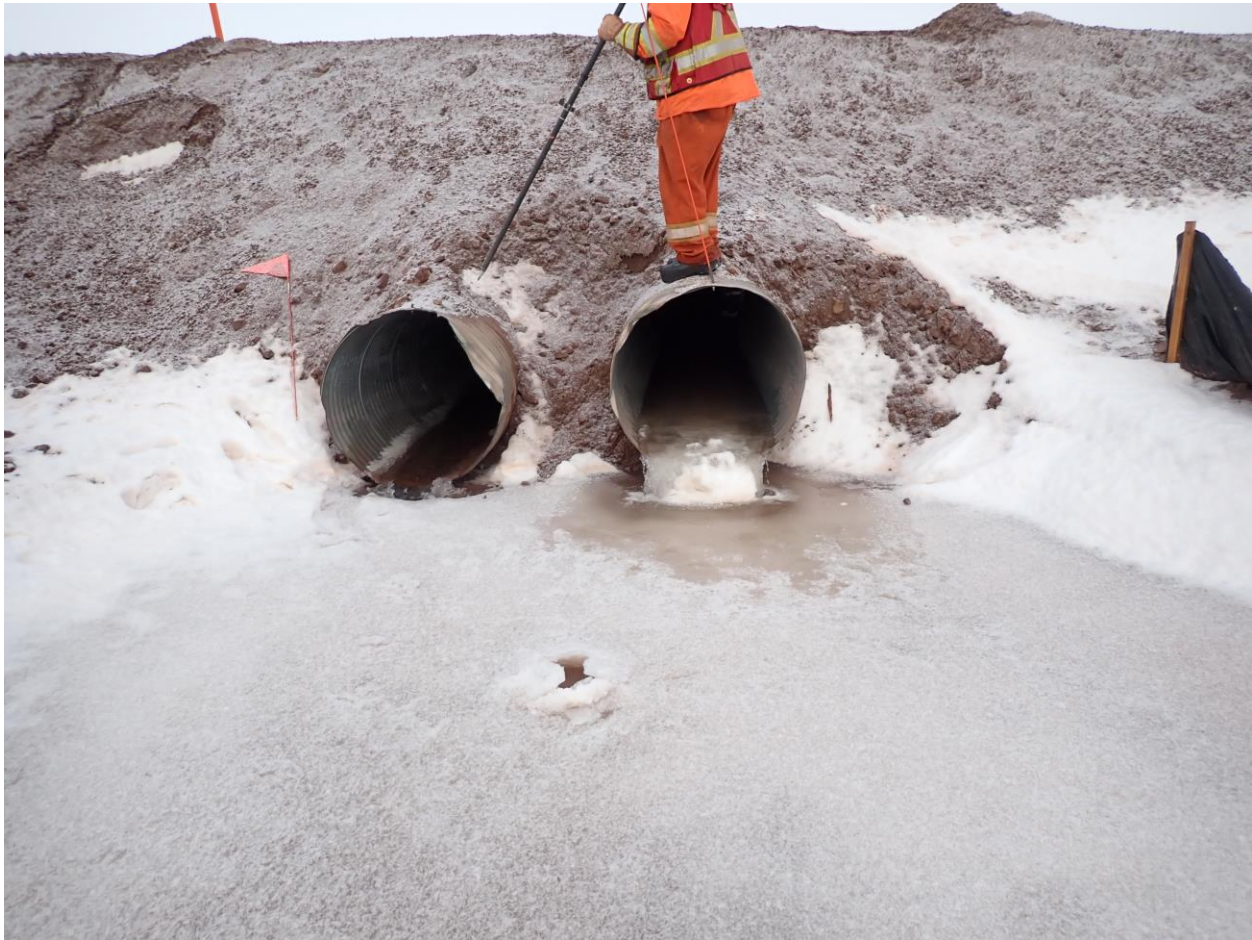
**Photo B18.2 CV-224 Culvert Outlet**

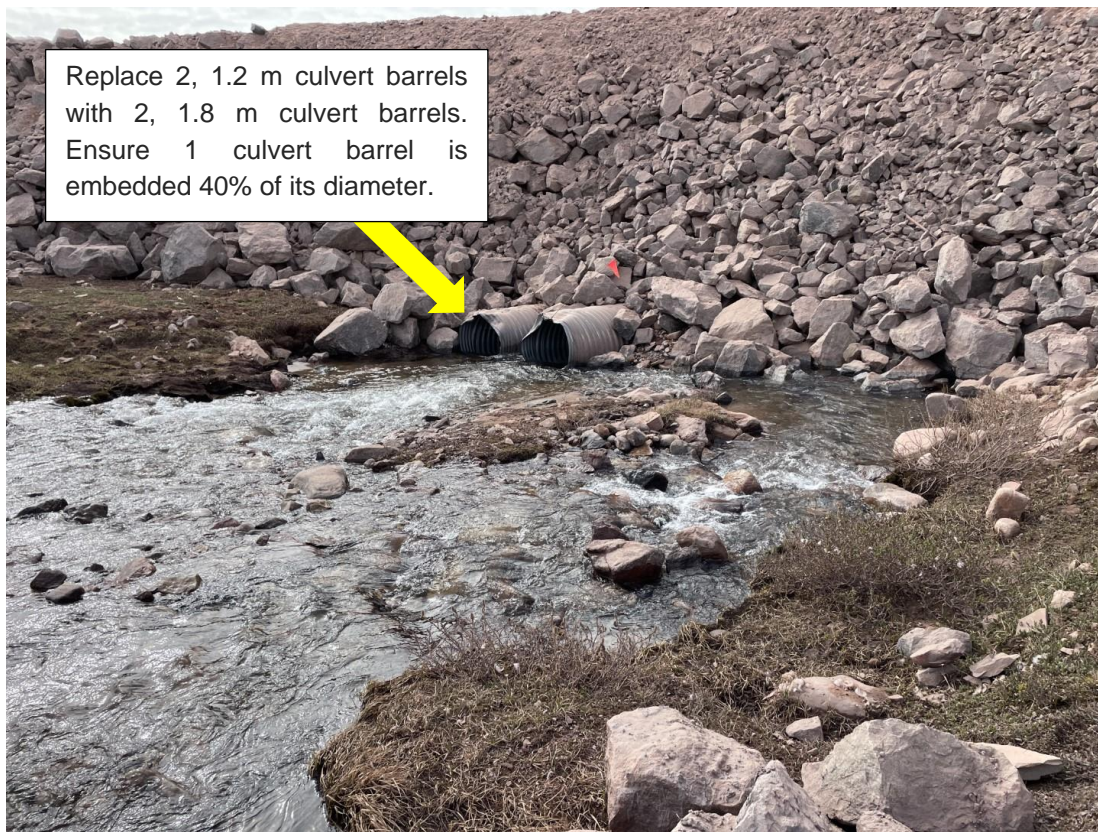
The existing water crossing was rated high risk as a barrier for fish passage (Appendix C).

**Photo B19.1 CV-225 Culvert Inlet**

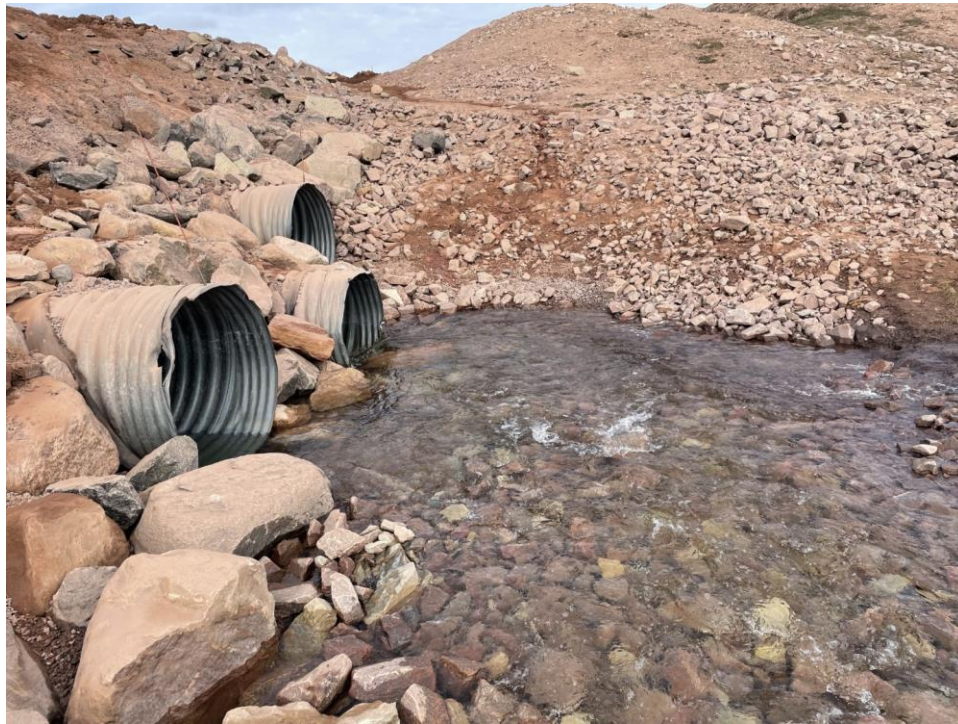
The existing water crossing was rated high risk as a barrier for fish passage (Appendix C).

**Photo B20.1 BG-01 Culvert Inlet**
