Re: Follow-up to Spill Reported on Oct 30th, 2013
Mary River Project - Water Licence No. 2AM-MRY1325

Summary:

On October 29th, 2013, at approximately 0005h, a leak of untreated sewage effluent was detected at the main lift station of the newly constructed accommodations facility at the Milne Port location. The breach was located about 12" from the top of the enclosed tank and was approximately four inches in diameter.

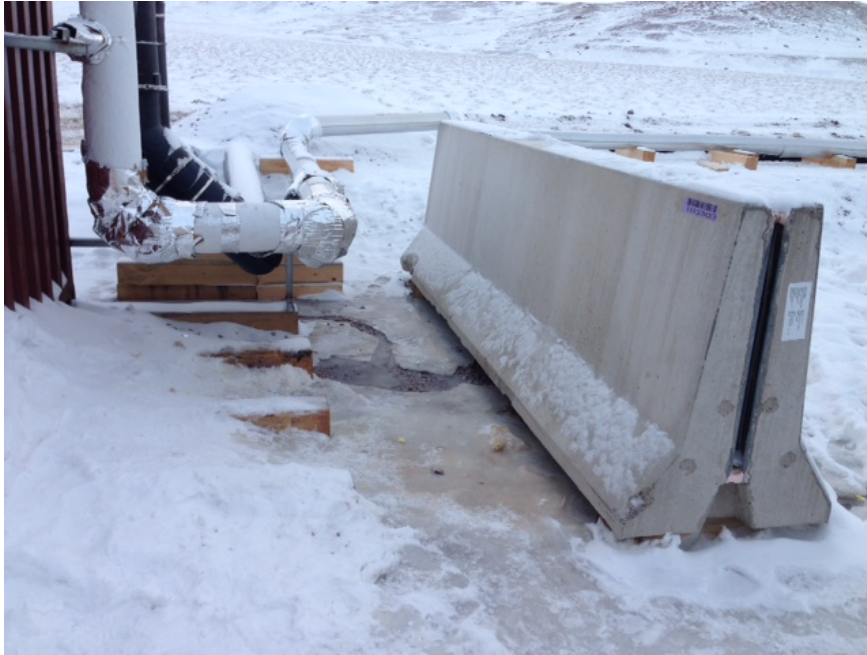
13 10 29 – Sewage Spill Behind Lift Station

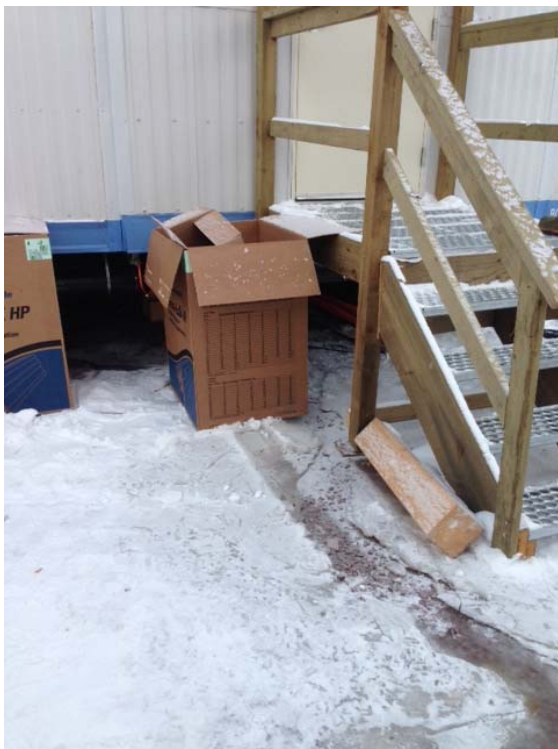
13 10 29 Sewage Spill Under Camp

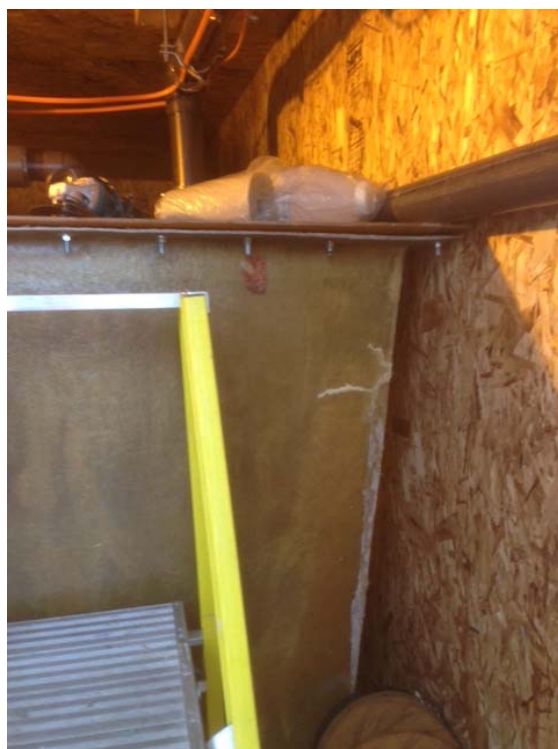
The cause of the breach is unknown, however, when the level of the tank reached the area of the hole, part of the tank "popped" out. The hole was securely, although temporarily, covered and will be repaired properly when fiberglass materials are delivered to site.

13 10 29 Tank Breach

Currently, we are awaiting hardener for the fiberglass repair.

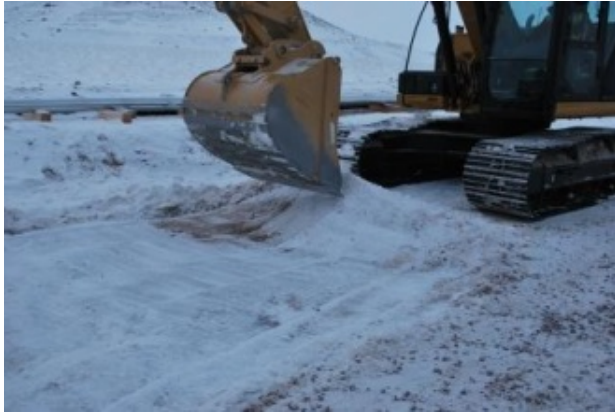
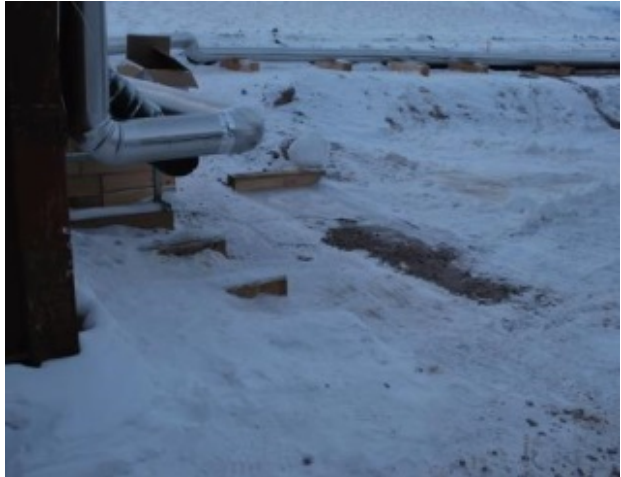
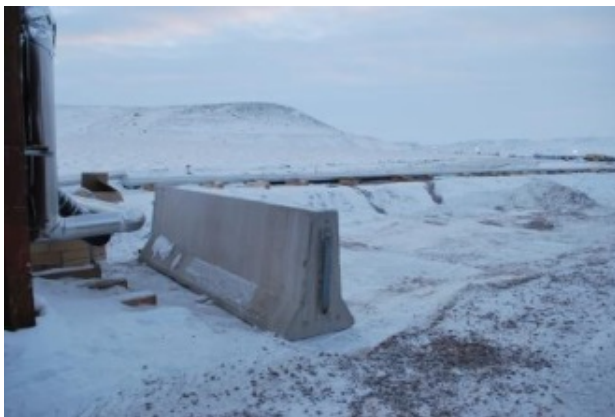
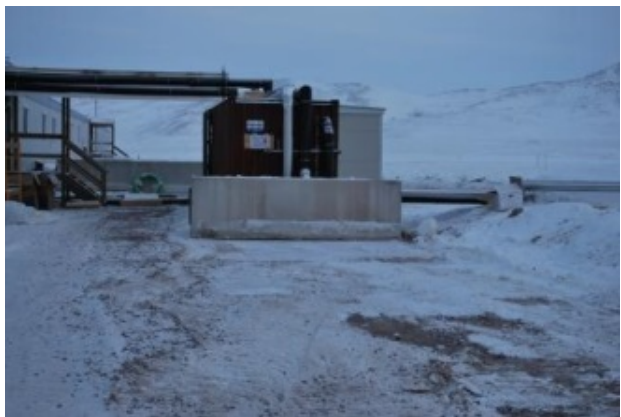
October 29th Lift Station Sewage Spill Cleanup

Personnel immediately acquired vacuum truck services to empty the tank. The primary lift station and the dorm lift stations were also cleaned out to ensure no further issues occurred throughout the night. The tank is being monitored regularly until it can be thoroughly inspected and repaired to ensure no further leakage. Approximately 500 litres was discharged to the adjacent land surface, with an approximate impacted area of 10 square meters. Frozen ground conditions limited the depth of soil contamination. The contaminated snow and untreated sewage effluent were transferred to the Milne Exploration Phase Sewage PWSP (MP-MRY-04a).
