**Re: Follow-up to Spill Reported on January 8, 2014**  
**Mary River Project - Water Licence No. 2AM-MRY1325**

## INVESTIGATION REPORT

**MARY RIVER PROJECT**

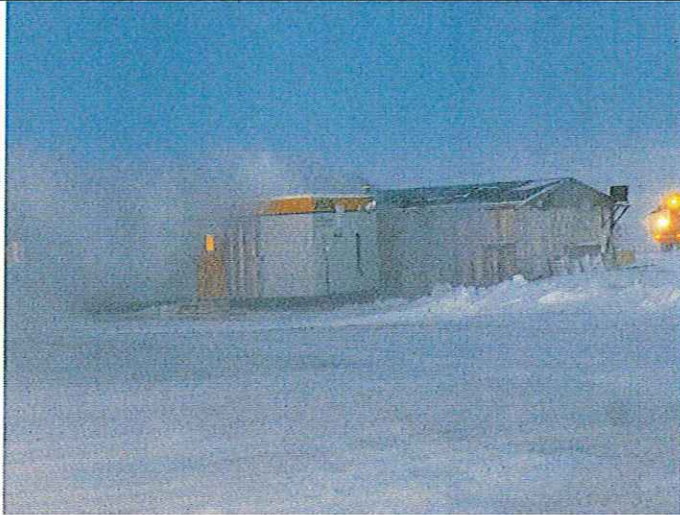
Fig. 1 12:46 – 8 minutes after Code 1 alert

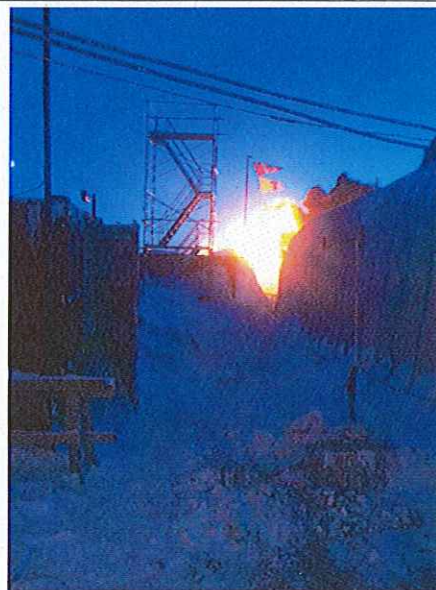
Fig. 2 13:01 – 23 minutes after Code 1 Alert

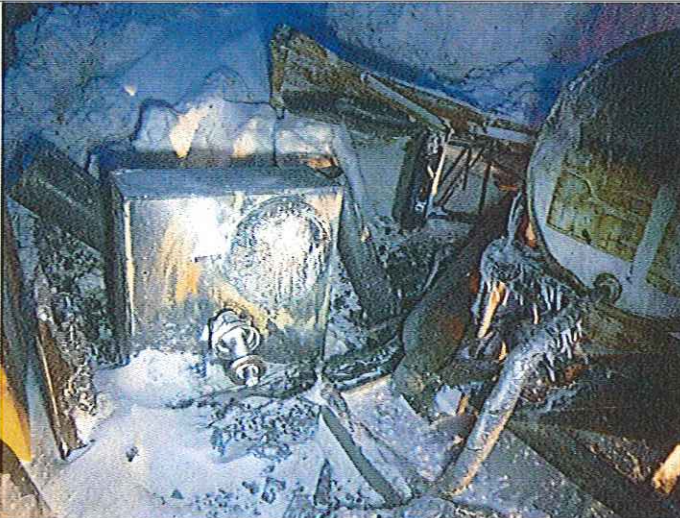
Initial causation indicates fire ignition source may not have been the oil furnace as originally thought. Ray Shipman (oil burner mechanic) upon interview believes the safety components of the current furnace prevent this.

Fig. 3 Oil furnace – January 8

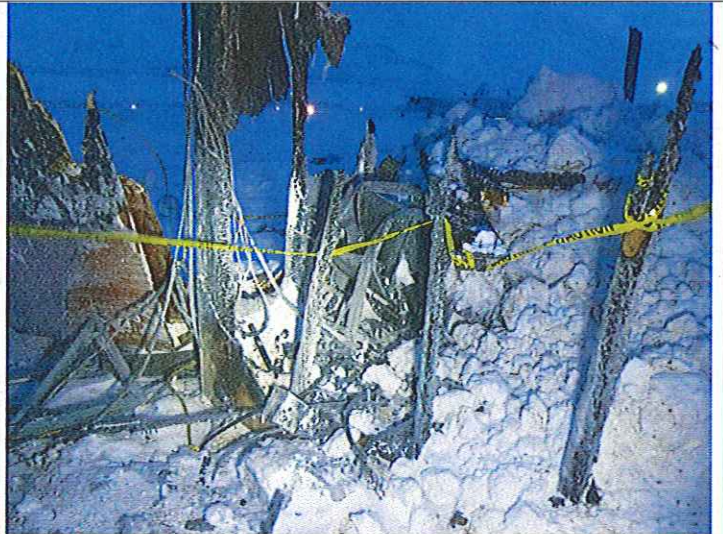
Fig. 4 East corner of Summit Air shack

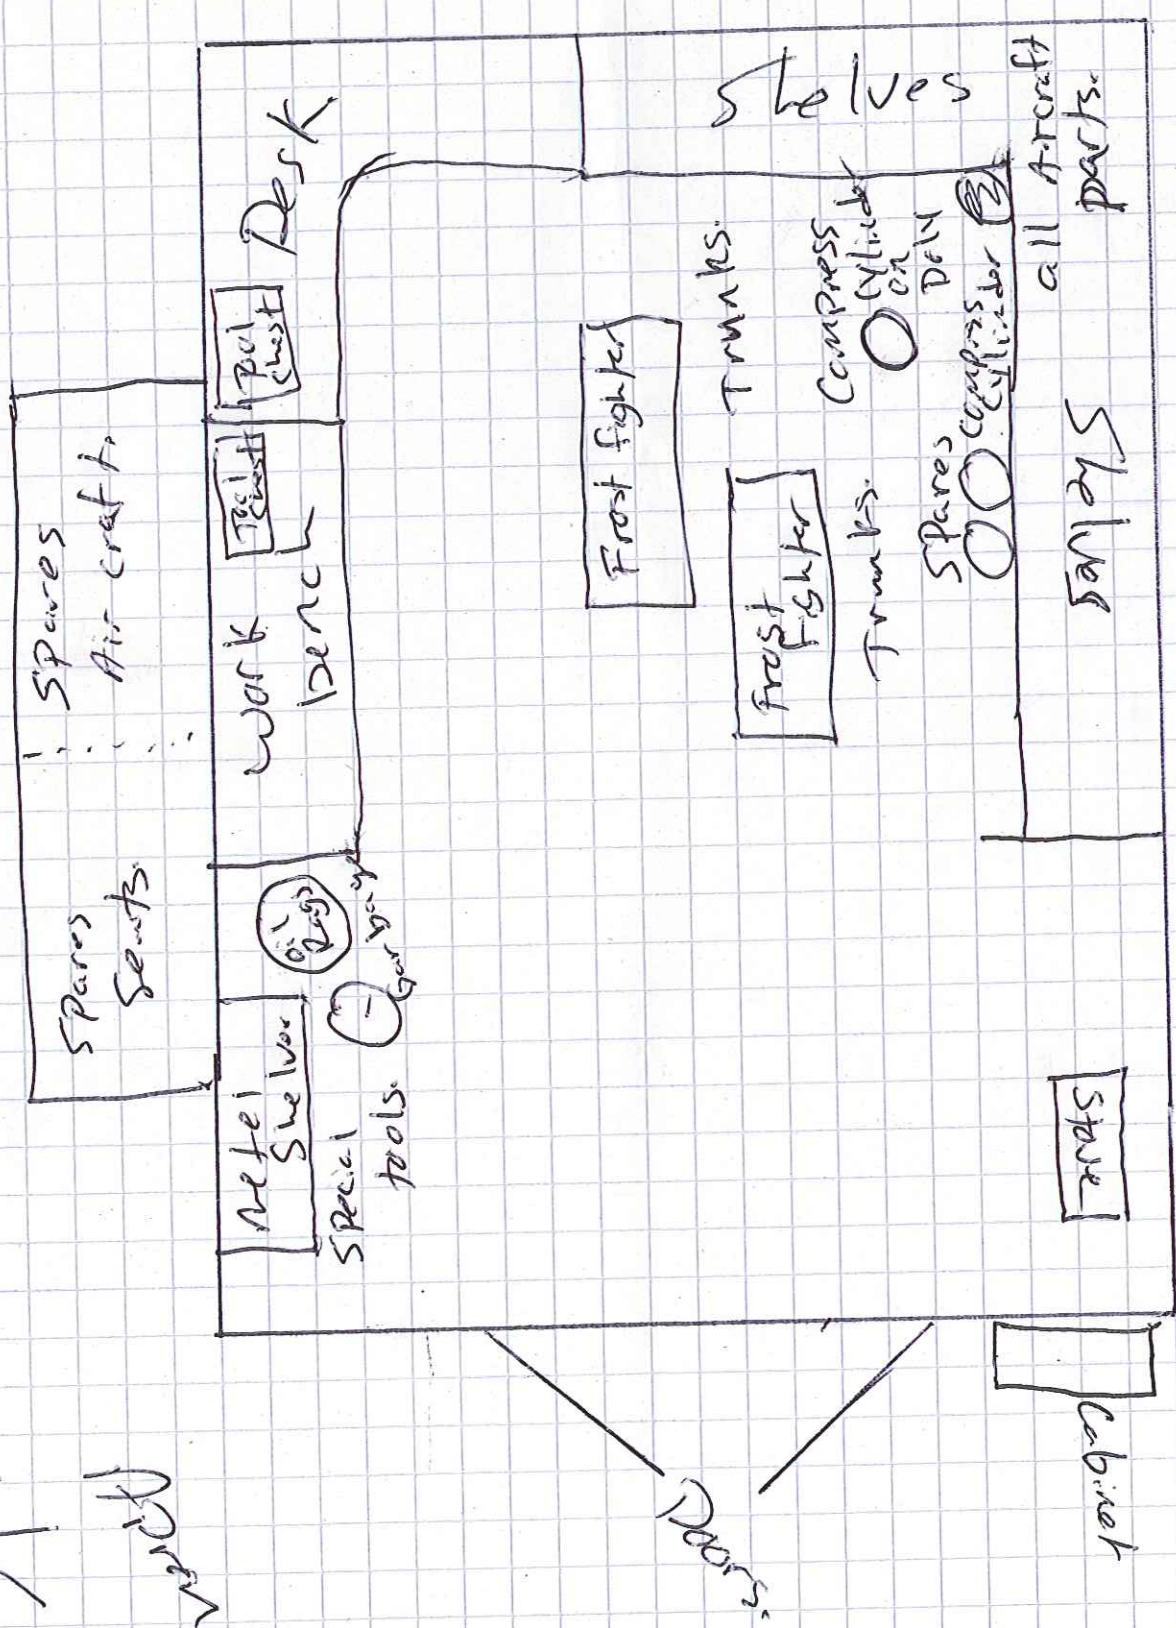
It is suspected that a near-by plug-in powering the fox cart (battery charger) (see Jim Vissers shack diagram) and heat trace for the oil supply may be the ignition source. Nearby flammables and combustibles supported the fire until the frost-fighters' diesel supply ignited which accelerated the blaze engulfing the interior of the shack.
