Re: Follow-up to Spill Reported on Mar. 7, 2013
Mary River Project - Water Licence No. 2AM-MRY1325

Summary:

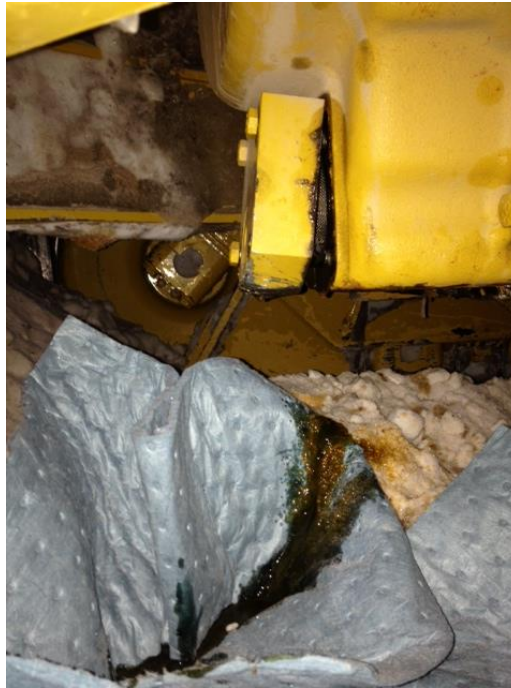
On March 6, 2014 at approximately 23:00, a D6 bulldozer was working in the area of KM 77 of the Tote Road. The operator was traveling over a snow covered portion of the area when the machine hit a large rock that was not visible due to the snow cover. The rock sheared off the transmission's inspection port cover, in turn causing the transmission oil to drain out (Photo 1). The conservative estimate of the spill volume is approximately 120 liters and impacted an approximate area of roughly 3 square meters.

Photo 1: Sheared Inspection Port Cover

Recommendations have been made to the operators that when travelling into new, snow covered areas for the first time they travel forward with the blade as low as possible to avoid striking snow covered boulders with the machines' undercarriage.

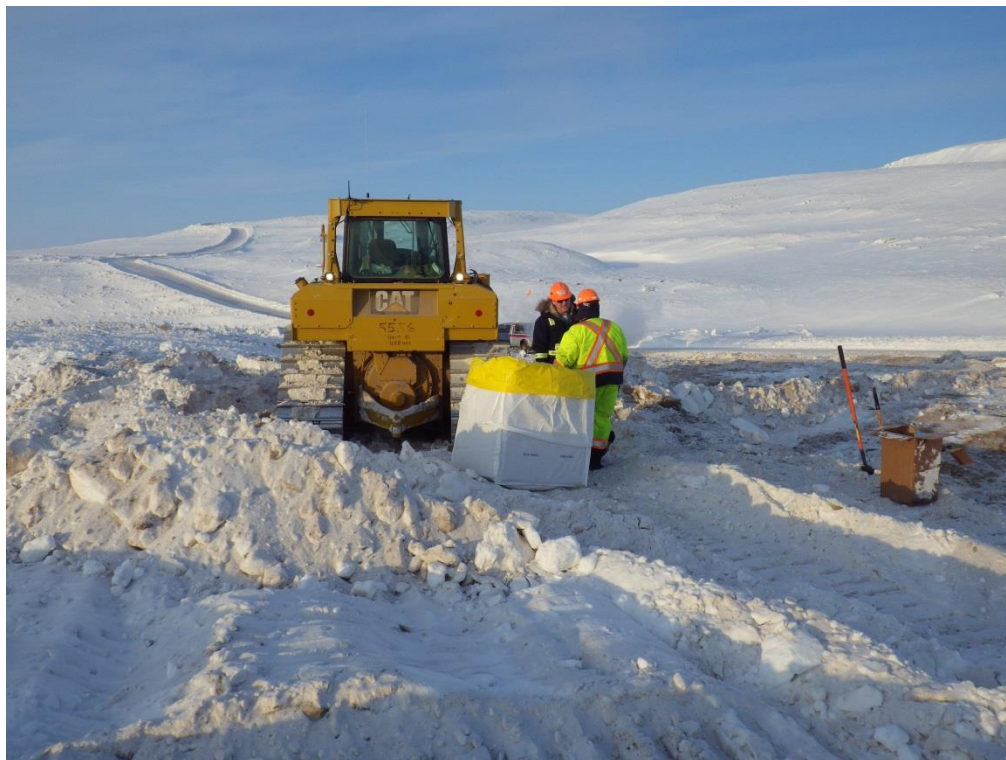
Photo 2: Spill Clean Up

The machine was shut down immediately and the spill was contained and cleaned up. All of the contaminated snow was collected and placed into a lined quatex bag (Photo 2). The quatex bag was brought back to the Mine Site and has been placed in lined secondary containment. It will be transferred to an overpack drum where it will melt out in the spring and then will be processed as part of our oily water treatment process this coming summer season. Once the machine was moved off the rock, the area was inspected further to ensure that all of the contaminated snow was captured (Photo 3).

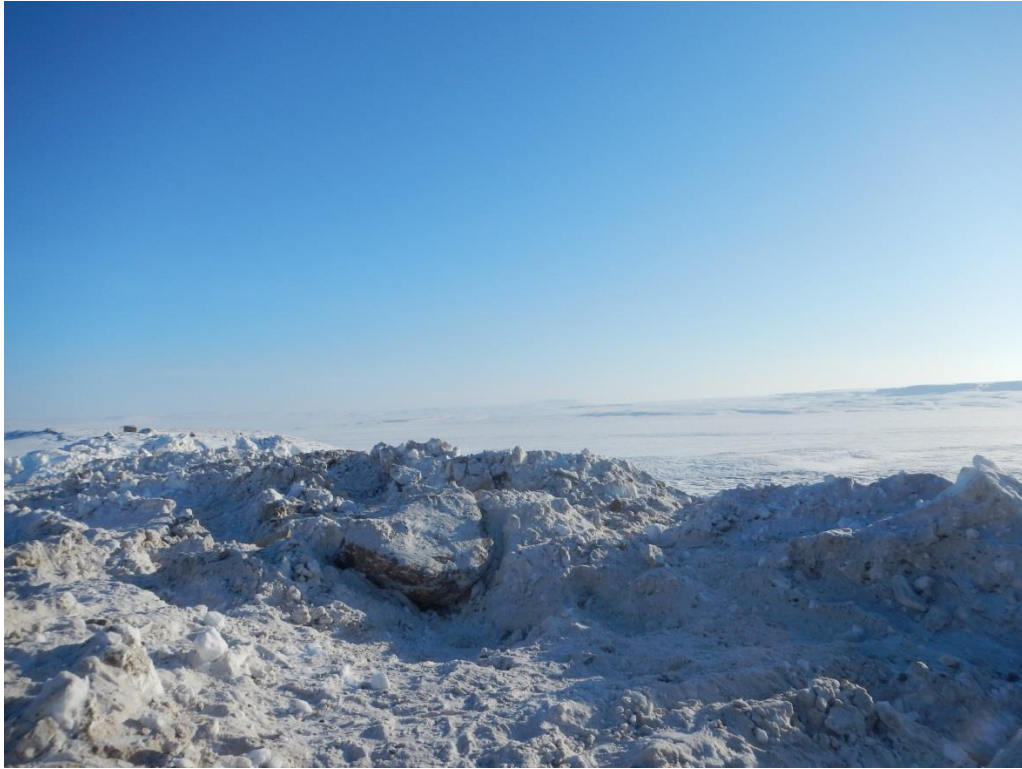
Photo 3: Area after clean-up
