Re: Follow-up to Spill Reported on April 7th, 2014
Mary River Project - Water Licence No. 2AM-MRY1325

Summary:

NT-NU SPILL REPORT

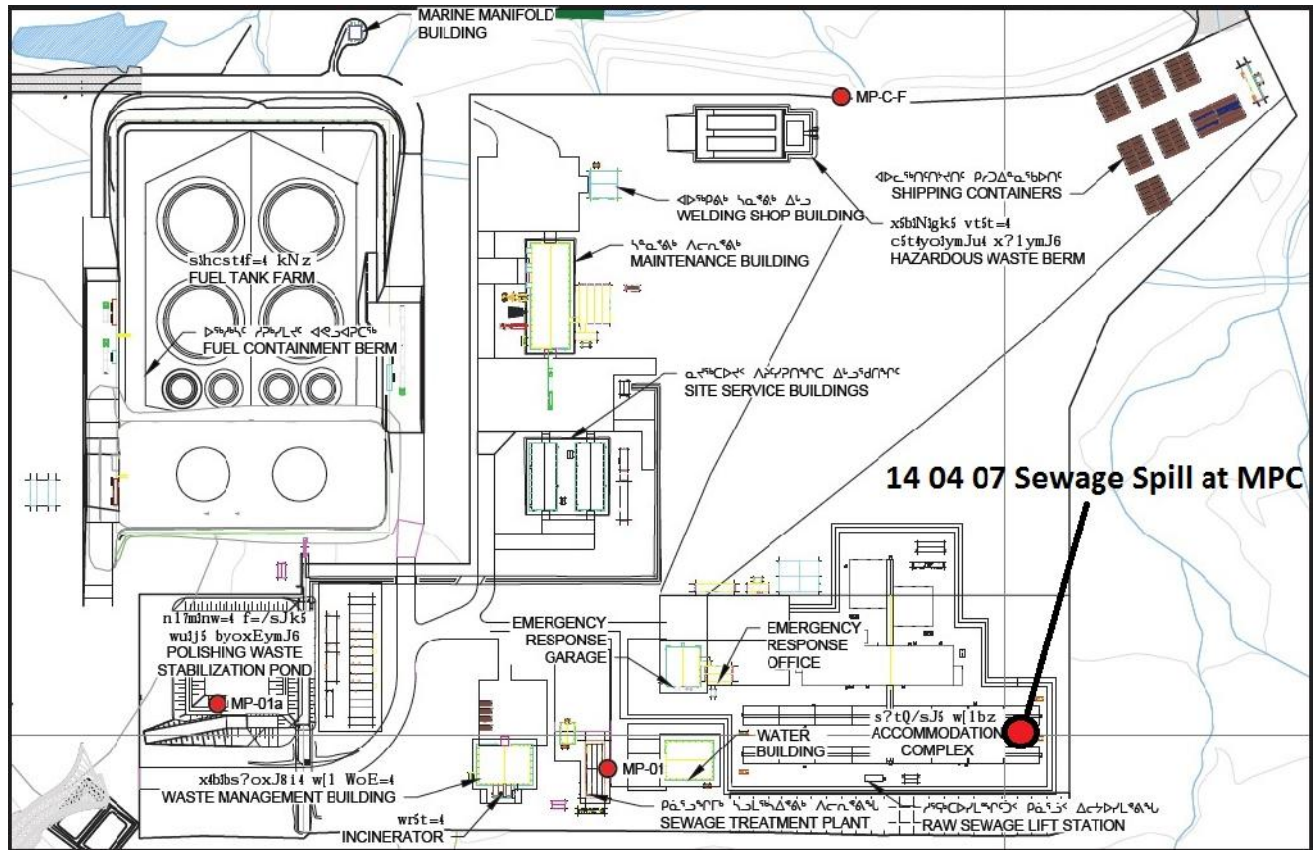
Figure 1: Location of Sewage Spill at MPC April 7, 2014

On Monday April 7, 2014, at approx. 06:30 HRS, ice and discoloured snow were observed under the sewage return line from one wing of the accommodations building. The situation was immediately reported and the Environmental Superintendent together with Site Services Department investigated and discovered that one or more joints on a section of the sewage return line had failed and were leaking. The sewage line was immediately taken out of commission for repairs. The leakage was not immediately detected due to the location of the line which is underneath the building as well as the snow cover on the ground. Estimates of the volume of sewage spilled were between 2 and 3 m³, based on the estimated impacted area of approximately 50 m². Cleanup of the sewage is not possible at the present time due to the inaccessibility of the location. The spill poses no immediate environmental or health risk.

Camp Maintenance crew located the leak and identified that it is a poor installation joint. Site services cleared out as much of the snow and ice as practical due to the location, investigated and repaired the joint.

All sewage lines are in progress of being investigated. Agricultural lime will be ordered and applied to the area during thaw to control odours and pathogens. The run-off water quality from the camp pad will be monitored, particularly during freshet, at Water Licence Monitoring locations.
