Submission Date: May 21, 2014

**Re: Follow-up to Diesel Spill Reported on April 20, 2014**  
**Mary River Project - Water Licence No. 2AM-MRY1325**

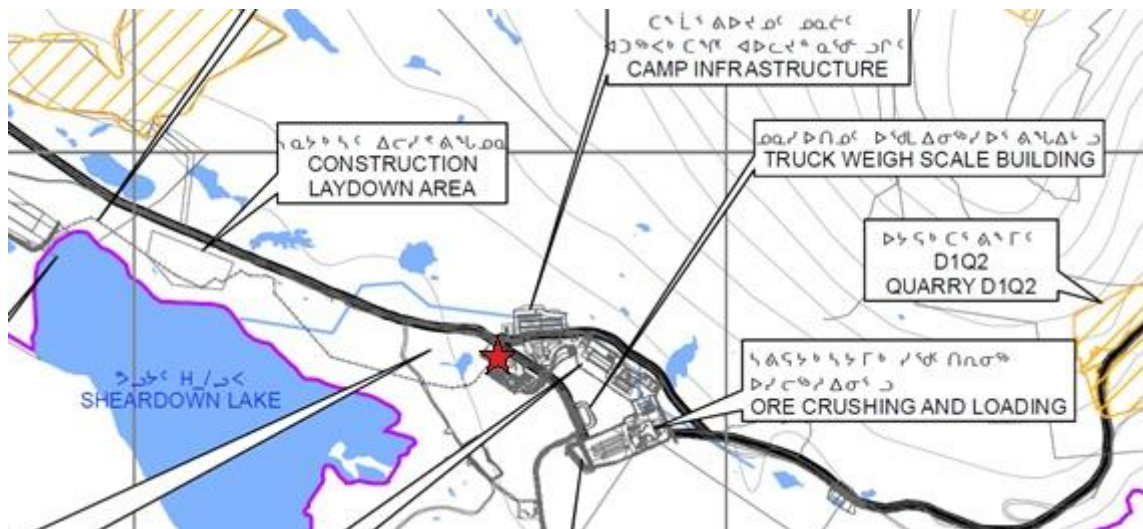
On April 20, 2014, at 6:00 hrs. Tanker Trucks were offloading P-50 diesel to the #4 – 500,000 litre tank of the Mine site Tank Farm. After completion of the offload, fuel was observed running down the side of the tank and into the engineered lined containment facility.

Figure 1 – Spill Location (N 71° 18' 49" W 79° 17' 06")

Tanks to be monitored on a daily basis, with checks by operators at each transfer.  
Install high level shutoffs.  
Install signage to indicate active tanks for dispensing and offloading.  
Perform audit of all fuel handling activities.
