Re: Follow-up to Spill 14-137 Reported on May 6th, 2014 Mary River Project - Water Licence No. 2AM-MRY1325

Summary:

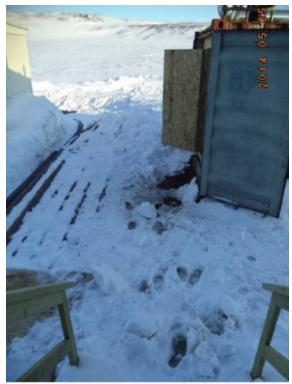
Figure 1. Snow Melt on Surface

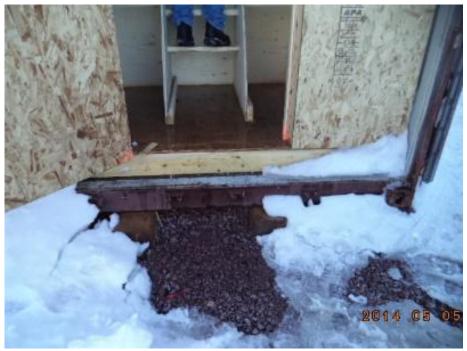
At approximately 20:40 HRS on May 5, 2014 a leak was detected at the main lift station of the Milne Port Complex. It appeared that a previously repaired breech in the tank failed again. An estimated 200 litres was discharged to the adjacent land surface, with an approximate impacted area of 8 square metres.

Figure 2. Sewage leak from Main Lift Station

This being the second incident related to the breech in the tank, the recommendation is to replace the tank with a new one.
