Re: Follow-up to Spill 14-189 Reported on May 31st, 2014 Mary River Project - Water Licence No. 2AM-MRY1325

Summary:

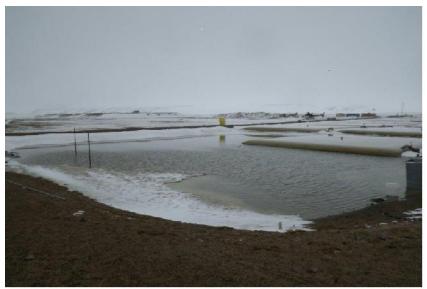
Photo 1: View from northwest end of facility, open water with floating product layer between 2-4 cm. 430 pm May 31.

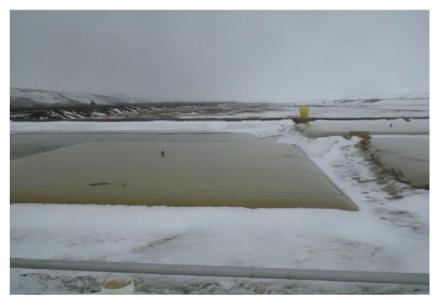
Photo 2: View from northwest end of facility looking southeast. Note bladders with snow/ice entrainment, making observation and inspection difficult. 430 pm May 31

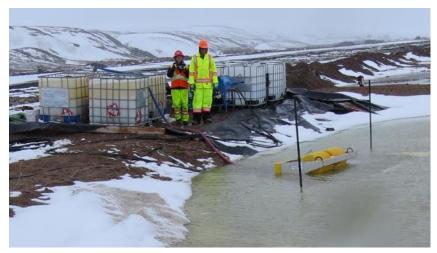
Photo 3: View of south end of facility, using drum skimmer to remove product. Operation conducted on a liner that drains back to the facility. June 1.

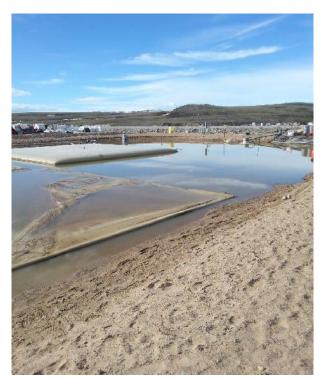
Photo 4: View of north end of facility on June 28, bladders no longer underwater allowing access bladders to view remaining fuel and to inspect.

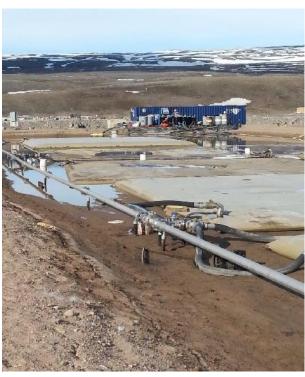
View of north end of facility showing oily water treatment plant and low levels of water and bladders remaining in facility. June 28.

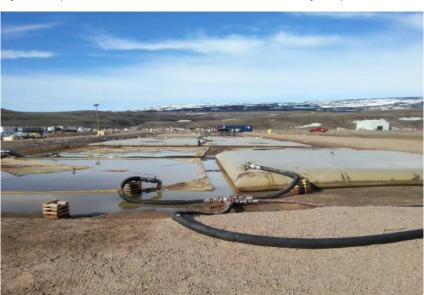
Photo 6: View from south end of facilty looking north showing low water levels and low volumes of fuel remaining in bladders. Only bladder remaining in use is a single Jet A bladder which is closely monitored.
