Re: Follow-up to Spill 14-240 Reported on June 26th, 2014
Mary River Project - Water Licence No. 2AM-MRY1325

Summary:

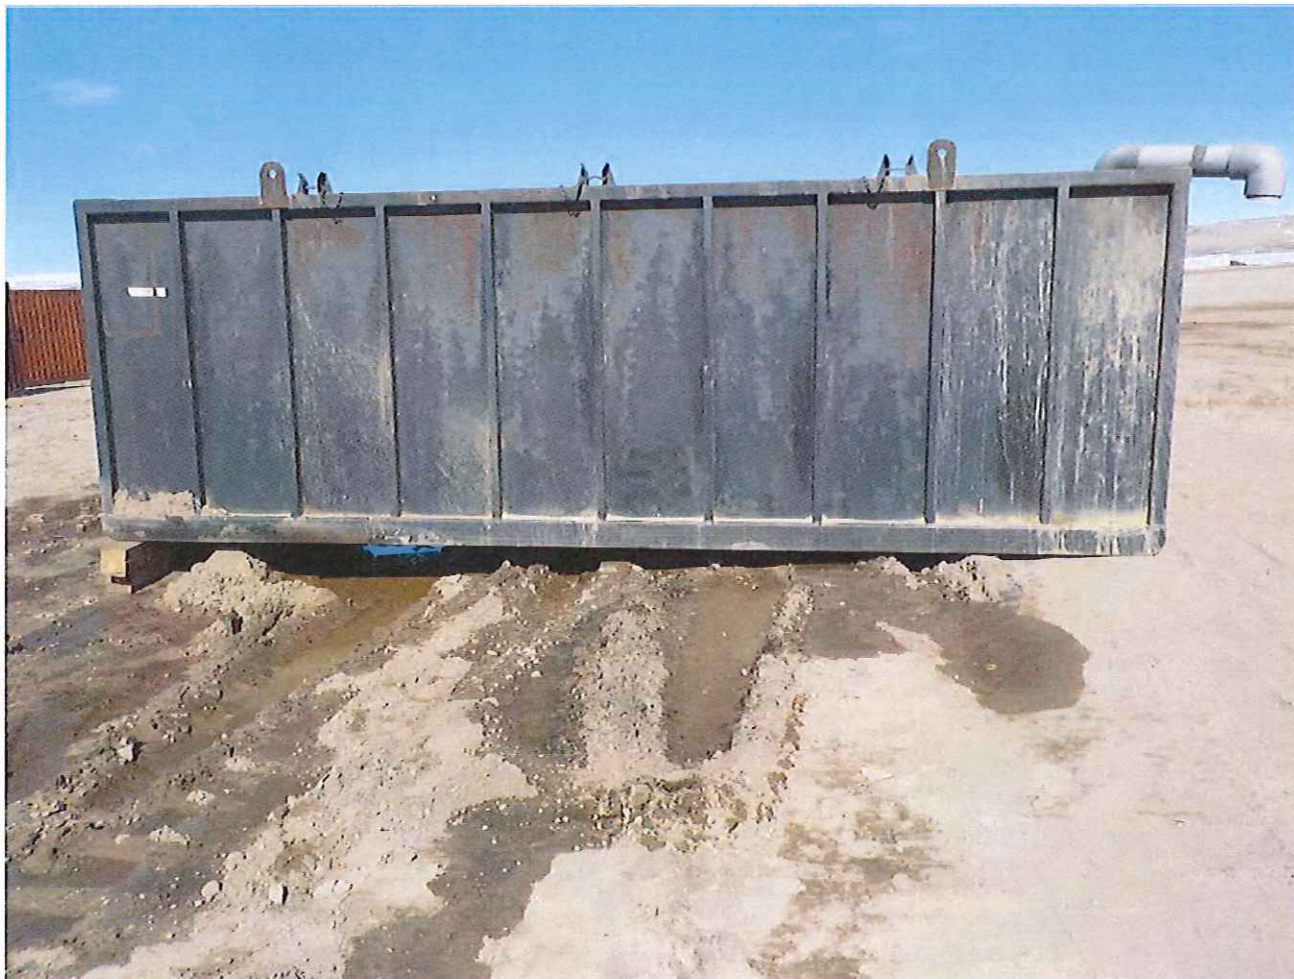
Figure 1: DAF Tank at Location after Release of Oily Water

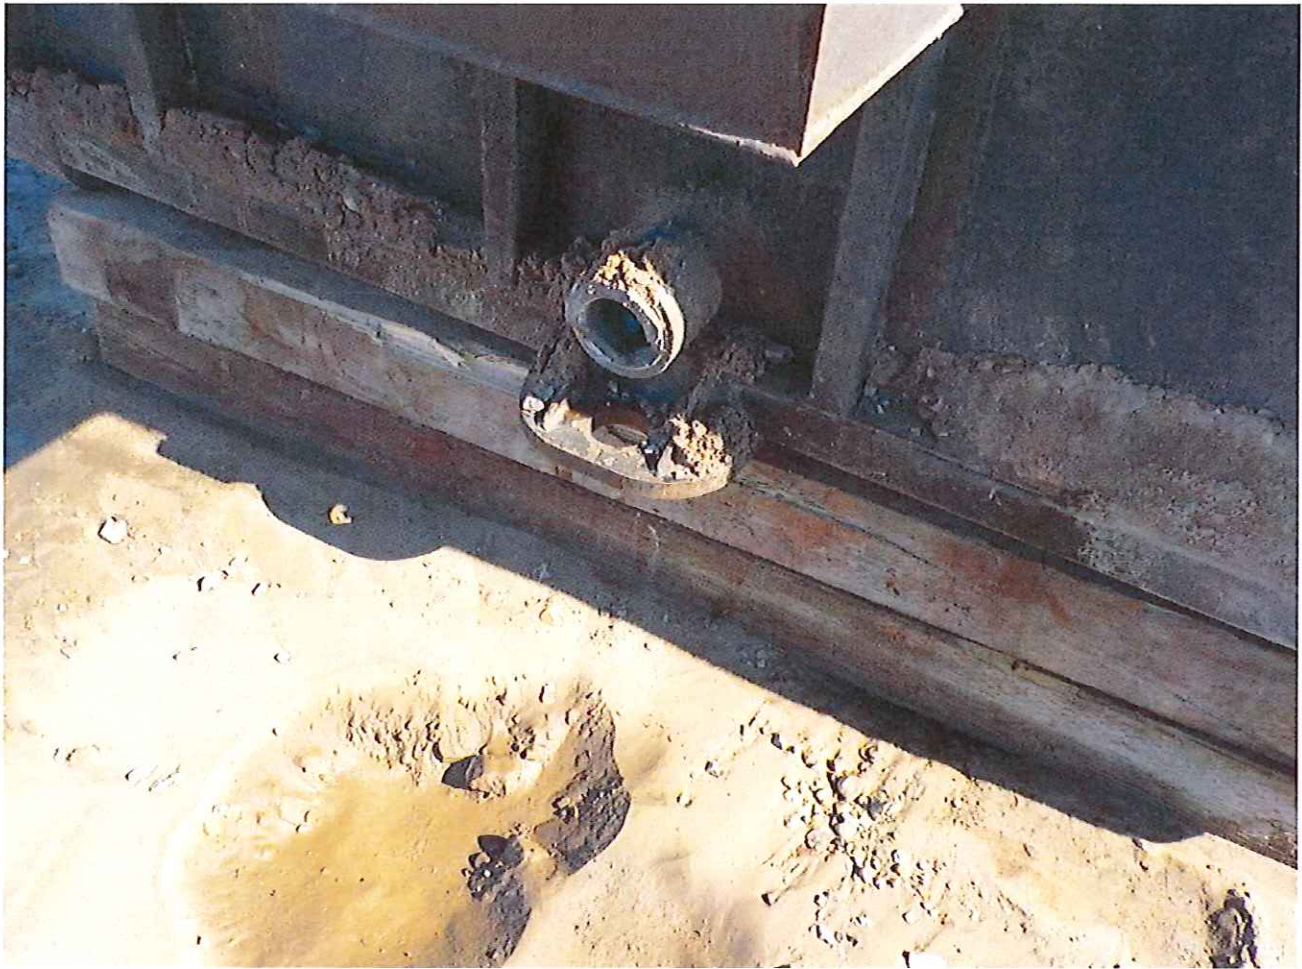
The cause of the release was the rupture of the discharge pipe located at the bottom of one side of the tank. The release spilled to the sand/gravel ground. When the operator moving the tank noticed the spill, movement of the tank ceased and the tank was immediately placed on an incline with the discharge upgrade to maintain some material within the tank, thus preventing the release of remaining water downgrade. The spill area was flagged off and the minor volume of free product present was collected by means of absorbent pads and shop vac.

Figure 2: Broken Discharge Pipe (Source of Release of Oily Water)

After the release, Baffinland implemented strict instructions for the completion of a more throughout inspection of all containers containing hazardous waste prior to intra and inter site movements. Such inspections shall be completed to assess the risks associated with the release of their contents to the surrounding environment and shall include inspections of container integrity (breaks/faults in container walls), loose hoses/pipes/valve fittings connected to the container, and the method of securing the container to the moving vehicle prior to transit to assess the risk of the container becoming dismounted en route.

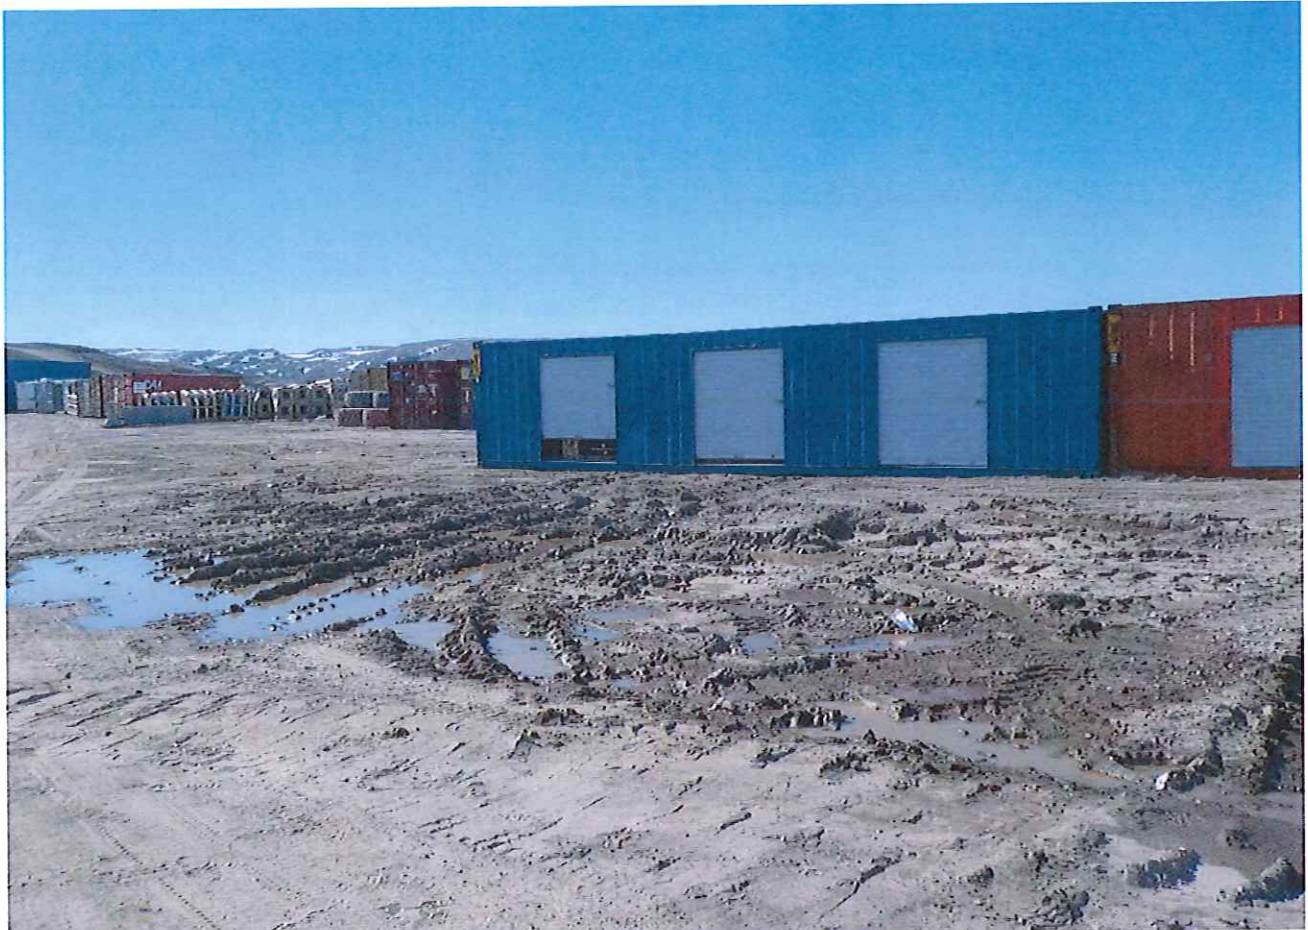
The area and extent of hydrocarbons present will be confirmed pending a limited soil assessment of the impacted area.

Figure 3: Oily Water Release Area, This Area Will Undergo Soil Sampling and Assessment
