Re: Follow-up to Spill 14-237 Reported on June 25th, 2014
Mary River Project - Water Licence No. 2AM-MRY1325

Summary:

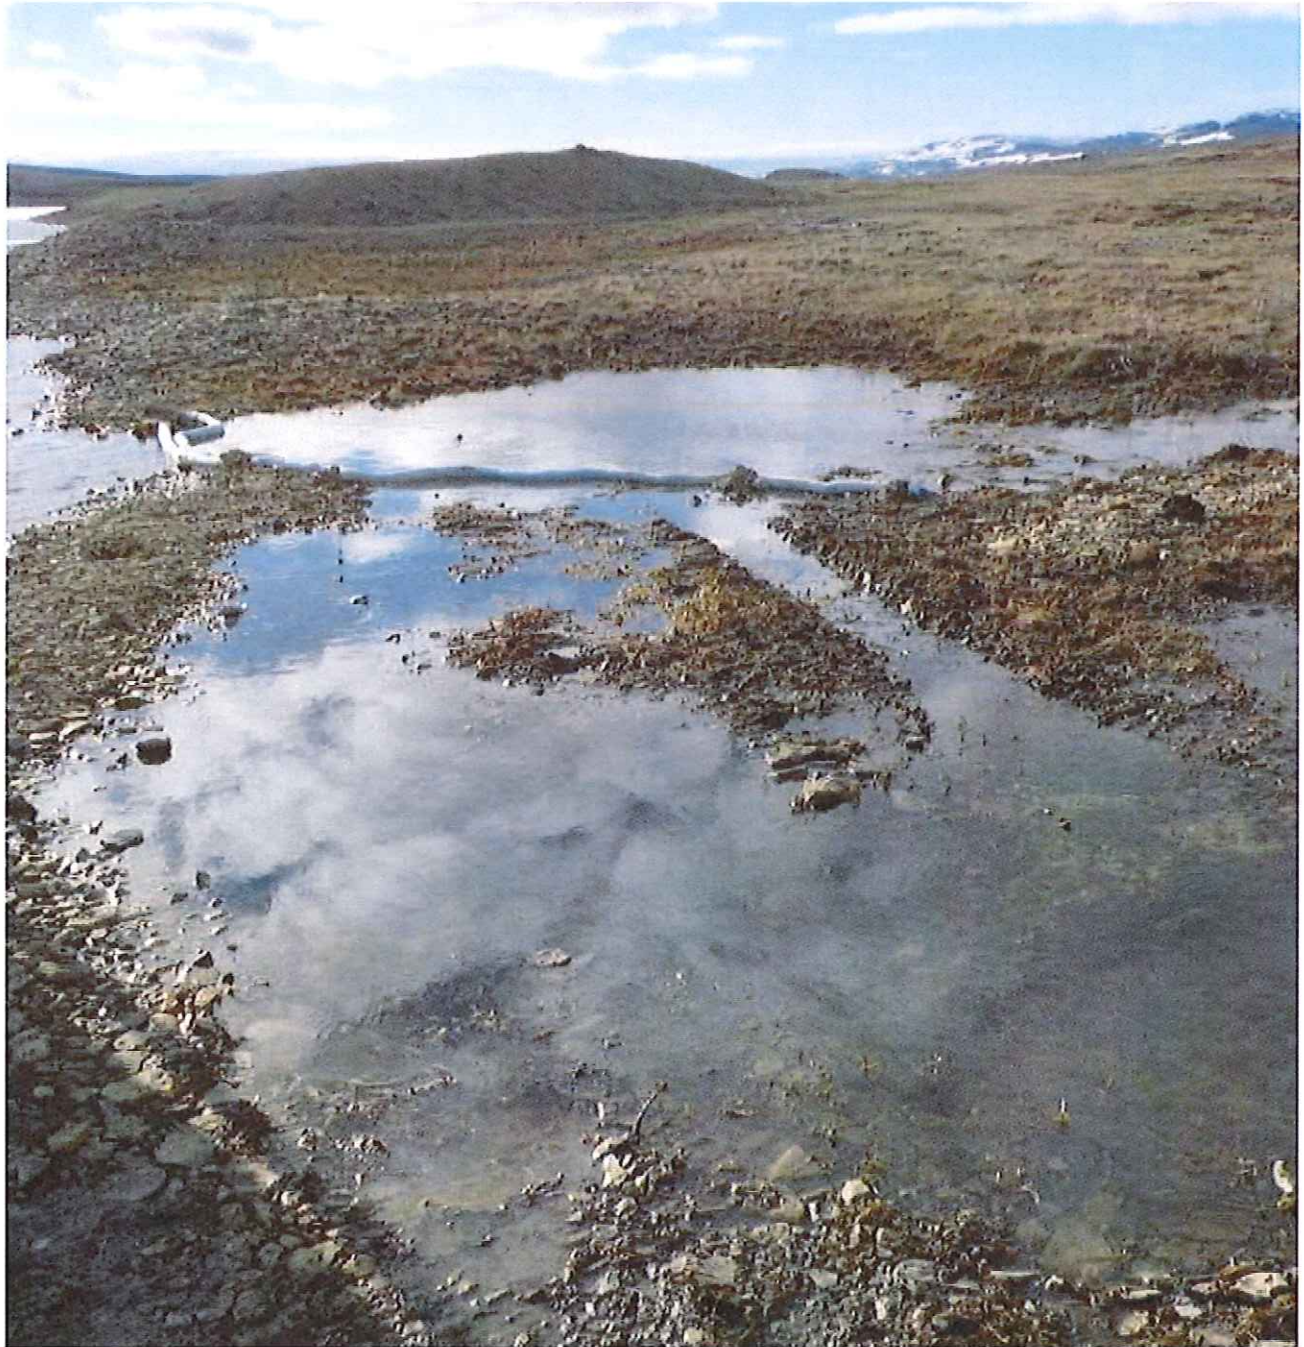
On June 25th at 16:00 HRS, the Milne Port water truck parked adjacent to the Km 32 intake location for routine water uptake (Water Licence Station MP-MRY-03). Upon engagement of the water pump it was noticed by the operator that the pump was releasing hydraulic oil onto the soil/water directly below the pump. The Operator stopped the pump immediately. Booms were set in place to contain the spilled hydraulic oil and prevent migration. Absorbent pads were used to soak up spilled product from the ground surface. Approximately 15 L of hydraulic oil was released. BIM Environment responded to the incident at 17:00 HRS.

The cause of the release was a disconnect to the hydraulic line feeding the water pump located on the driver's side of the vehicle. Upon engagement of the water pump, the hydraulic line became pressurized causing it to separate from the hydraulic oil tank, thus releasing the hydraulic oil that was contained within the line in addition to a volume released from the tank for an approximated combined volume of less than 15 L.

Figure 1: Spill Location – Impacted Area After Spill and Before Clean-up

As per Baffinland protocol, a spill kit was present at the site from which spill response supplies (booms/absorbent pads) were obtained. Booms were set in place downstream from the spill area to contain the spilled hydraulic oil and prevent migration. Absorbent pads were used to soak-up free product from the ground surface. Residual hydrocarbon sheen was suctioned from impacted surface water puddles.

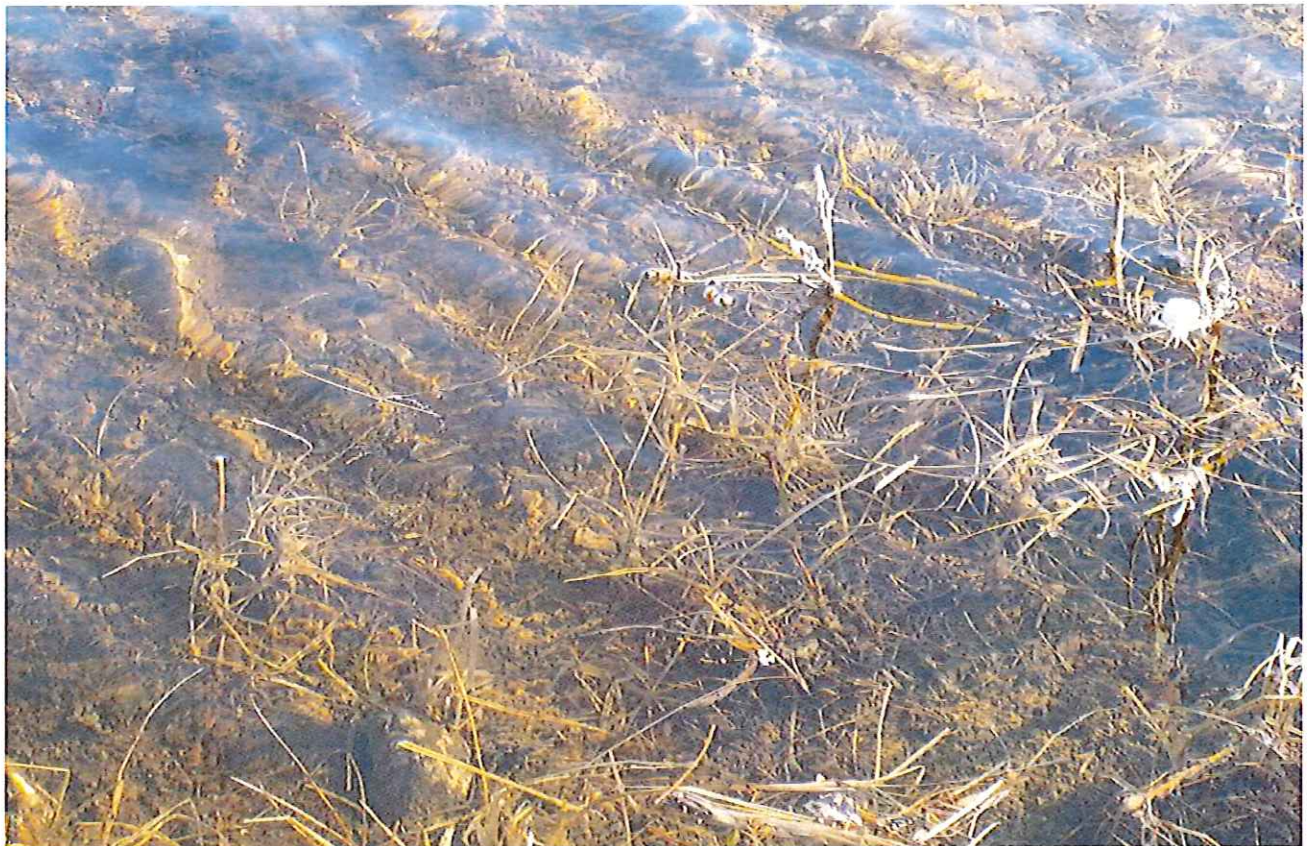
A post clean-up verification sample was collected to confirm that the area was free of residual contamination thus insuring successful clean-up of the area. Results of the TOG analysis indicated a concentration less than detection limit indicating negligible impact. Further clean-up was therefore not warranted.

Figure 2: Close-up of Area Most Impacted After Clean-up – No Visible Sheen Observed
