Re: Follow-up to Spill 14-297 Reported on August 12th, 2014 Mary River Project - Water Licence No. 2AM-MRY1325

Summary:

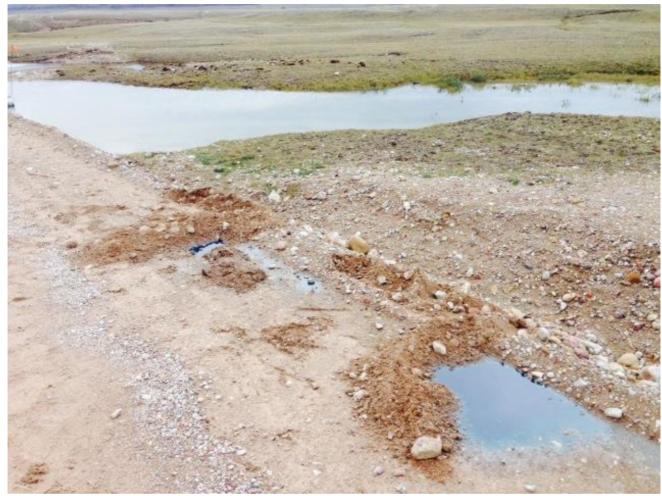
Figure 1: Earthen berms preventing oil from entering waterway

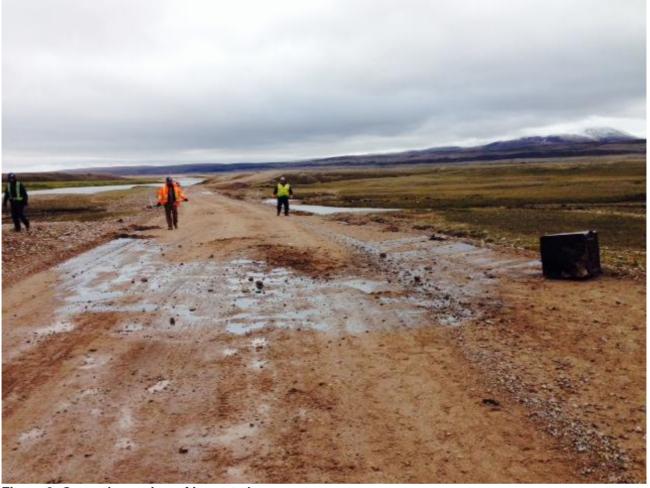
Figure 2: General overview of impacted area

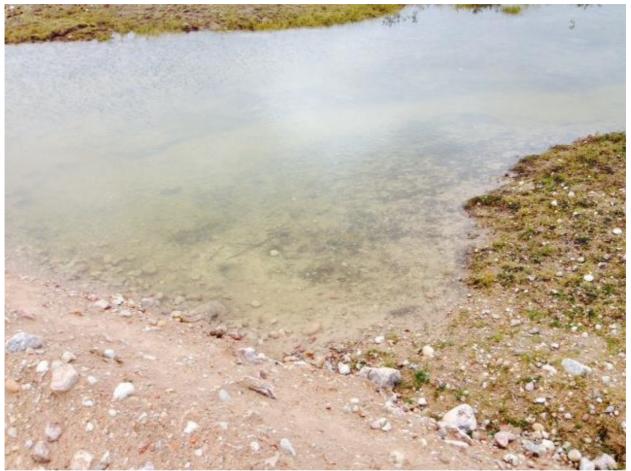
Figure 3: Adjacent waterway not impacted by spill

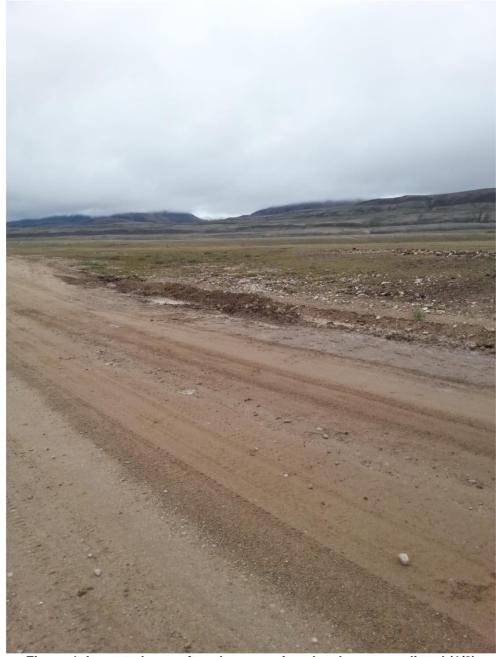
Figure 4: Impacted area after clean-up - Area has been remediated (1/2)

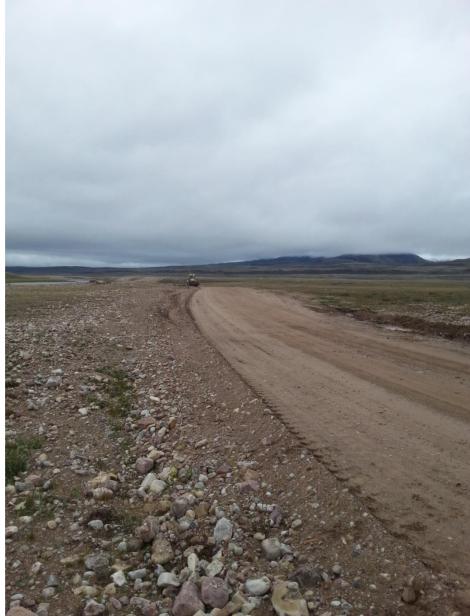
Figure 5: Impacted area after clean-up - Area has been remediated (2/2)
