## **APPENDIX C**

### **Sequence of Events and Actions Taken by Spill Report (Including Photos)**

### **Spill Report 17-161**

### **Spill Report 17-162**

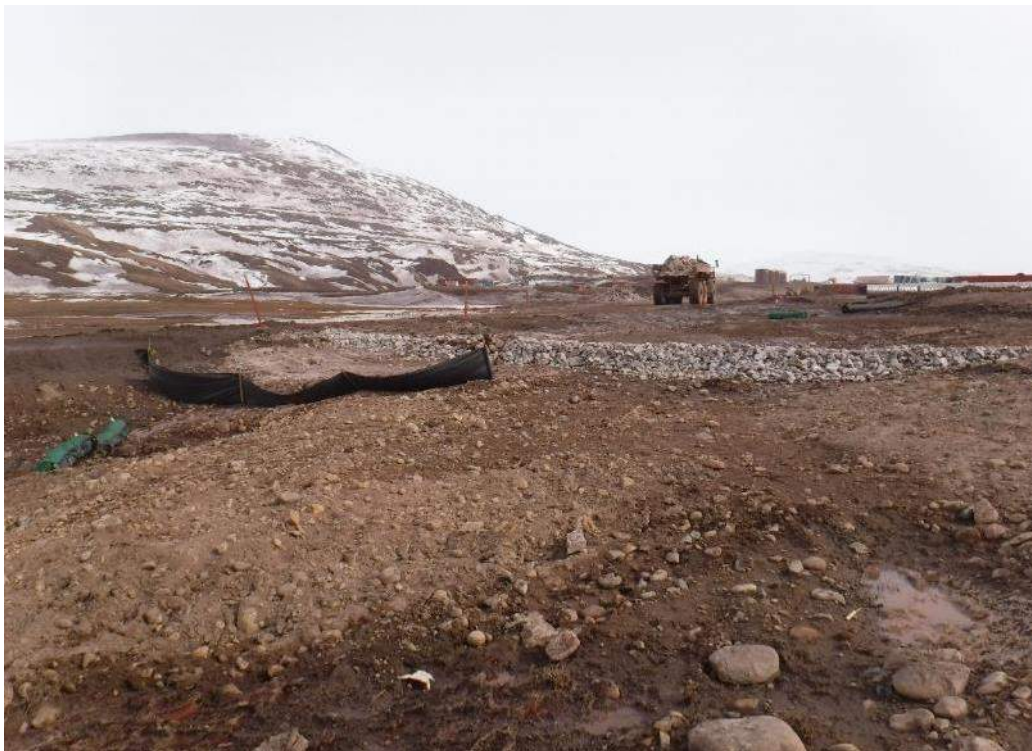
May 16, 2017 - Construction of check dam north of culvert CV-186 (Sheardown Lake Tributary 1)

| Date | Description |
|---|---|
| May 16 - May 23 | Road embankments near SDLT1 culvert (CV-186) armoured with aggregate (rip-rap). Check dams constructed near culverts CV-186 and CV-187 to control surface runoff entering SDLT1. Sediment laden snow removed near SDLT1 and placed in natural sumps away from water bodies to allow for sediment settling. Water sampling conducted for additional parameters on May 16, 2017, including acute toxicity, metals, nutrients, oil & grease and major ions. |

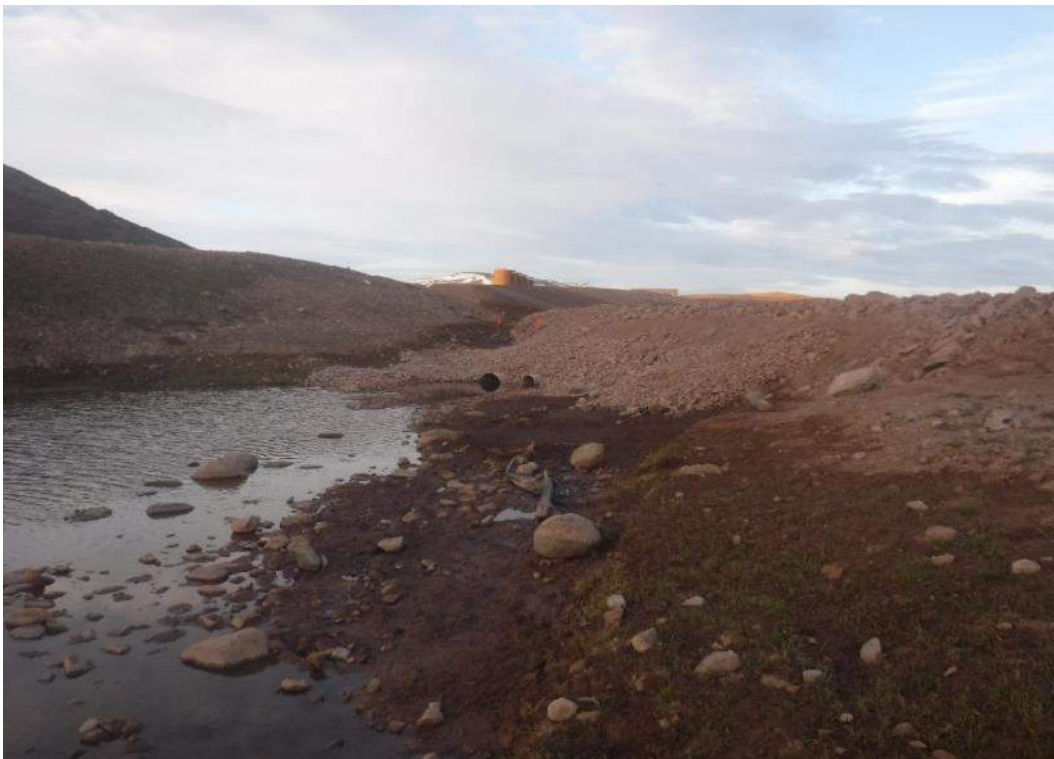
July 2, 2017 - Downstream of CV-187 (Upgraded in April 2017)

| Date | Description |
|---|---|
| April 2017 | Culverts at CV-187 water crossing replaced and upgraded as proposed in Tote Road Earthworks Execution Plan (TREETP). |

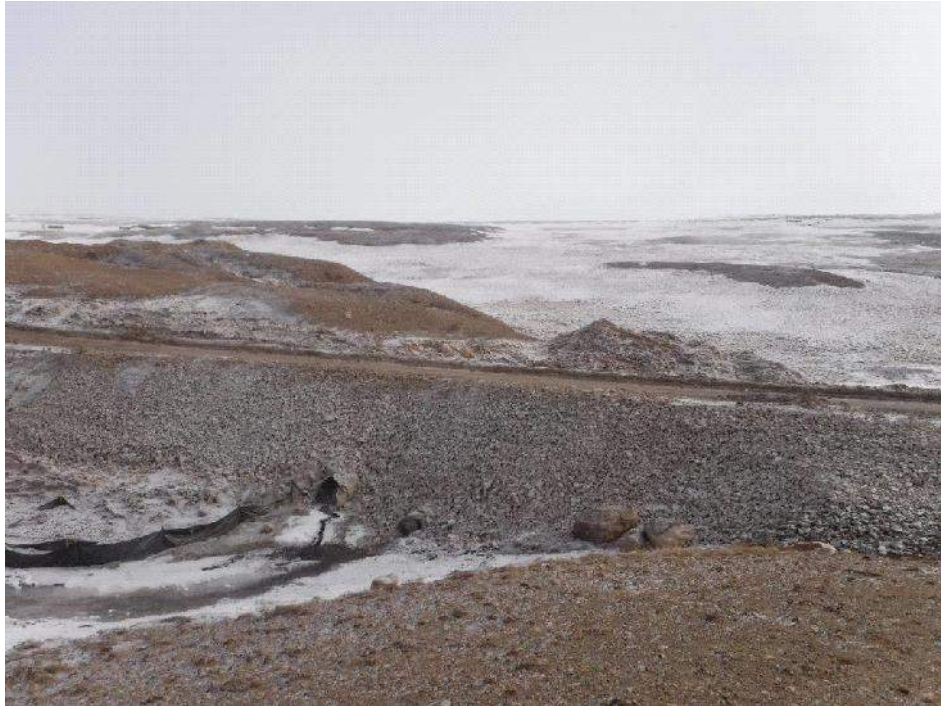
May 21, 2017 – Armouring of road embankments near culvert BG-01 (Camp Lake Tributary 1)

| Date | Description |
|---|---|
| May 17 to May 20 | Road embankments near CLT1 culvert BG-01 armoured with aggregate (rip-rap). Sediment laden snow near BG-01 removed and placed in natural sumps away from water bodies to allow for sediment settling. |

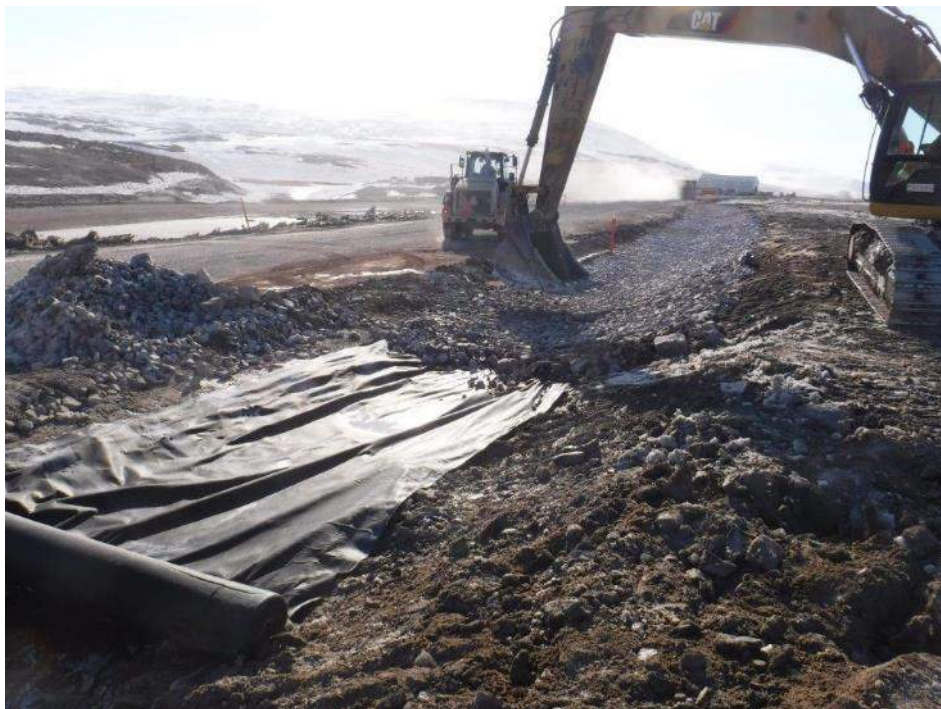
May 23, 2017 – Armouring of drainage ditch on South end of Mine Site airstrip near Km 100  
(Upstream of Camp Lake Tributary 1)

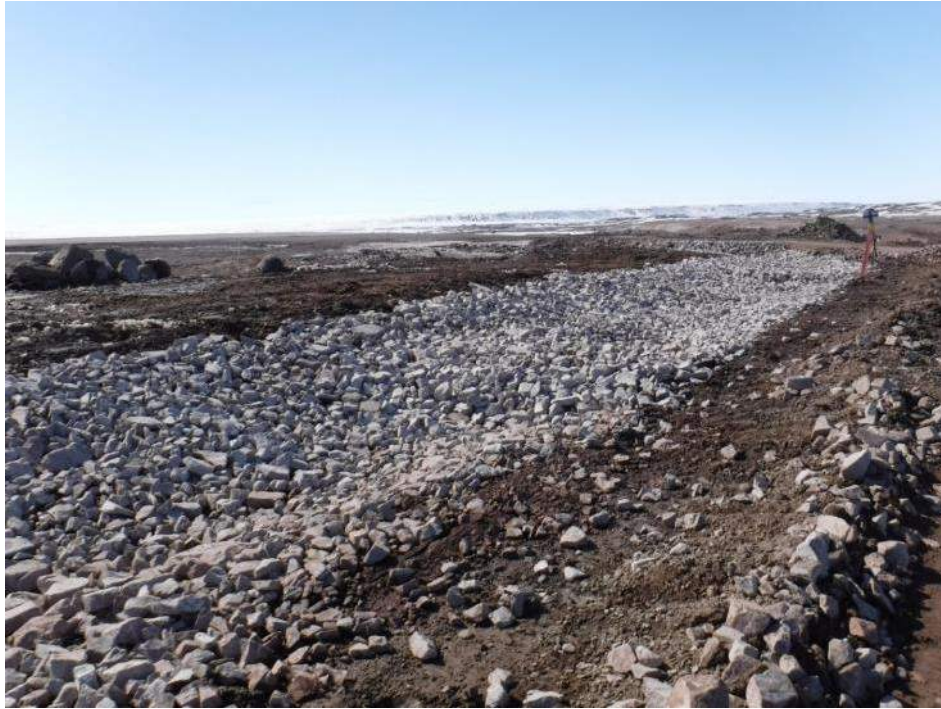
May 23, 2017 – Completion of drainage ditch armoring on South end of Mine Site airstrip near Km 100  
(Upstream of Camp Lake Tributary 1)

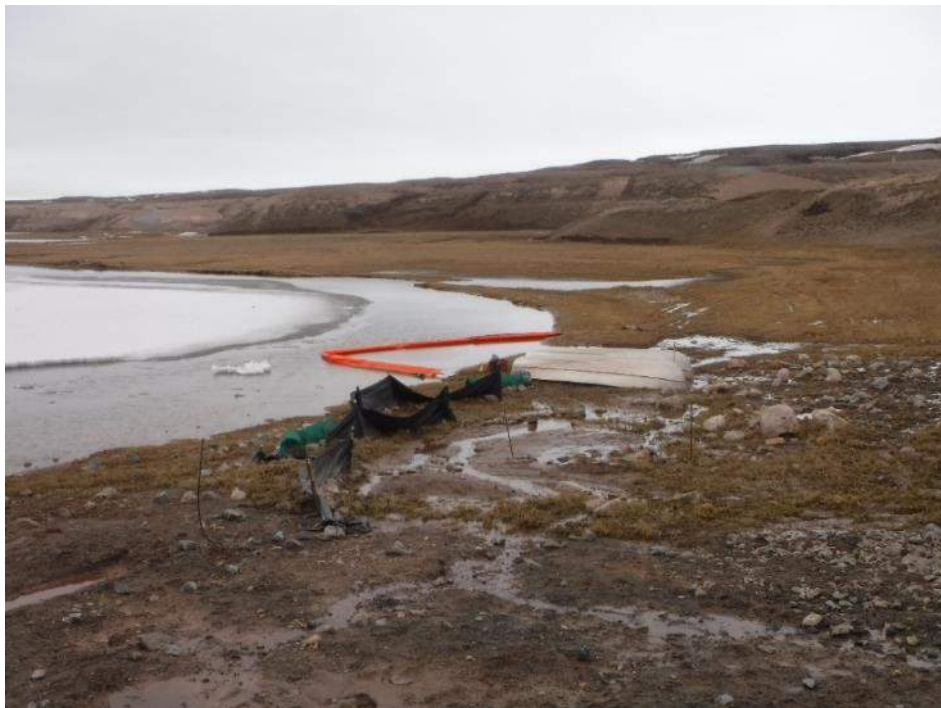
June 11, 2017 – Installation of silt curtain on the outlet of Camp Lake Sedimentation Ponds.  
Spring berms and silt fences installed.

| Date | Description |
|---|---|
| June 11 | Silt curtain installed in Camp Lake near outlet of Camp Lake Sedimentation Ponds to address sedimentation concerns. |

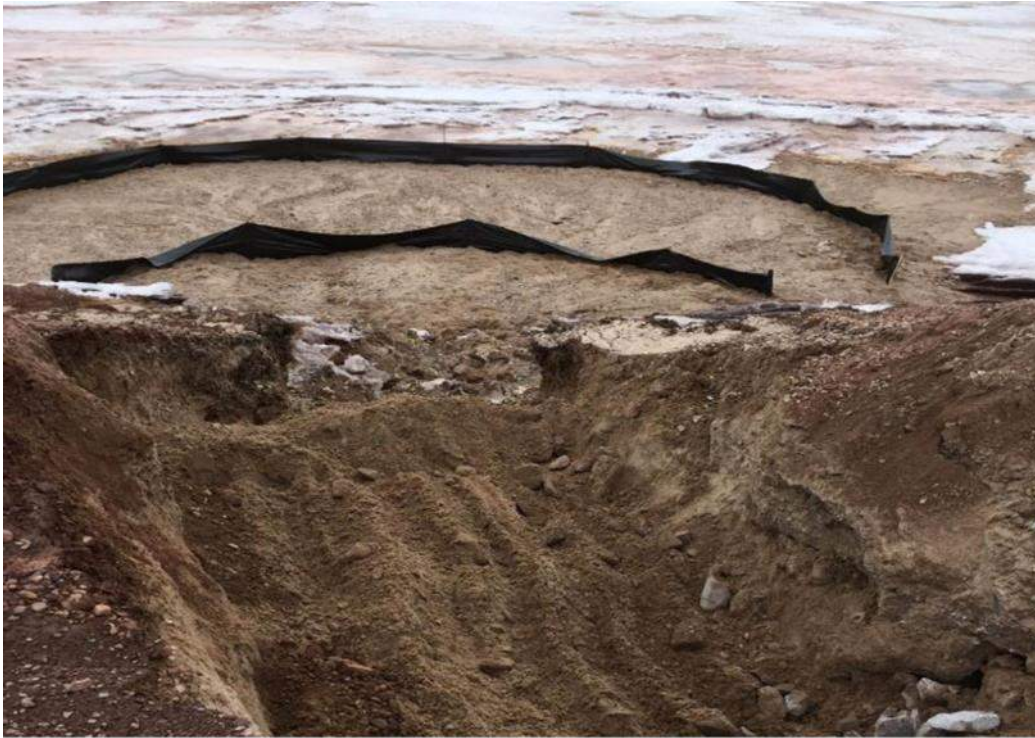
May 26, 2017 – Silt fences installed to mitigate sand washed out from MP-05 overflow

| Date | Description |
|---|---|
| | Control measures (i.e. armouring of bank with aggregate, culvert installation downstream of pond spillway) implemented to mitigate bank erosion downstream of MP-05. |

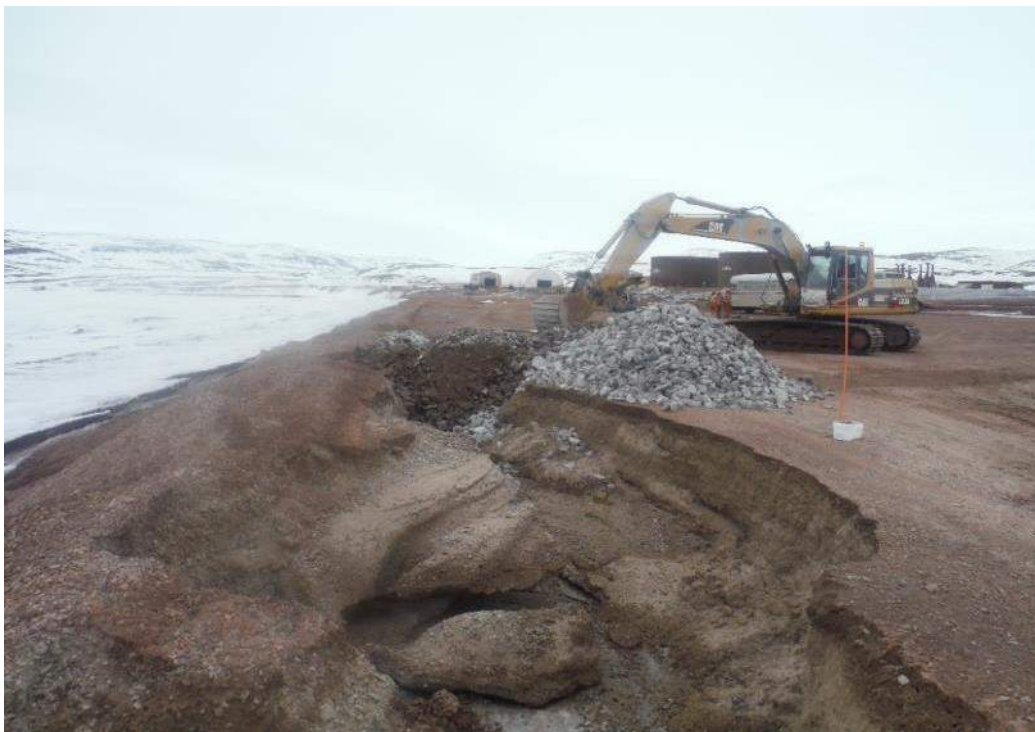
May 26, 2017 – Rip rap used to fill in beach area that was eroded by MP-05 overflow

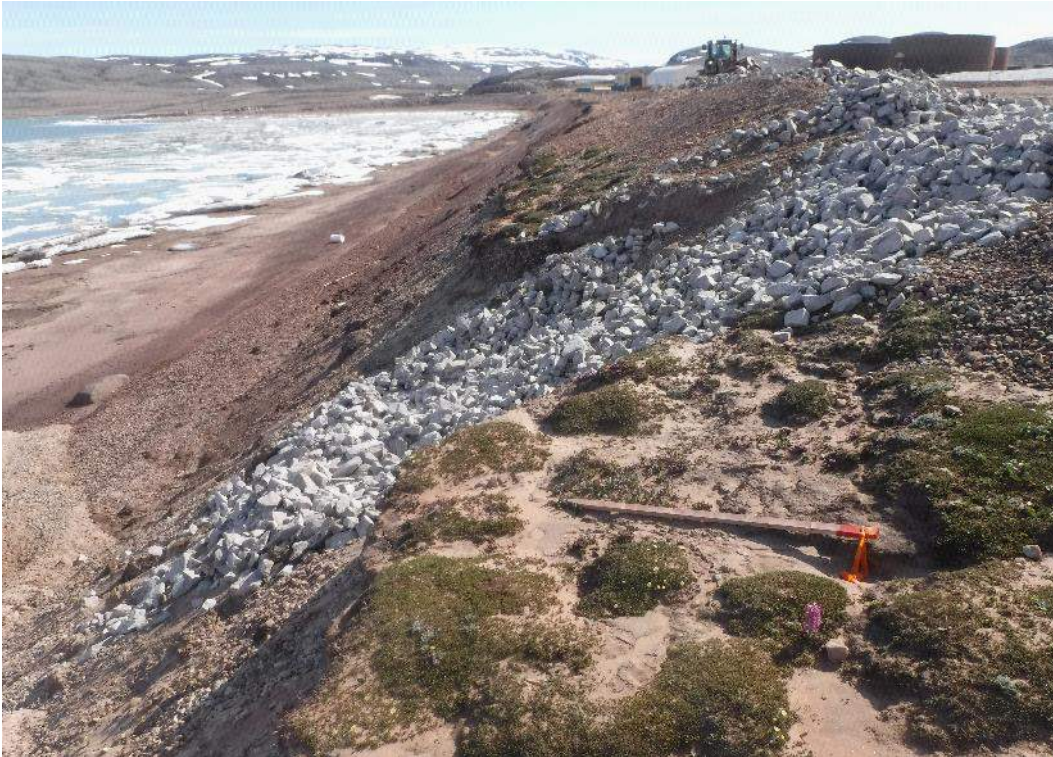
July 1, 2017 - Additional rip-rap placed downstream of MP-05

| Date | Description |
|---|---|
| June 25 | Culvert and the emergency spillway modifications removed as directed by the INAC Inspector. Eroded and scour areas downstream of MP-05 graded and armored with aggregate (rip rap). |

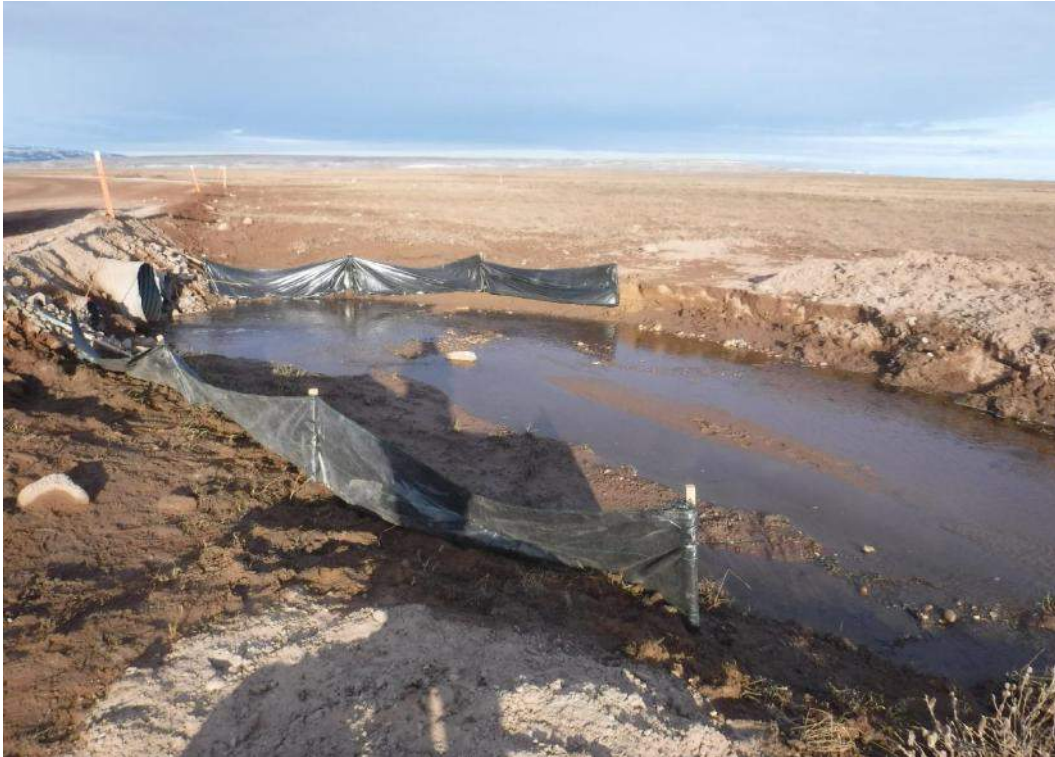
June 25, 2017 – Silt fences installed near CV-001 (downstream)

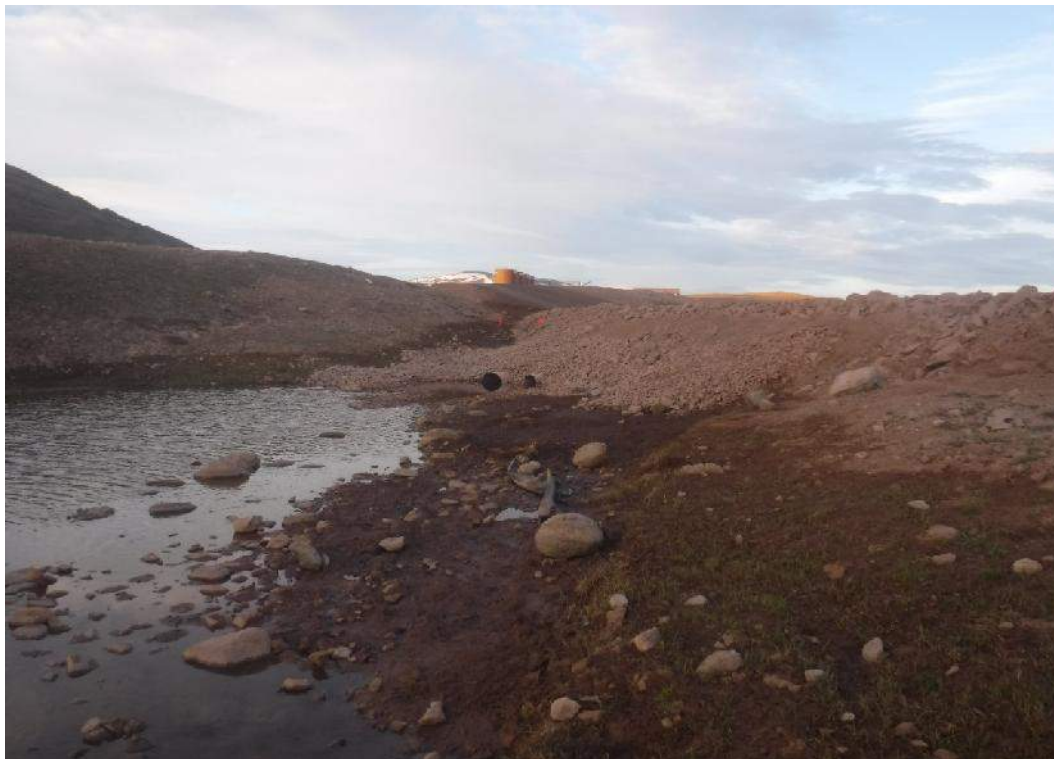
July 2, 2017 - Downstream of CV-187 (Upgraded in April 2017)

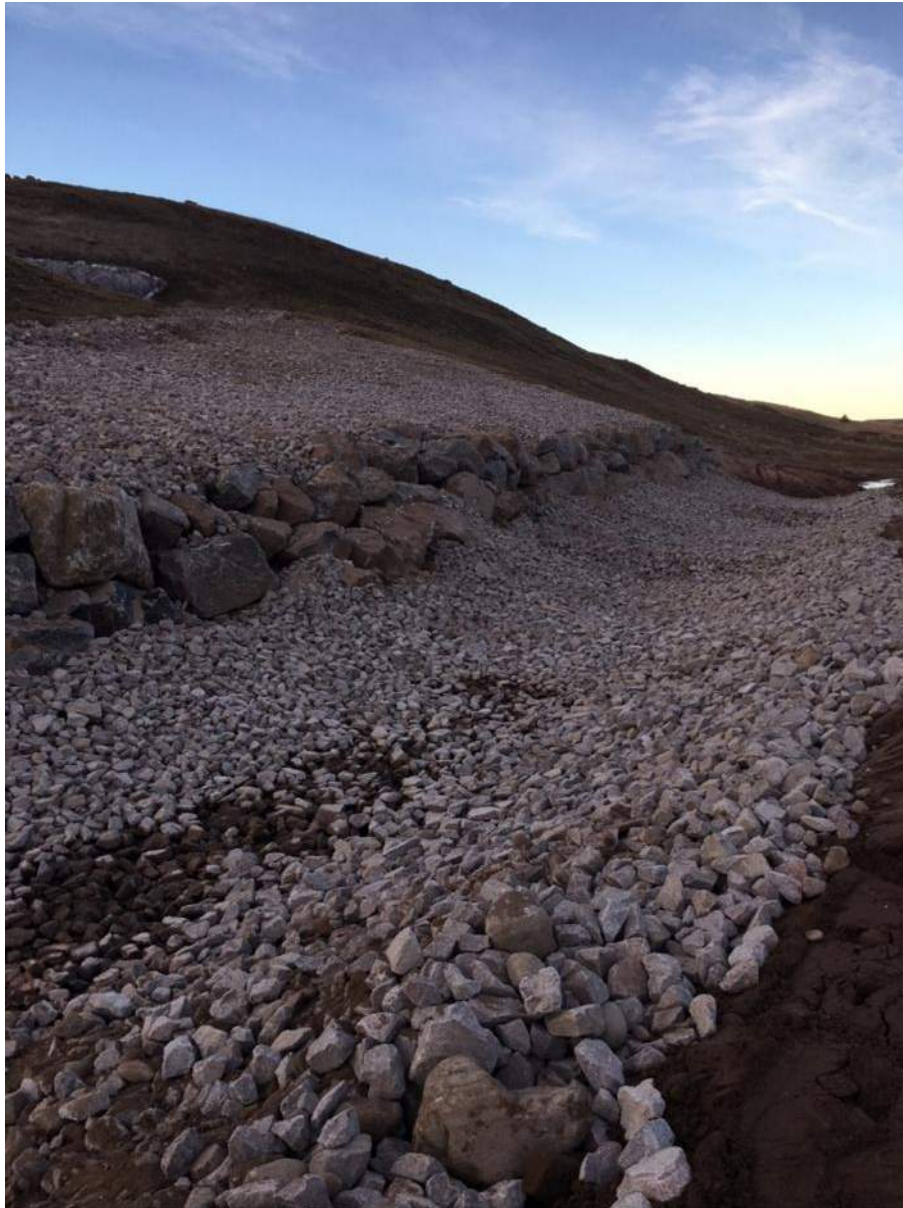
July 4, 2017 – Completion of ditch and slope armouring near Km 90

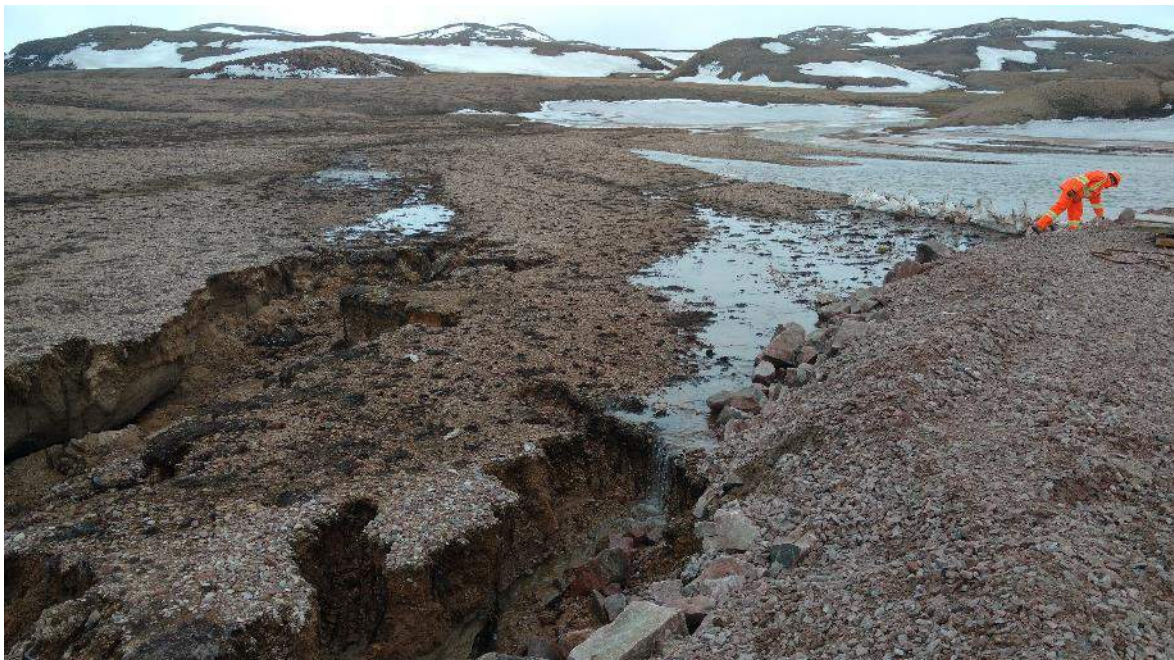
June 15, 2017 – Sand bags installation (looking SE)

| Date | Description |
|---|---|
| June 15 | During a follow-up site inspection, it was observed that water levels had increased significantly and the tributary's surface water flows were once again being diverted to areas that had previously been eroded. Sand bags were placed to reduce flows toward the eroded beach areas. Follow up inspections of the tributary noted that water levels continued to recede. |
