**APPENDIX C – SEQUENCE OF EVENTS AND ACTIONS TAKEN BY  
SPILL REPORT (INCLUDING PHOTOS)**

**APPENDIX C.1 – Spill Report 18-180 – Camp Lake Settling  
Ponds**

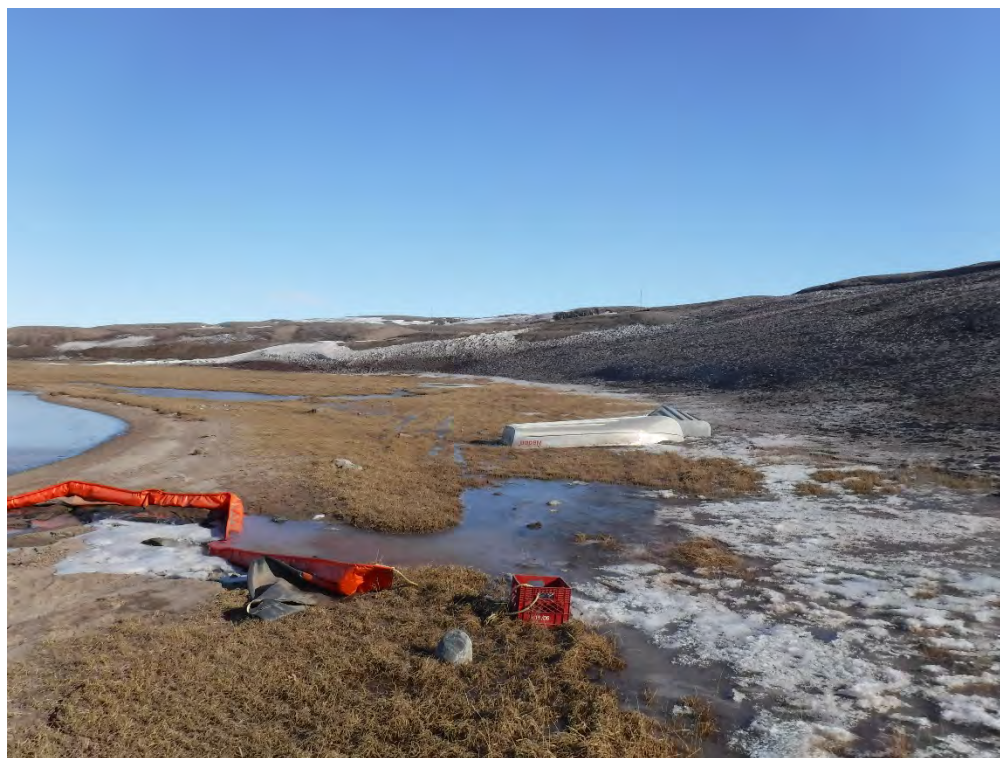
**May 17, 2018: Downstream View of CLSP-OUT**

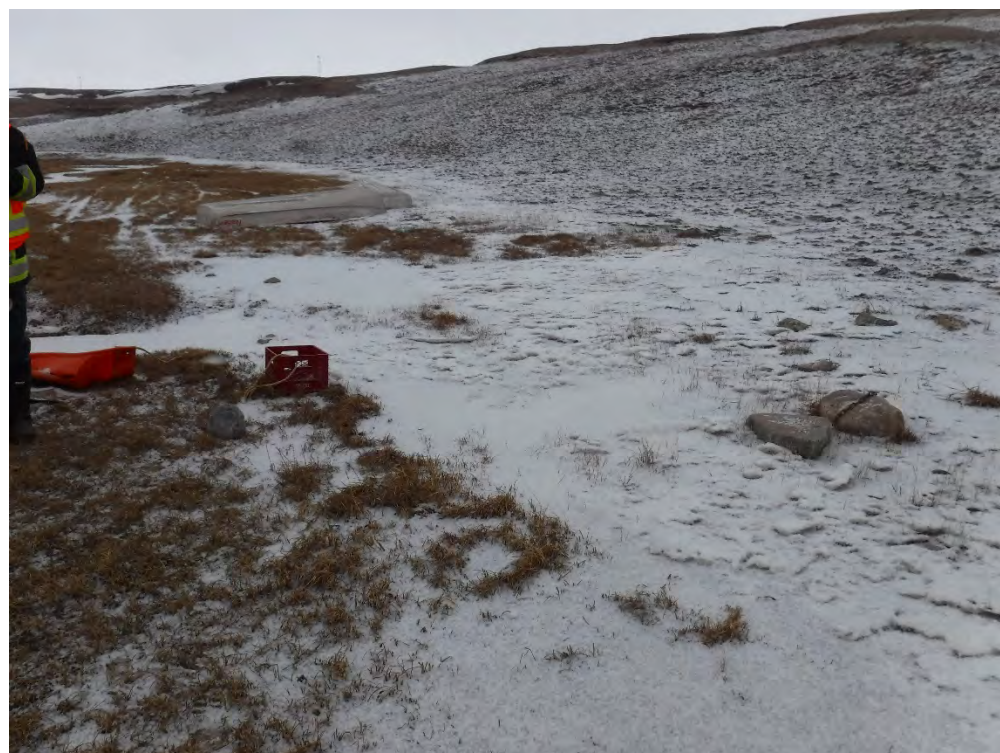
**May 18, 2018: Downstream View of Frozen Conditions at CLSP-OUT**

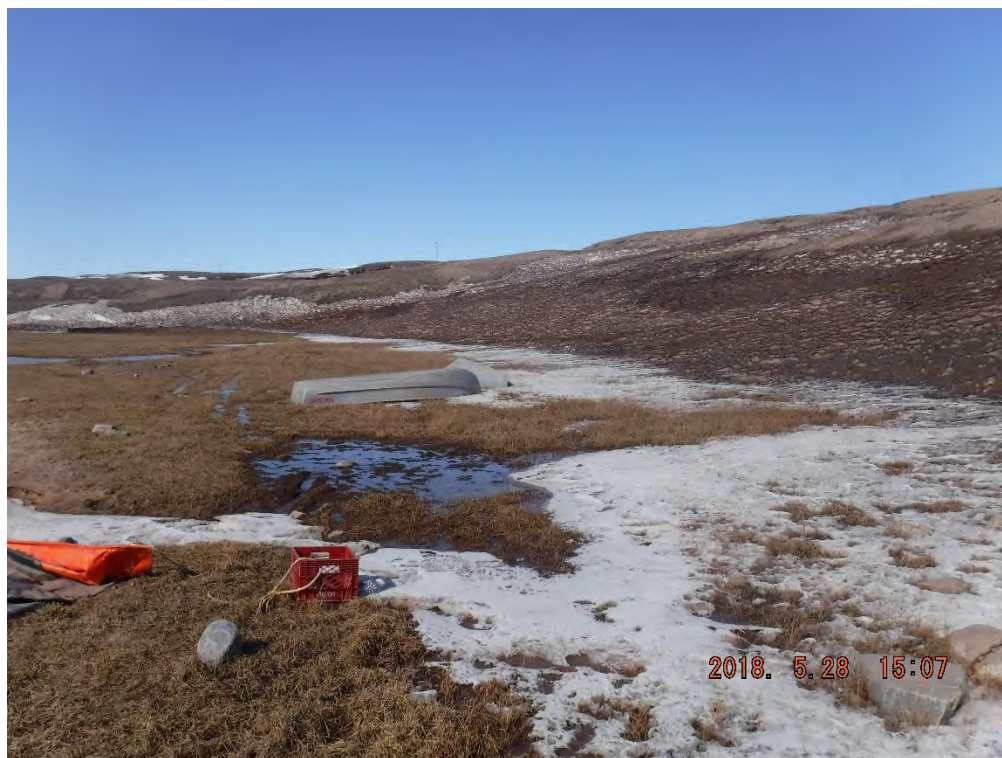
May 28, 2018: Downstream View of Frozen Conditions at CLSP-OUT

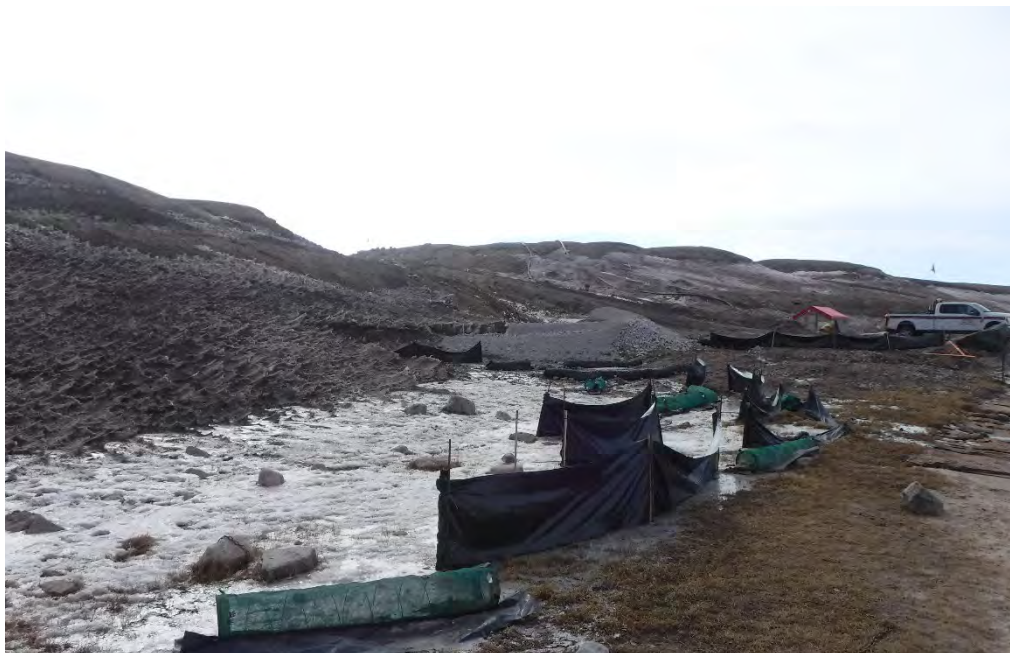
May 28, 2018: Downstream view of CLSP-OUT

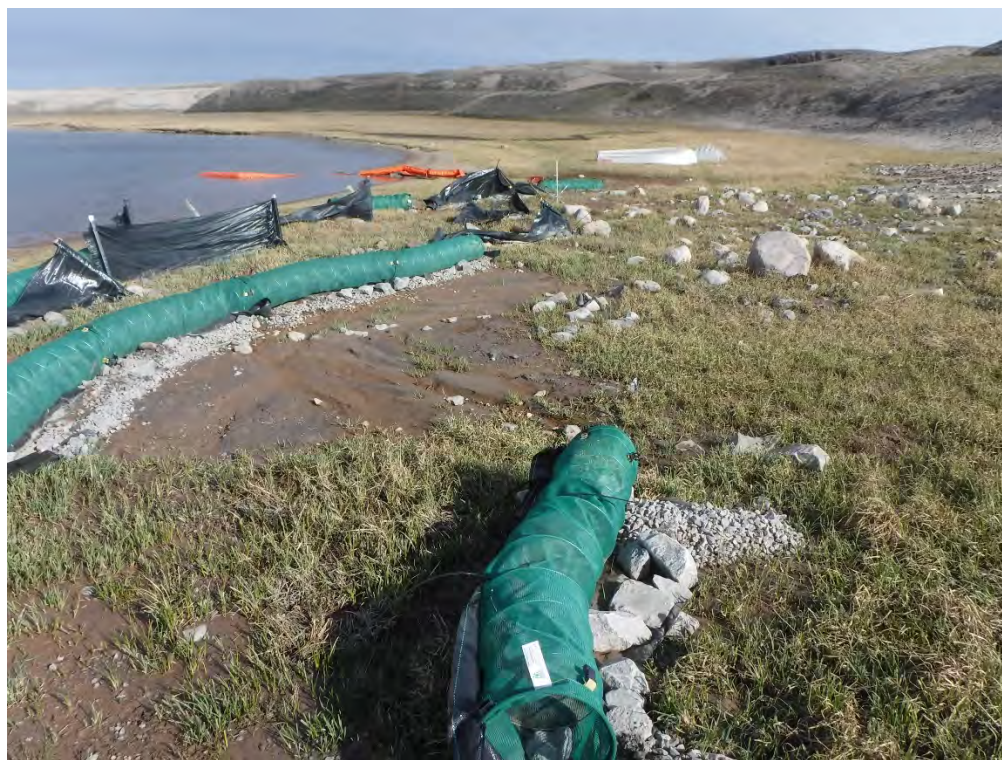
**June 23, 2018: Downstream view of CLSP-OUT**

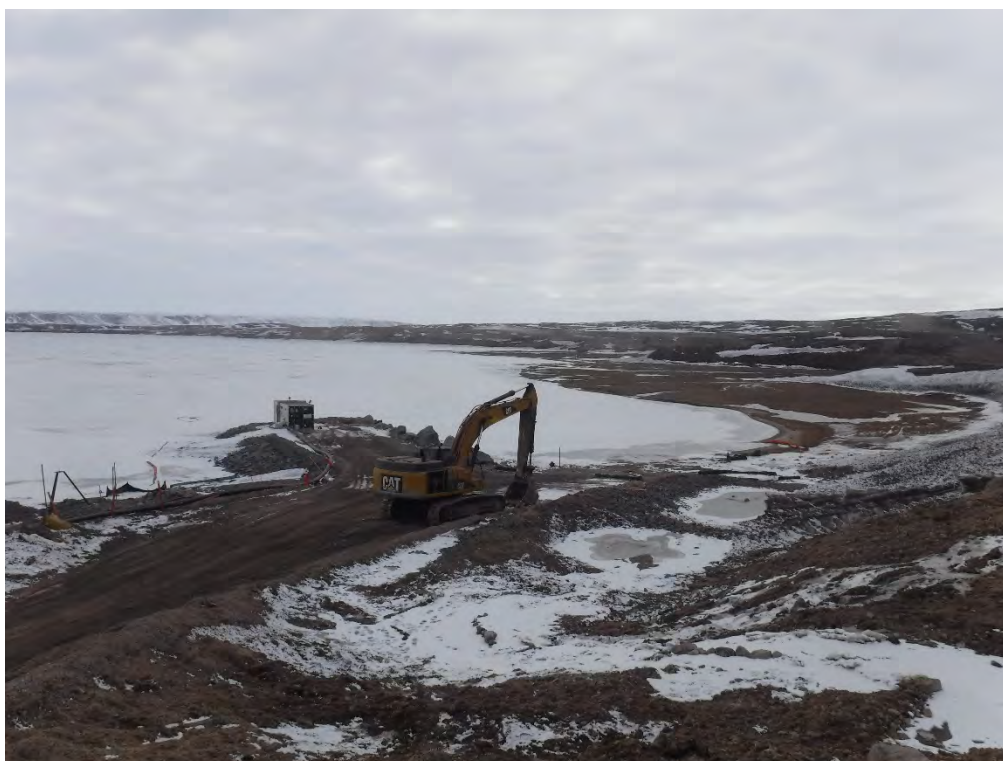
**May 20, 2018: Camp Lake Settling Ponds Before Construction Upgrades**

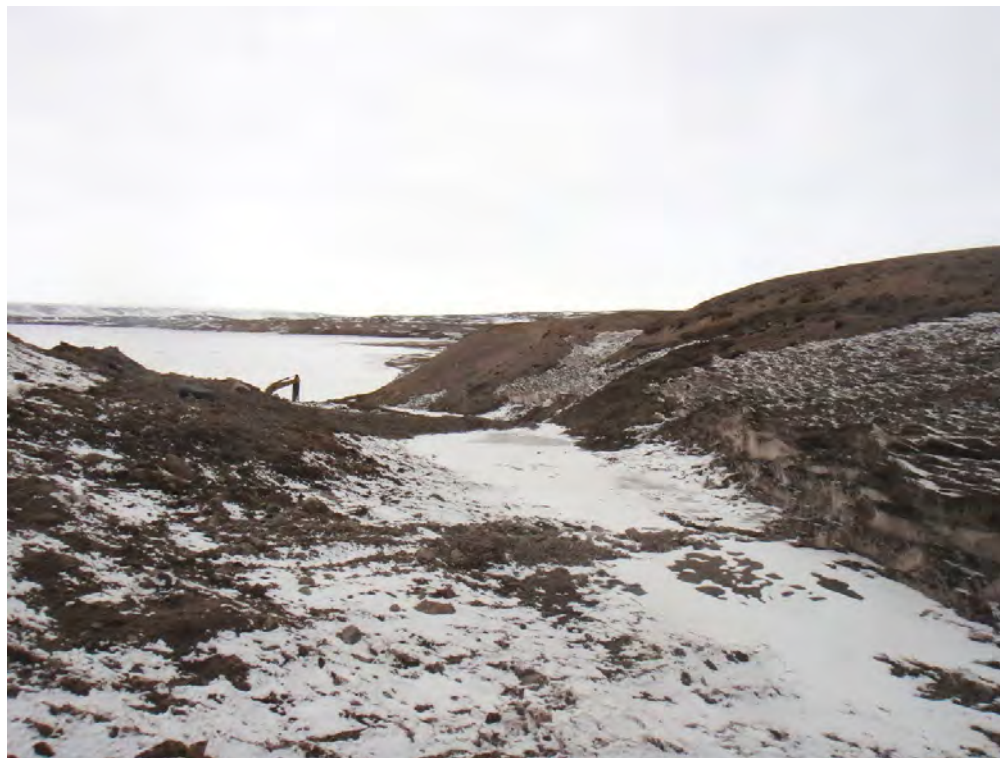
**May 20, 2018: Check Dams in Camp Lake Settling Pond Drainage Channel Before Construction Upgrades**

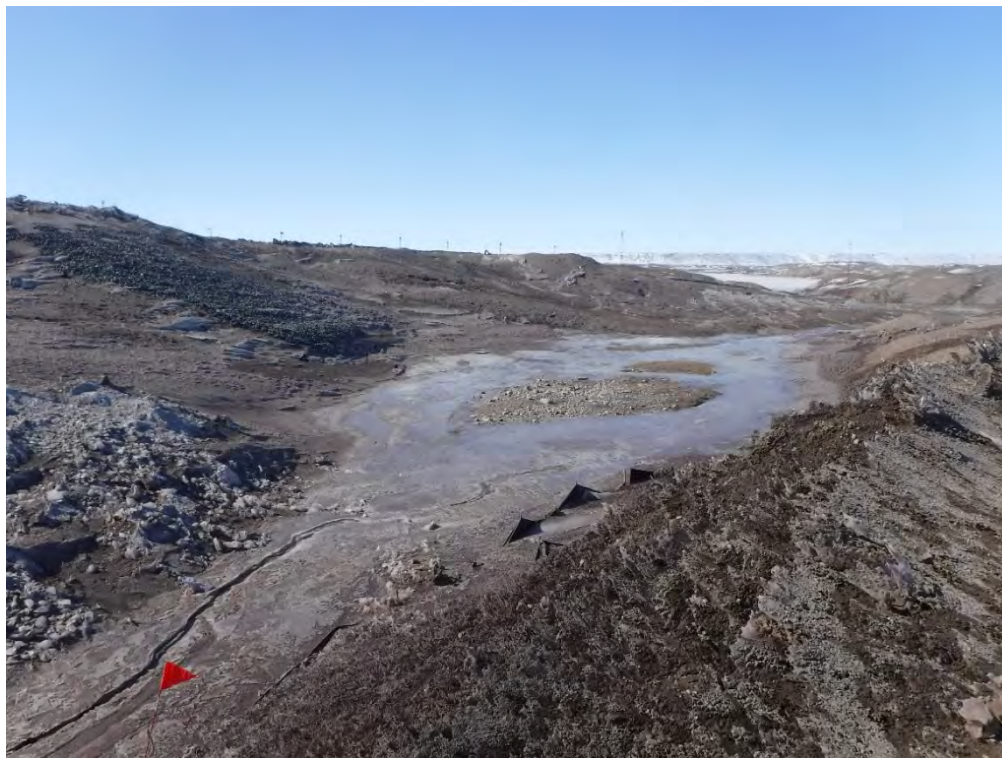
**May 13, 2018: BG-01-DS Road Crossing Upstream of CLT-OUT Before Snow Removal**

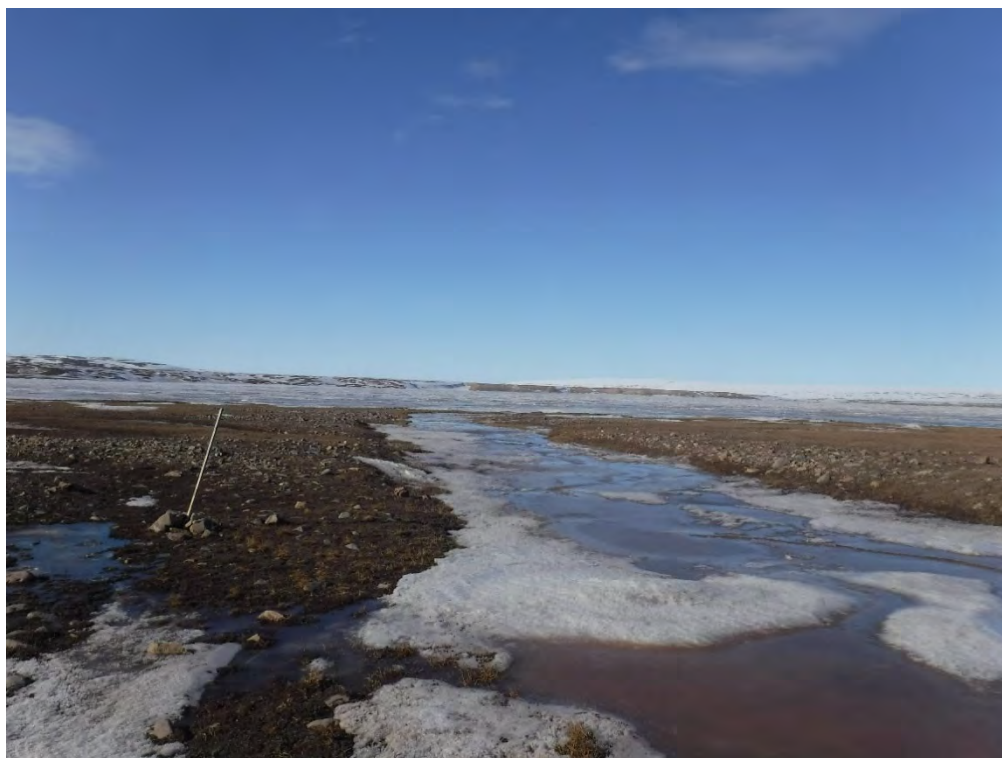
**May 17, 2018: Downstream View of CLT-OUT**

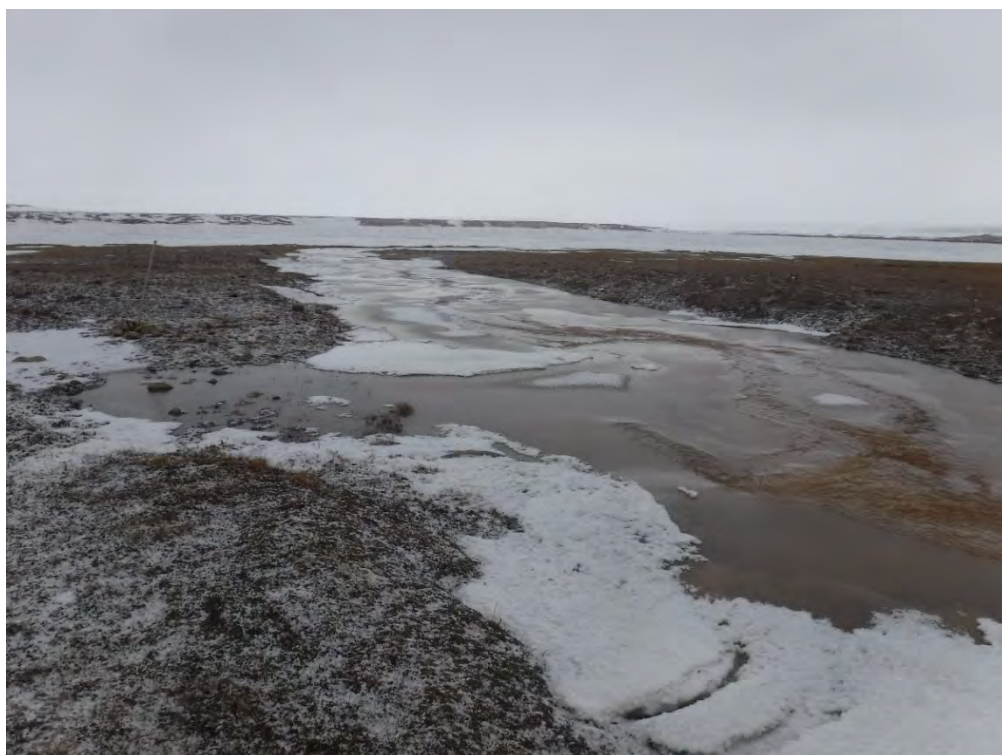
**May 18, 2018: Downstream View of CLT-OUT**

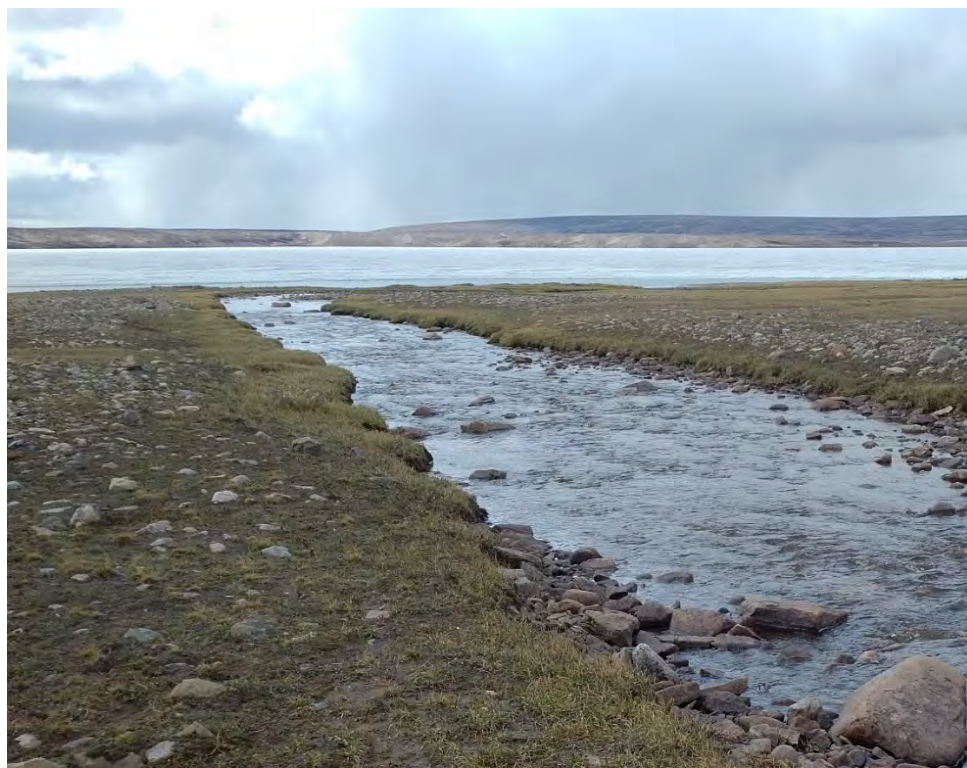
**June 25, 2018: Downstream View of CLT-OUT**

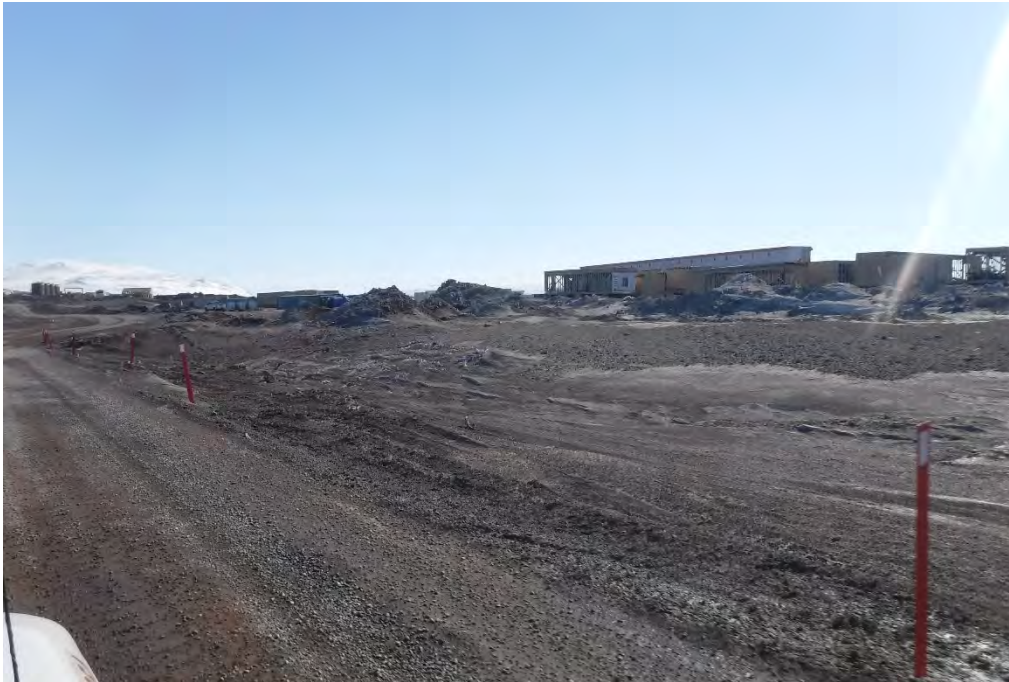
**May 8, 2018: CV-186-DS Road Crossing Upstream of SDLT-OUT Before Snow Removal**

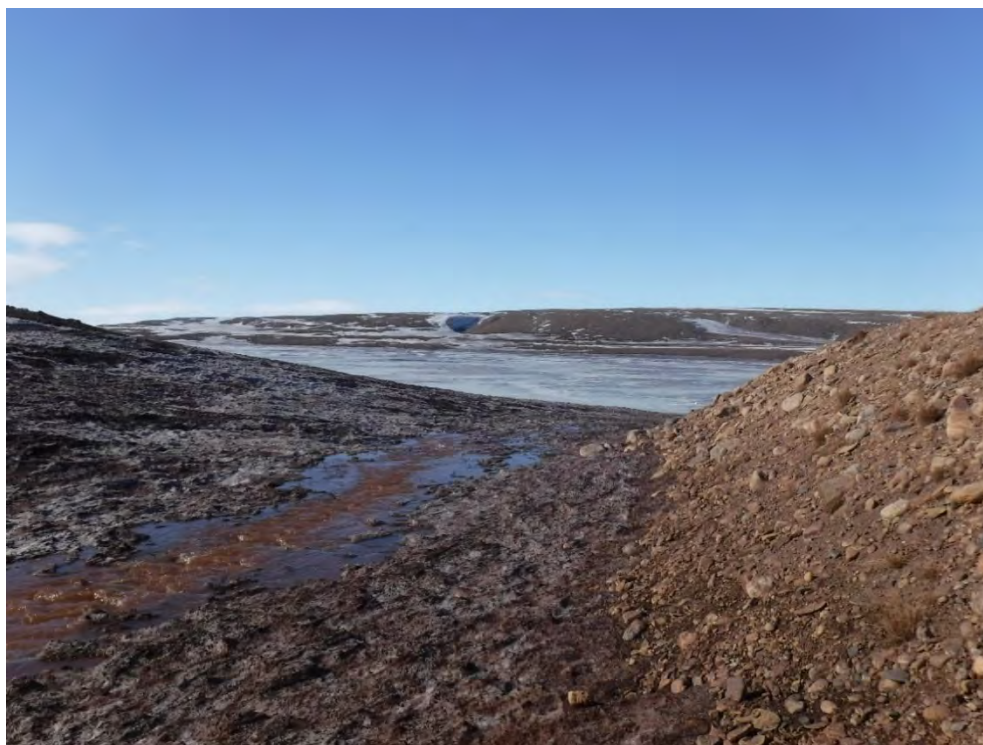
**May 17, 2018: Downstream View of SDLT-OUT**

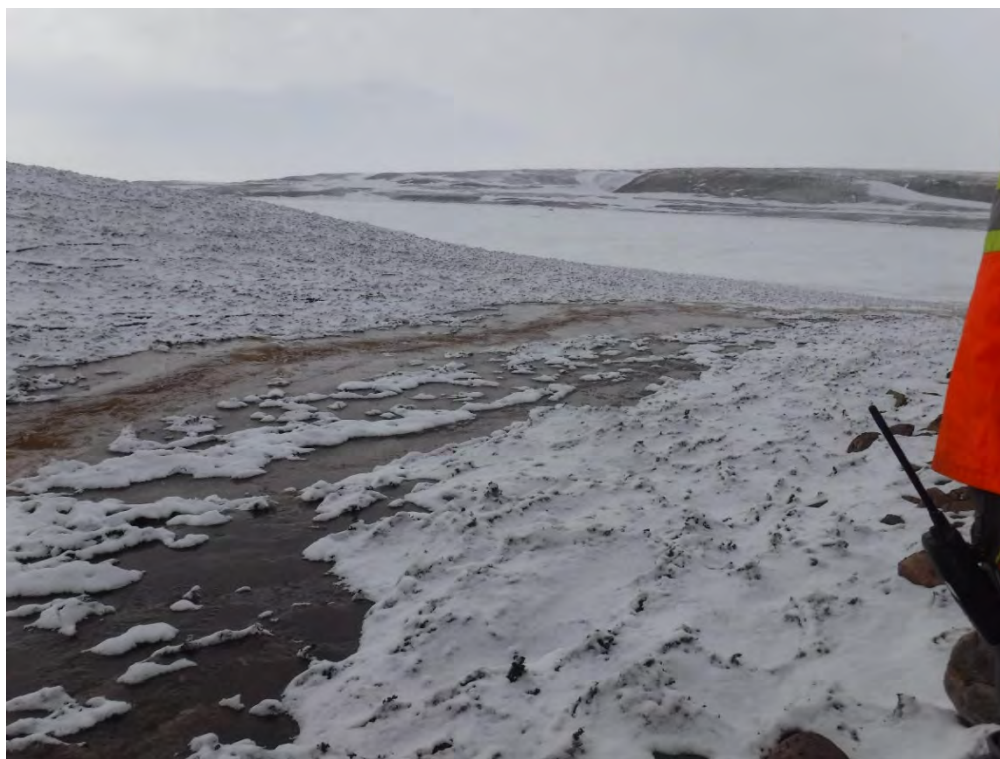
**May 19, 2018: Downstream View of SDLT-OUT**

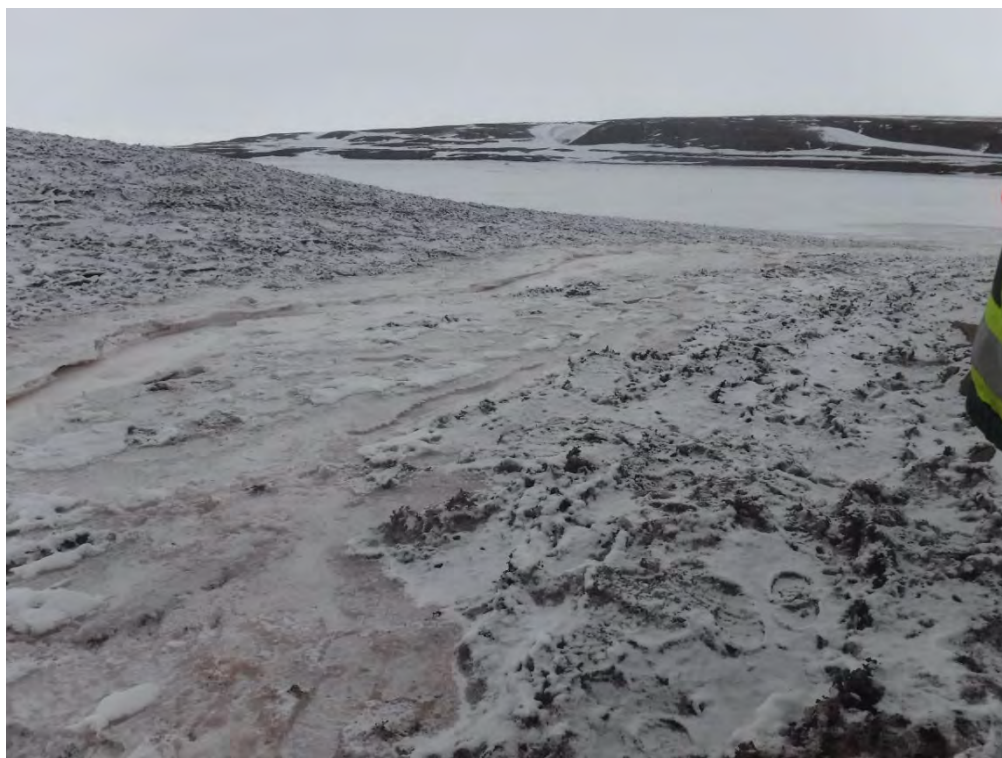
**May 20, 2018: Downstream View of SDLT-OUT**

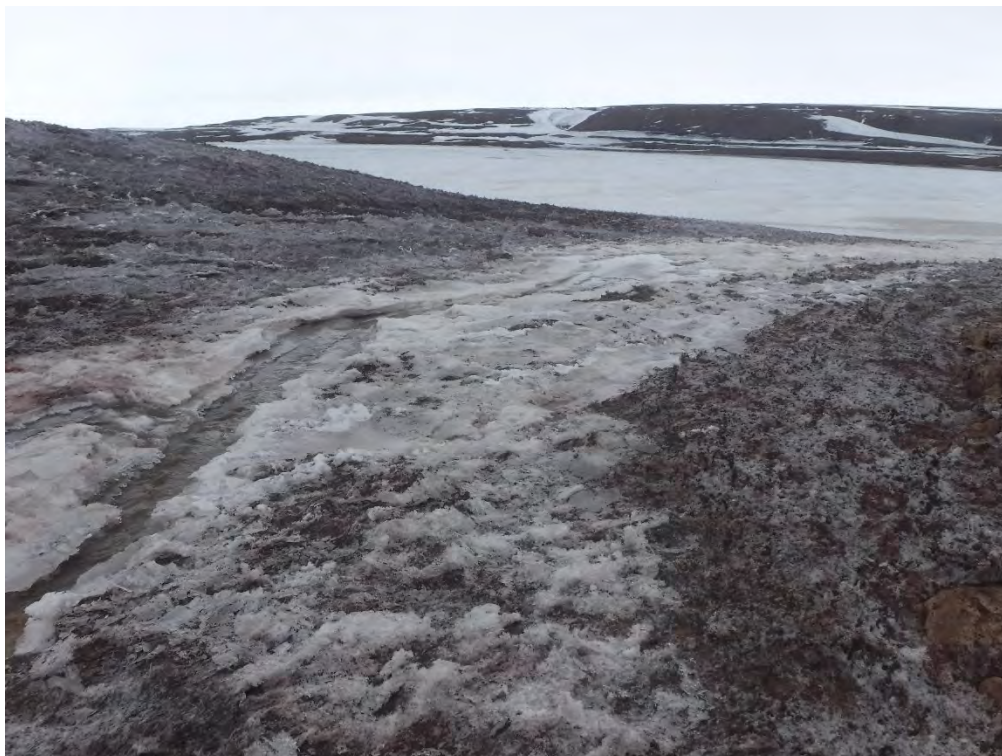
**May 22, 2018: Downstream View of SDLT-OUT**

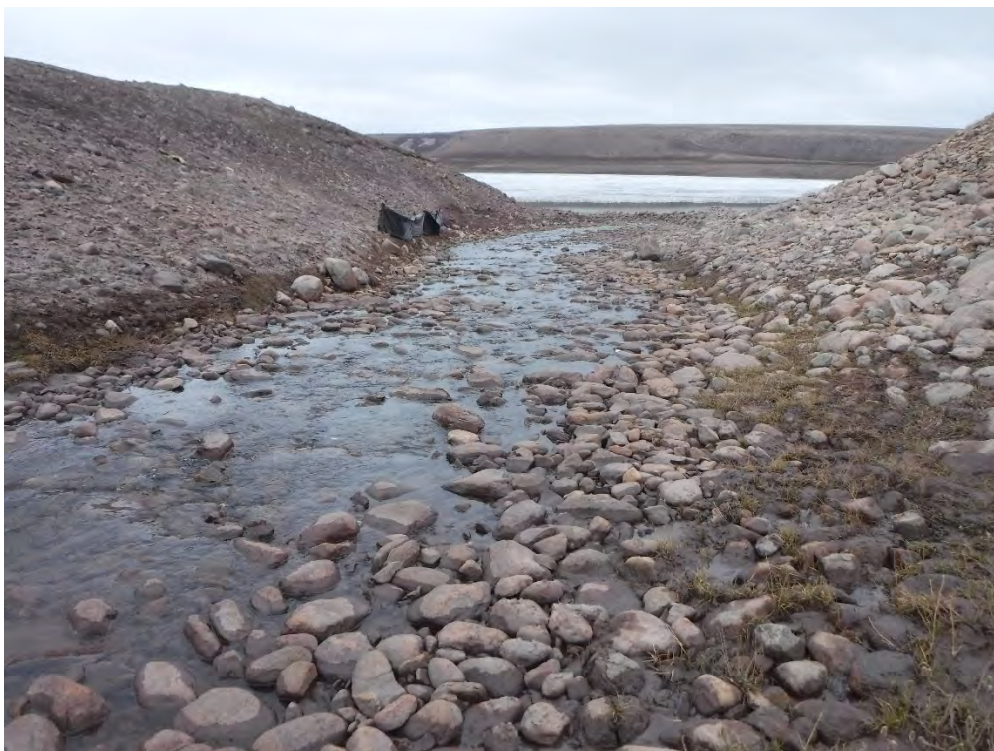
**June 24, 2018: Downstream View of SDLT-OUT**

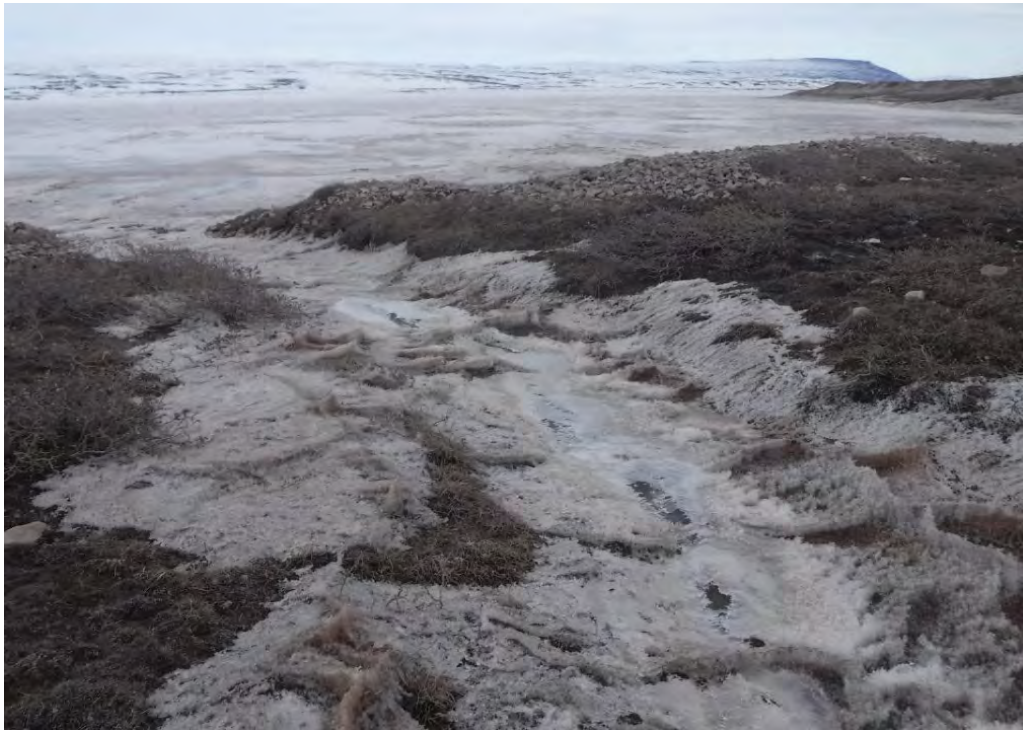
**May 30, 2018: Viewing Downstream BG27 Entering Waterbody**

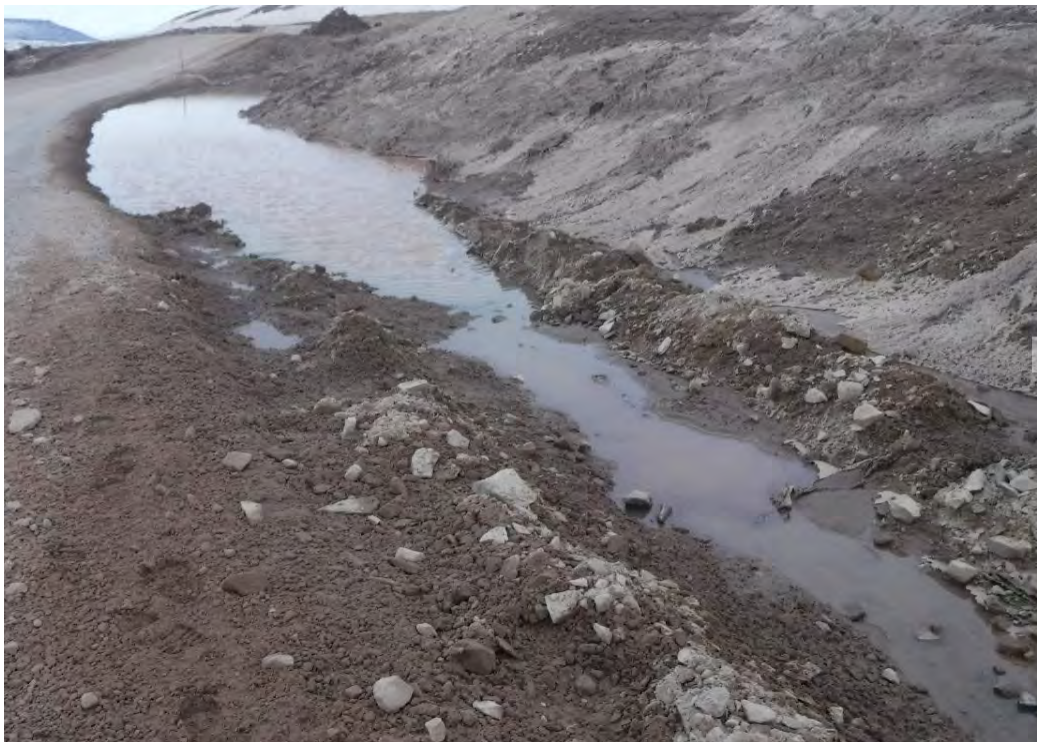
**May 30, 2018: Upstream View of BG27 Looking Downstream**

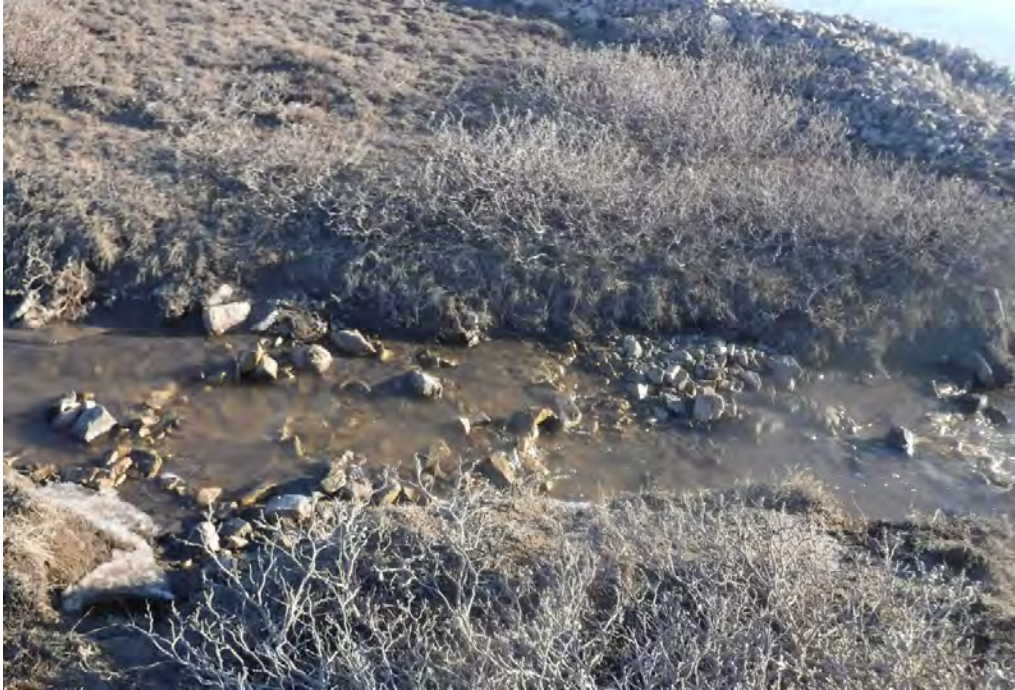
**June 7, 2018: Water flowing clear following mitigation measure in place**

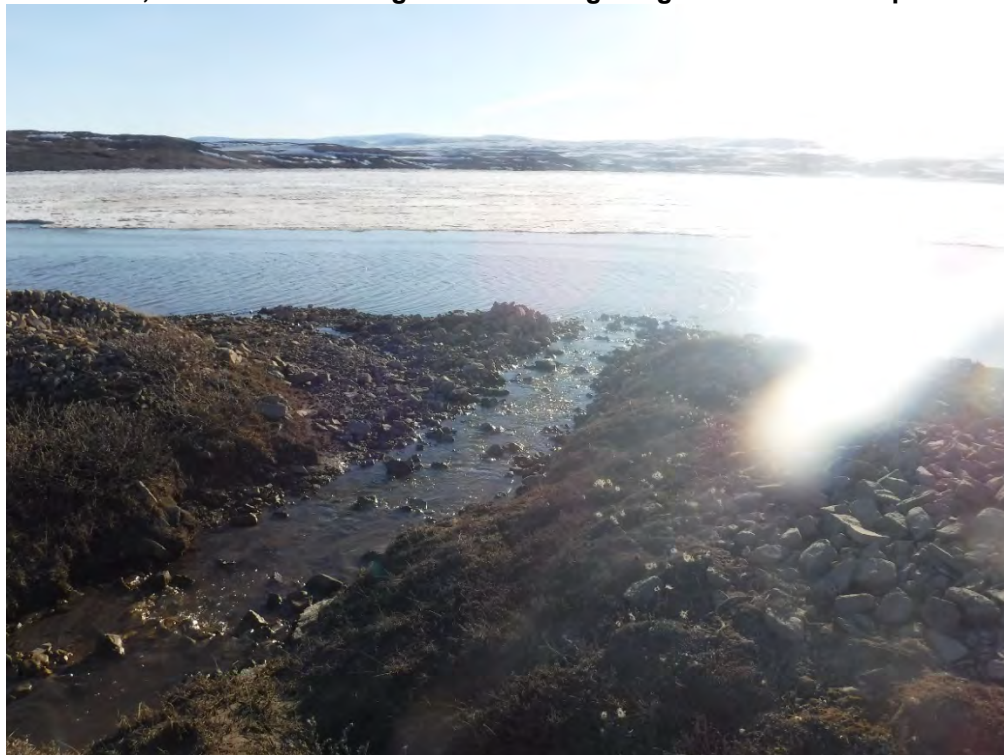
**June 7, 2018: Water flowing clear following mitigation measure in place**

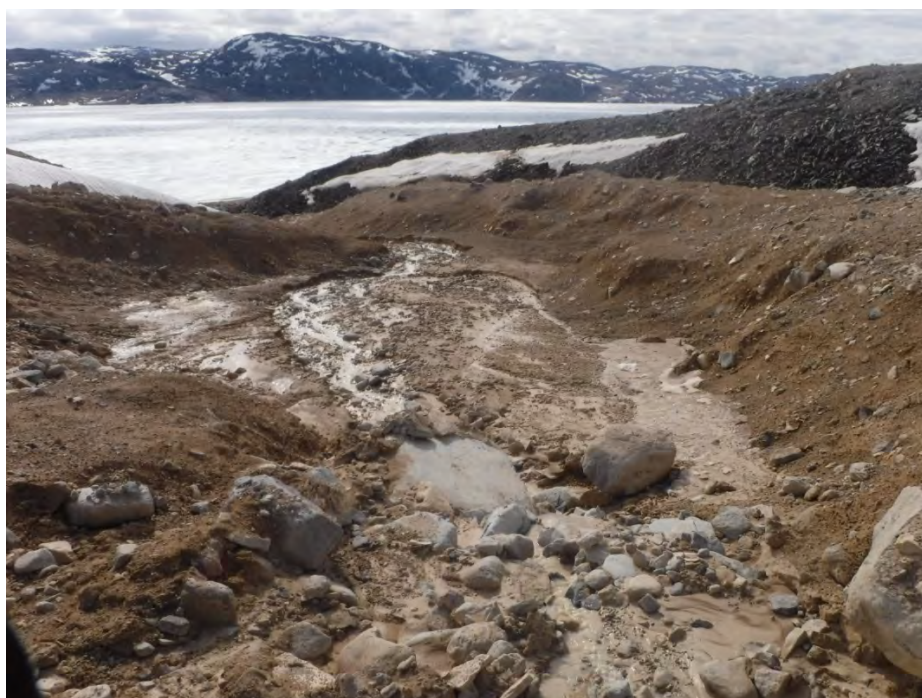
**June 23, 2018: Downstream View of MP-NS-01**

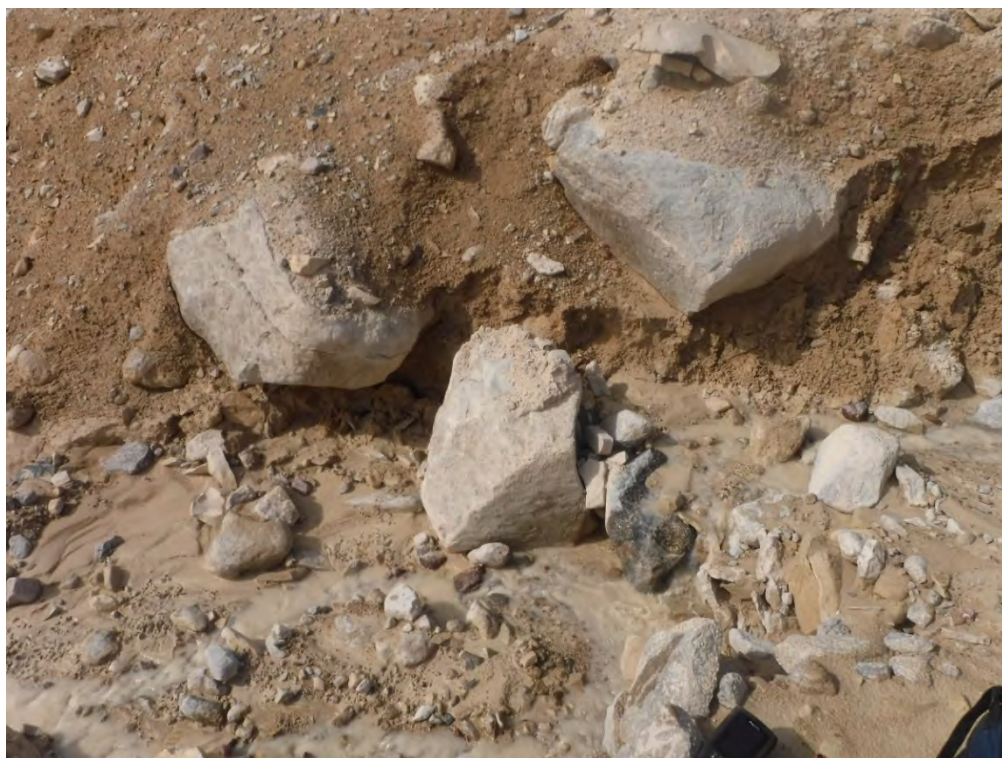
**June 23, 2018: Cross-Section View of MP-NS-01**
