RE: Submission of 2022 Geotechnical Inspection Report No. 2 (September 2022)

Mary River Project – Nunavut

WSP Environment & Infrastructure Canada Ltd., (formerly Wood E&I Canada Ltd.), has completed the second geotechnical field inspection of 2022 at the Mary River Project, which is a condition of the Type "A" Water Licence No: 2AM-MRY1325 – Amendment No.1 ("Water Licence").

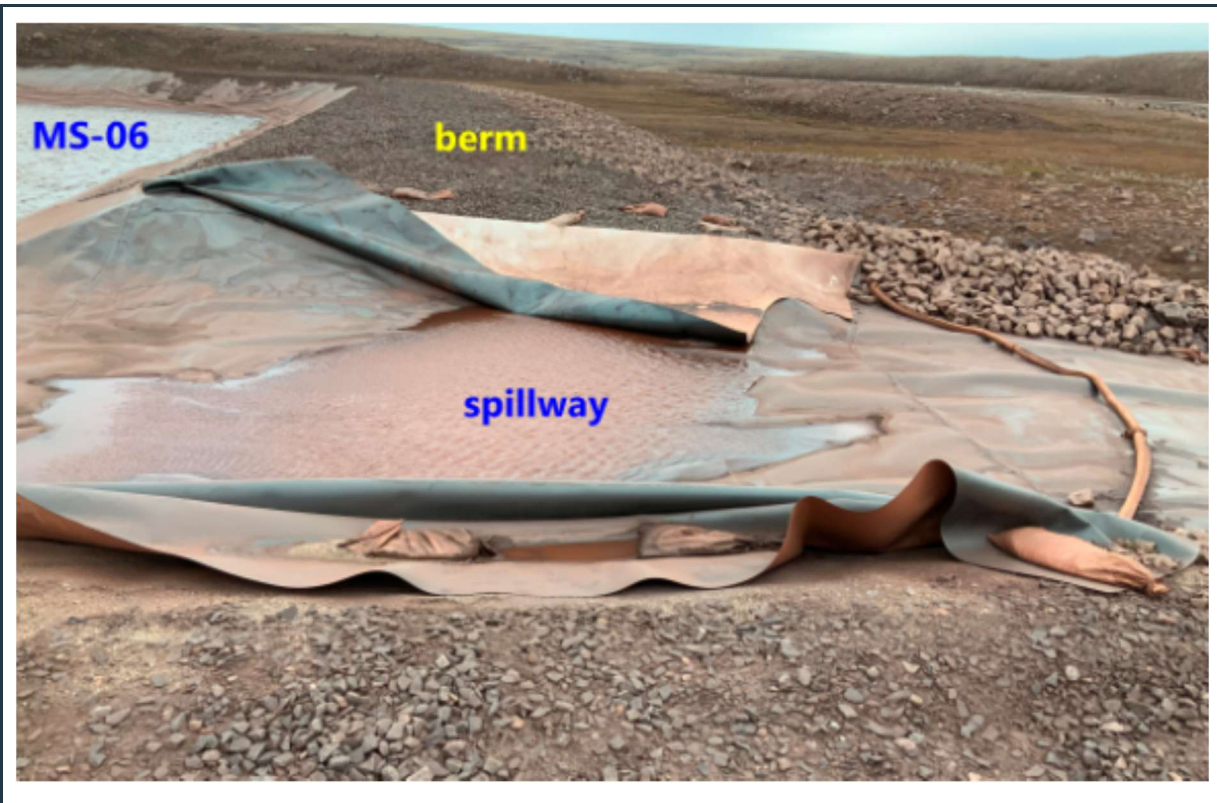
Figure 21: View of the robust, stable berm around the MS-06 pond, with temporary problem with the liner (lift-up by wind) at its spillway. The problem was rectified during the site visit.

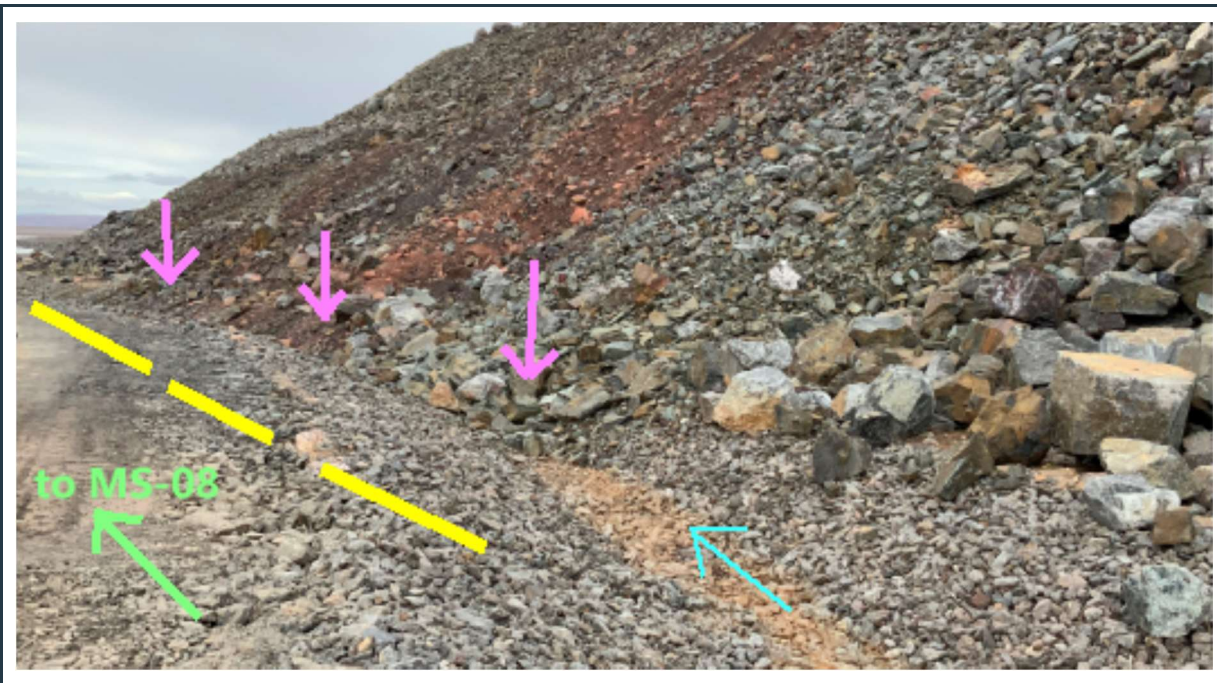
Figure 25: Drainage ditch around the west side of the waste rock facility. Note a short section of the ditch blocked by waste rock (purple arrows). It is suggested to excavate the ditch along the yellow line to facilitate easier flow of surface water within the ditch to the pond.

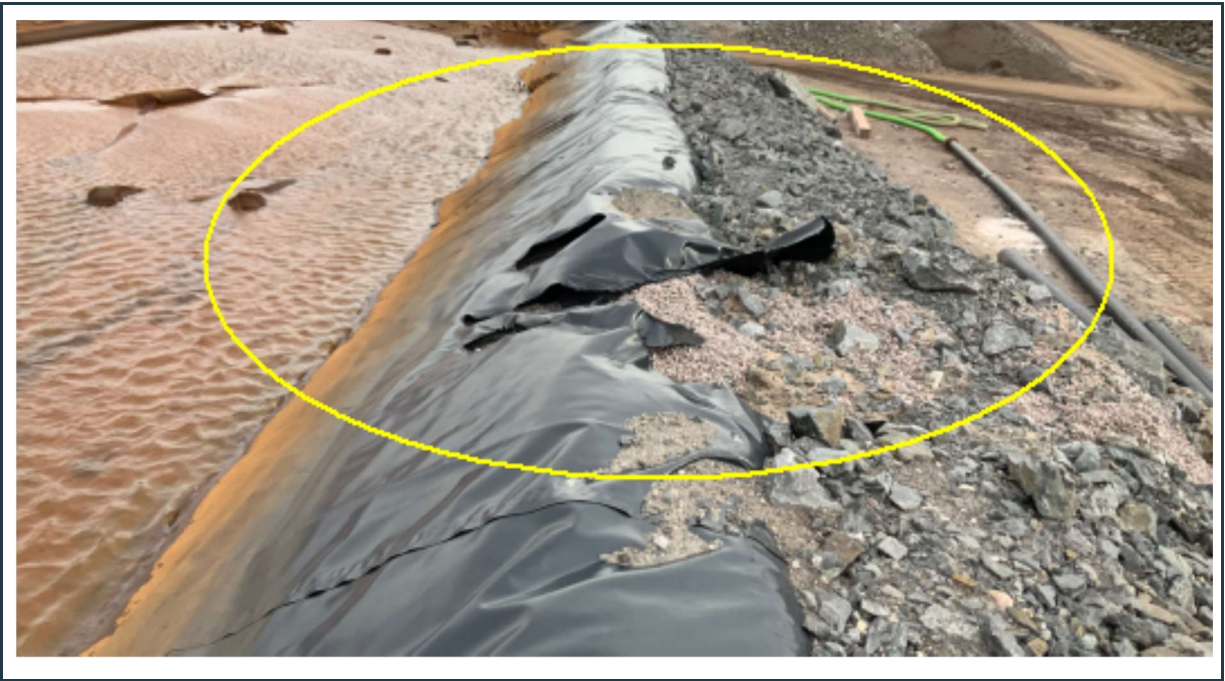
A section of the rock fill berm and liner at the south west berm of the WTP Geotube pond is damaged. The damaged berm section and liner should be repaired as soon as practically possible.

Figure 27: Damaged liner at the south-west section of the berm (yellow circle) at the geotube pond, located adjacent to the treatment plant and waste rock disposal facility.

Baffinland Action: Baffinland will repair the damaged berm section and liner when the contractors are on site during summer 2023. A field investigation determined that there is minimal risk to the Geotube pond capacity due to the location of the damage on the top of the crest (Completion Q3 2023).

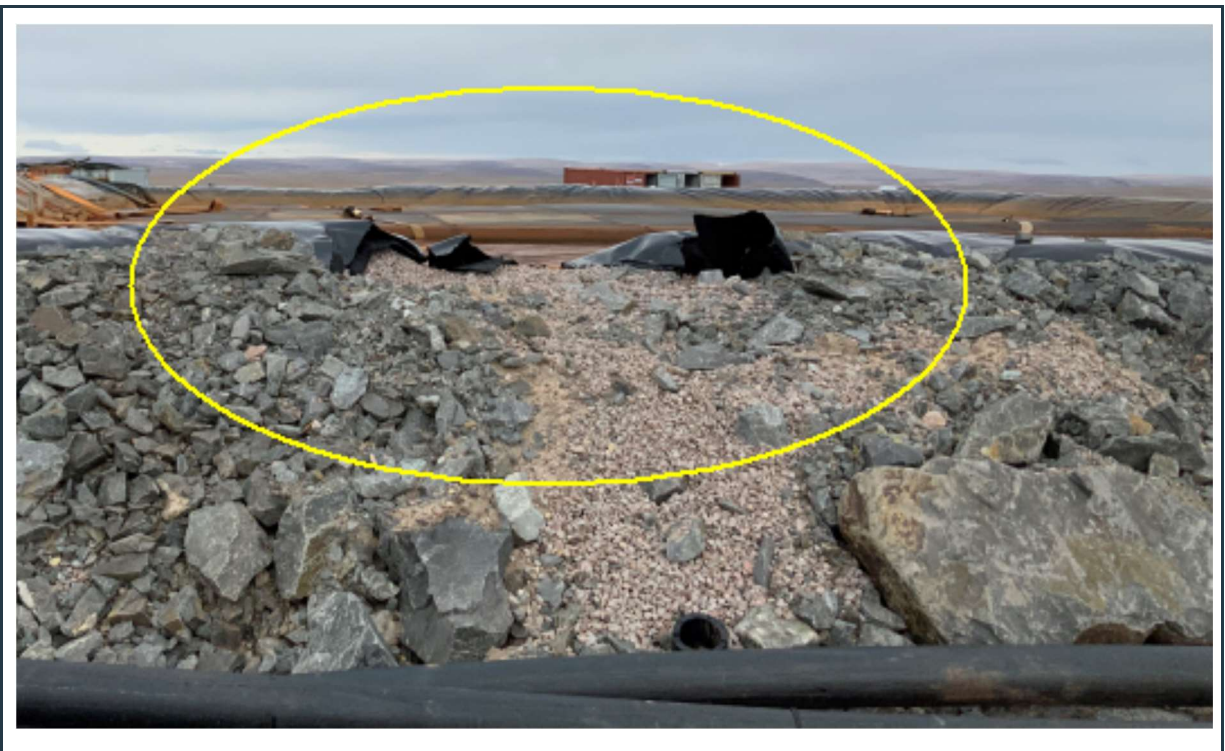
Figure 28: Damaged rock fill berm and liner at the south-west section of the berm at the geotube pond, located adjacent to the treatment plant and waste rock disposal facility.

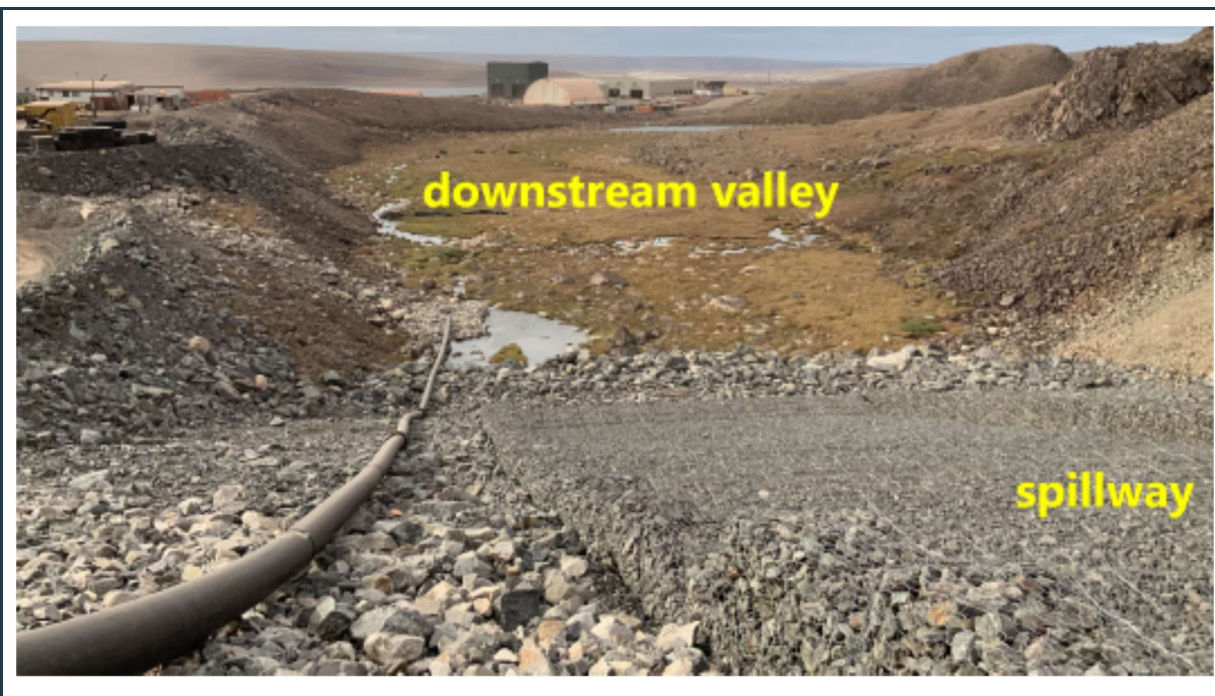
Figure 30: View of the robust and stable emergency spillway (gabion baskets and blankets filled with crushed rock) at KM105. Note the water seepage at the toe of the spillway.

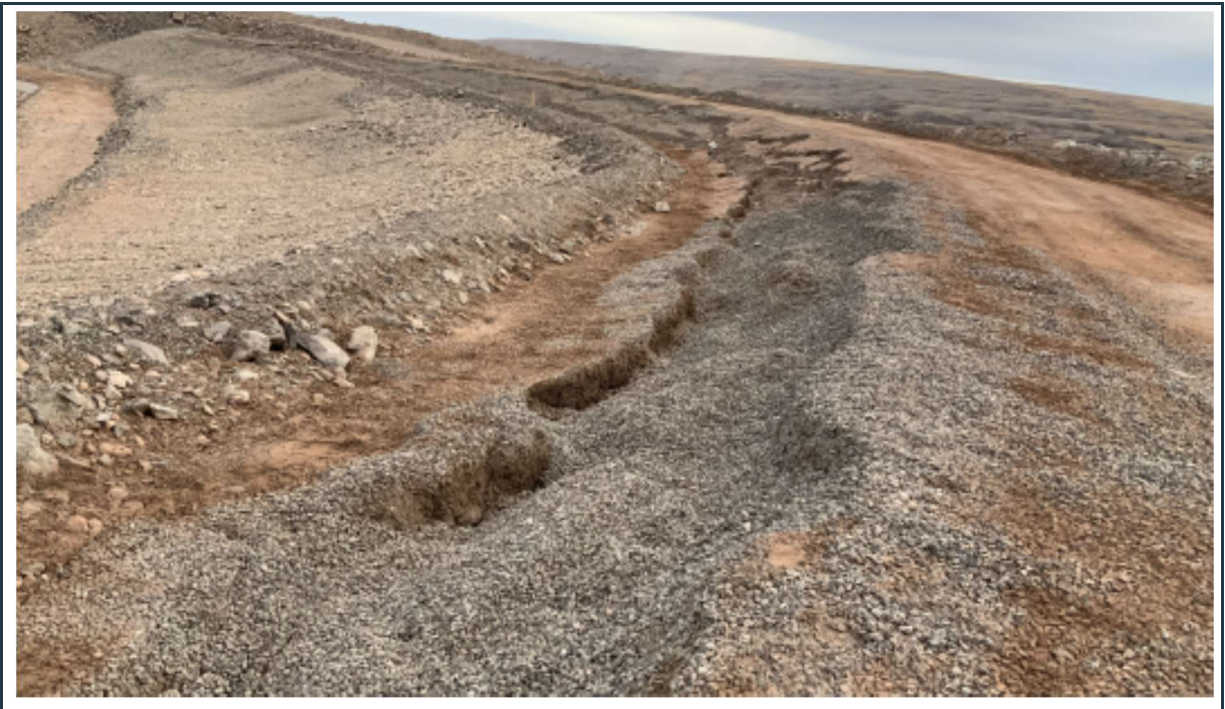
Some frost related damages were observed during the first inspection in 2022 along the road next to the southern zone of the MS-11 pond's slope. During the second inspection, some crushed stone was observed placed in some of the cracks however was not complete at the time. The cracks must be completely regraded/filled and compacted as soon as practically possible to prevent water collection in those cracks in the future.

Figure 31: View of freeze/thaw related ground movement along the road next to the MS-11 slope. The area of the cracks should be regraded/compacted to minimize water infiltration into the ground next to the slope.

Baffinland Action: Baffinland will review the potential frost related damages to the south embankment with the design engineer during 2023 repair work to correct the above observation, and implement corrective actions as per the design engineer's recommendations.

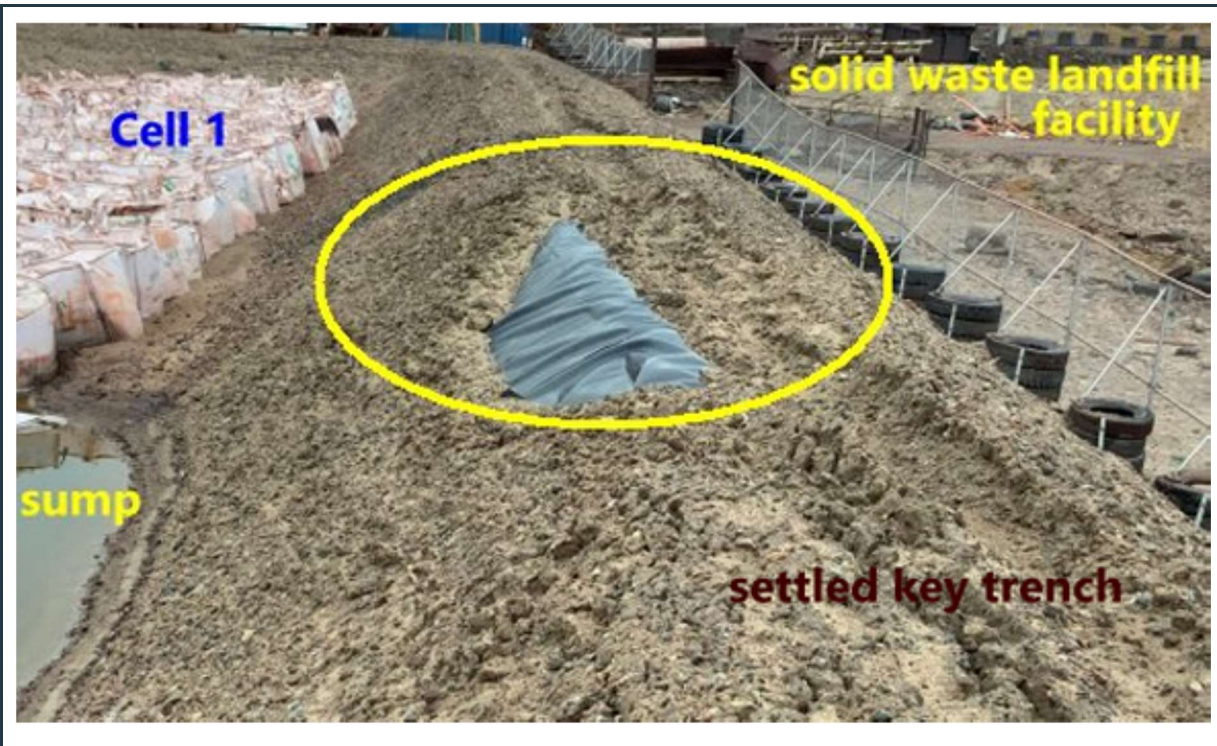
The slopes of the berms (upstream and downstream) appear to be steeper than the design. Also, the loose granular material anchoring the liner on the top of the berms has settled significantly, resulting in a long depression along the top of the berms. The water in the sump has resulted in slumping of the granular cover layer on top of the liner, which resulted in slumping of the granular cover layer on the slope of the berms. It is recommended that the deficiencies be repaired/rectified in both cells. The problems should also be considered (lessons learned) in the design and construction of the still planned two additional cells to prevent such problems in the future.

Figure 39: View of a section of the recently constructed berm at the land-farm's Cell 1. Note the exposed liner above the sump area and the settled anchor trench along the top of the berm.

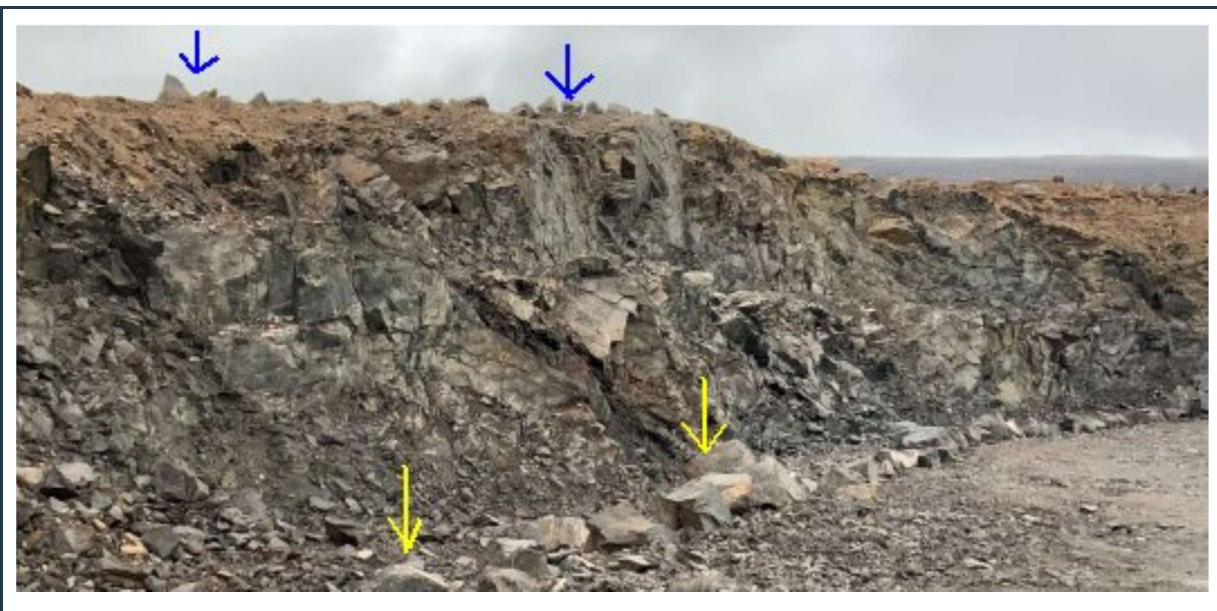
Figure 44: View of the rock face at the upper quarry level with some potential rolling rock hazard. Note the row of boulders placed on the crest and toe of the rock face to prevent unauthorized access to the wall. No activity is currently carried out in this quarry.

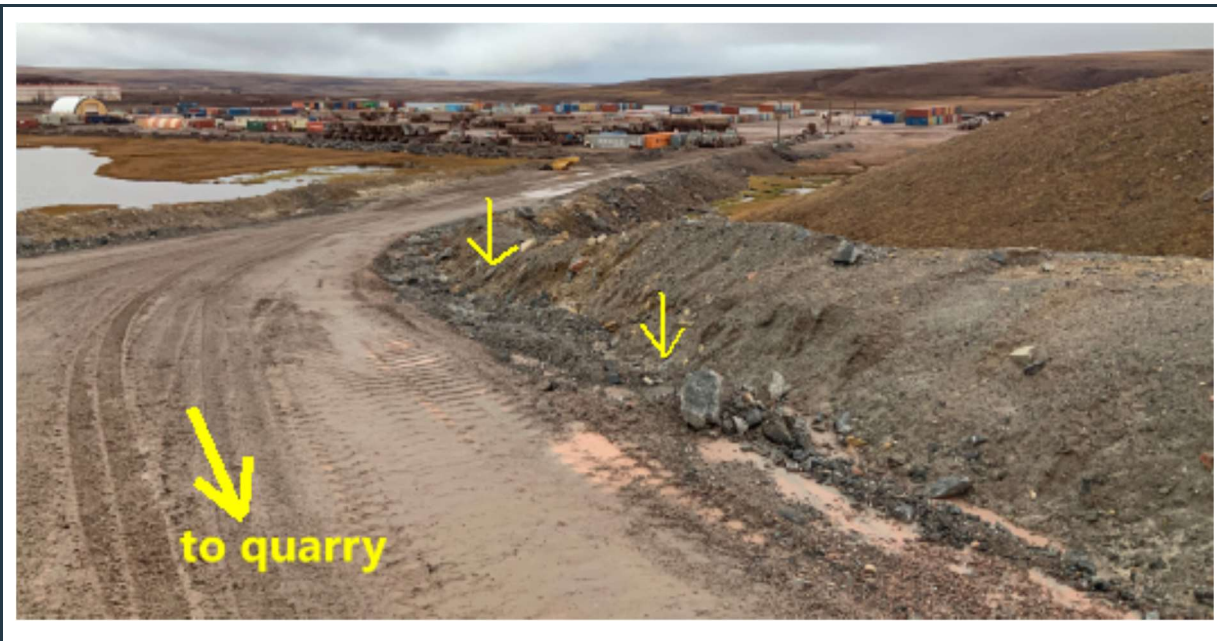
Figure 45: Erosion problem still exists along the edge of the access road to the quarry.

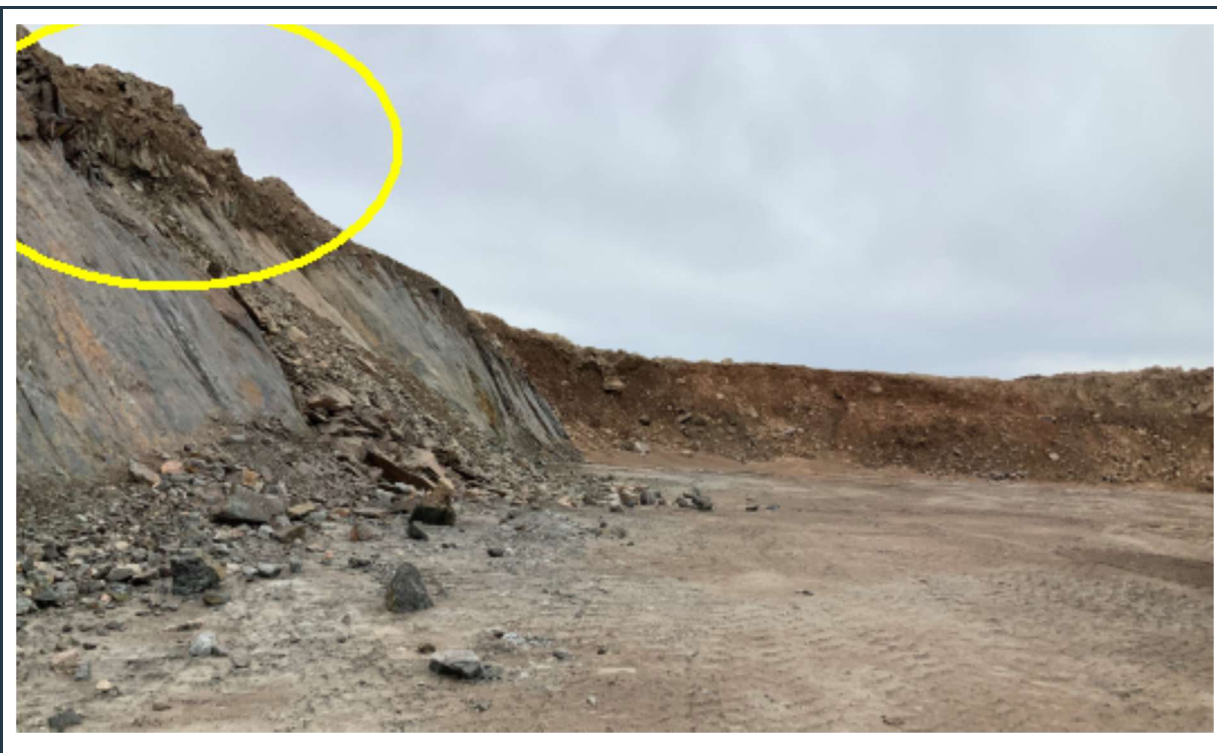
A few boulders were observed close to the edge of the crest of the slope of the D1Q1 quarry, from the overburden left in place on the upper ground surface. The soil cover on the top of the rock slope should be scaled back once the operation will restart in the quarry.

Figure 46: View of the exposed stable slope of the rock quarry with some boulders rolling down on the slope from the overburden. The soil cover on the top of the rock slope should be scaled back.

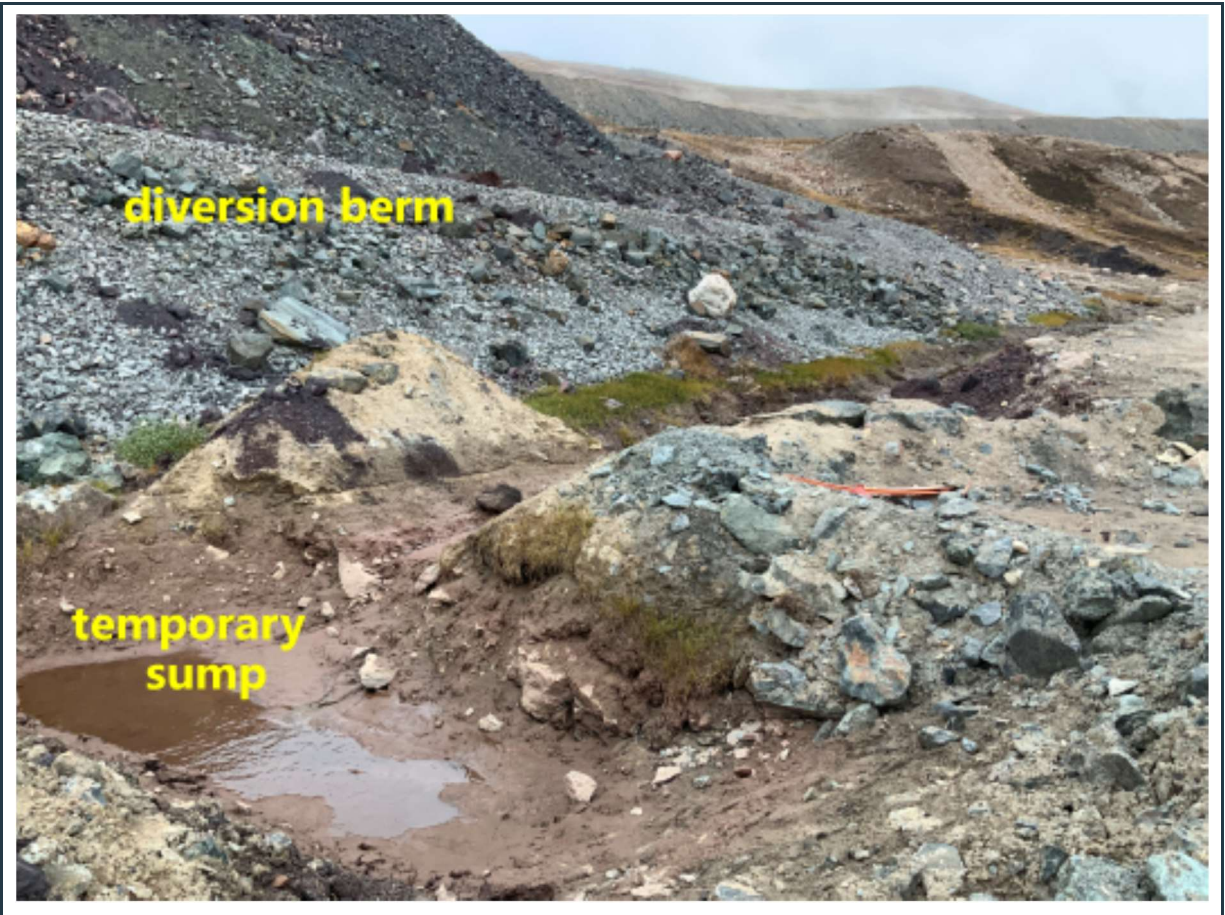
Figure 47: View of the surface water diversion berm at the new KM-106 ore stockpile area. Note the water seepage through the berm into a temporary sump, downstream from the diversion berm. The water from the sump is periodically pumped into the new nearby MS-07 surface water management pond.

It is recommended to cover the base and slopes of the temporary containment sump adjacent to the Facility Diversion Berm with riprap.

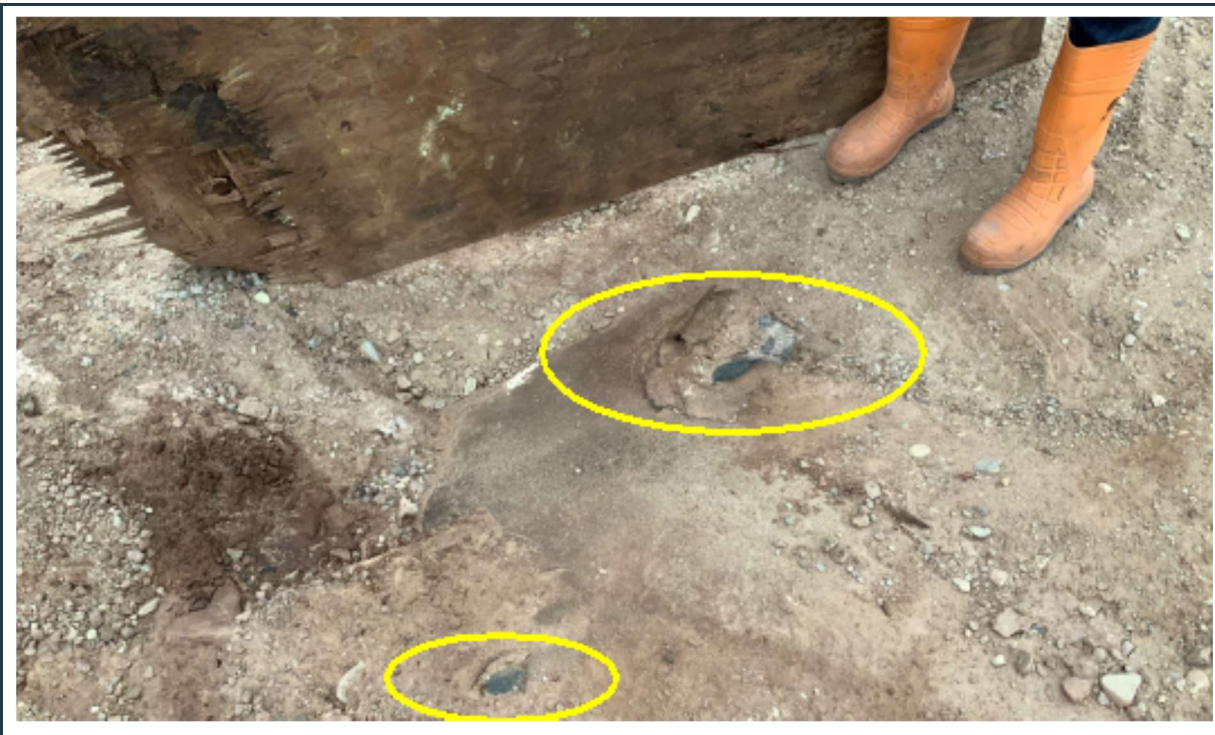
The geotextile was noted to be damaged in two areas on the access ramp to MP-04A, although there was no damage to the liner noted. It is recommended that the granular fill be carefully removed from the area and the damaged geotextile be replaced, followed by the placement of additional granular fill cover layer. The placement of somewhat thicker granular fill is recommended on the ramp and over the top of the berm in this area to assist in future prevention of a similar issue.

Figure 57: View of damaged geotextile at the access ramp to the MP-04A cell. The liner is still intact, but the geotextile should be repaired, and granular fill should be placed over the ramp.

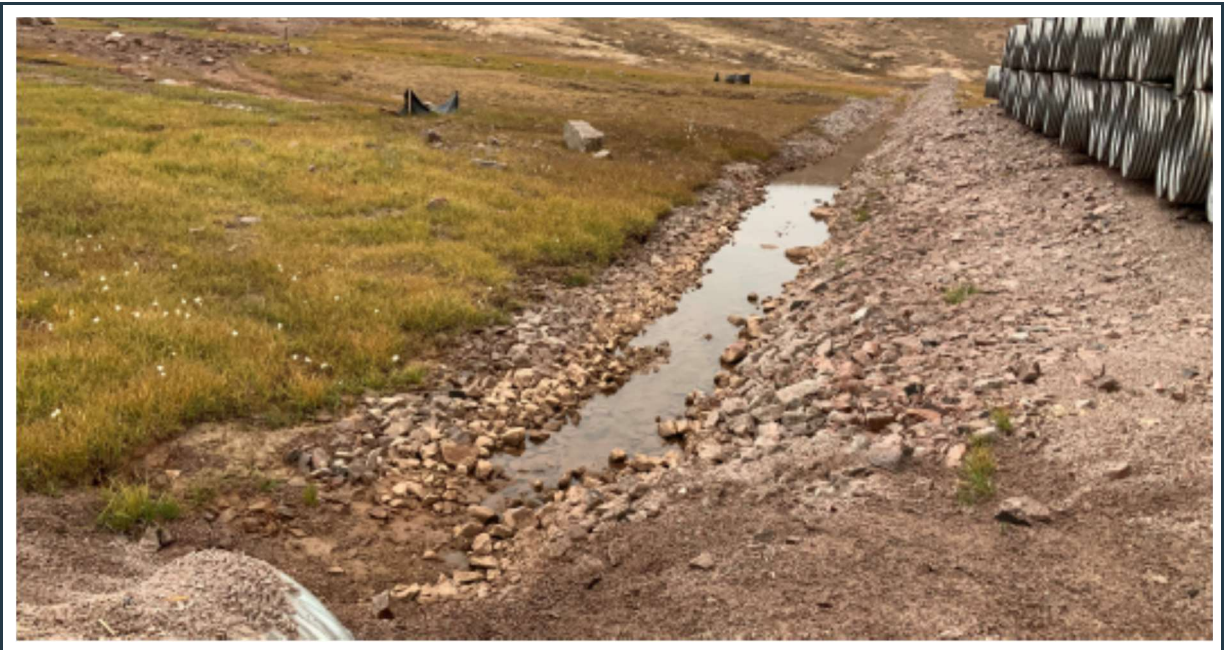
Sloughing of the sides of the P-SWD-3 ditch, adjacent to the LP2 laydown area, has occurred at several locations along the ditch however the ditch is not able to convey the collected water to the required location. To improve the drainage capability of this ditch, it is recommended that it should be redesigned and reconstructed to drain the large amount of surface water from the snow-dump to the north-east. The design must consider the fact that large amount of snow is stockpiled adjacent to this ditch every winter that generates excessive quantity of run-off water in the spring/summer that must be drained more efficiently toward the north-east. It is also suggested that a perimeter diversion berm be provided around the snow stockpile area and the surface water generated by the melting snow be conveyed to the P-SWD-3 ditch in a separate new drainage ditch.

Figure 66: View of the southern part of the P-SWD-3 surface water collection ditch with failed slope sections, and ponding water due to inadequate longitudinal channel slope.

Baffinland Action: Baffinland will complete the remaining improvement work in this drainage ditch in 2023. A review of the water management design in this area is required, to include consideration of snow stockpile melt, which will occur prior to Freshet 2023. The resulting remedial plan will be implemented when ground conditions permit in Q3 2023. In the interim, all water will continue to be actively pumped downstream of this area to the proper receiving location until permanent remedial work to the drainage ditch is complete.

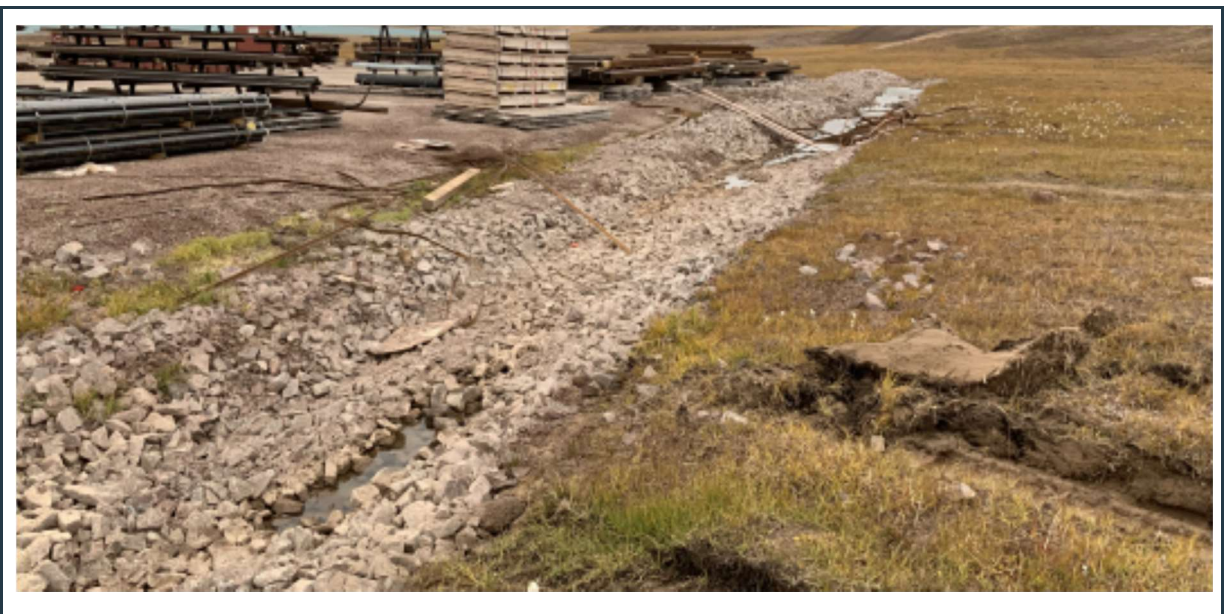
Figure 67: View of the northern part of the P-SWD-3 surface water collection ditch with failed slope sections and some debris left in the channel, which should be removed.

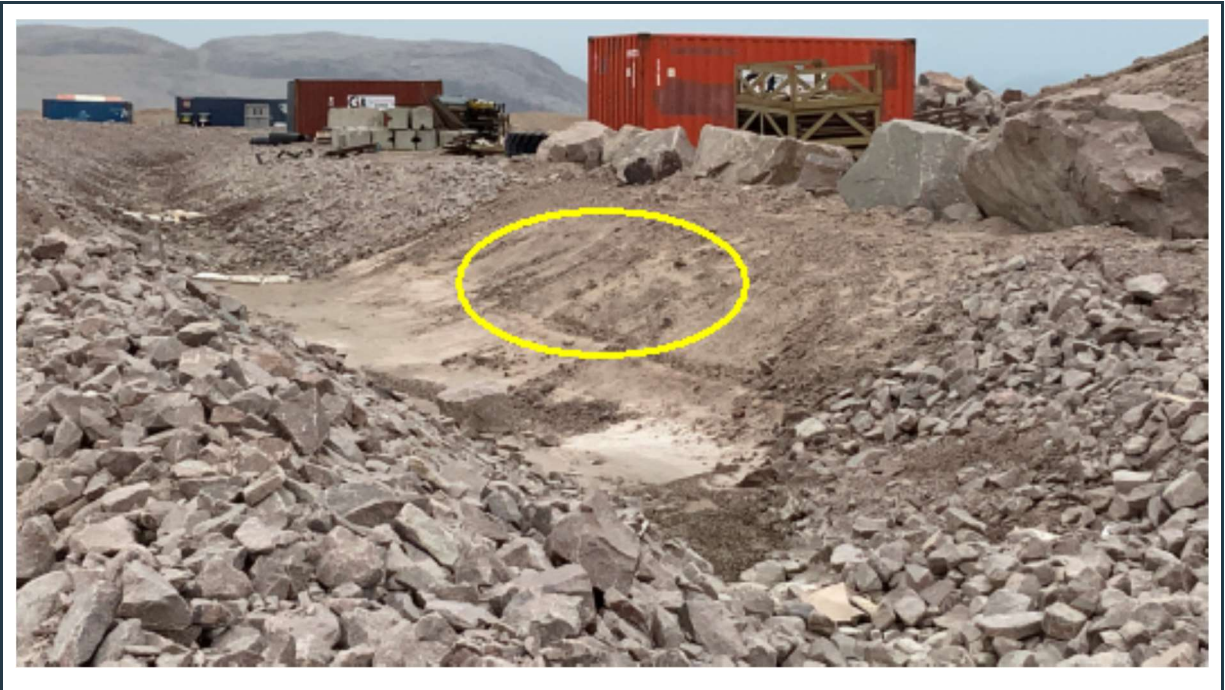
A short section of the P-SWD-5 ditch was noted with missing riprap and continuous water seepage from the side-slope was observed resulting in the periodic sloughing/erosion of the side of the ditch along this short section. It is recommended that the finer soil, currently forming the side of the ditch, be removed to a depth of around 1 m and replaced with crushed rock fill. To minimize migration of fine soil particles from the quarry pad to the ditch, the crushed rock fill should be placed over geotextile. There is also a clogged culvert along this ditch, located beneath the road at the entrance to the quarry. The clogged culvert should be cleaned or replaced if necessary; preferably with a larger diameter culvert.

Figure 68: P-SWD-5 – “Q01-North” surface water collection ditch with missing riprap at a short section.

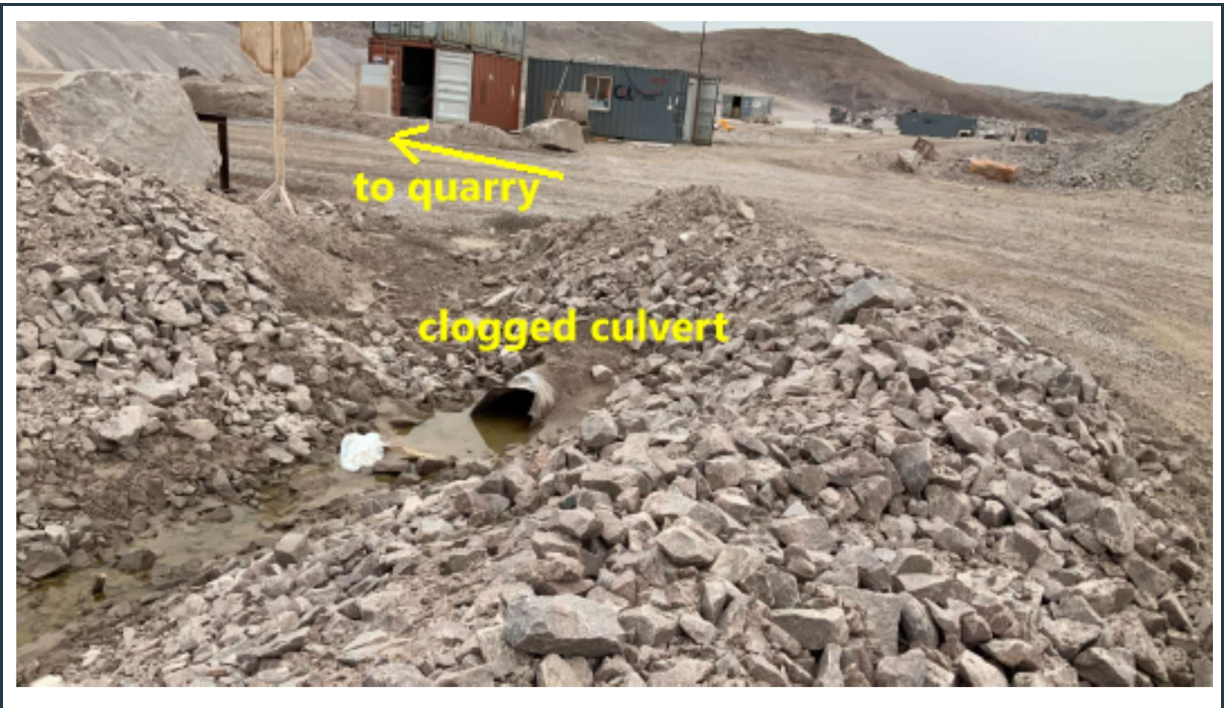
Figure 69: Clogged culvert at the entrance to the quarry in P-SWD-5/Q01-North surface water collection ditch. Should be replaced with a new, larger diameter culvert.

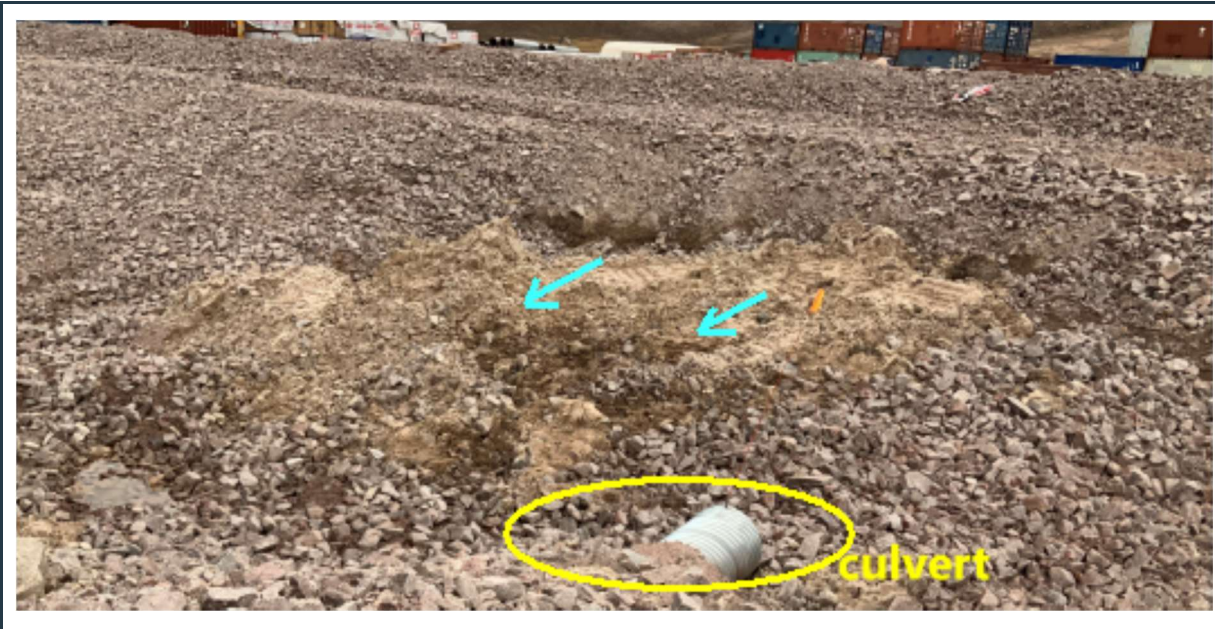
Minor localized slope movements/failure at the west end of the ditch should be repaired, regraded and the riprap rock fill cover reinstated. The sloughing of the slope is apparently caused by frequent water seepage from the granular fill of the LP-2 laydown that likely is a result of the inefficient drainage of

surface water from the P-SWD-3 ditch that seeps into the LP-2 laydown and most likely exits at the location in the PSC ditch requiring repairs. Once the drainage conditions in the P-SWD-3 ditch are improved/rectified, the failed slope at the PSC ditch can also be repaired. Consideration should be given to reshape the west section of the ditch and reinstall the culvert to a lower invert level to prevent ponding in this section of the ditch.

Figure 76: View of the PSC surface water collection ditch. Note the localized slope degradation due to frequent water seepage from the granular fill of the LP-2 laydown pad (blue arrows).

Baffinland Action: Baffinland will repair and regrade the identified area in the ditch where localized slope movements/failure have occurred and reinstate the riprap rock cover in Q2 2023. Baffinland will inspect in Q2 2023 and, if required, repair the invert level of the west ditch section culvert, prior to completion of the construction of the PSC drainage ditch.

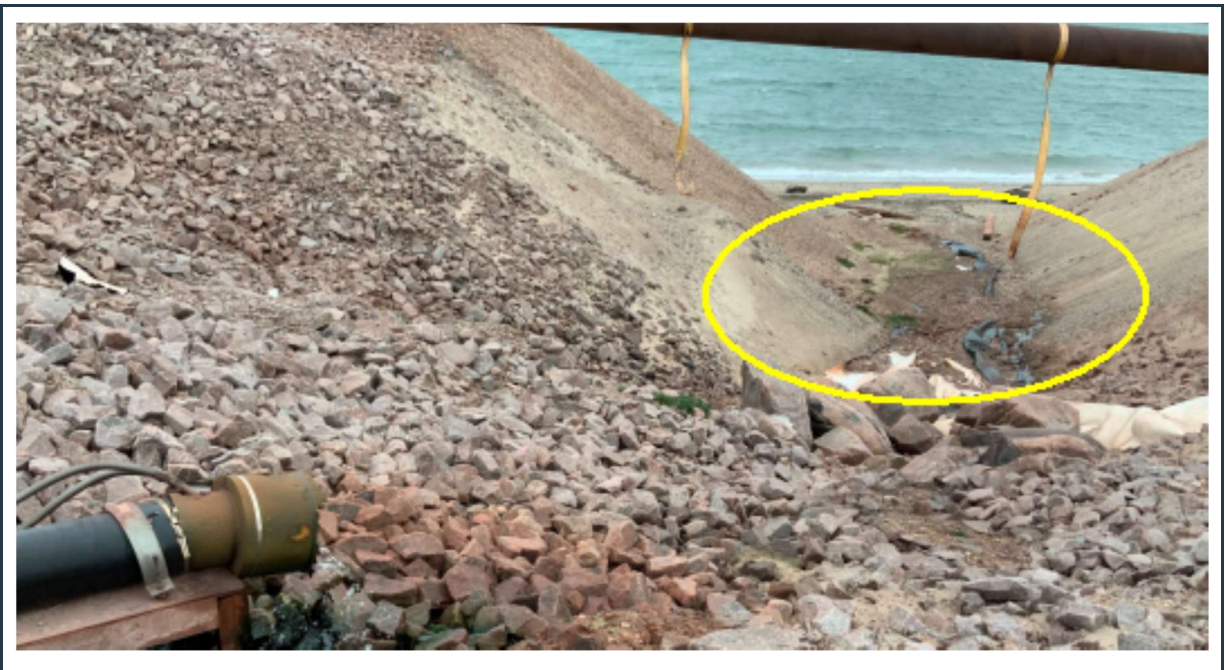
Figure 79: View of the water discharge pipe with rockfill riprap on the adjacent stable slope. More well-graded rockfill riprap should be placed over geotextile along the valley floor (yellow circle), to prevent erosion of finer soil from that area.

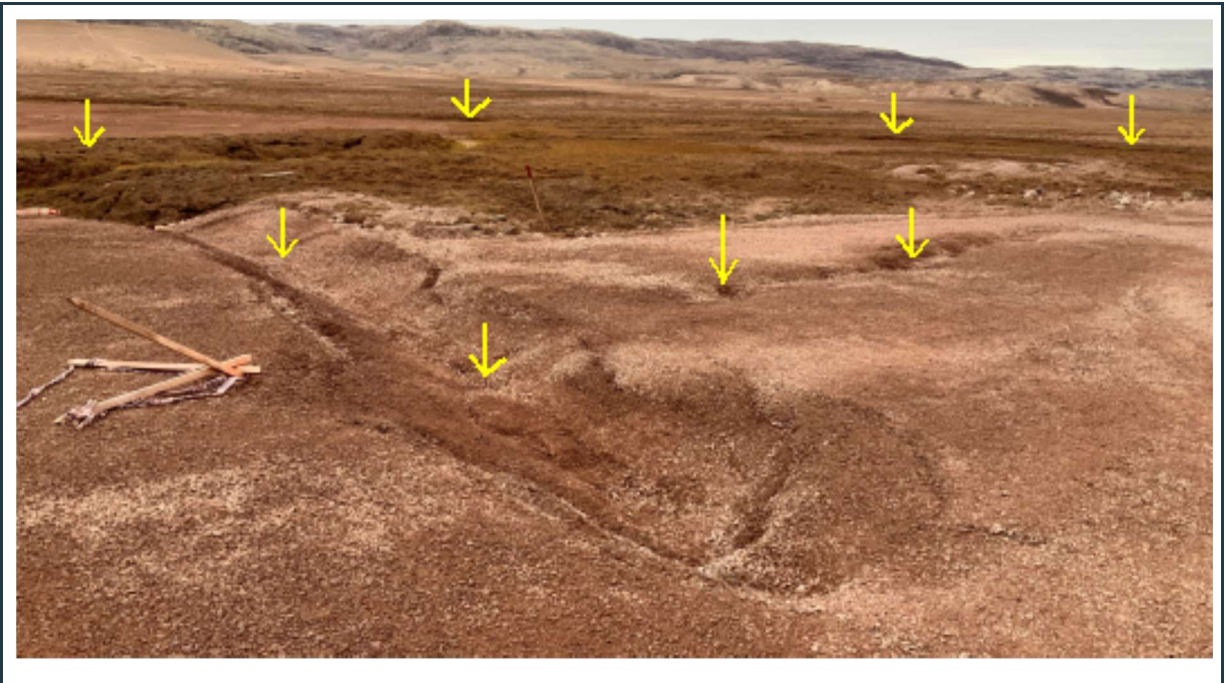
A network of natural cracks and depressions were noted on the surface at the edge of the LP-5 Laydown, and periodic formation and thawing of ice wedges resulted in a network of “stripes” (depressions/ cracks) within the active layer of the laydown. It was suggested to fill the cracks with the same material that was used for the laydown construction (sand and gravel), to minimize ice-wedge development in the future.

Figure 80: View of a network of natural cracks and depressions on the surface in the area at and adjacent to the LP-5 storage area. The depressions across the storage area should be filled with more sand and gravel and the surface shall be regraded.

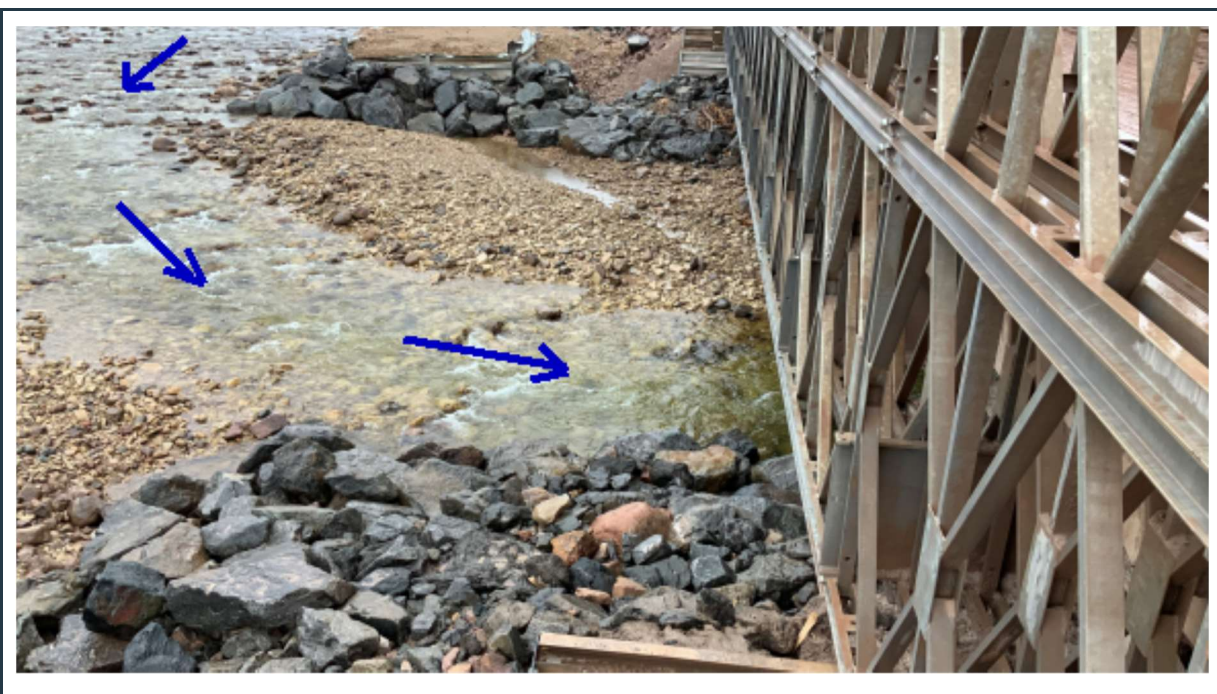
Figure 84: View of the stable abutments with low flow at the east side of bridge 63. Also note one of the two “old” abutments with riprap erosion protection.

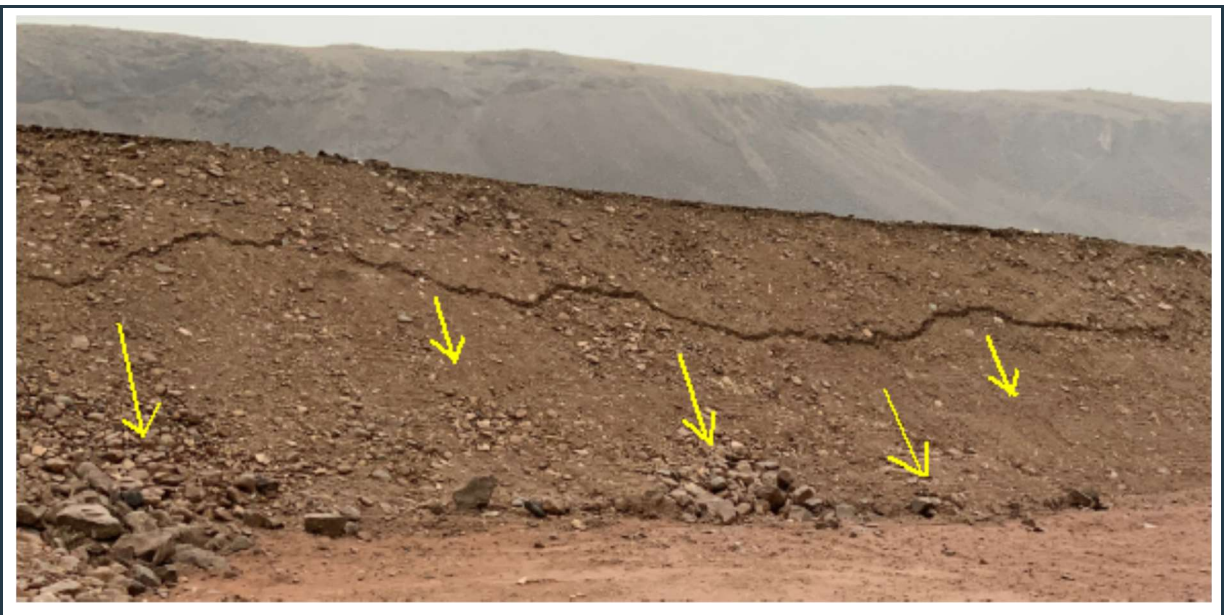
Figure 92: View of the face of the slope at KM 09+700. Note the slumping/spalling/raveling of material trickling/rolling down on sections of the face of the slope without endangering the traffic on the tote road, located well away from the slope.

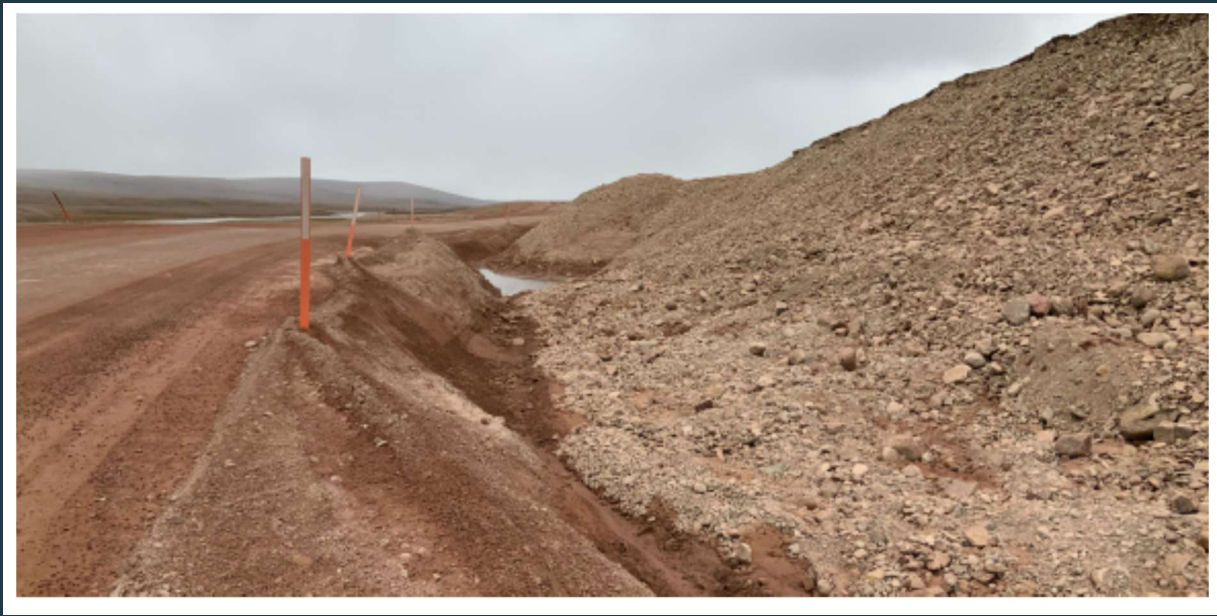
Figure 93: View of the slope at a cut section of the tote road at KM 28+900.

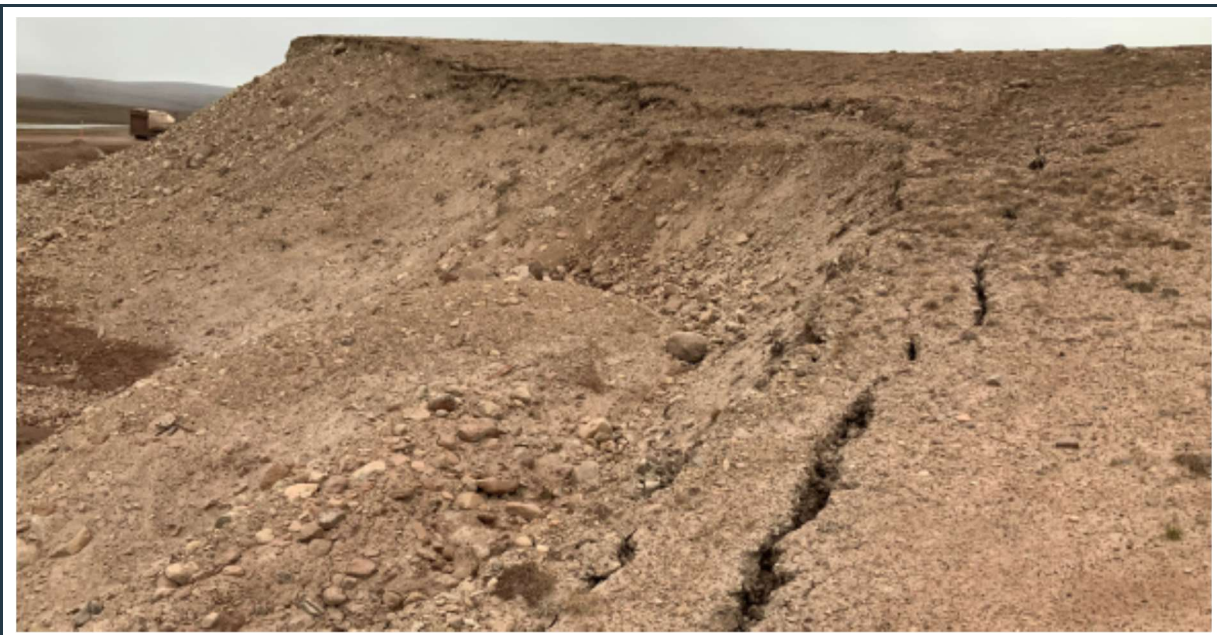
The toe of the slope at the historic borrow pit at KM28.9 to KM29 is located somewhat closer to the edge of the road and the slope appears to be as steep as 1H:1V. The raveling face of the slope and the development of tension cracks indicate further slumping of the slope can be expected in the future. Although there is no immediate risk to the traffic on the road, the sloughing soil from the steep slope is filling up the drainage ditch along the road, preventing surface water from flowing in the ditch. At the subject road section, it is suggested that the slope should be reshaped (cut back) to shallower inclination (preferably to 2H:1V) and the drainage ditch be cleaned of soils, as soon as practically possible.

Figure 94: View of the slope at a cut section of the road at KM 28+900. Note the tension cracks on the crest of the slope due to freezing and thawing action in the ground. The slope is located somewhat closer to the road, but at this stage it may not present any risk to the traffic on the road or to the stability of the road. However, the slope should be monitored and reshaped to shallower inclination if necessary.

Baffinland Action: Baffinland will complete this when ground conditions permit in Q3 2023.
