2020 Site Update Report

Meadowbank Gold Mine Project (NIRB File No. 03MN107) & *Whale Tail Pit Project* (NIRB File No. 16MN056)

Agnico Eagle Mines Limited

October 2020

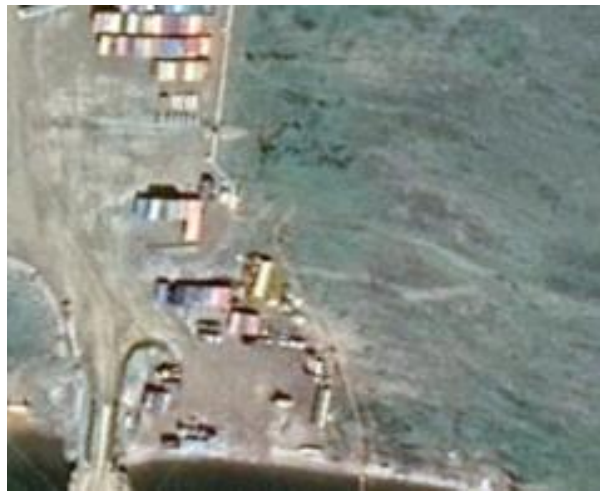
- c) Agnico Eagle confirmed that the lower all-terrain vehicle (ATV) trail that goes through the Baker Lake bulk fuel storage facility/marshalling area remains in place allowing members of the community to travel to their cabins along the shoreline (Photo 5).
- d) Agnico Eagle noted that there is 24-hour security at the Baker Lake facility.

Photo 5: Lower ATV Trail

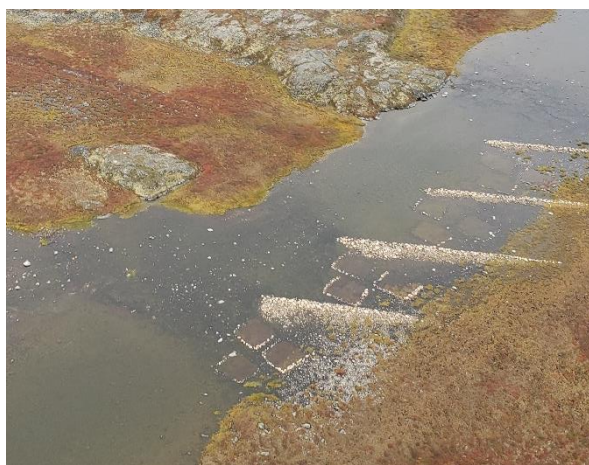
Photo 11: Spawning Pad

- a) Seacans with emergency spill response equipment are located at every bridge crossing (Photo 10).
- b) The spawning habitat rock structure located at the first bridge (Photo 11) was monitored in 2019 (see *2019 Annual Report*) with the next monitoring campaign planned for 2021.

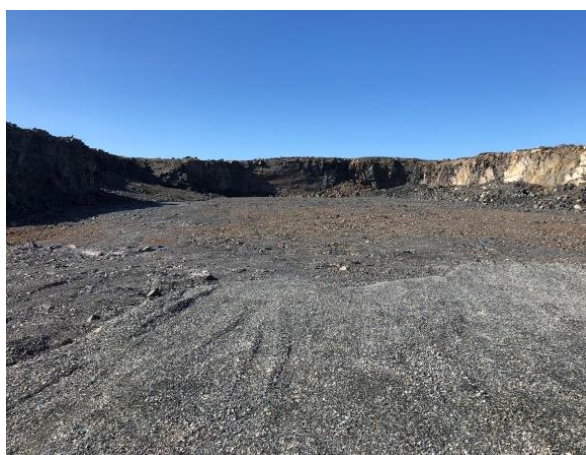
Photo 12: Quarry 22

- e) Remediation has been ongoing at Quarry 22 following storage of contaminated hydrocarbon soil in previous years with the soil/gravel still testing positive for hydrocarbons (Photo 12). In 2020 Agnico Eagle tried to prevent nesting with a bird decoy (Photo 13) and bird cannon; however, the birds were not deterred and nested in 2020 and the equipment was removed.

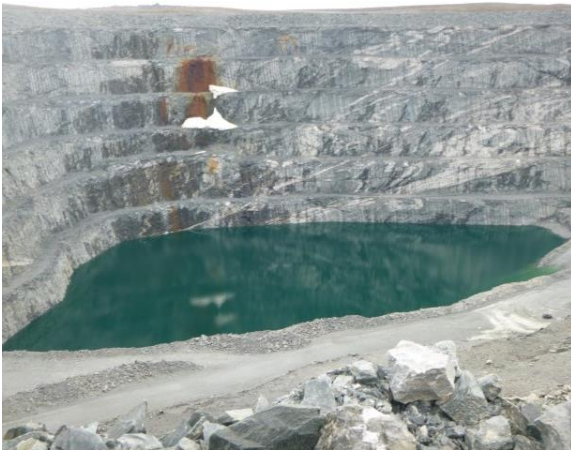
- a) Active mining was completed at all pits by the end of fourth quarter in 2019. Some residual stockpiles are still being processed at the mill.
- b) Mining completed in Vault Pit in March 2019. As observed in previous years, an ice sheet had formed on the walls of the Vault Pit and remains present in 2020 (Photo 14 and Photo 15).

Photo 14: Vault Pit Ice Sheet

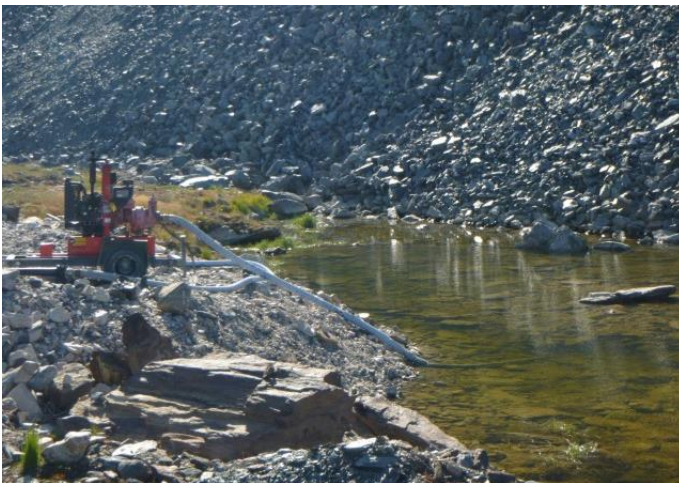
Photo 21: Seepage from Portage Waste Rock Storage Facility

- f) In 2013, Agnico Eagle noted seepage from the Portage waste rock storage facility with potentially acid generating rock (which has a high sulphur content, heavy metals, and other contaminants) at a location near the south shore of a fish bearing lake (referred to as North Pole 2 or NP-2 lake). Agnico Eagle stated that in 2020 seepage water continued to be pumped to the Tailings Storage Facility North Cell (Photo 21).

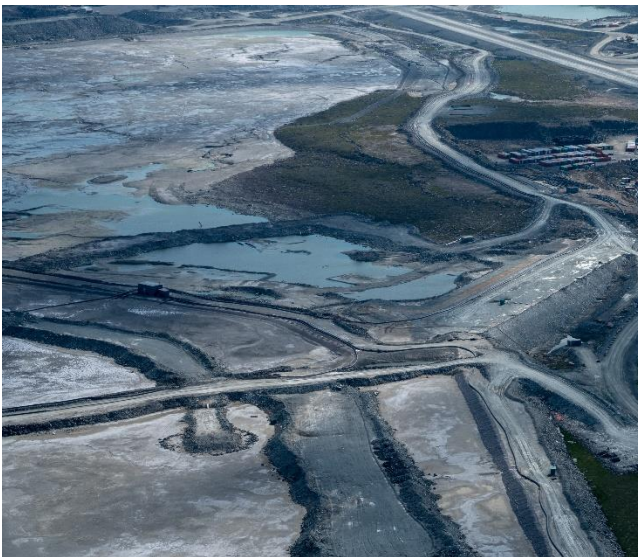
Agnico Eagle stated that no tailings were disposed at the Tailings Storage Facility (TSF) in 2020. Reclamation is ongoing on the North Cell with new capping present ([Photo 31](#)). No update was provided on reclamation of the South Cell in 2020 (Photo 32).

Photo 31: Tailings Storage Facility – North Cell

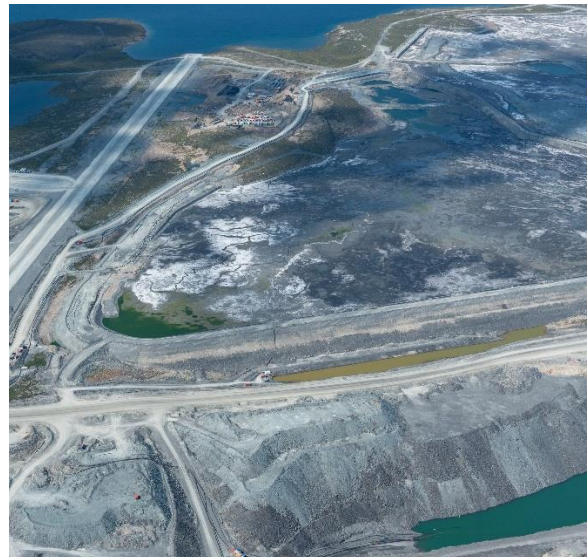
Photo 32: Tailings Storage Facility – South Cell

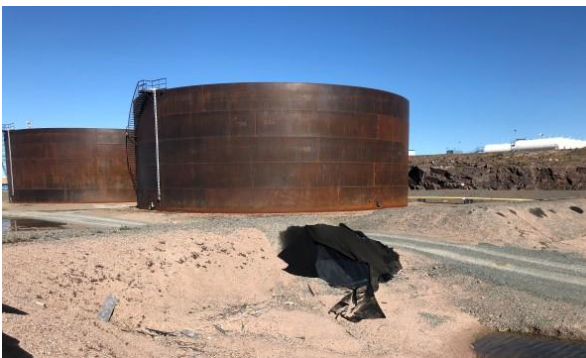
During their 2019 site visit NIRB staff noted that the liner at the Baker Lake Fuel Storage facility was exposed and Agnico Eagle informed the NIRB that it continues to be exposed in 2020 (Photo 37). Agnico Eagle noted no liner is seen exposed at the Meadowbank Tank Farm. As with 2019, water pooled within the secondary containment facility at the Meadowbank fuel tank farm in 2020 (Photo 38). This water is discharged towards the Stormwater Management Pond which is then directed to the Tailings Storage Facility.

Photo 37: Exposed Liner at Fuel Tanks

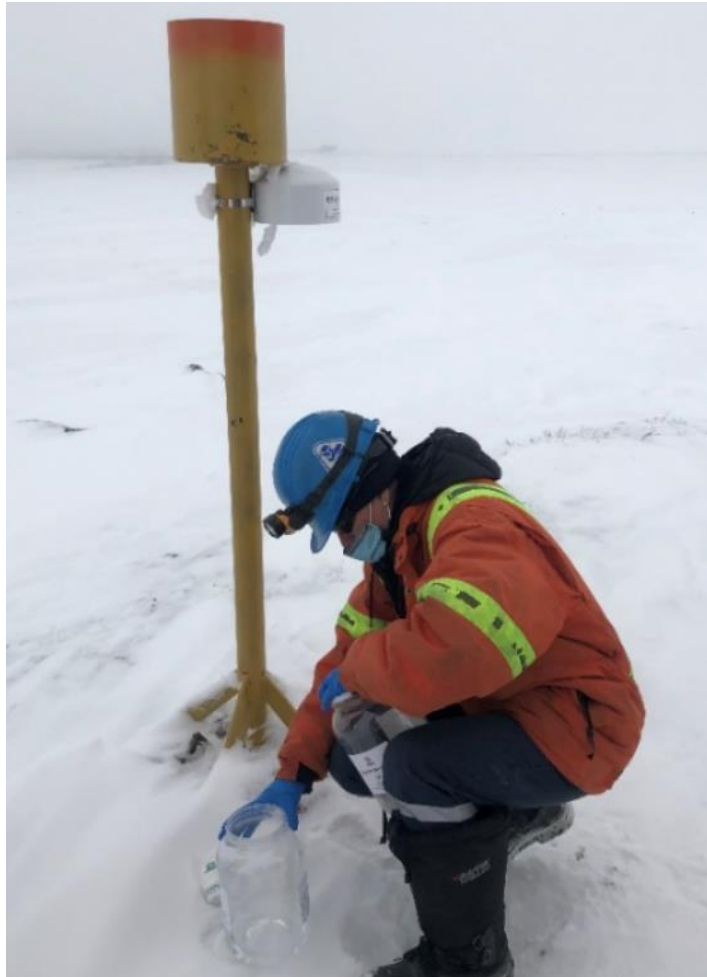
Condition 1 was revised during the Whale Tail Expansion Reconsideration to include a requirement for the Proponent to undertake continuous NO₂ monitoring downwind of mining activities. There is currently one (1) station with dustfall and NO₂ samplers on site (Photo 66). Agnico Eagle noted that a NO₂ continuous monitoring station will be installed by the end of 2020.

Photo 66: Dust and NO₂ sampler at station DF-6

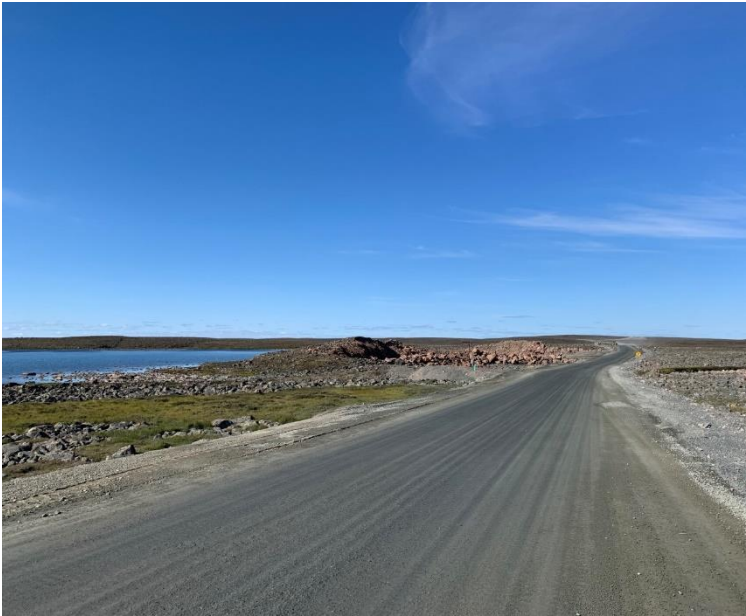
During their 2019 site visit, NIRB staff observed that dust suppressant was not being applied to the whole AWAR (see section 2.1.2.2), along the Whale Tail Haul Road (WTHR) nor at the Whale Tail site. In 2020 Agnico Eagle noted that calcium chloride dust suppressant was applied to the entire length of the WTHR (Photo 67). Also similar to the AWAR, dust monitoring stations have

Photo 67: Whale Tail Haul Road After Dust Suppression

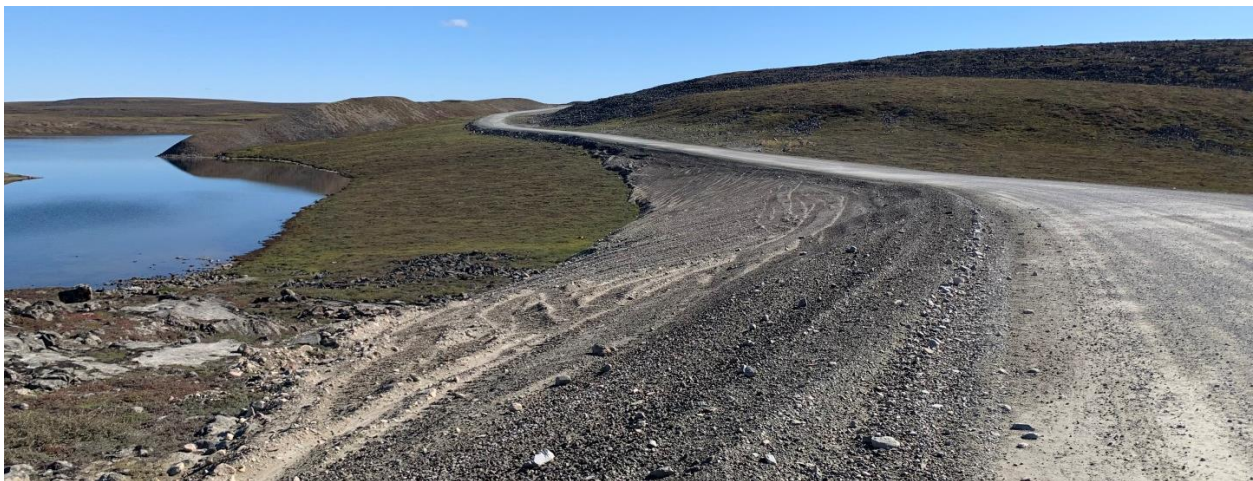
During their 2019 site visit Agnico NIRB staff noted that no specific caribou/wildlife crossings were in place. In addition, it was observed that the Haul-road was not sloped to assist wildlife in crossing the road. Agnico Eagle stated that the snowmobile crossing also serves as the wildlife crossing and that no additional crossings were needed by the Baker Lake Hunters and Trappers Organization (BLHTO). In 2020 Agnico Eagle also updated that the WTHR has since been resloped allowing easier crossing (Photo 69).

Photo 69: Whale Tail Haul Road Resloped
