WATER LICENCE INSPECTION FORM

Licensee	Licensee Representative
Agnico-Eagle Mines Limited	Robin Allard
Licence No. / Expiry	Representative's Title
2AM-WTP1826 / May 28 th 2026	Senior Environmental Coordinator
Land / Other Authorizations	Land / Other Authorizations
--	--
Date of Inspection	Inspector
August 28 th 2018	WRO T.Morton
Activities Inspected	
<input checked="" type="checkbox"/> Camp <input checked="" type="checkbox"/> Roads/Hauling	<input type="checkbox"/> Drilling <input checked="" type="checkbox"/> Other: Water Supply
<input checked="" type="checkbox"/> Mining	<input checked="" type="checkbox"/> Construction <input type="checkbox"/> Other:
<input type="checkbox"/> Reclamation	<input checked="" type="checkbox"/> Fuel Storage

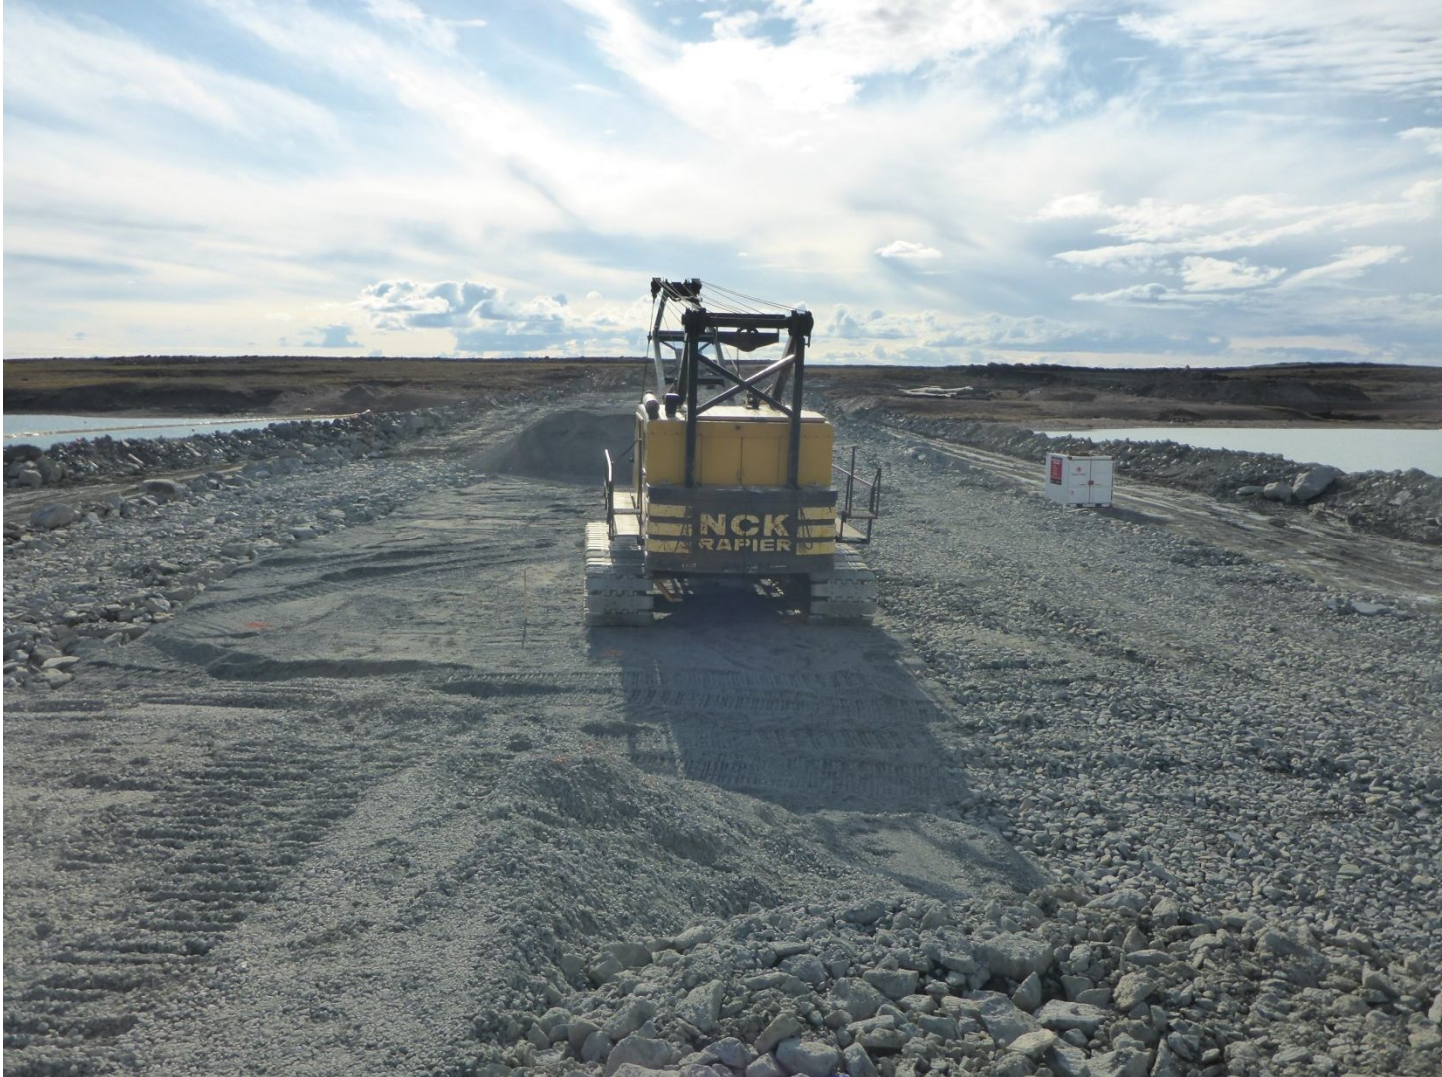
Date:	Authorization Number:	Camera/Model:	Inspector
August 28 th , 2018	2AM-WTP1826	Panasonic Lumix DMC-TS5	WRO Morton
Photo No.	Lat/Long (DD.MM.SS.SS, NAD83)		
Photo 1

Description:
Southwest view of the Whale Tail Dyke.

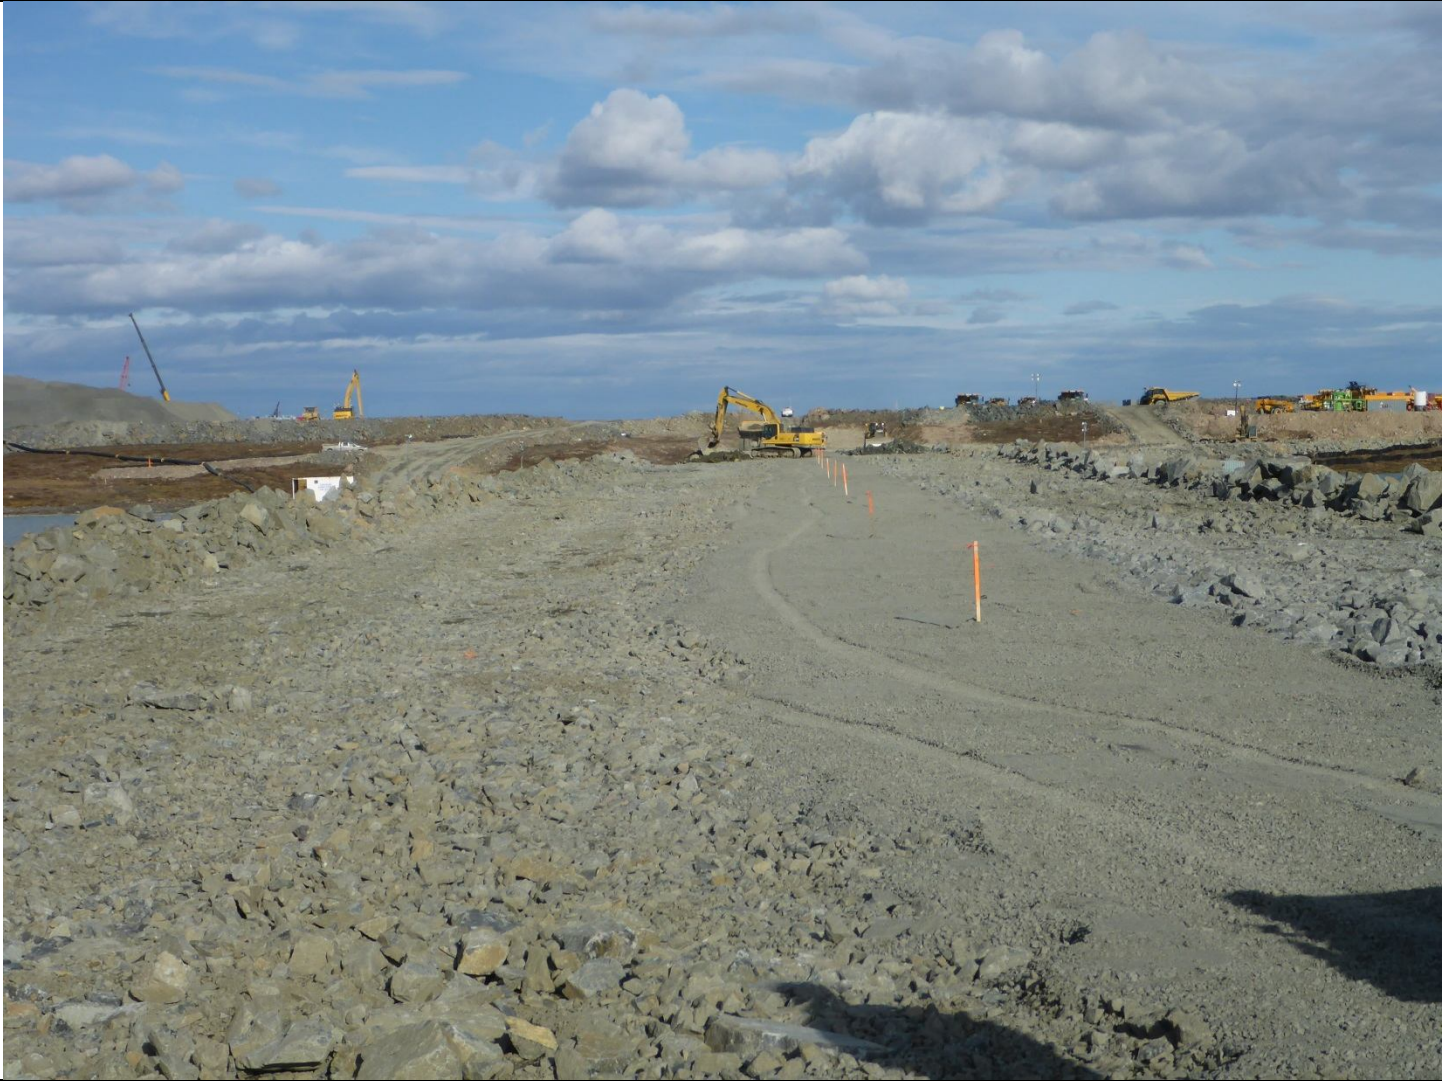
Date:	Authorization Number:	Camera/Model:	Inspector
August 28 th , 2018	2AM-WTP1826	Panasonic Lumix DMC-TS5	WRO Morton
Photo No.	Lat/Long (DD.MM.SS.SS, NAD83)		
Photo 2

Description:
Northeast view of the Whale Tail dyke.

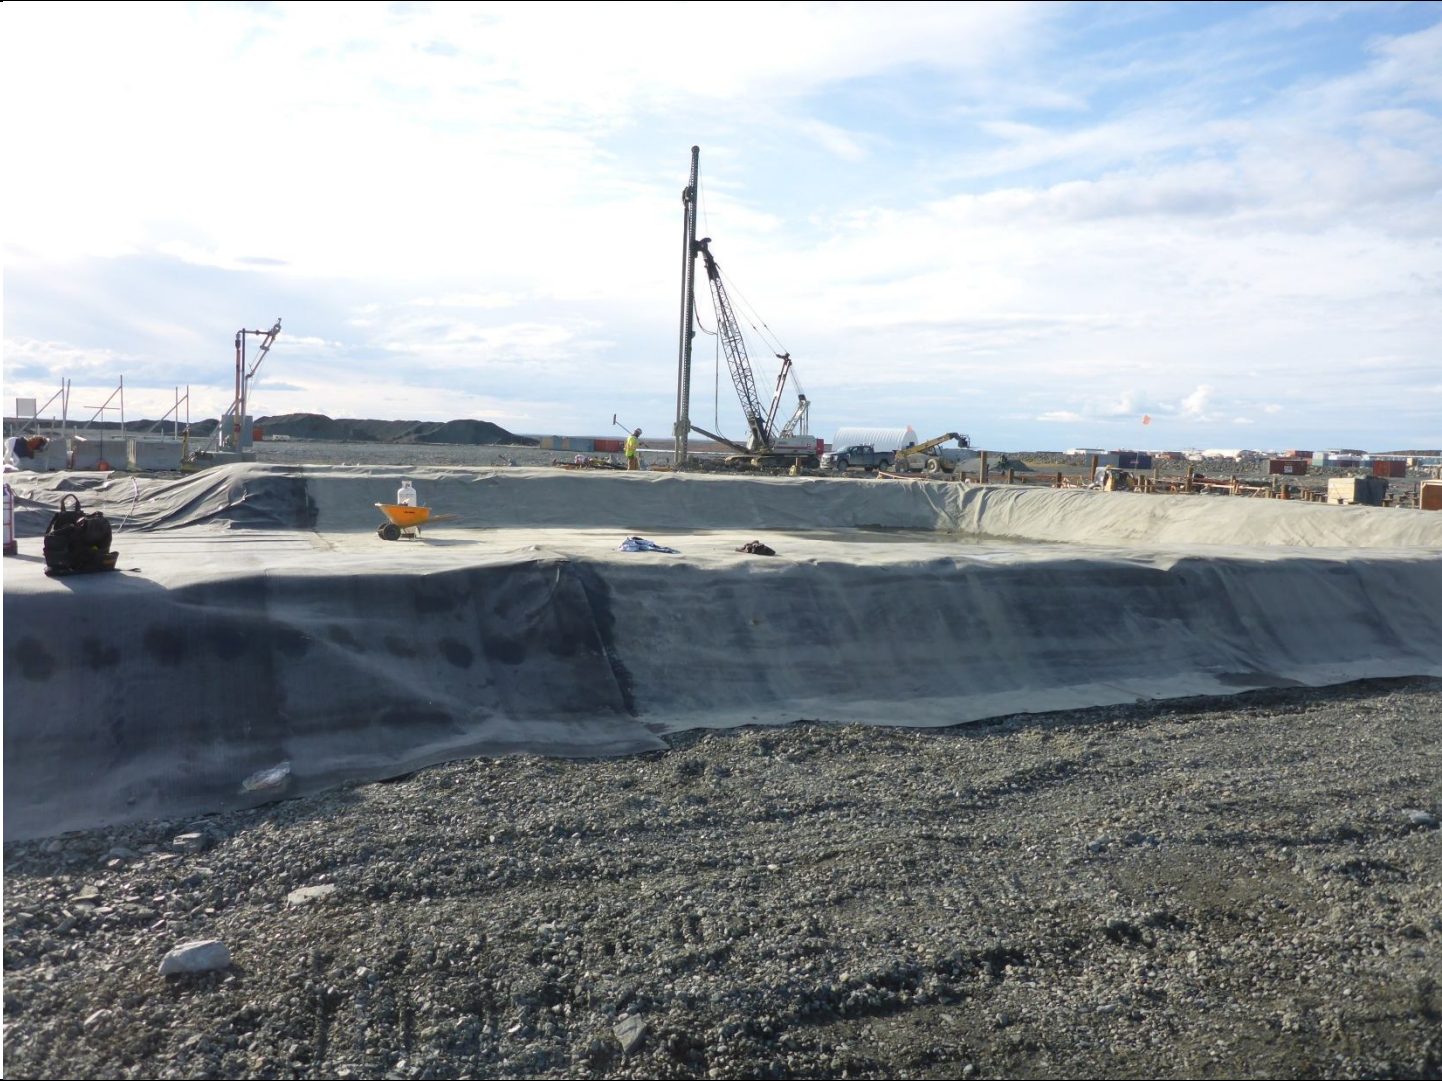
Date:	Authorization Number:	Camera/Model:	Inspector
August 29 th , 2018	2AM-WTP1826	Panasonic Lumix DMC-TS5	WRO Morton
Photo No.	Lat/Long (DD.MM.SS.SS, NAD83)		
Photo 3

Description:
Construction of the lined area that will contain the powerhouse and associated fuel.

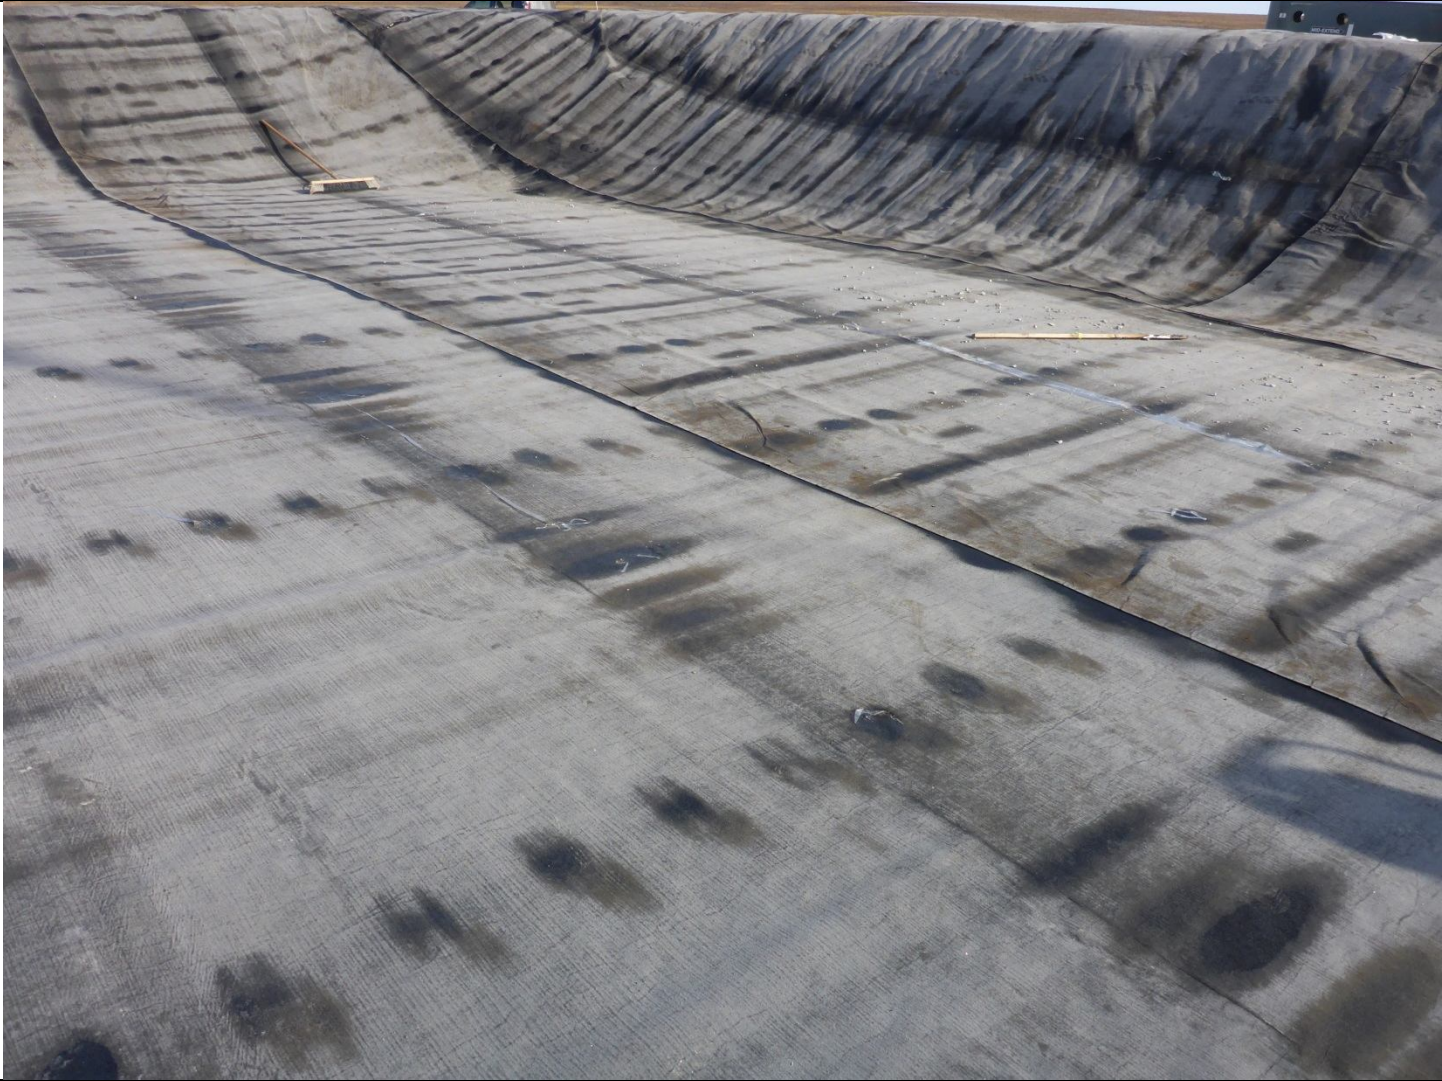
Date:	Authorization Number:	Camera/Model:	Inspector
August 29 th , 2018	2AM-WTP1826	Panasonic Lumix DMC-TS5	WRO Morton
Photo No.	Lat/Long (DD.MM.SS.SS, NAD83)		
Photo 4

Description:
Close up of the Coletanche geomembrane used in the construction of the powerhouse secondary containment.

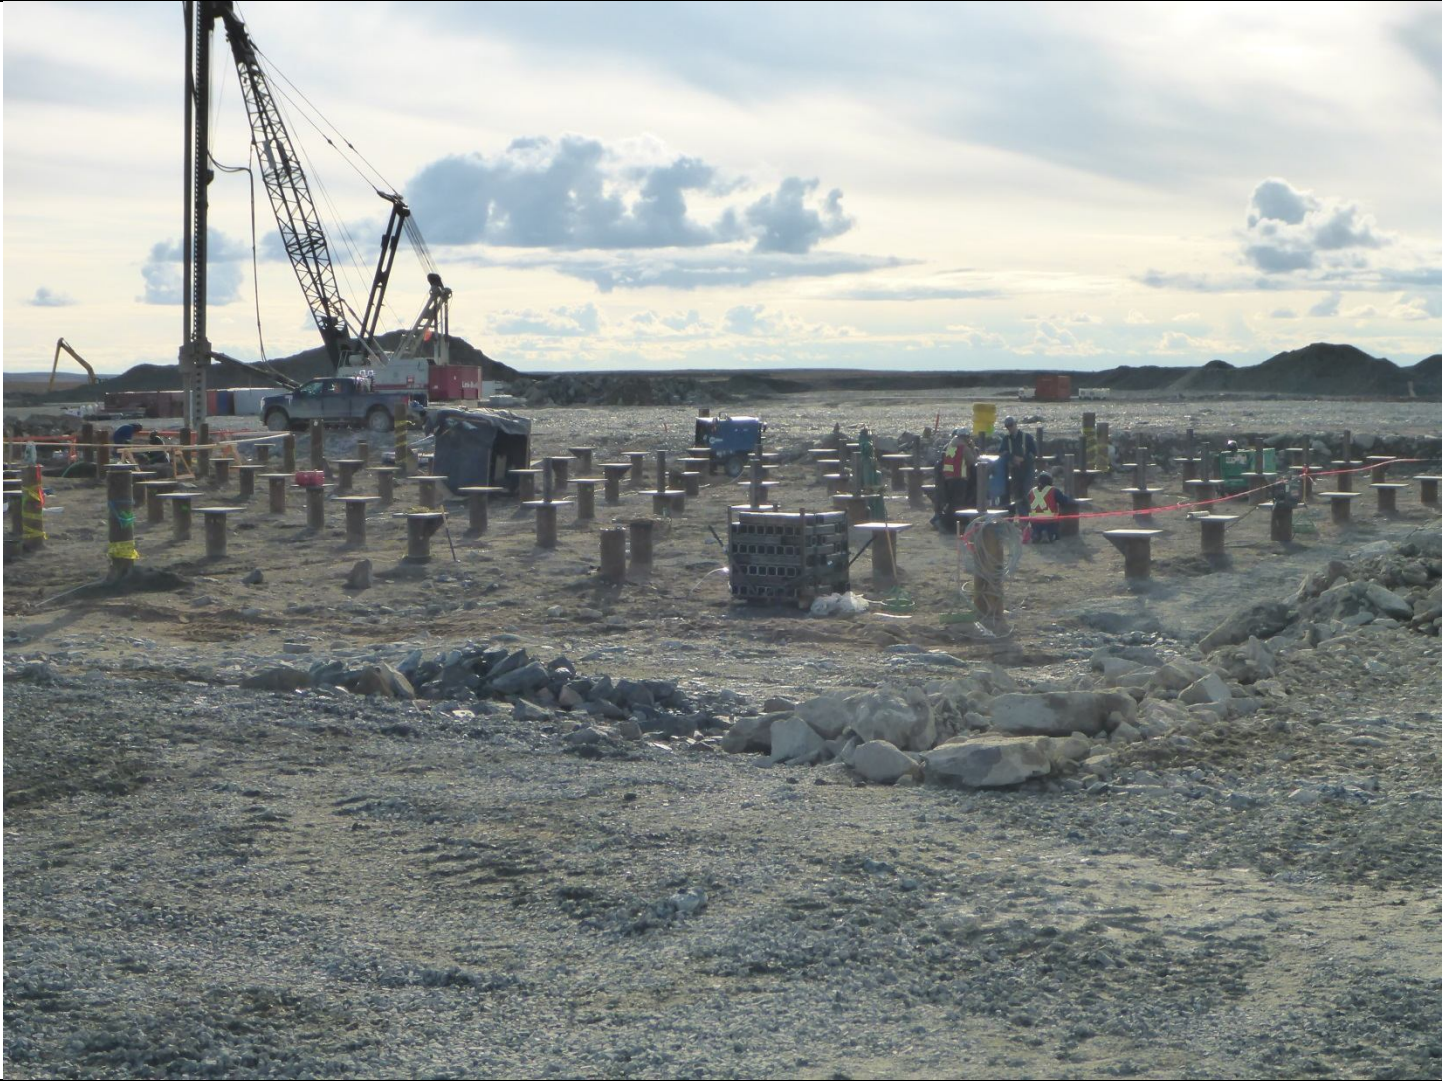
Date:	Authorization Number:	Camera/Model:	Inspector
August 29 th , 2018	2AM-WTP1826	Panasonic Lumix DMC-TS5	WRO Morton
Photo No.	Lat/Long (DD.MM.SS.SS, NAD83)		
Photo 5

Description:
Overview of the construction of the new camp and associated facilities.
