WATER LICENCE INSPECTION FORM

Licensee		Licensee Representative	
Agnico Eagle Mines Limited		Martin Archambault	
Licence No. / Expiry		Representative's Title	
2AM-WTP1826		Environmental Coordinator	
Land / Other Authorizations		Land / Other Authorizations	
Date of Inspection		Inspector	
June 15 2019			
Activities Inspected			
<input checked="" type="checkbox"/> Camp	<input type="checkbox"/> Drilling	<input type="checkbox"/> Mining	<input checked="" type="checkbox"/> Construction
<input type="checkbox"/> Roads/Hauling	<input type="checkbox"/> Other:		<input type="checkbox"/> Reclamation
			<input checked="" type="checkbox"/> Fuel Storage
			<input type="checkbox"/> Other:

On June 14<sup>th</sup> 2019 a Water Licence Inspection was conducted on the Agnico Eagle Mines Ltd. (AEM) Whale Tail project. This Inspection was to ensure compliance with the water licence 2AM-WTP1826 and the Acts; Nunavut Planning and Project Assessment Act (NUPPA), Nunavut Waters and Nunavut Surface Rights Tribunal Act (NWNSTRA), and Arctic Waters Pollution Prevention Act (AWPPA).

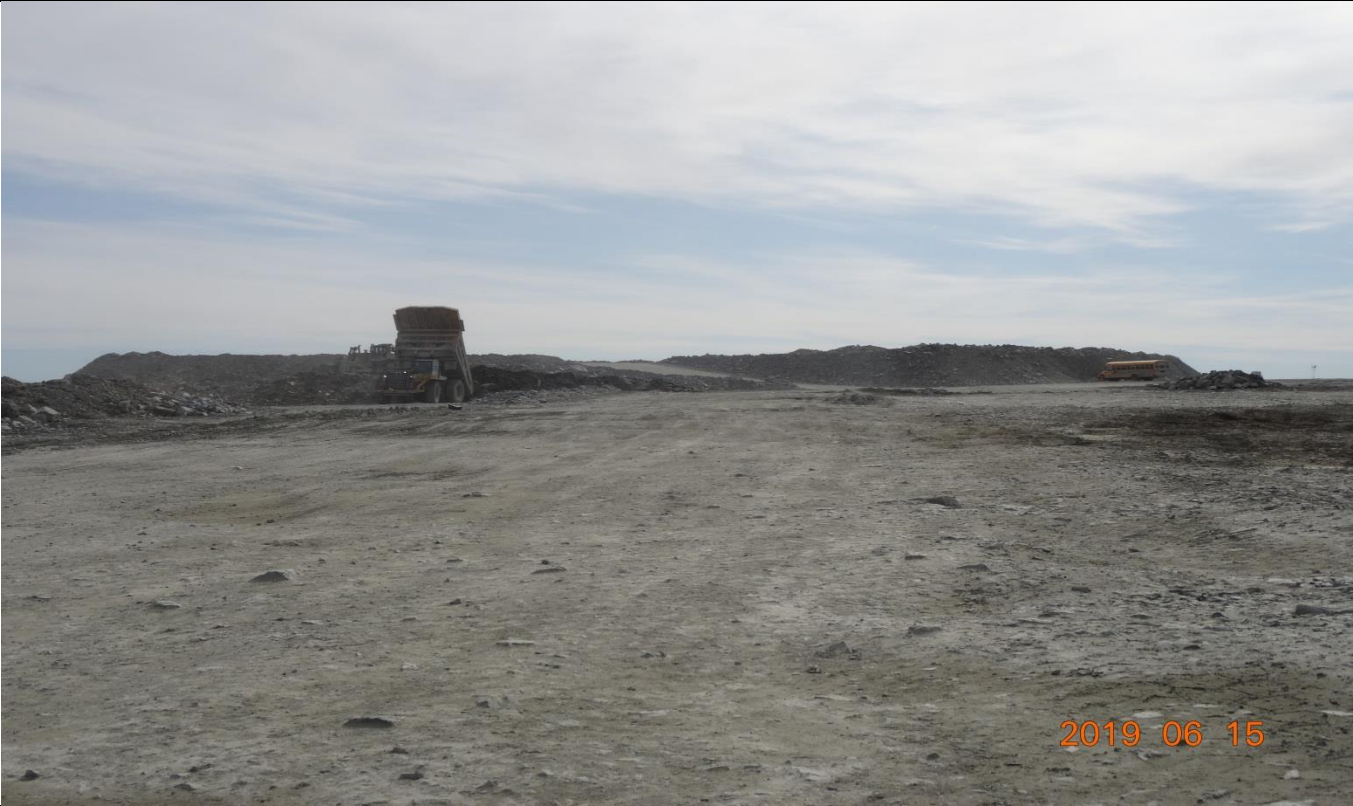
Photo #3

The Waste Rock Storage Facility (WRSF) is in operation. The waste rock within the facility appears to be segregated into Potentially Acid Generating (PAG) and Non-Potentially Acid Generating (Non PAG) material. Segregation of the waste rock is predetermined by AEM staff. No concerns related to this activity. (*see photo 3*)

Description: Waste Rock Storage Facility
