**WATER LICENCE INSPECTION FORM**☒ Original  
☐ Follow-Up Report

<b>Licensee</b>	<b>Licensee Representative</b>
Agnico Eagle Mines Limited.	Eric HALEY
<b>Licence No. / Expiry</b>	<b>Representative's Title</b>
2AM-WTP1830, March 27th, 2030	Interim Environmental Coordinator
<b>Land Authorization No. / Expiry</b>	<b>Project Name</b>
66H/8-02-1	Whale Tail Project
<b>Date of Inspection</b>	<b>Inspector</b>
October 1 <sup>st</sup> , 2020	RMO J.Voisey
<b>Activities Inspected</b>	
<input type="checkbox"/> Camp <input type="checkbox"/> Drilling <input type="checkbox"/> Mining <input type="checkbox"/> Construction <input type="checkbox"/> Reclamation <input type="checkbox"/> Fuel Storage <input checked="" type="checkbox"/> Roads/Hauling <input type="checkbox"/> Other: Airstrip <input type="checkbox"/> Other: Bulk Sample

On October 1<sup>st</sup>, 2020 an inspection was conducted of the Whale Tail Water Licence 2AM-WTP1830 by Crown Indigenous Relations and Northern Affairs Canada (CIRNAC)'s Resource Management Officer (RMO), Jakob VOISEY. The inspection was conducted to ensure compliance with applicable terms and conditions of the water licence.

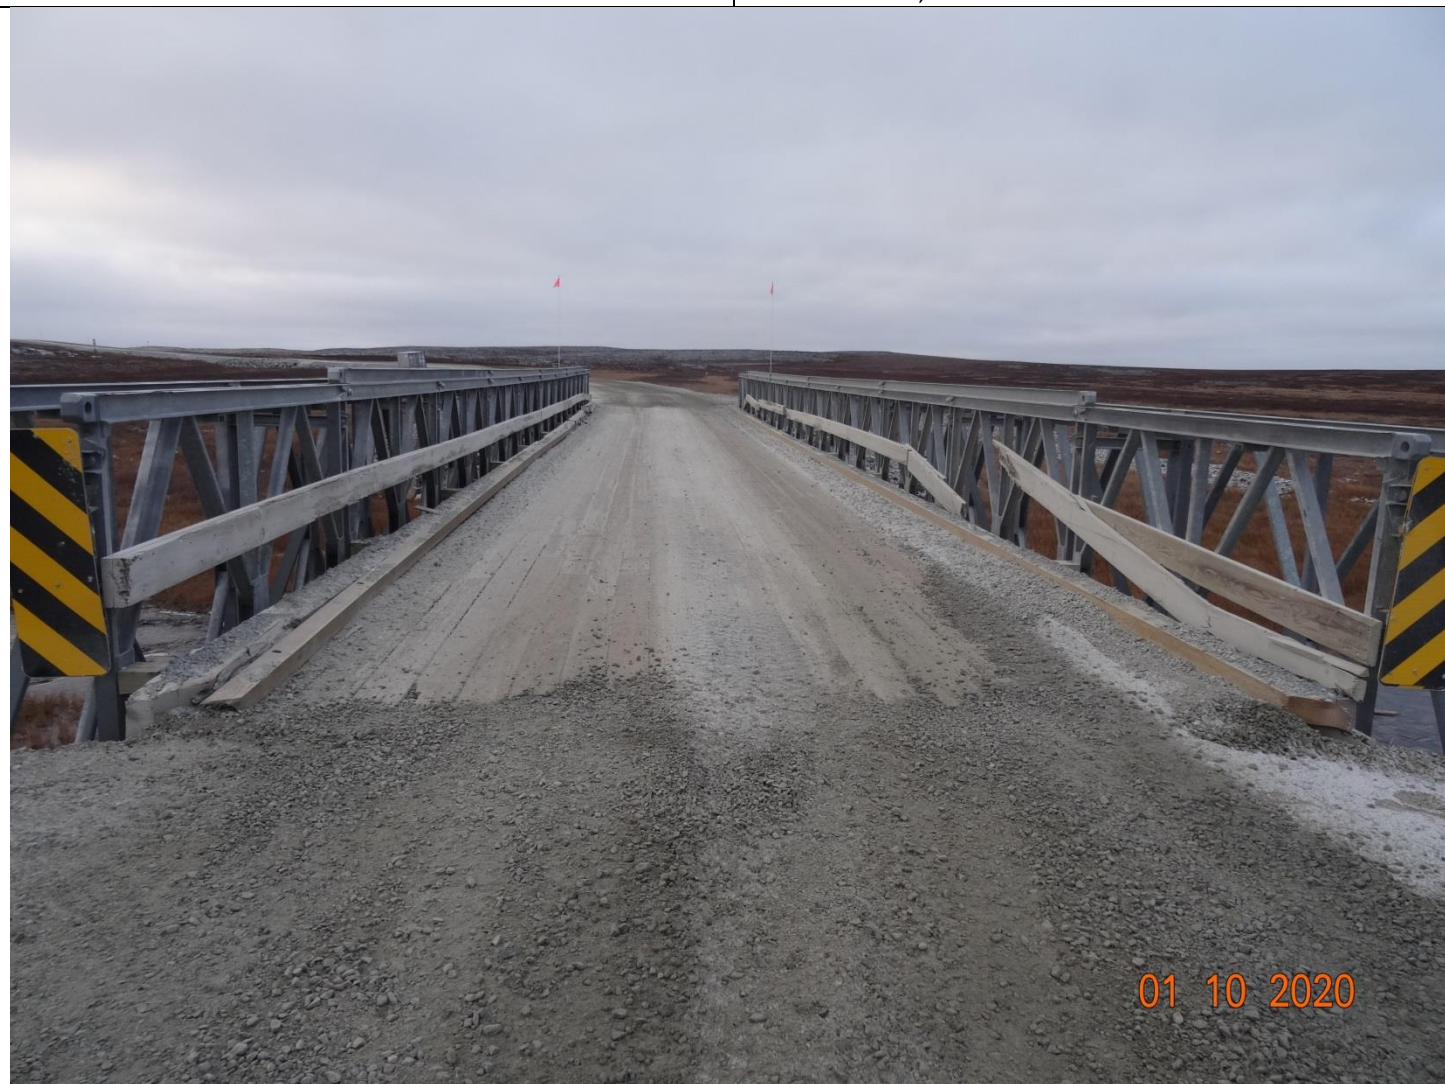
Many of the bridges use different construction methods, for example a flat top deck verses the wire grating or skirting around the deck versus no skirting (photo 1). The observation noted from the water crossings that utilized the flat top deck and the skirting show that this design indeed limits the amount of sediment in the water course.

Bridge at km 17. Photo from Meadowbank inspection, example of flat top deck and skirting.

The Licensee shall provide the inspector with a summary of the maintenance that will be completed this year on all the water crossings to prevent further sediment from entering the water course. This summary is due July 1<sup>st</sup> 2021.

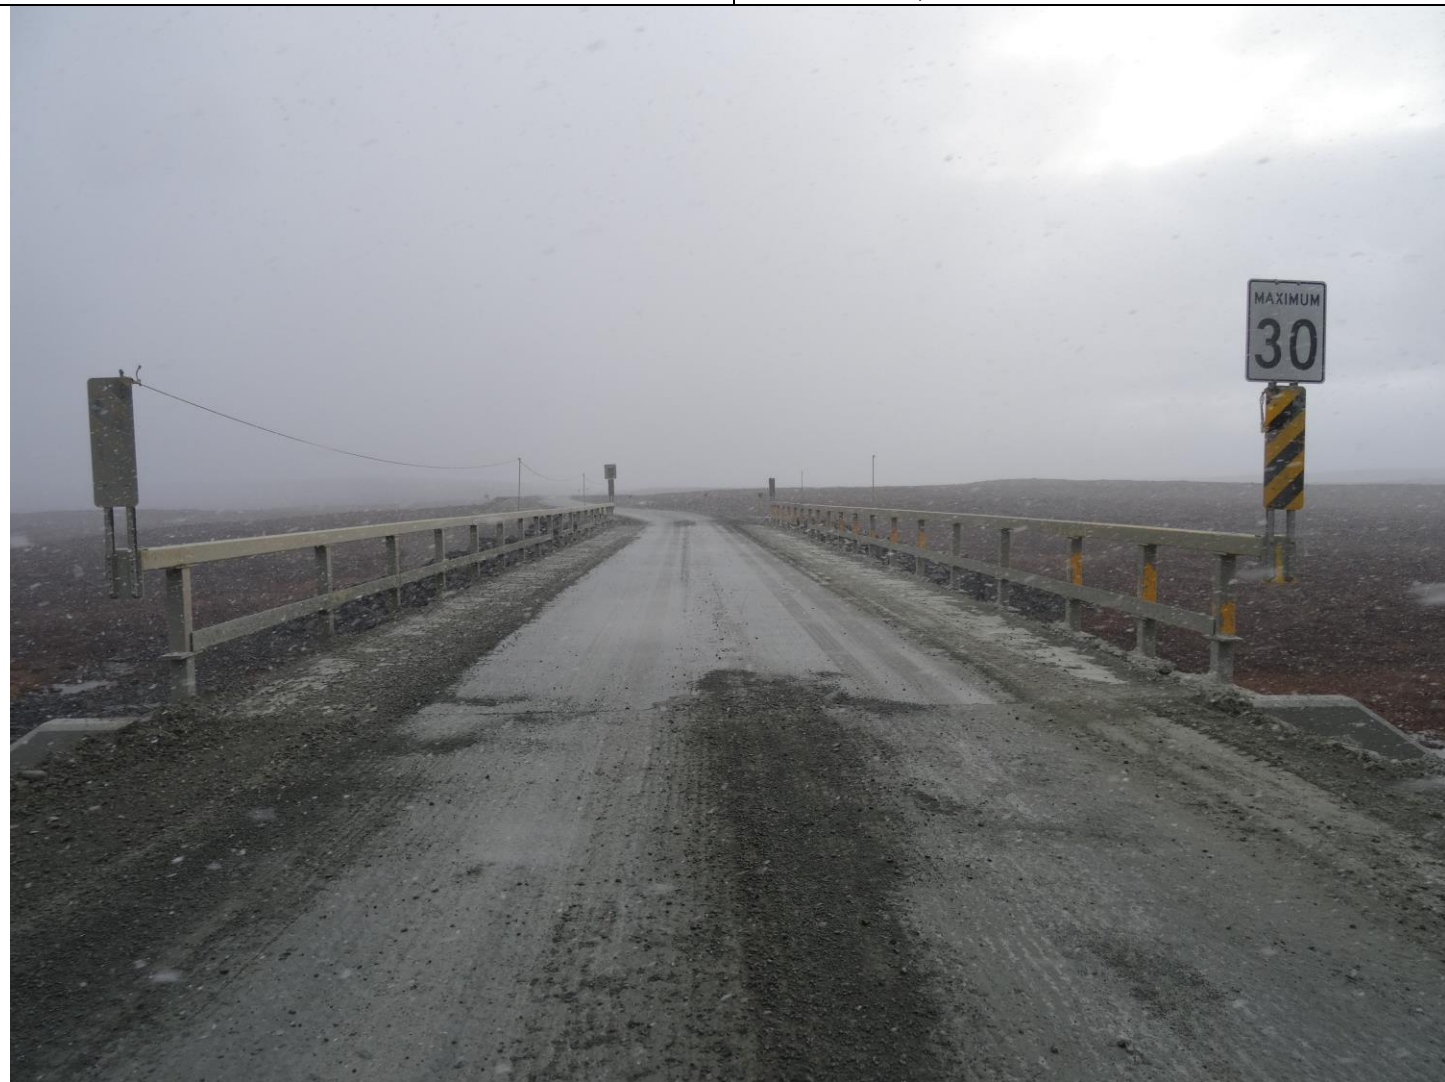
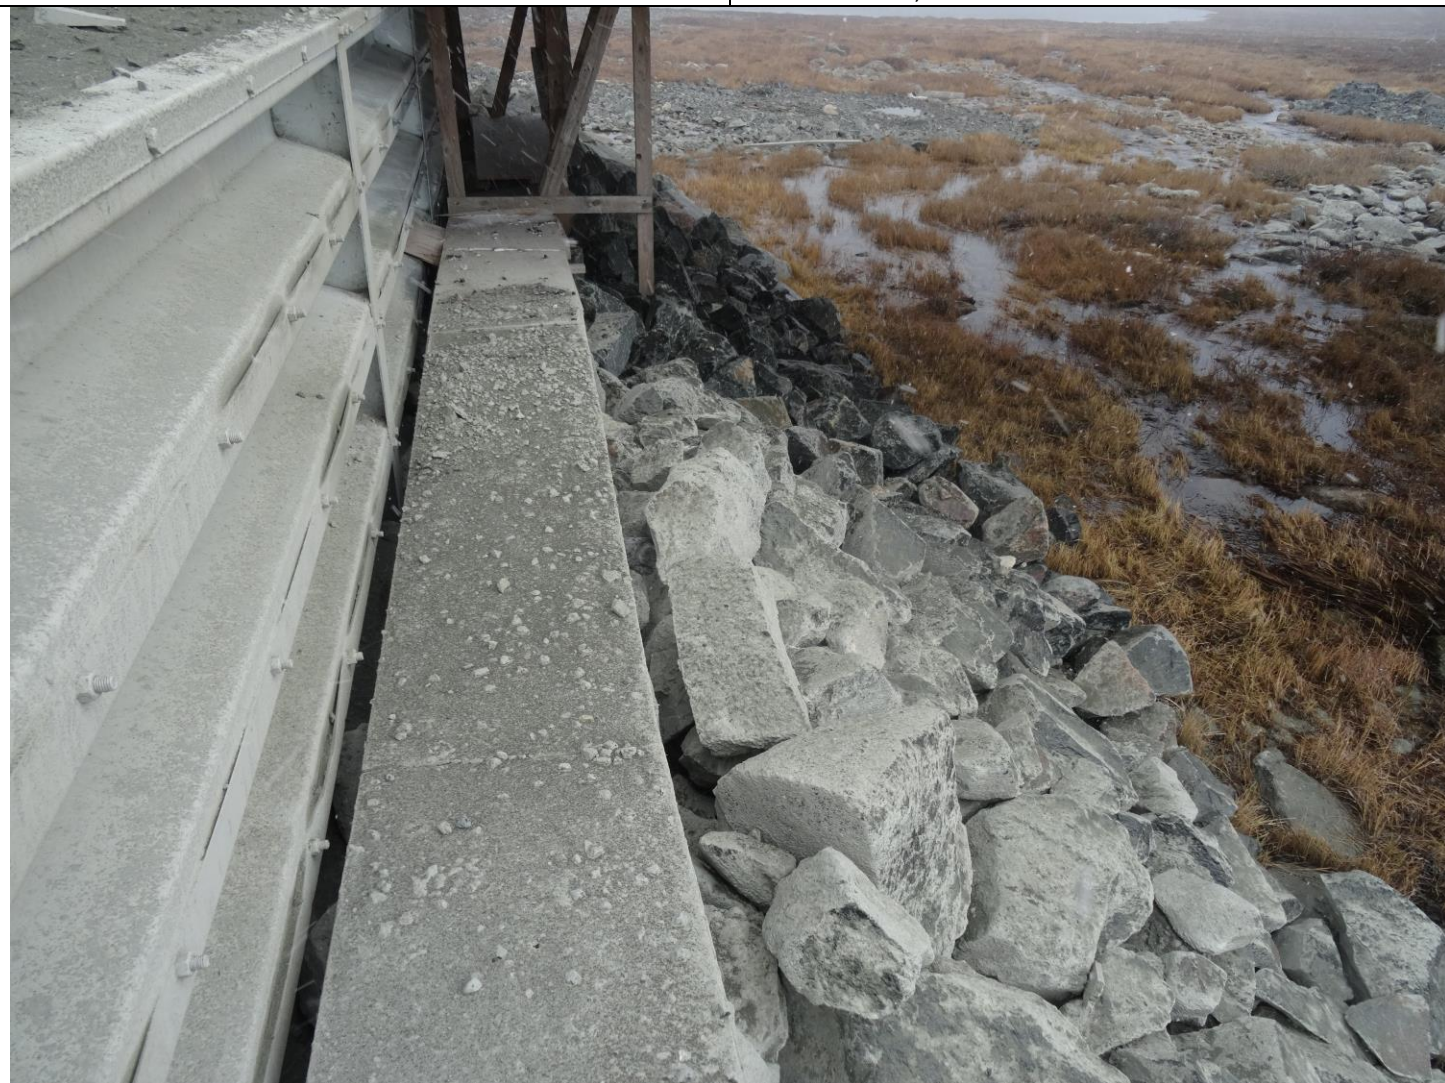
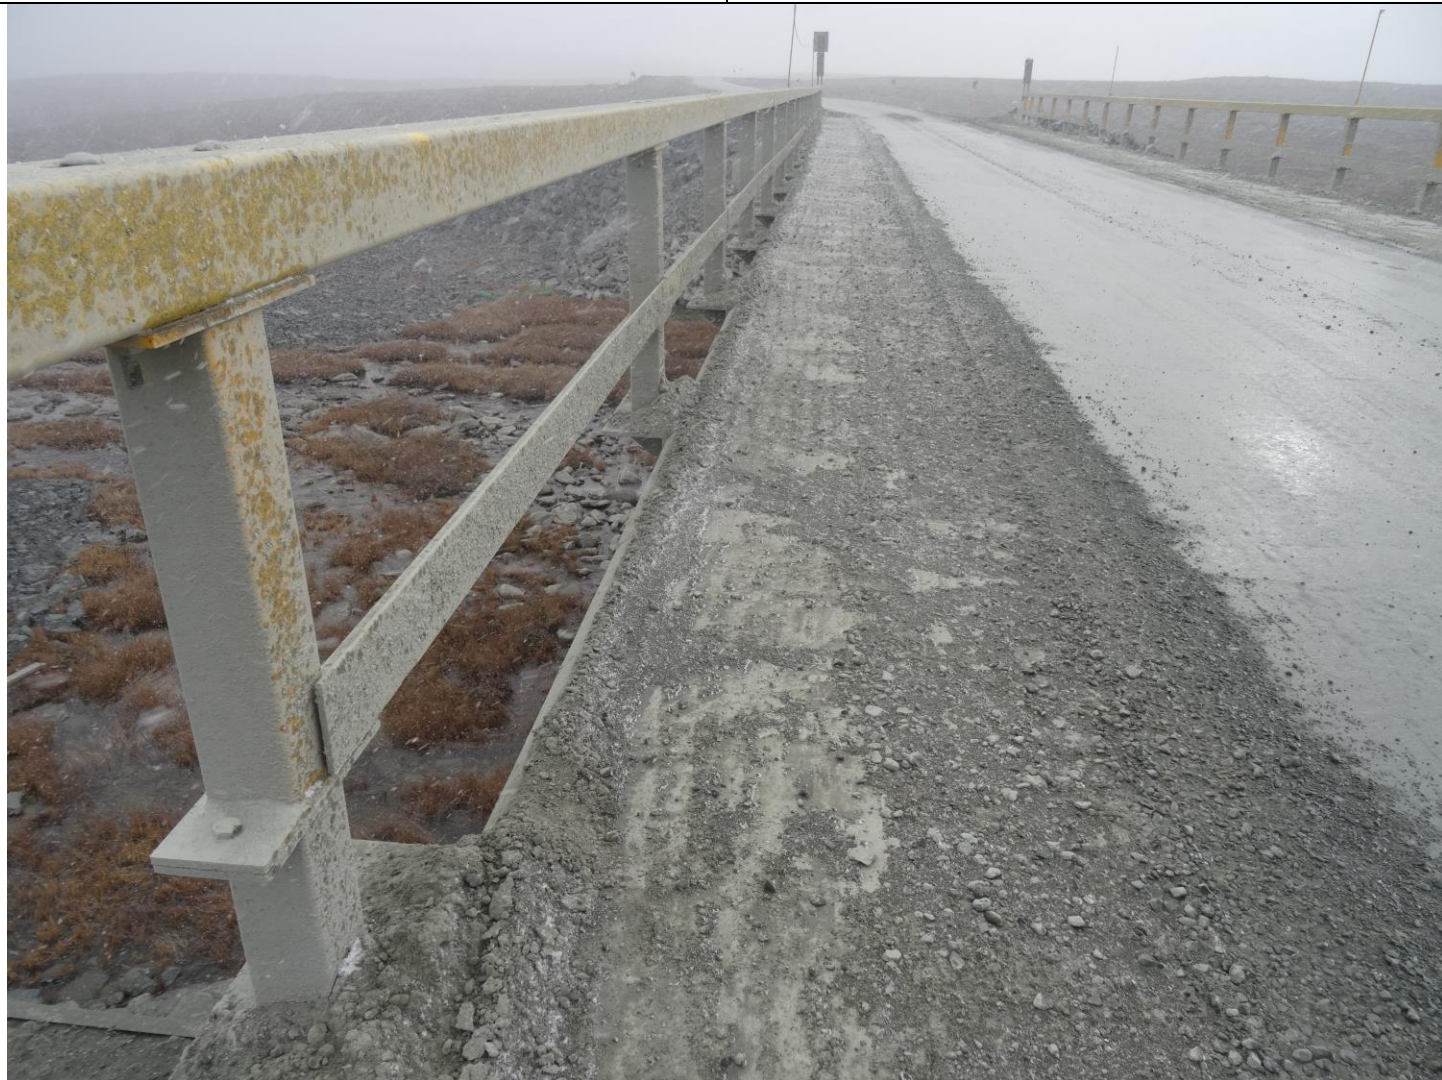
1. KM 160 Bridge, concern related to erosion and deposition of sediment into a water course. Erosion prevention measures and maintenance of these prevention measure should be implemented at this water crossing. Spill response kit was noted at this water crossing (photo 2-5).

Bridge at km 160.

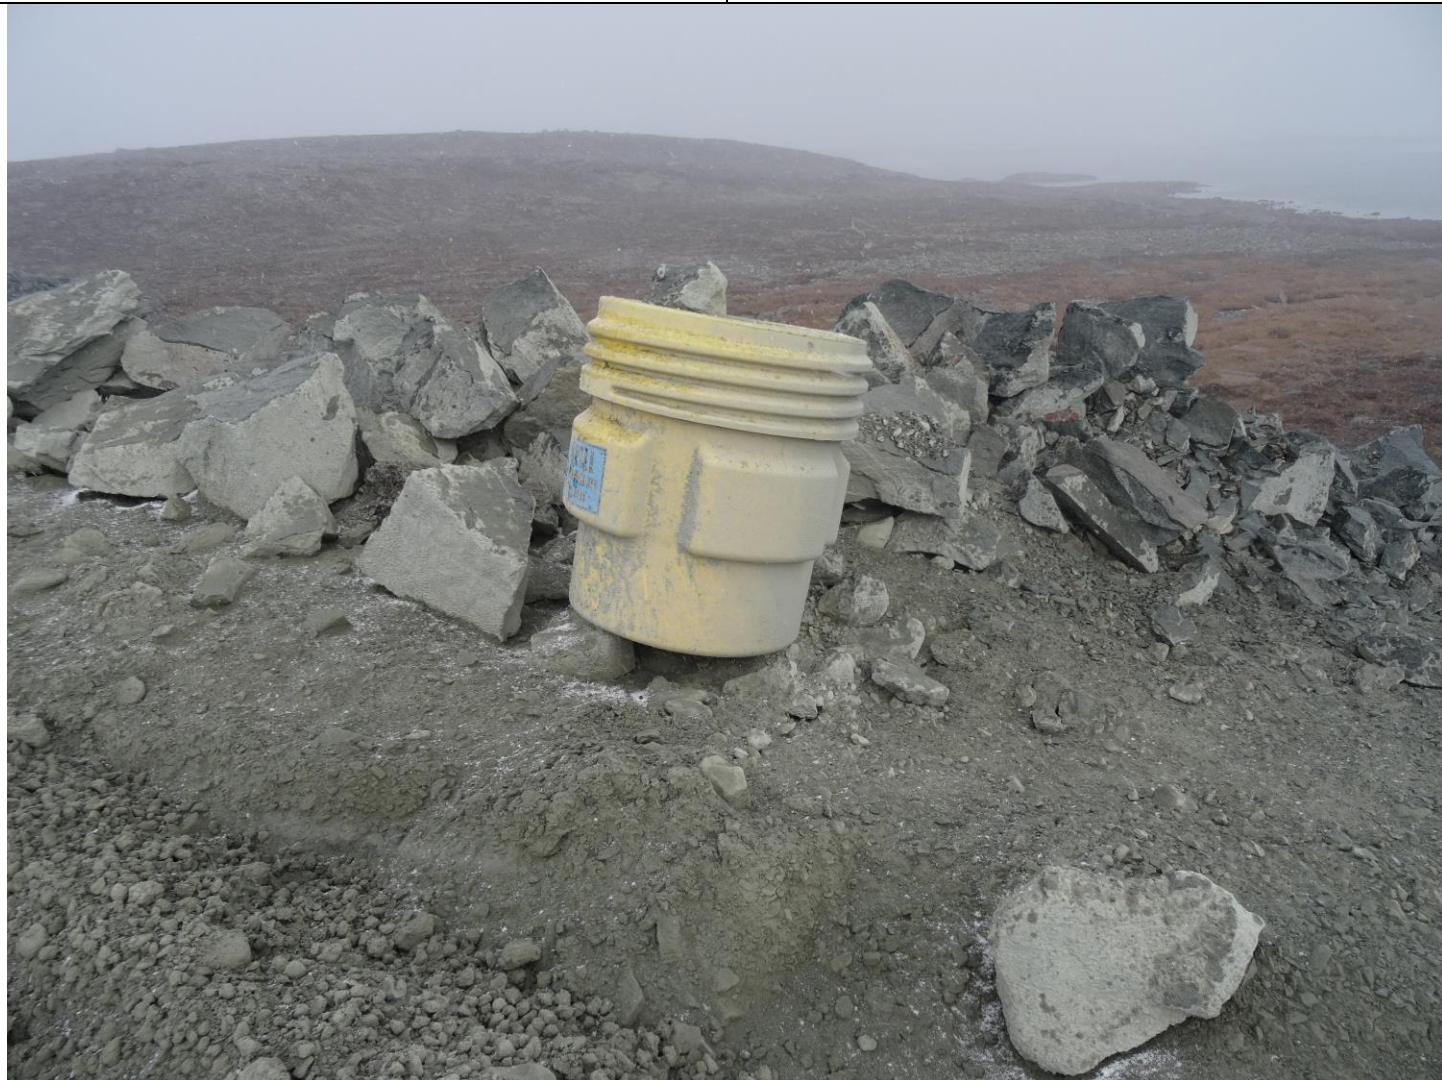
Photo 3

Spill response kit at bridge km 160.

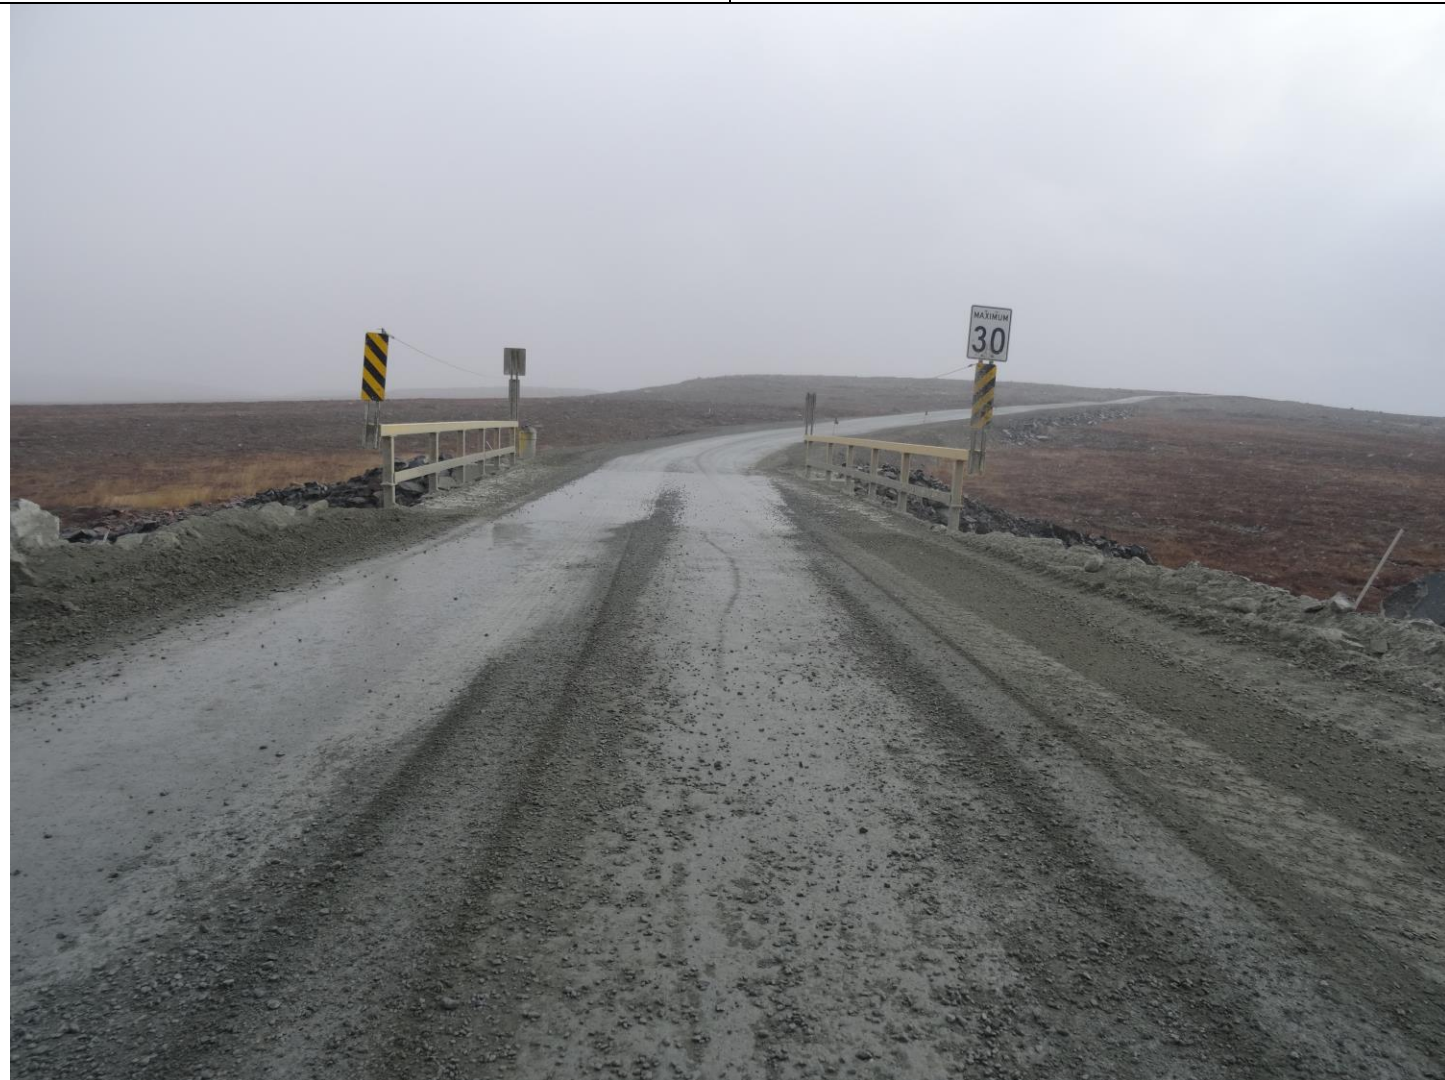
Photo 6

2. KM 159.8 bridge, no concerns at this water crossing (photo 6-7).
3. KM 148 bridge, concern related to erosion and deposition of sediment into a water course. Erosion prevention measures and maintenance of these prevention measure should be implemented at this water crossing (photo 8-10).

Bridge at km 159.8.

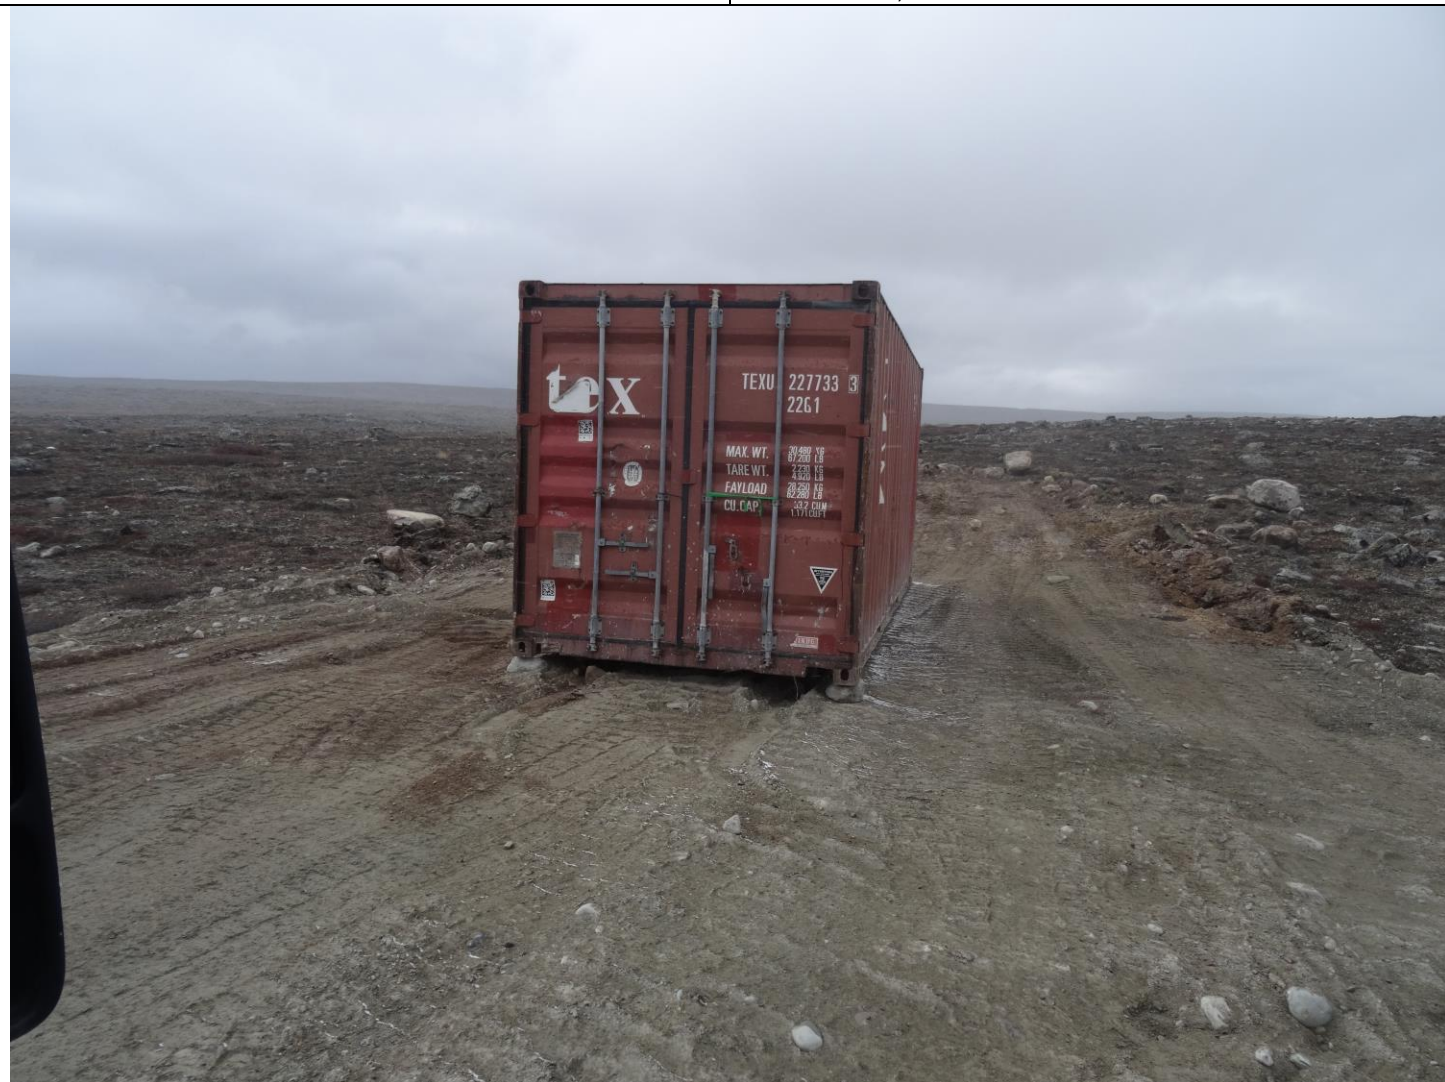
Photo 7

Spill response kit at bridge km 159.8.

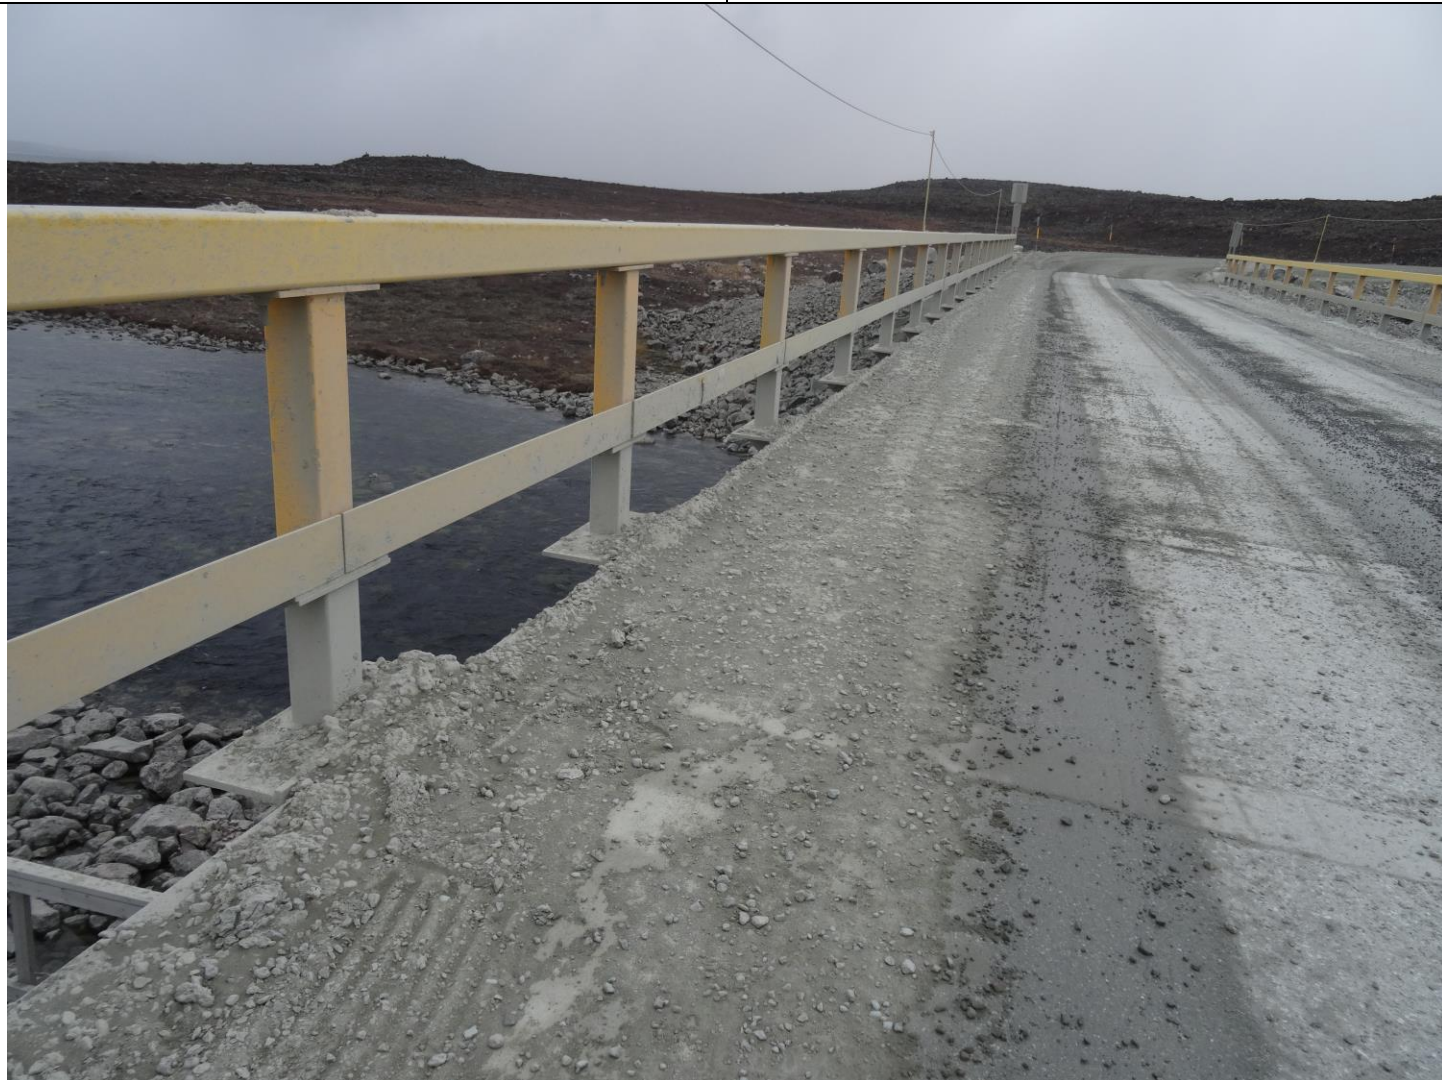
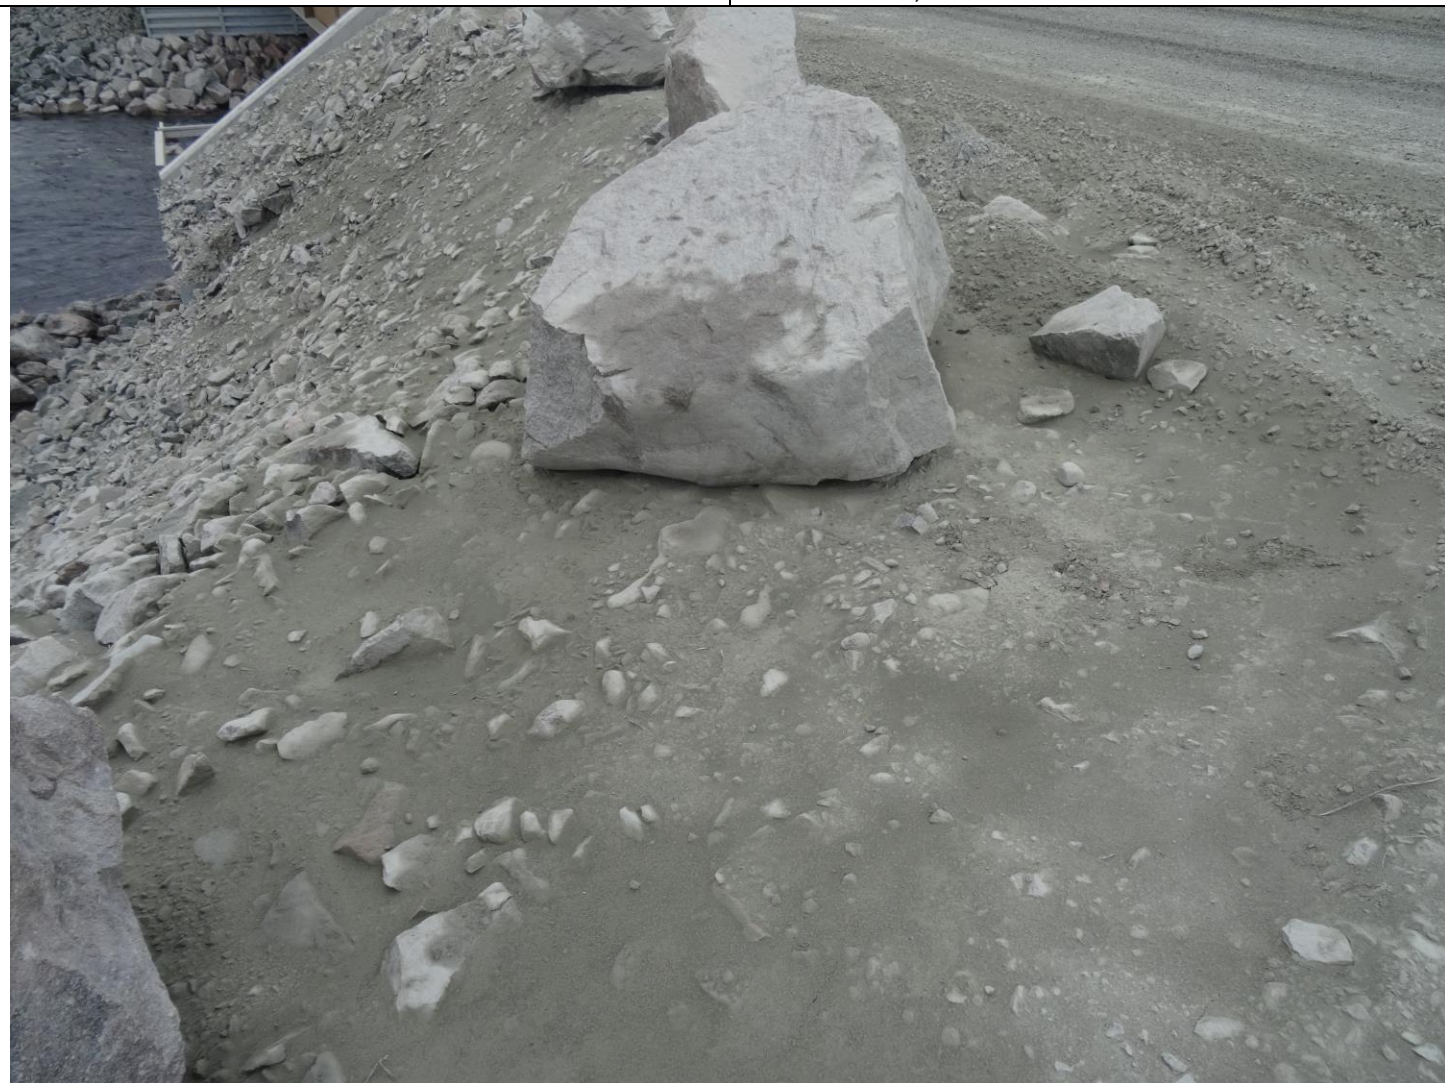
Bridge at km 148.

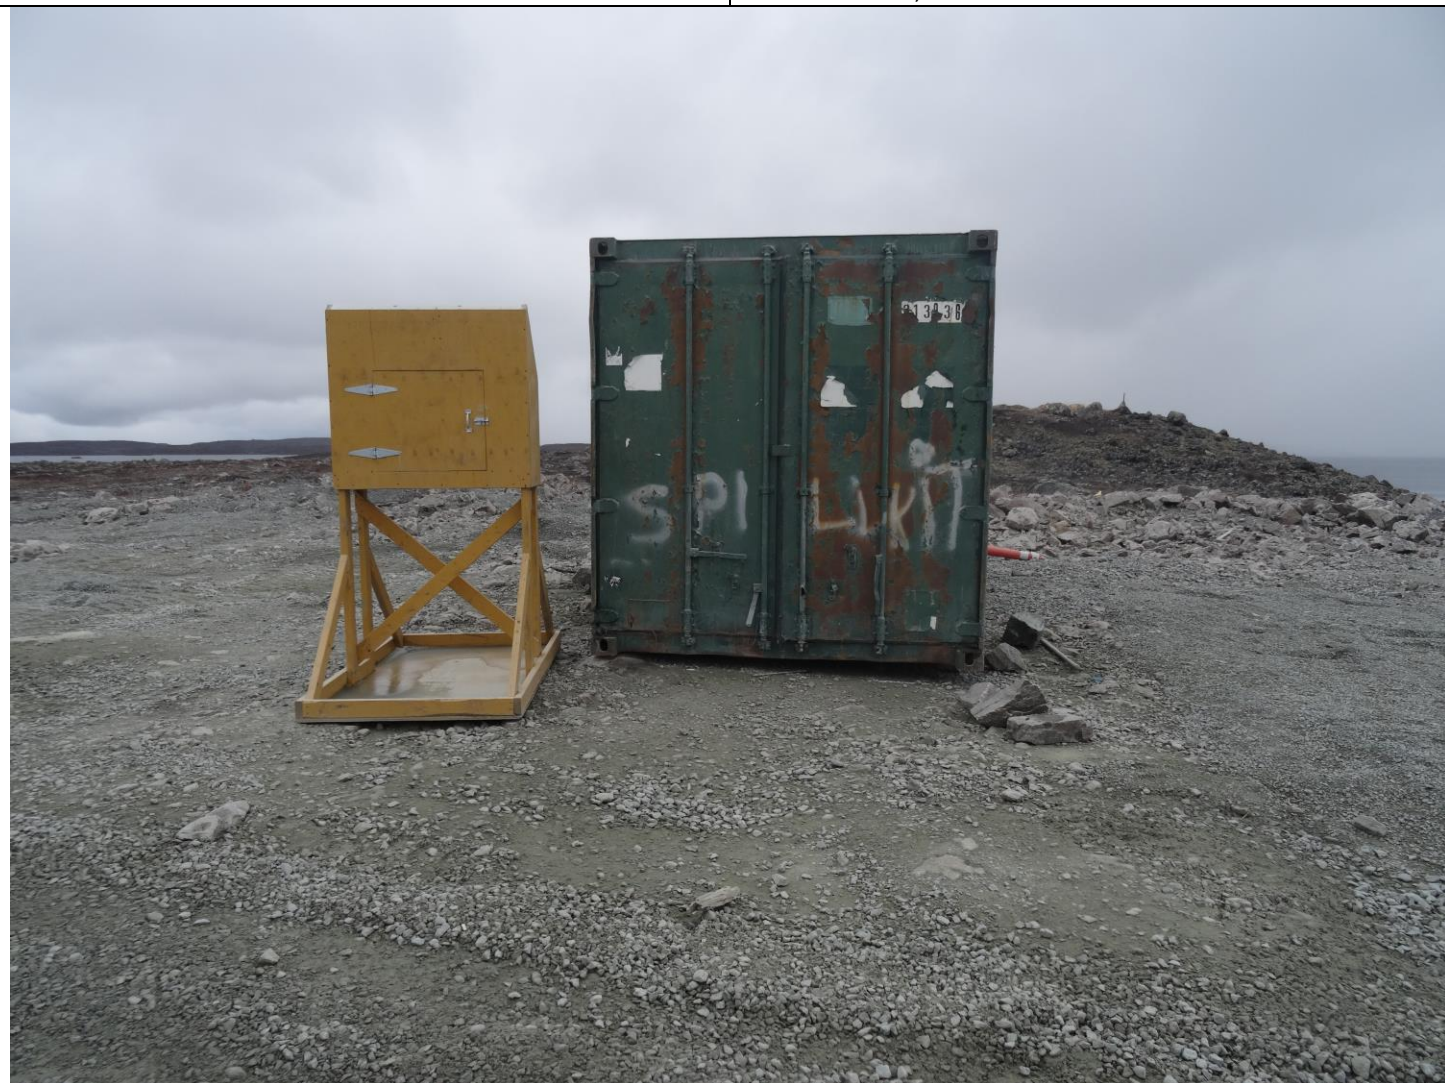
Photo 10

Spill response kit at bridge at km 148.

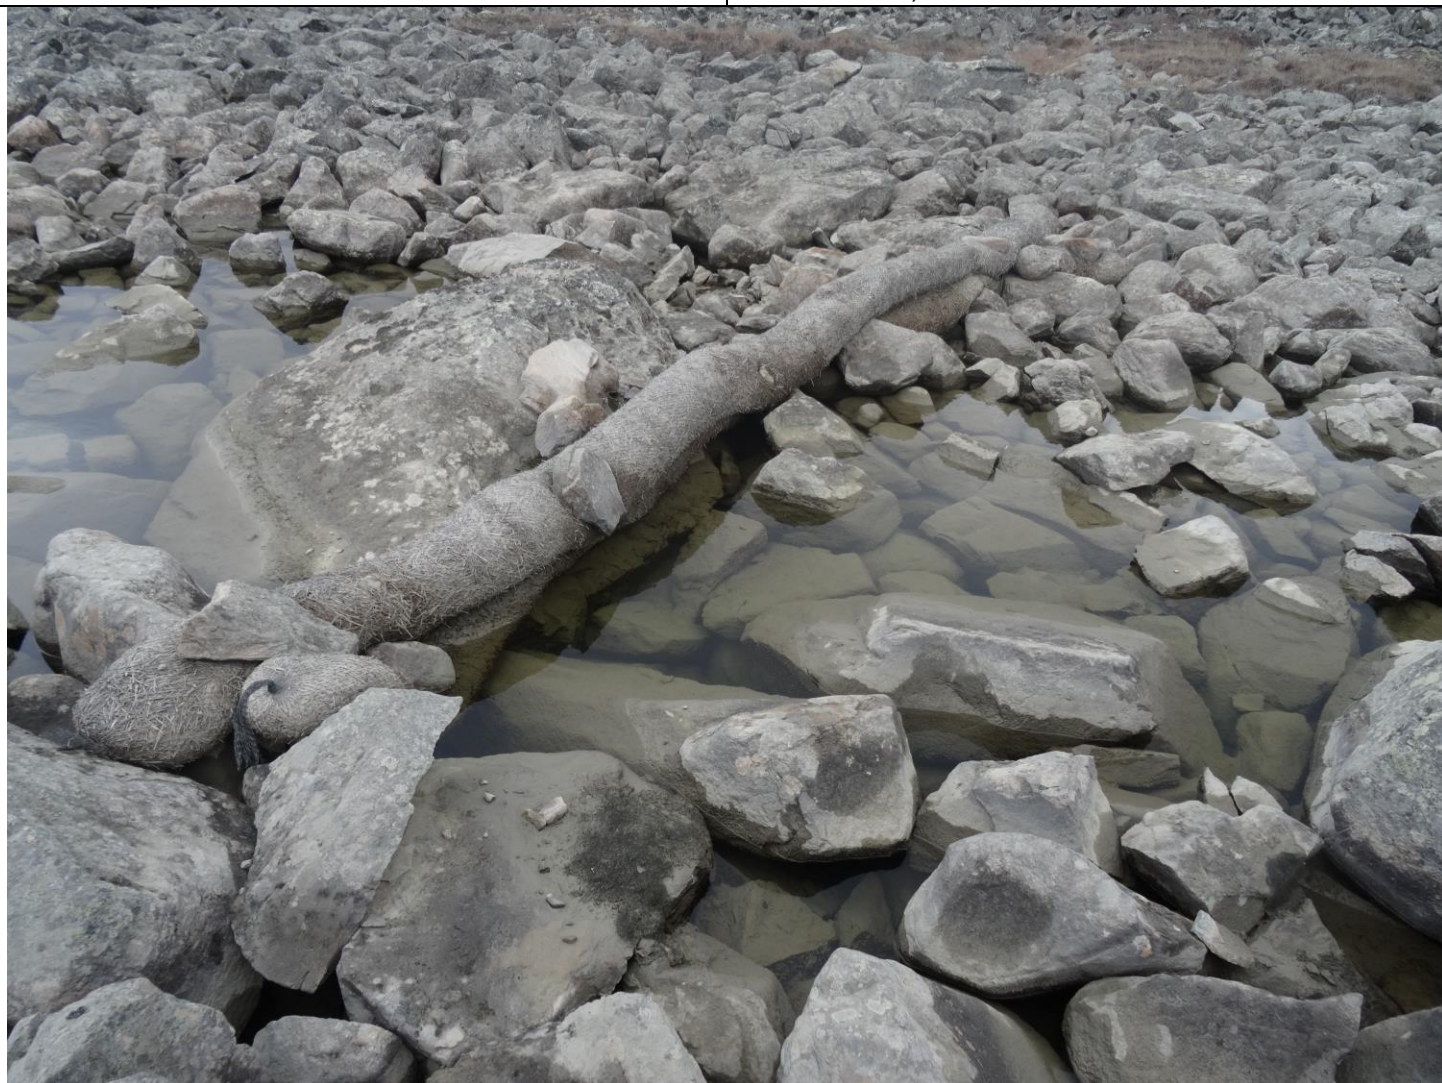
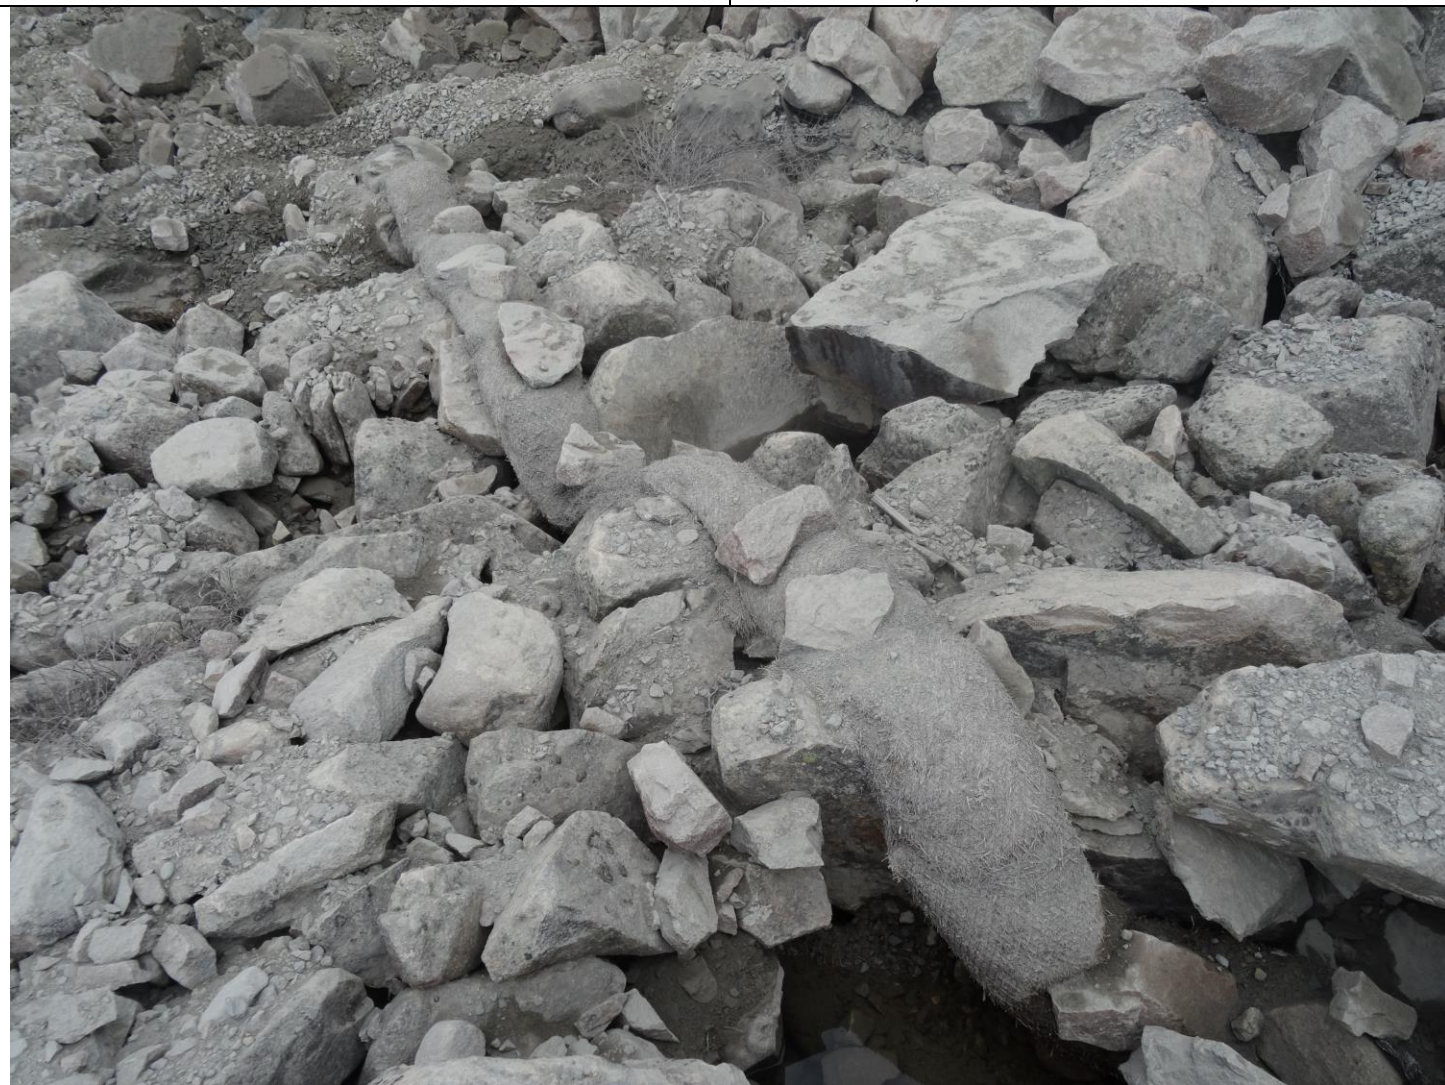
4. Straw logs were noted downstream of km 141 bridge. concern related to erosion and deposition of sediment into a water course. Erosion prevention measures and maintenance of these prevention measure should be implemented at this water crossing (photo 11-15).

Straw logs found downstream near bridge km 141.

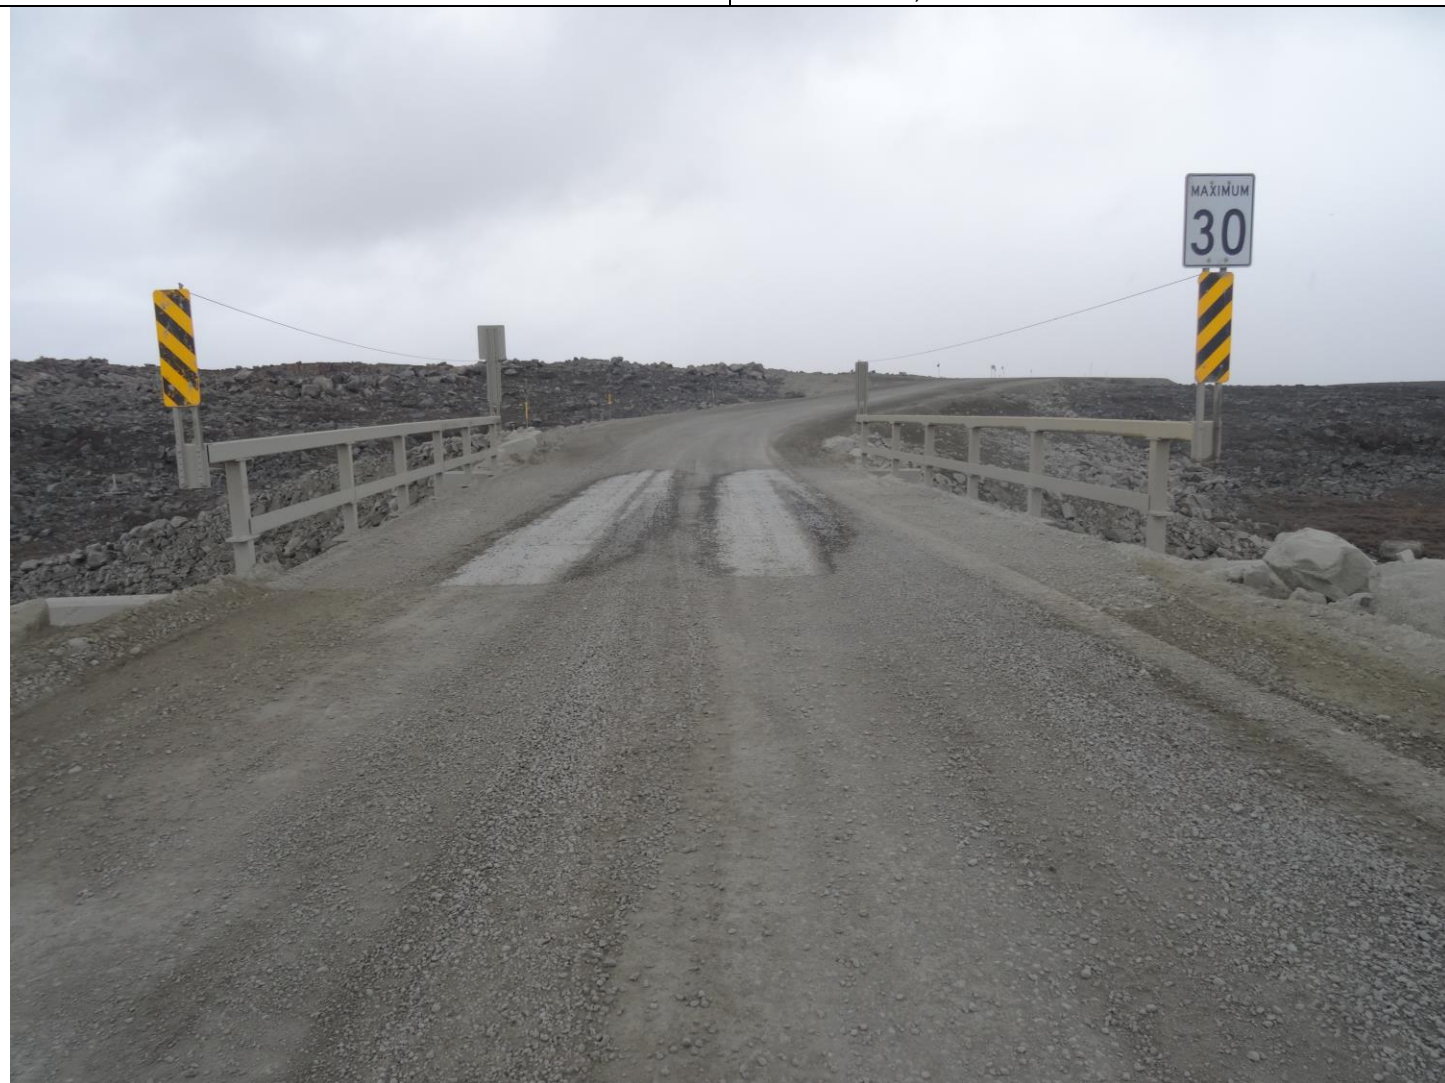
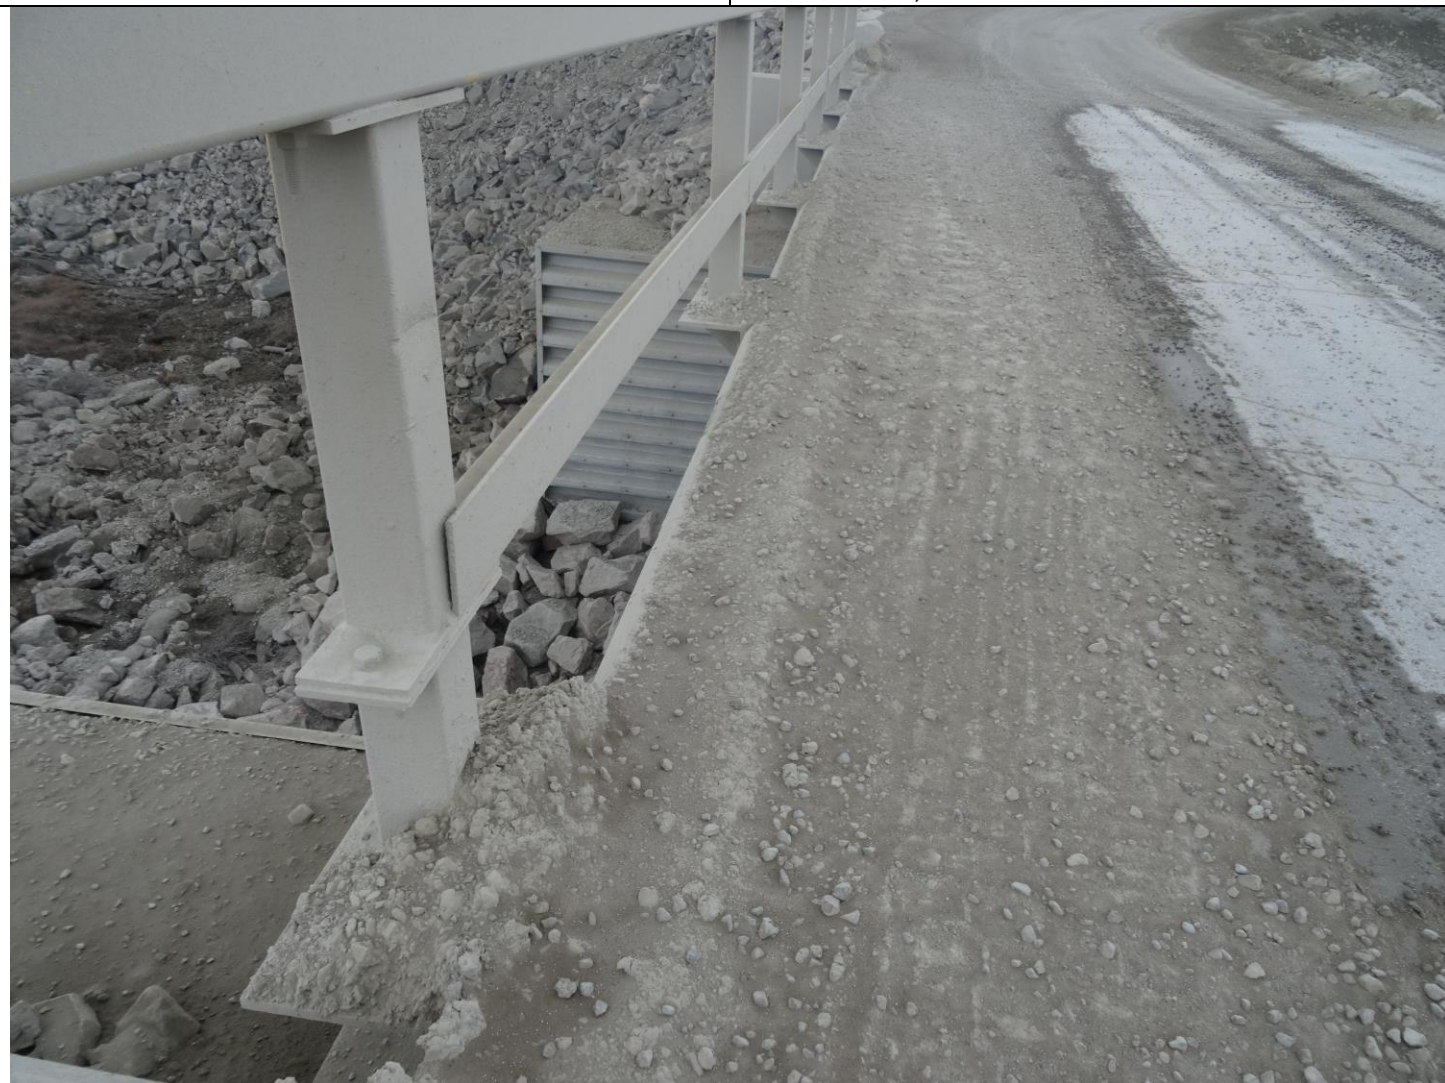
Bridge at km 141.
