**WATER LICENCE INSPECTION FORM**☒ Original  
☐ Follow-Up Report

<b>Licensee</b>	<b>Licensee Representative</b>
Agnico Eagle Mines Limited.	Eric HALEY
<b>Licence No. / Expiry</b>	<b>Representative's Title</b>
2AM-WTP1830, March 27th, 2030	Interim Environmental Coordinator
<b>Land Authorization No. / Expiry</b>	<b>Project Name</b>
66H/8-02-1	Whale Tail Project
<b>Date of Inspection</b>	<b>Inspector</b>
October 1 <sup>st</sup> , 2020	RMO J.Voisey
<b>Activities Inspected</b>	
<input type="checkbox"/> Camp <input type="checkbox"/> Drilling <input type="checkbox"/> Mining <input type="checkbox"/> Construction <input type="checkbox"/> Reclamation <input type="checkbox"/> Fuel Storage <input checked="" type="checkbox"/> Roads/Hauling <input type="checkbox"/> Other: Airstrip <input type="checkbox"/> Other: Bulk Sample

On October 1<sup>st</sup>, 2020 an inspection was conducted of the Whale Tail Water Licence 2AM-WTP1830 by Crown Indigenous Relations and Northern Affairs Canada (CIRNAC)'s Resource Management Officer (RMO), Jakob VOISEY. The inspection was conducted to ensure compliance with applicable terms and conditions of the water licence.

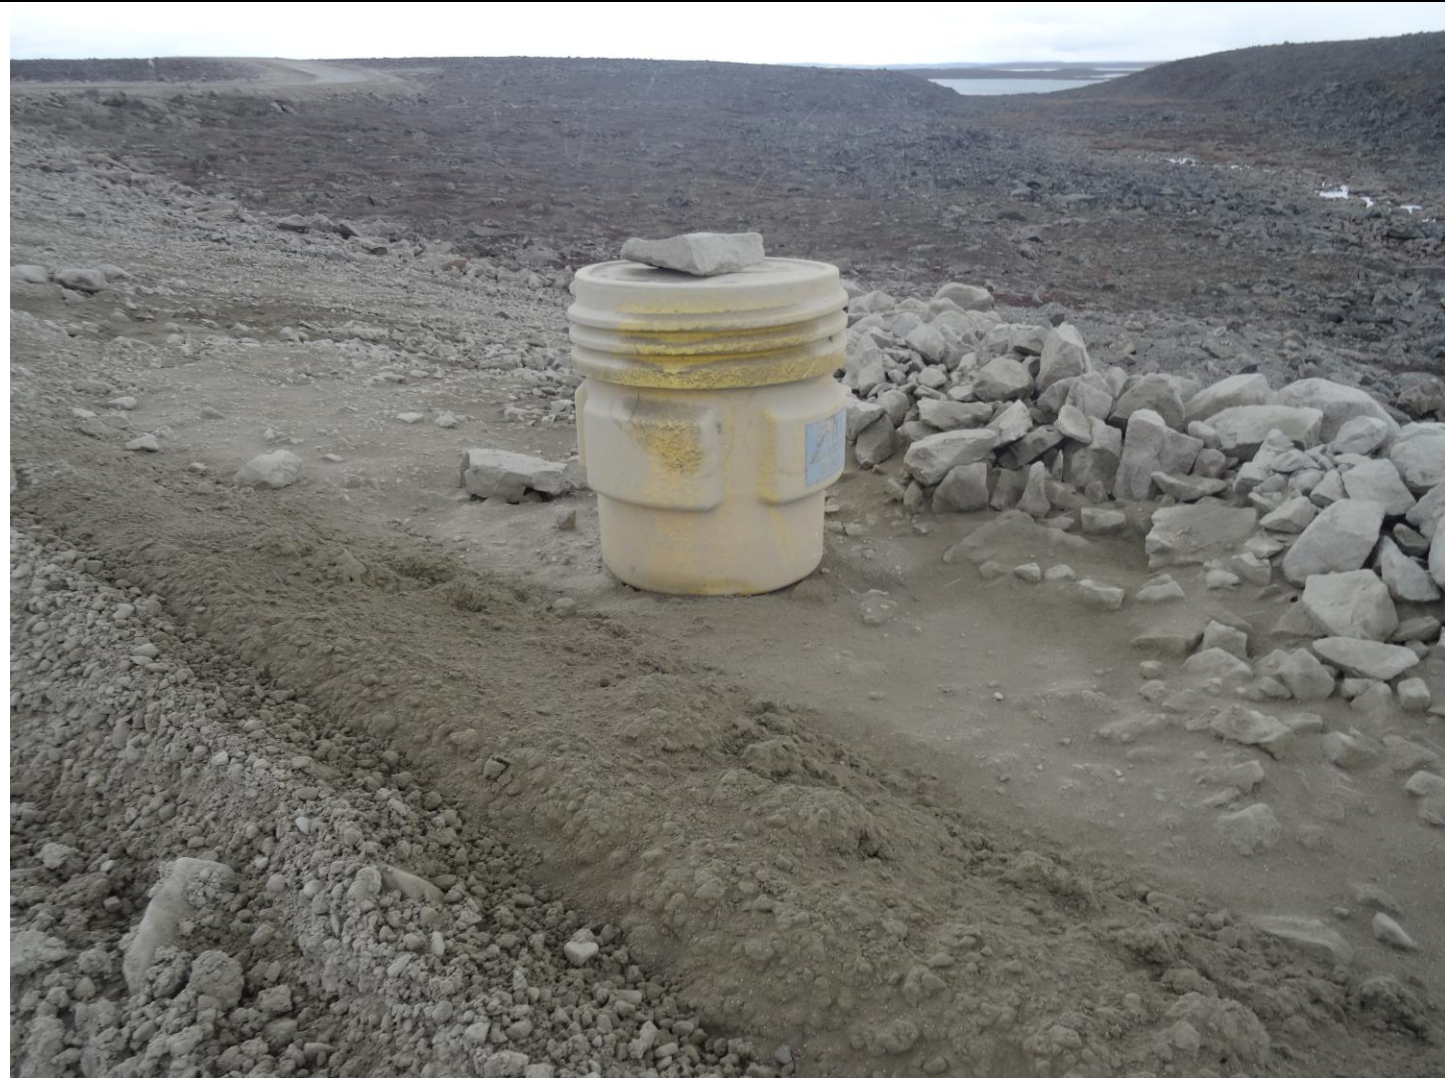
Photo 15

Spill response kit at bridge km 141.

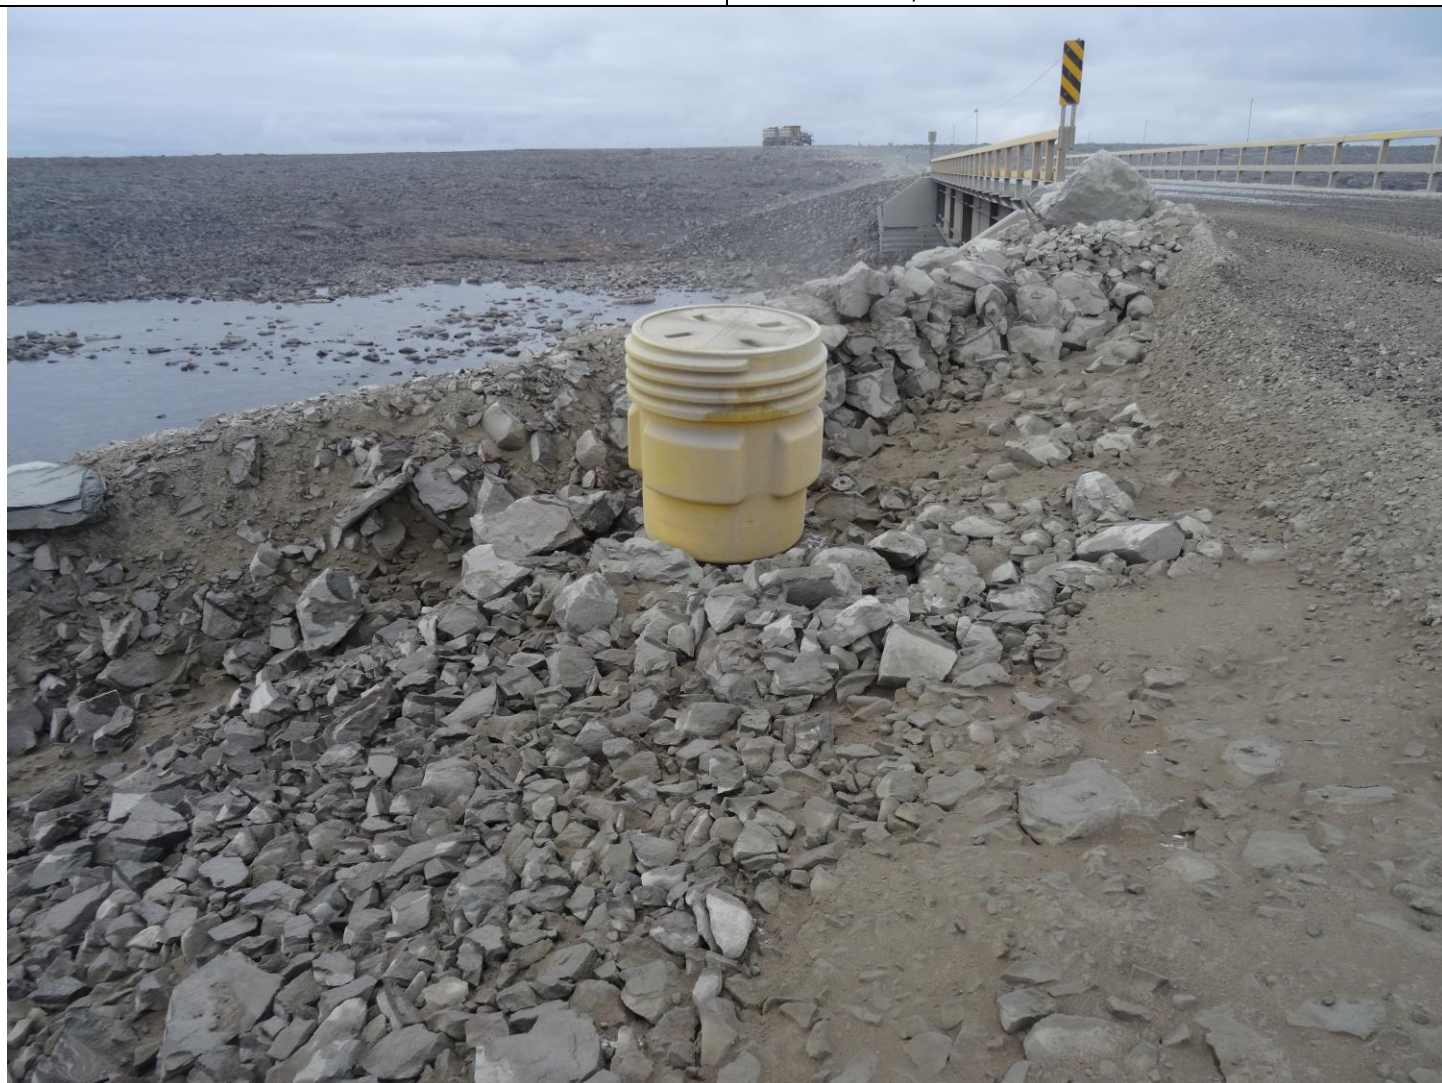
Photo 16

Spill response kit at bridge km 138.

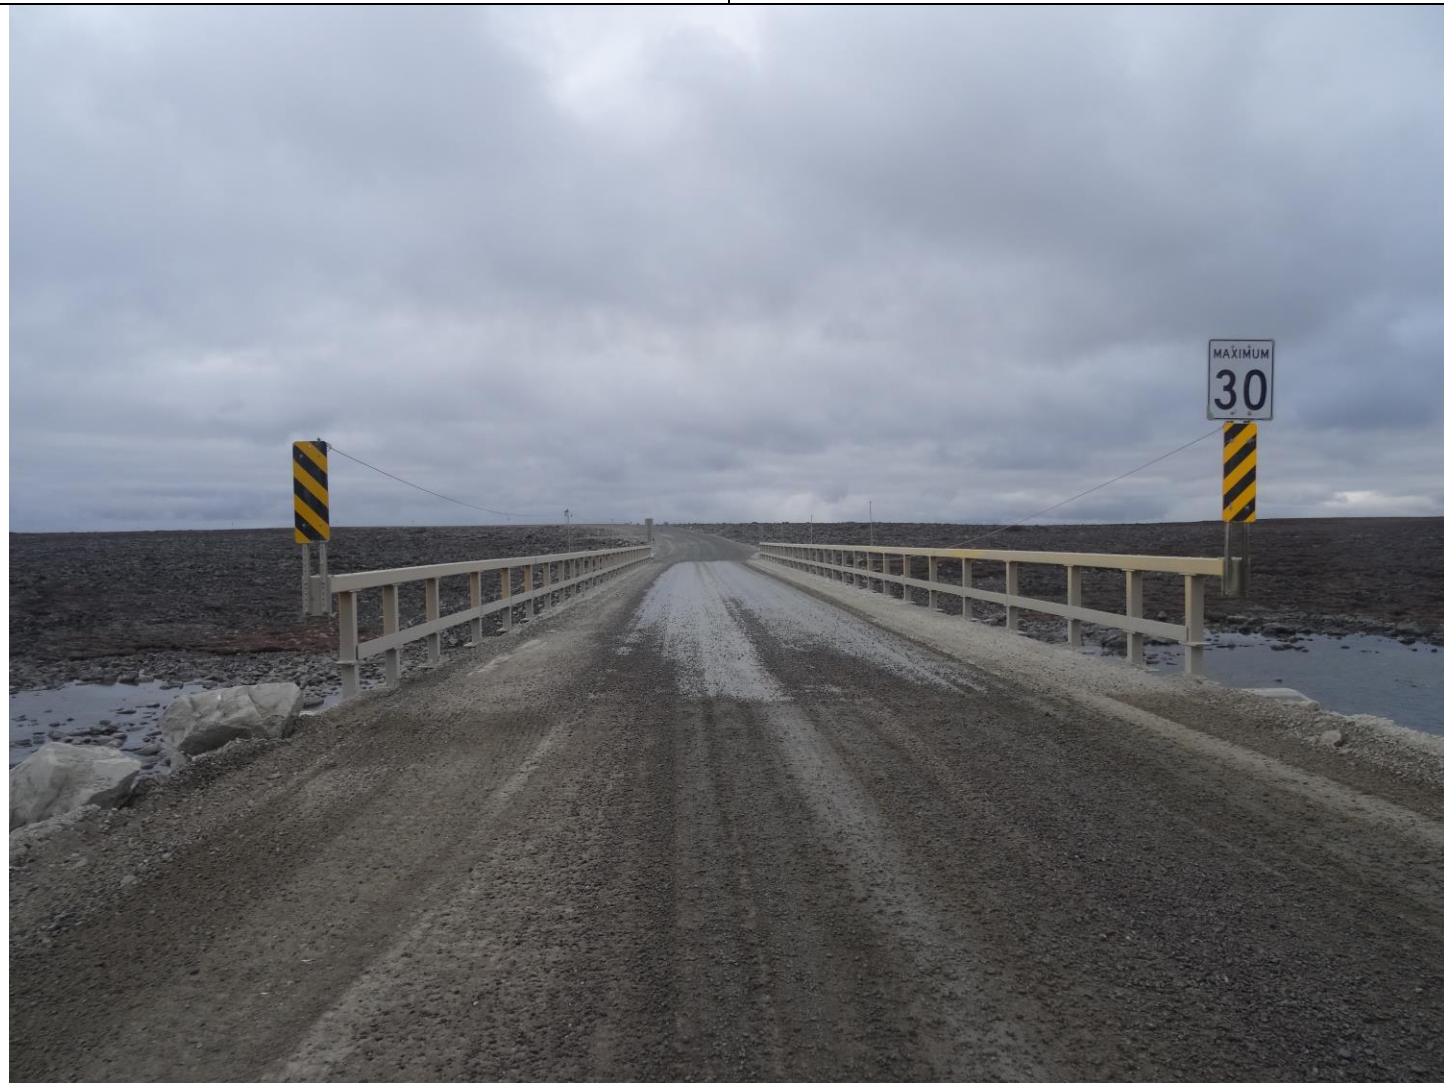
Photo 17

5. KM 138 Bridge, concern related to erosion and deposition of sediment into a water course. Erosion prevention measures and maintenance of these prevention measure should be implemented at this water crossing (photo 16-17).

Bridge at km 138.

The Licensee shall provide the inspector with a summary of the maintenance that will be completed this year on all the water crossings to prevent further sediment from entering the water course. This summary is due July 1<sup>st</sup> 2021.

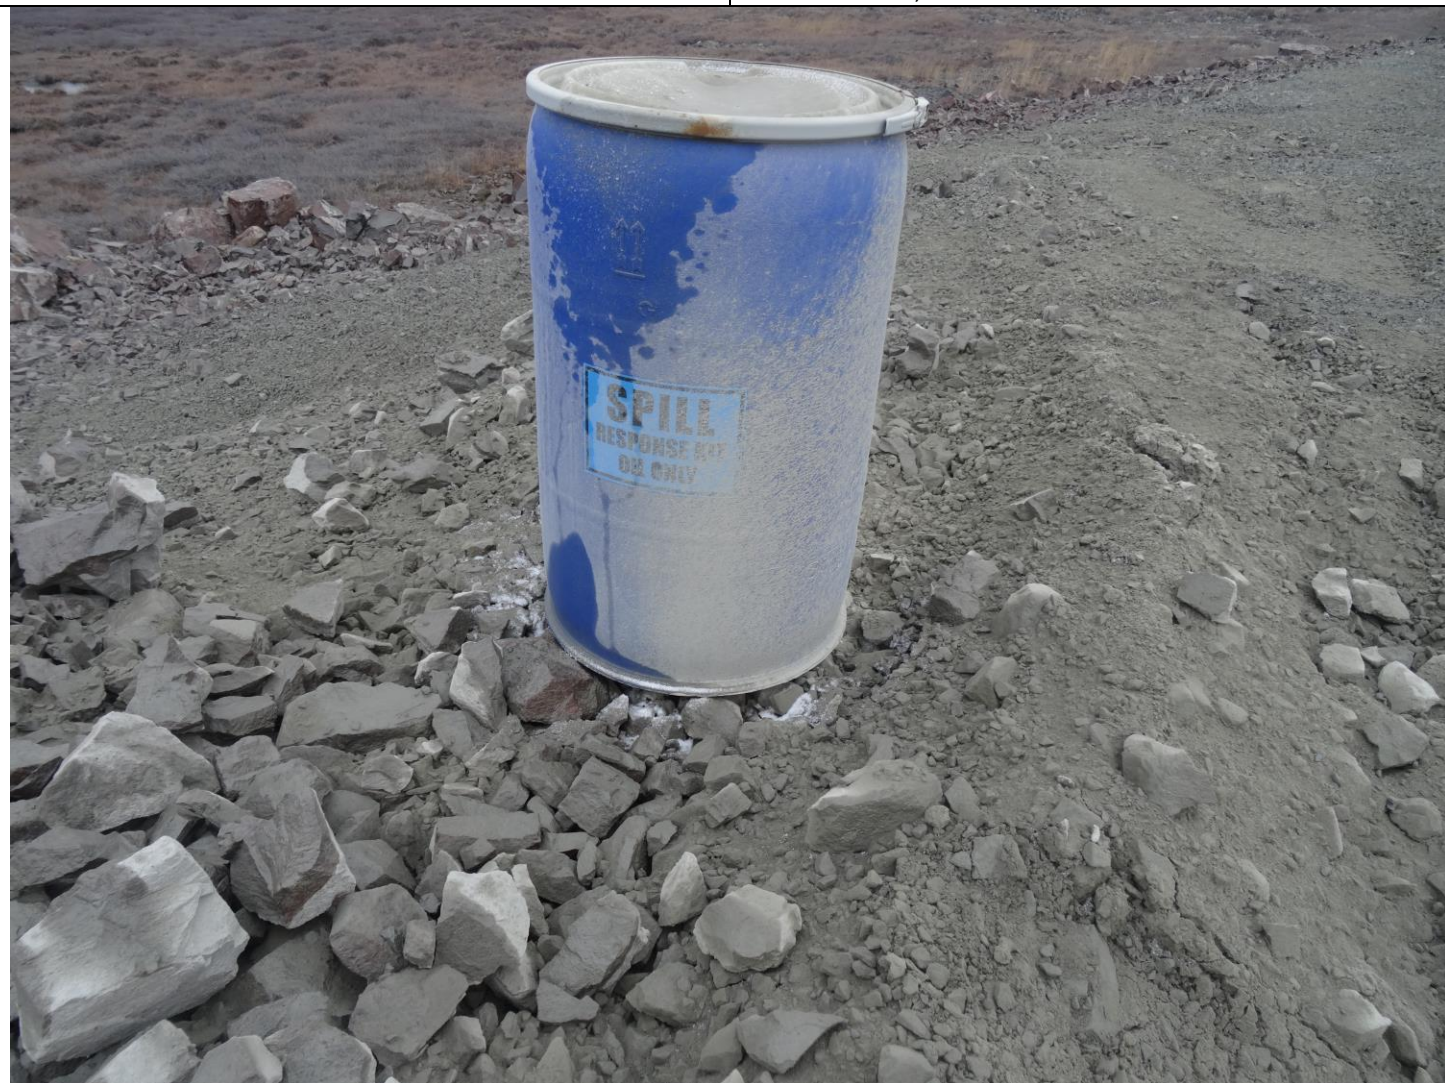
Photo 18

Spill response kit at bridge km 135.

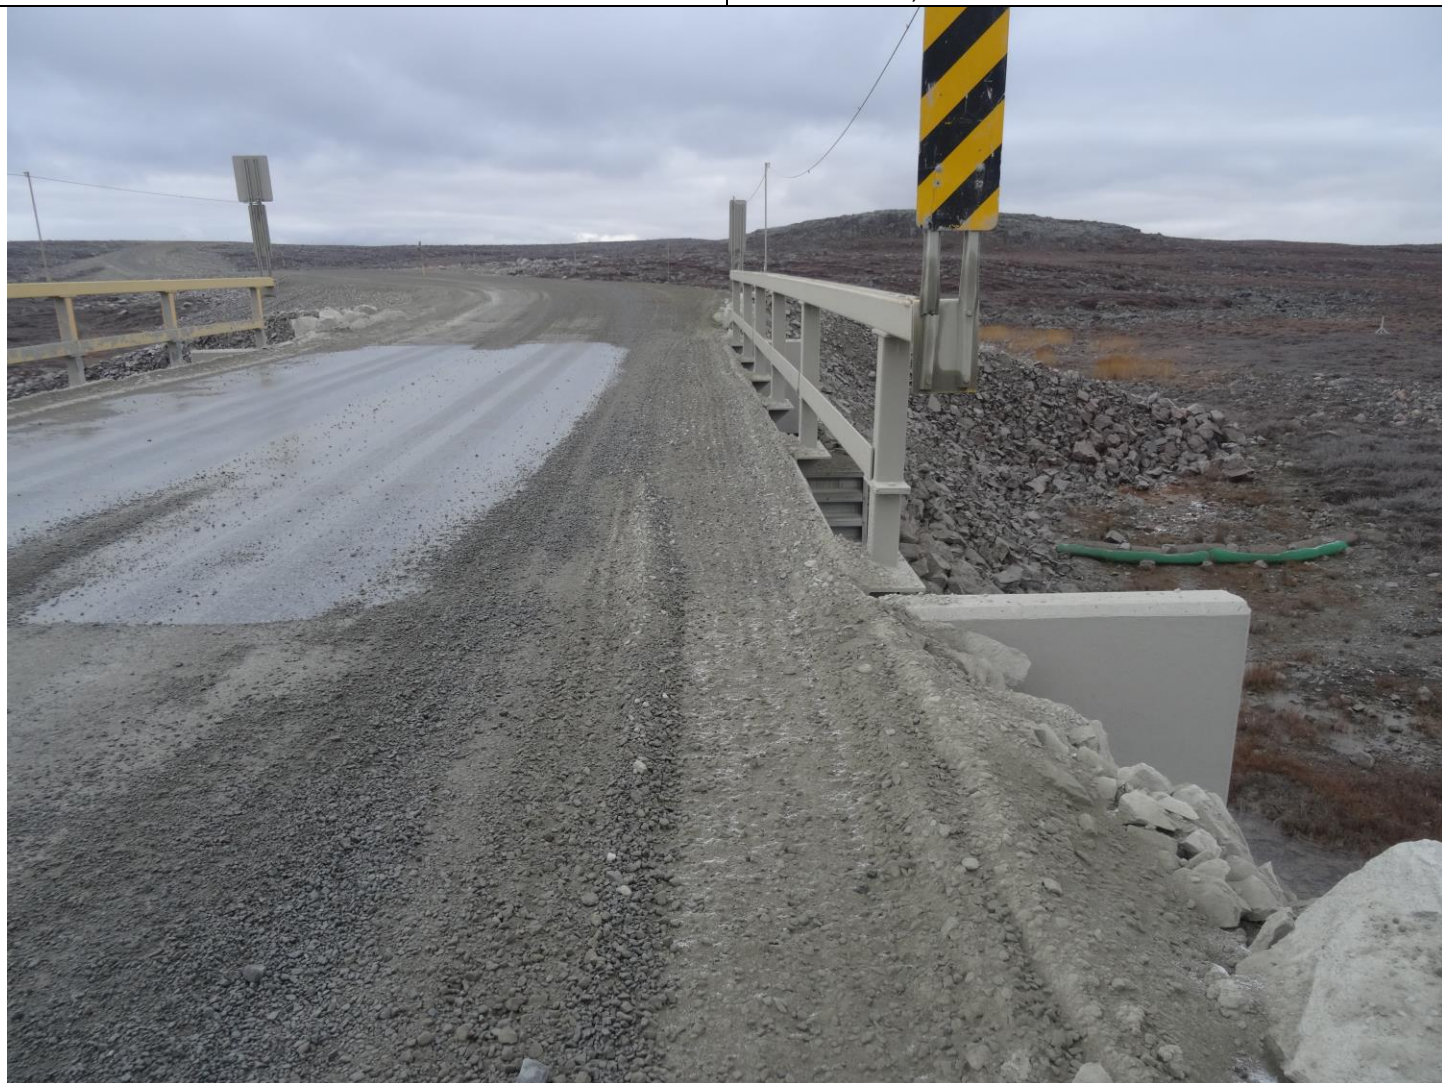
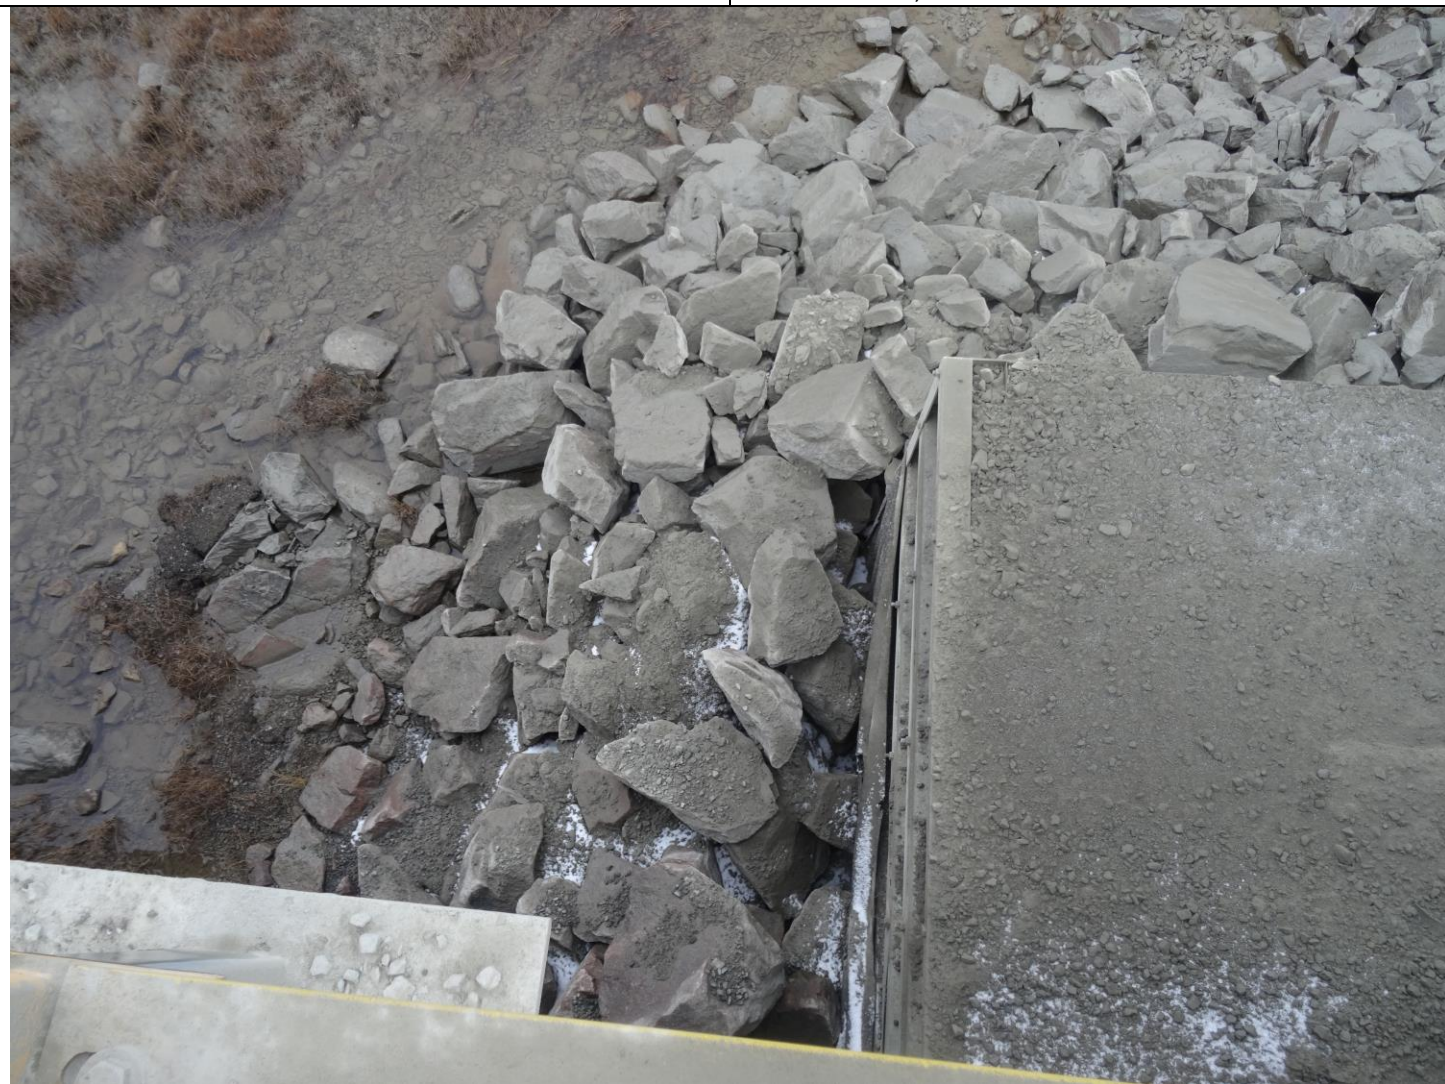
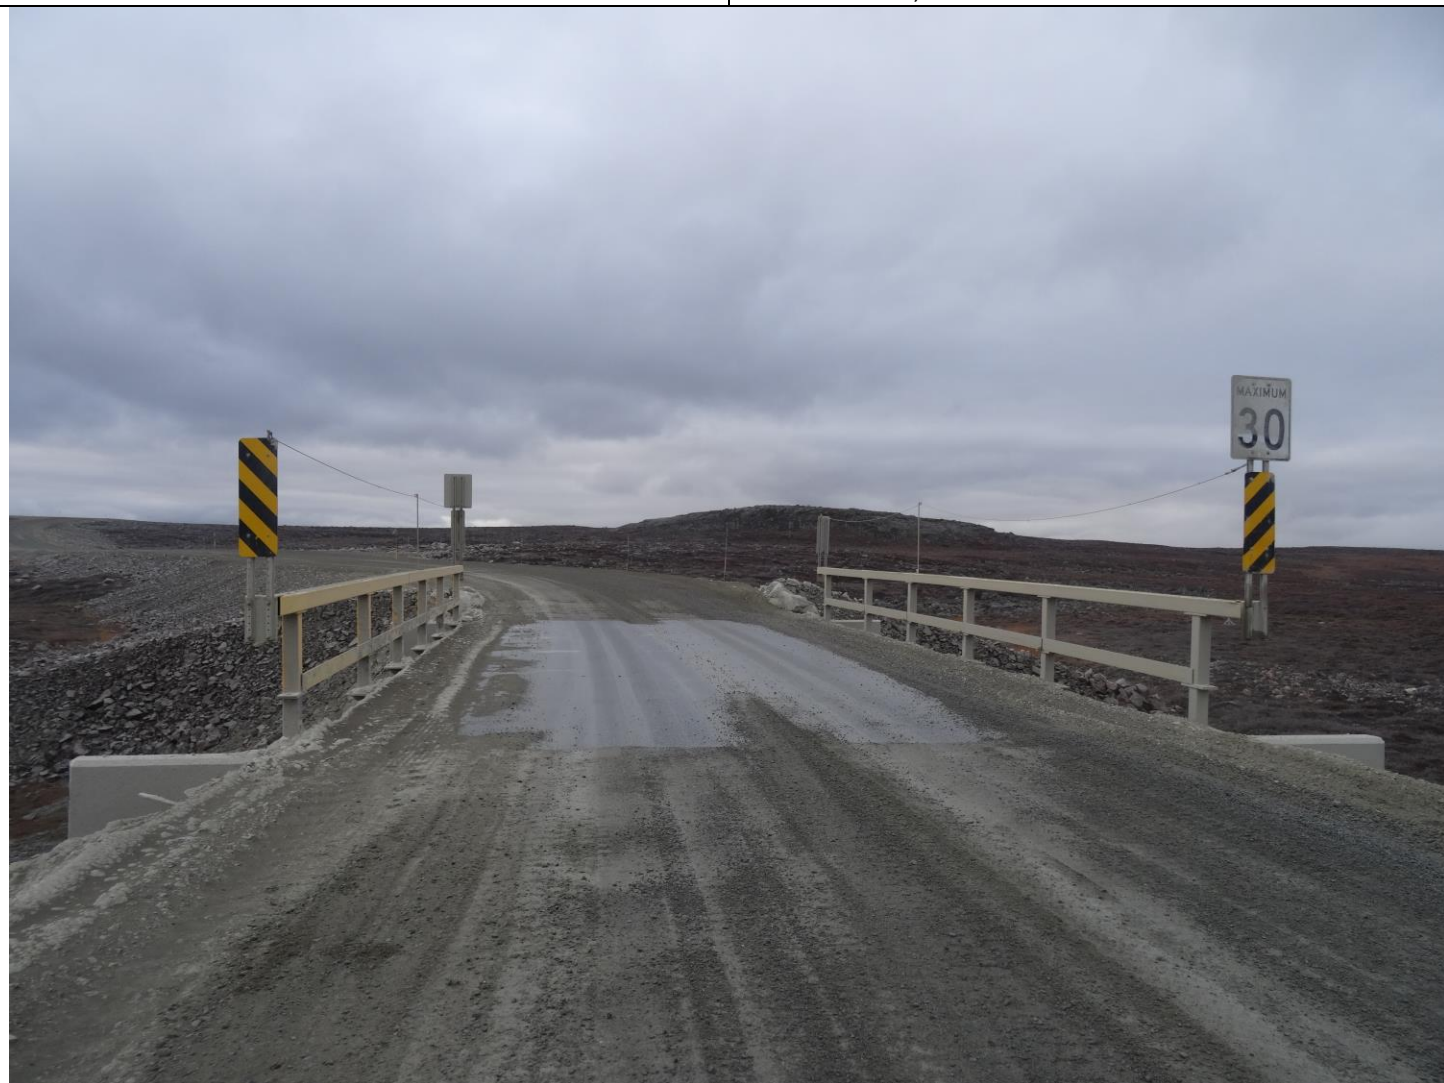
6. KM 135 Bridge, concern related to erosion and deposition of sediment into a water course. Erosion prevention measures and maintenance of these prevention measure should be implemented at this water crossing (photo 18-21).

Bridge at km 135.

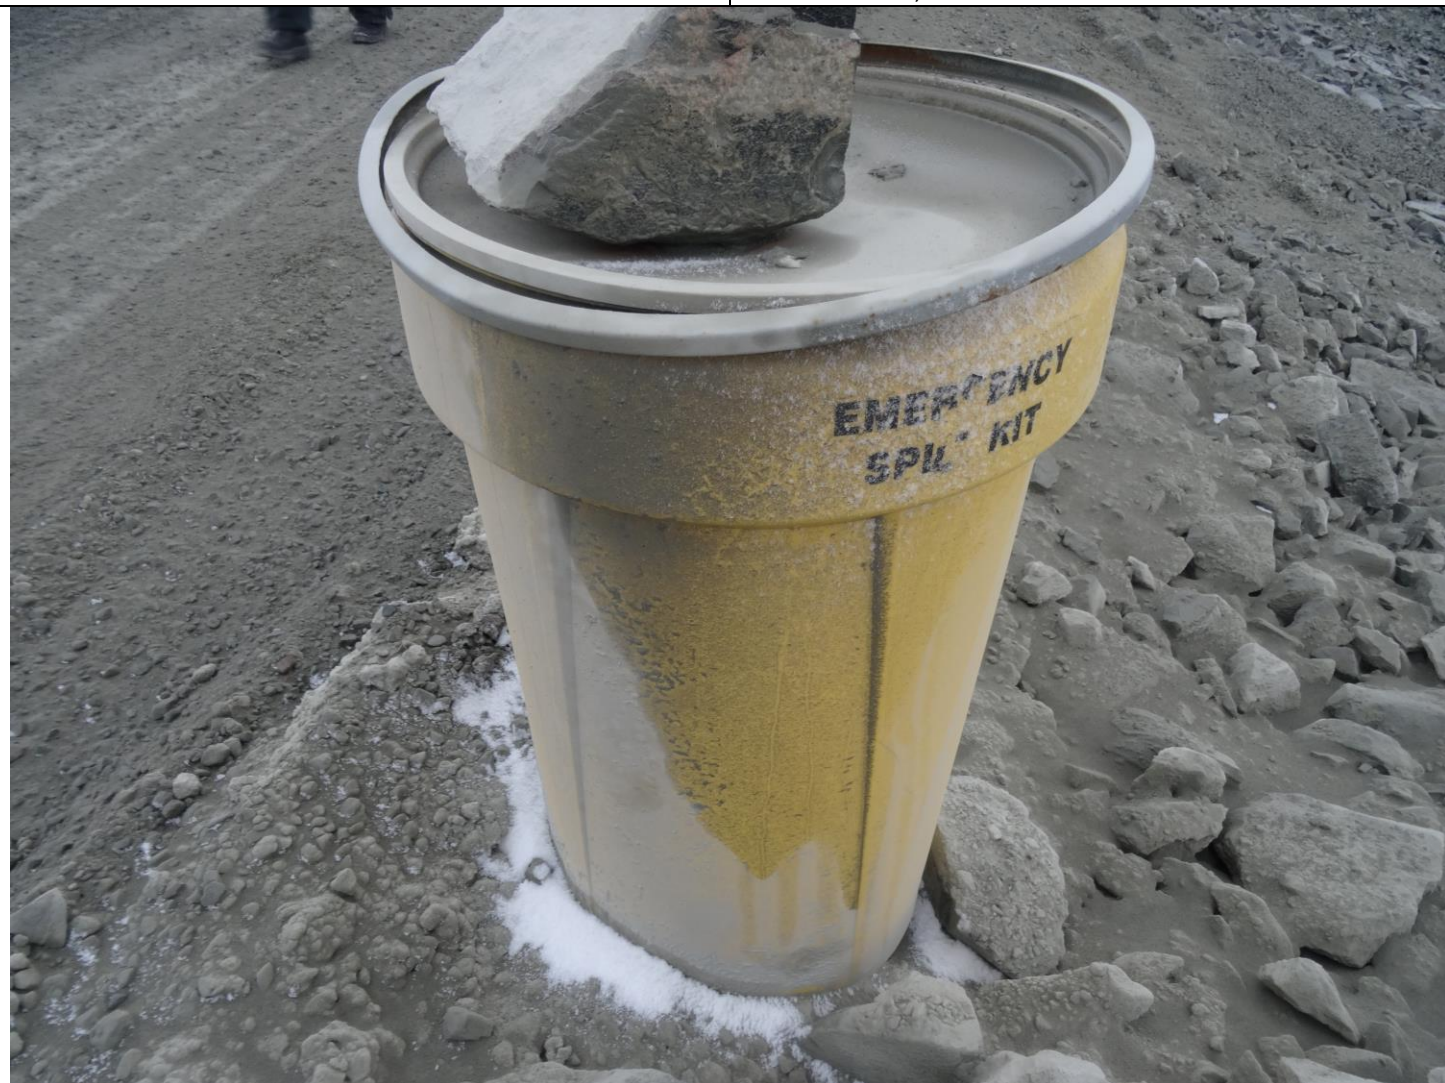
Photo 22

Spill response kit at bridge km 131.

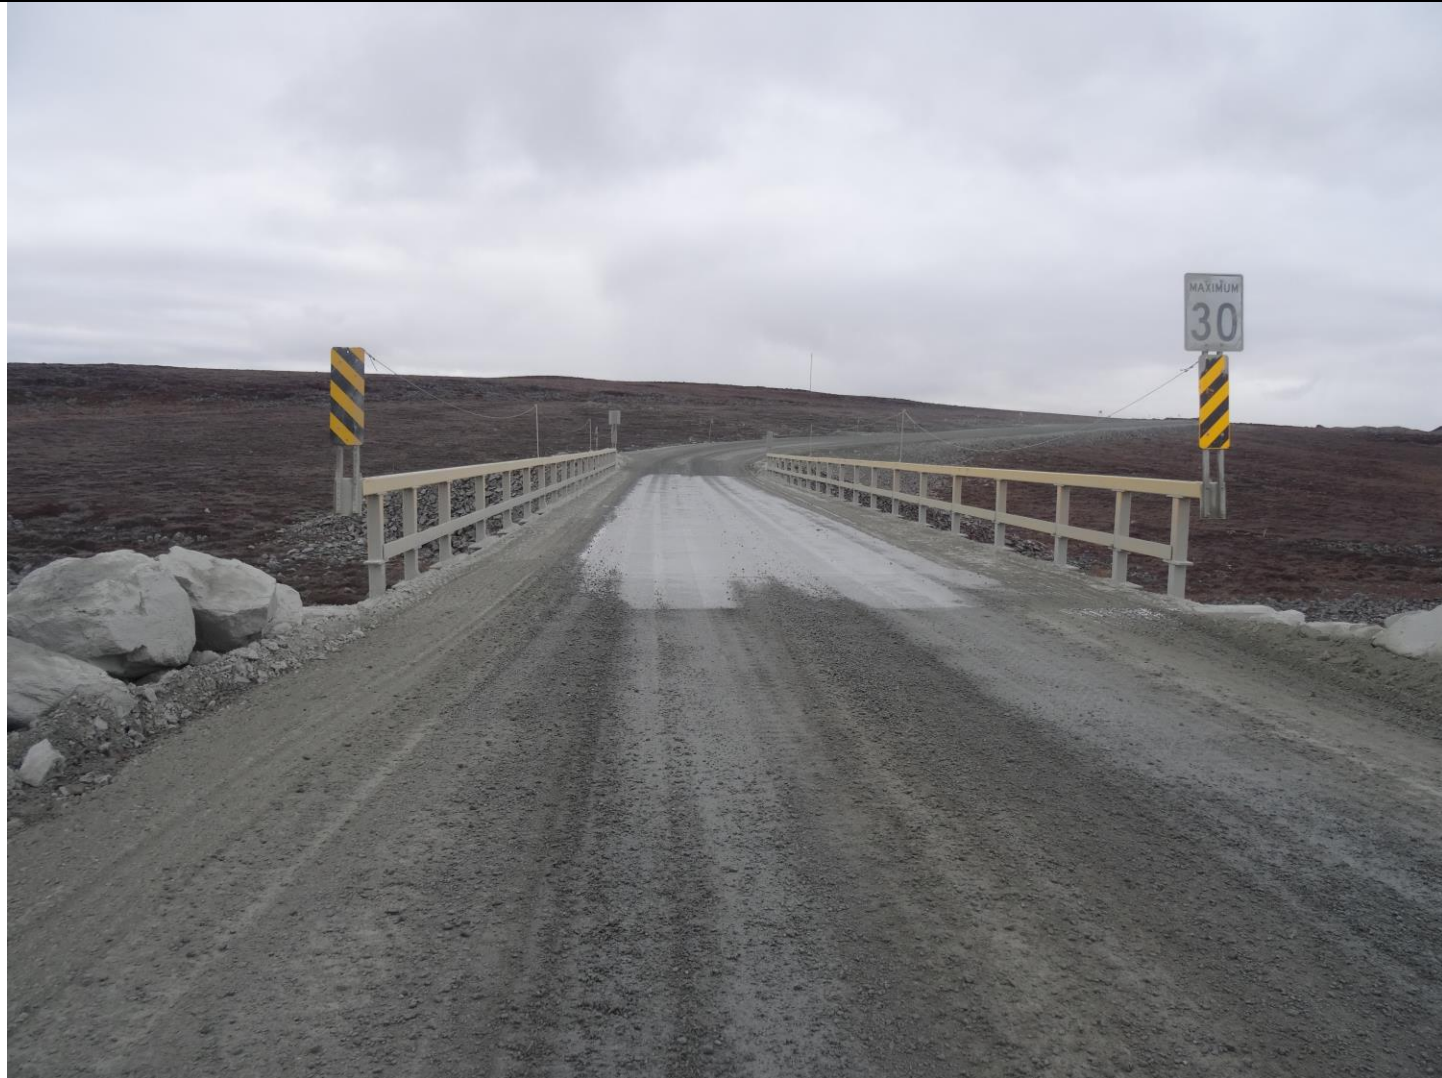
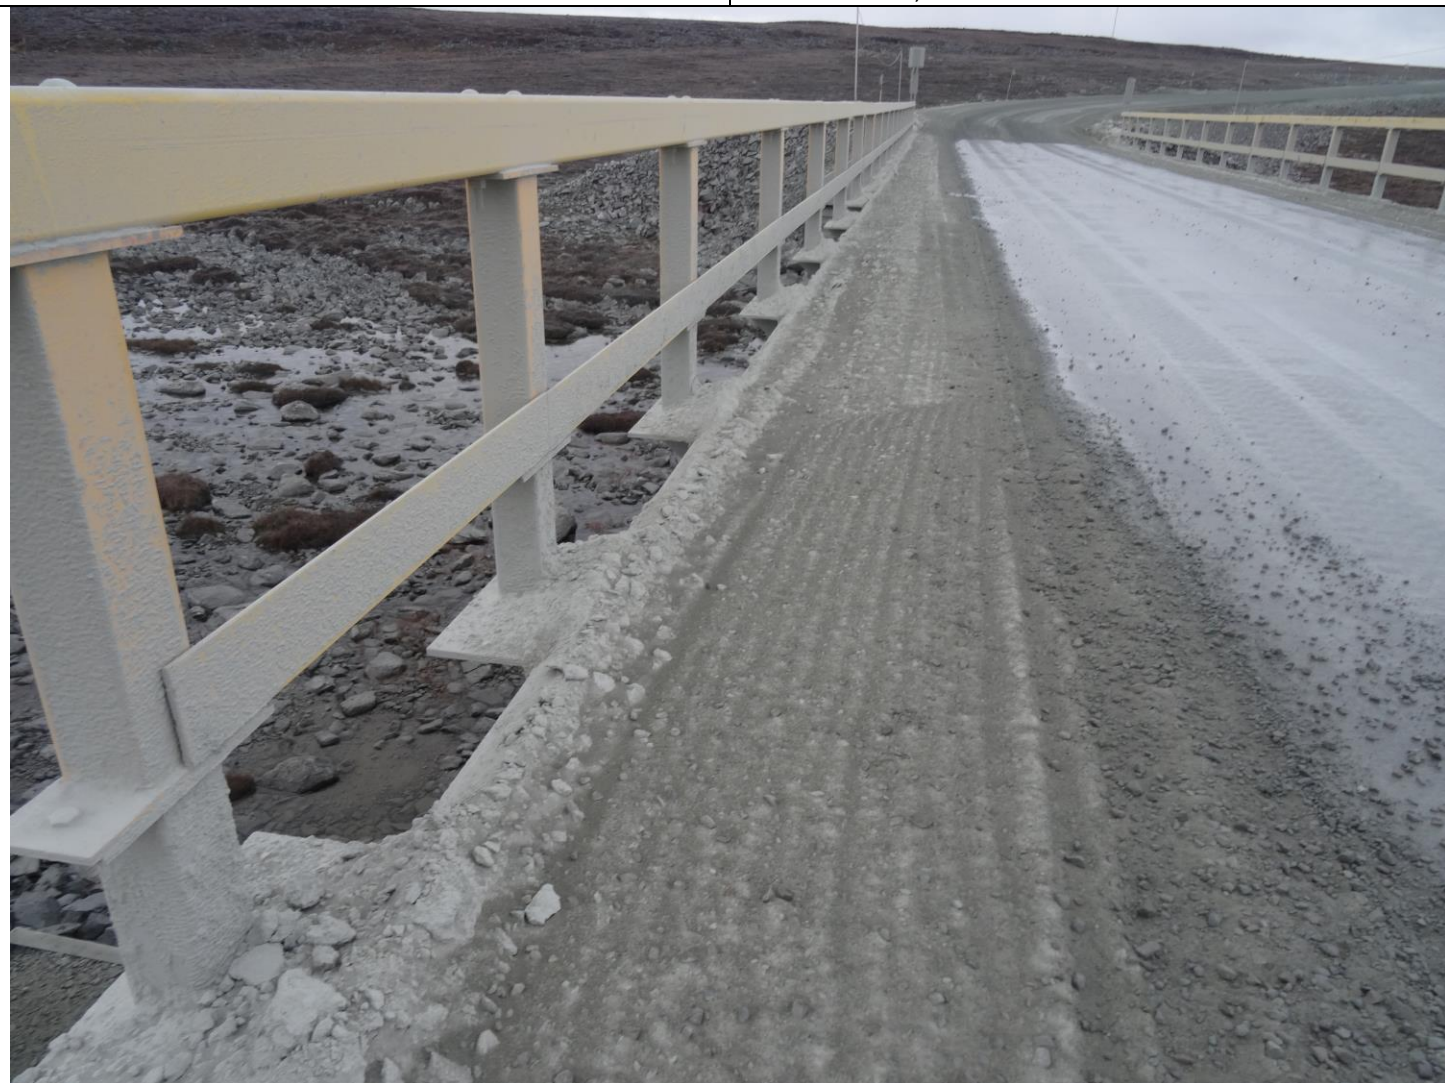
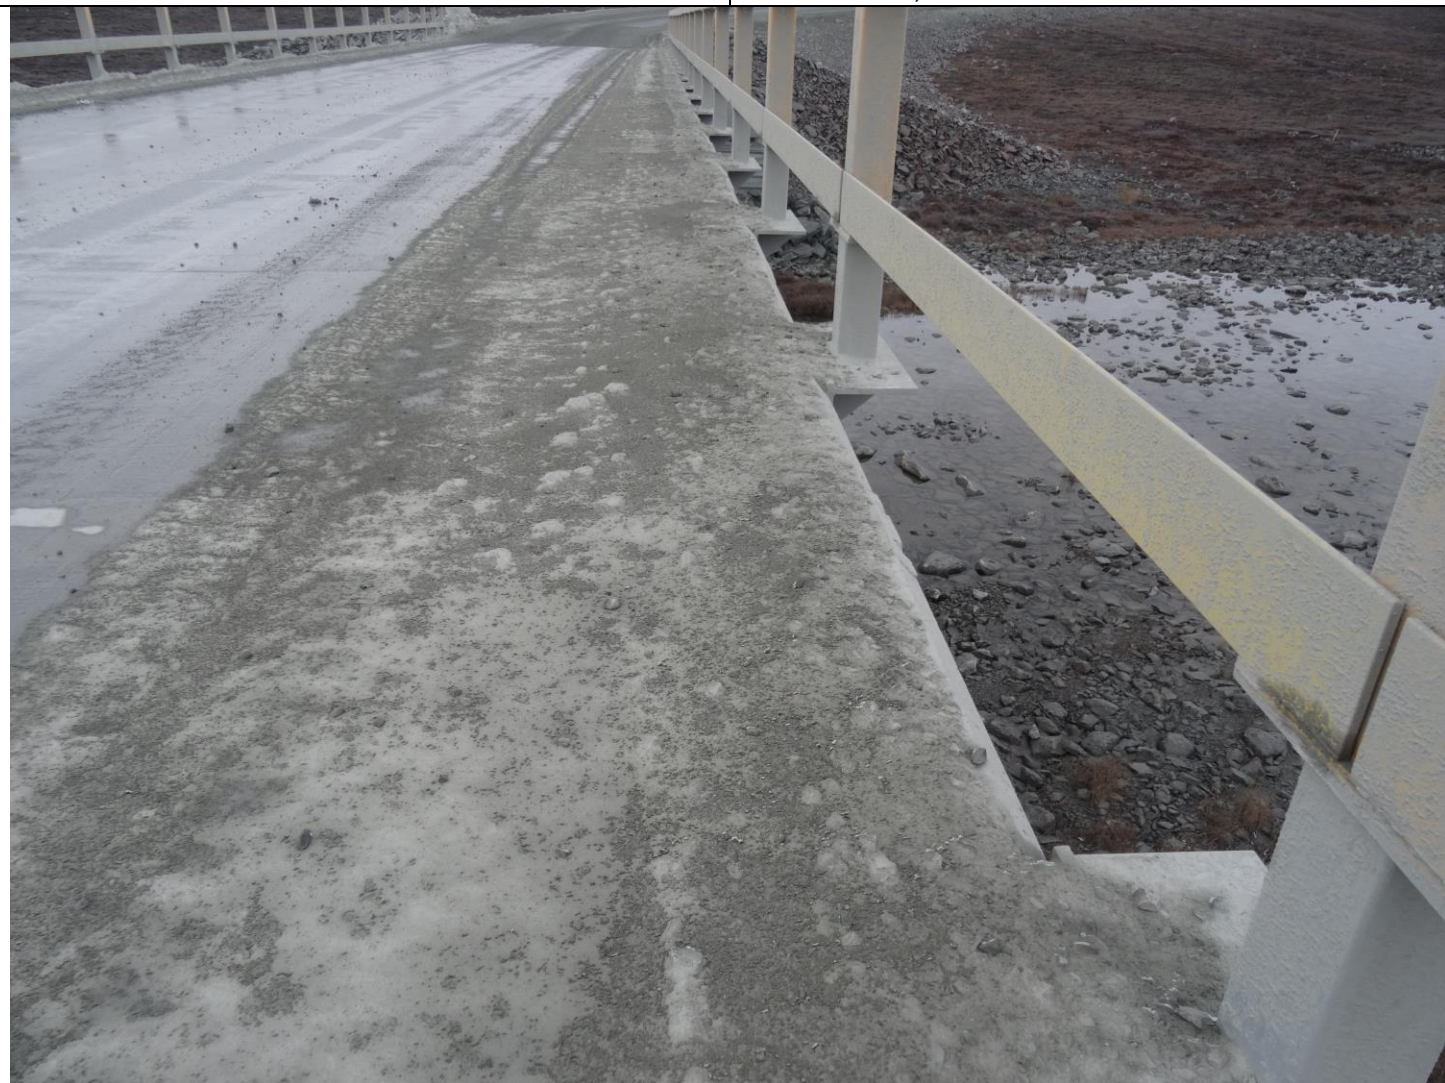
7. KM 131 Bridge, concern related to erosion and deposition of sediment into a water course.

Erosion prevention measures and maintenance of these prevention measure should be implemented at this water crossing (photo 22-25).

Bridge at km 131.

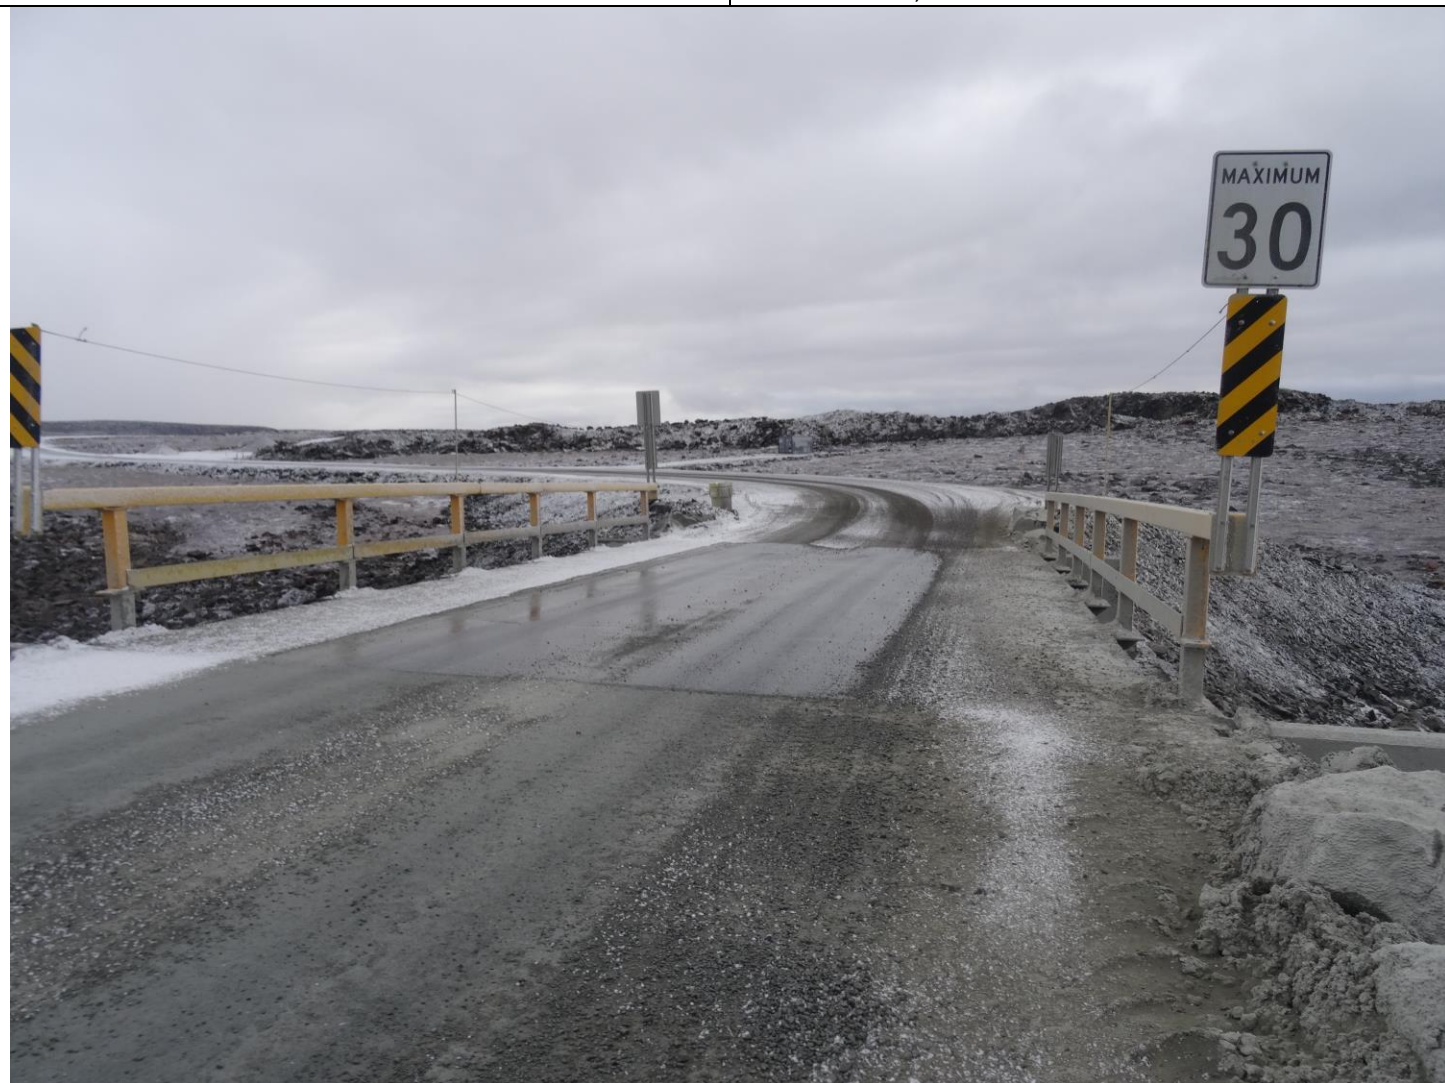
Photo 26

8. KM 125.7 Bridge, no concerns noted at this water crossing. (photo 26-27).

Bridge at km 125.7.

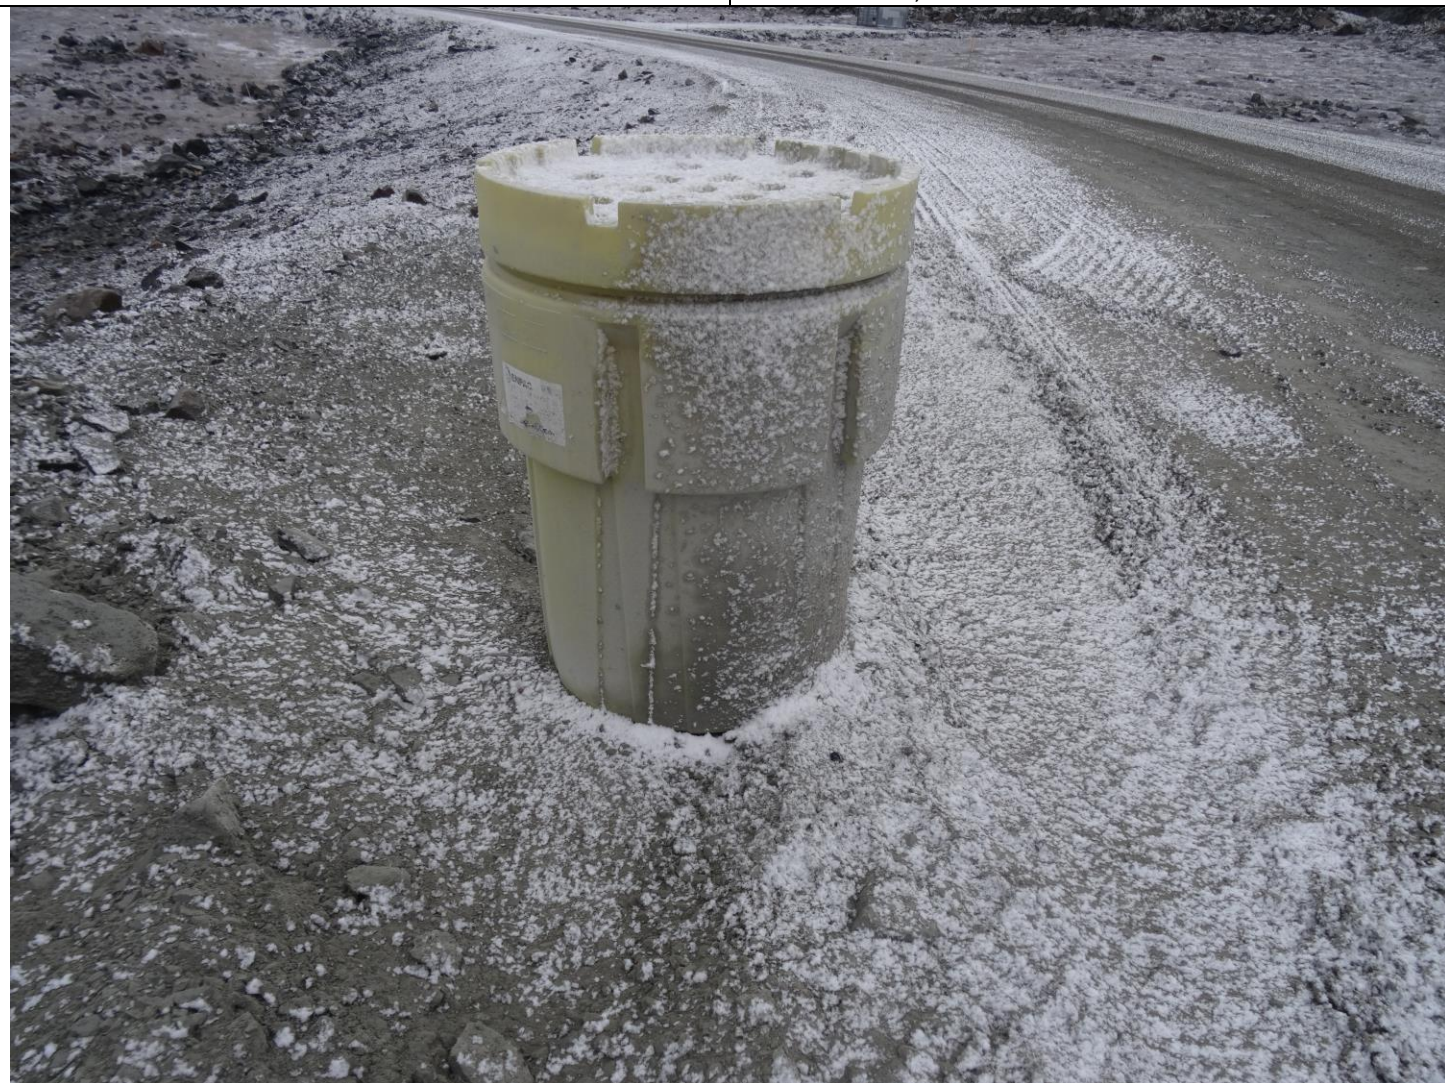
Photo 27

Spill response kit at bridge km 125.7.
