**WATER LICENCE INSPECTION FORM**☒ Original
☐ Follow-Up Report

Licensee	Licensee Representative
Agnico Eagle Mines Ltd.	Eric Haley
Licence No. / Expiry	Purpose
2AM-WTP1830 / March 27 th 2030	Mining
Land Authorization No. / Expiry	Project Name
IOL	Meadowbank Mining Complex
Date of Inspection	Inspector
June 14, 2022	WRO Kyle Amsel
Activities Inspected	
<input checked="" type="checkbox"/> Camp <input type="checkbox"/> Drilling <input checked="" type="checkbox"/> Mining <input type="checkbox"/> Construction <input type="checkbox"/> Reclamation <input checked="" type="checkbox"/> Fuel Storage <input checked="" type="checkbox"/> Roads/Hauling <input type="checkbox"/> Other: <input type="checkbox"/> Other:

On June 14, 2022 an inspection of Agnico Eagle Mines Ltd.'s Whale Tale Gold Project was completed by Crown-Indigenous Relations and Northern Affairs Canada ('CIRNAC')s, Water Resource Officer, Kyle Amsel (Inspector) and Christine Wilson.

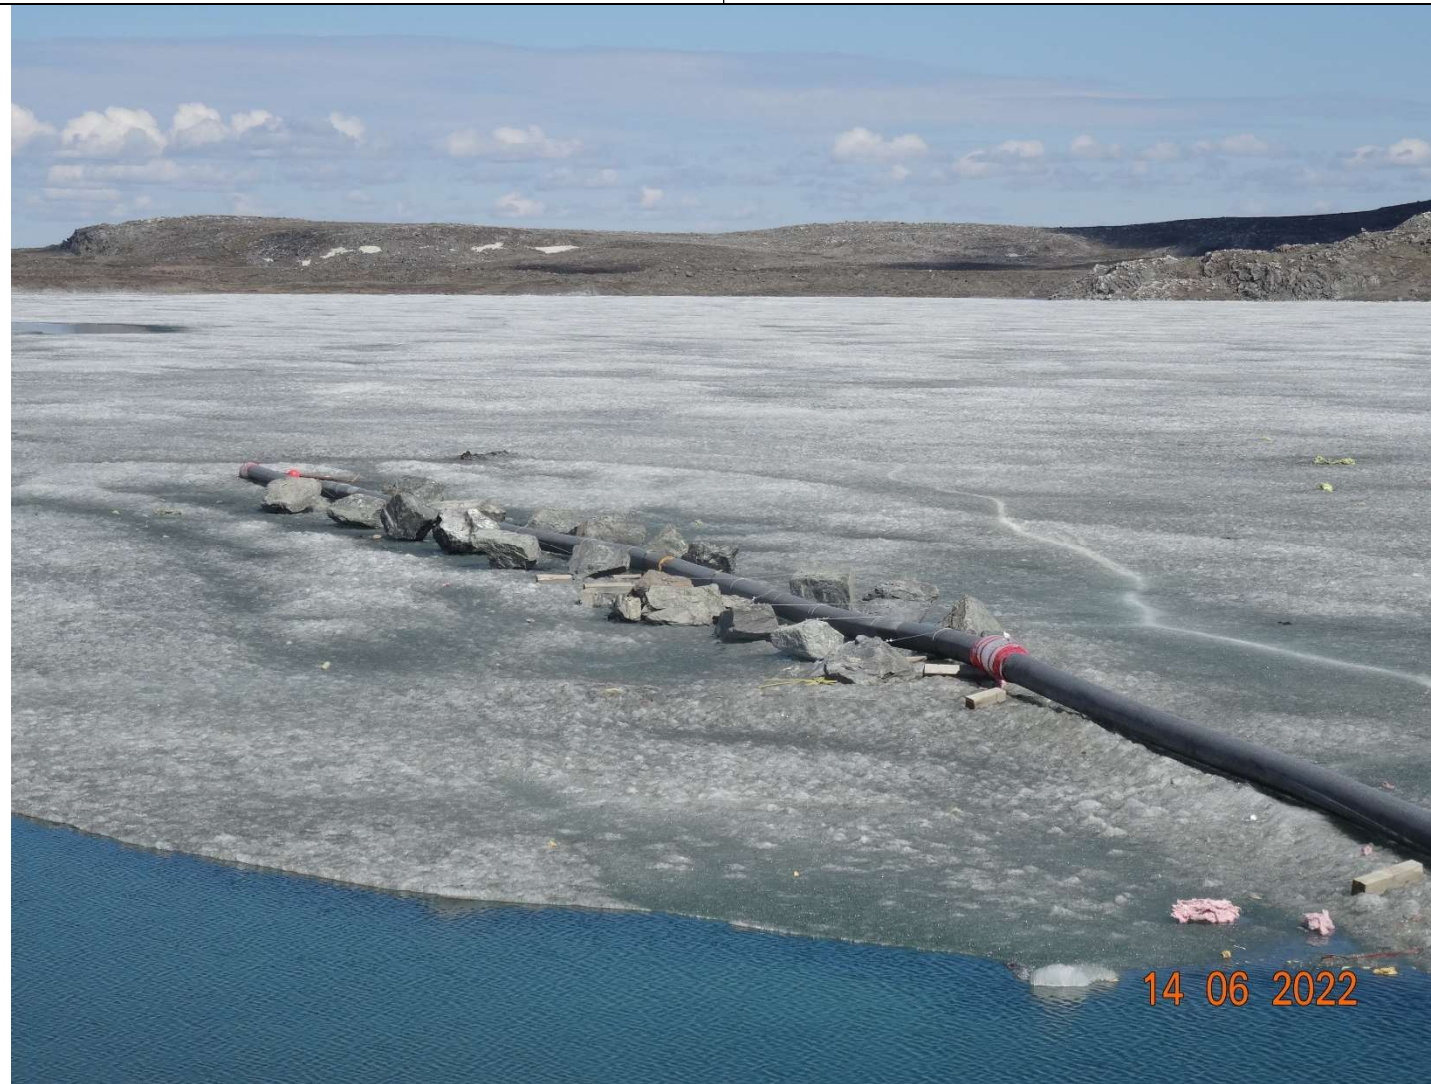
Date:	Authorization Number:	Camera/Model:	Inspector
June 14, 2022	2AM-WTP1830	Sony DSC-HX50V	WRO Amsel
Photo No.	Lat/Long (DD.MM.SS.SS, NAD83)		
Photo 1	N 65° 25' 08.8" W 96° 42' 16.17"

- Water is withdrawn from the lake via pipe, the pipe is laying on the ice with debris on the ice next to the pipe. Representatives indicated the debris will be removed by boat once the ice on the lake has thawed (photo 1)

Current water intake at Nemo Lake and debris on ice surface

- Install signage at sampling points, water intake facilities and waste disposal facilities
- Remove debris from the surface of Nemo Lake as soon as practical

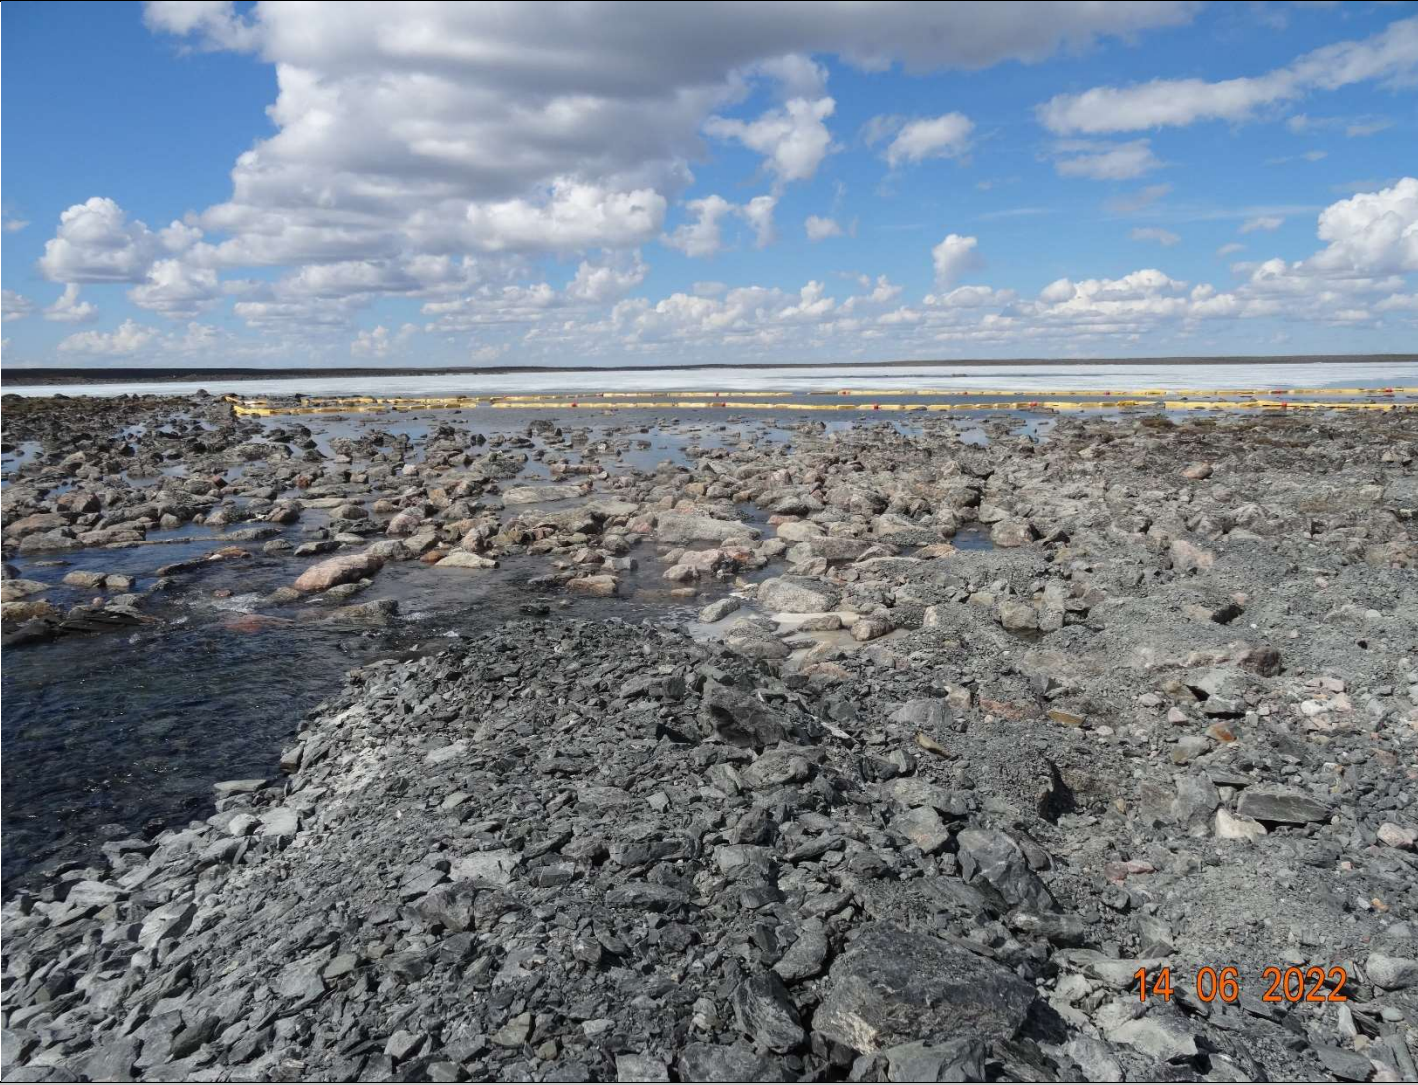
Date:	Authorization Number:	Camera/Model:	Inspector
June 14, 2022	2AM-WTP1830	Sony DSC-HX50V	WRO Amsel
Photo No.	Lat/Long (DD.MM.SS.SS, NAD83)		
Photo 2	N 65° 23' 17.3" W 96° 45' 00.6"

- c. Water is flowing through the channel
 - d. The channel inlet is located at N 65° 23' 17.3", W 96° 45' 00.8"
 - e. A silt curtain located at N 65° 23' 17.3", W 96° 45' 00.6" at the channel outlet into Mammoth Lake is still in place (photo 2)

Description: Outflow of Whale Tale South Diversion Channel into Mammoth Lake. Two silt curtains in background in Mammoth Lake

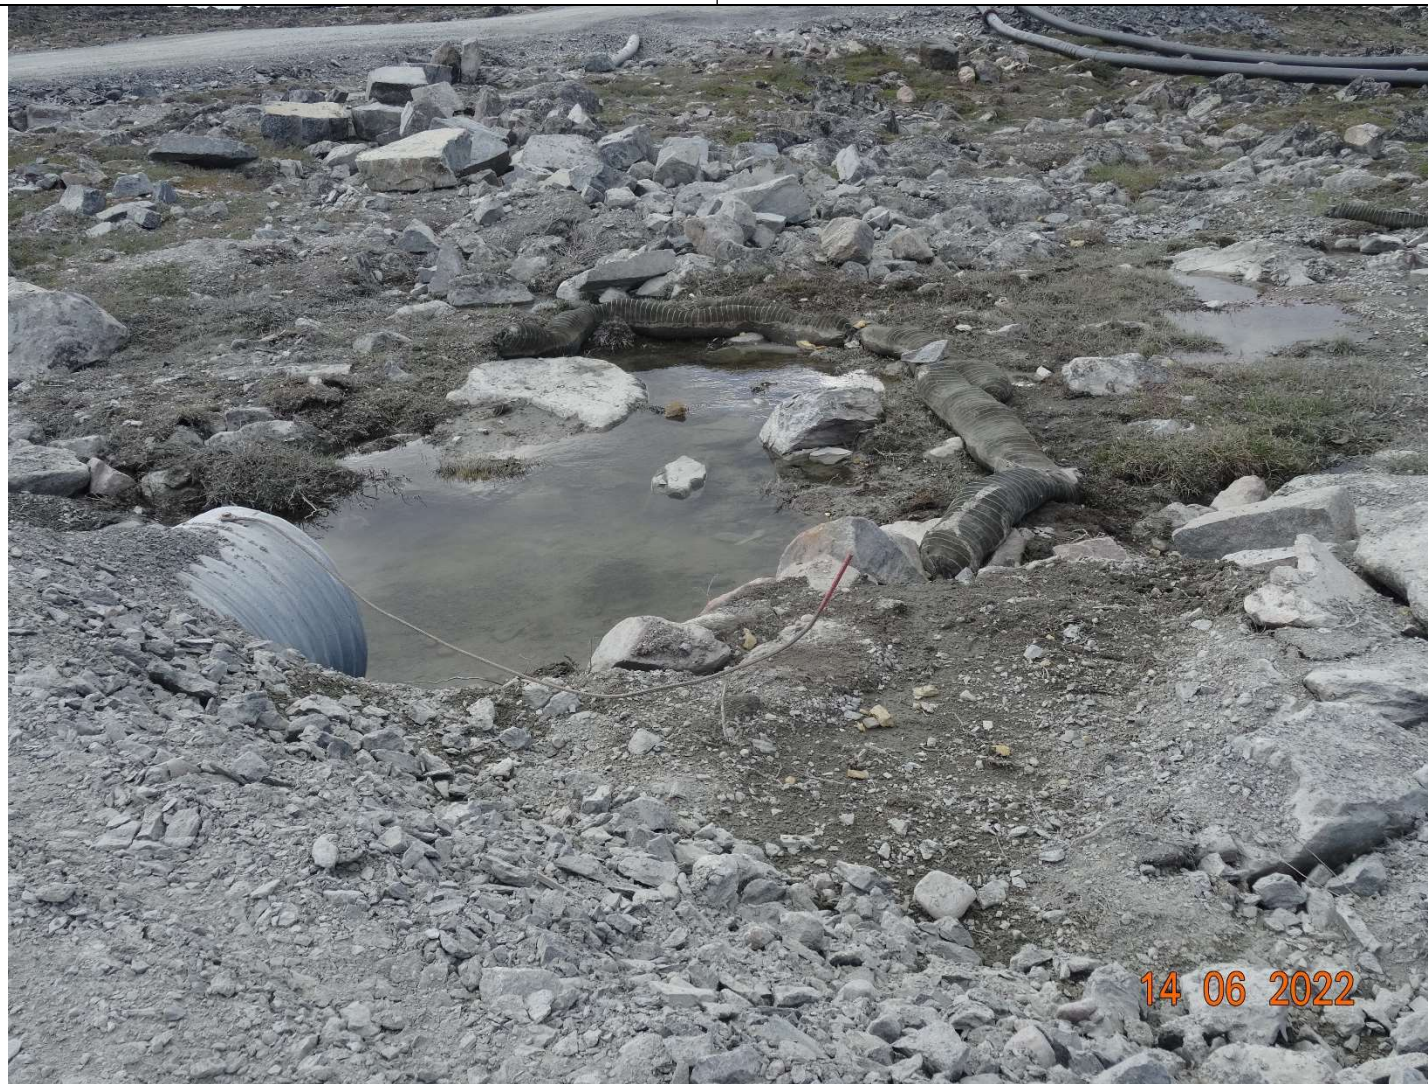
Date:	Authorization Number:	Camera/Model:	Inspector
June 14, 2022	2AM-WTP1830	Sony DSC-HX50V	RMO Wilson
Photo No.		Lat/Long (DD.MM.SS.SS, NAD83)	
Photo 3		N 650 23' 49.4" W 960 43' 51.5"

- a. Signs of sedimentation and erosion on the downstream side of the culvert into Mammoth Lake, straw booms are deployed to mitigate impacts (photo 3)

Signs of sediment being moved from water flowing through culvert and straw booms deployed

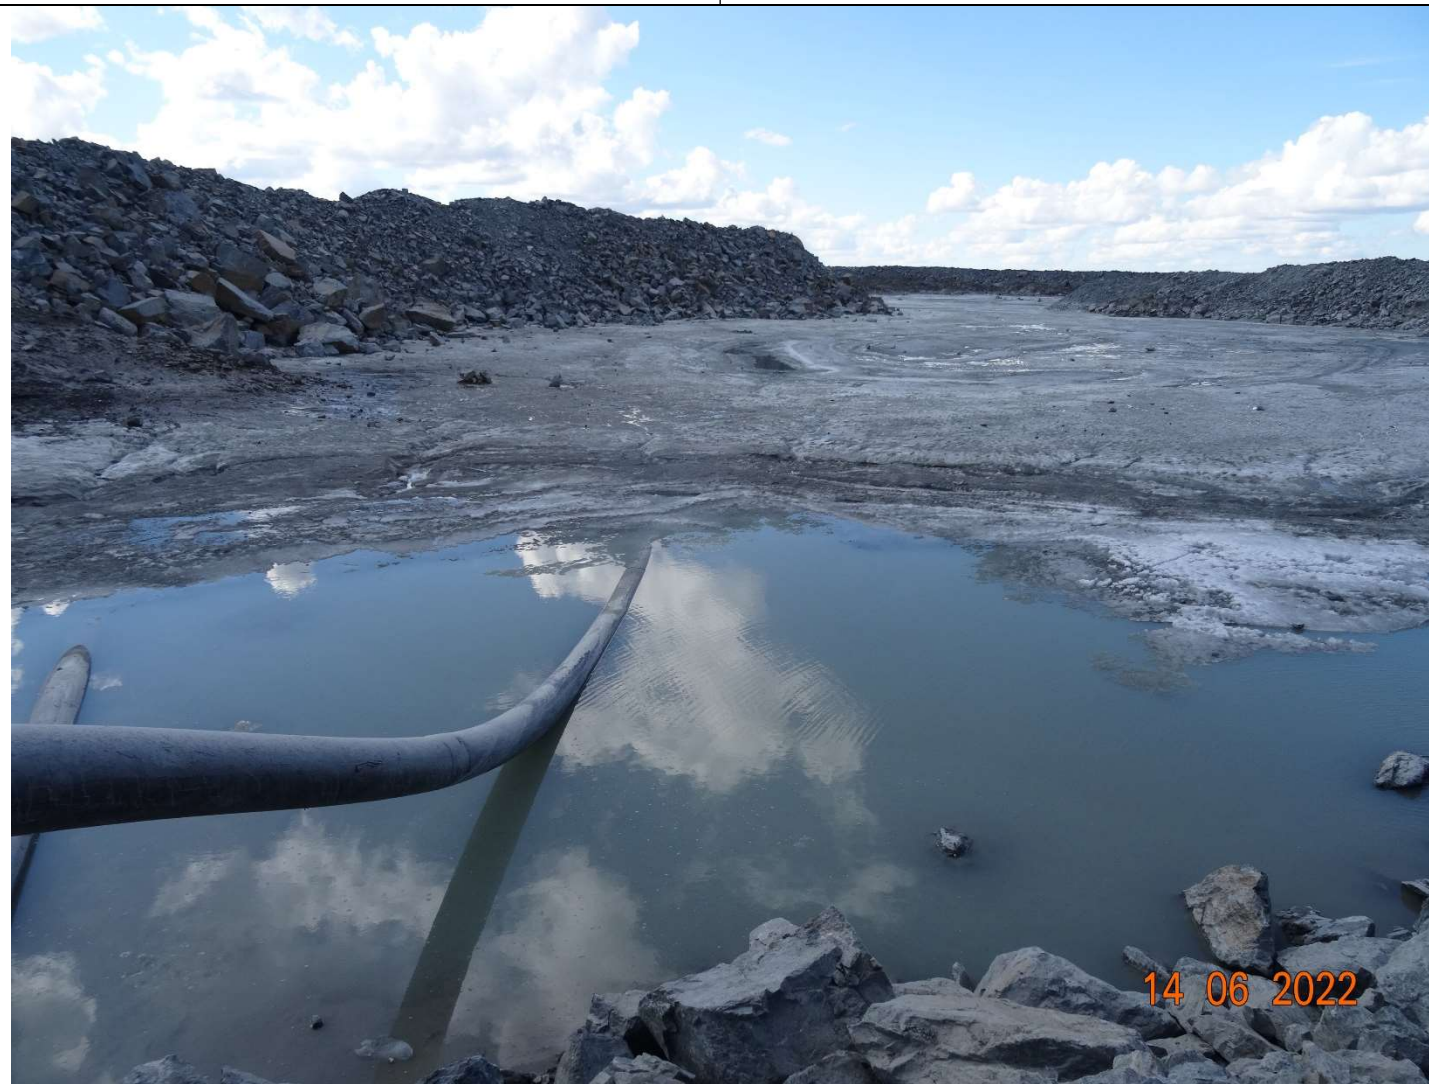
Date:	Authorization Number:	Camera/Model:	Inspector
June 14, 2022	2AM-WTP1830	Sony DSC-HX50V	WRO Amsel
Photo No.		Lat/Long (DD.MM.SS.SS, NAD83)	
Photo 5		N 65° 24' 37.8" W 96° 41' 58.8"

11. A49 Sump
 - a. Area appears to be used as an attenuation pond (photo 5), representatives stated that all the WT RSF sumps, and Mammoth Dyke sump report to this location prior to IVR attenuation pond

Lake /Sump A-49

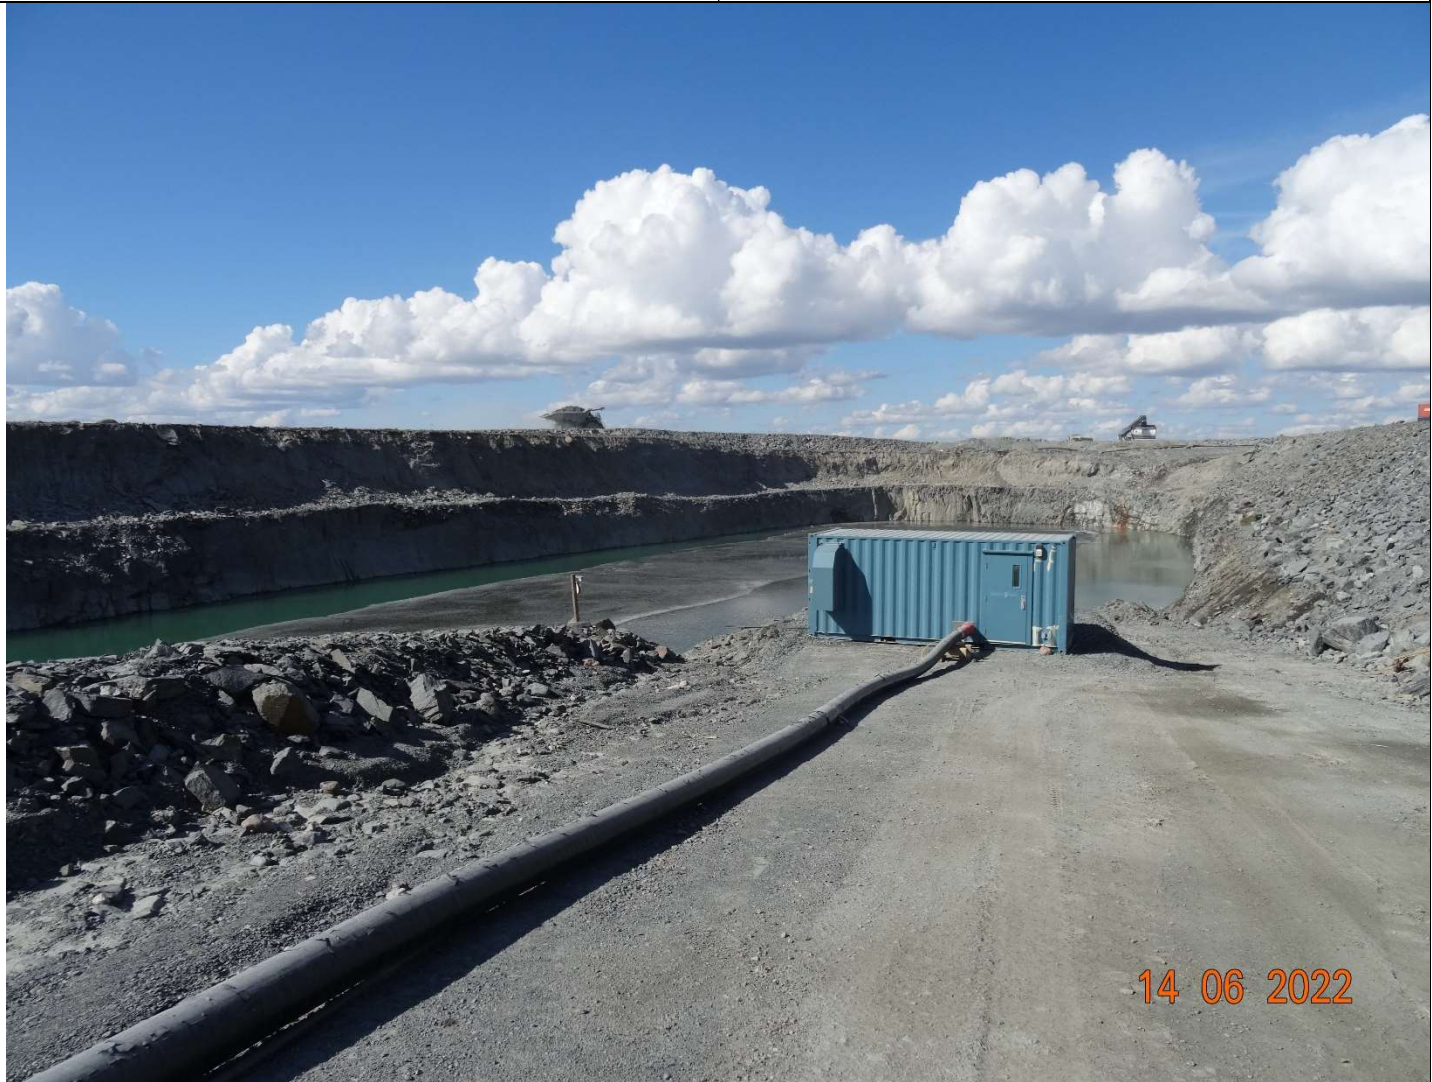
Date:	Authorization Number:	Camera/Model:	Inspector
June 14, 2022	2AM-WTP1830	Sony DSC-HX50V	WRO Amsel
Photo No.	Lat/Long (DD.MM.SS.SS, NAD83)		
Photo 6	N 65° 24' 27.9" W 96° 41' 15.3"

- a. Water here is collected from the underground operation, as well as runoff from the Underground Rock Storage (photo 6)
- b. The water is saline due to the use of calcium chloride in the drilling process, and that water is re-used in underground activities
- c. Pond is located at N 65° 24' 27.9", W 96° 41' 15.3"

Groundwater Storage Pond

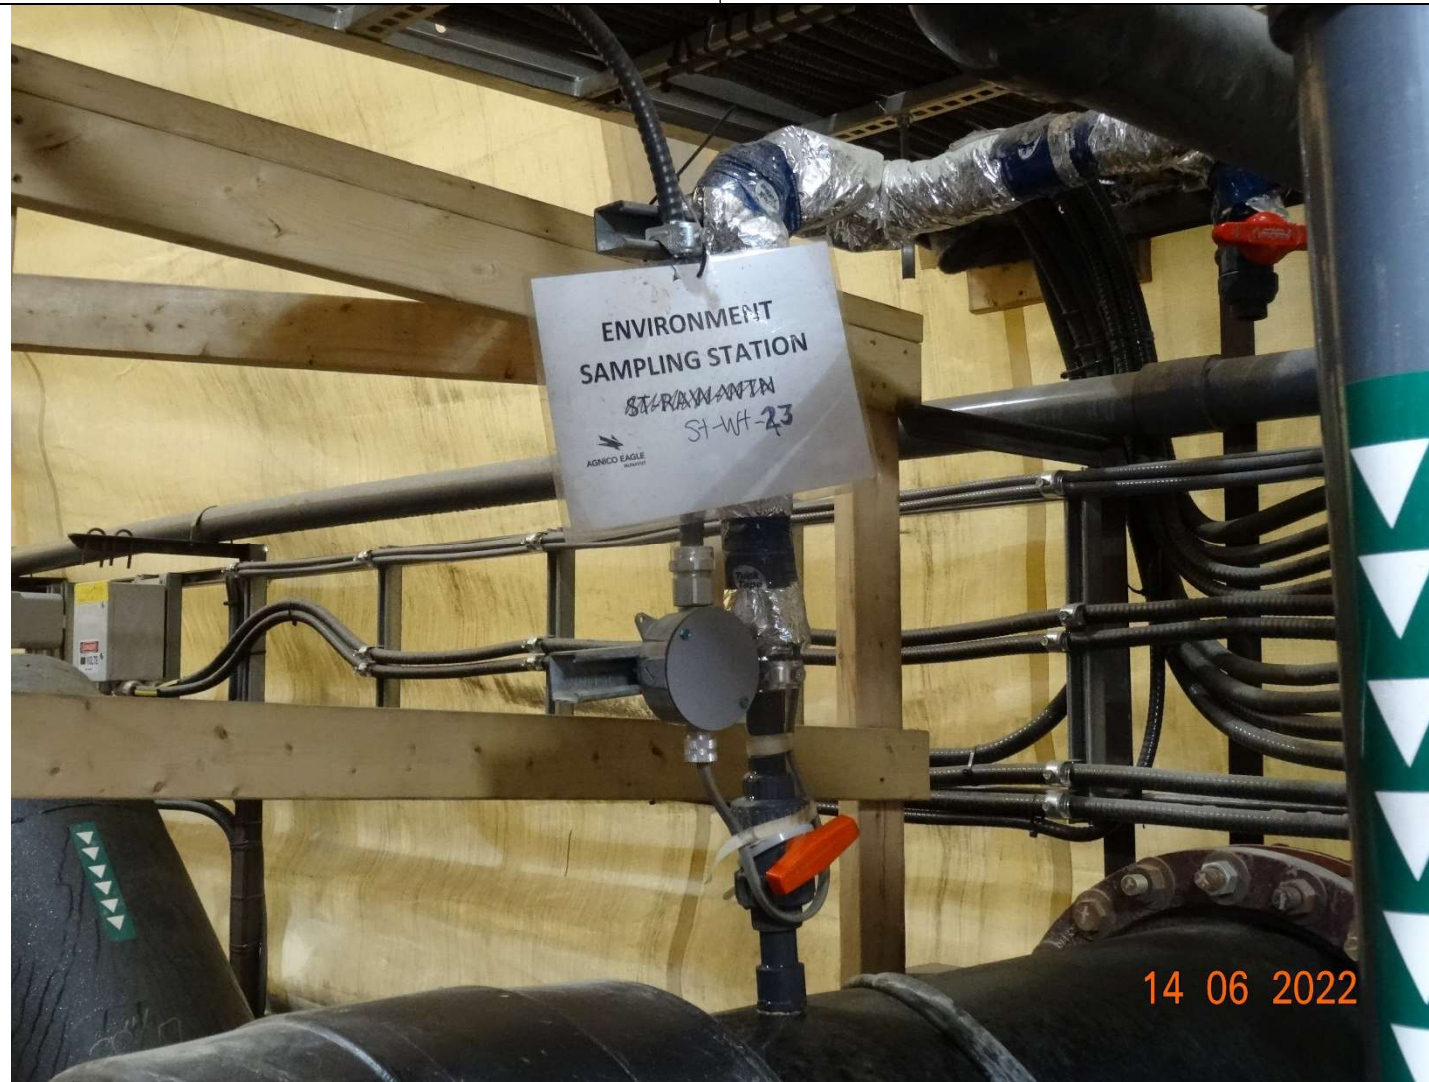
Date:	Authorization Number:	Camera/Model:	Inspector
June 14, 2022	2AM-WTP1830	Sony DSC-HX50V	WRO Amsel
Photo No.	Lat/Long (DD.MM.SS.SS, NAD83)		
Photo 7	N 65° 24' 10.6" W 96° 40' 56.6"

- a. ST-WT-23 is equip with a monitoring station sign inside the plant as required by PART I item 7 (photo 7). This station monitors untreated contact water prior to treatment and discharge
- b. Wastewater Treatment Plant and ST-WT-23 is located at N 65° 24' 10.6" W 96° 40' 56.6"
- c. The water being pumped into the Whale Tale diffuser passes through a header pump where monitoring station ST-WT-24 is located. (photo 8) Water quality samples were collected and sent for analysis, Results were not available at the writing of this report
- d. No monitoring station sign, or sign notifying the public of waste disposal facilities is present at this location as per licence Part I Item 7 and Part B Item 10
- e. ST-WT-24 is located generally at N 65° 24' 10.6", W 96° 40' 56.6"

Monitoring Station ST-WT-23 sign inside Wastewater Treatment Plant

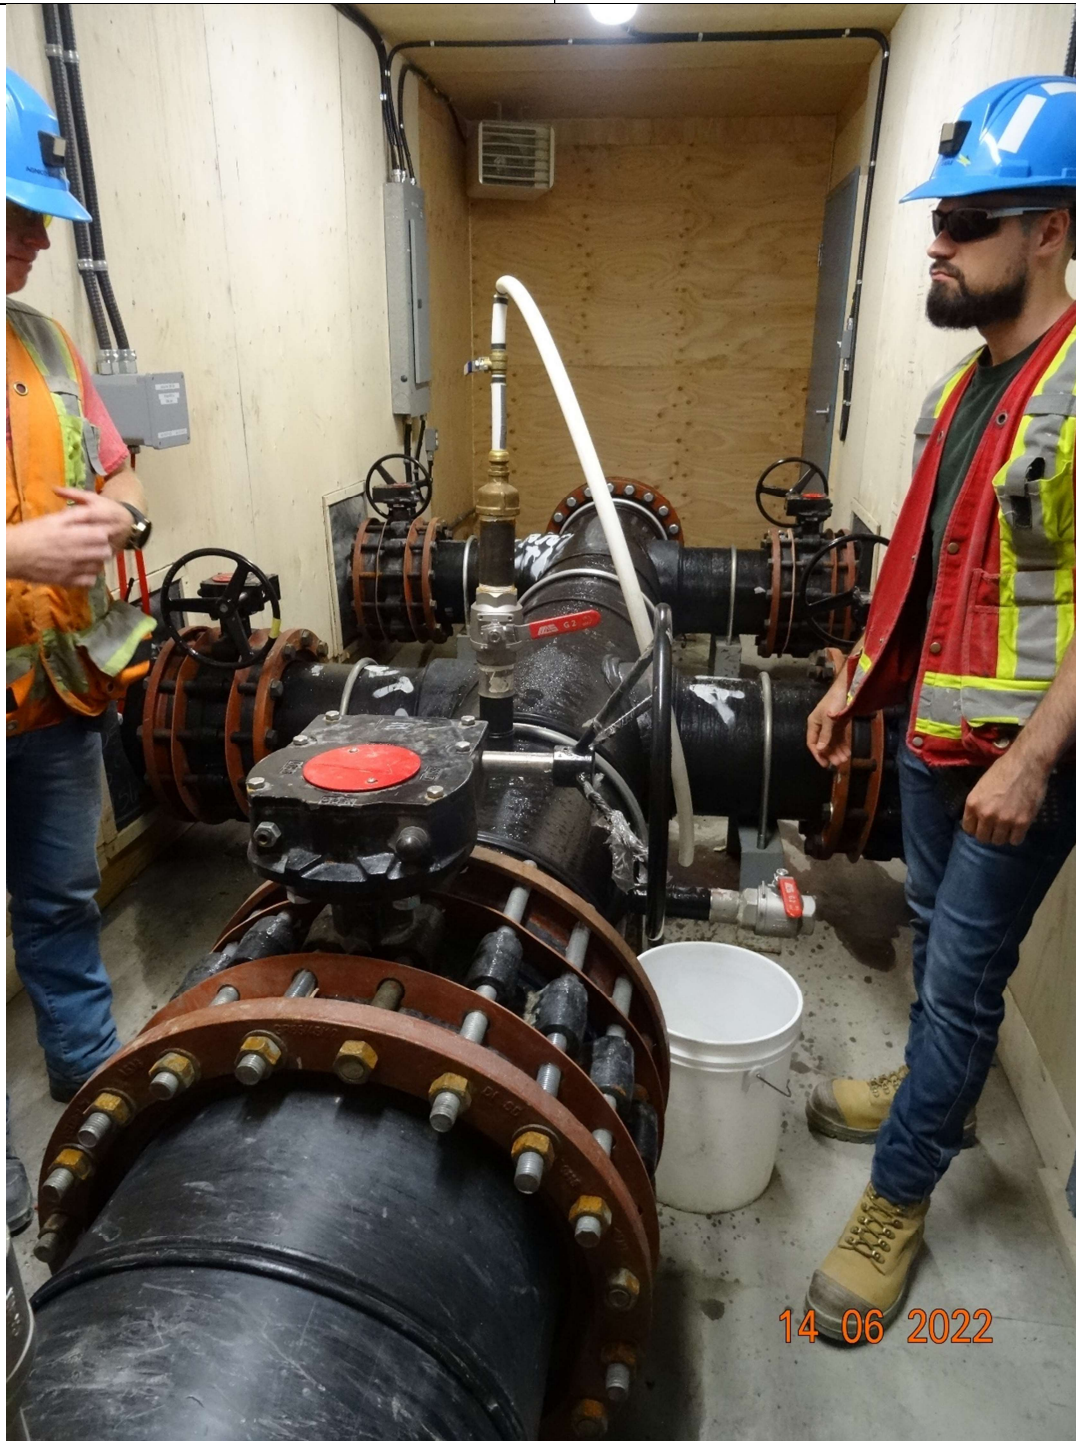
Date:	Authorization Number:	Camera/Model:	Inspector
June 14, 2022	2AM-WTP1830	Sony DSC-HX50V	WRO Amsel
Photo No.		Lat/Long (DD.MM.SS.SS, NAD83)	
Photo 8		N 65° 24' 09.9" W 96° 41' 05.9"

Monitoring Station ST-WT-24, header pump
