Meadowbank and Whale Tail 2018 Annual Geotechnical Inspection

2018 Annual Geotechnical Inspection

Meadowbank Gold Mine, Nunavut

18101627-1583-R-Rev0

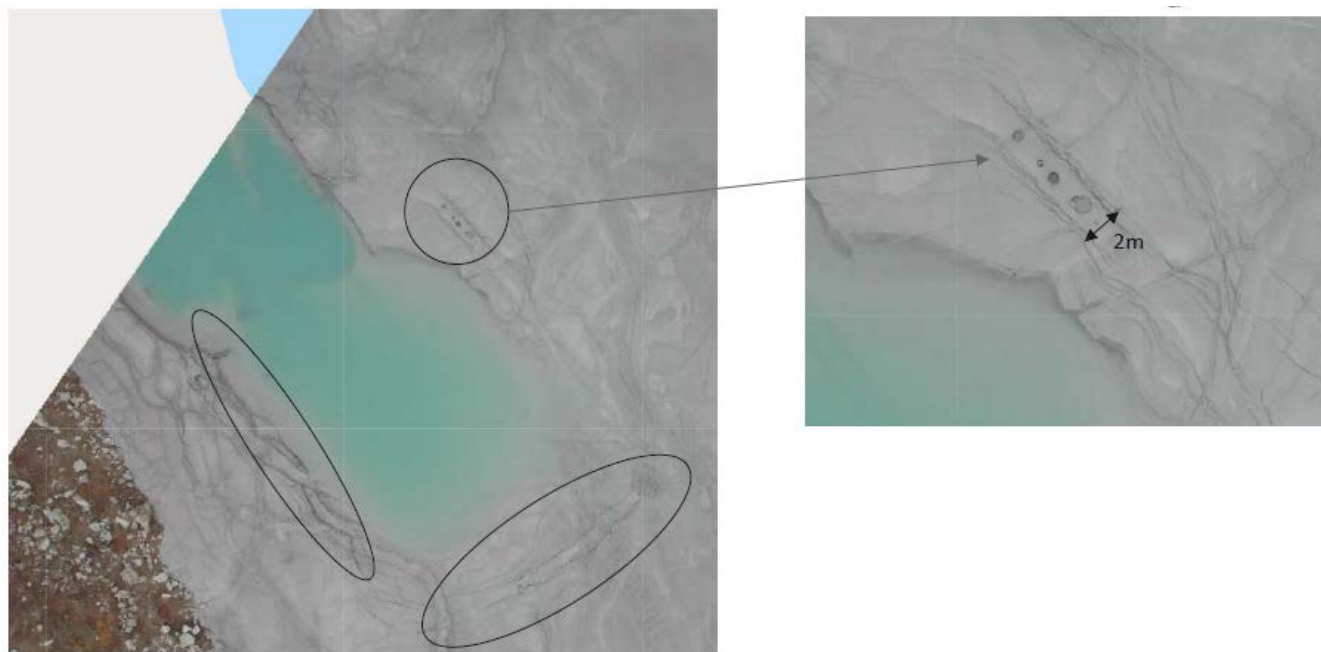
Figure 1: Aerial view of the depressions observed in the tailings (source: AEM)

A set of 1 to 2 m wide circular depressions scattered in a horseshoe-shaped area was visible in the tailings of the South Cell, off the north-western extremity of Saddle Dam 4 (see Figure 1). It is assumed that this pattern indicates a fracture zone on the bedrock floor from which the seepage under Central Dike may originate. The circular depressions are a sign of tailings migration through the TSF foundation.

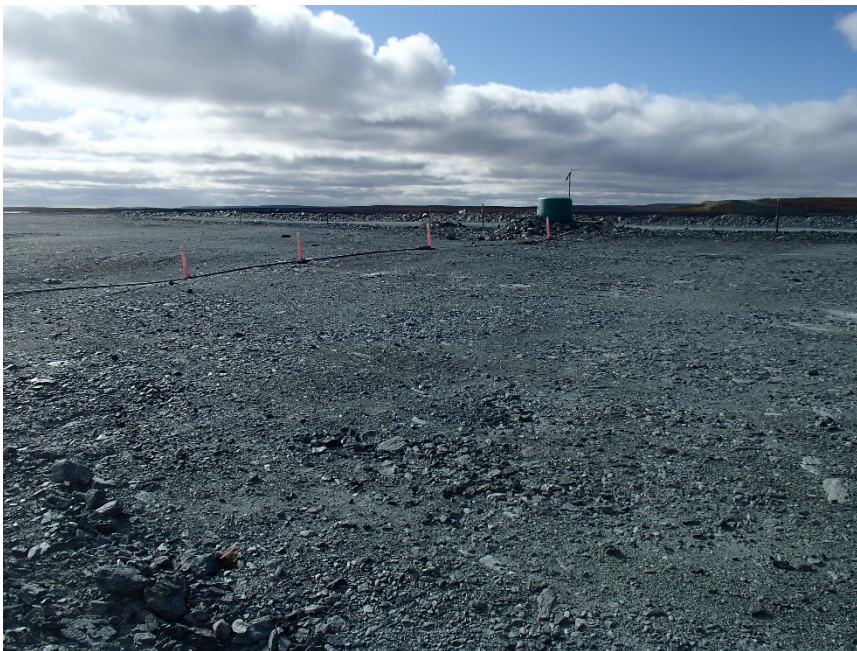
Photograph A3-20 Bay Goose Dike

Description: From approximately Sta. 31+080 on the crest, looking southwest at the pond of water at Central Channel seepage at Sta. 31+165.

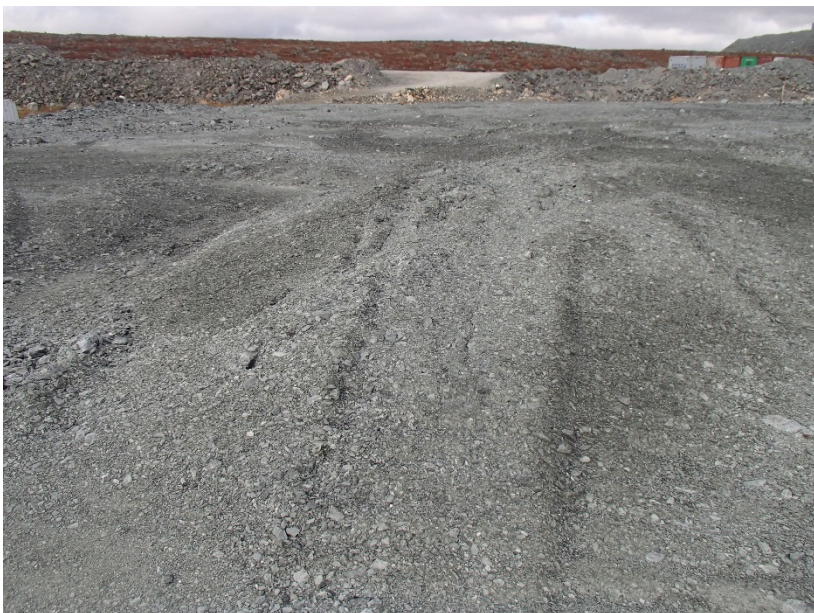
Photograph A3-47 Bay Goose Dike

Description: From approximately Sta. 32+025 (south abutment) looking east at the crest. Zone of high magnitude settlement in the ultramafic cap. The tension cracks seem no longer active.

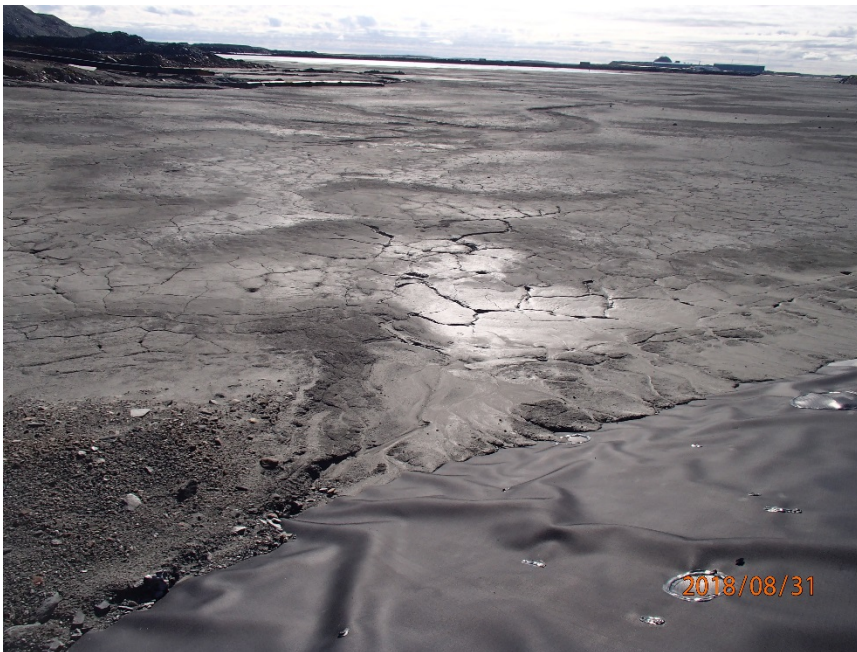
Photograph B1-2 Tailings Storage Facility

Description: From Saddle Dam 1 (approximately Sta. 0+410) looking northeast at the North Cell tailings pond. Adequate tailings beach against SD1.

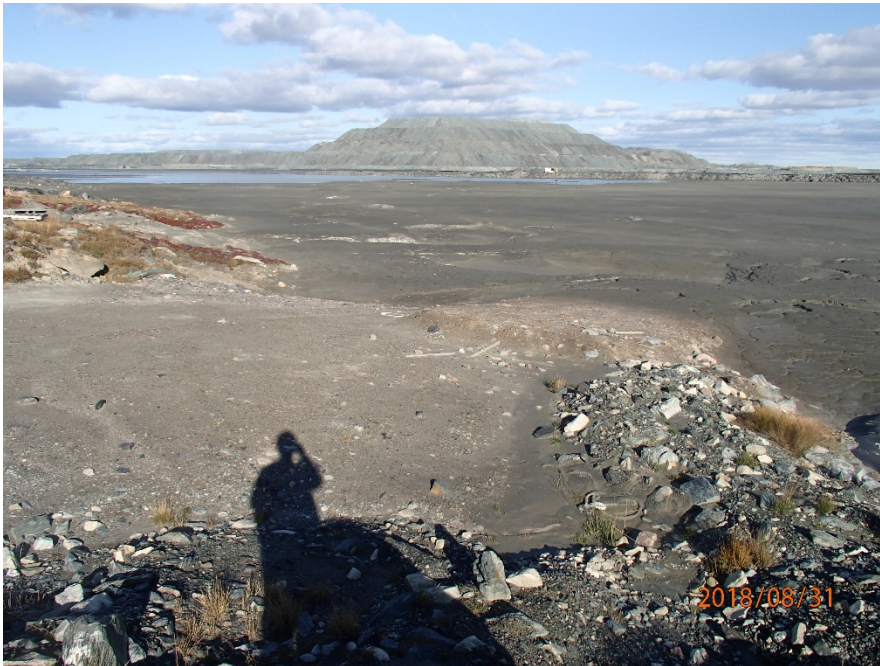
Photograph B1-3 Tailings Storage Facility

Description: From Saddle Dam 1 (approximately Sta. 0+070) looking east at the North Cell tailings pond. Adequate tailings beach against SD1.

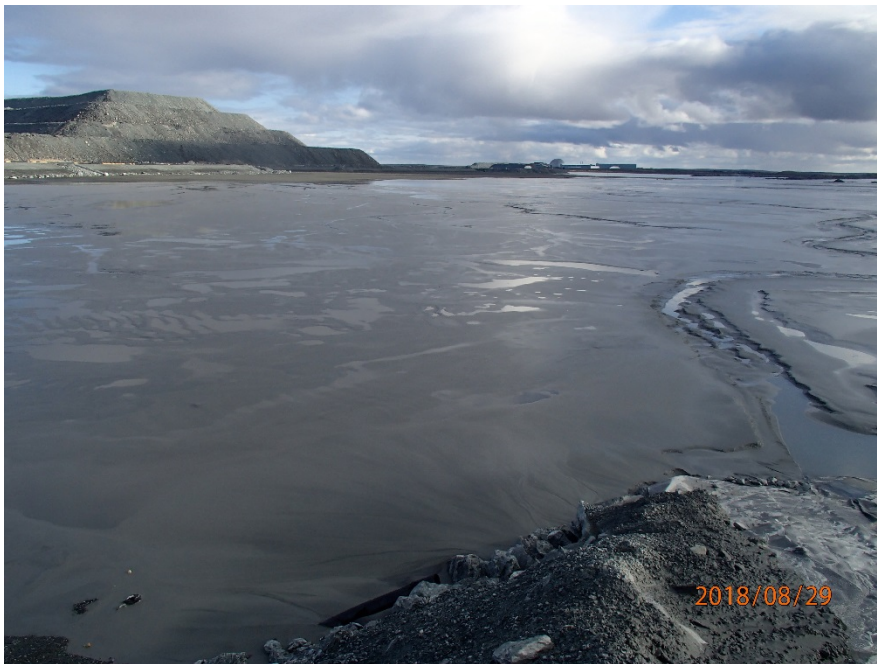
Photograph B1-17 Tailings Storage Facility

Description: From Stormwater Dike, looking Northwest at the upstream slope and the 2018 capping. Large rocks are present near the liner.
