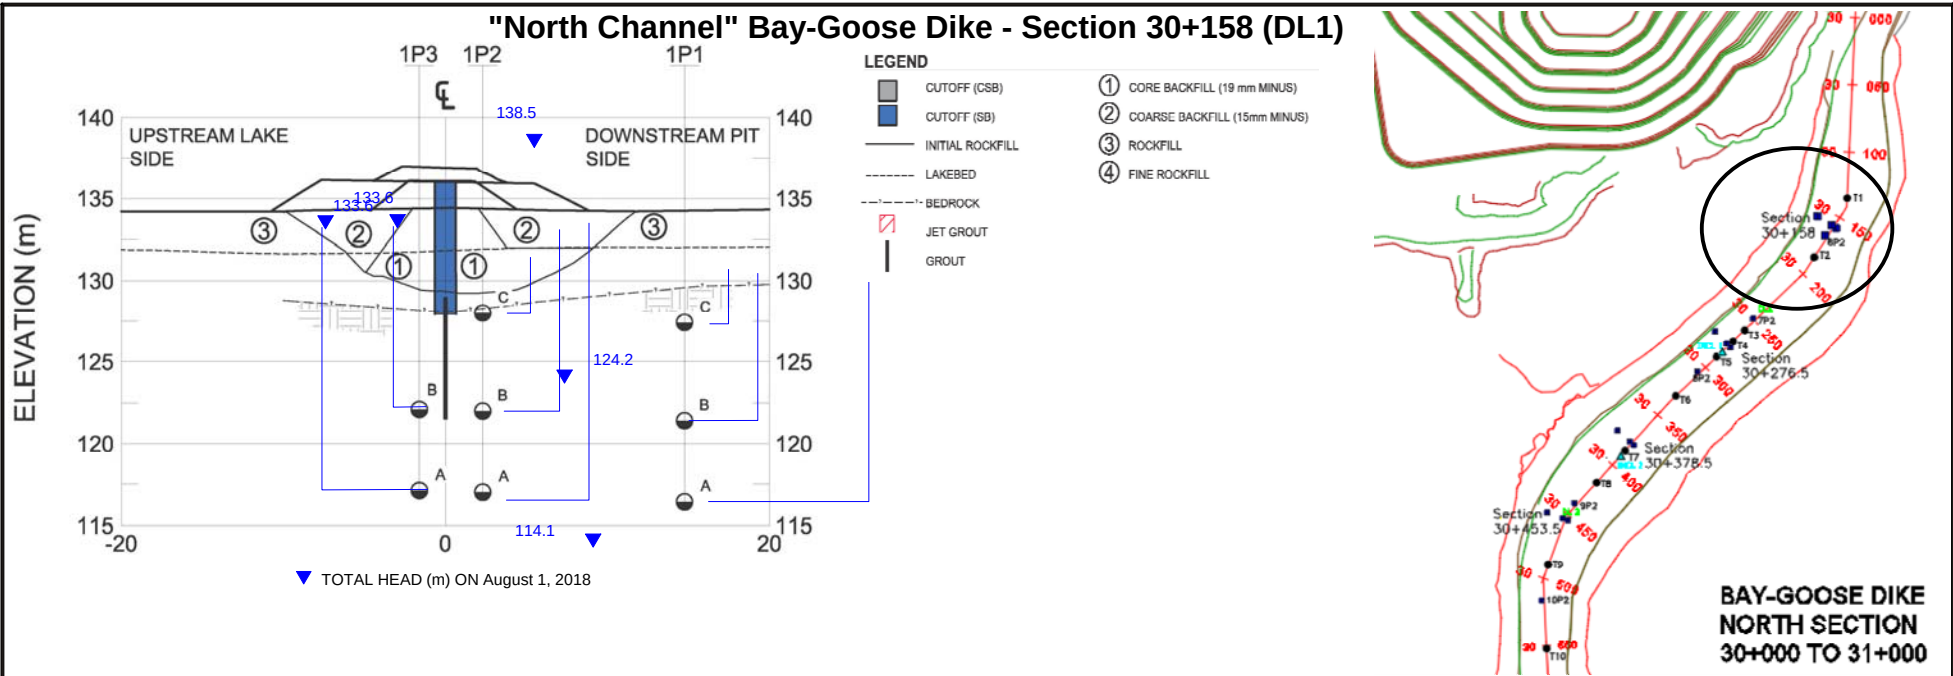
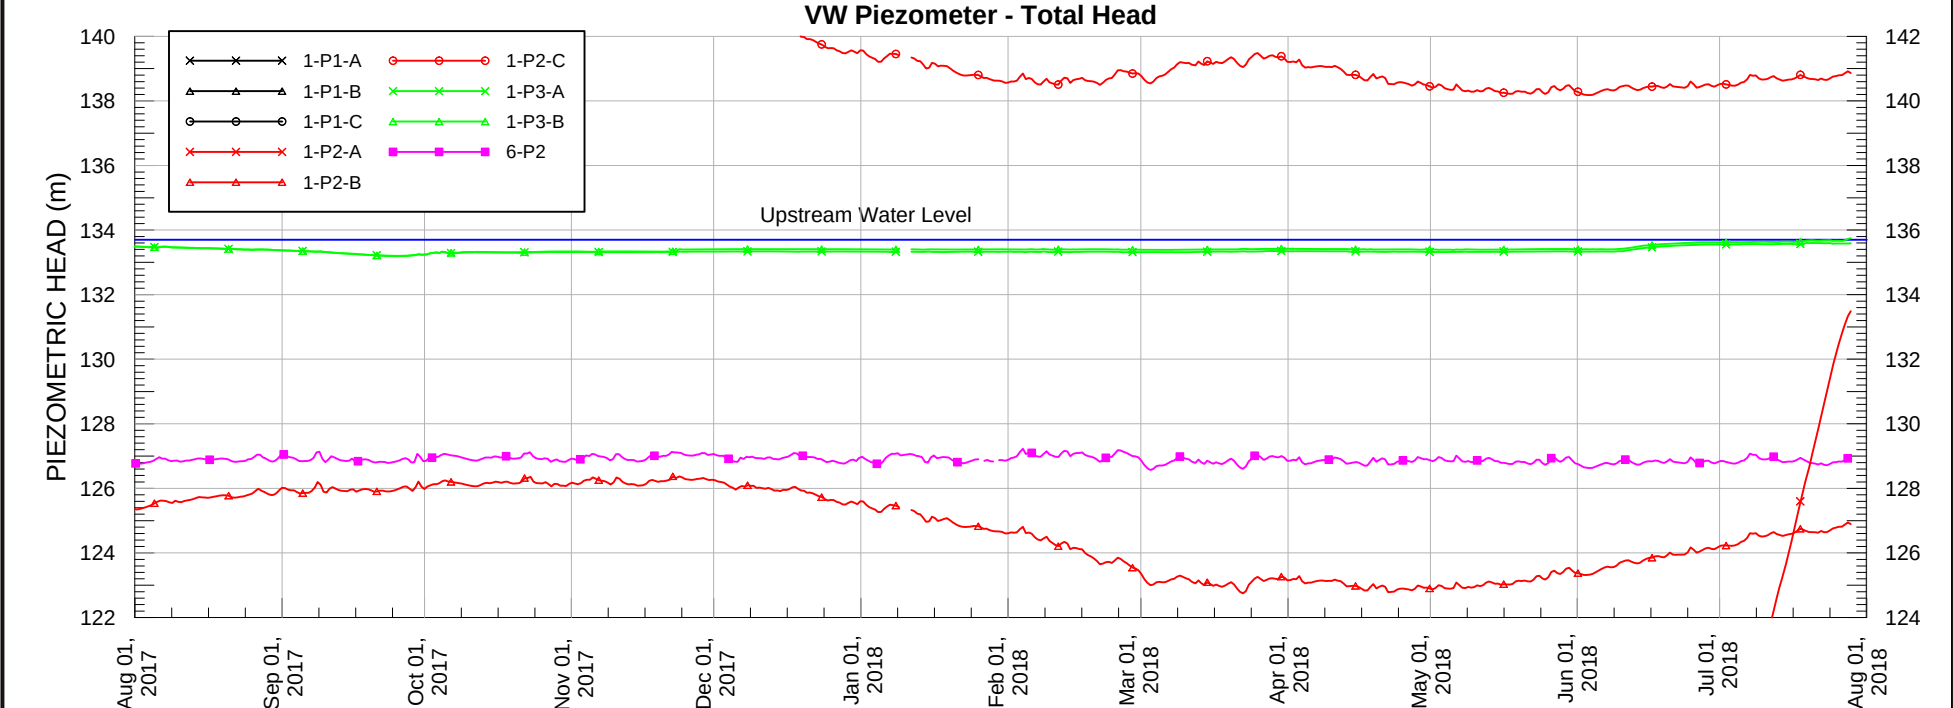
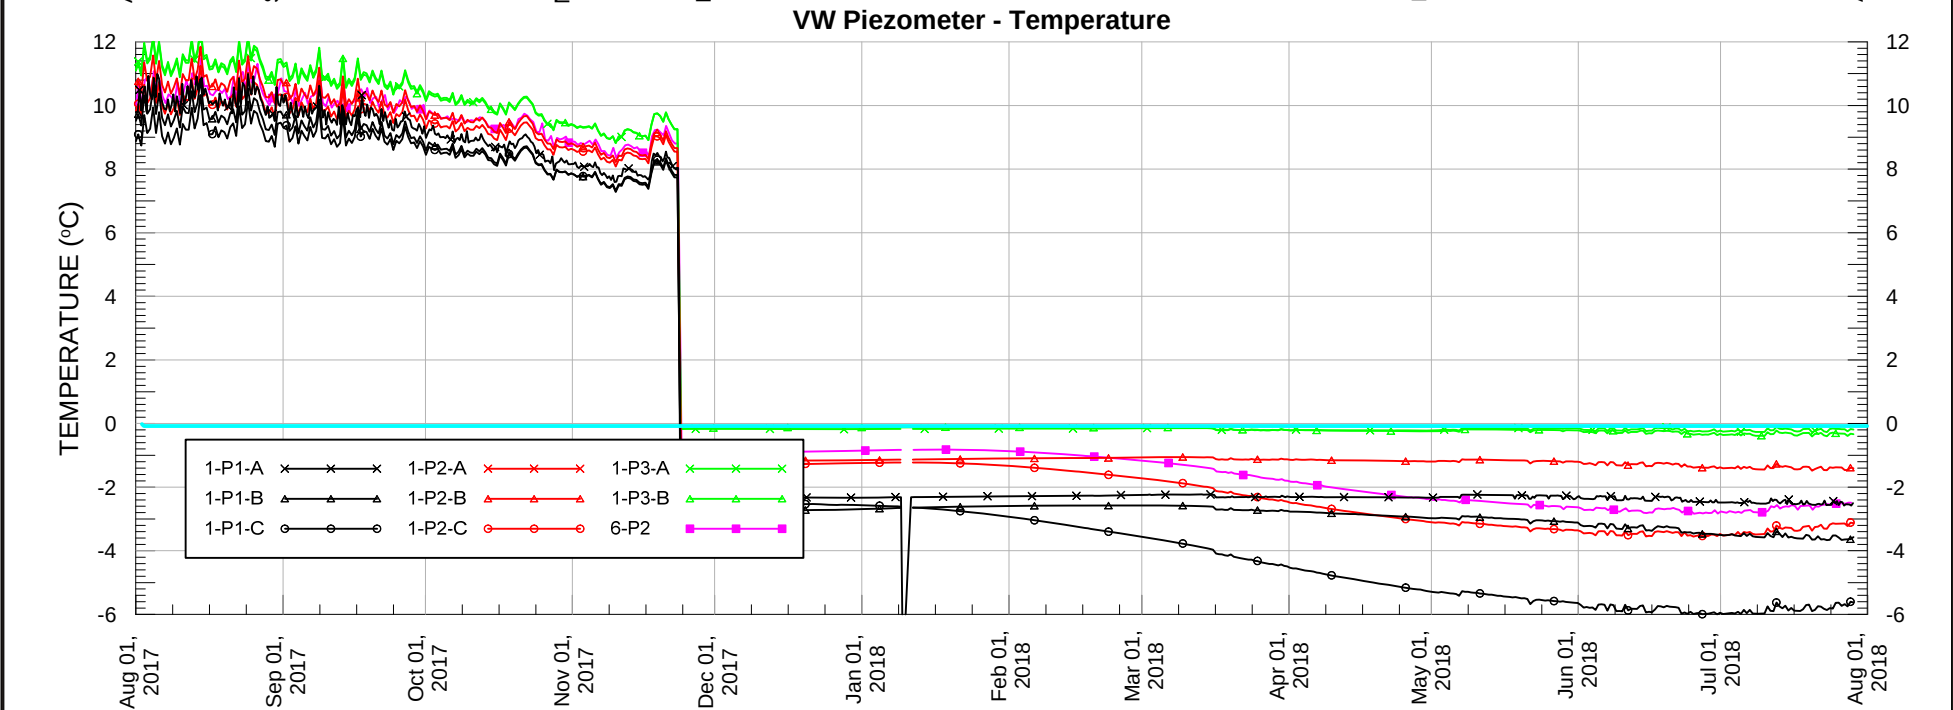
- 1-P1-A, 1-P2-B, 1-P1-C, 1-P2-A and 6P2 are assumed to be frozen and not giving good data. The PWP not reliable.
- GKM investigated the large jump in the temperature and changed the multiplexer as this turned out to be the issue. Old one is being fixed to have spare. Readings have since stabilized.

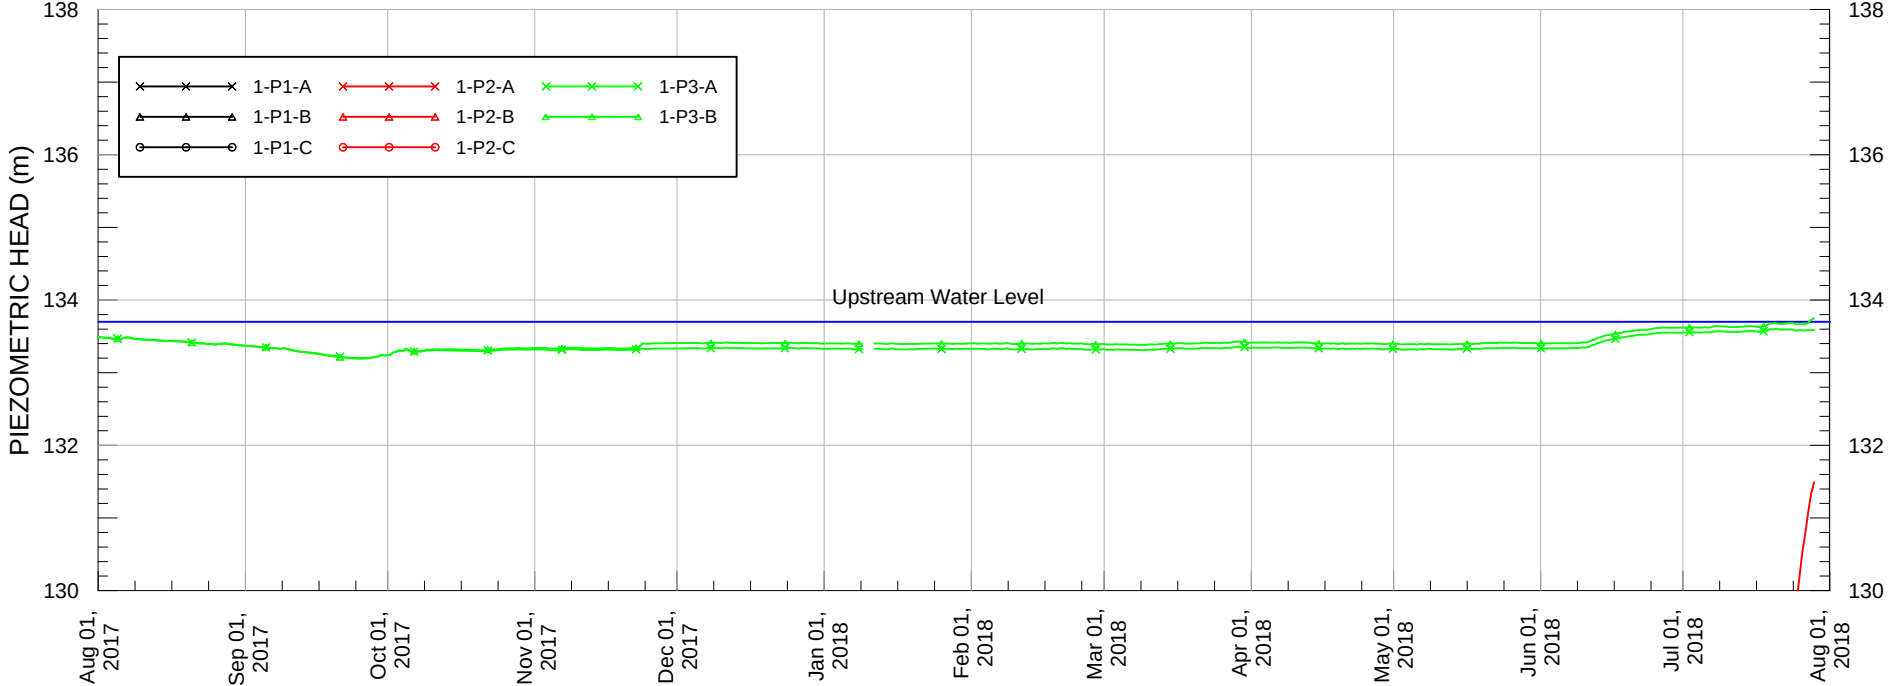
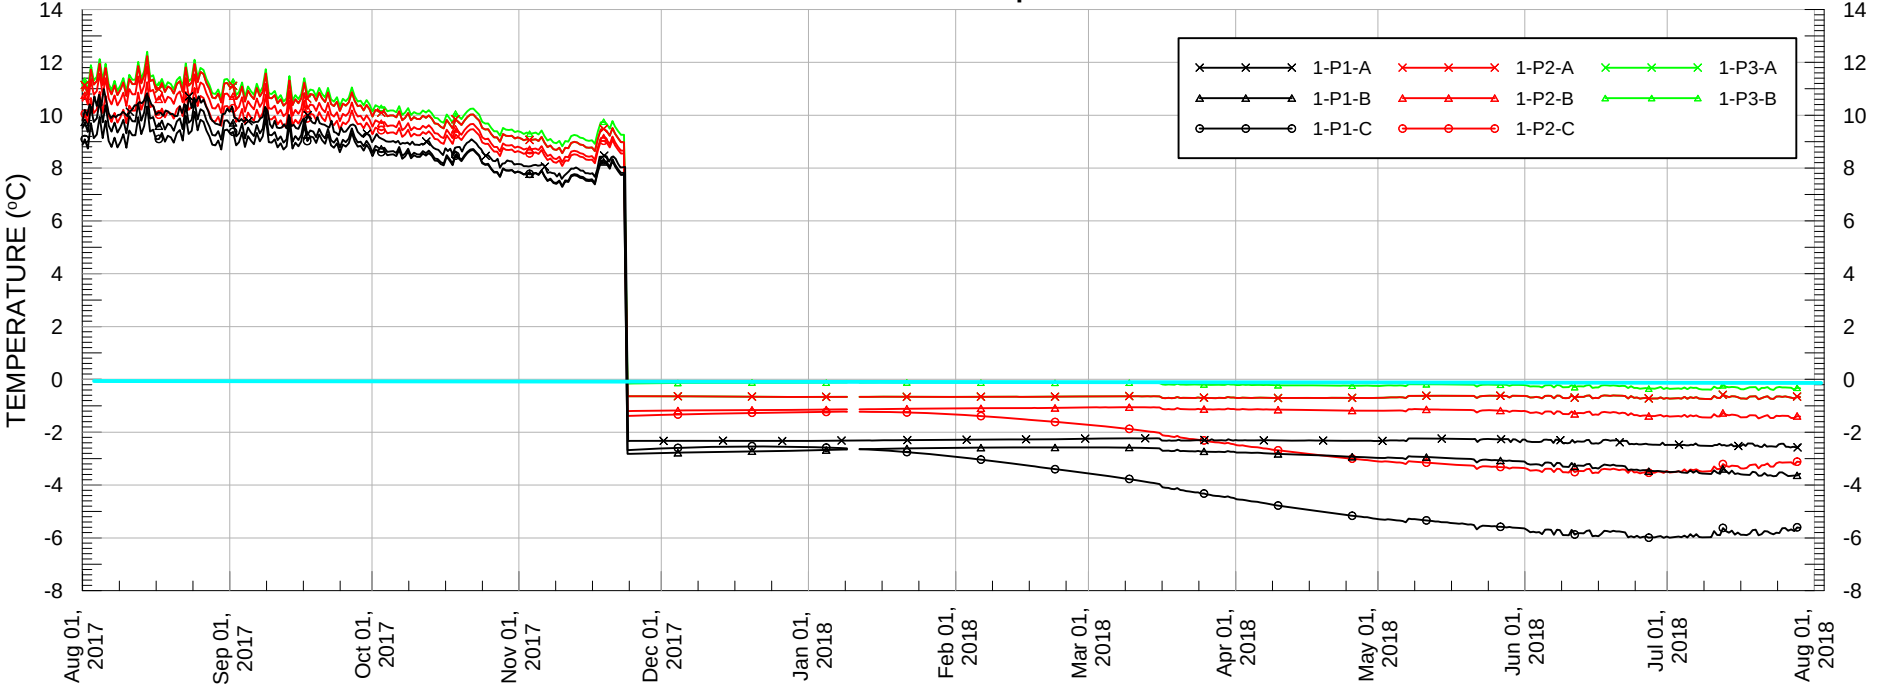
BAY-GOOSE DIKE  
NORTH SECTION  
30+000 TO 31+000

- 1-P1-A, 1-P2-B, 1-P1-C, 1-P2-A and 6P2 are assumed to be frozen and not giving good data. The PWP not reliable.
- GKM investigated the large jump in the temperature and changed the multiplexer as this turned out to be the issue. Old one is being fixed to have spare. Readings have since stabilized.
- Gap in data in January is due to low battery. Battery was changed the following day.

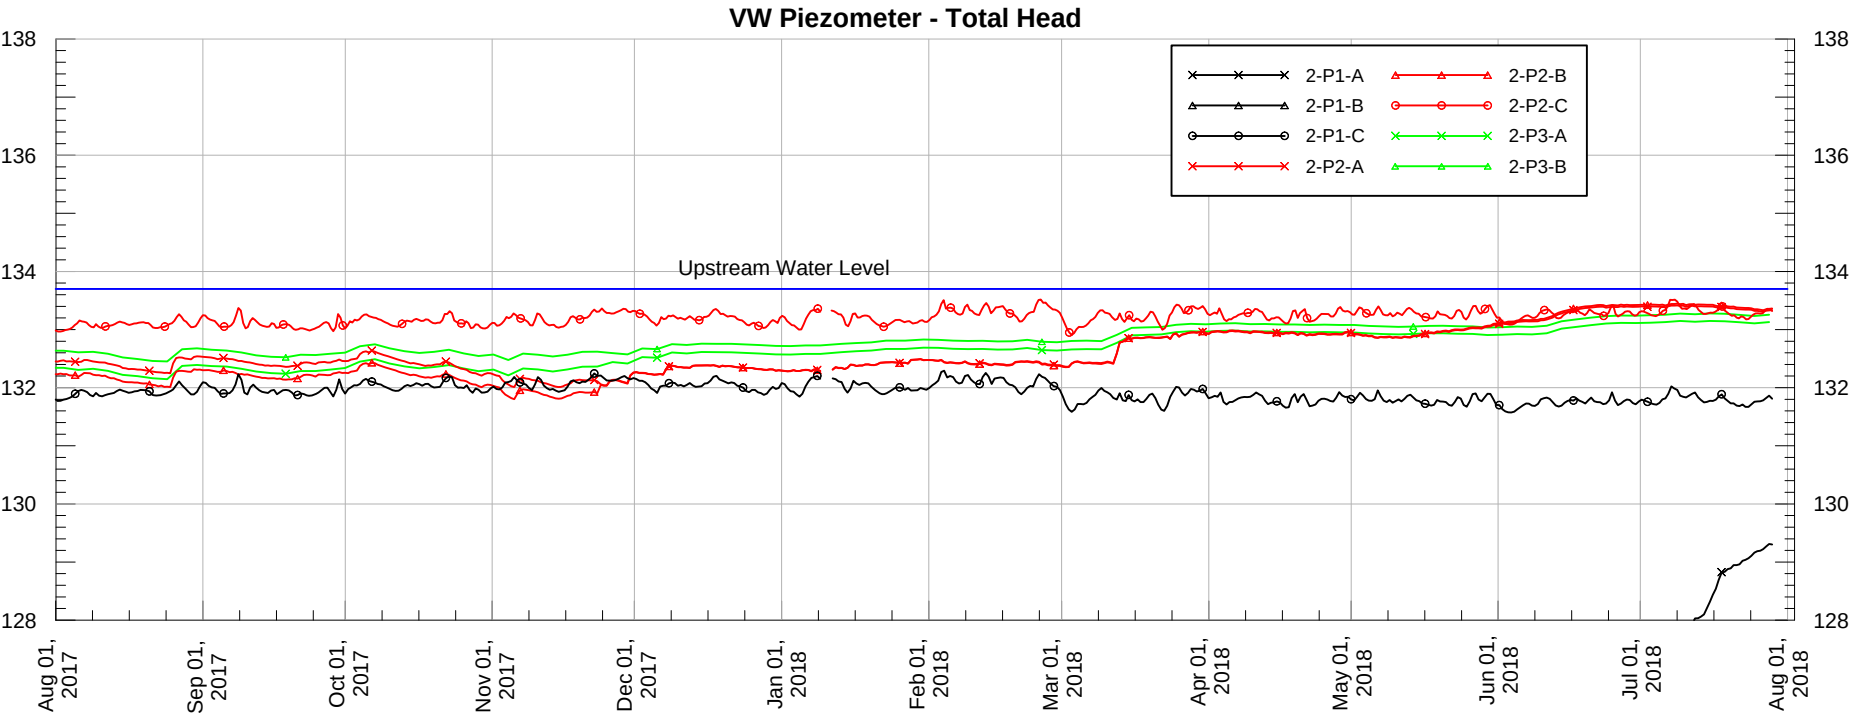
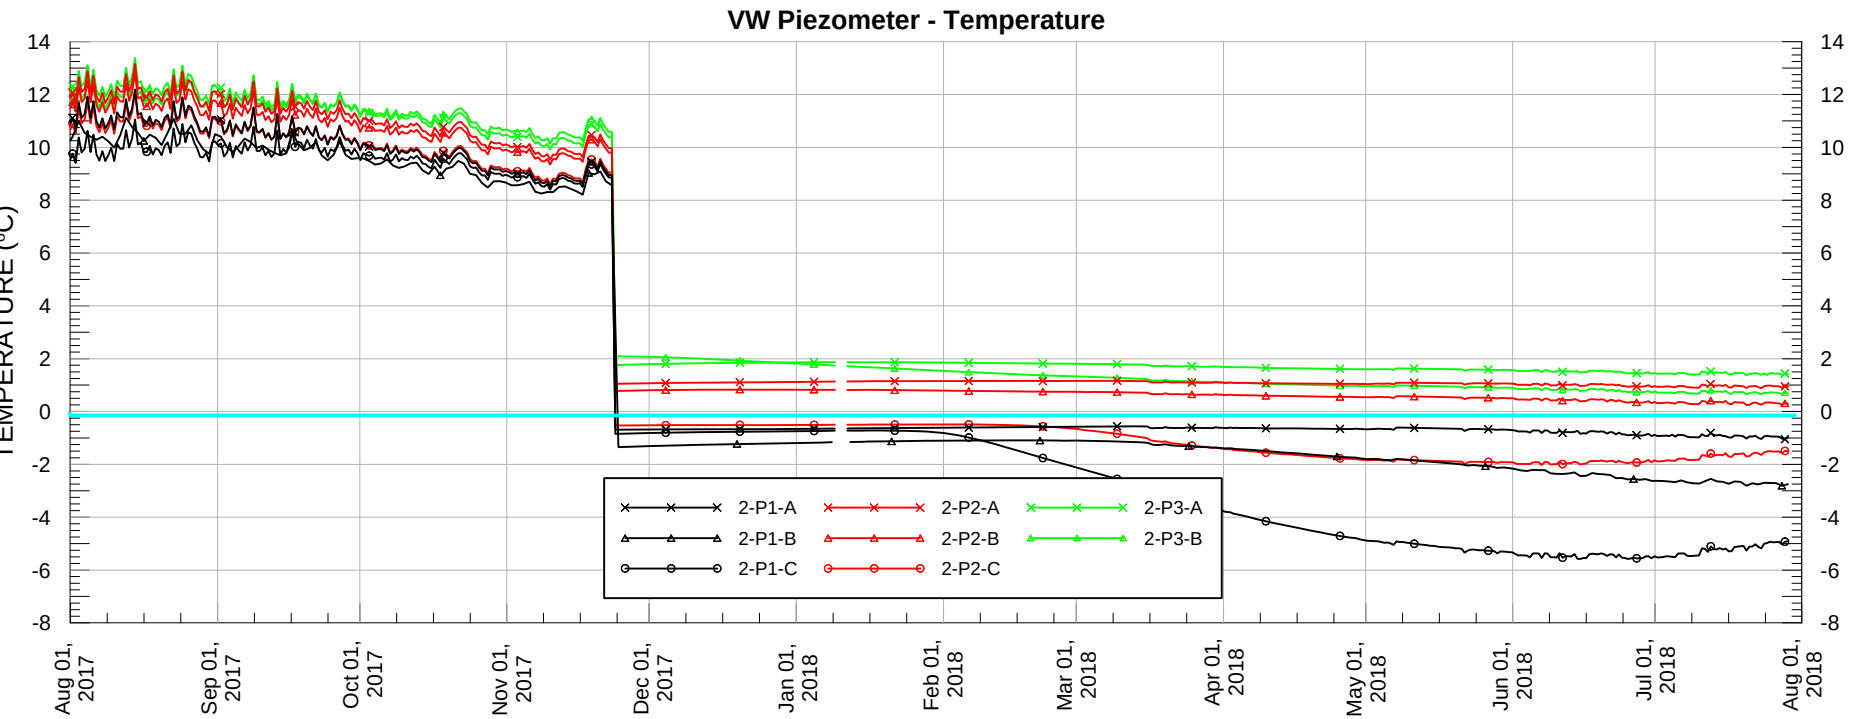
▼ TOTAL HEAD (m) ON August 1, 2018

- 1: 2P1A, 2P1B and 2P2C are assumed to be frozen. 7P2 is also frozen therefore the data is considered not feasible as the previous trend shows.
2. GKM investigated the large jump in the temperature and changed the multiplexer as this turned out to be the issue. Readings have since stabilized.
3. Gap in data in January is due to low battery. Battery was changed the following day.

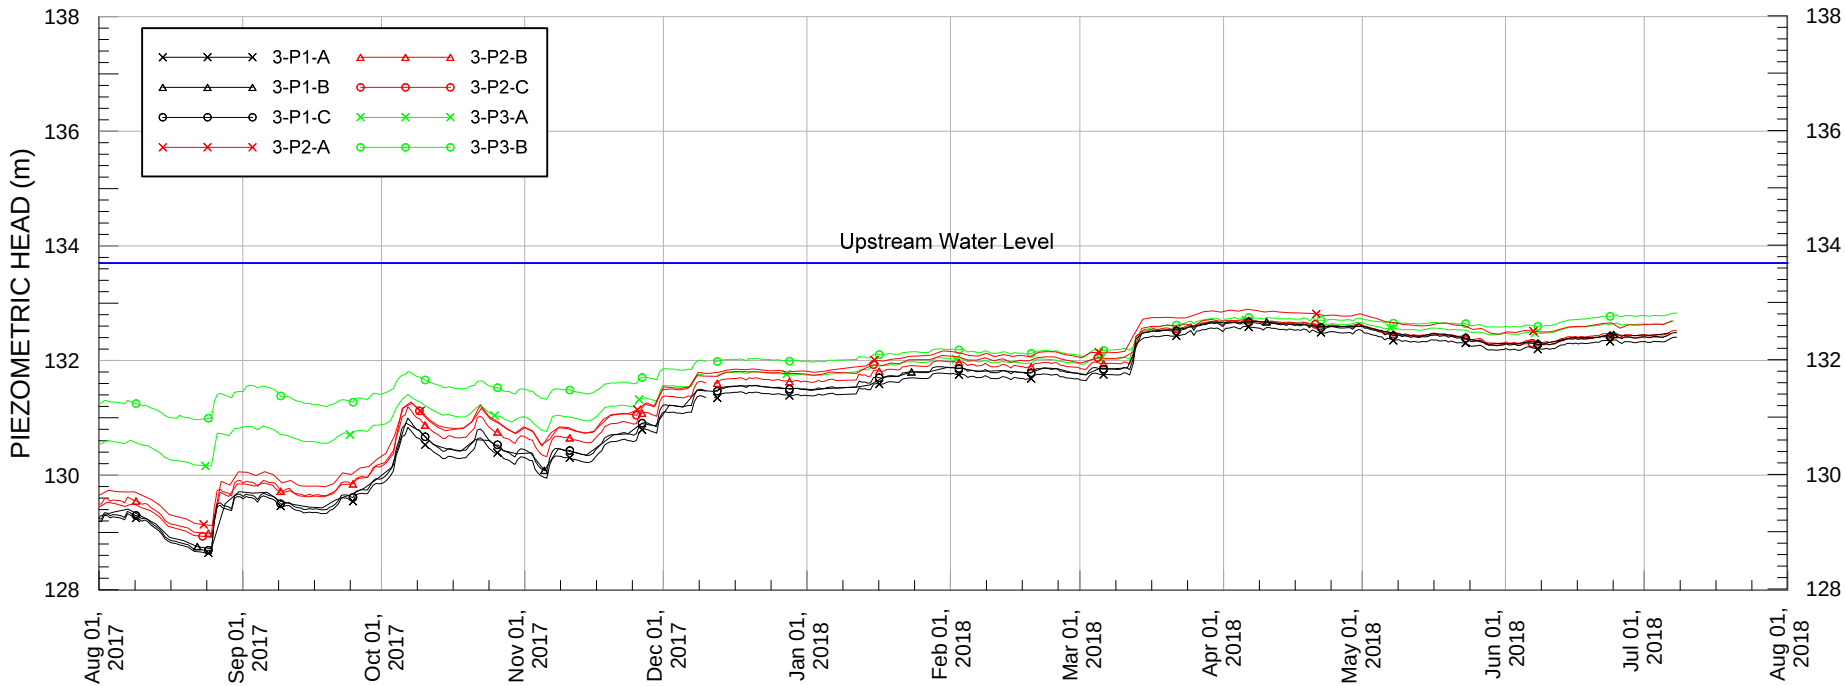
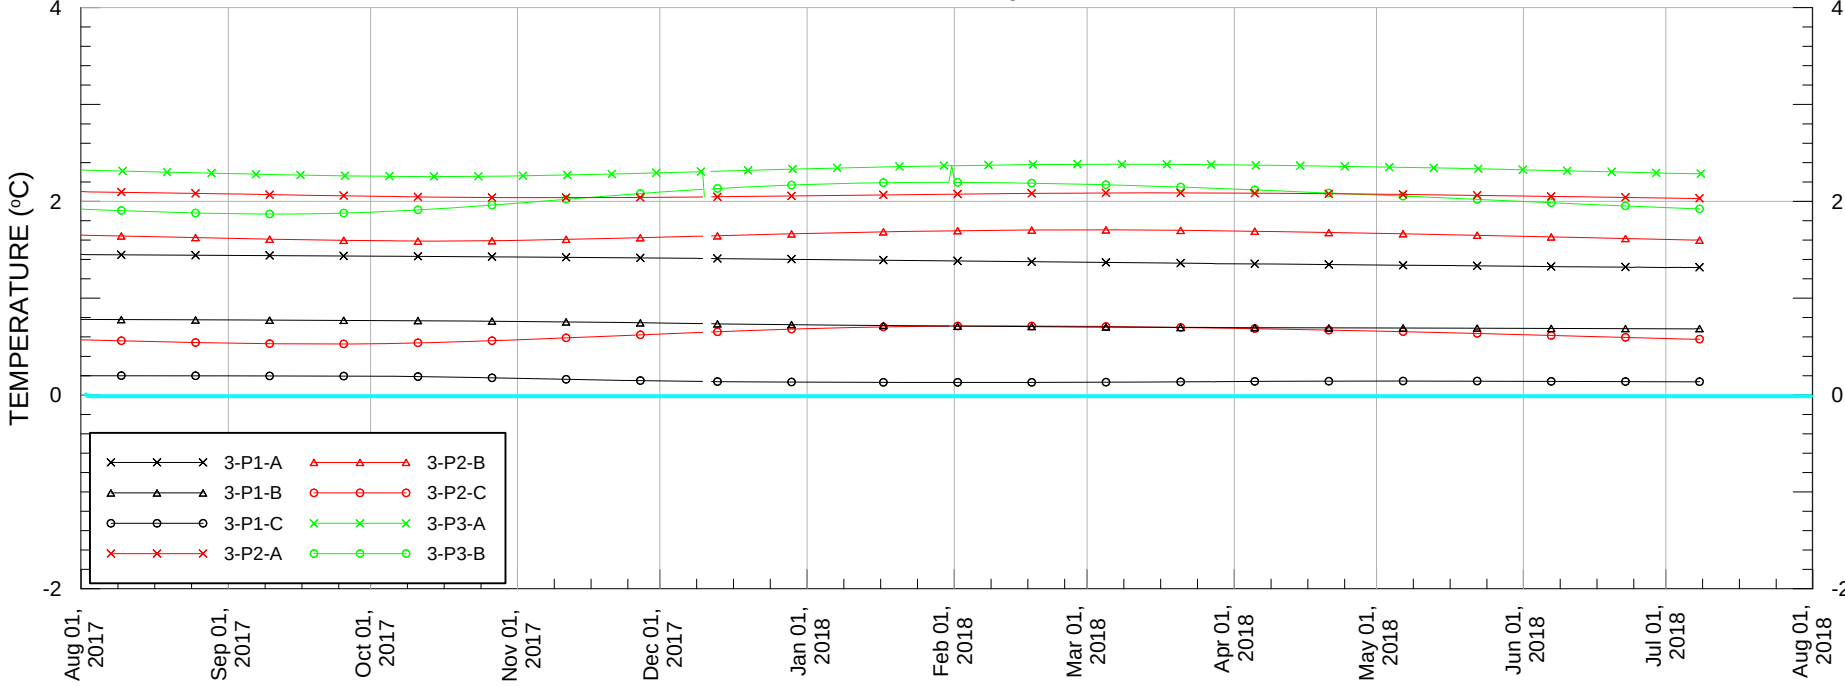
BAY-GOOSE DIKE  
NORTH SECTION  
30+000 TO 31+000

1. The gap in data from Dec. 10 to Dec. 11 was due to low battery. Battery was changed the following day.
2. Changes in PWP pressure are directly related to the drill and blasting that is currently ongoing in Portage Pit E5. Ice buildup is also a factor.

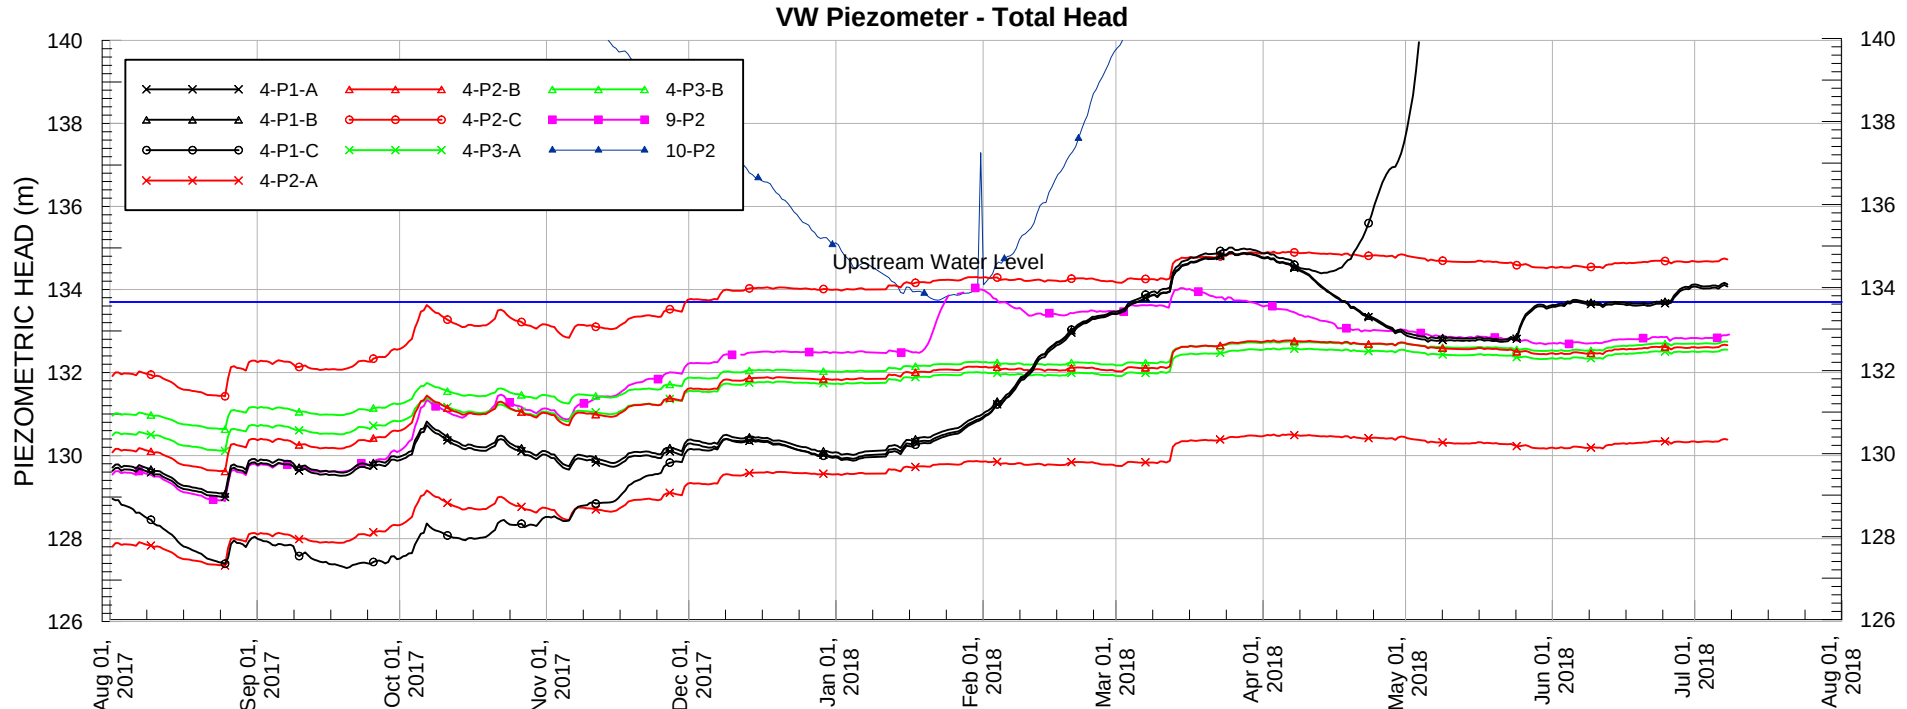
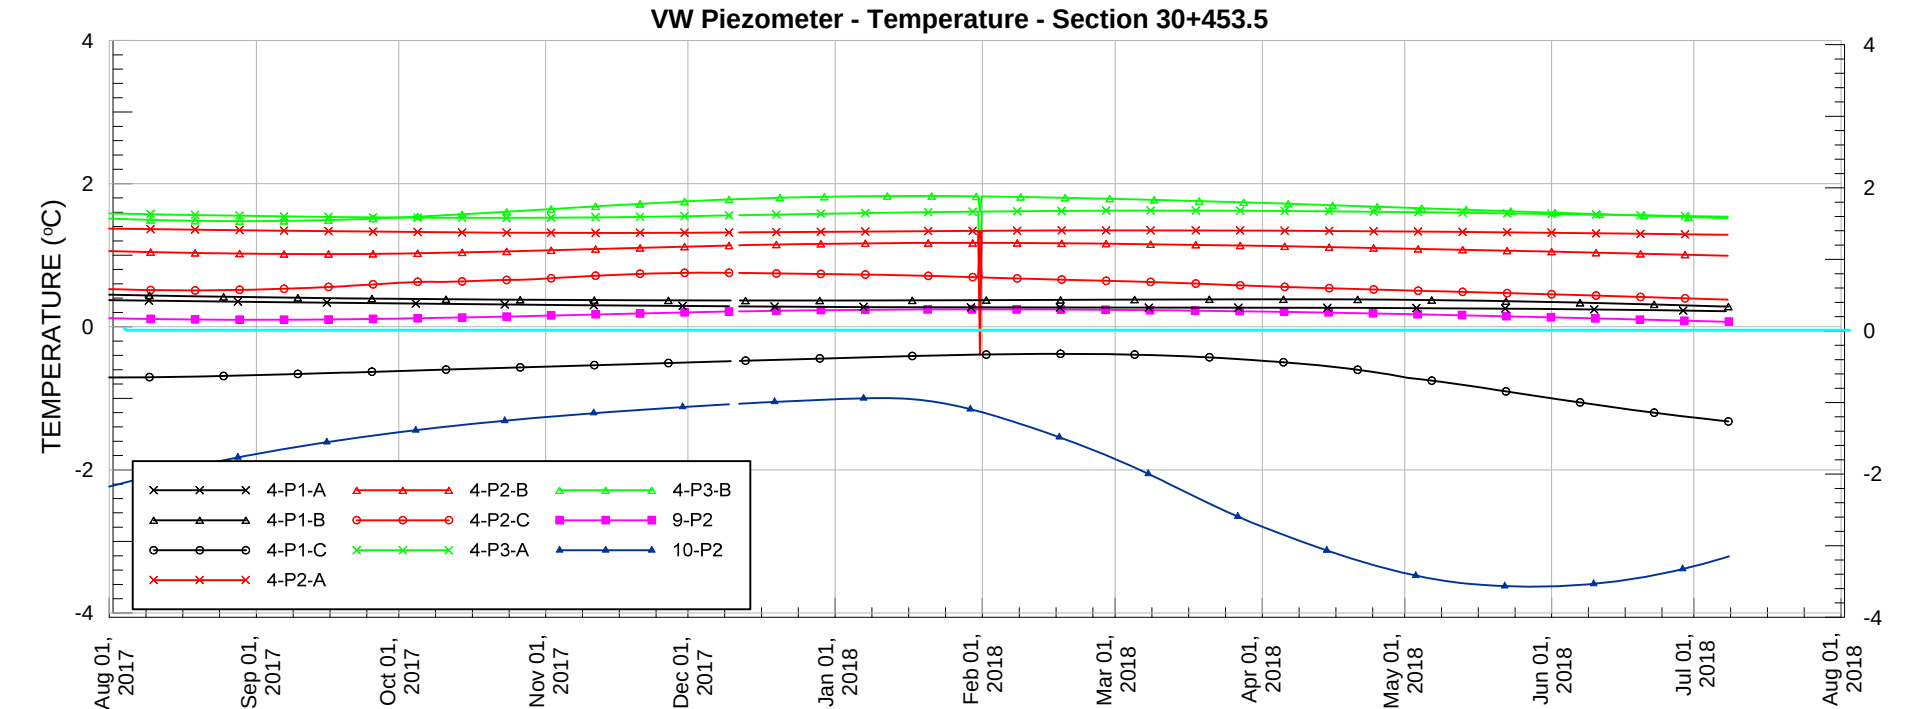
- All 4P1, 4P2C and 10P2 is given unstable readings and since the temperature either shows a negative reading or is close to a negative reading it is assumed to be frozen.
- Pressure changes are attributed to the drill and blast in Portage Pit E5 along with ice buildup that occurs.
- Some of the PWP that are over the Upstream Water Level can be attributed to having a negative temperature and assumed frozen.
- Gap in data in December is due to a low battery. Battery was changed the following day.

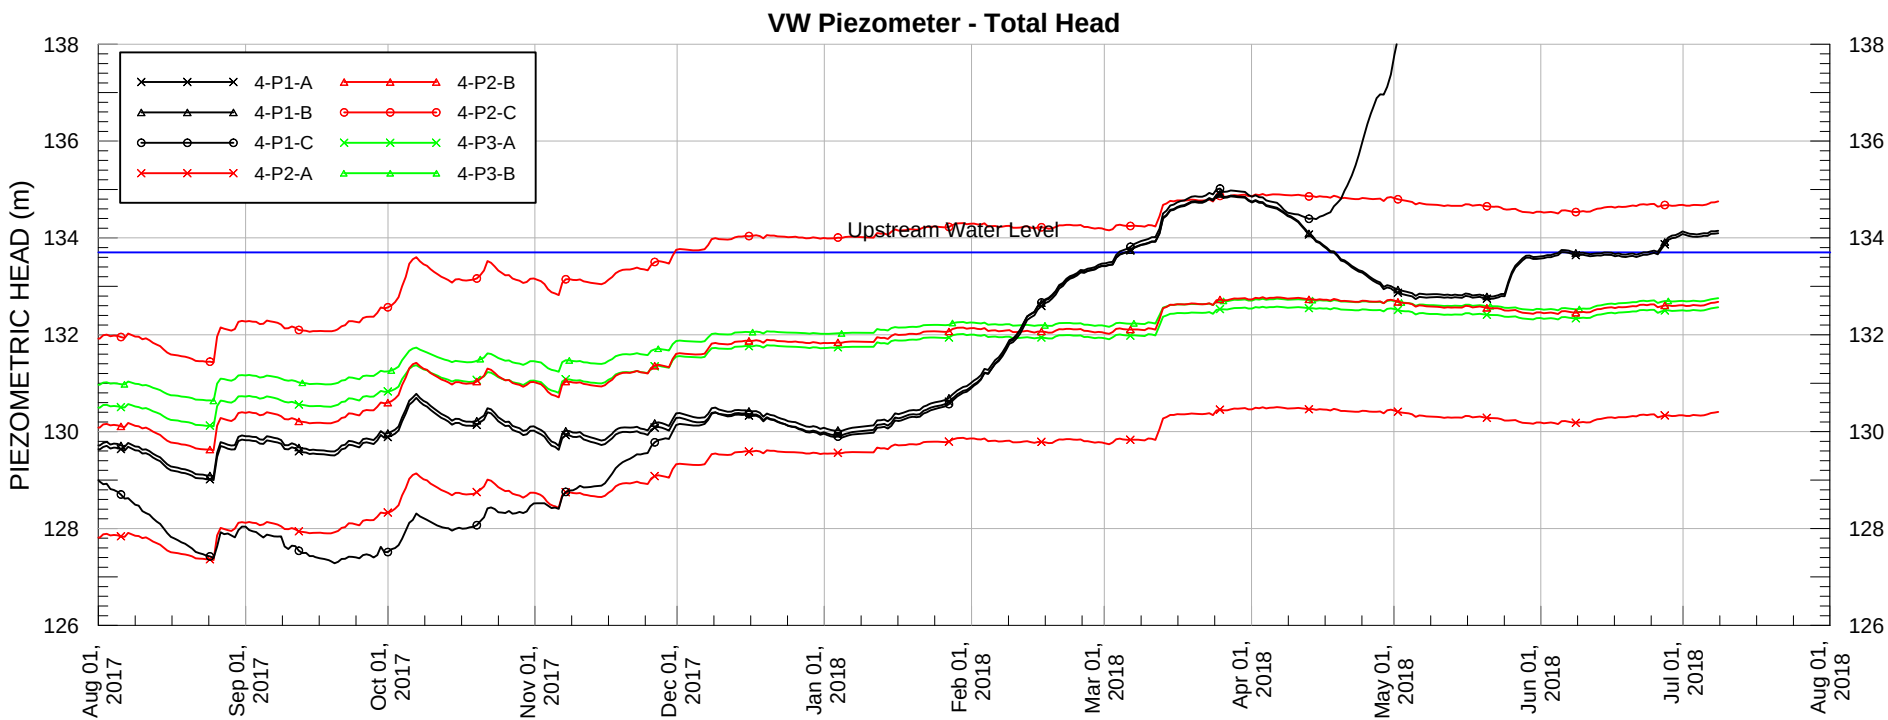
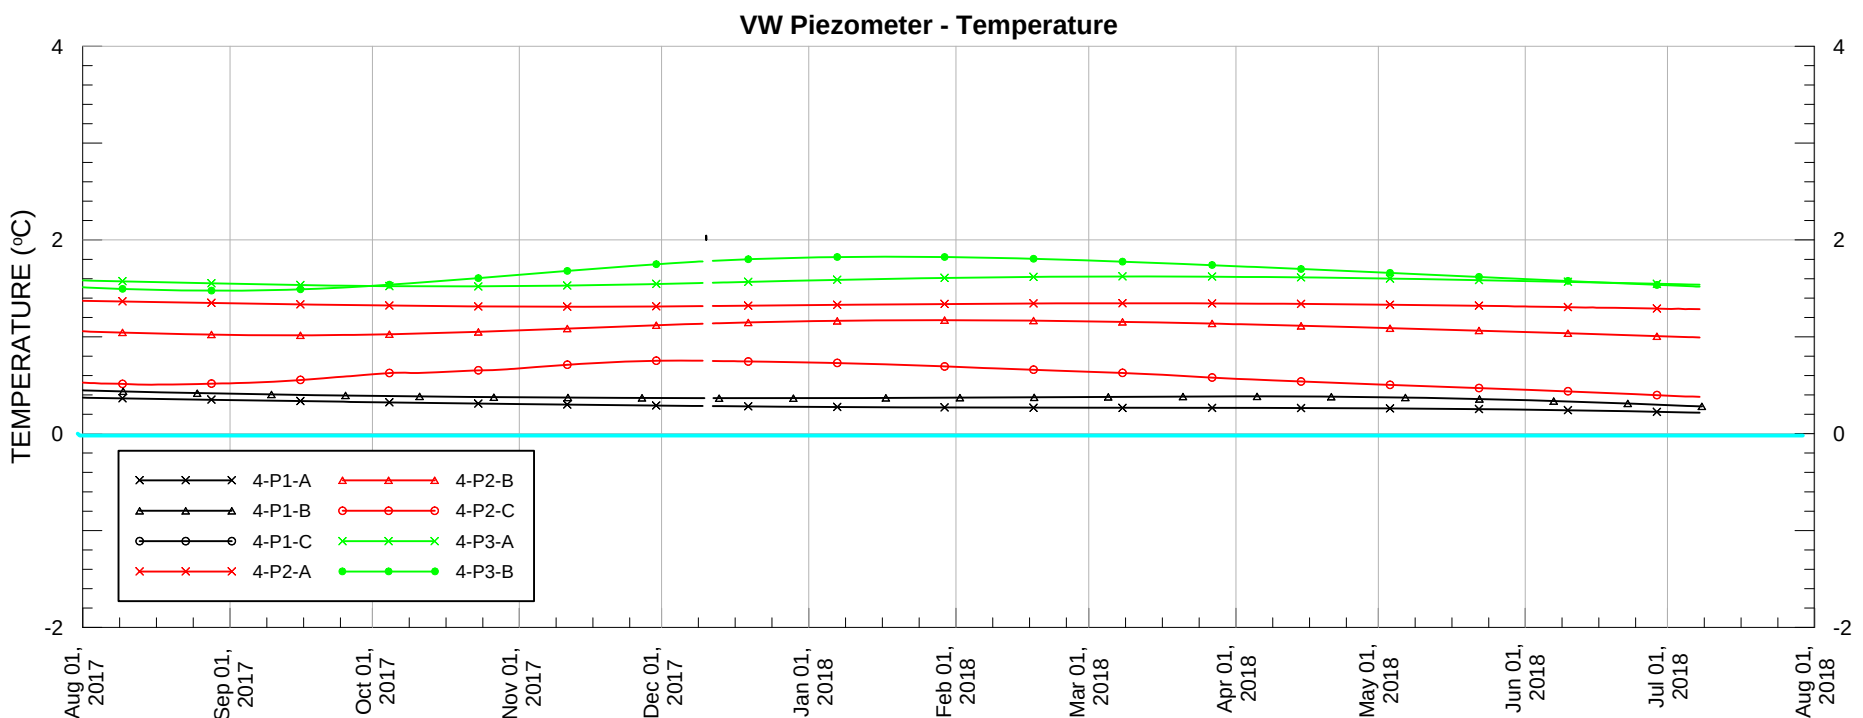
**BAY-GOOSE DIKE  
NORTH SECTION  
30+000 TO 31+000**

1. 4P1 and 4P2CPWP is given unstable readings and since the temperature is close to a freezing temperature it is assumed to be frozen.
2. Pressure changes are attributed to the drill and blast in Portage Pit E5 along with ice buildup that occurs.
3. Some of the PWP that are over the Upstream Water Level can be attributed to having a negative temperature and assumed frozen.
4. Data gap in December is due to low battery. Battery was changed the following day.

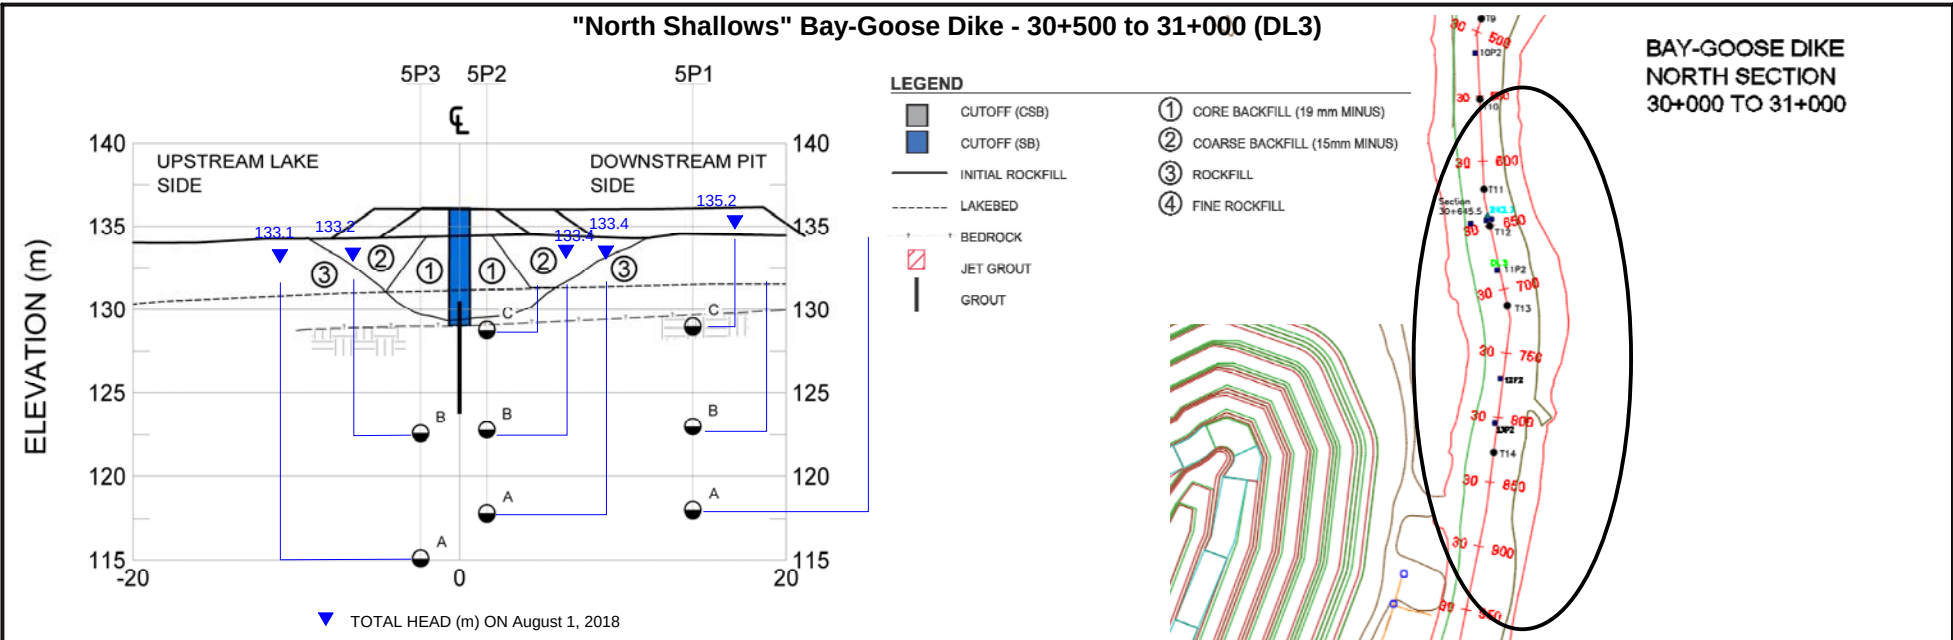
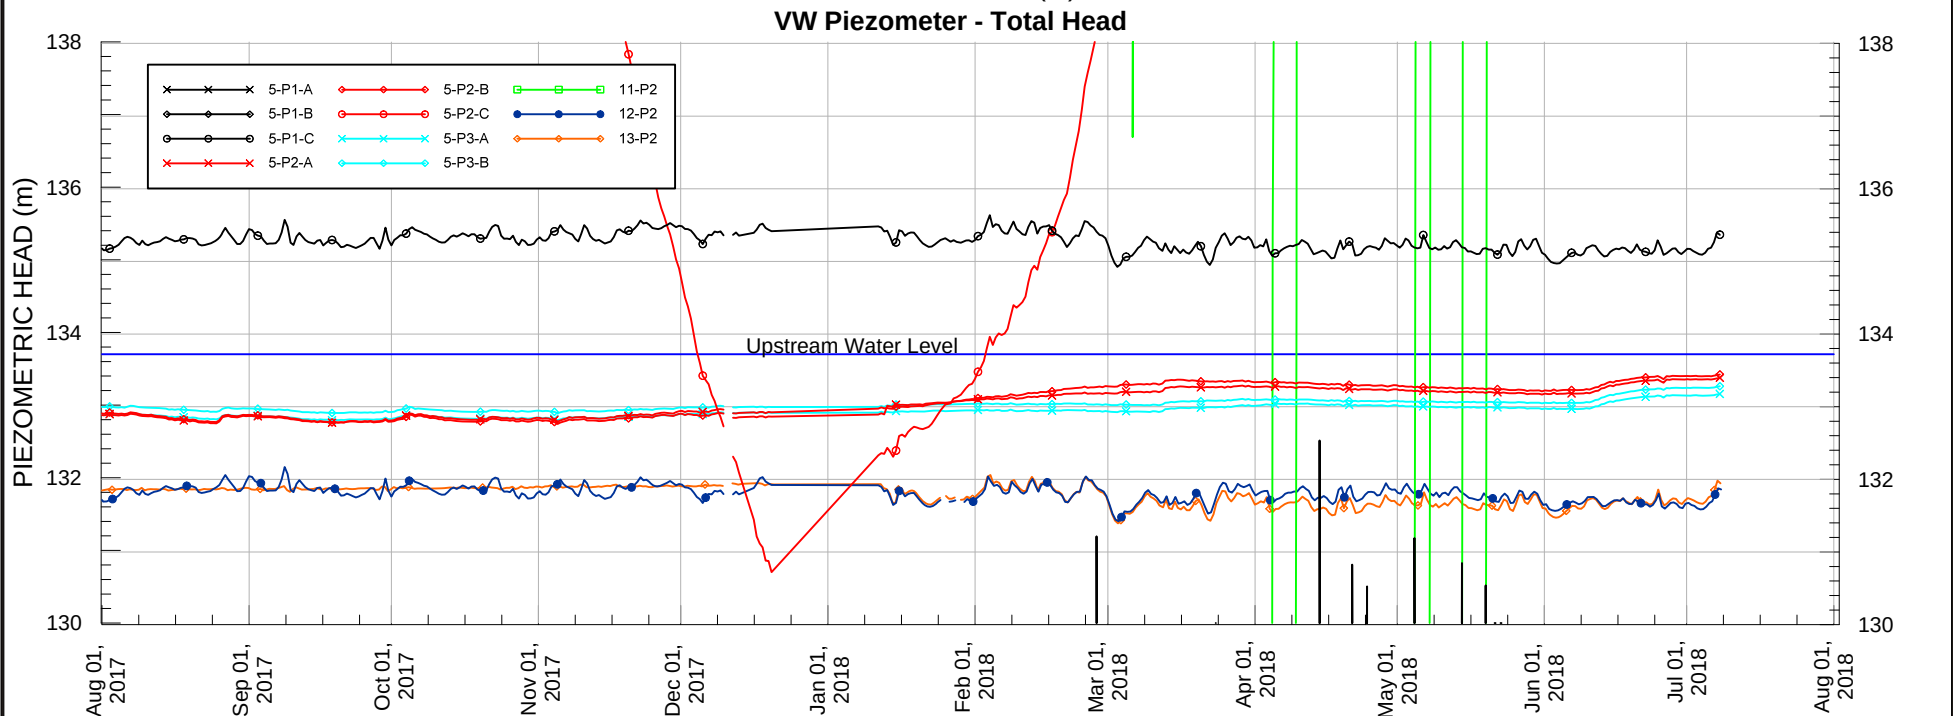
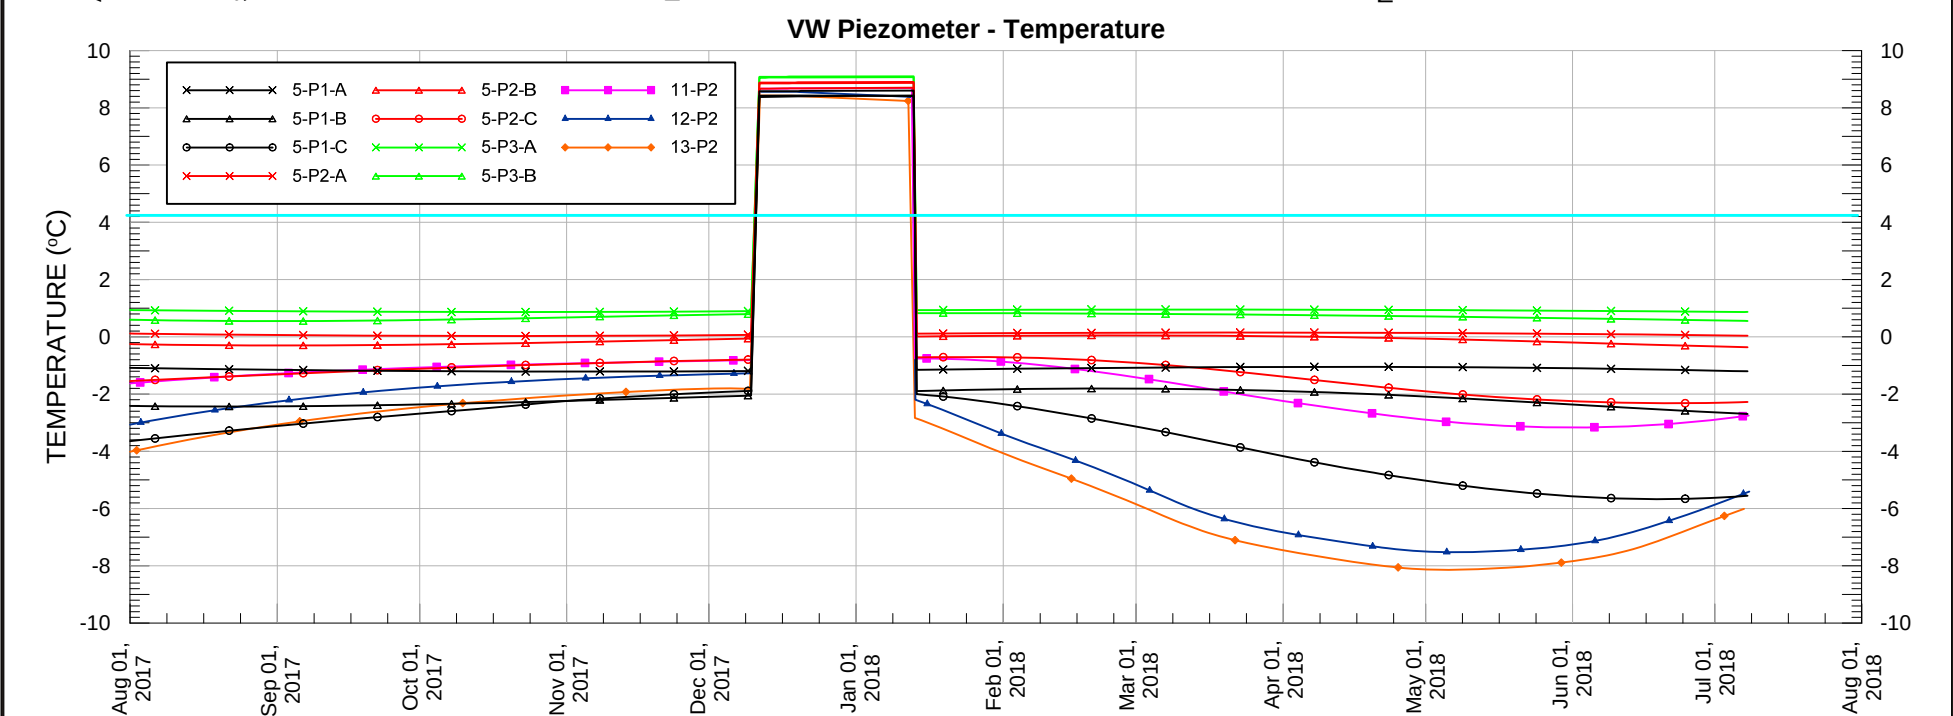
- 5P1A, 5P1B, 5P1C, 5P2C and 11P2 are giving unstable readings and since the temperature shows a negative reading it is assumed to be frozen.
- A spike in temperature also has been corrected and stabilized due to a faulty MUX board.
- Gap in data in December was due to a low battery. Battery was changed the following day.
