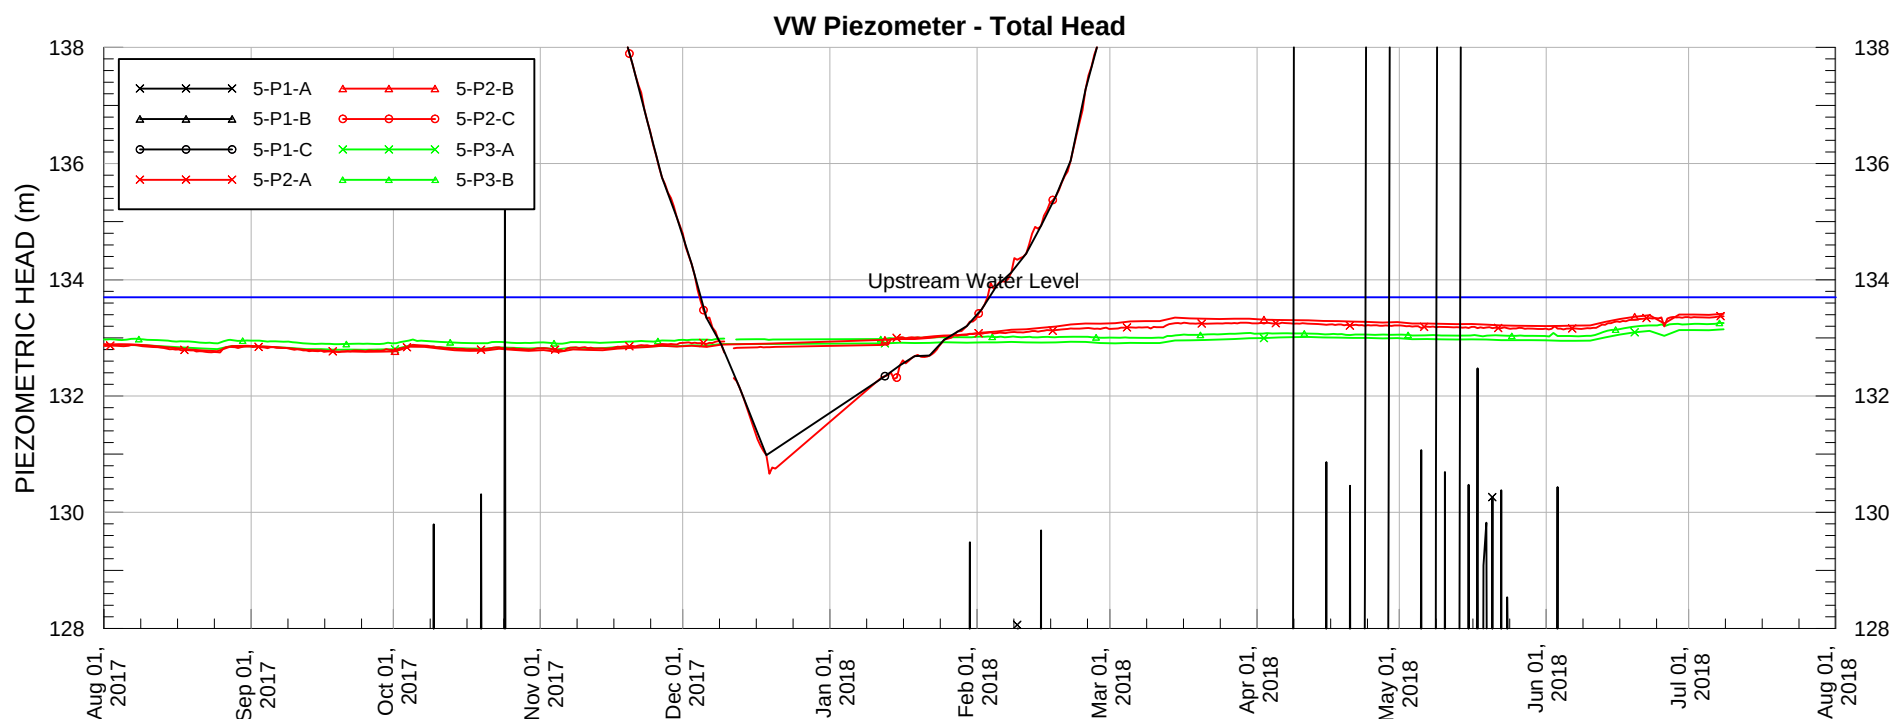
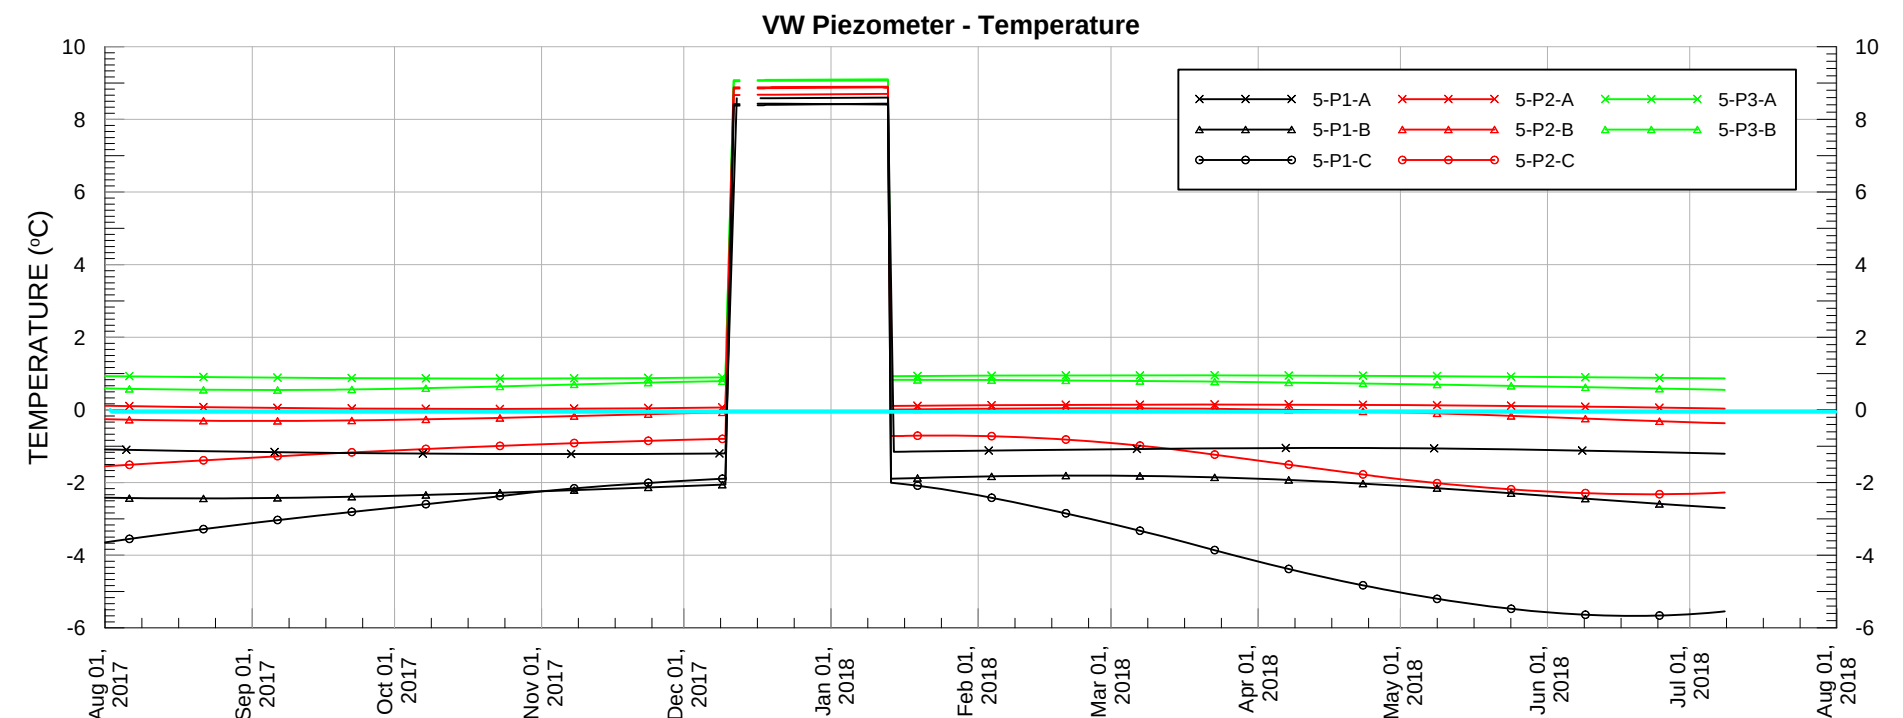
- 5P1A, 5P1B, 5P1C, 5P2C are giving unstable readings and since the temperature shows a negative reading it is assumed to be frozen.
- A spike in temperature also has been corrected and stabilized due to a faulty MUX board.
- Gap in data in December was due to a low battery. Battery was changed the following day.

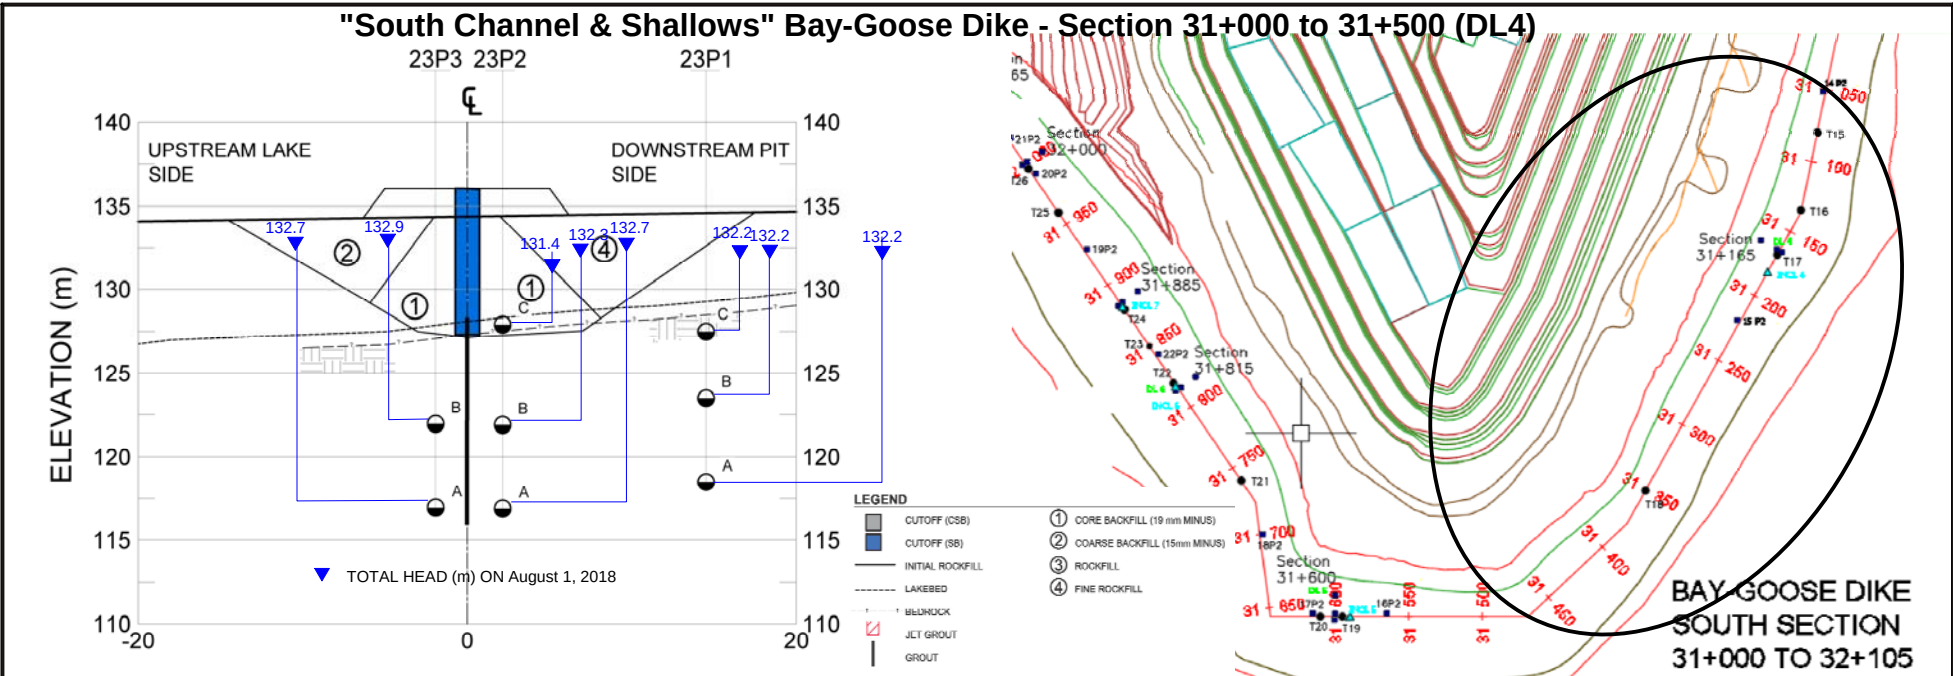
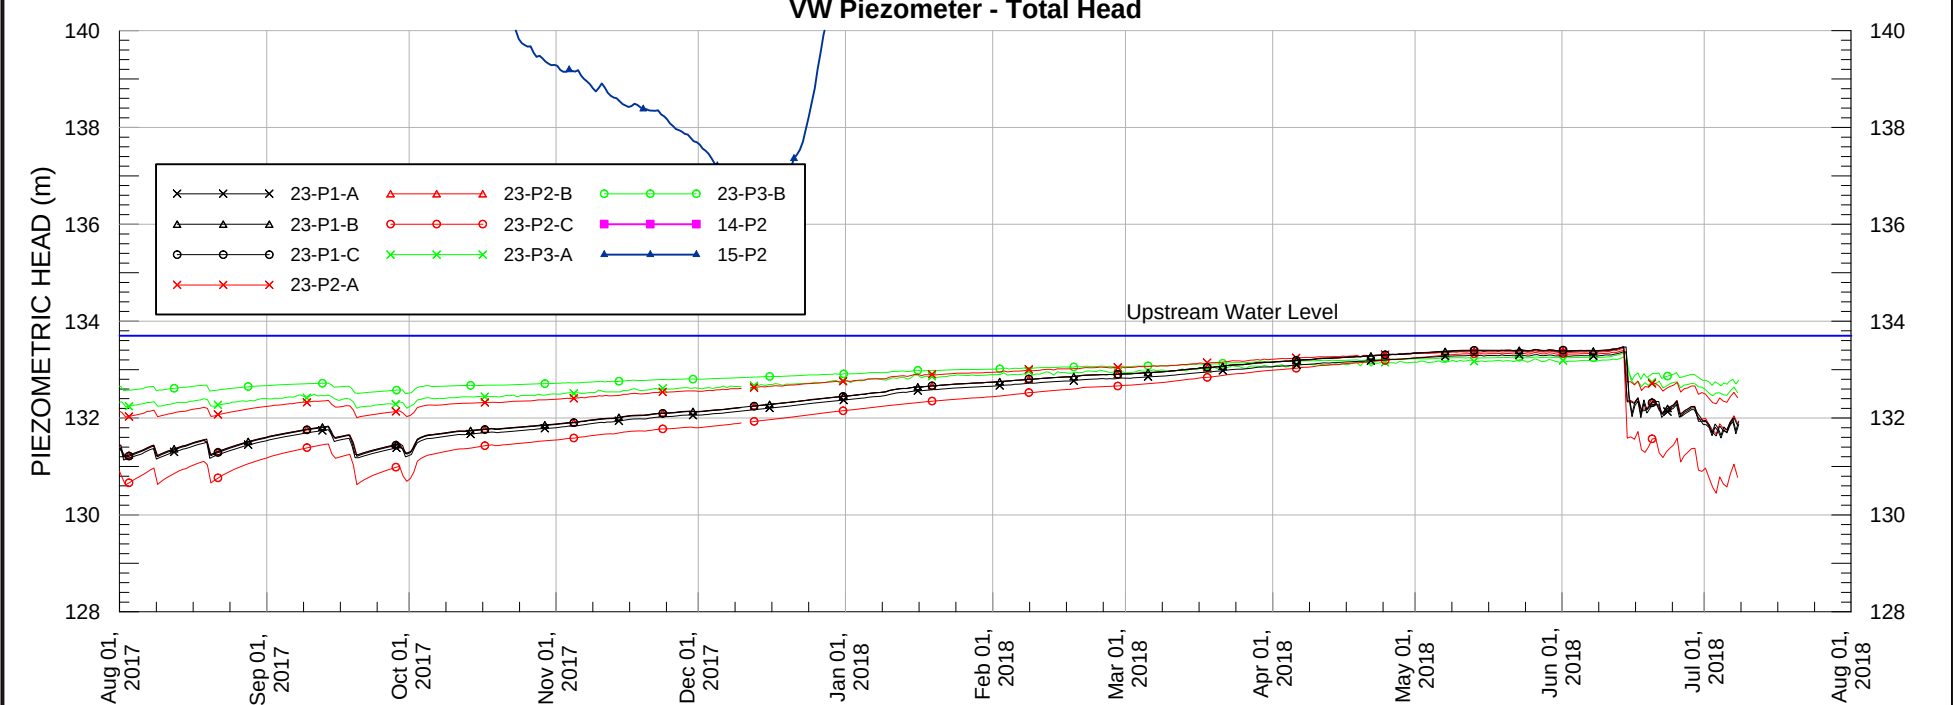
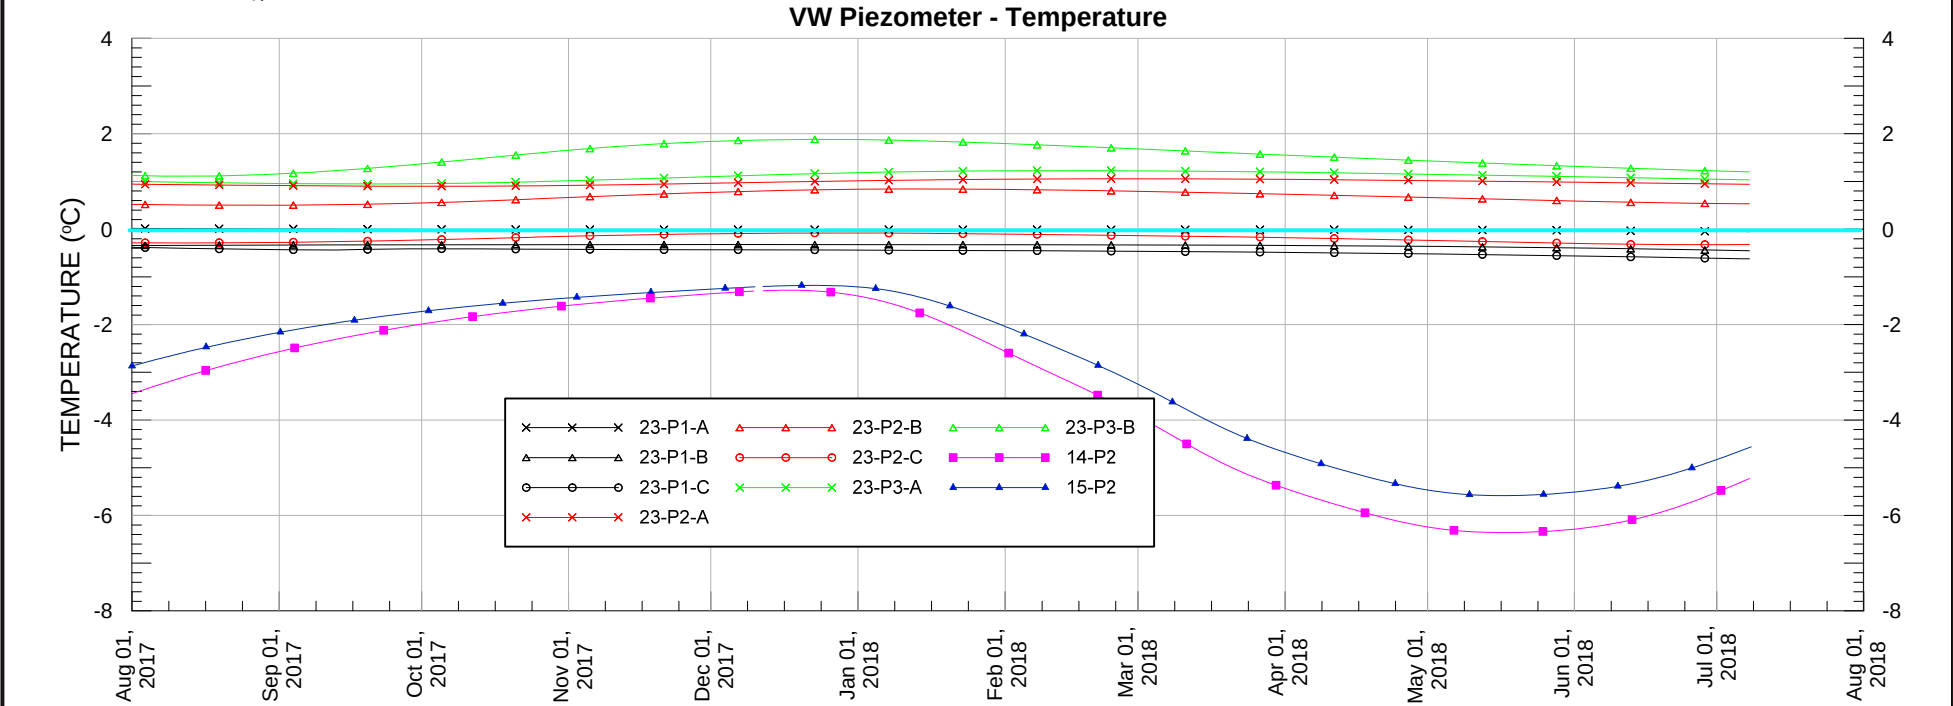
1. 14P2 and 15P2 are given unstable readings and since the temperature shows a negative reading it is assumed to be frozen.
2. PWP rises and falls due to ponding in the area and continuous pumping, and allowing the ponding to raise. The steady increase is when the ponding area freezes, and no pumping is done till the thawing of the area.
3. Gap in data in December is due to low battery. Battery was changed the following day.

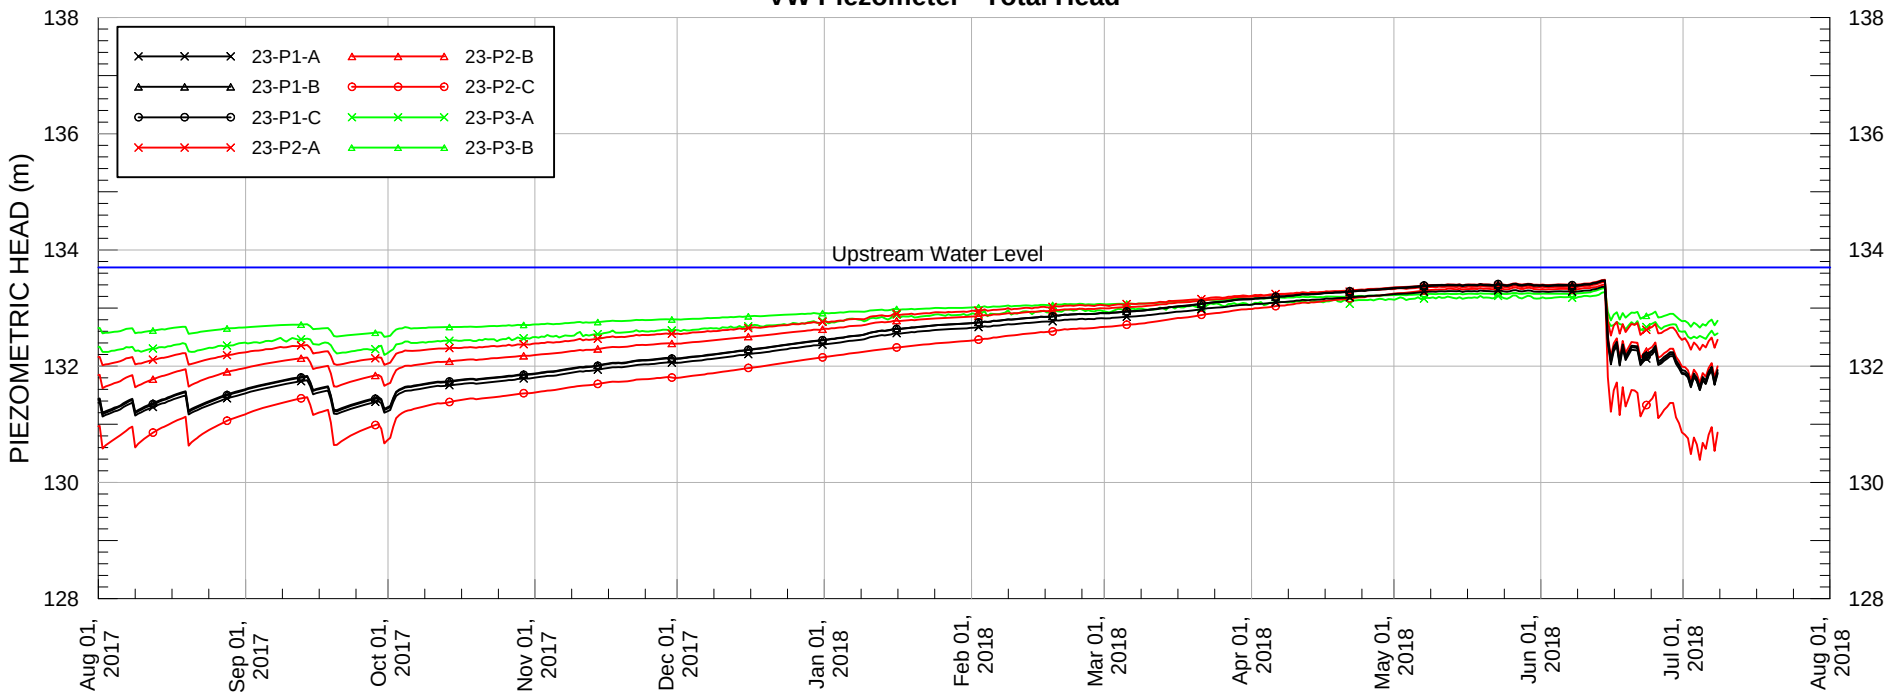
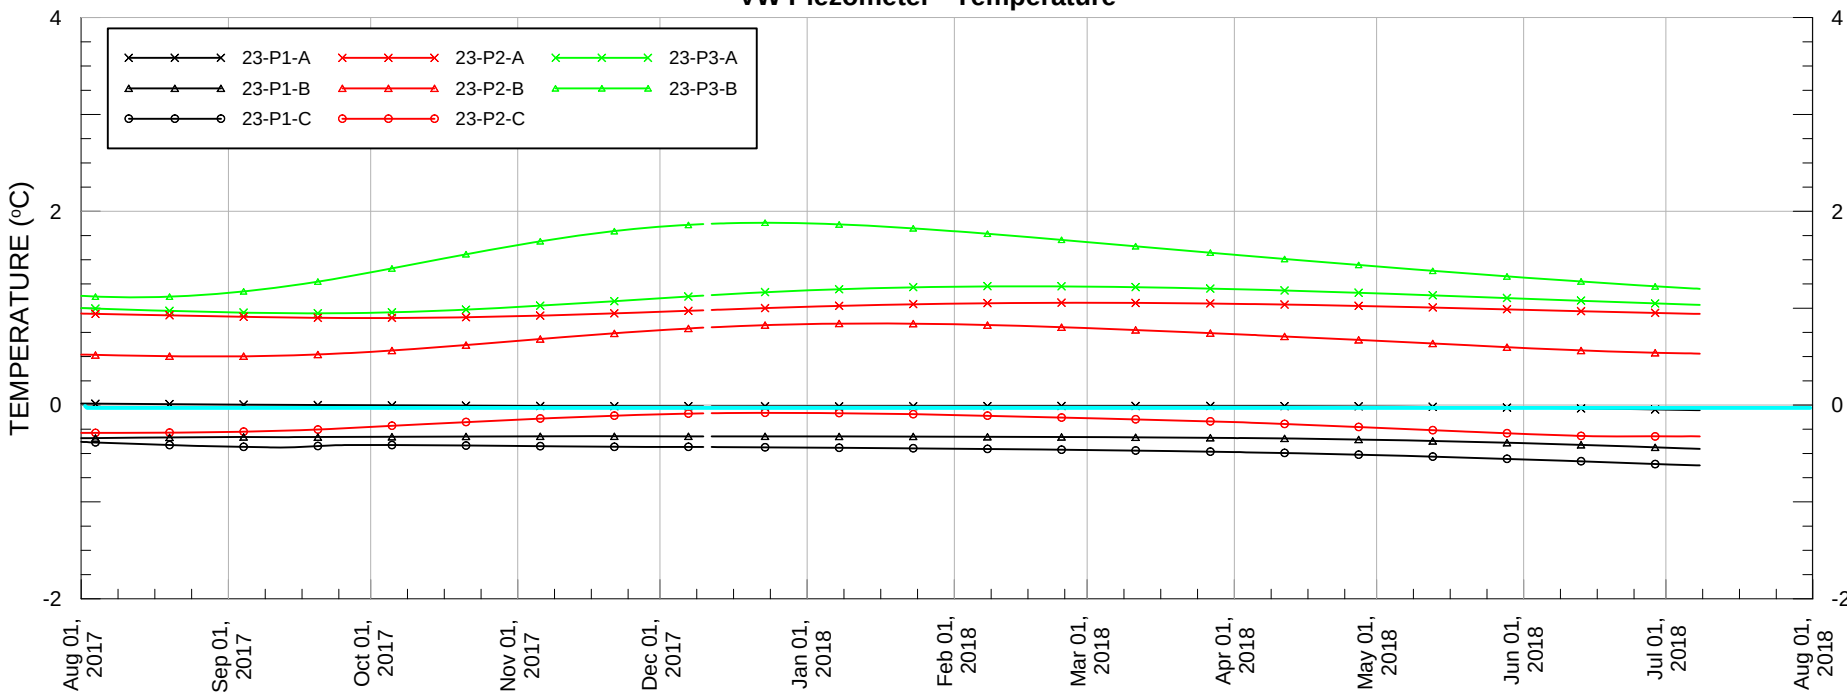
1. PWP rises and falls due to ponding in the area and continous pumping, and allowing the ponding to raise. The steady increase is when the ponding area freezes, and no pumping is done till the thawing of the area.
2. Gap in data in December is due to low battery. Battery was changed he following day.

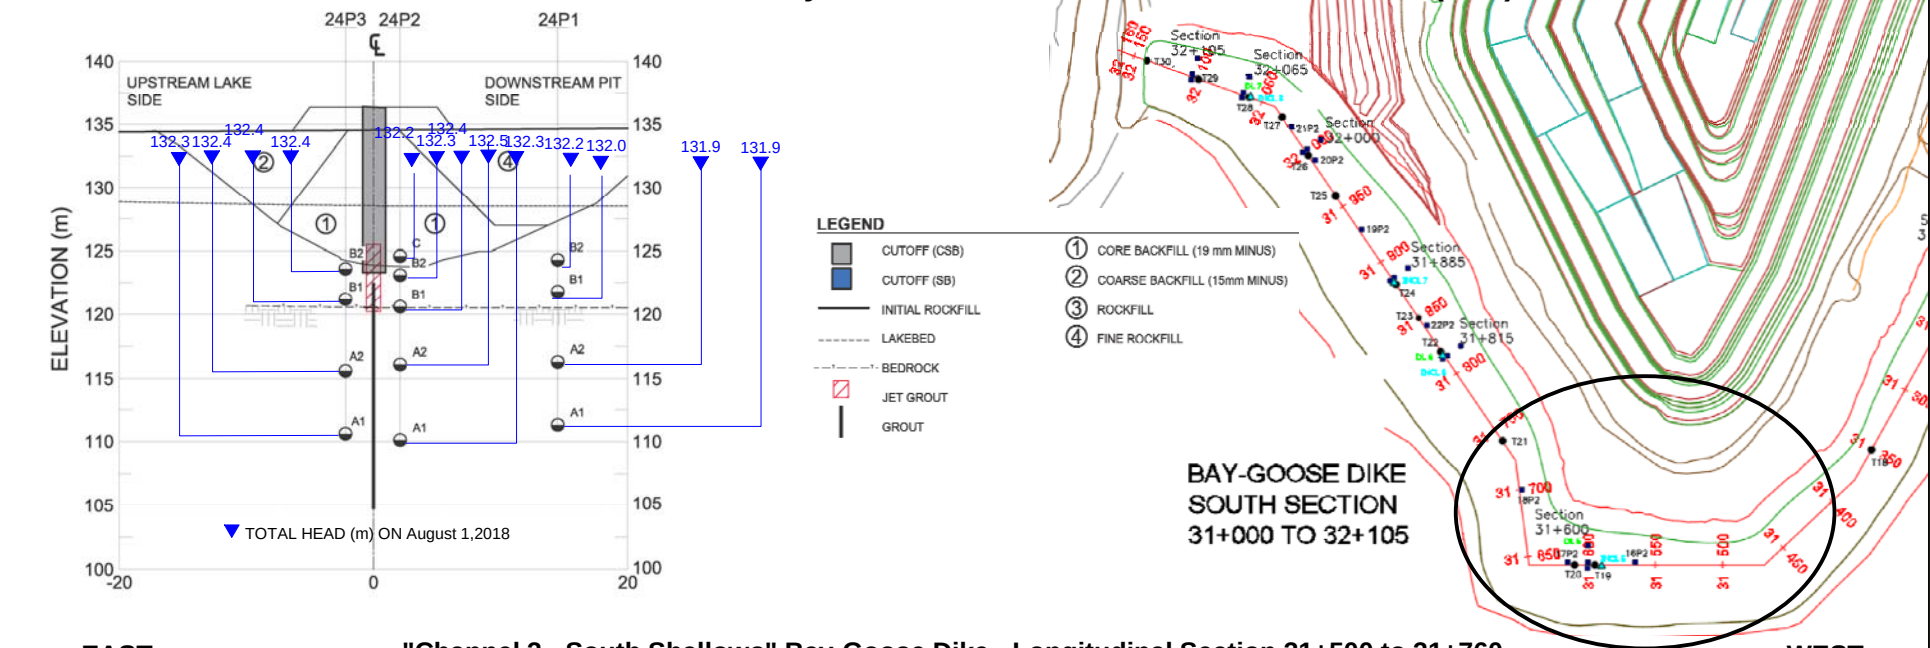
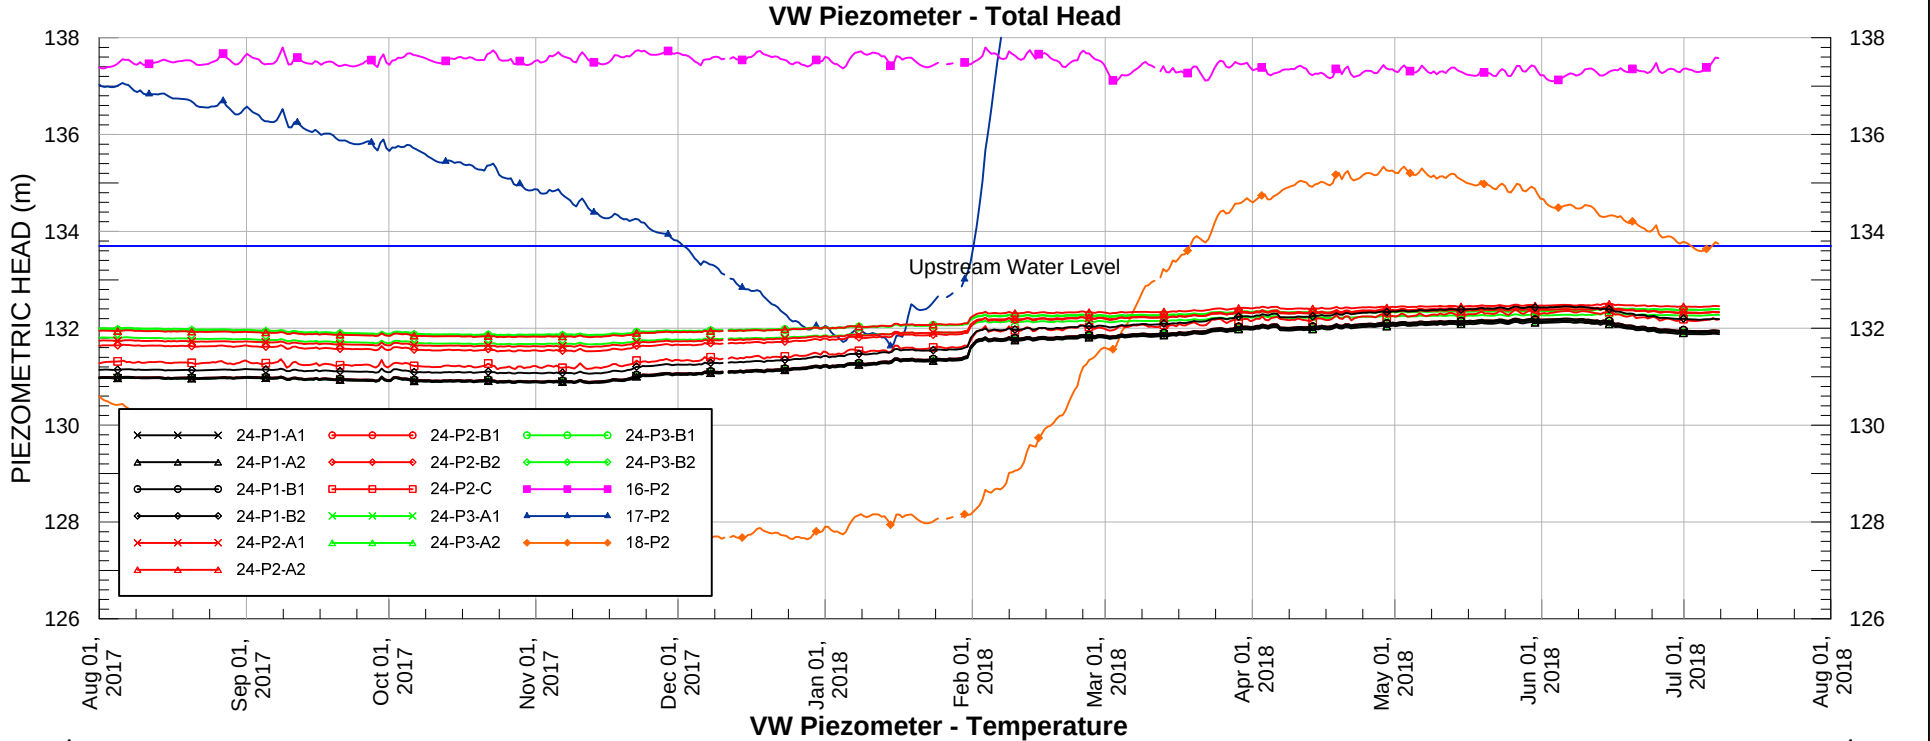
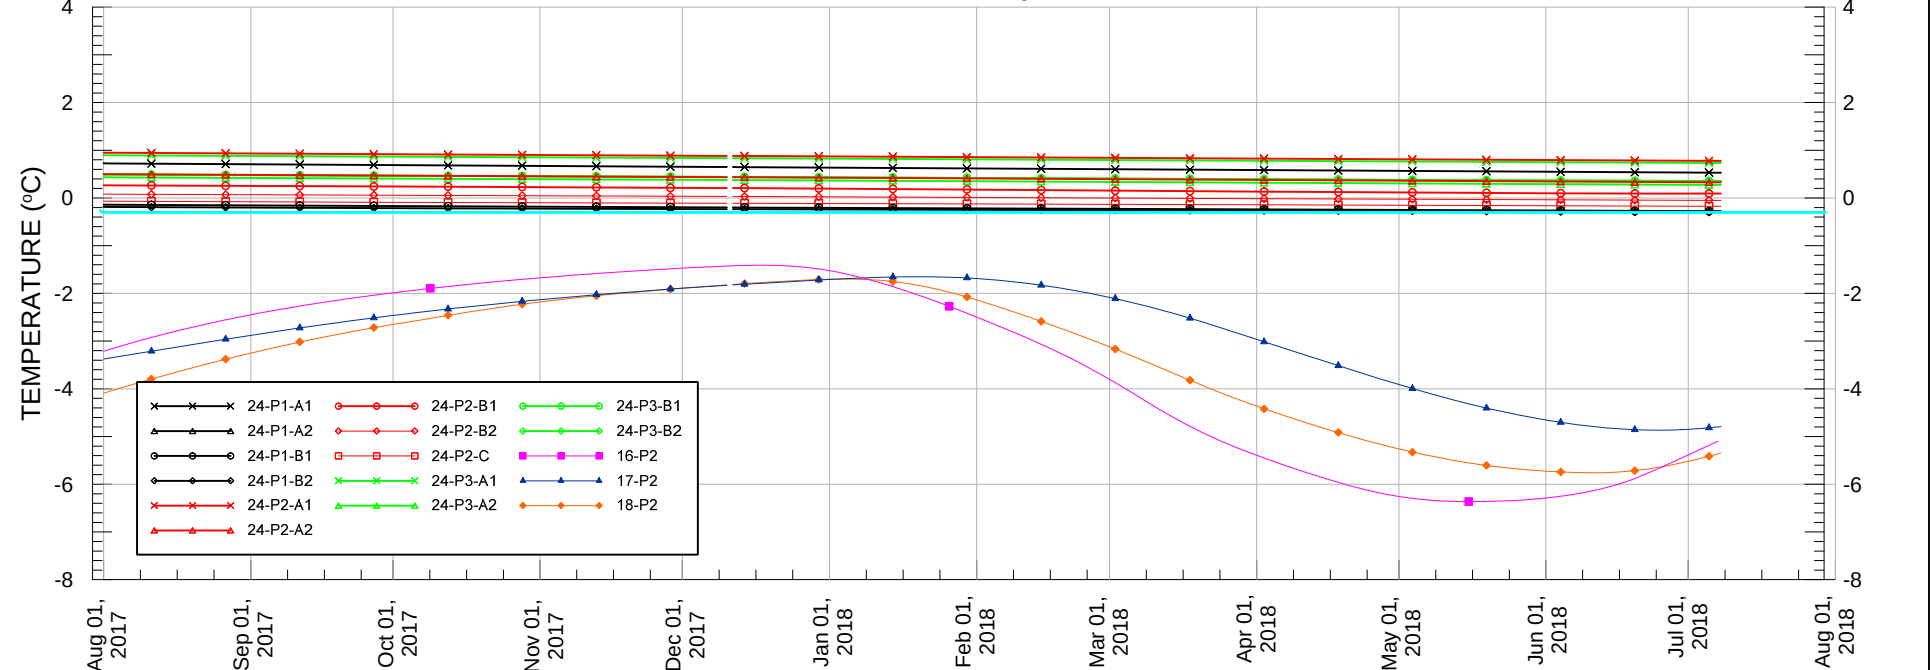
"Channel 3 - South Shallows" Bay-Goose Dike - Section 31+500 to 31+760 (DL5)

- 16P2, 17P2 and 18P2 are given unstable readings and since the temperature shows a negative reading it is assumed to be frozen.
- PWP is following same trend as previous years. When ice builds the pressure increases and when it melts in summer the pressure decreases
- Gap in data in December is due to low battery. Battery was changed the following day.

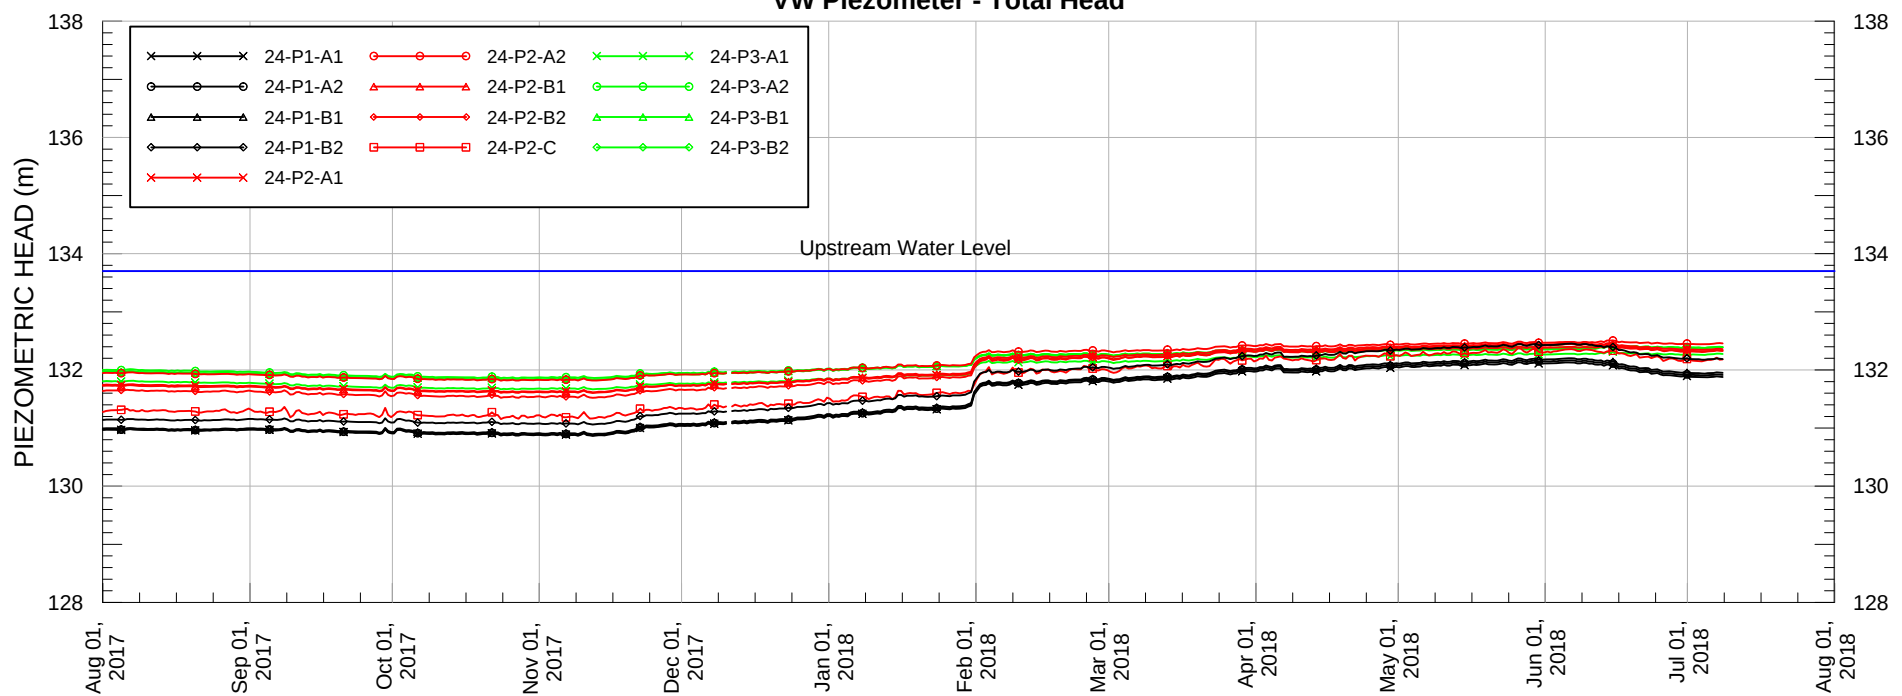
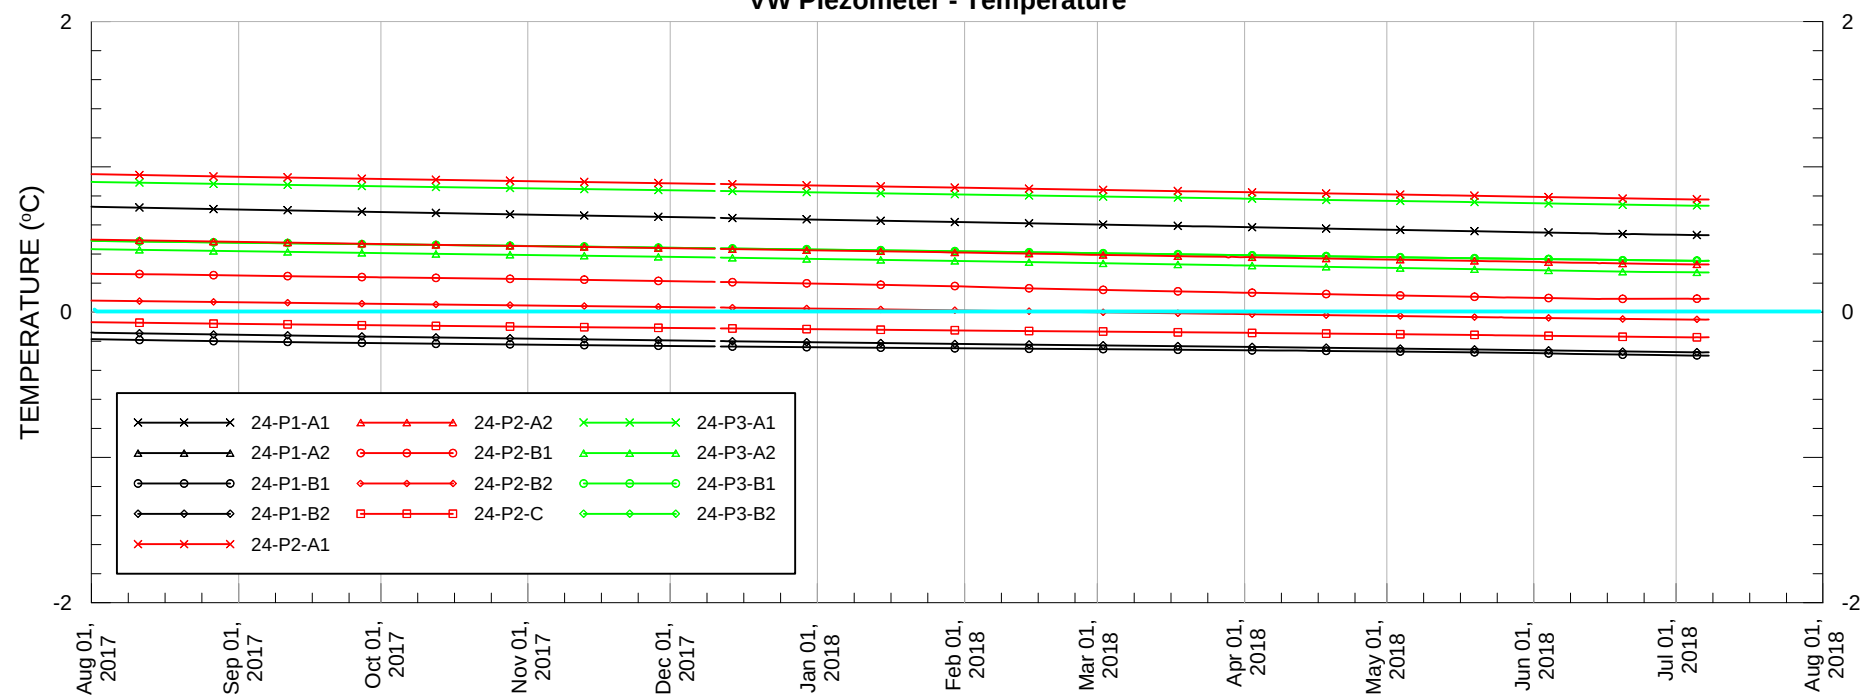
- PWP is following same trend as previous years. When ice builds the pressure increases and when it melts in summer the pressure decreases
- Gap in data in December was due to a low battery. Battery was changed the following day.

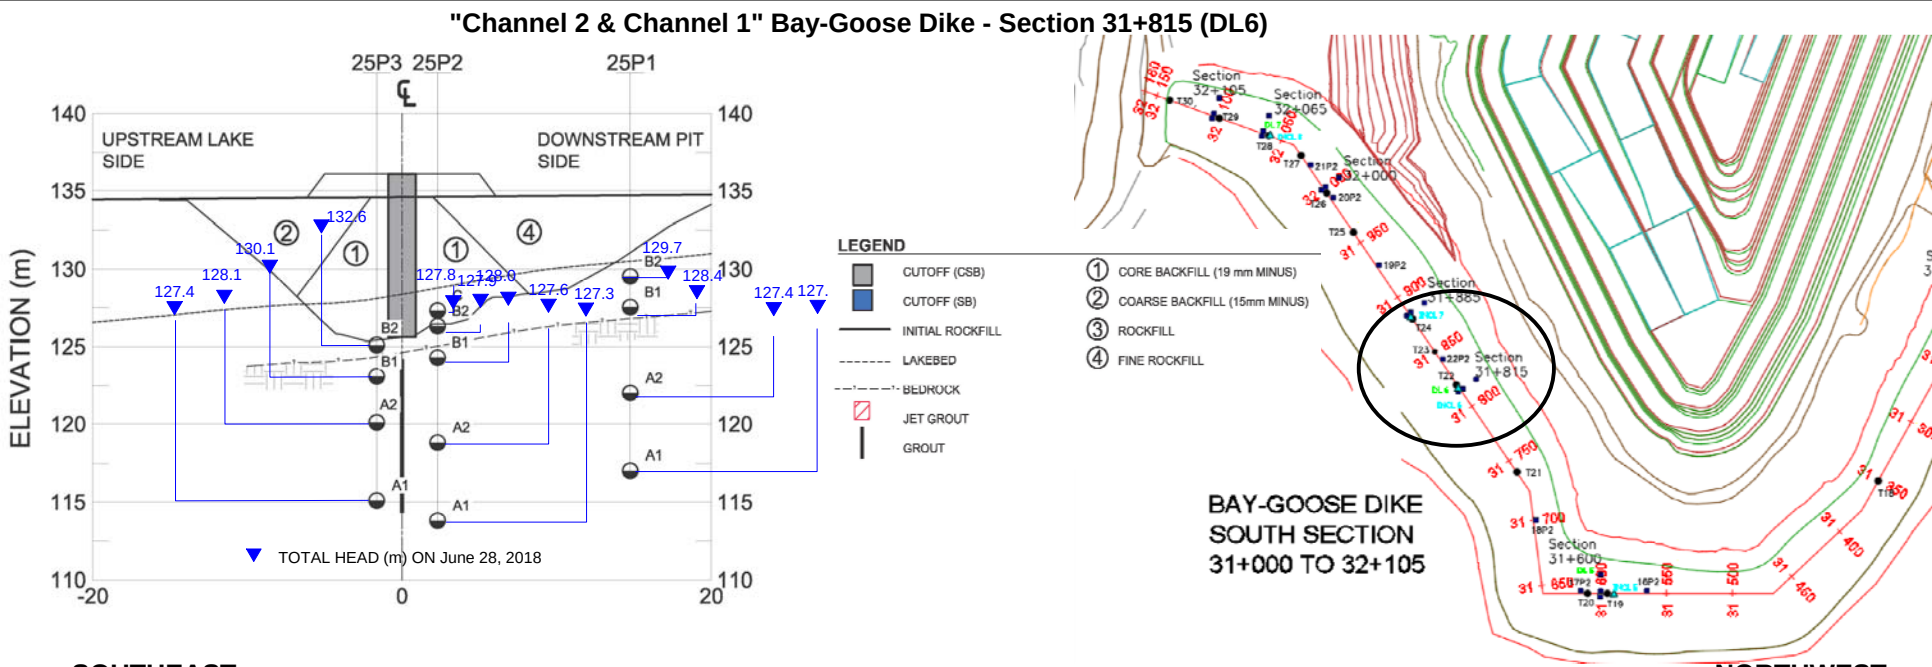
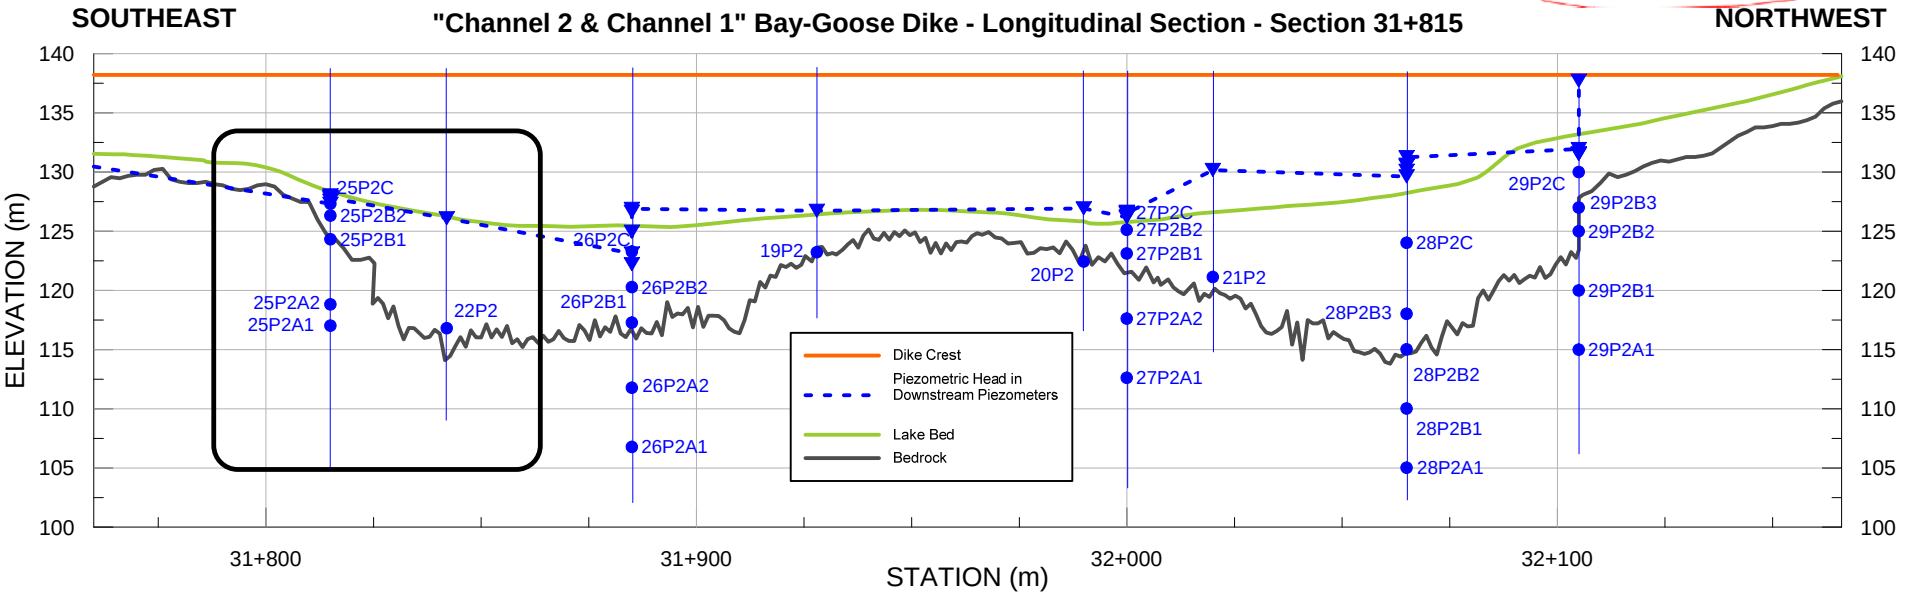
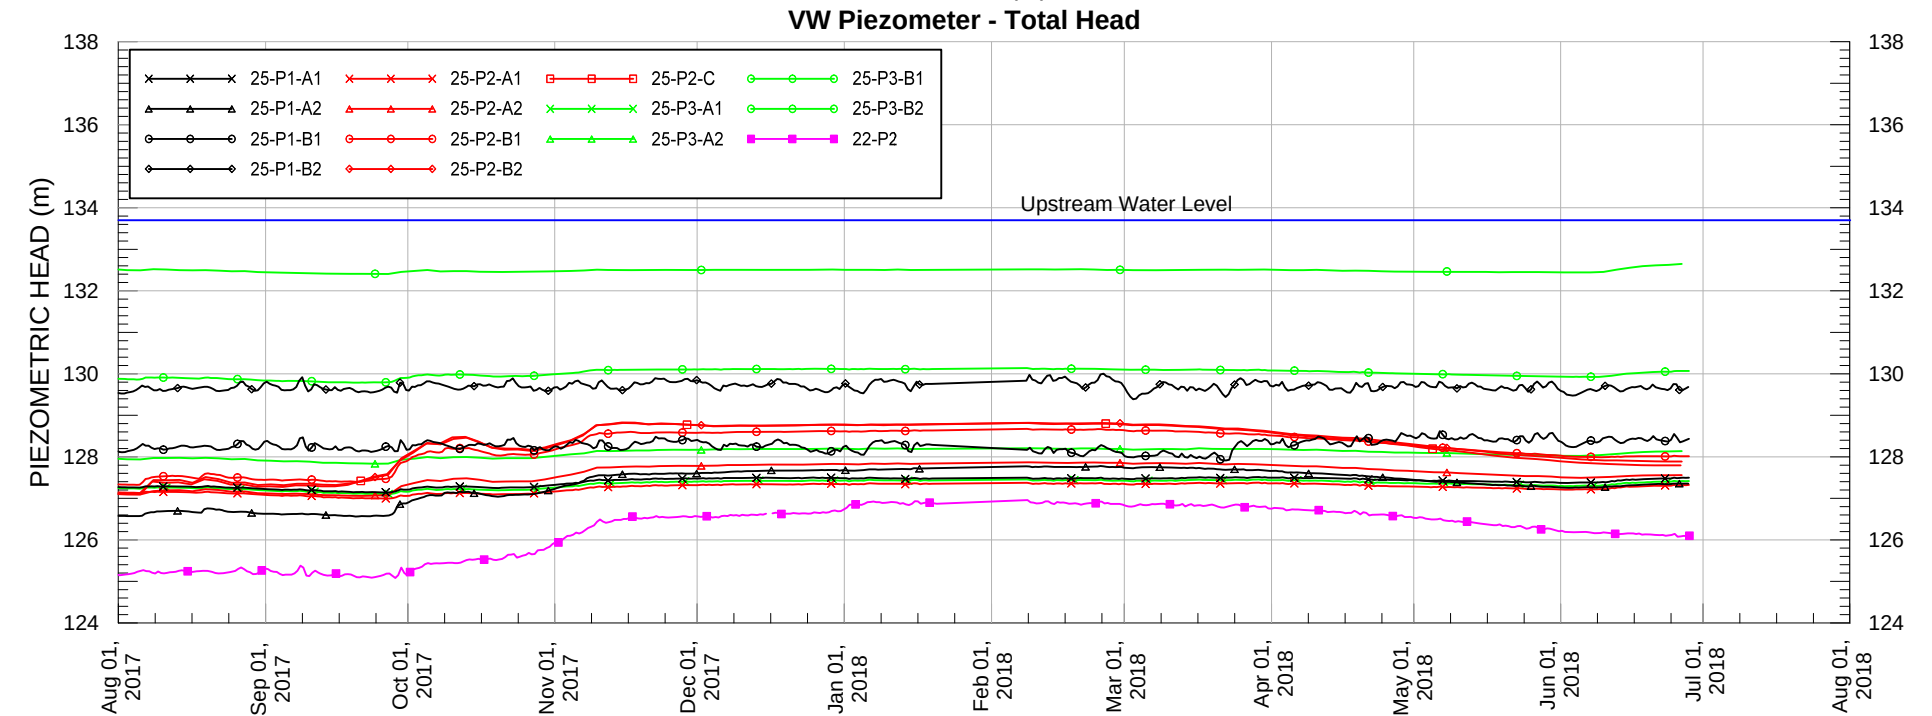
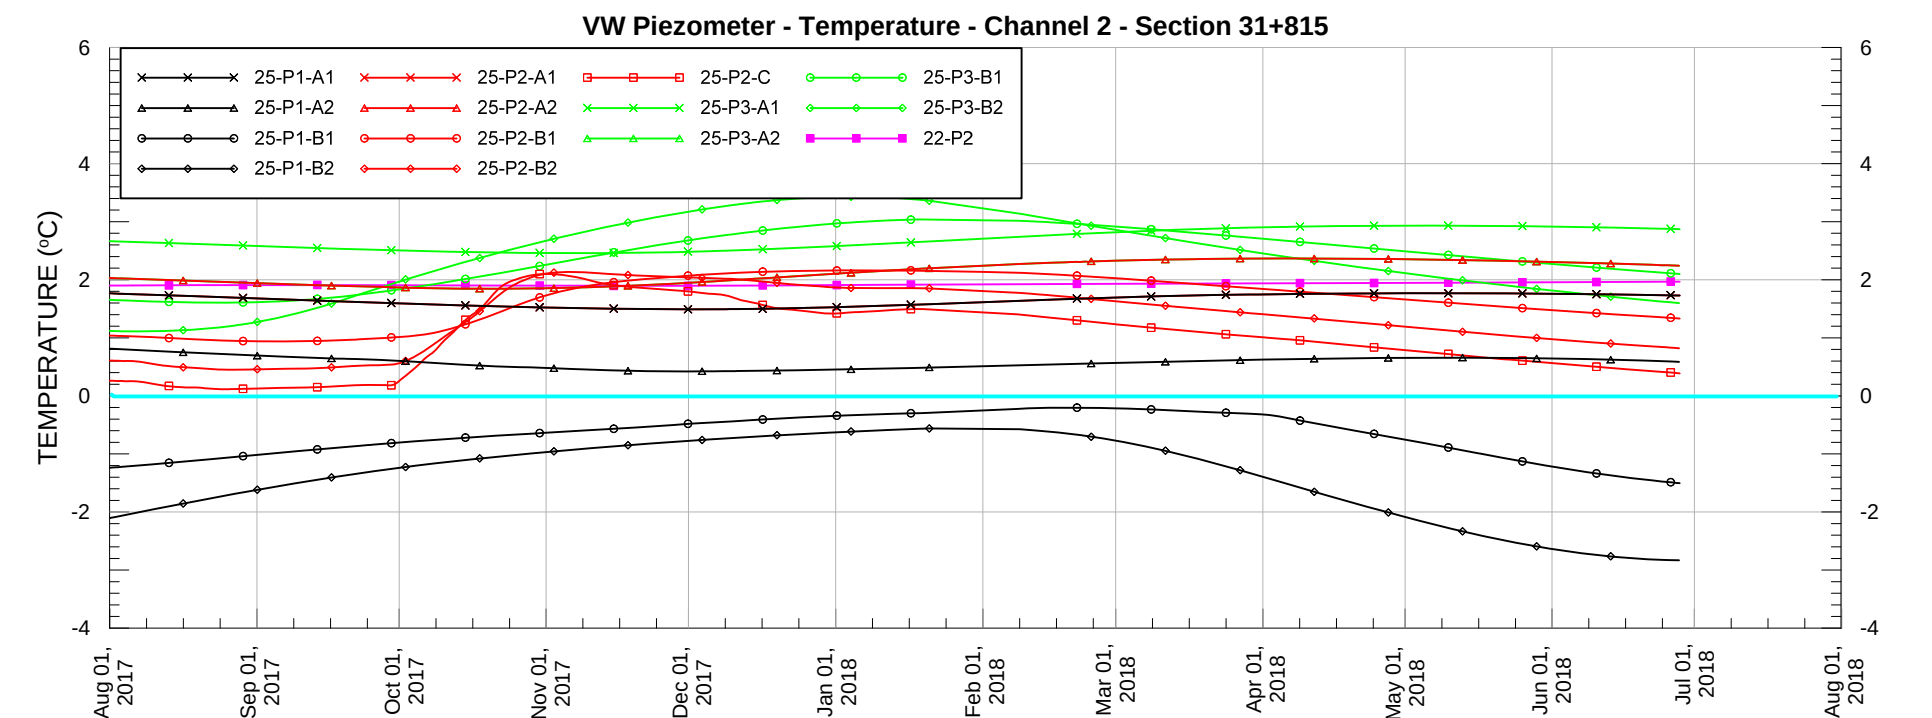
1. The rise in temperature and PWP was interpreted as the permafrost at the toe of the dike blocking the seepage path which led to this events. Will continue to monitor in the field and the instruments. Since the snow melt the blockage is not longer there and the PWP is on a downtrend.
2. There is a signal loss since March 7/18 which is due to the snow accumulating on the Goose Waste Dump pile. Since the snow melt signal is back.
