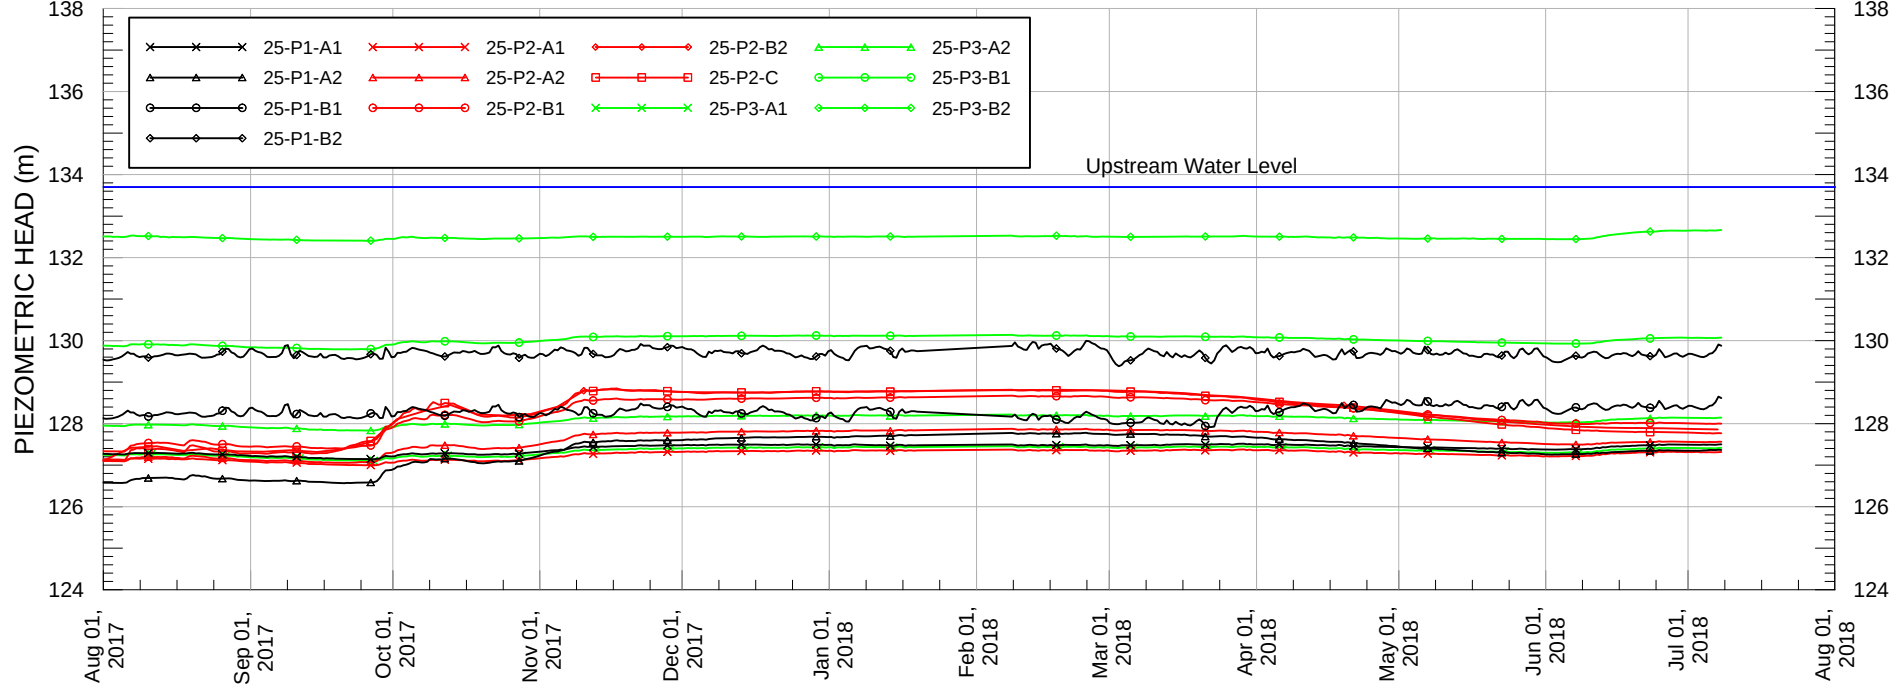
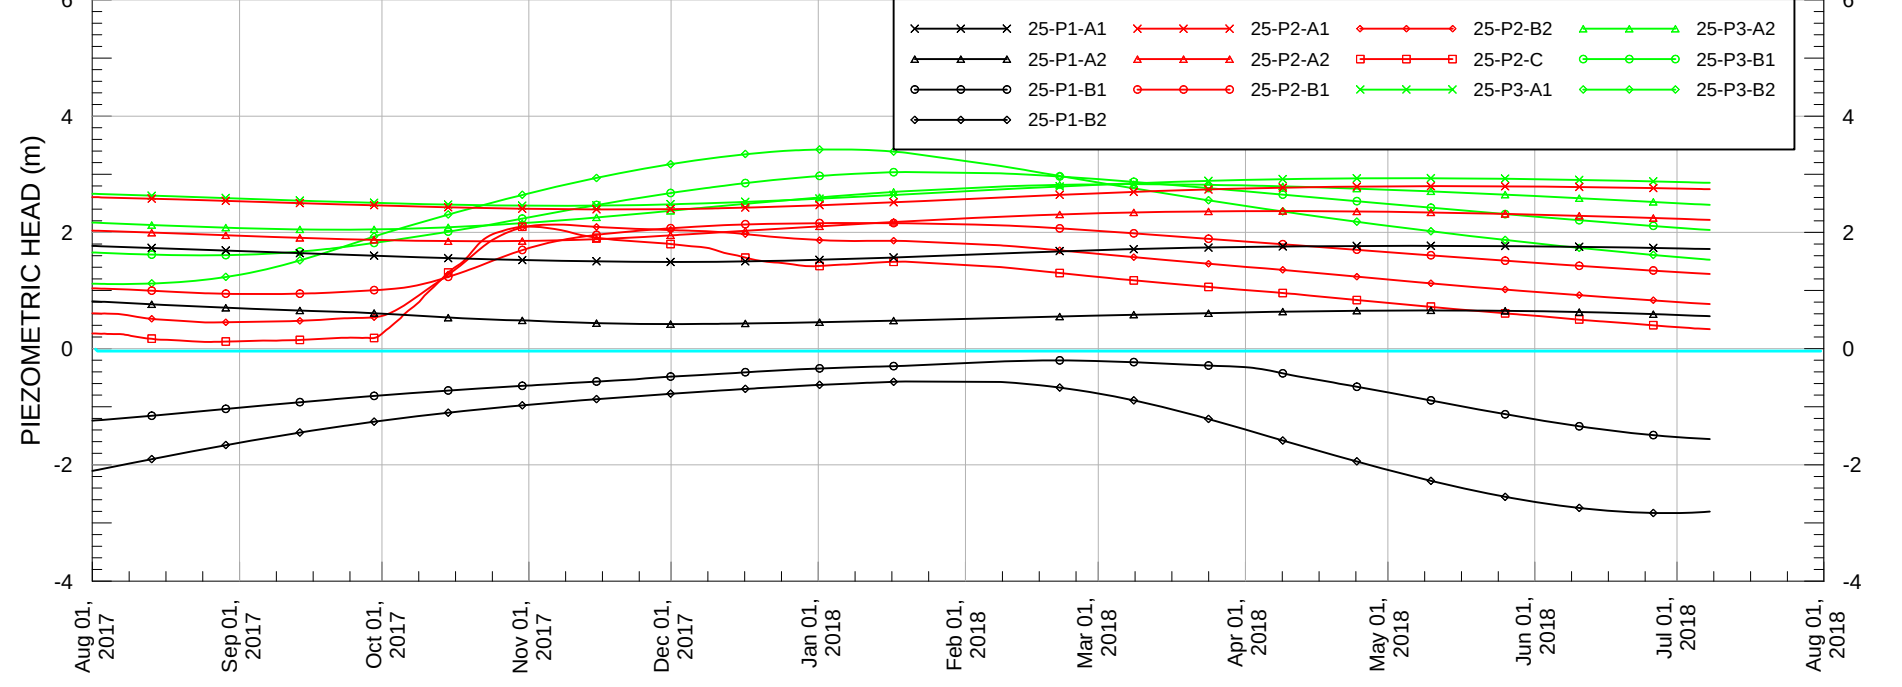
- The rise in temperature and PWP was interpreted as the permafrost at the toe of the dike blocking the seepage path which led to this events. Will continue to monitor in the field and the instruments. Since the snow melt the blockage is no longer there and the PWP is on a downtrend.
- There is a signal loss since March 7/18 which is due to the snow accumulating on the Goose Waste Dump pile. Since the snow melt signal is back.

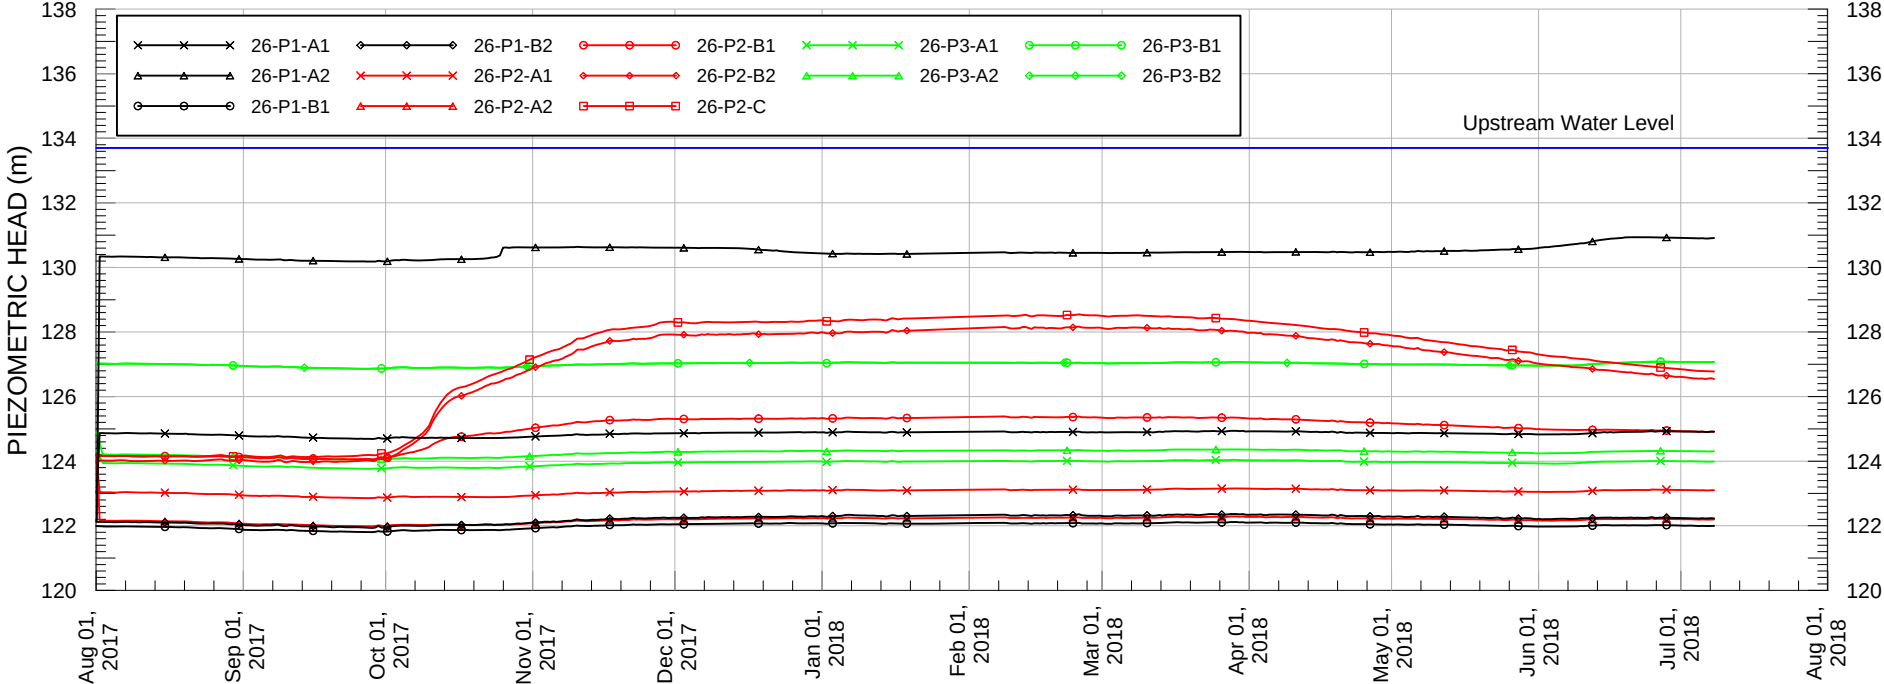
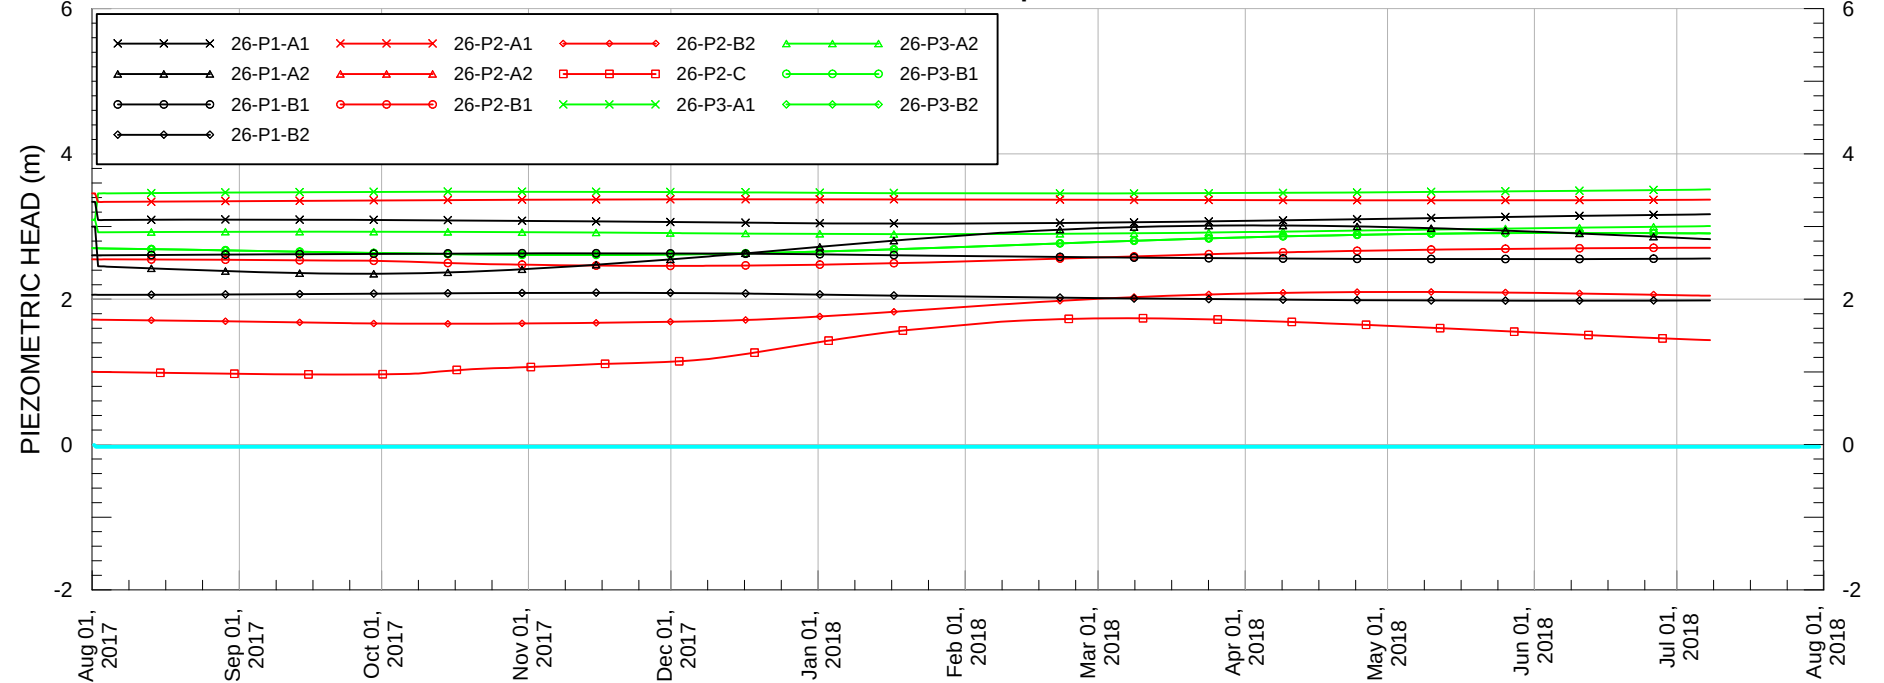
BAY-GOOSE DIKE  
SOUTH SECTION  
31+000 TO 32+105

- The rise in temperature and PWP was interpreted as the permafrost at the toe of the dike blocking the seepage path which led to this events. Will continue to monitor in the field and the instruments. Now that ice has melted the PWP has decreased as the seepage path is no longer blocked.
- There is a signal loss since March 7/18 which is due to the snow accumulating on the Goose Waste Dump pile. Signal since snow melt has resumed.

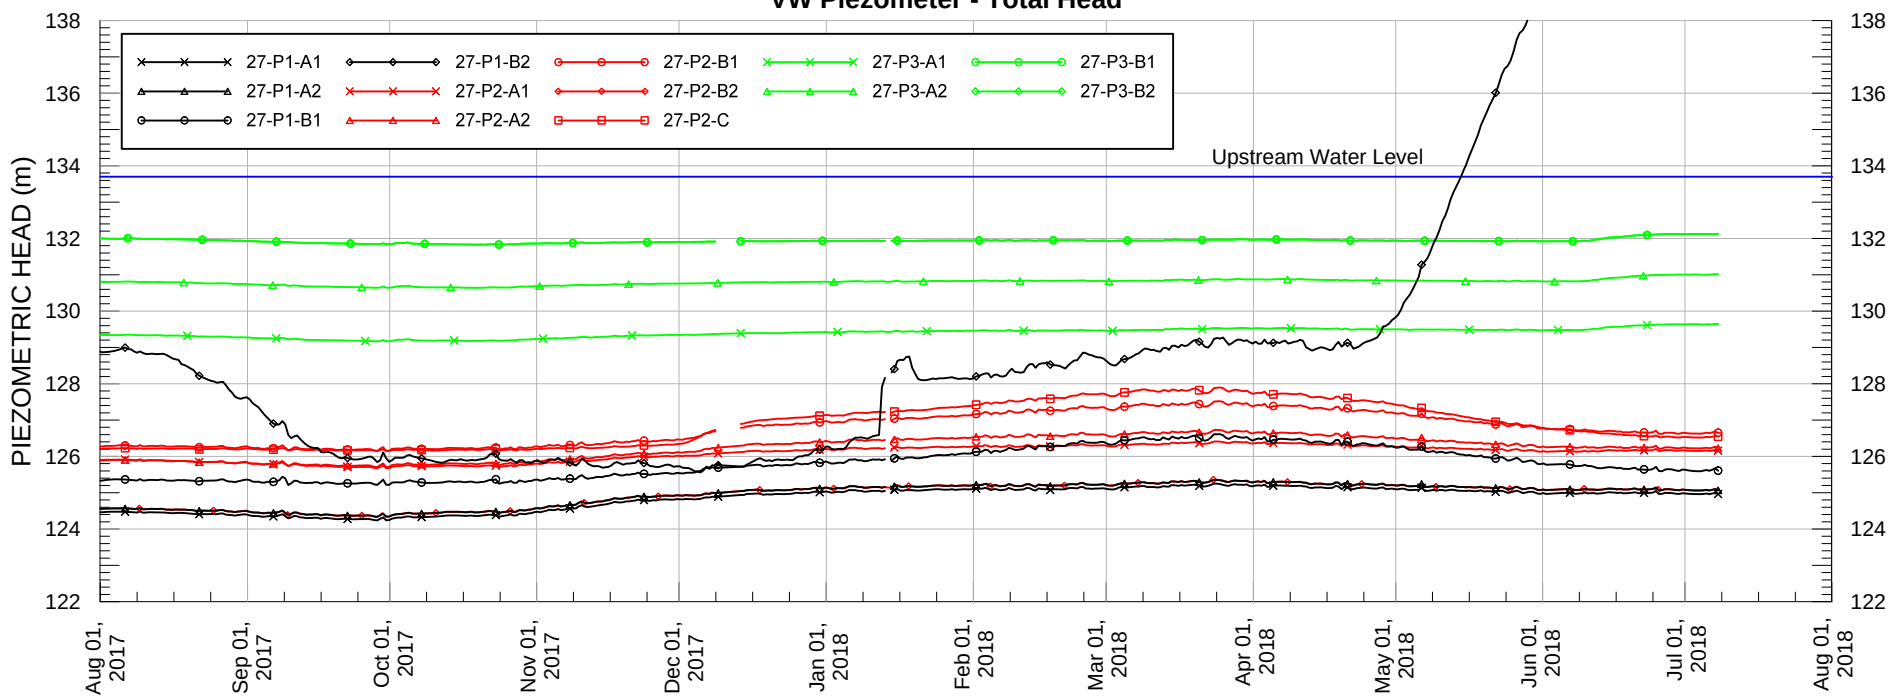
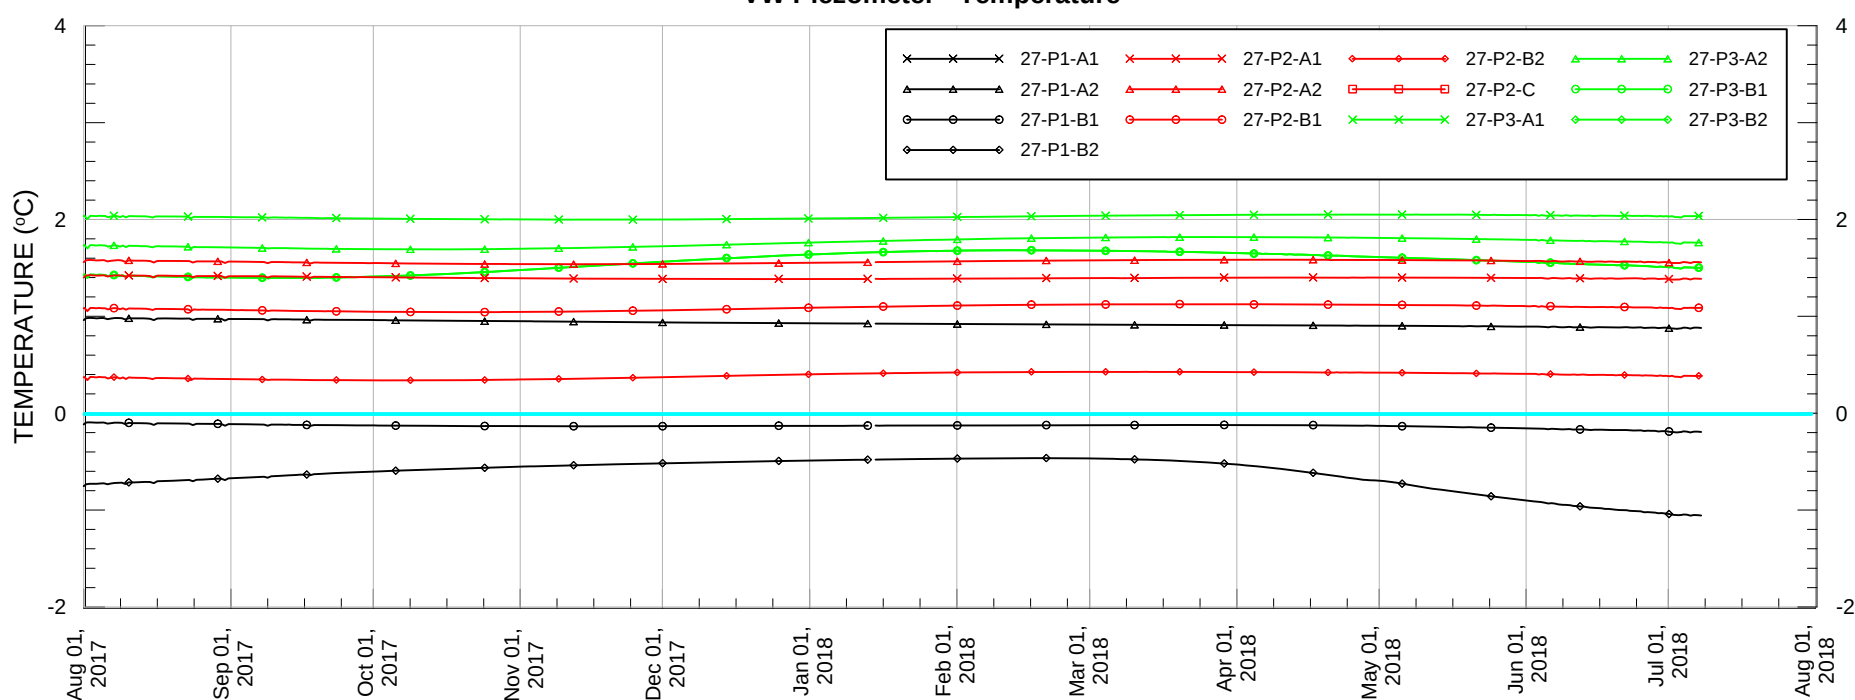
1. There is a signal loss since March 7/18 which is due to the snow accumulating on the Goose Waste Dump pile. Since the snow melt the signal has returned.
2. With the spike PWP pressure in 27-P1-B2 it is assumed that this instrument is not functioning anymore as the PWP pressure is higher than the lake elevation.

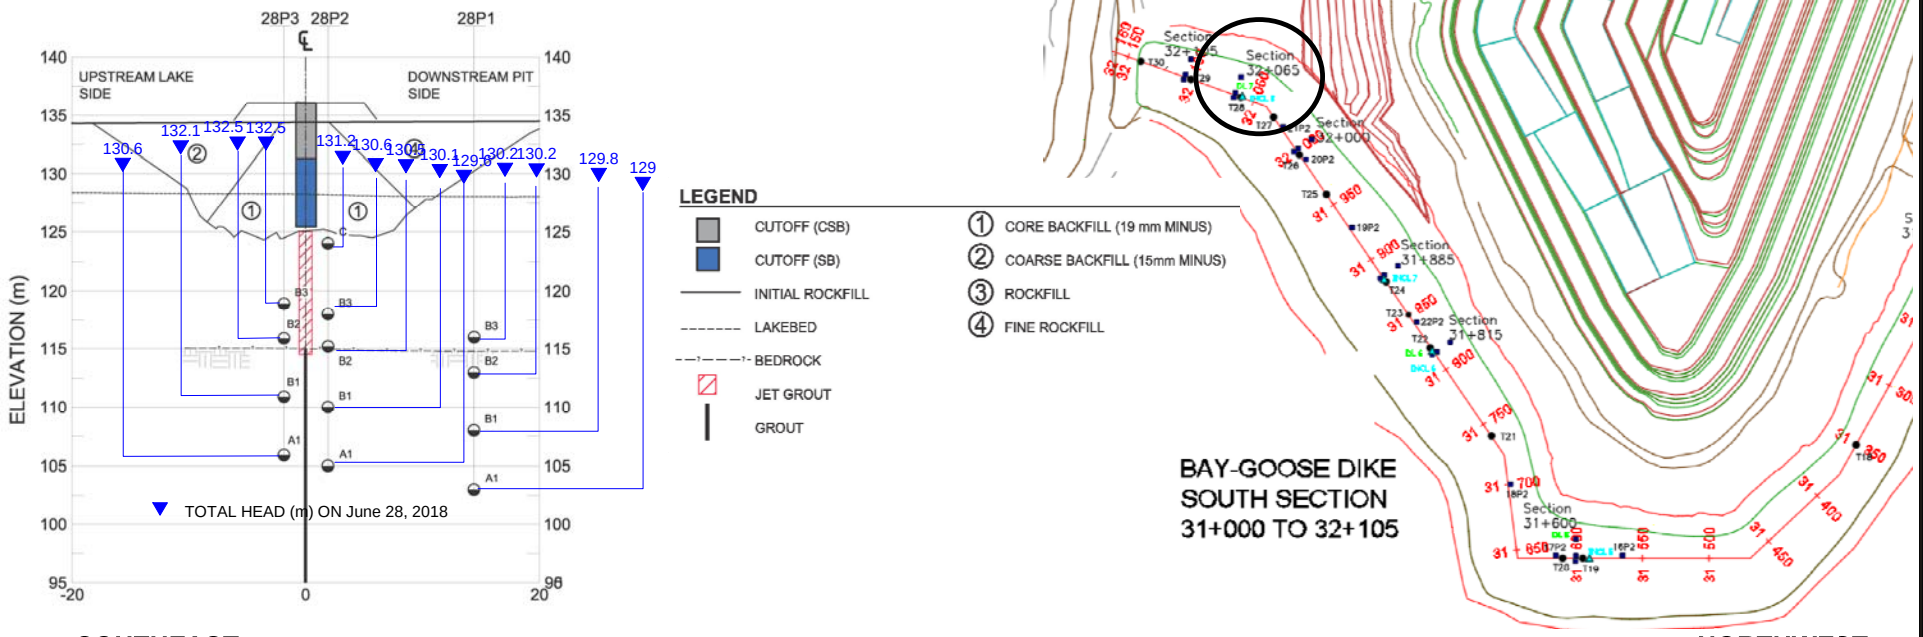
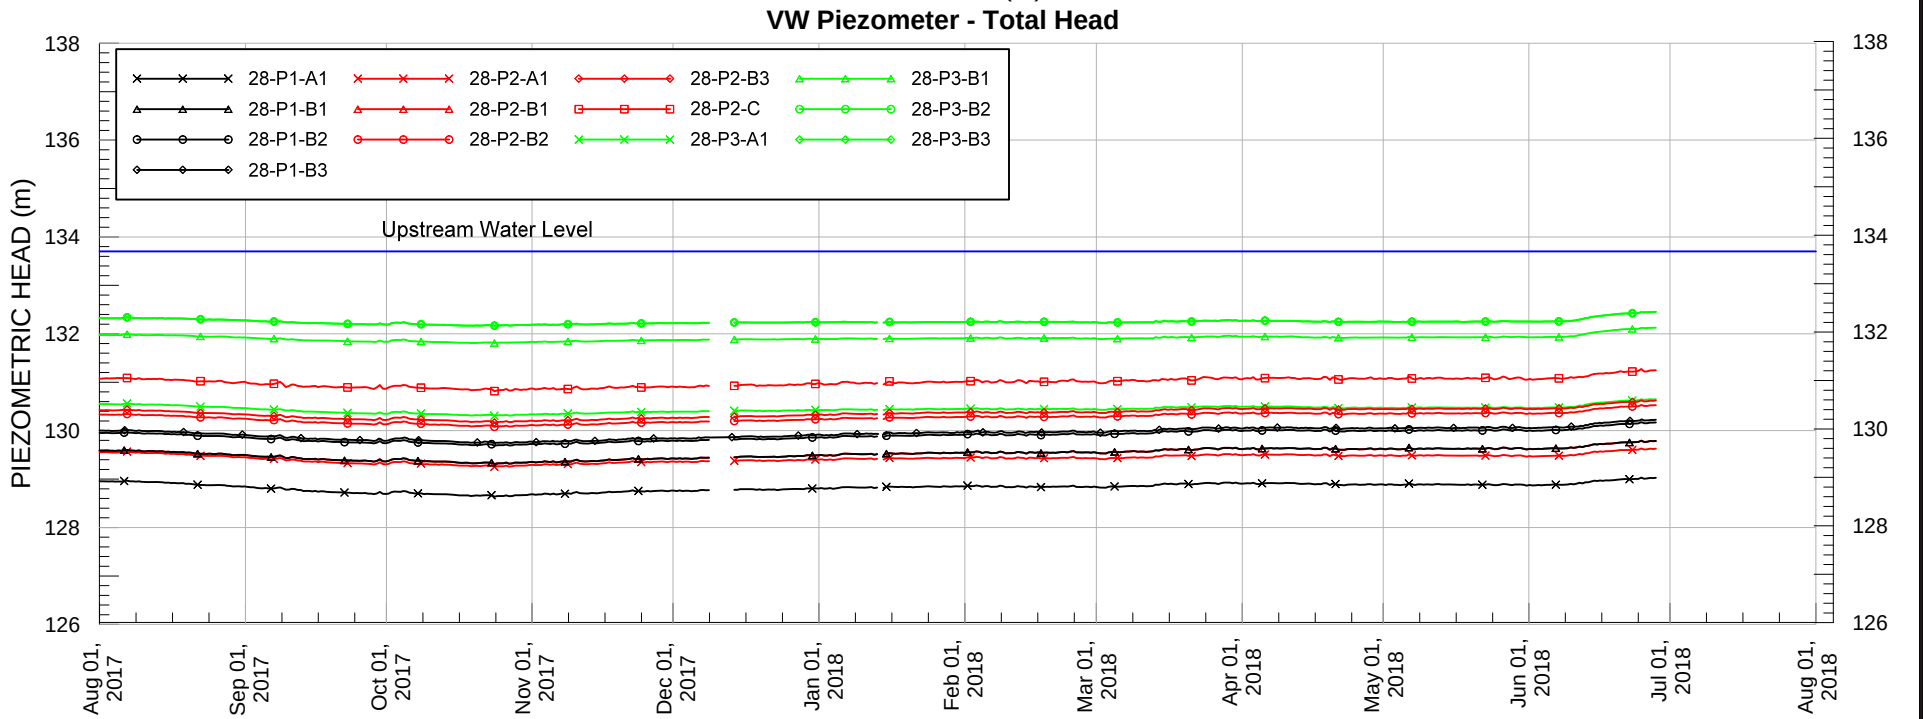
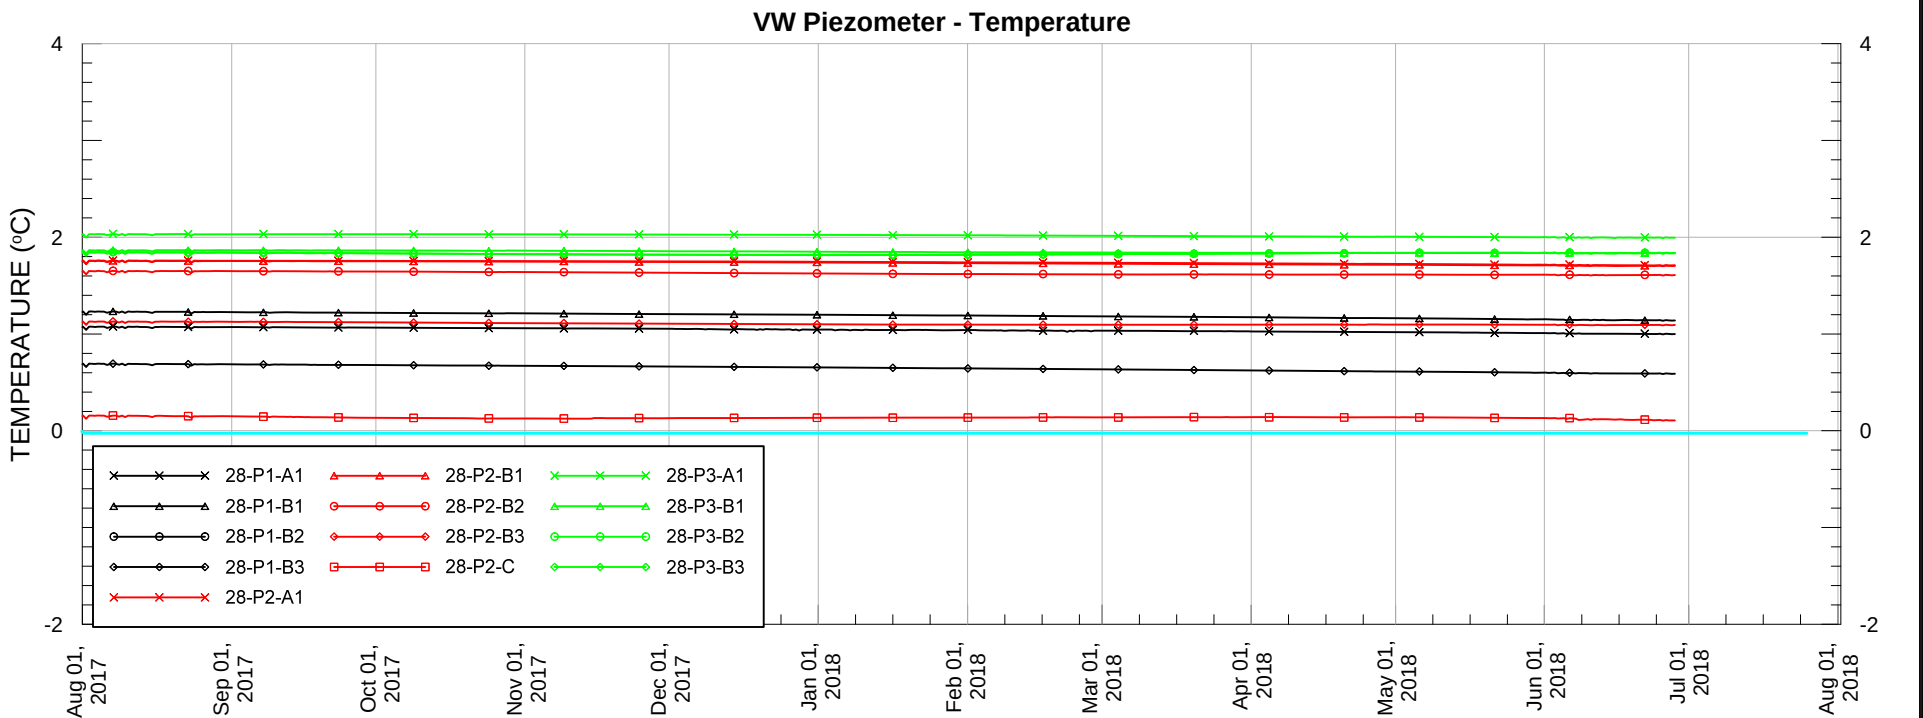
"Channel 2 & Channel 1" Bay-Goose Dike - Section 32+065 (DL7)

1. There are some anomaly readings from Dec. 10 to Dec. 11 which is due to low battery, which was changed.
2. There is a signal loss since March 7/18 which is due to the snow accumulating on the Goose Waste Dump pile. Since the snow melt the signal has returned.
3. Gap in data in December and January is due to low battery. Battery was changed the following day after.

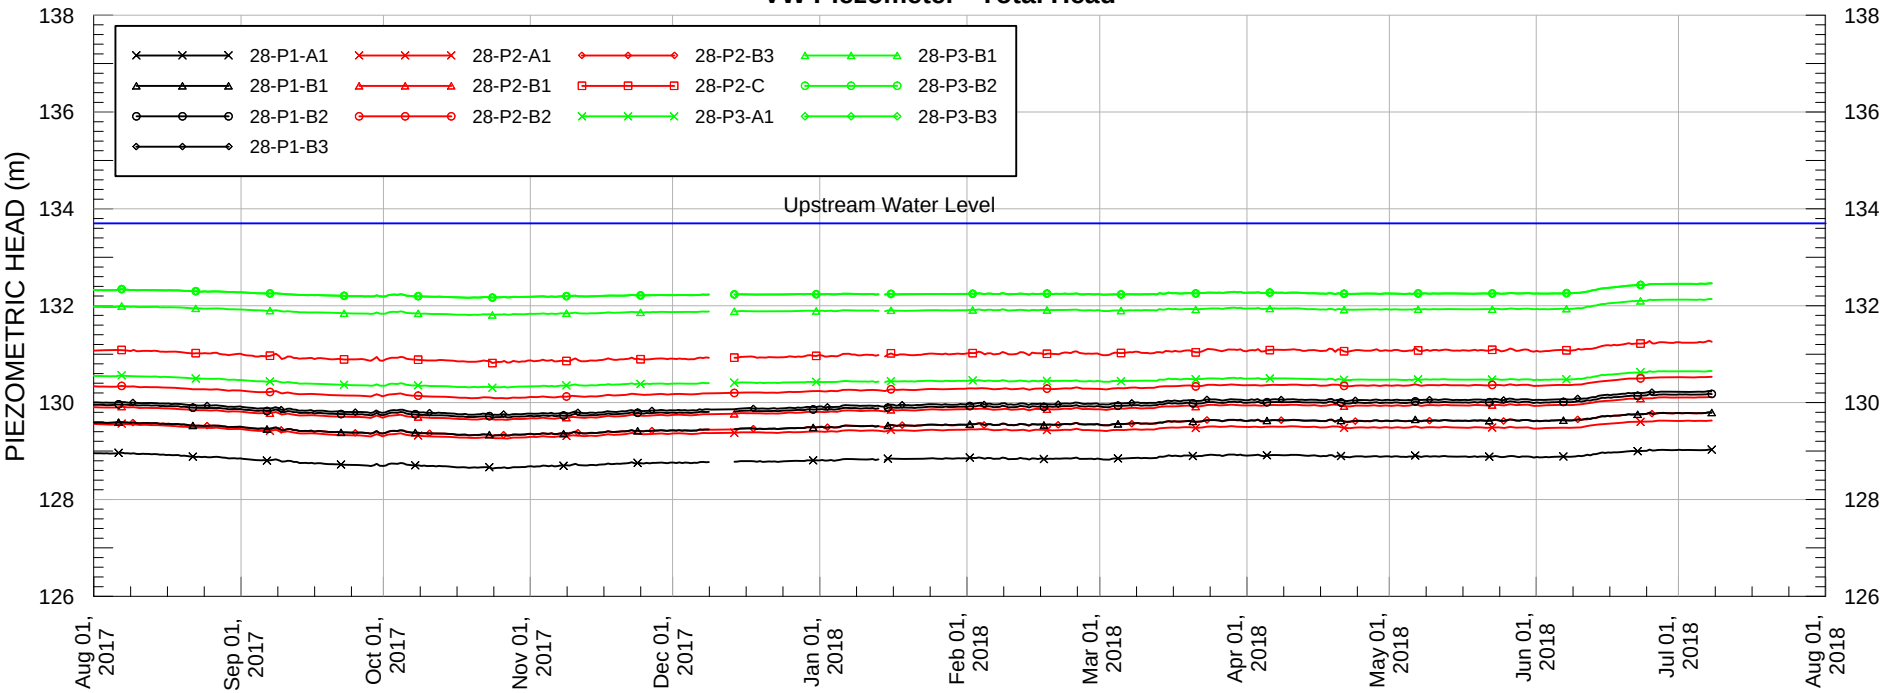
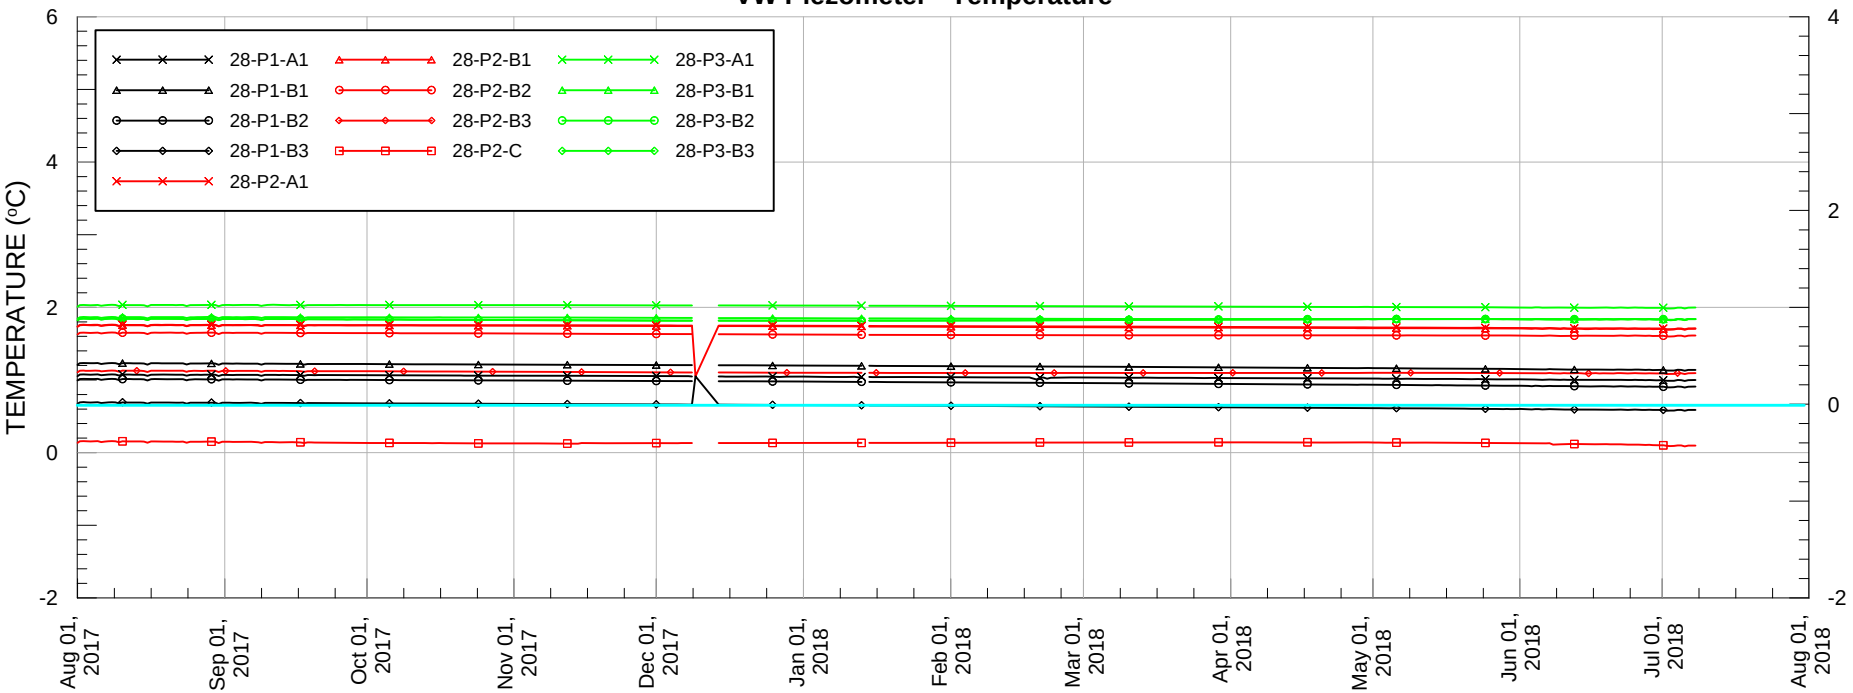
- There is a signal loss since March 7/18 which is due to the snow accumulating on the Goose Waste Dump pile. Since the snow melt the signal has returned.
- With the spike PWP pressure in 27-P3-A2 it is assumed that this instrument is not functioning anymore as the PWP pressure is higher than the lake elevation.
- Gap in data in December and January is due to low battery. Battery was changed the following day after.

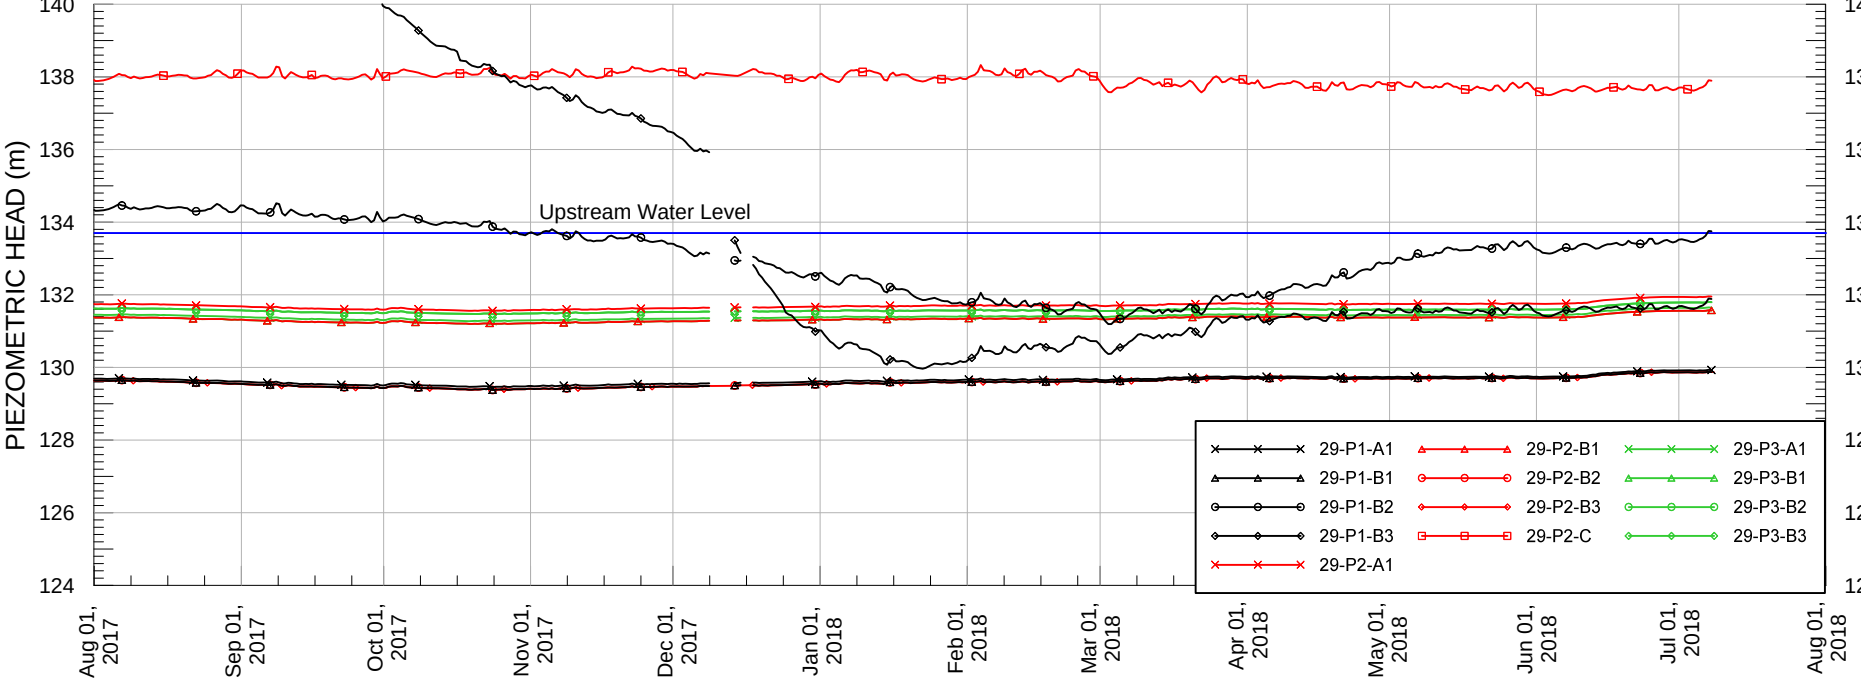
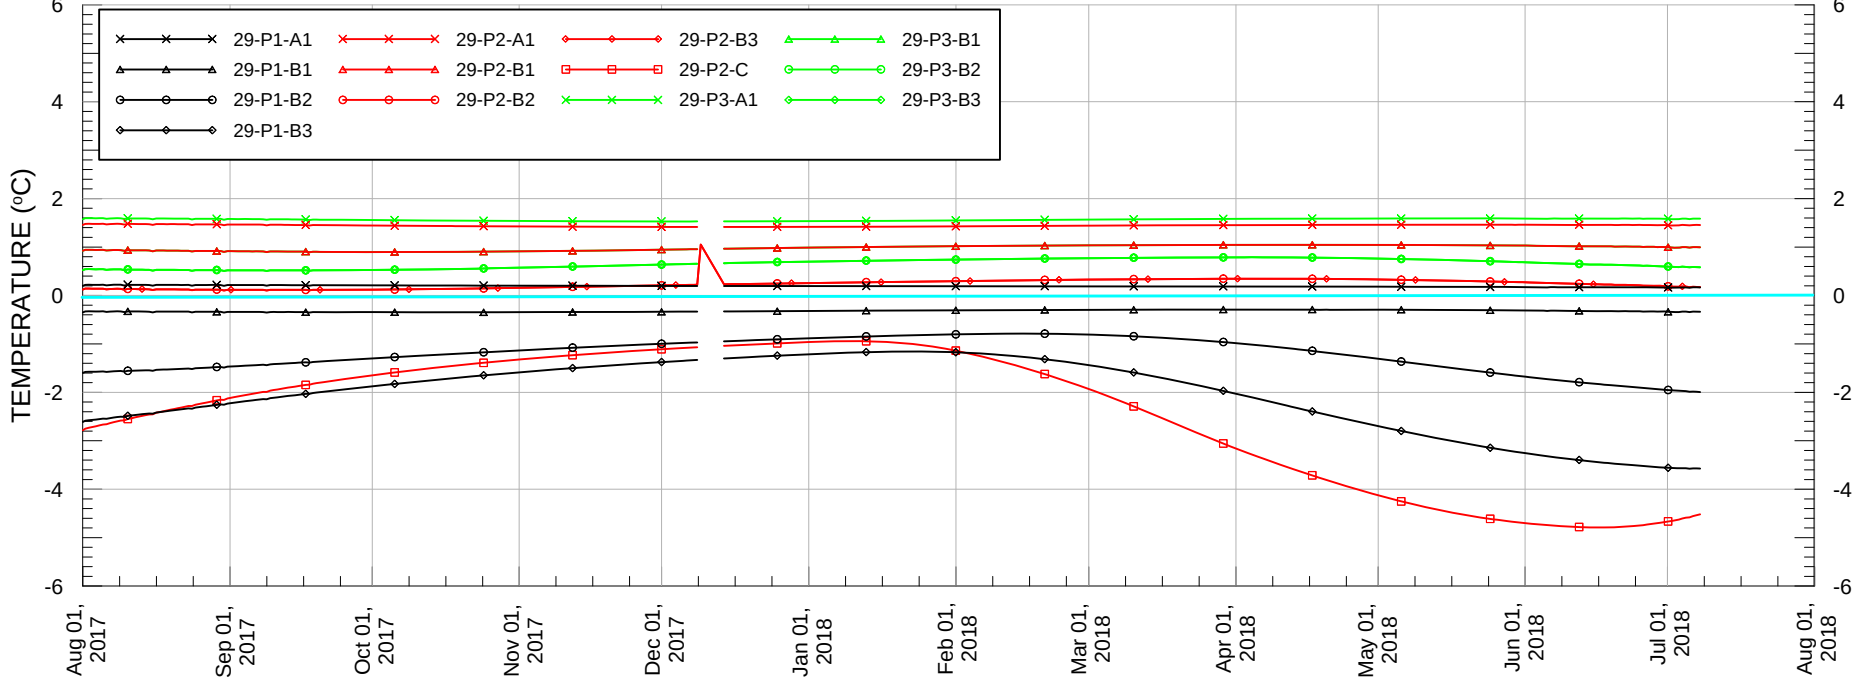
BAY-GOOSE DIKE SOUTH SECTION 31+000 TO 32+105

- 29P1B2, 29P1B3, 29P2B3, 29P3B3 and 29P2C are given unstable readings and since the temperature shows a negative reading it is assumed to be frozen.
- There is a signal loss since March 7/18 which is due to the snow accumulating on the Goose Waste Dump pile. Since the snow melt the signal has returned.
- Gap in data in December is due to low battery. Battery was changed the following day after.

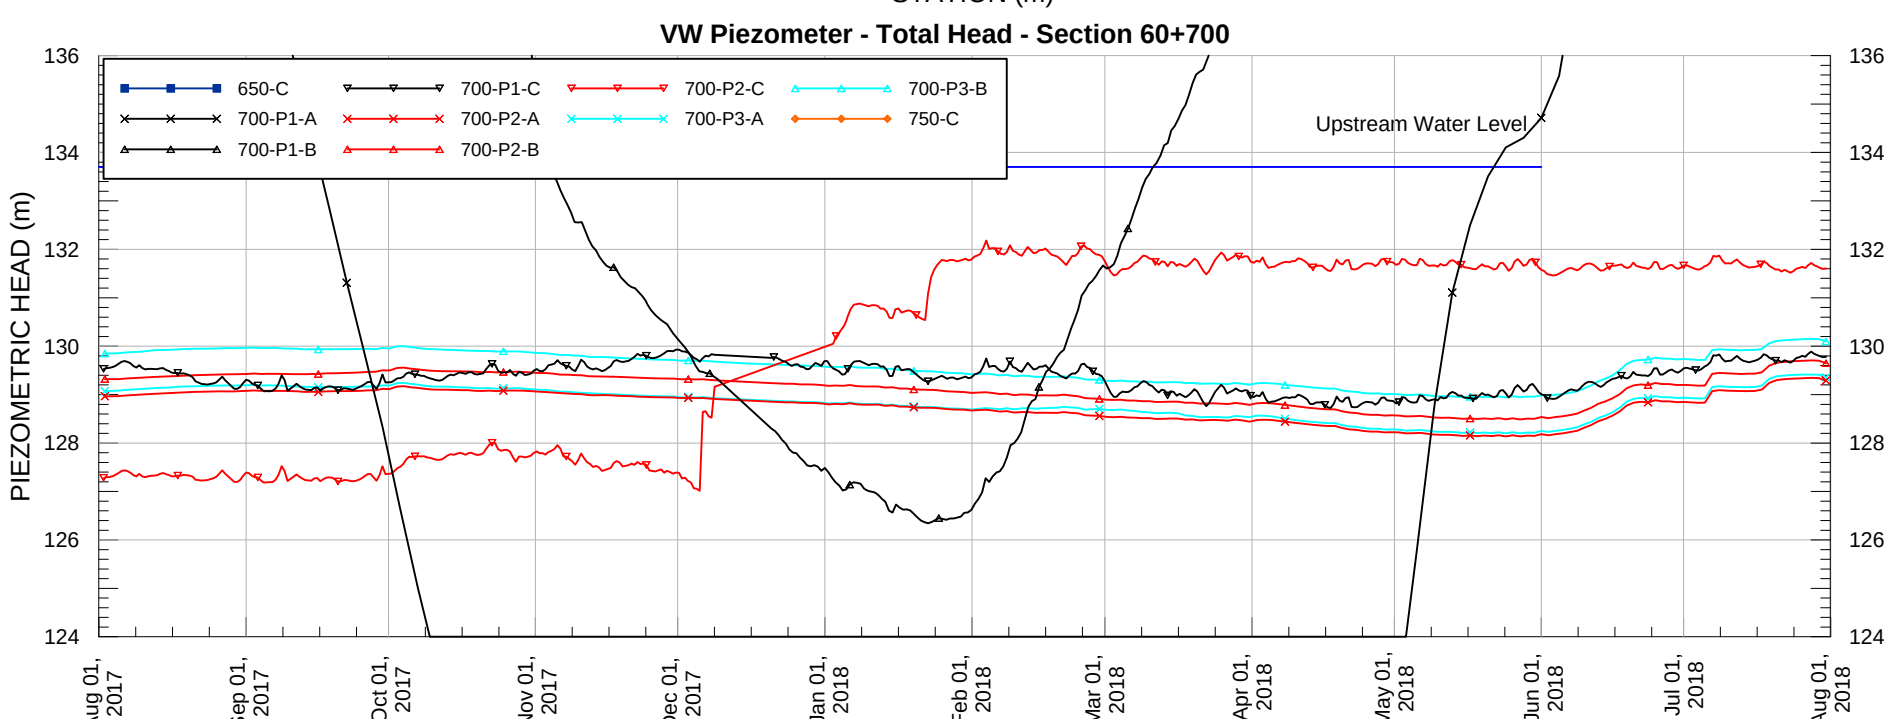
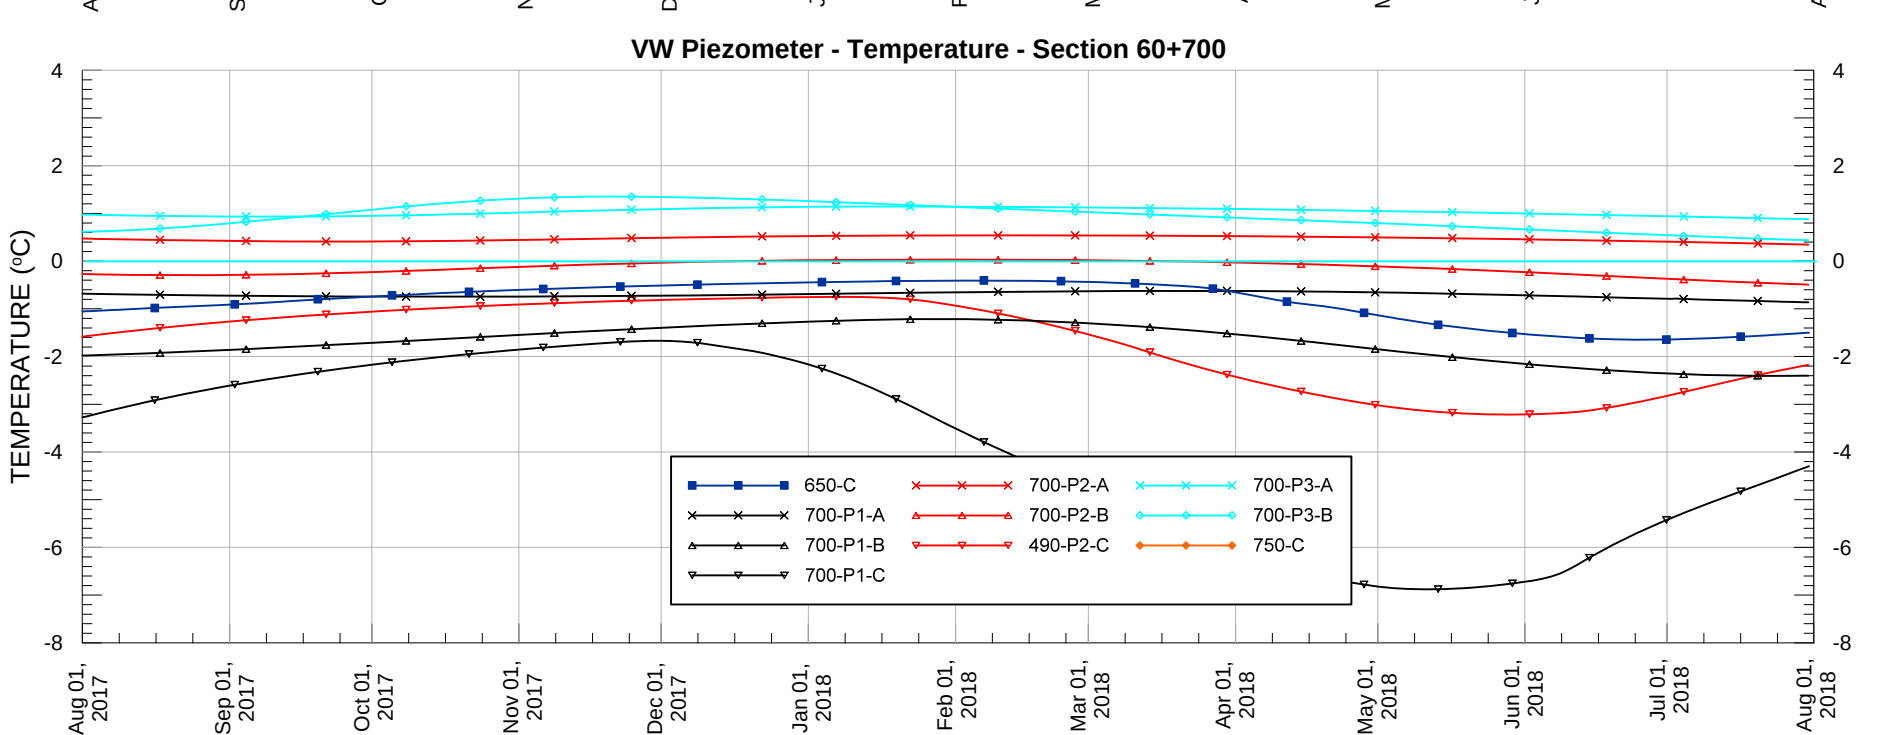
- 1: 700-P1-B and 750-C are giving anomaly readings and with a negative temperature are assumed to be frozen.
2. There was a rise in PWP in June. This was an unknown reason as there were no indications in the field.
