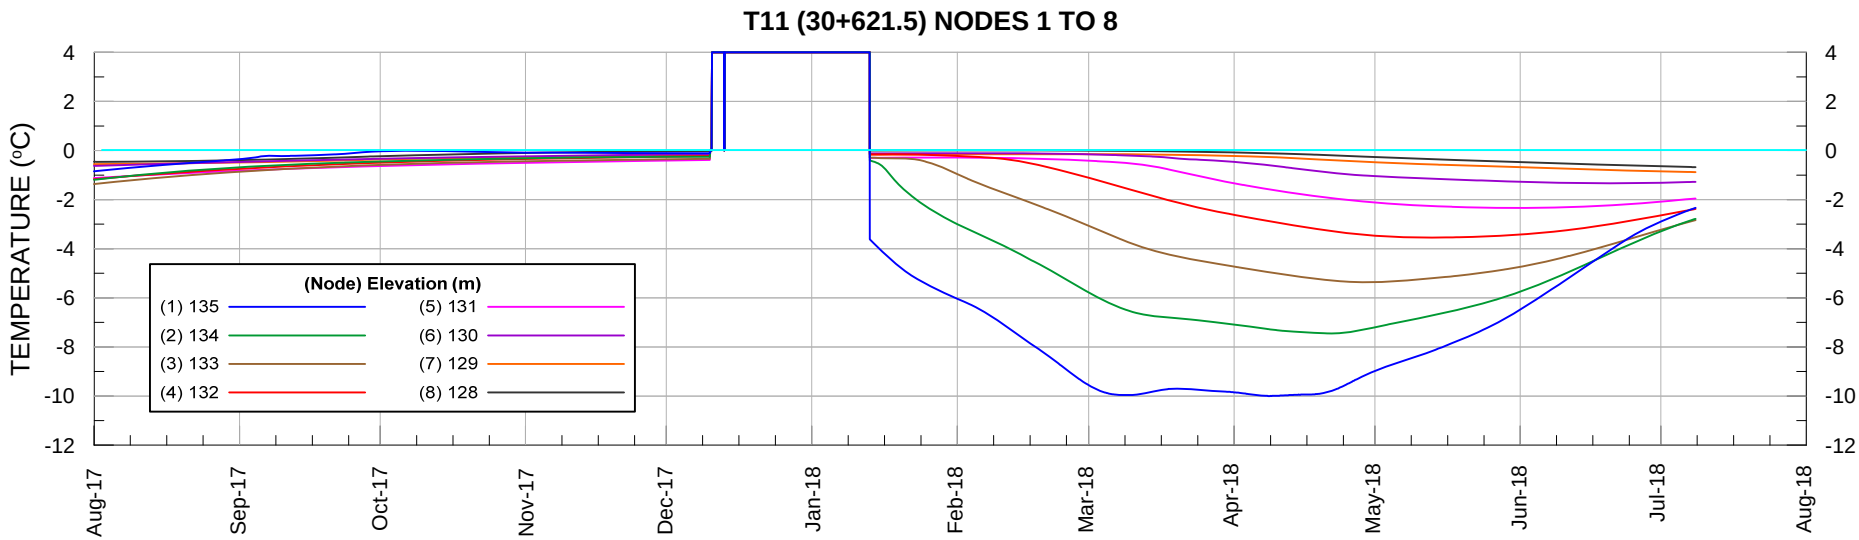
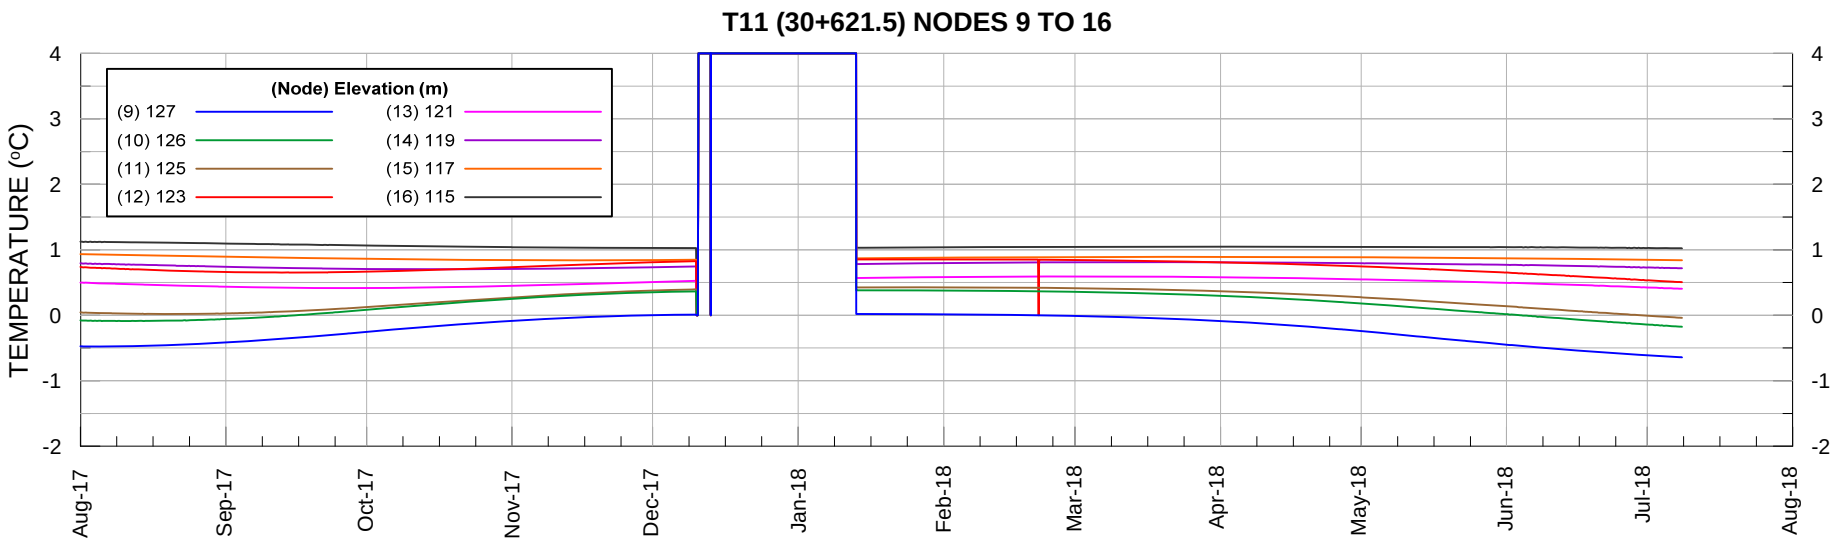
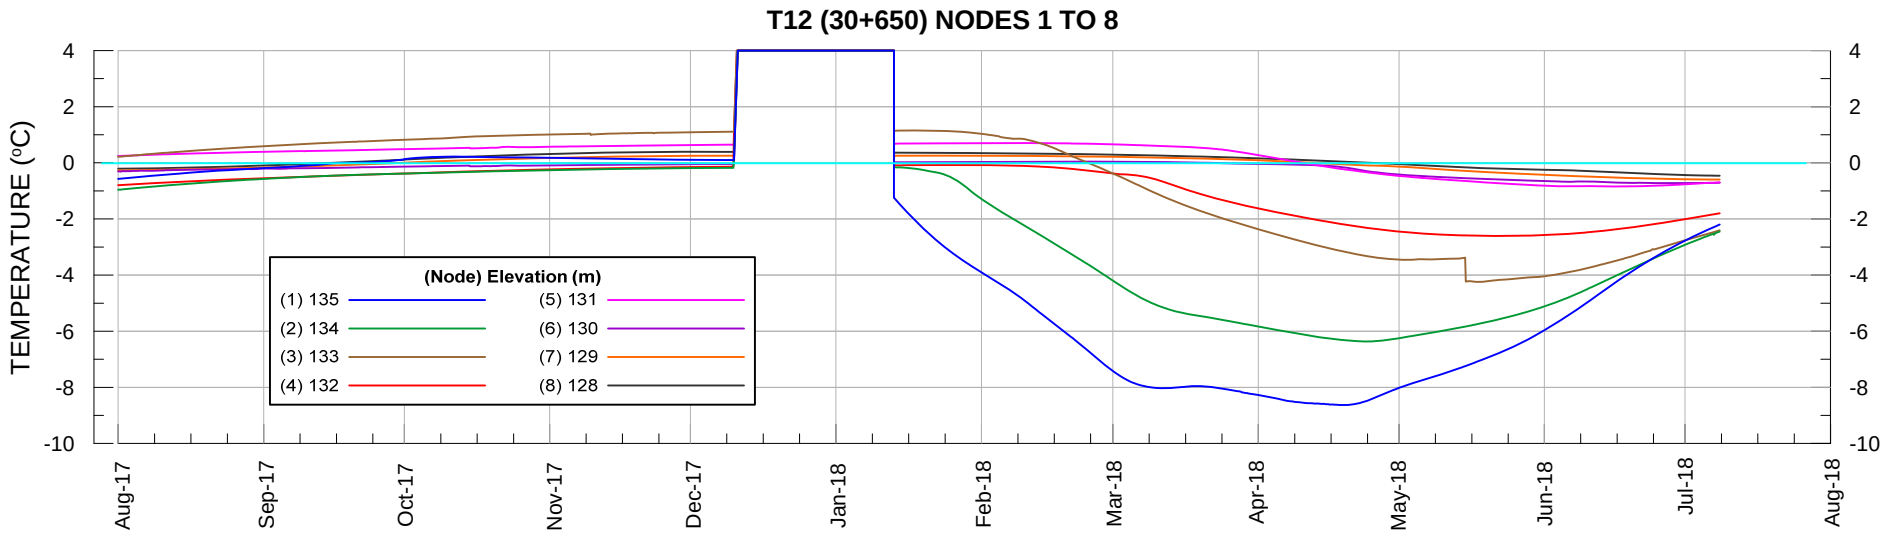
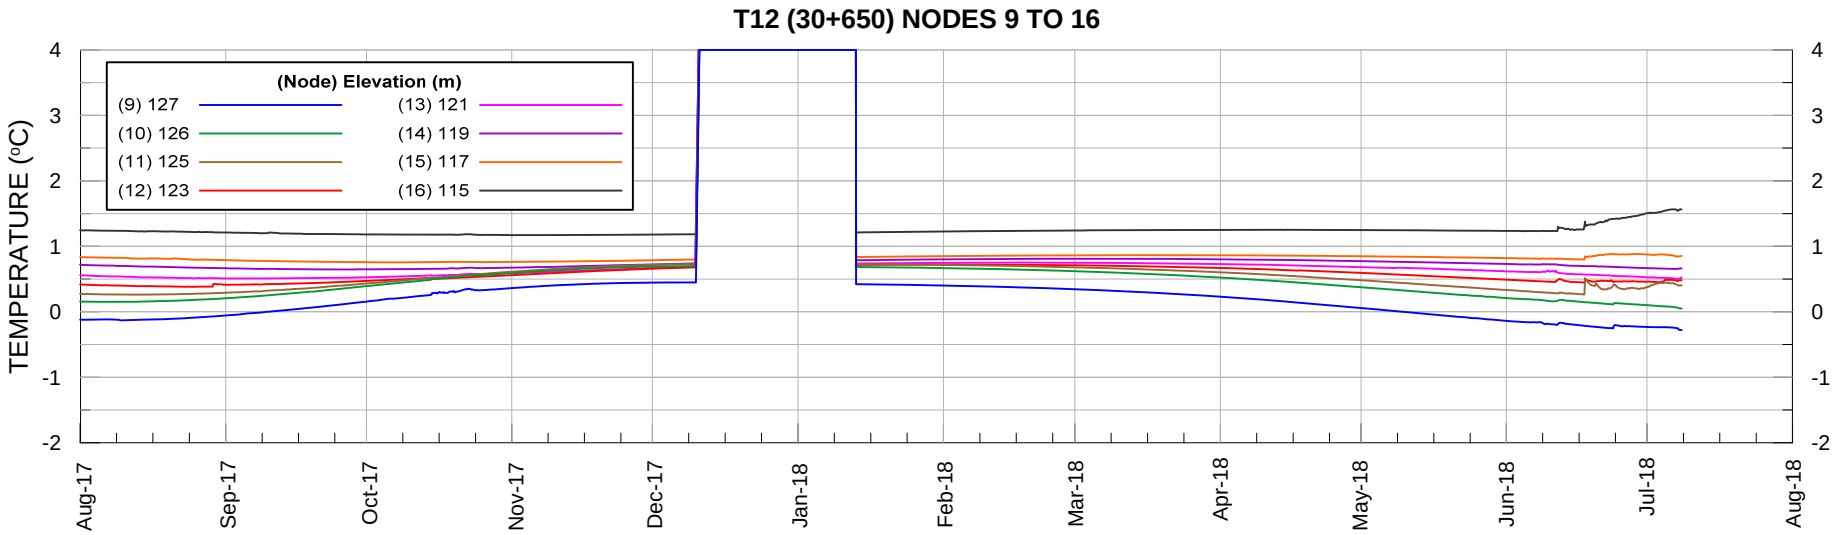
Note: The jump in temperature is an error with the MUX board in the data logger.  
Board was replaced.

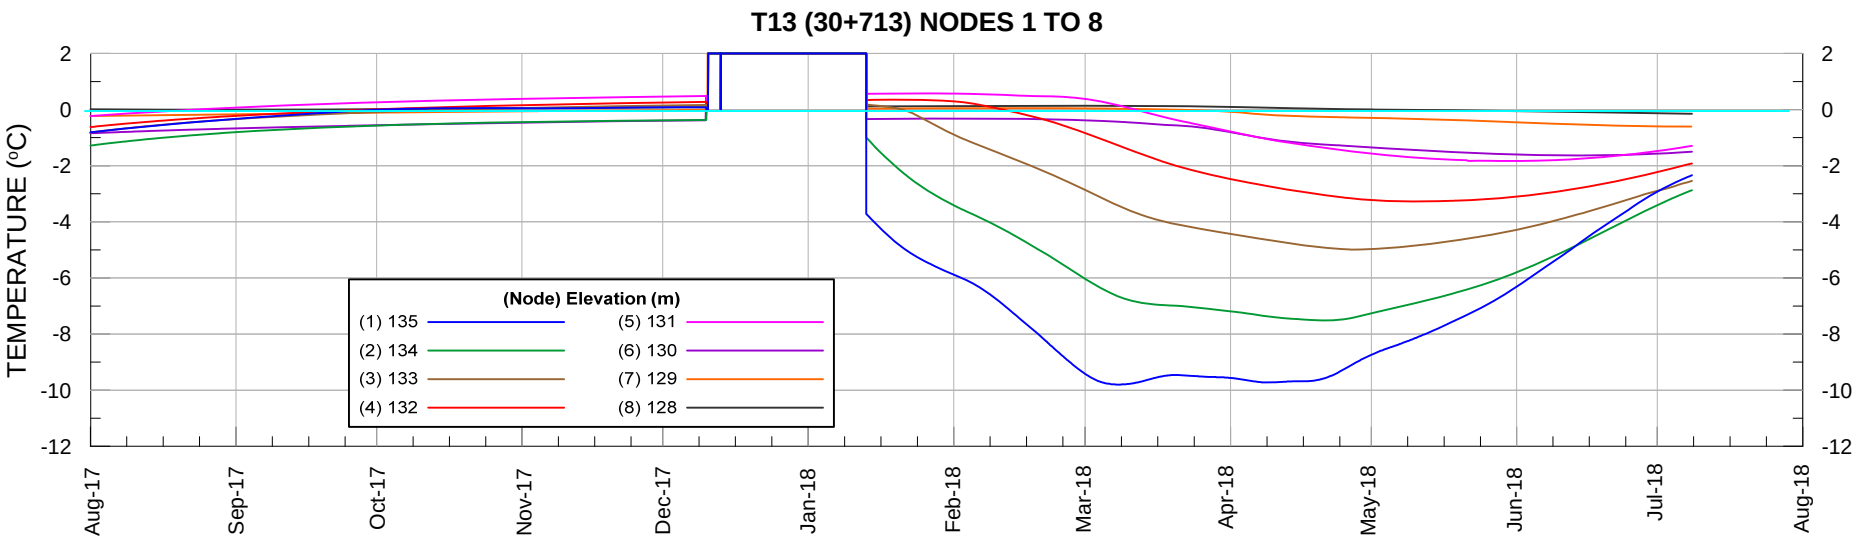
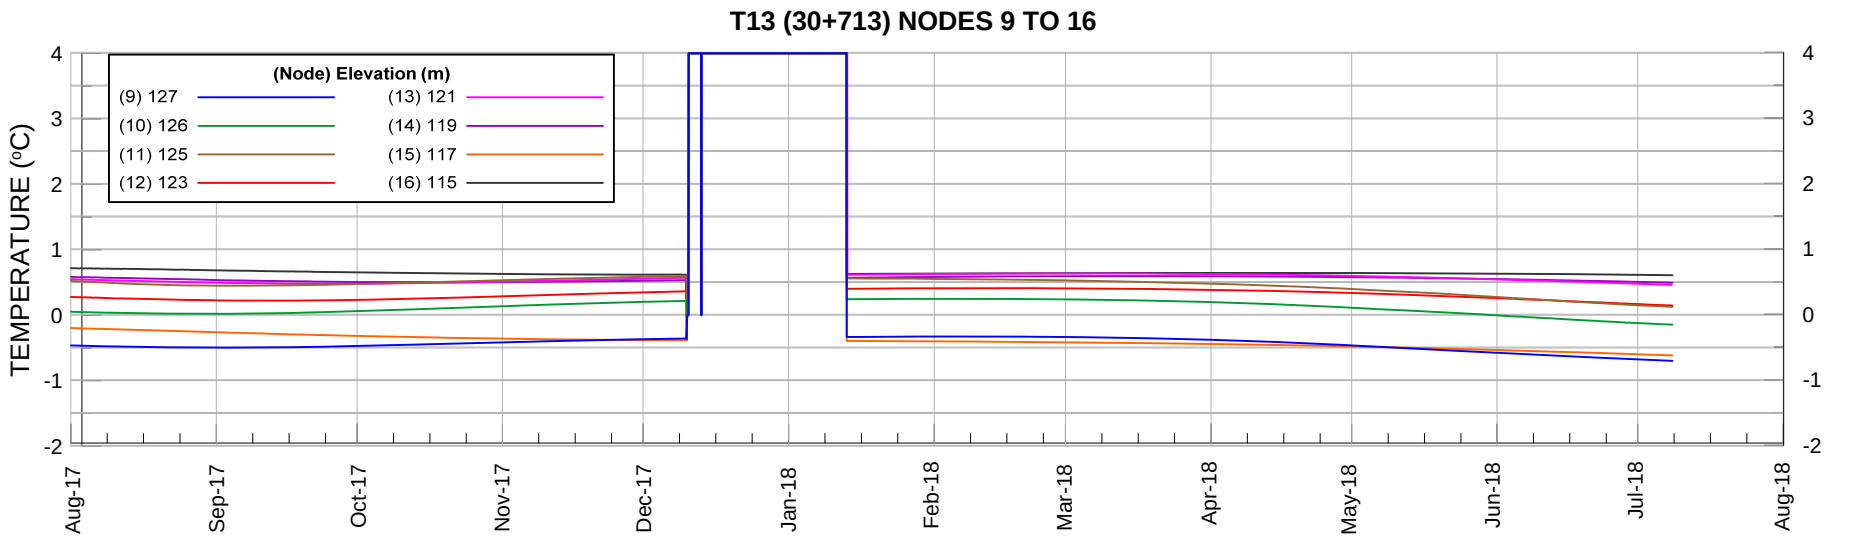
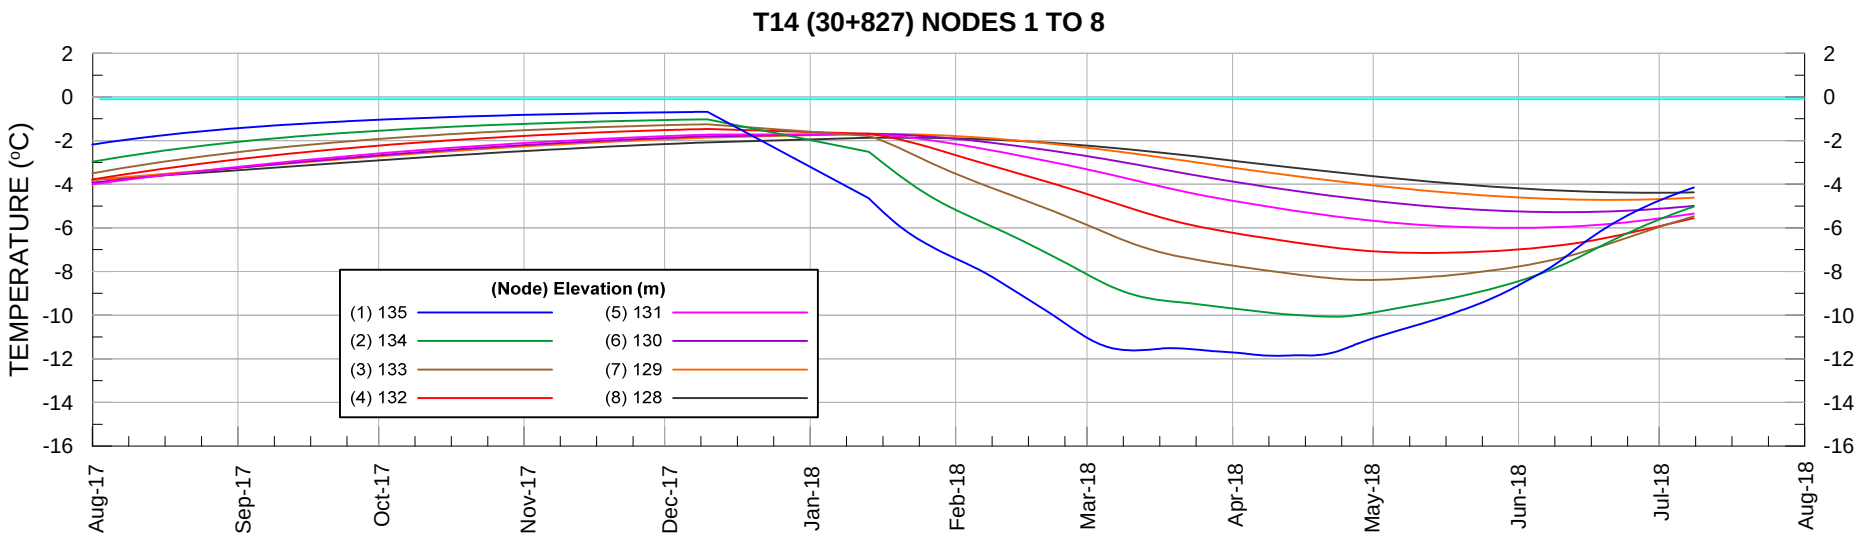
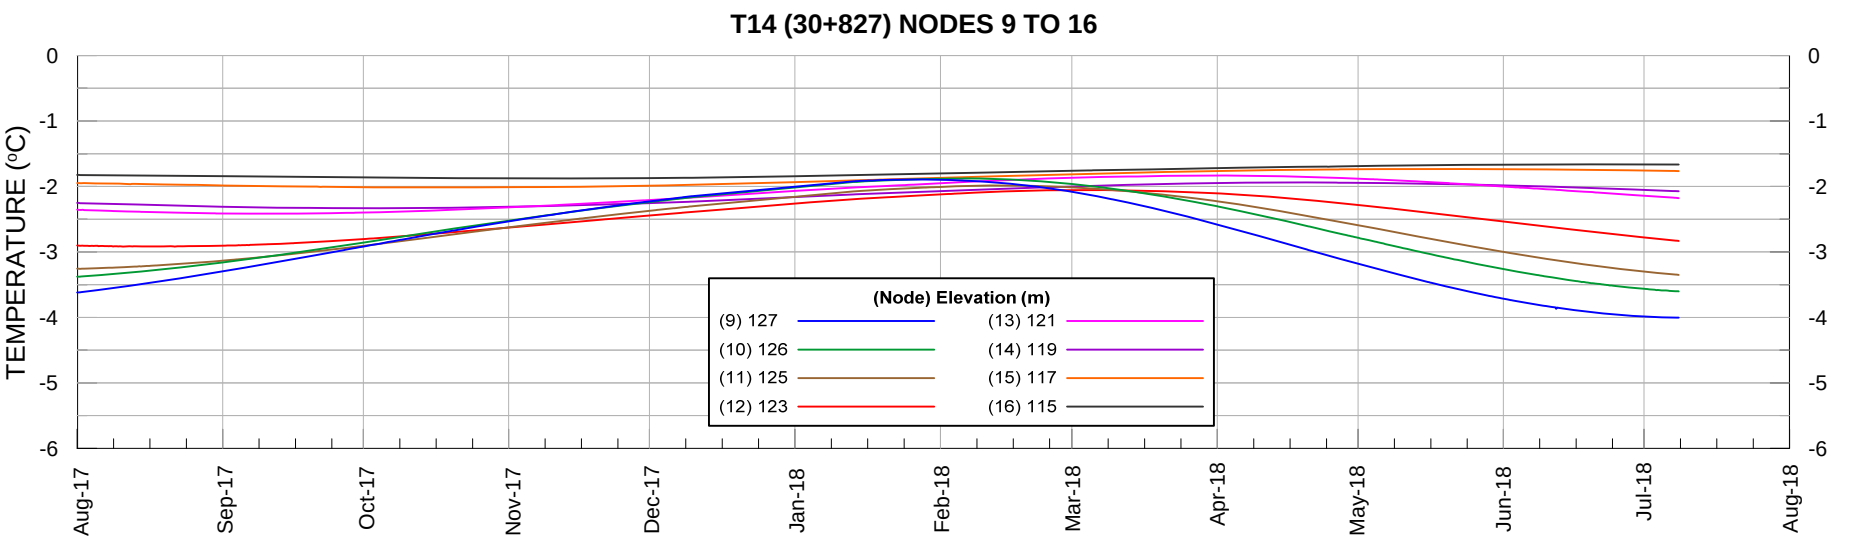
Note: The jump in temperature is an error with the MUX board in the data logger.  
Board was replaced.

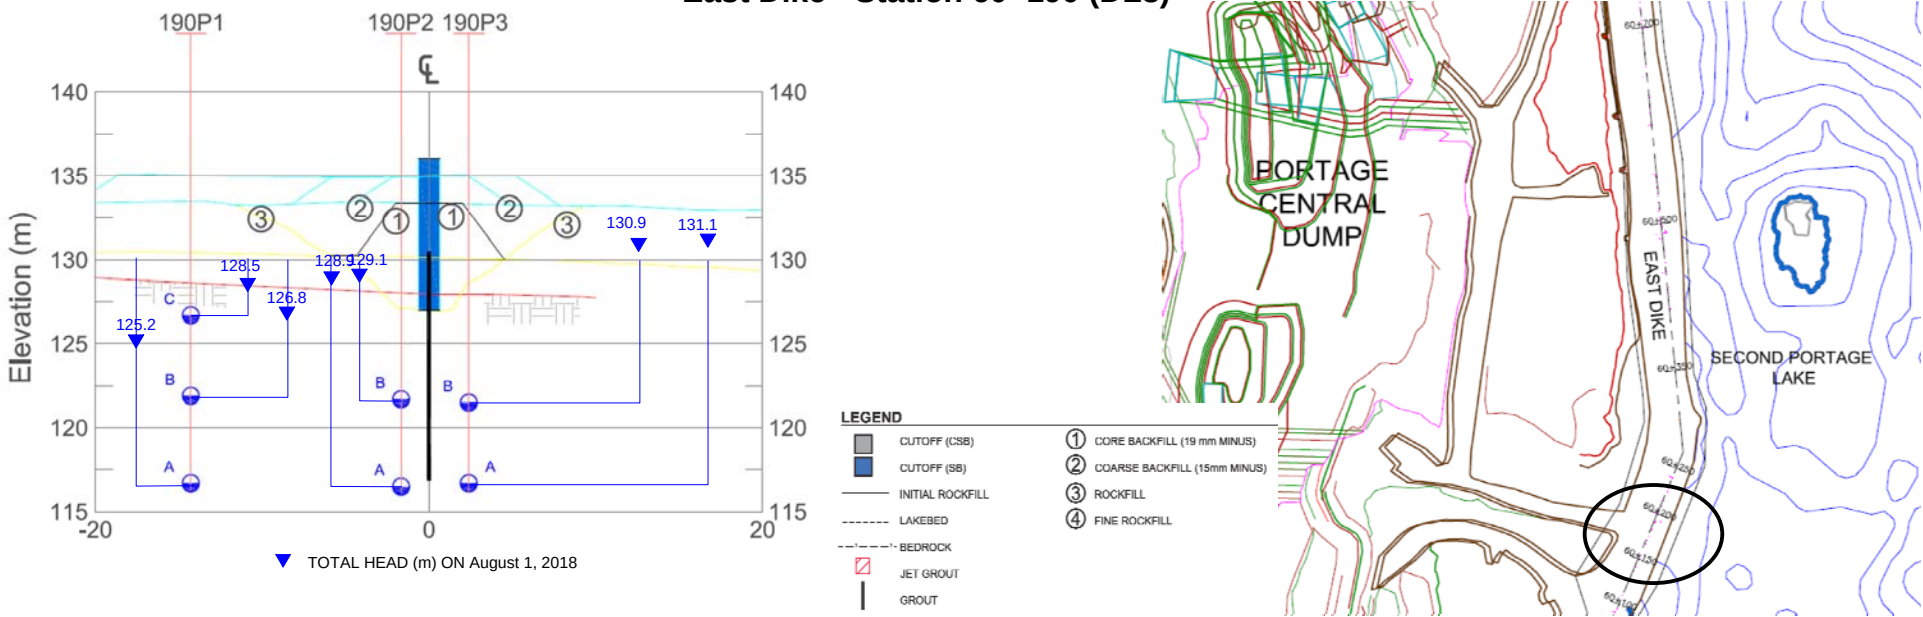
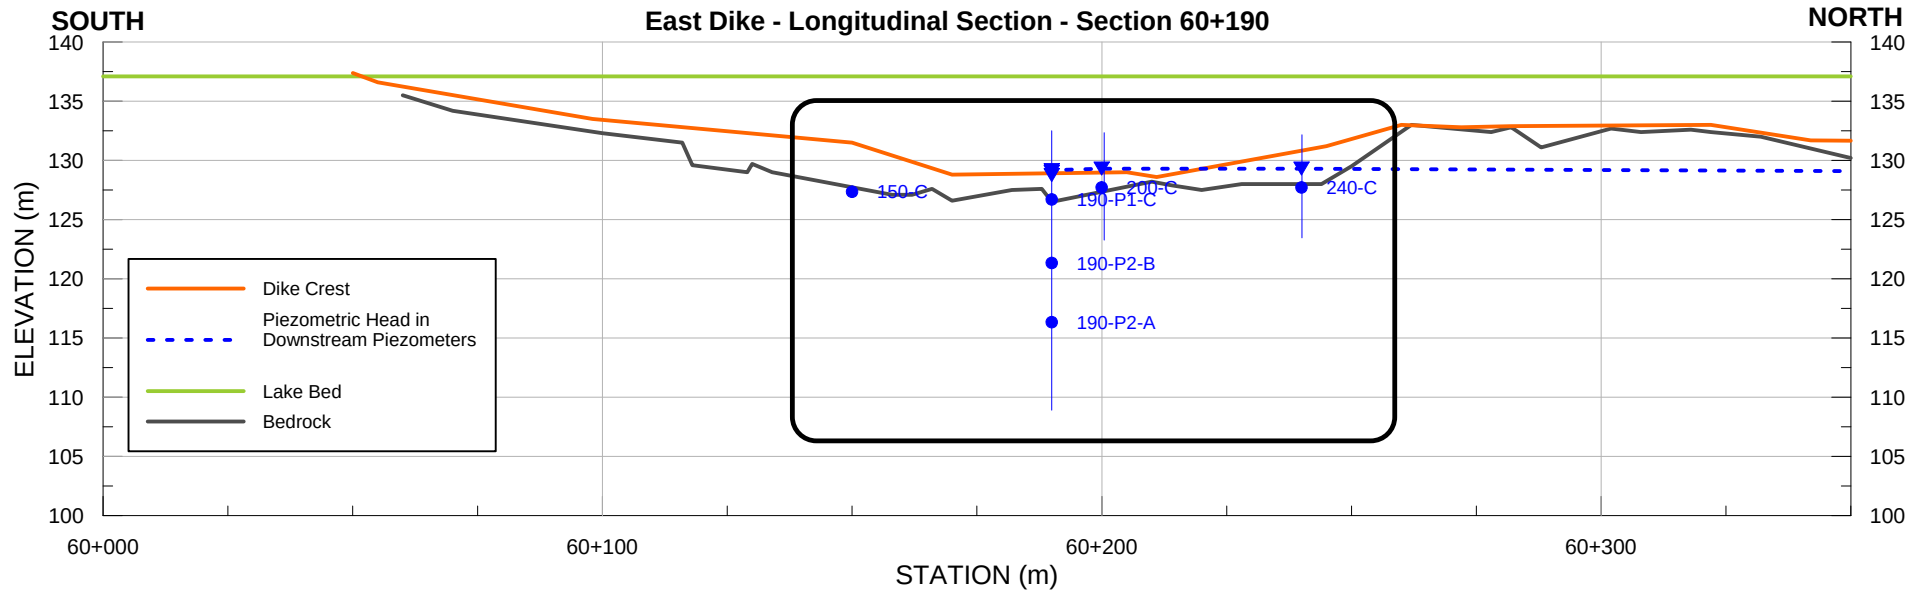
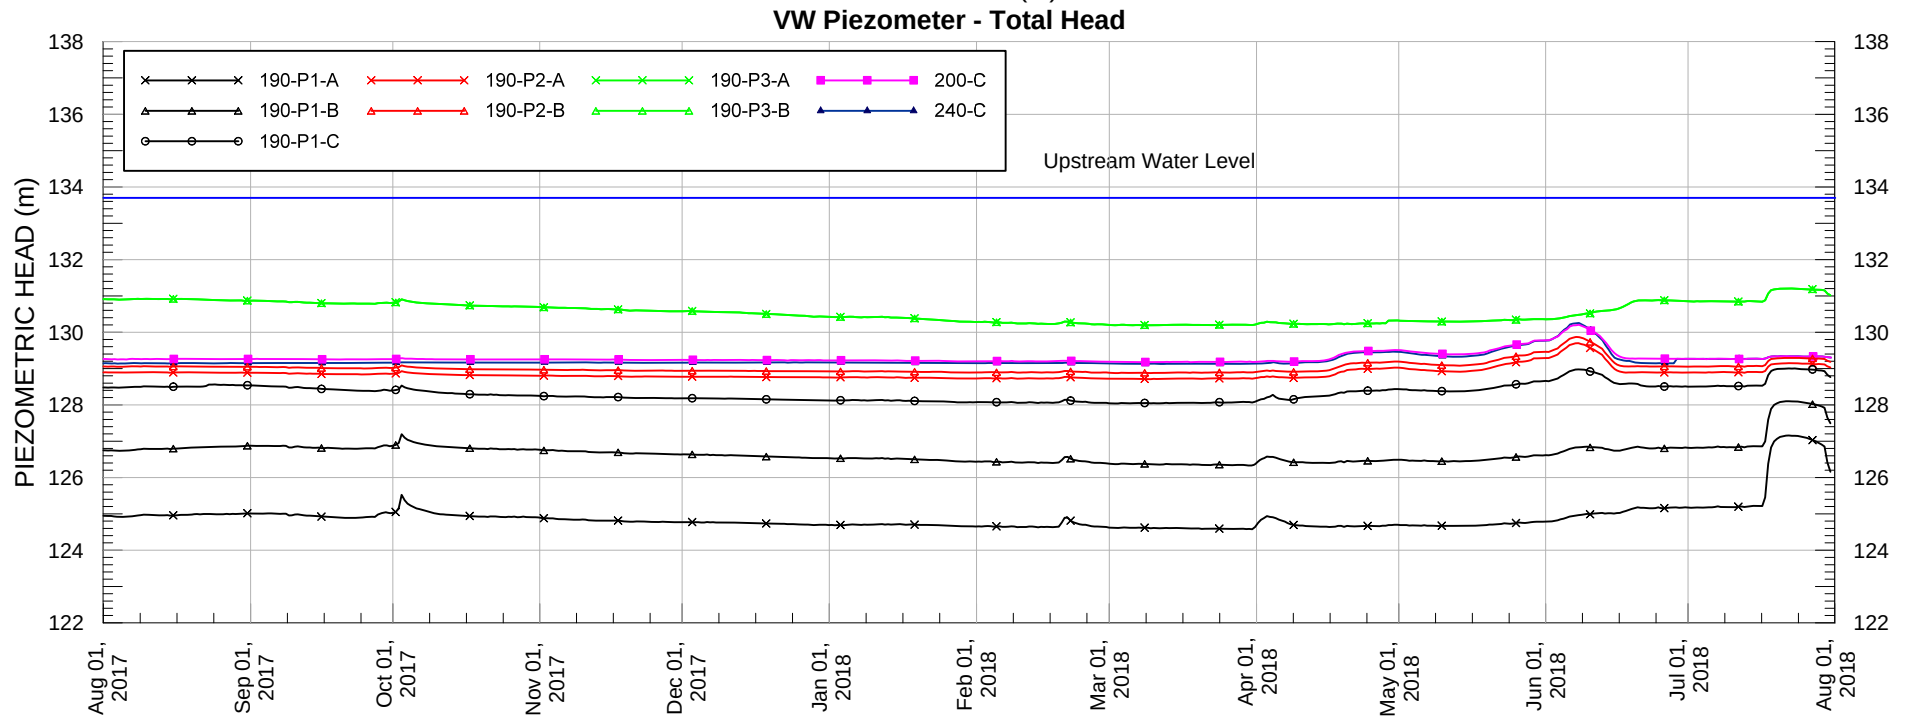
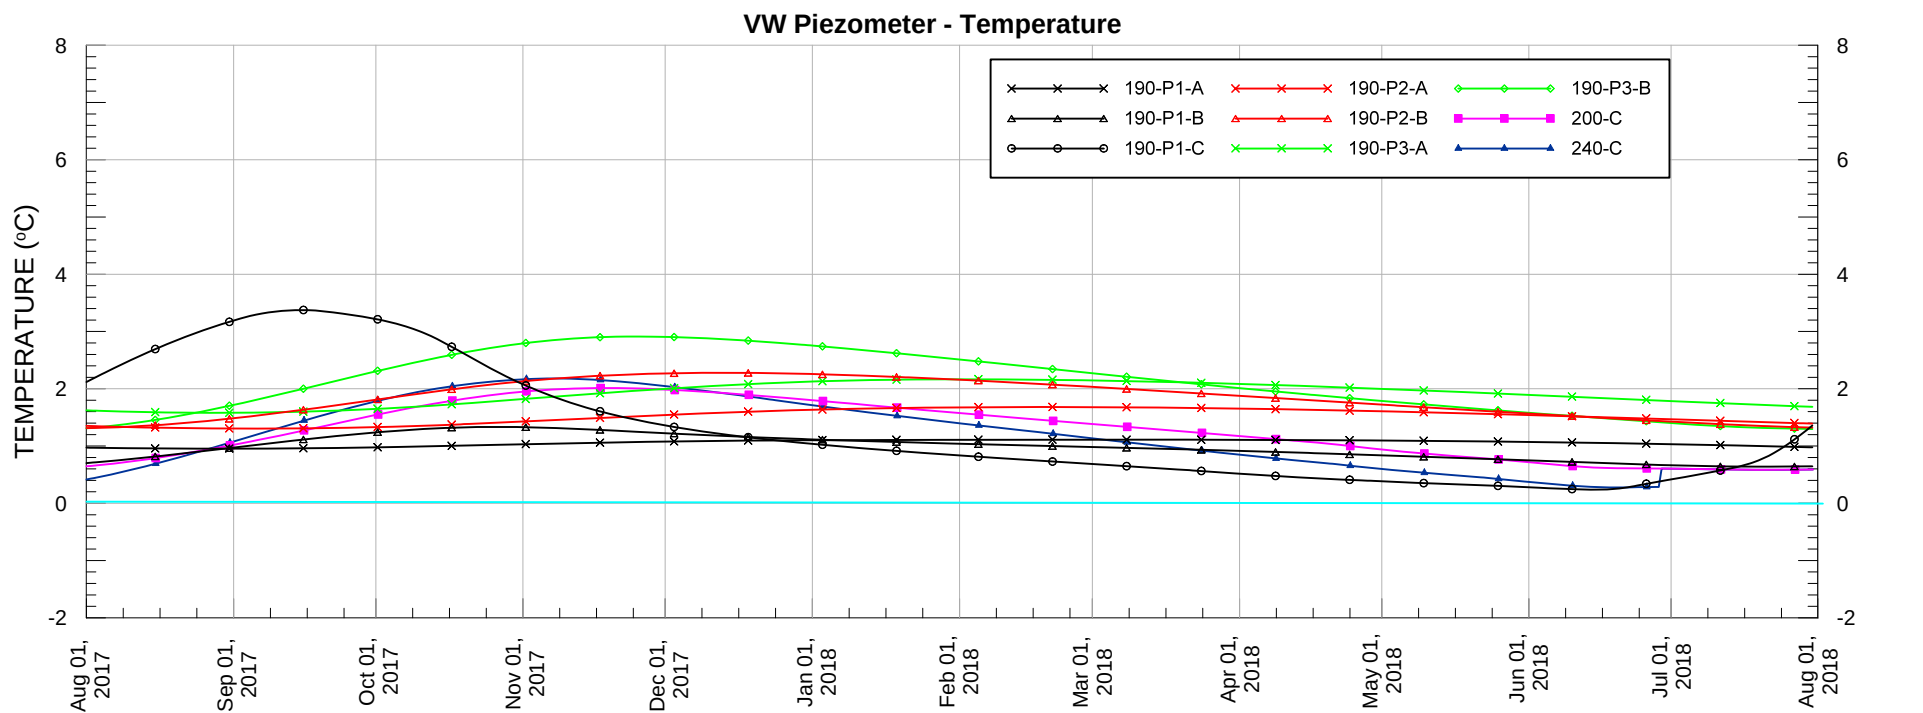
East Dike - Station 60+190 (DL8)

- 1: 150-C stopped working in Nov 2012
- 2: Change in PWP and temperature are related to the discharge pipe changed from pit to lake.
- 3: There was a rise in PWP in June. Inspections of the area noted no changes.

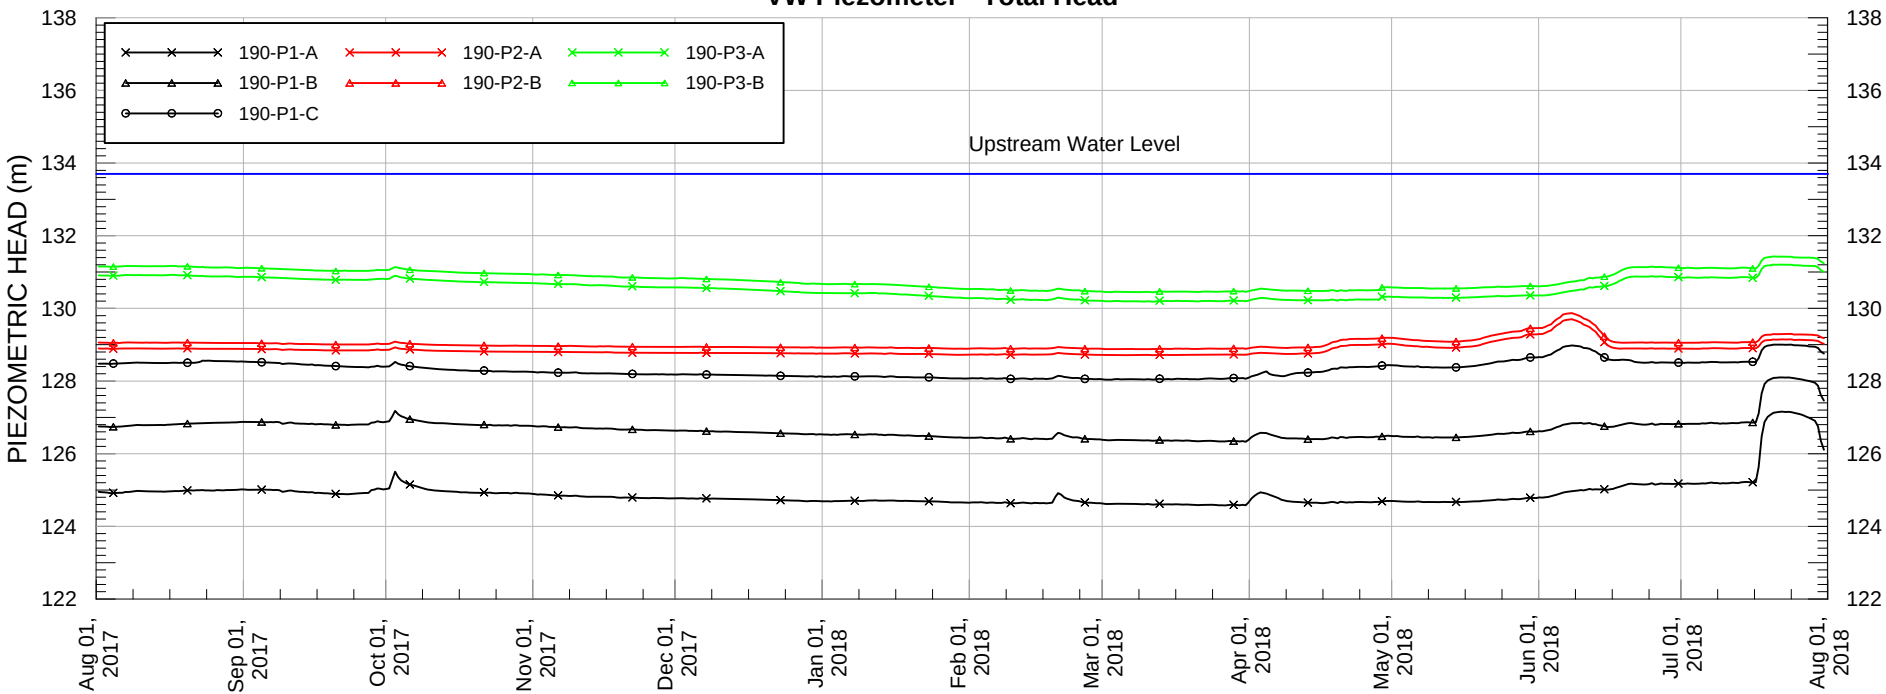
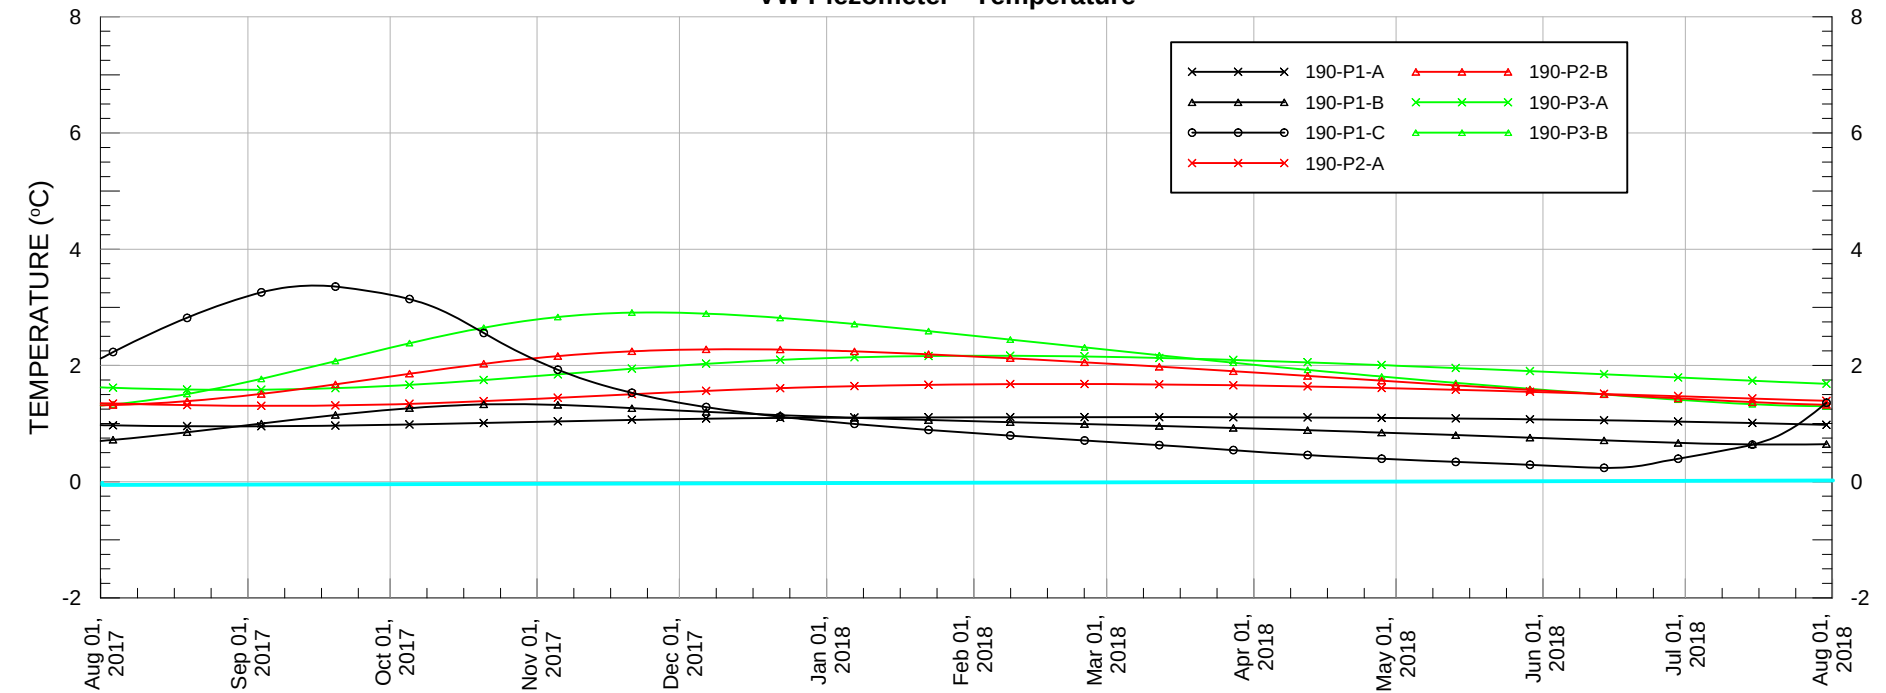
1. Change in PWP and temperature are related to the discharge pipe changed from pit to lake and lake to pit.

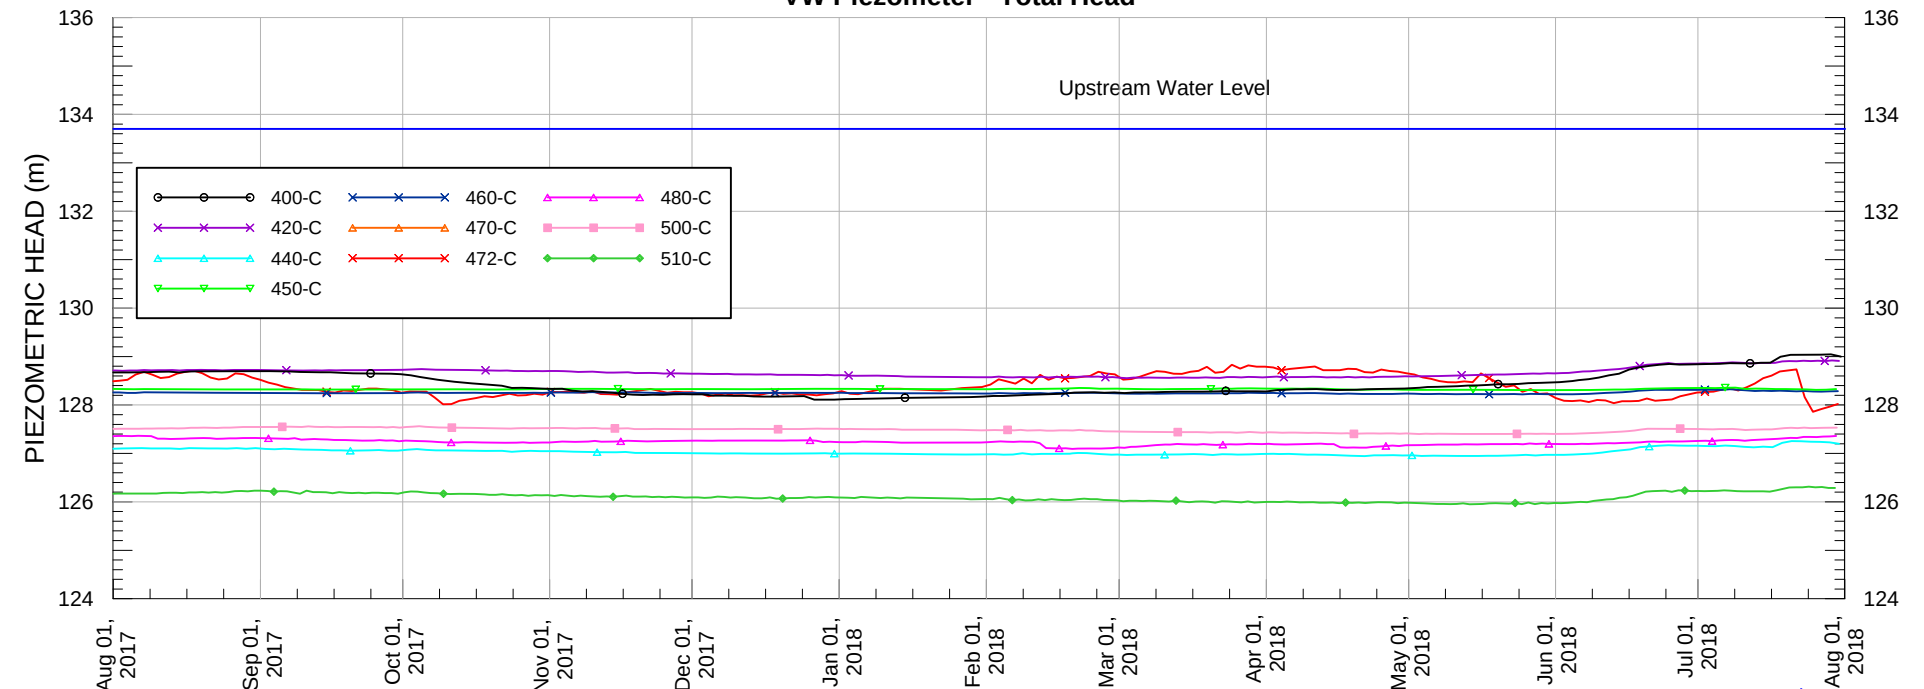
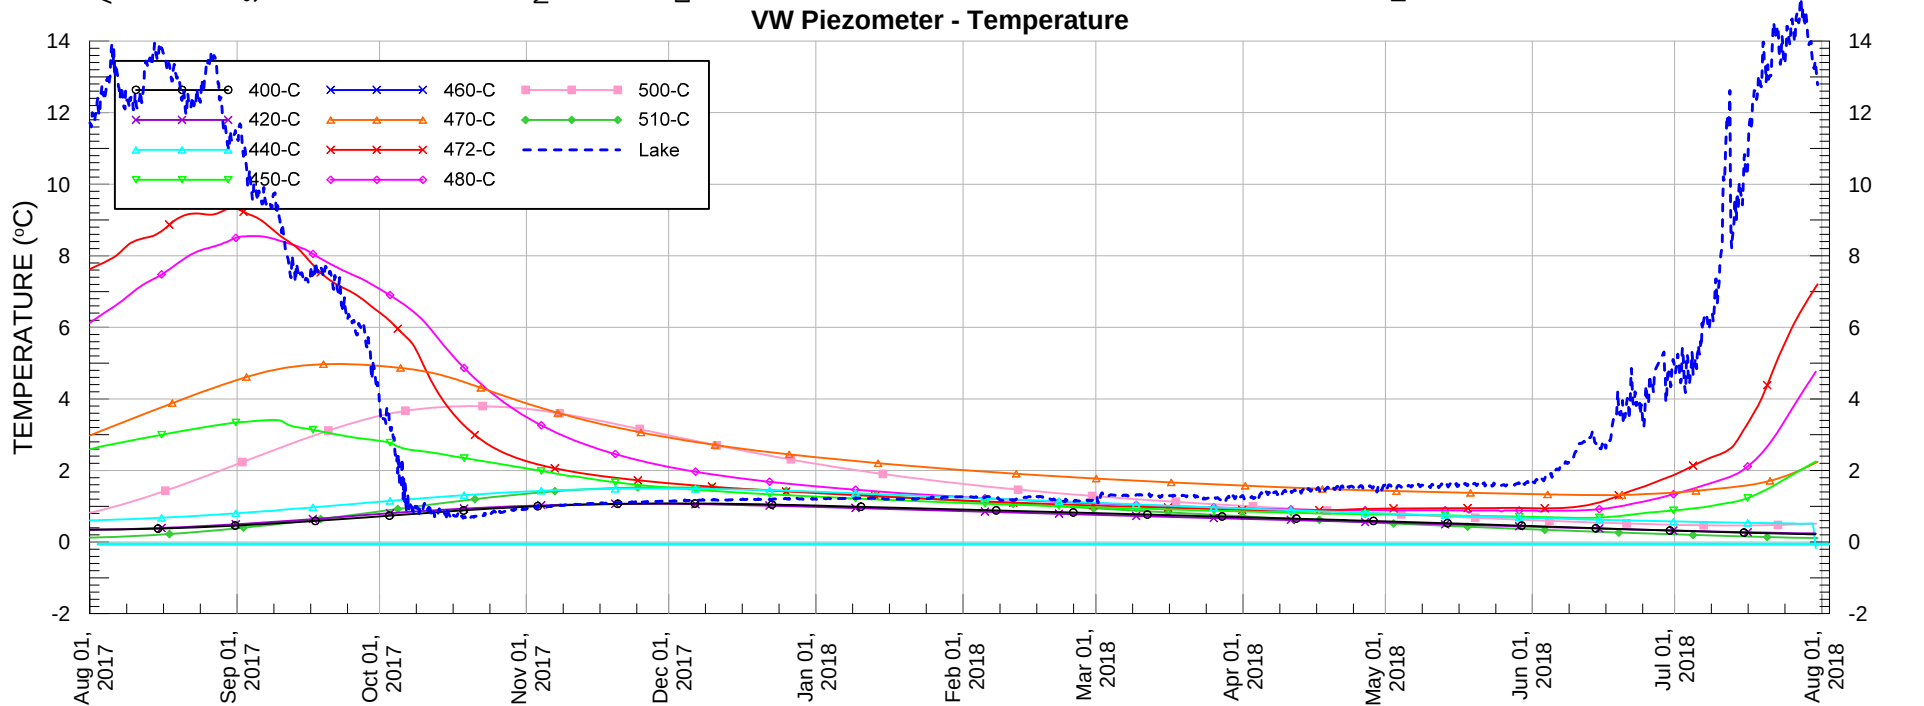
East Dike - Longitudinal Section - Station 60+350 to 60+550

**NOTES:**  
1. As seen in the graph on the side, the progression of the temperature in the Pz follows the lake temperature closely. Usually it takes approximately one to two weeks to see the trend following the lake temperature.

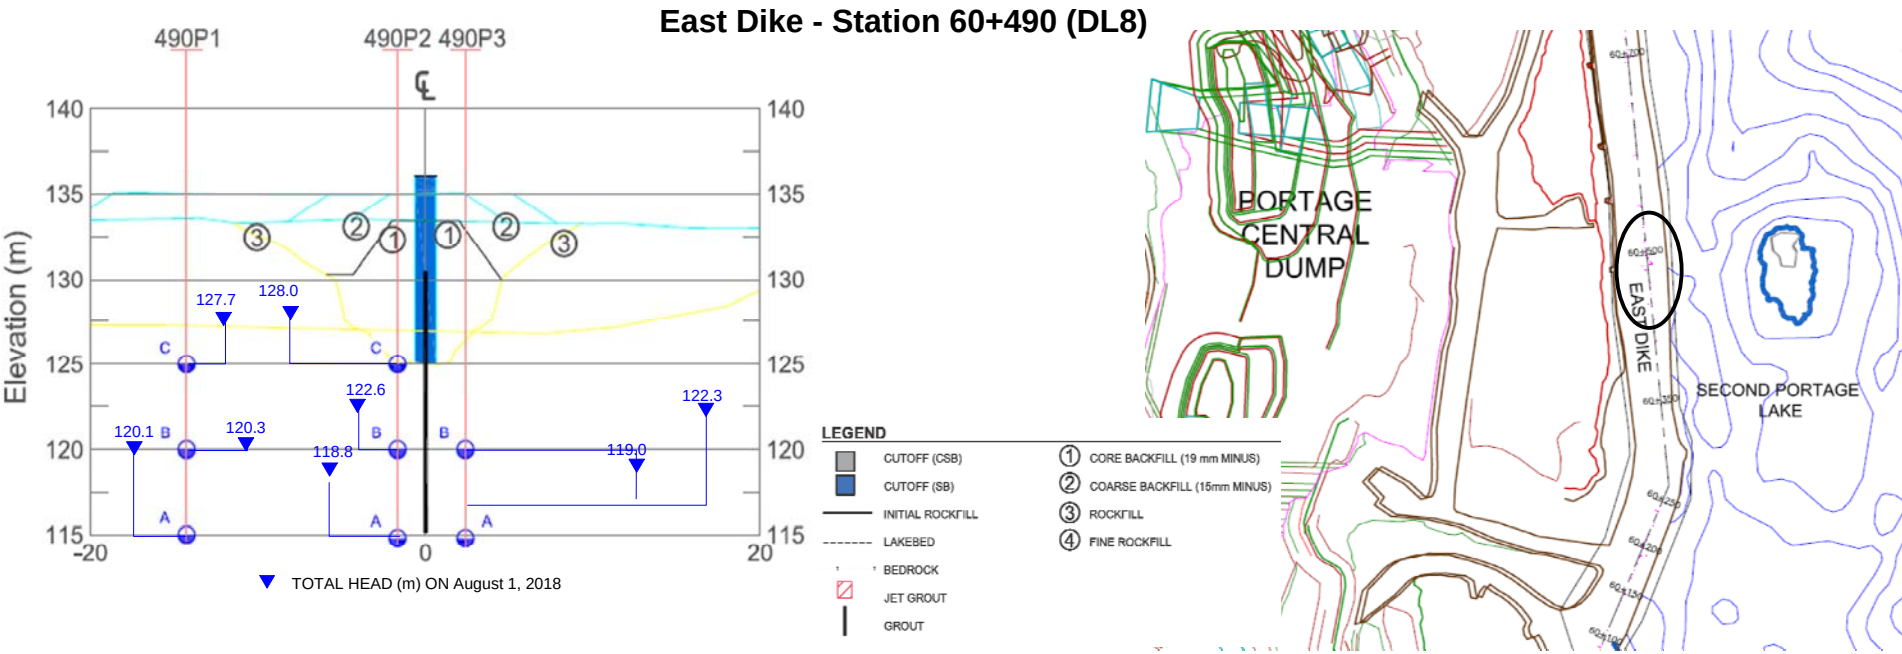
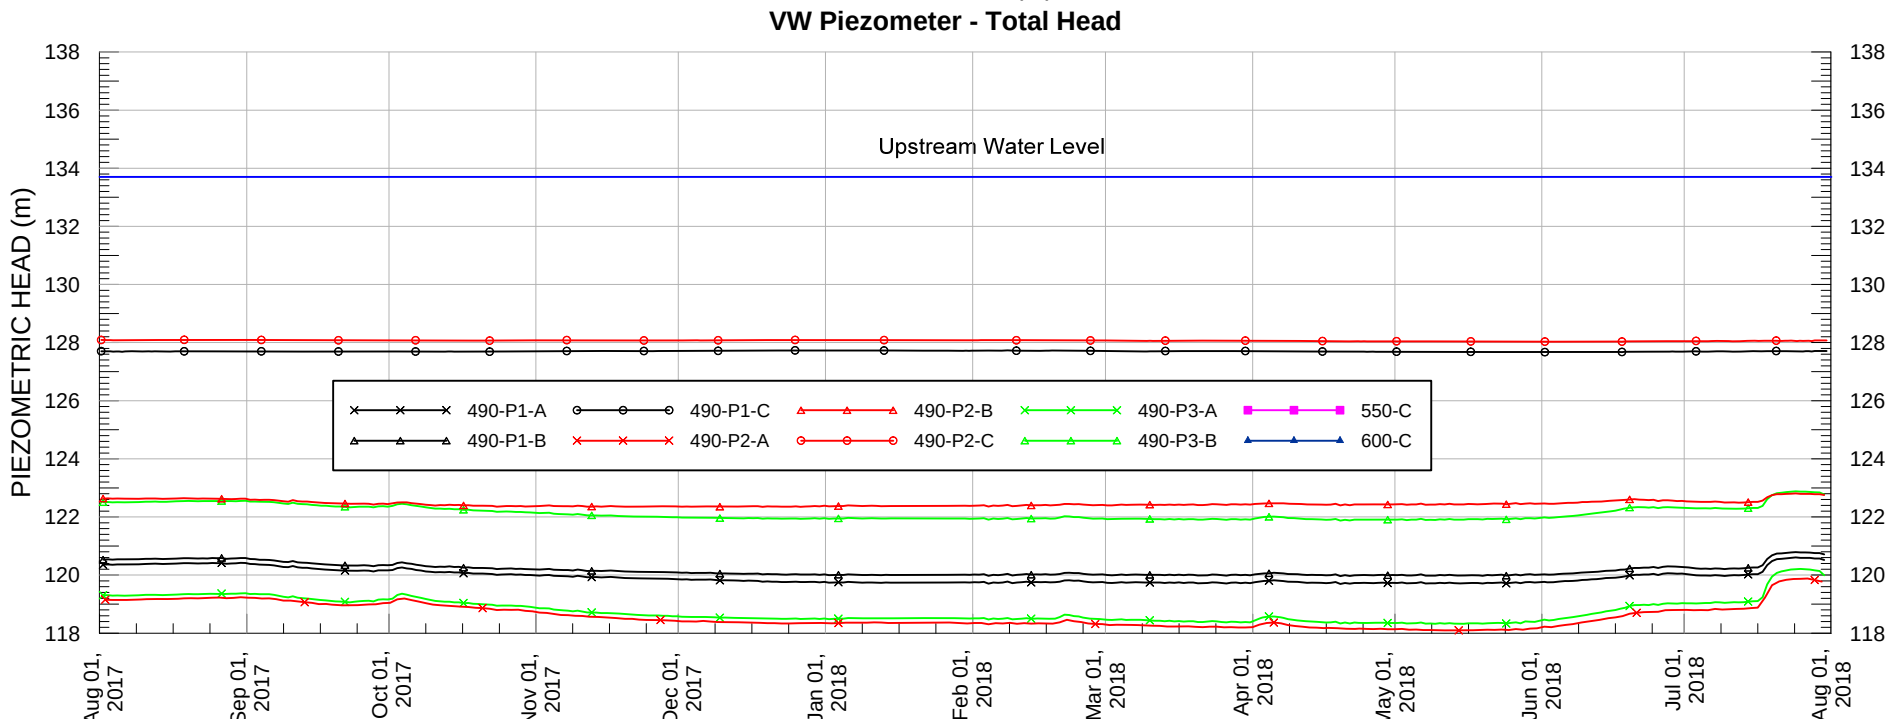
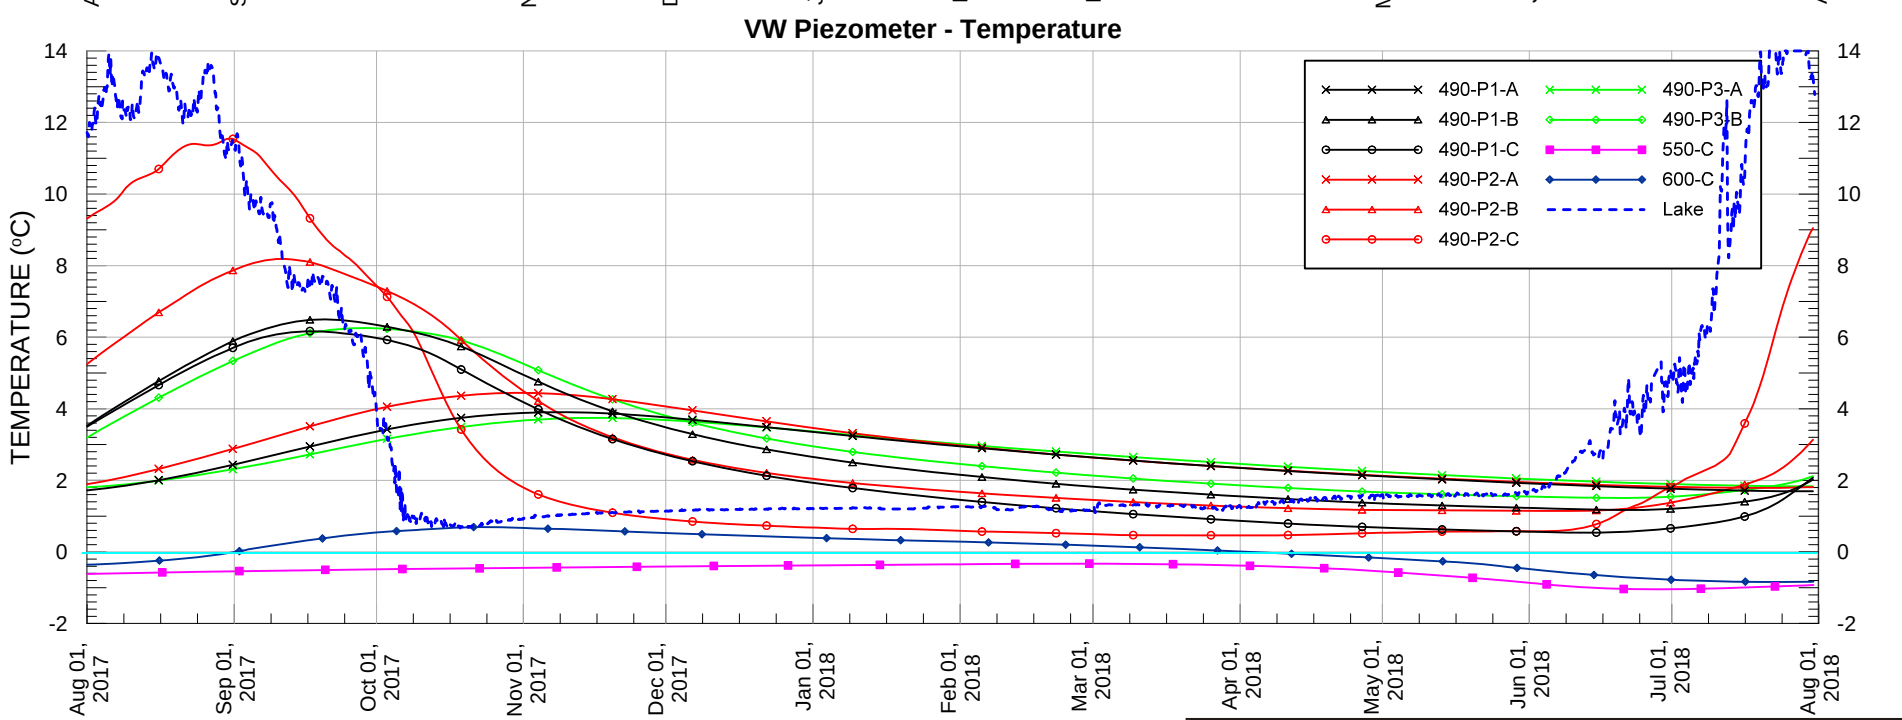
1: 550-C and 600-C are giving anomaly readings and with a negative temperature are assumed to be frozen.
