PROJECT	AGNICO EAGLE MINES LIMITED MEADOWBANK GOLD PROJECT NUNAVUT				
TITLE	PG 28AUG14 EAST DIKE - SECTION 60+490 PIEZOMETRIC DATA (Aug 1/17 to Aug 1/18)

APPENDIX C2

P4– CENTRAL DIKE UPDATE

CENTRAL DIKE UPDATE 2018

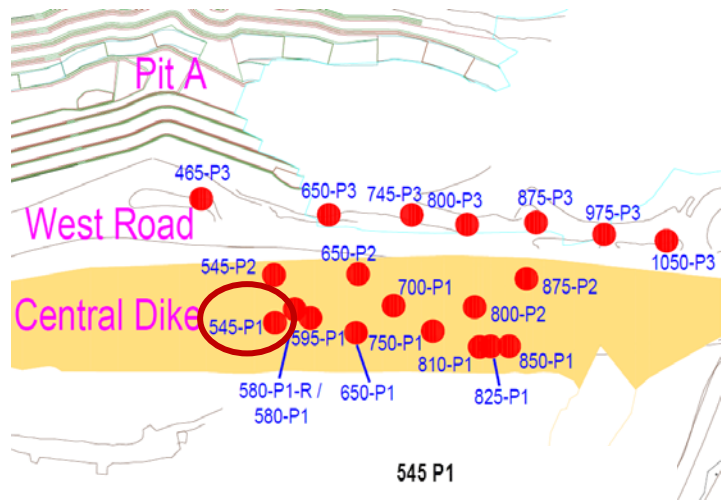
THERMISTOR 545-P1

- 545-P1 thermistor is showing the same temperature profile than last year. Warmer peak observed at elevation 81.
- Temperature in the bedrock/till unit is in between 1.1°C and 1.4°C .

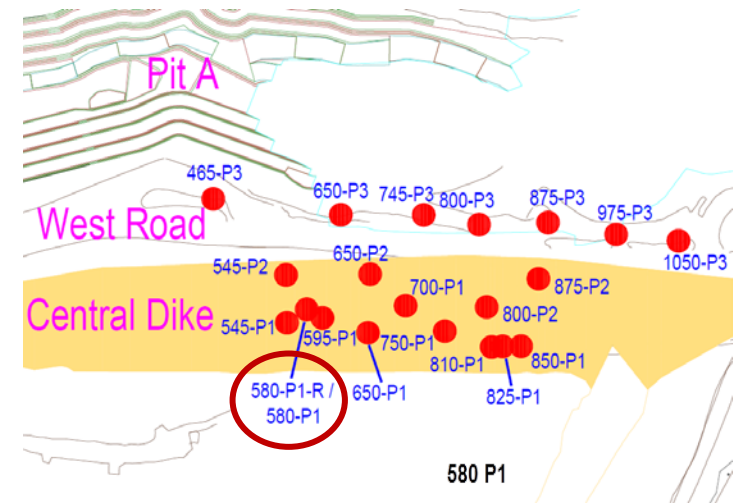
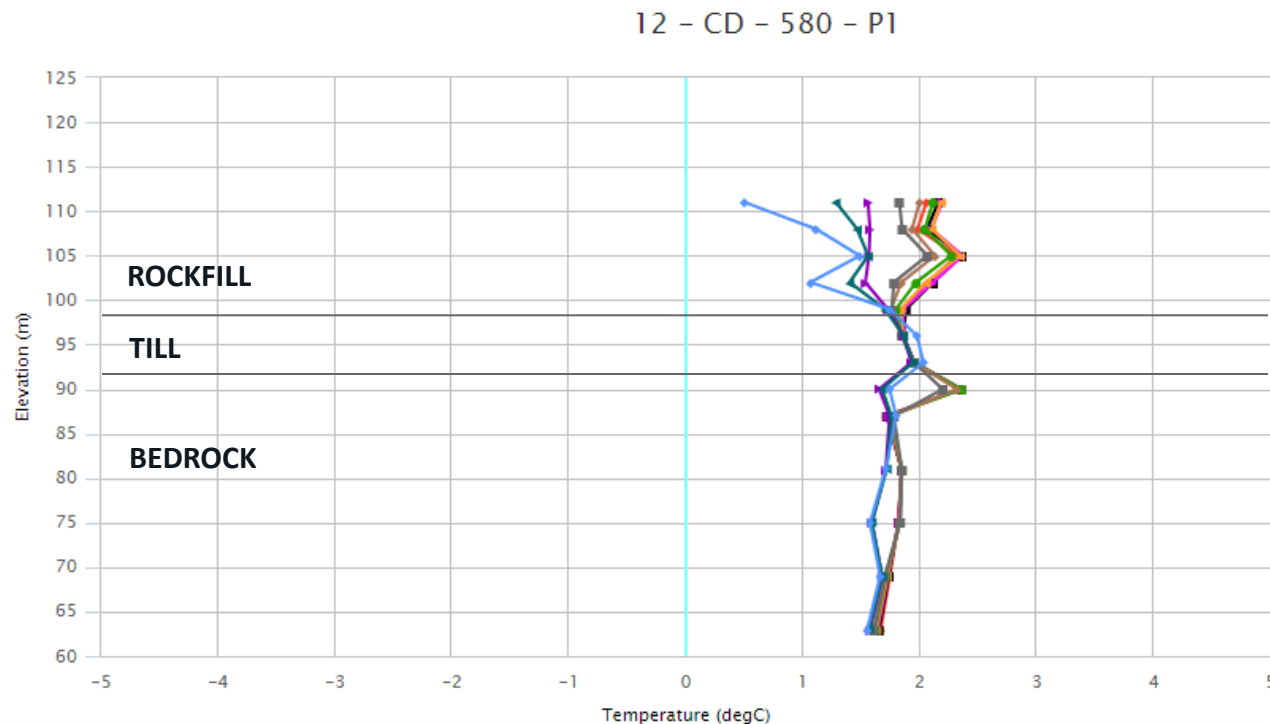
580-P1

- Piezometer and thermistance readings are not functional since July 2016
- Replacement hole 580-P1R drilled during 2017 campaign

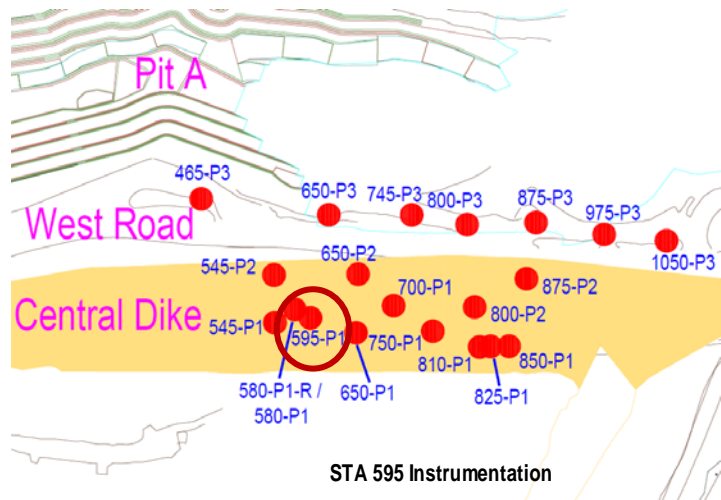
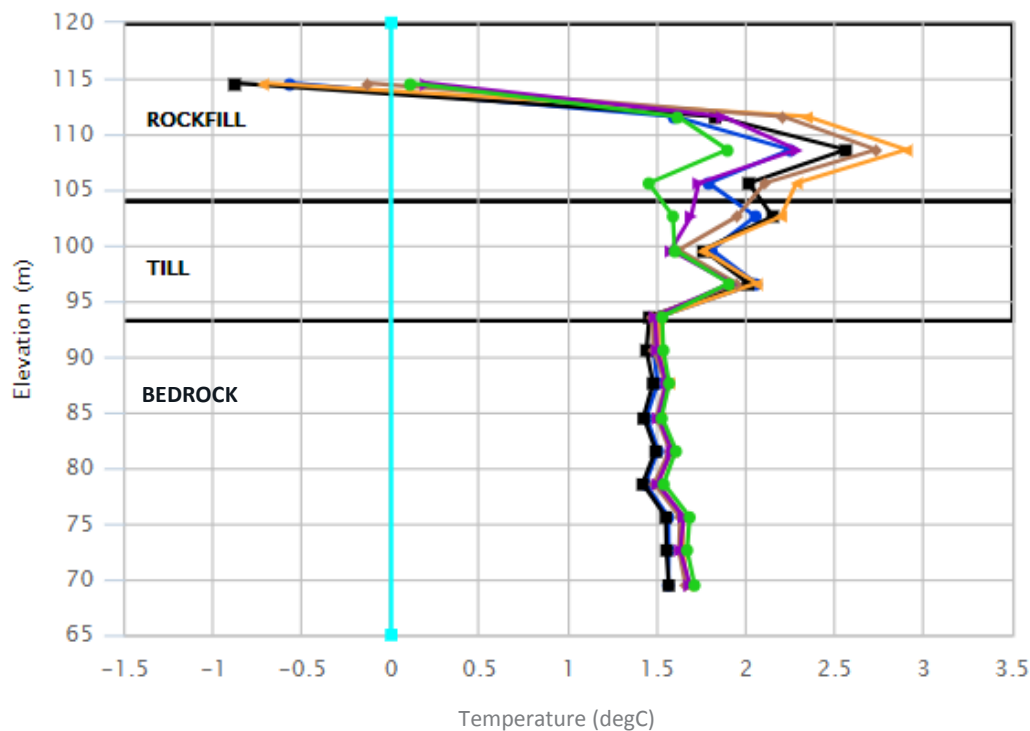
THERMISTOR 595-P1

- Temperature in the bedrock/till unit is in between 1.5°C and 2.0°C .
- Glitch of 0.25°C could be caused by the automatization works done in August 2017.

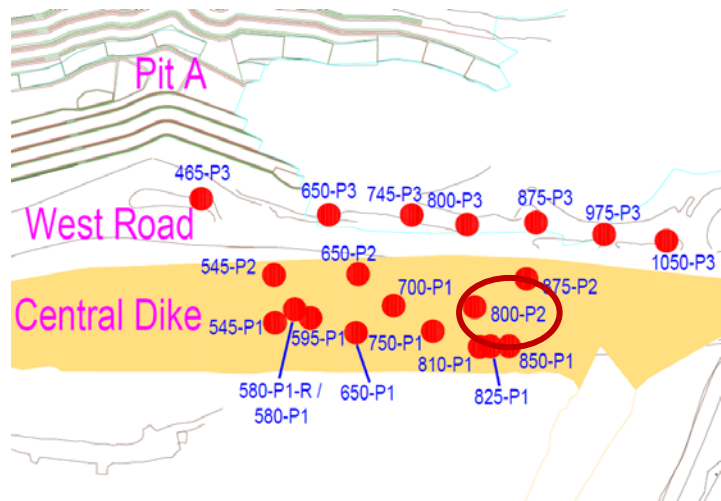
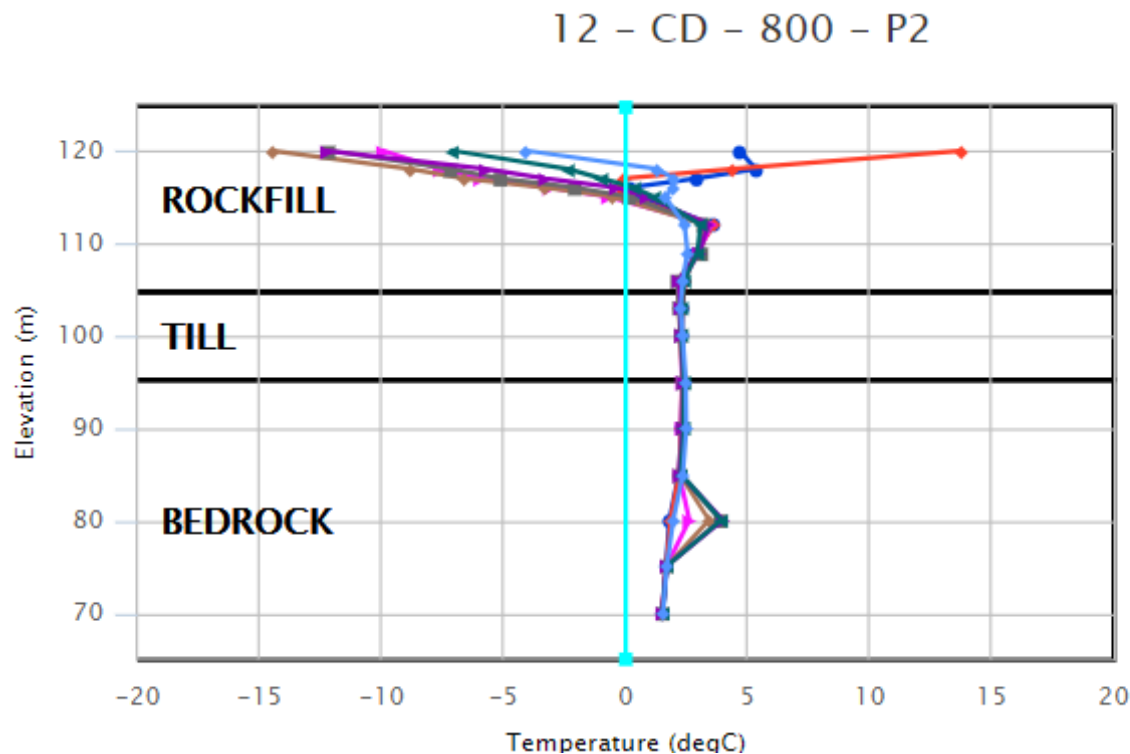
THERMISTOR 800-P2

- New instrument installed in 2017
- Capacitance effect was observed at the end of 2017/beginning 2018. Stabilized since June 2018.
- Temperature above 0 °C

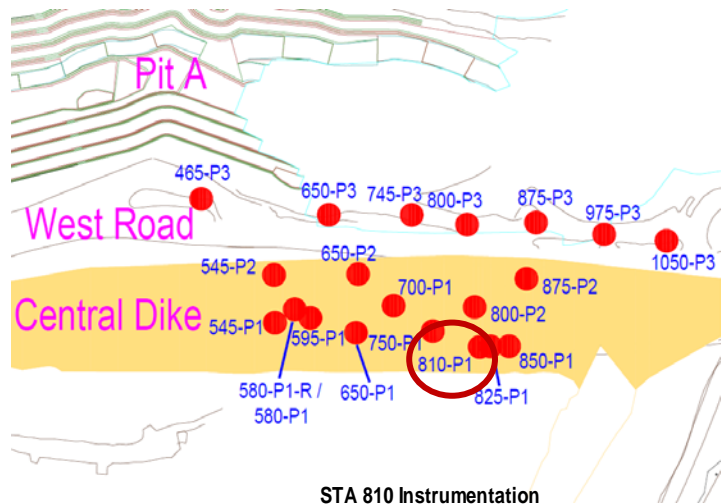
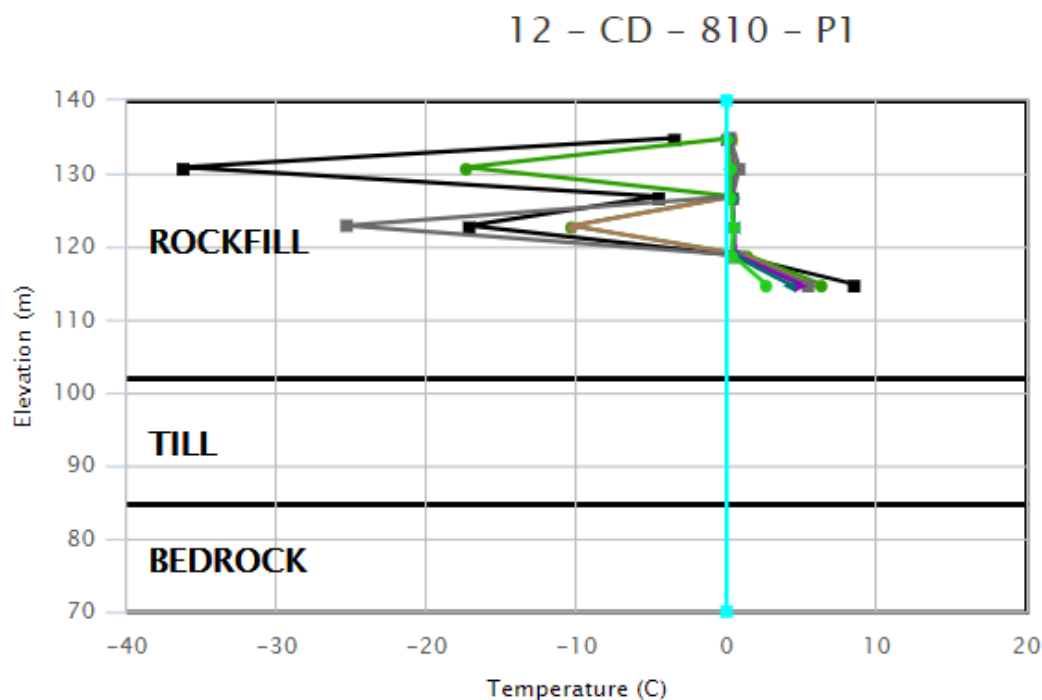
THERMISTOR 810-P1

- Bead below El. 114.84 m stop working in February 2017
- Higher temperature observed in this hole (might be the instrument progressively failing)

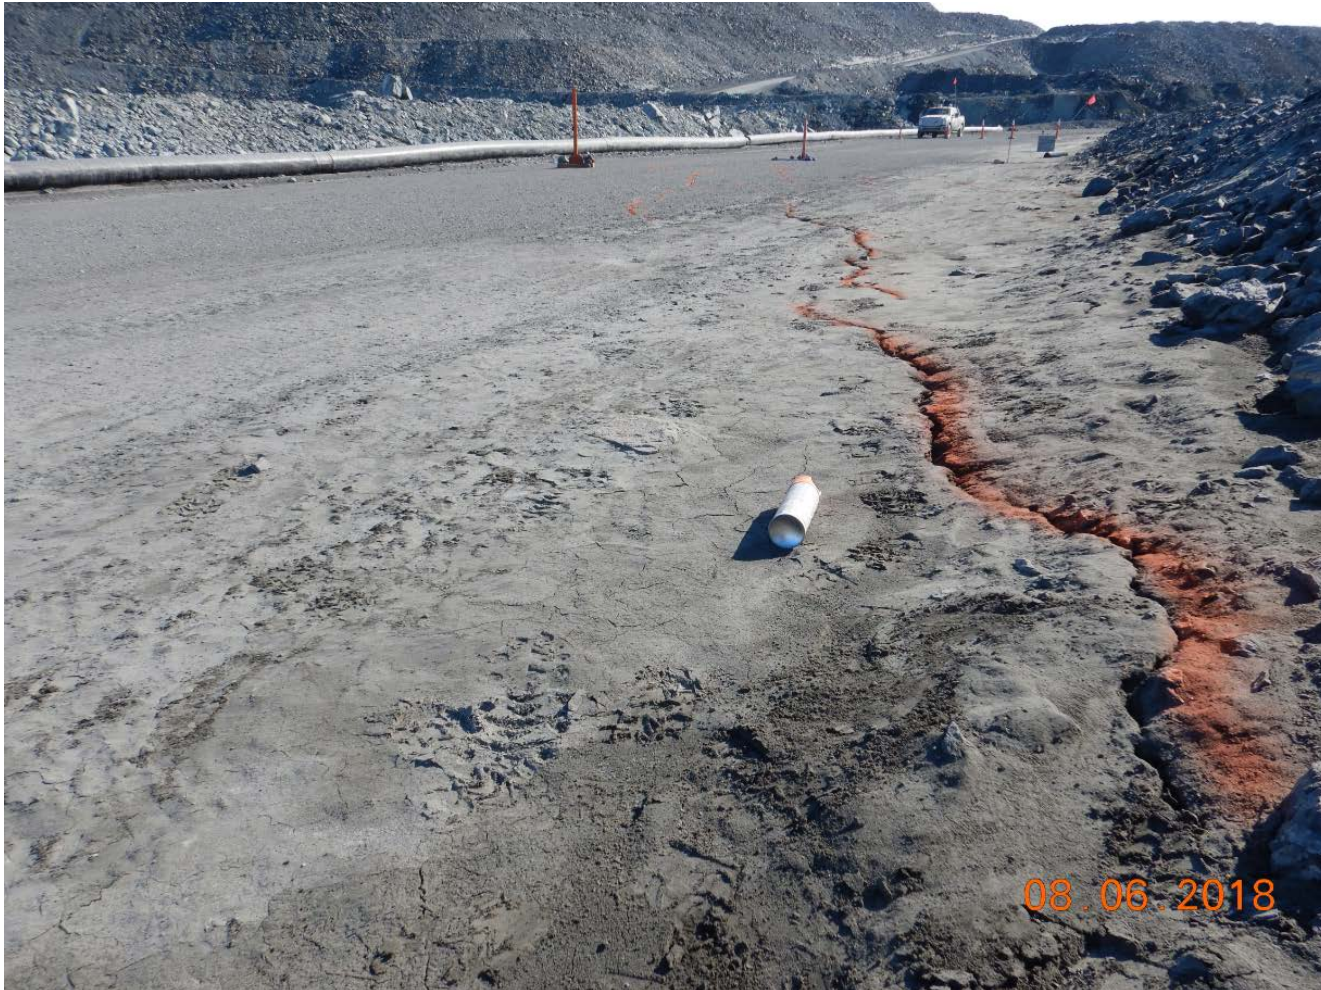
New cracks formed between station 10+950 and 11+000

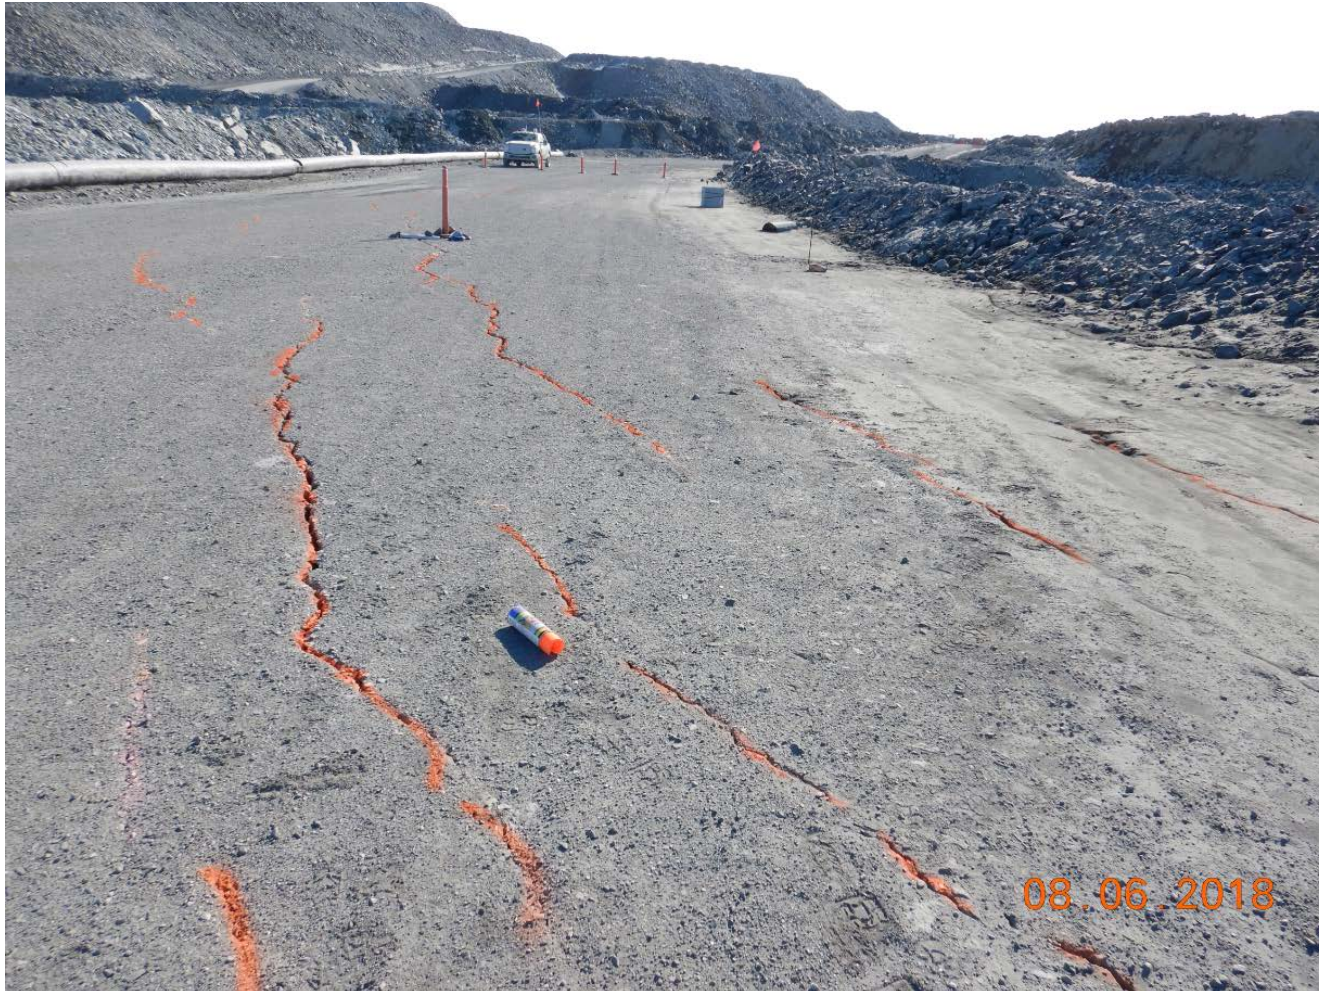
New cracks formed between station 10+950 and 11+000

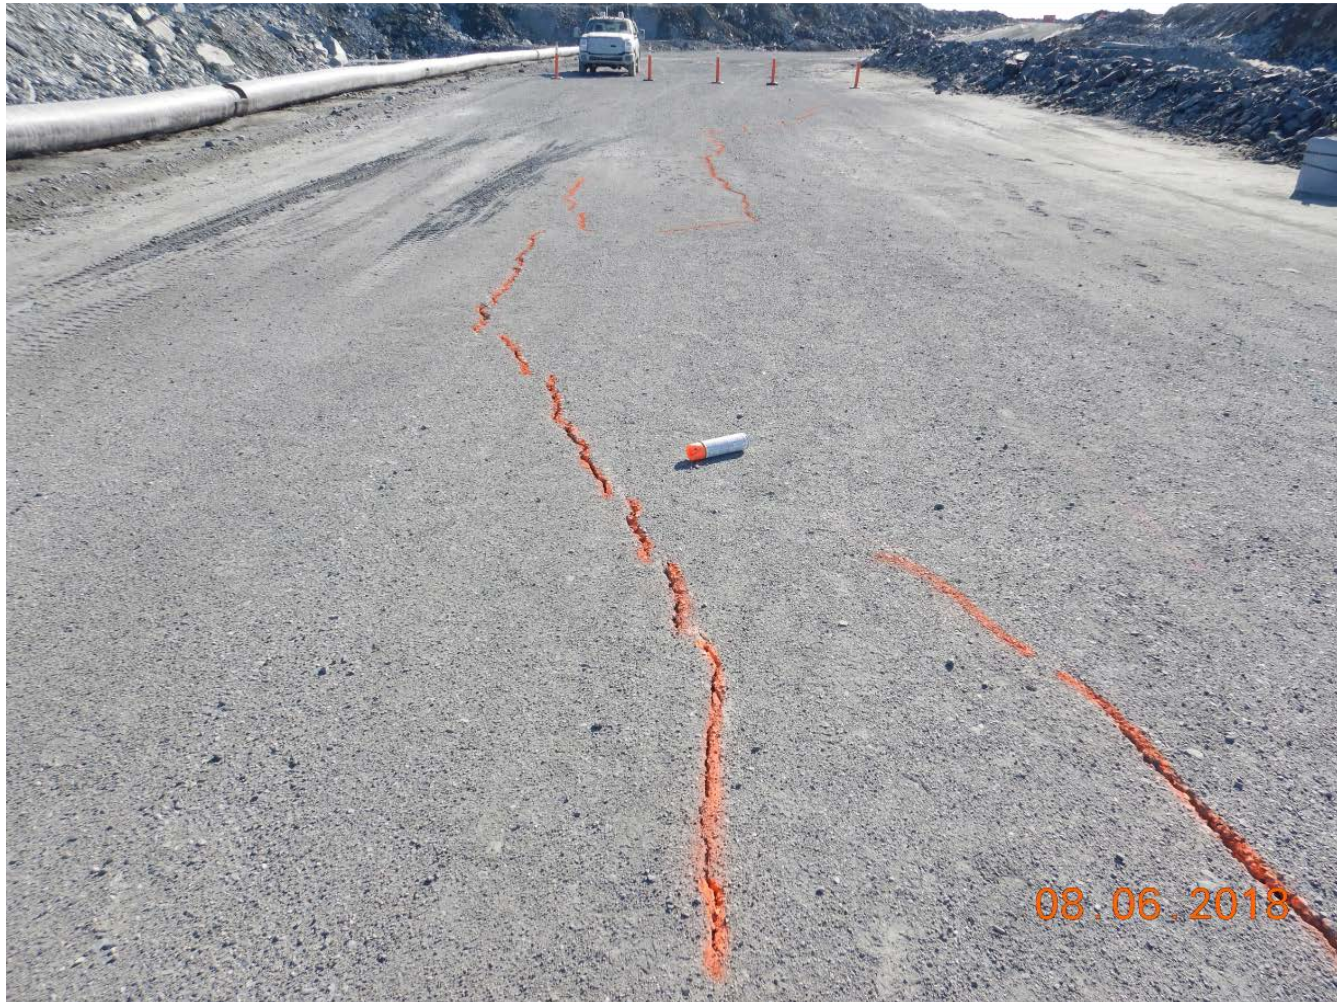
New cracks formed between station 10+950 and 11+000

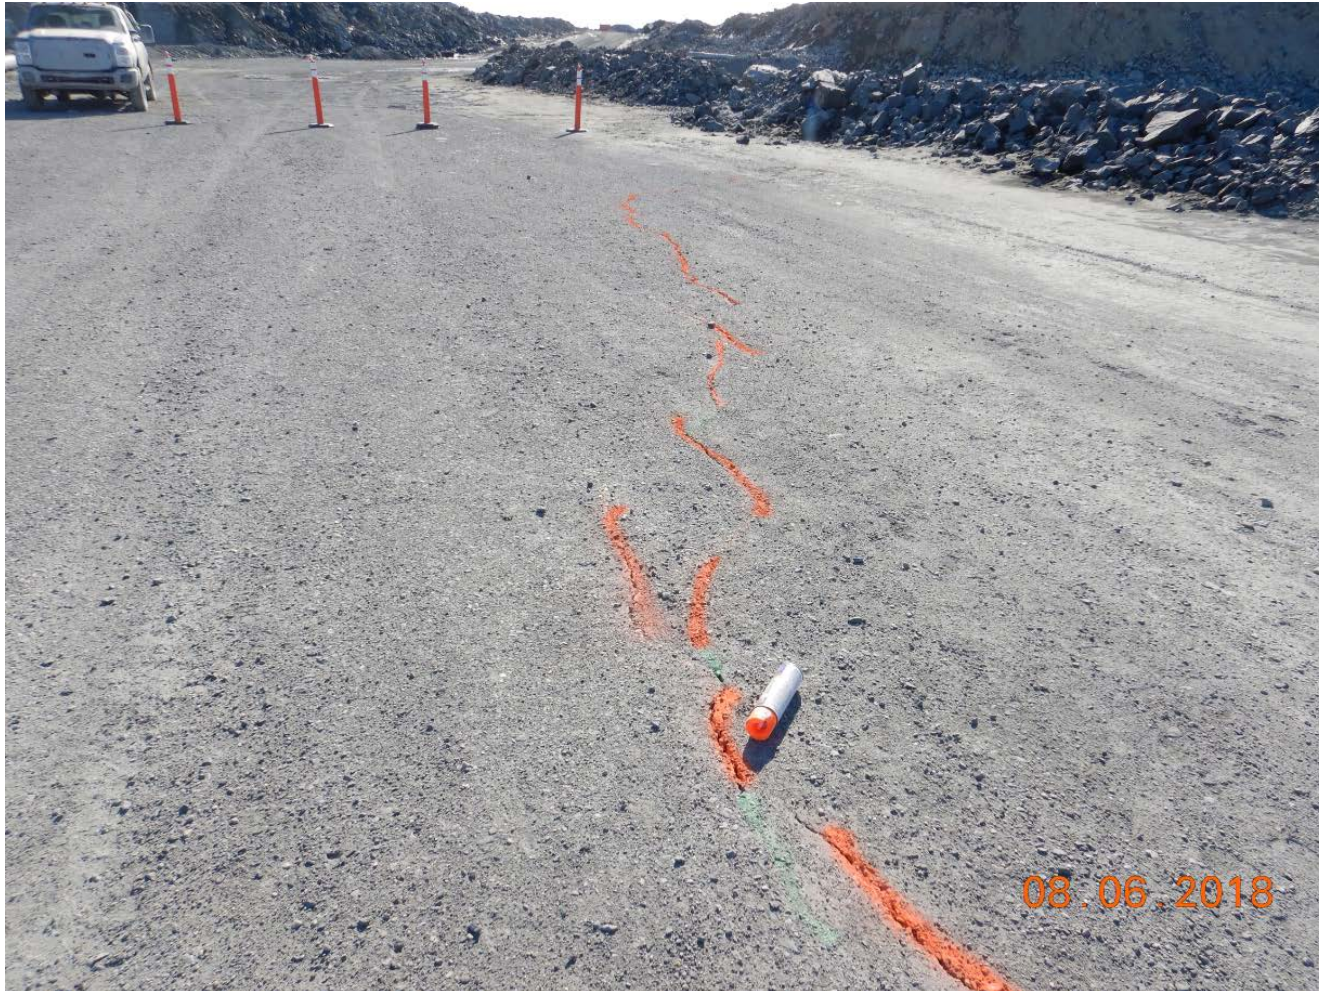
New cracks formed between station 10+950 and 11+000

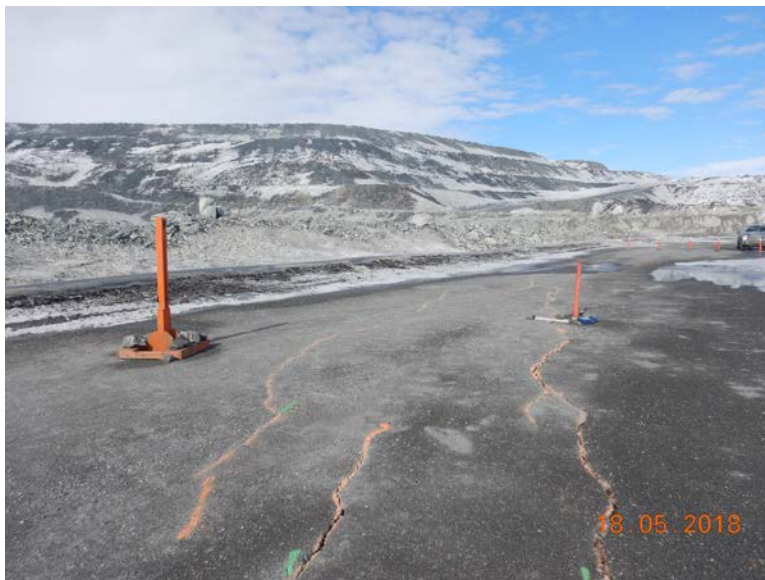
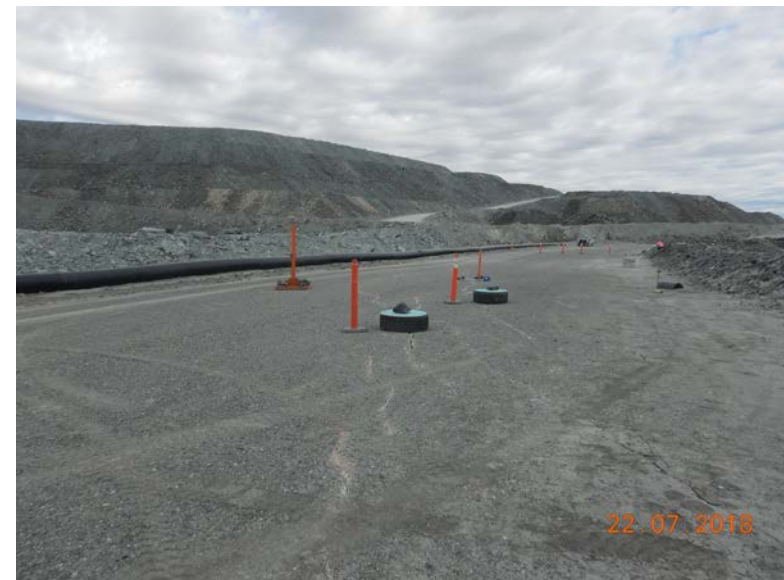
- Observed initially on April 27th 2018
- Appeared at the end of the winter with warmer temperature
- Cracks width varying approximately from 1cm to 4 cm
- No significant visual changes since April 27th 2018

July 23 - Cracks were filled with bentonite to prevent water infiltration

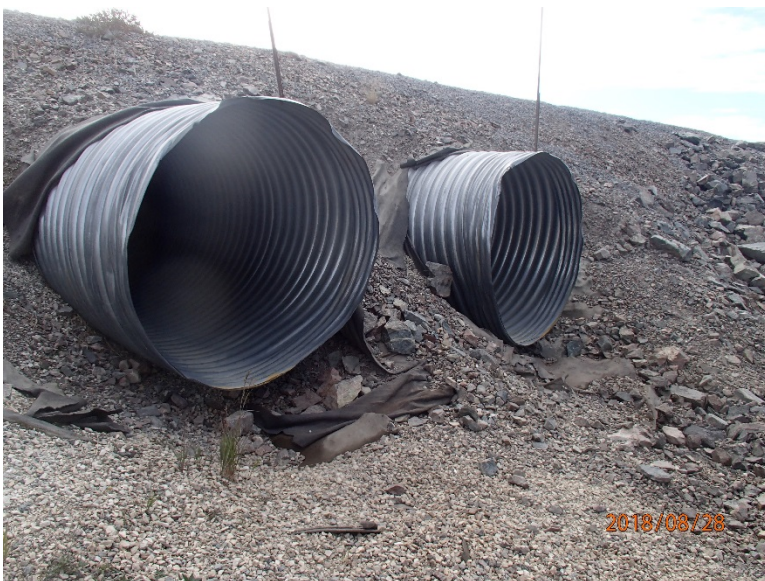
Description: View of the culvert inlet. Good condition, inlet is short in length as the road rolling surface is at the edge of the inlet.

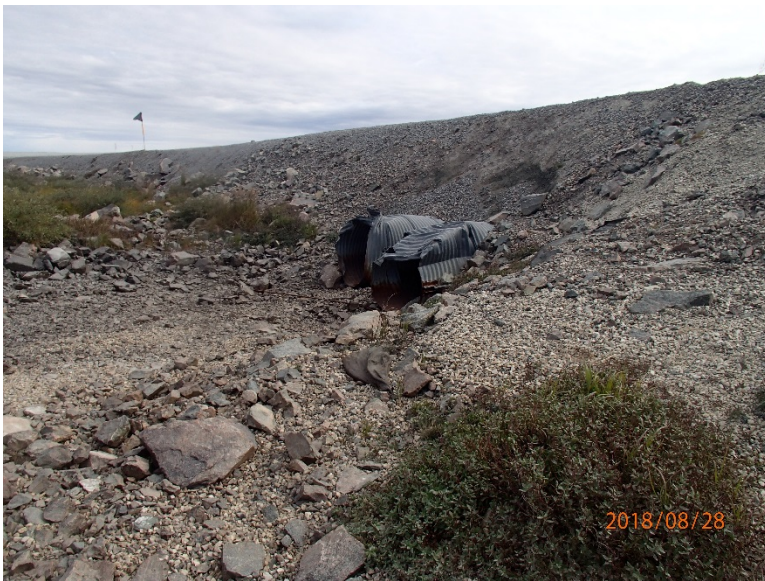
Photograph D1-3: PC-17A km 8+830

Description: View of the culverts outlet. No sign of degradation since last year.

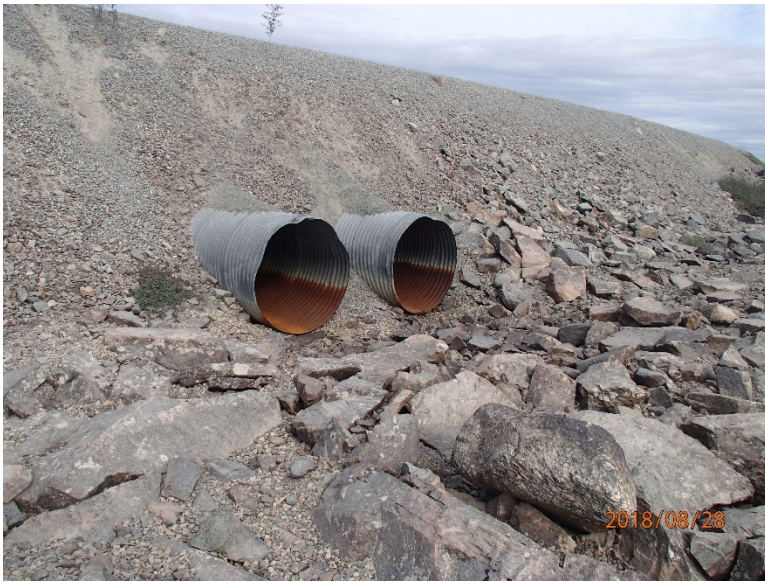
Photograph D1-4: PC-17 km 8+850

Description: View of the culverts inlet. Good condition.

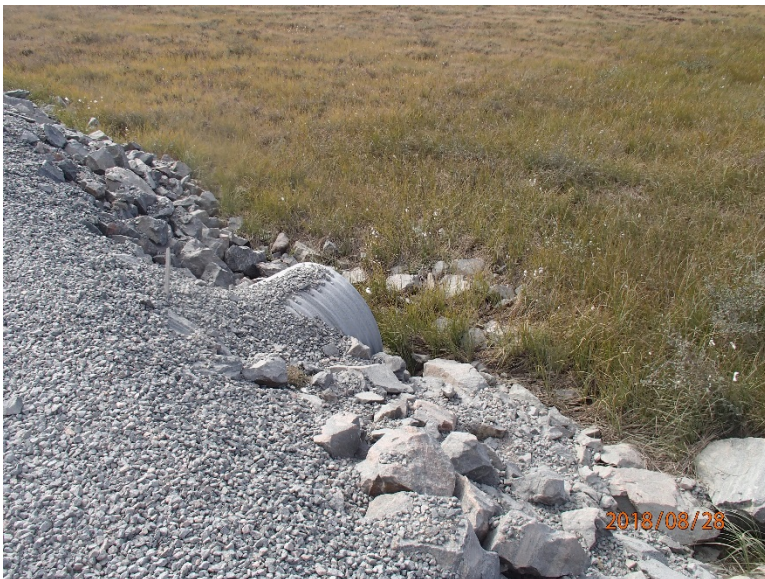
Photograph D1-5: PC-17 km 8+850

Description: View of the culverts outlet (right side of the picture). Good condition.

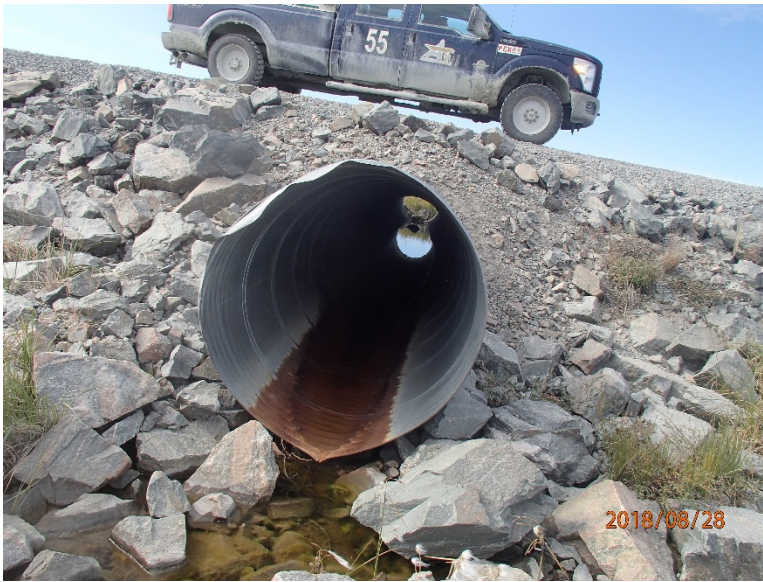
Photograph D1-6: R-04 km 12+050

Description: View of the culvert inlet. In good condition.

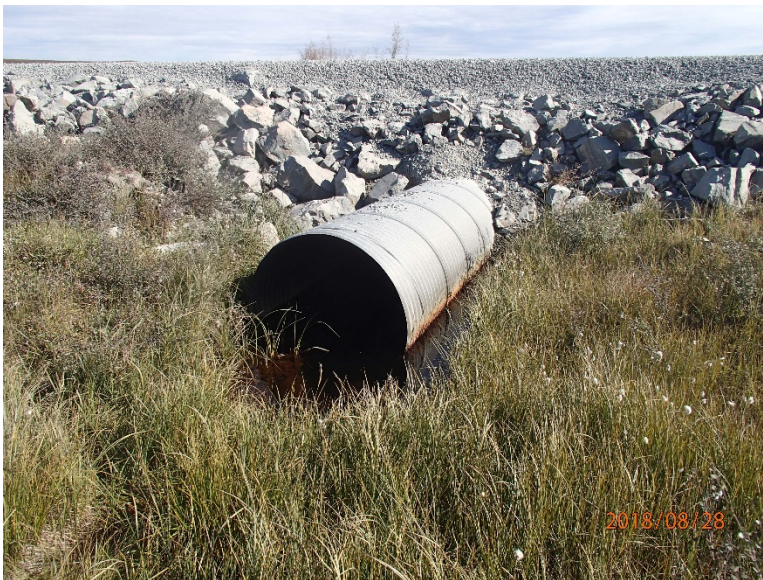
Photograph D1-7: R-04 km 12+050

Description: View of the culvert outlet. In good condition.

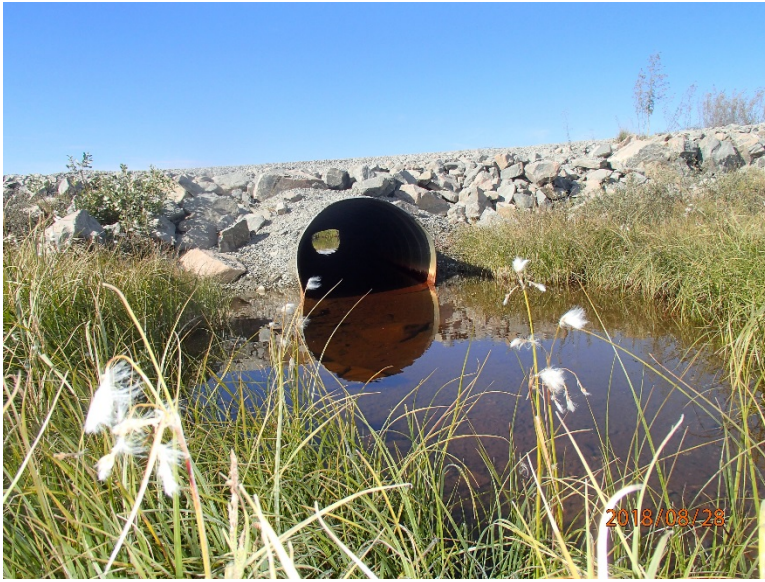
Photograph D1-8: R-05A km 15+745

Description: View of the culvert inlet. In good condition.

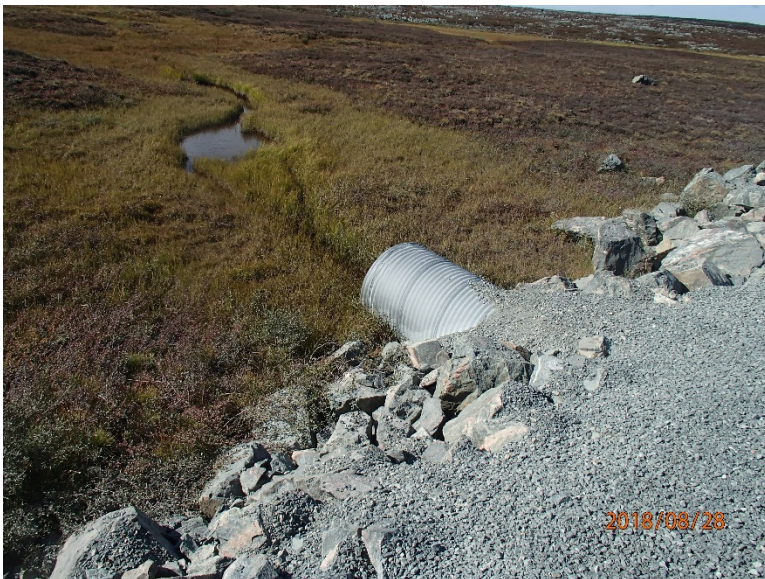
Photograph D1-9: R-05A km 15+745

Description: View of the culvert outlet. In good condition.

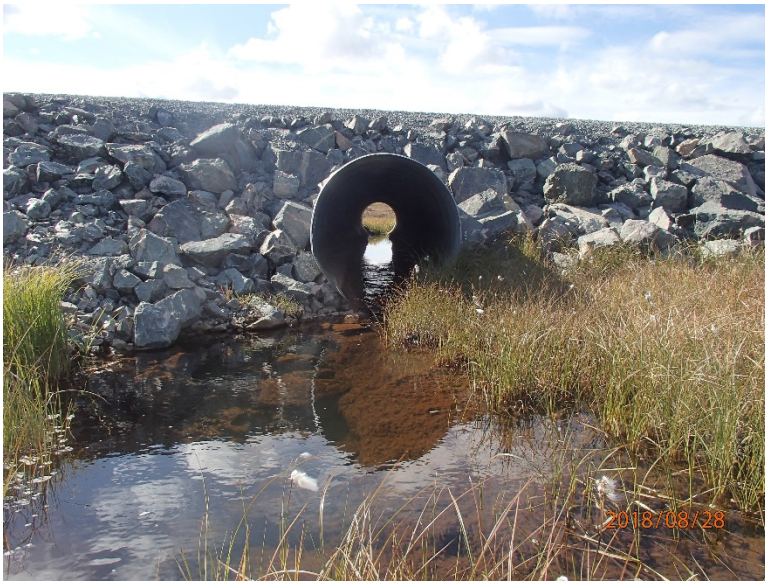
Photograph D1-10: R-07 km 25+900

Description: View of the culvert inlet. In good condition.

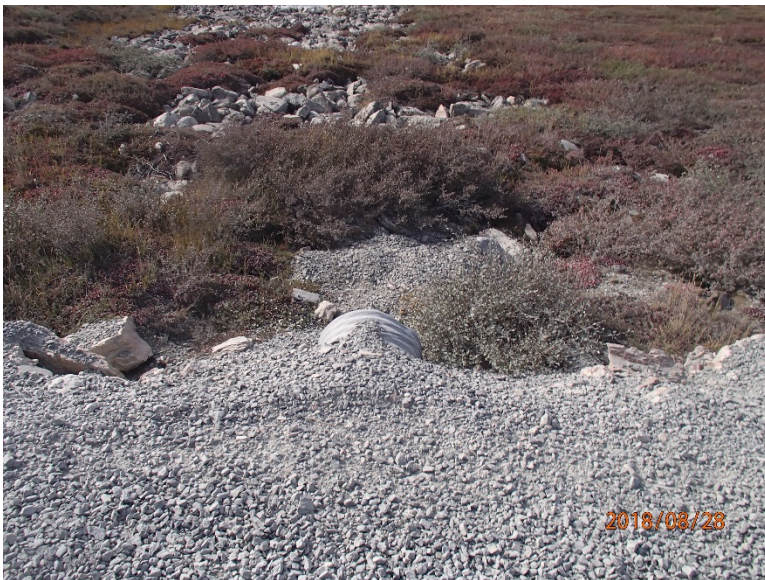
Photograph D1-11: R-07 km 25+900

Description: View of the culvert outlet. In good condition.

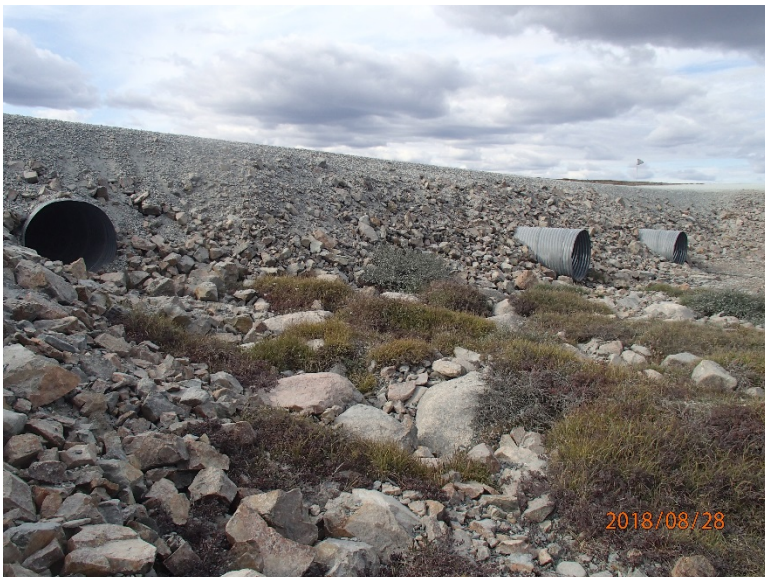
Description: View of the culvert outlet. In good condition, almost submerged.

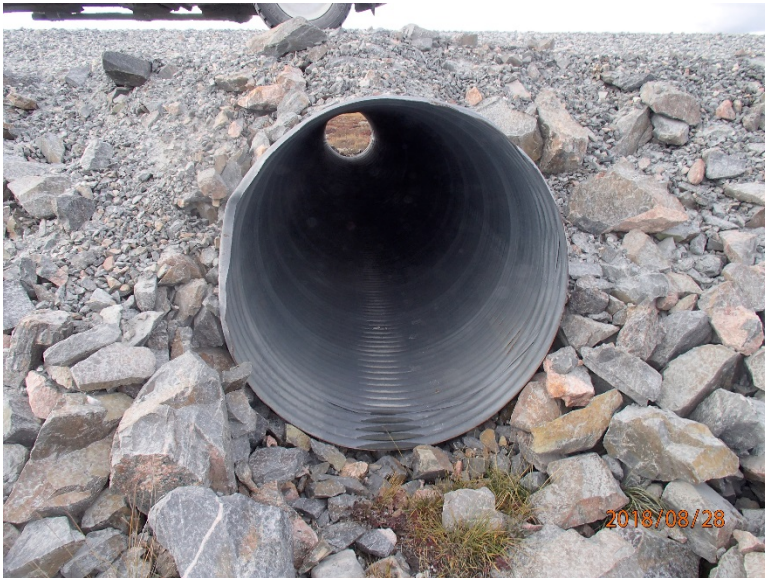
Description: View of the culvert inlet. In good condition.

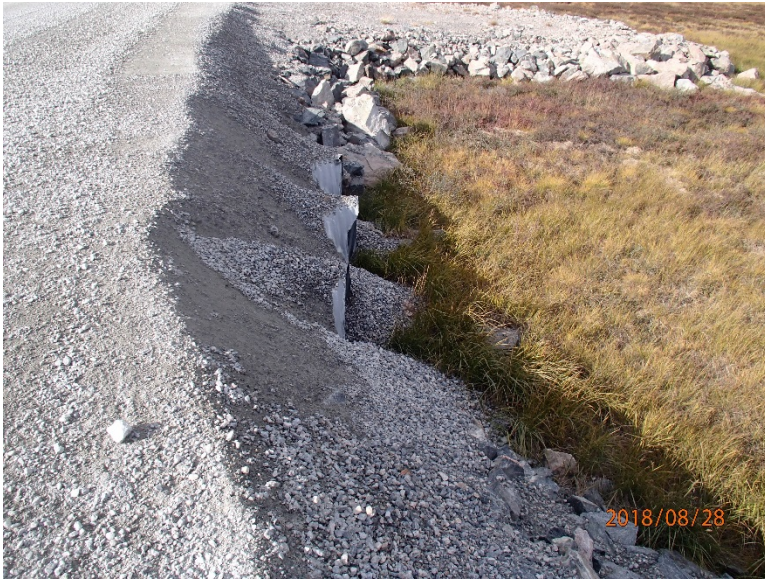
Photograph D1-16: R-17 km 77+440

Description: View of the culvert outlet. In good condition.

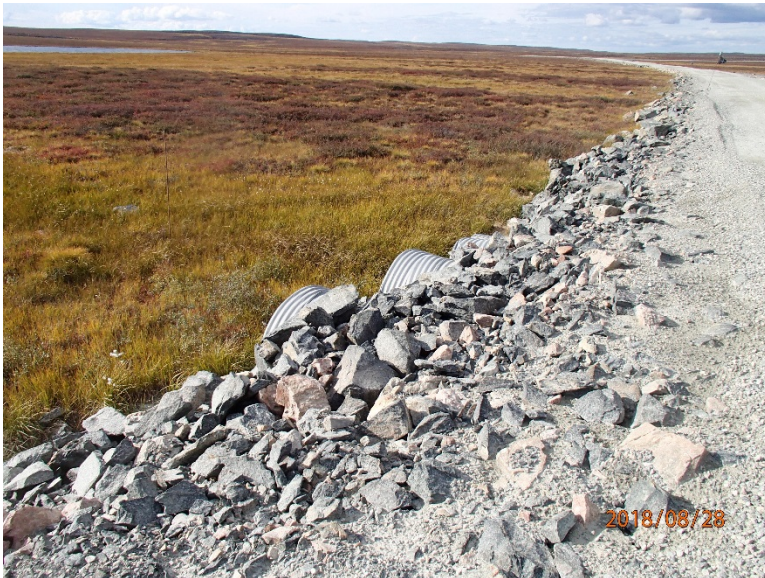
Photograph D1-17: R-18A km 80+950

Description: View of the culverts inlet. In good condition. The southern culvert inlet is partially buried.

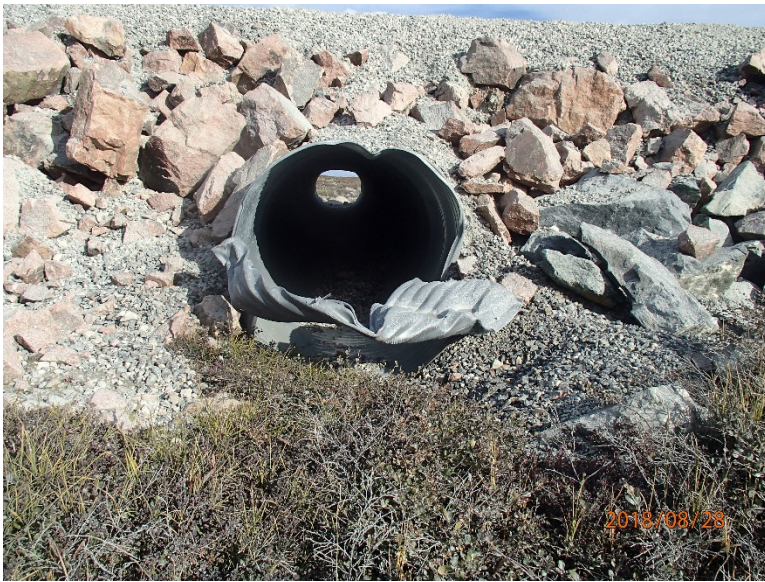
Photograph D1-18: R-18A km 80+950

Description: View of the culverts outlet. In good condition.

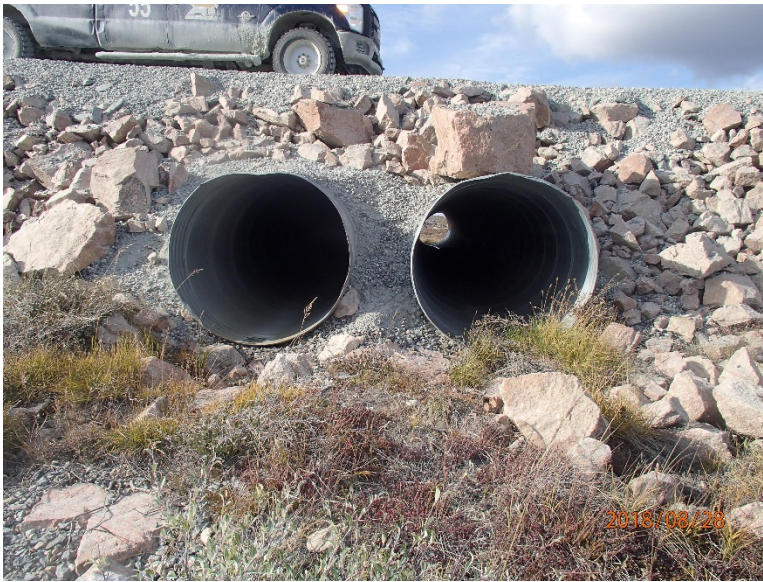
Photograph D1-20: R-21 km 87+300

Description: View of the culverts inlet. Both culverts are slightly collapsed in the middle. In stable condition, but should have been installed lower to avoid erosion issue.

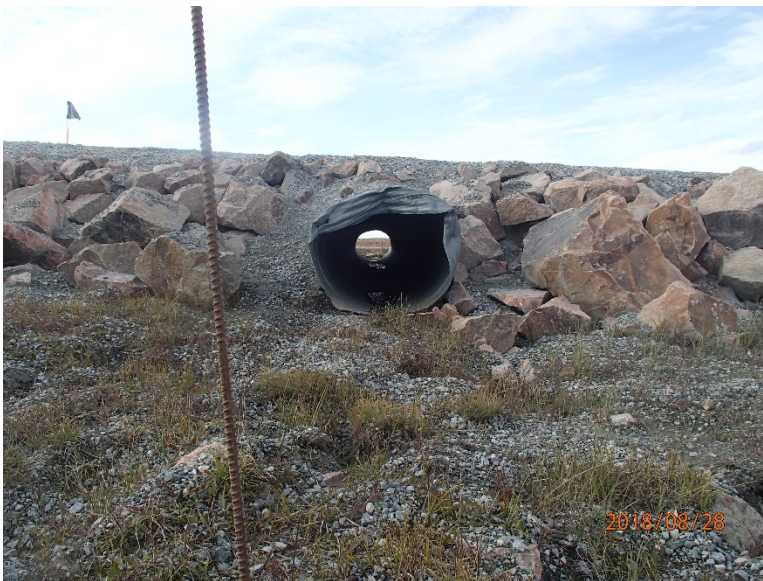
Photograph D1-21: R-21 km 87+300

Description: View of the culverts outlet. Both culverts are slightly collapsed in the middle. In stable condition, but should have been installed lower to avoid erosion issue.

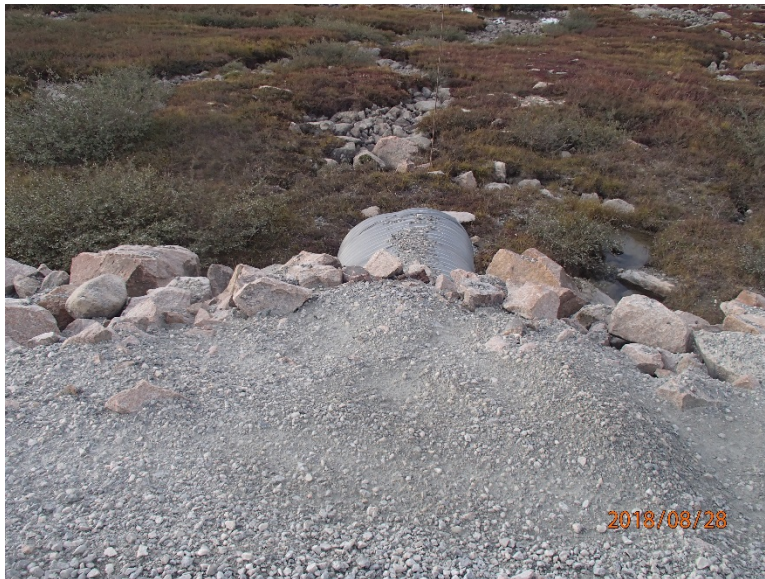
Photograph D1-22: R-23 km 93+600

Description: View of the culvert inlet. The culvert is installed too high and there is a low flow of water through the road rockfill. In good condition.

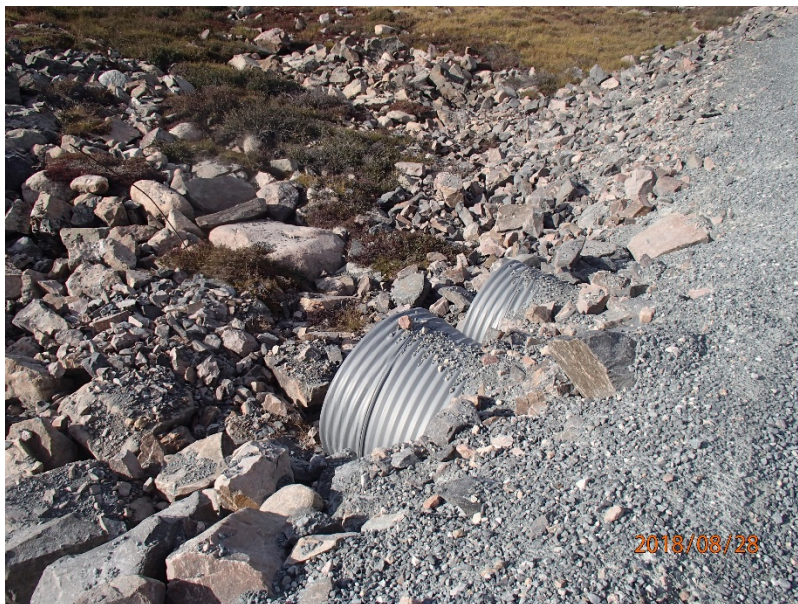
Photograph D1-23: R-23 km 93+600

Description: View of the culvert outlet. The culvert is installed too high and there is a low flow of water through the road rockfill. In good condition.

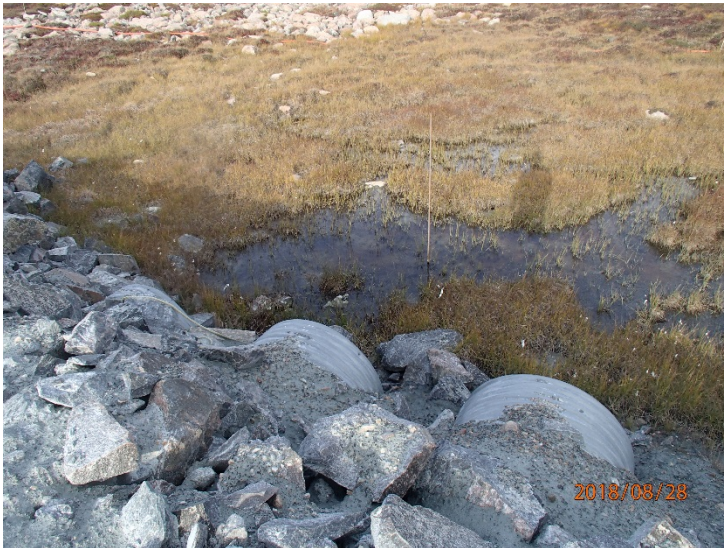
Description: View of the culverts outlet. In good condition.

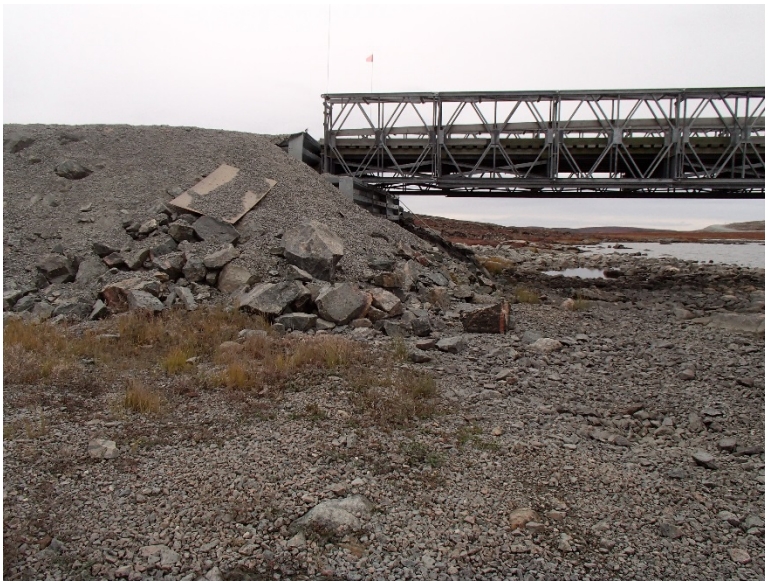
Description: Looking at the south abutment. Minor damage to the bin wall.

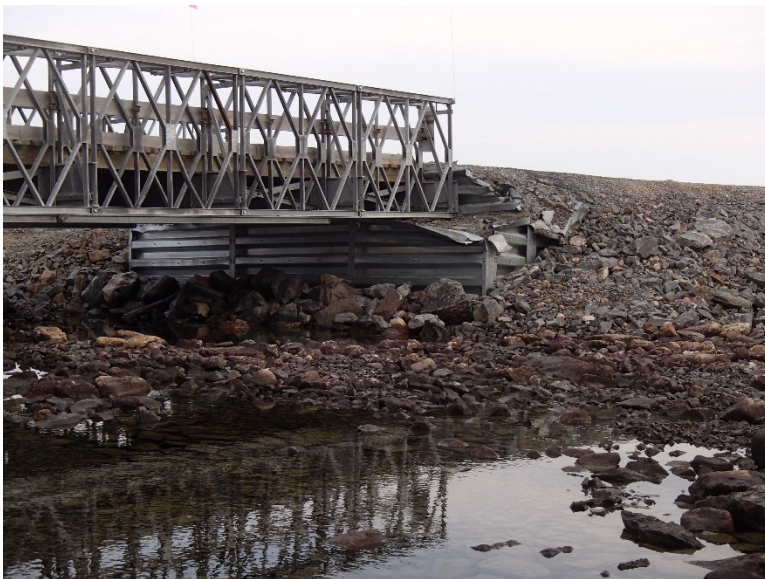
Description: Looking at the south abutment. Damage to the bin wall likely caused during snow removal activities. Bridge is tipping toward the west side on the abutment.

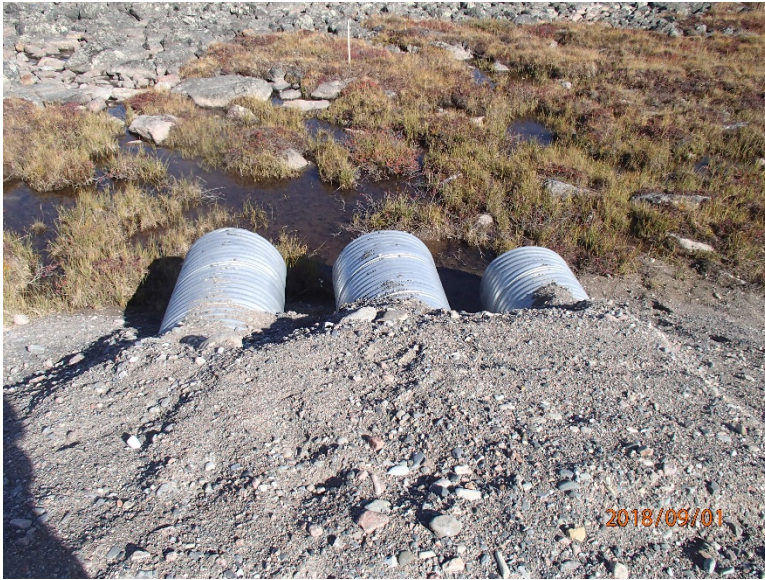
Description: View of culvert outlet, in good condition.

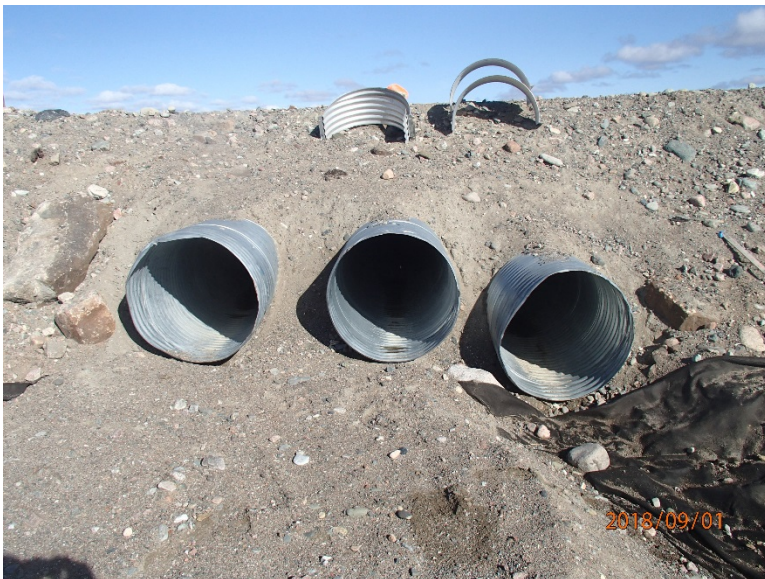
Photograph E1-3: Culverts #208, #209 and #210, km 49+431 to 49+435

Description: View of culvert outlets, in good condition.
