PROJECT	AGNICO EAGLE MINES LIMITED MEADOWBANK GOLD PROJECT NUNAVUT				
TITLE	PG 28AUG14 EAST DIKE - SECTION 60+490 PIEZOMETRIC DATA (Aug 1/17 to Aug 1/18)

APPENDIX C2

P4– CENTRAL DIKE UPDATE

CENTRAL DIKE UPDATE 2018

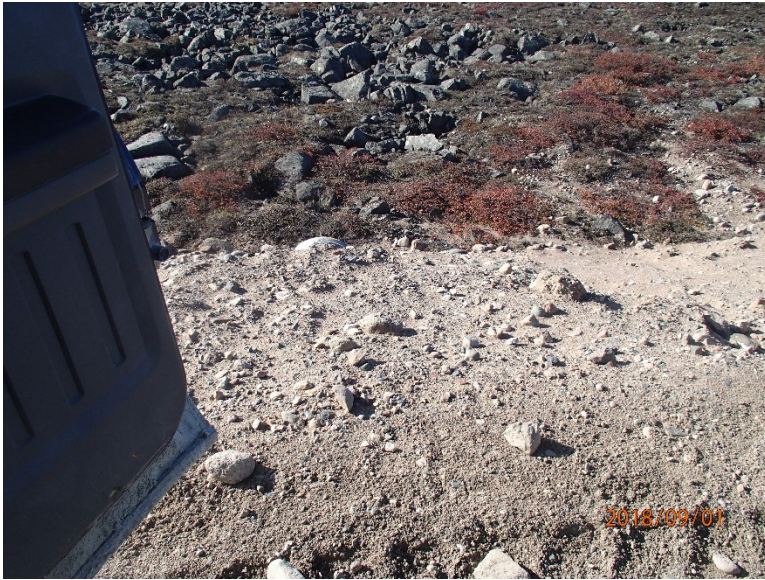
Photograph E1-4: Culverts #208, #209 and #210, km 49+431 to 49+435

Description: View of culvert inlets, in good condition.

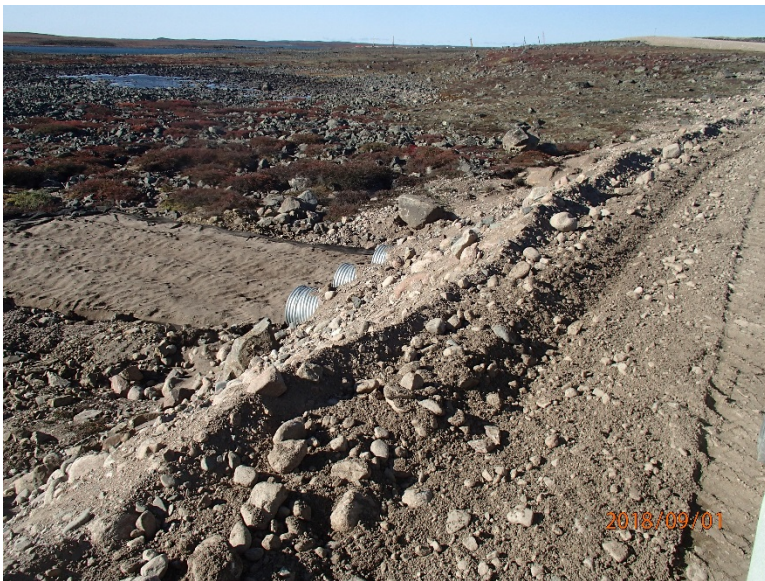
Photograph E1-5: Culvert #283 km 62+965

Description: View of culvert outlet, in good condition.
