APPENDIX F

Amaruq Road Photographic Log

APPENDIX G1

**Baker Lake Tank Farm
Photographic Log**

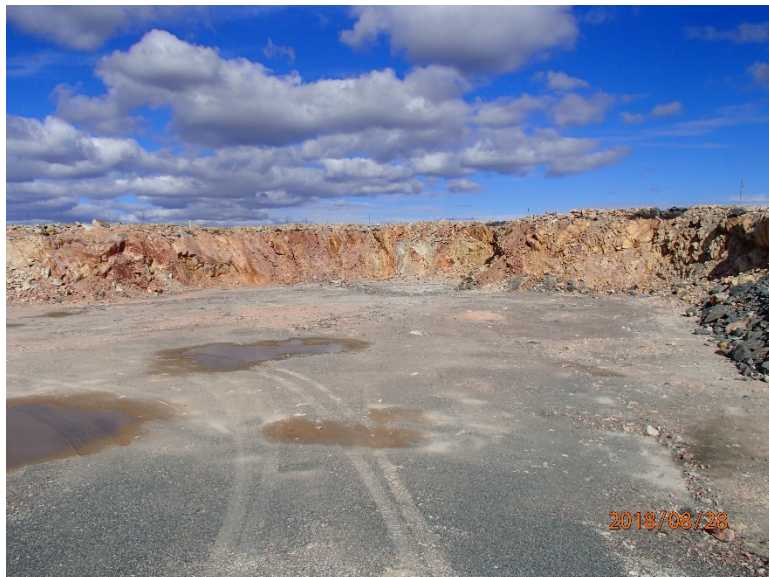
Photograph F1-6: Quarry 3 – km 23+700

Description: View of west wall. Presence of loose rock along steep wall.

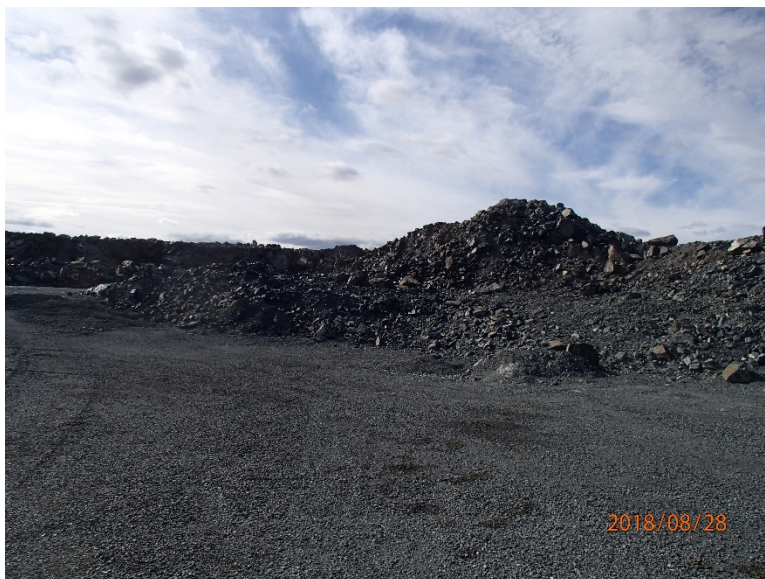
Photograph F1-11: Quarry 8 – km 42+950

Description: View of south wall. Presence of loose blocks.

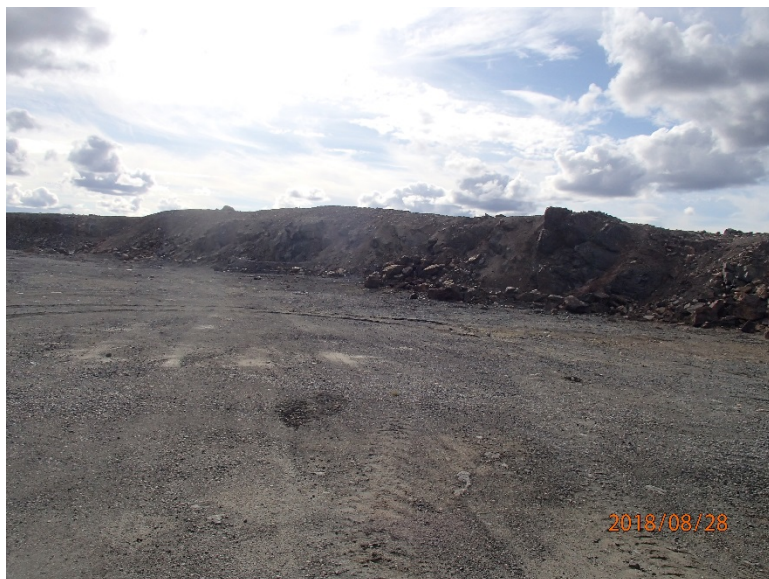
Photograph F1-27: Quarry 16 – km 70+400

Description: View of the south and west walls. Presence of loose rocks on steep wall.

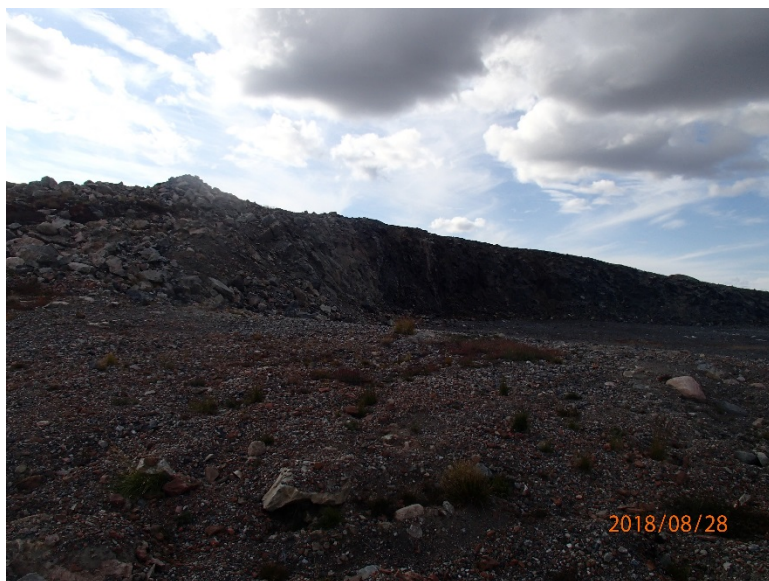
Photograph F1-28: Quarry 16 – km 70+400

Description: View of the east wall. Presence of loose rocks on steep wall.

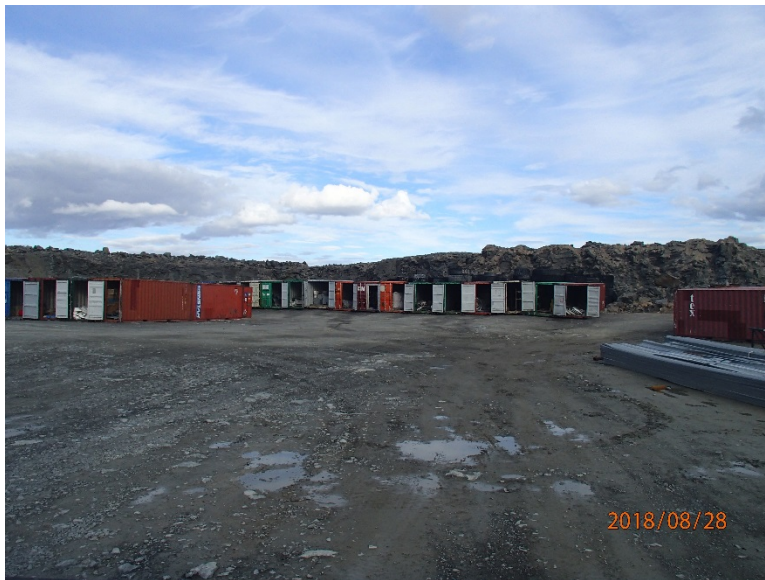
Photograph F1-39: Quarry 23 (Airstrip Quarry)

Description: Looking at the north wall. Presence of loose rocks along steep wall.

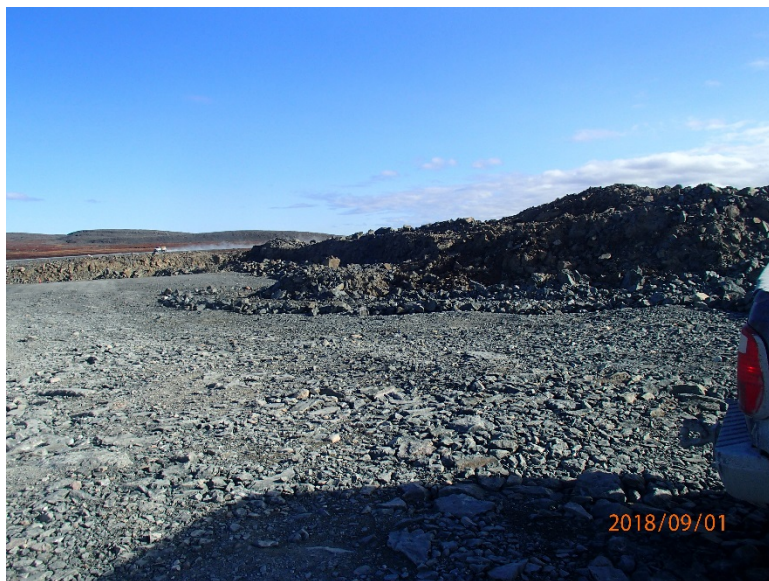
Photograph F2-1 Eskers and Quarries 1 – km 10+500

Description: View of Quarry 10.5. Loose rock is present on the steep wall.

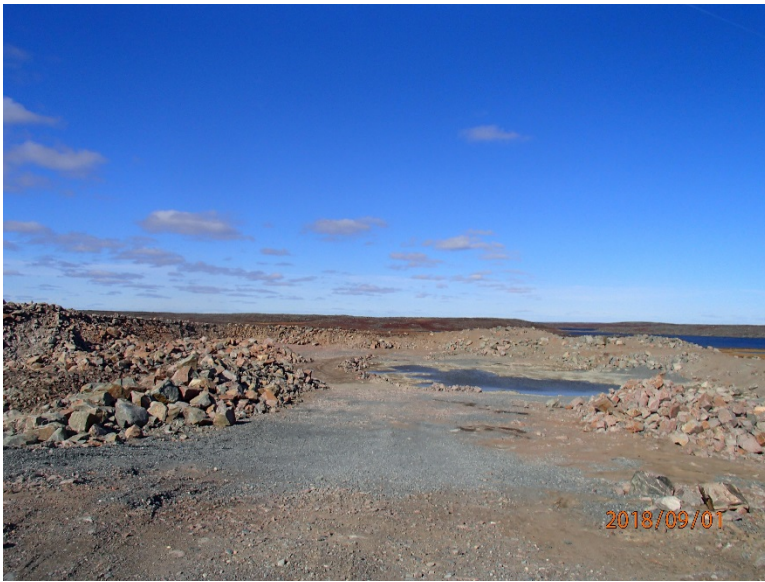
Photograph F2-2 Eskers and Quarries 1 – km 10+500

Description: View of Quarry 10.5. Loose rock is present on the steep wall.

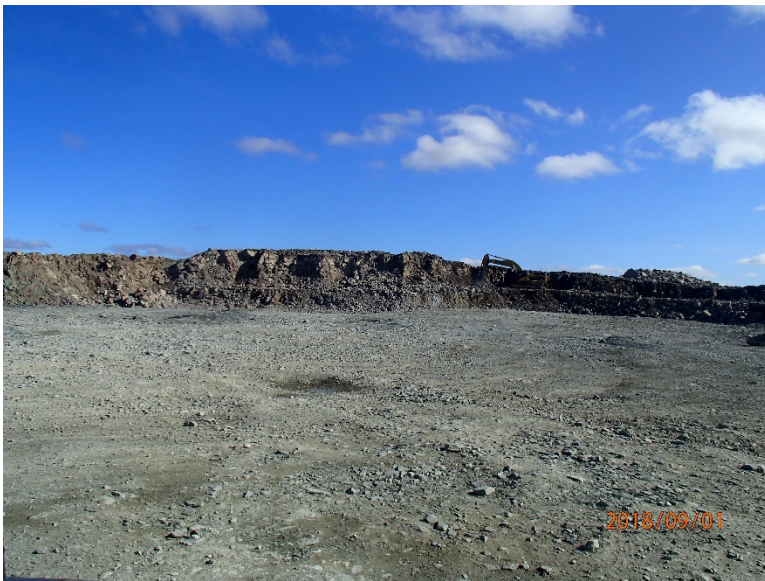
Photograph F2-3 Eskers and Quarries 2 – km 25+000

Description: View of esker #2. General good condition but some steep walls and loose rocks.

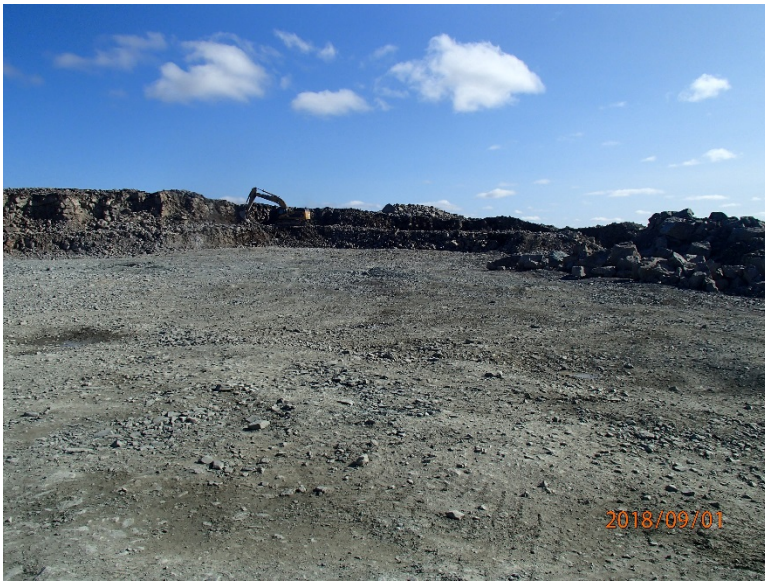
Photograph F2-4 Eskers and Quarries 3 – km 30+180

Description: View of Quarry 30.5. Most walls are in unstable condition.

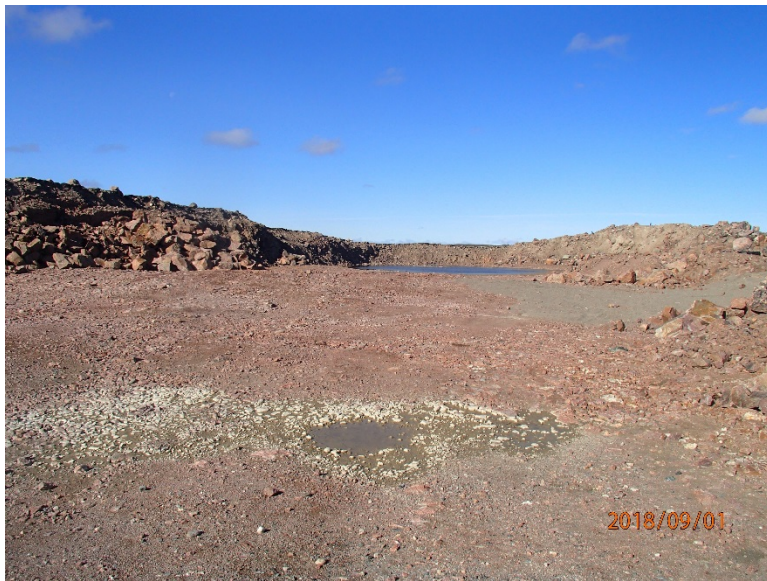
Photograph F2-7 Eskers and Quarries 5 – km 52+000

Description: View of the rock quarry at km 52. In good conditions with loose blocks and cobbles on the north wall.

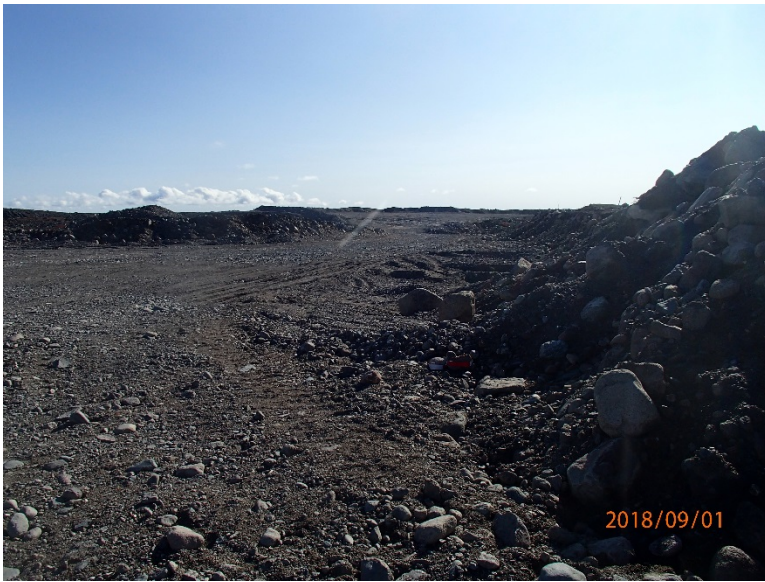
Photograph F2-8 Eskers and Quarries 5 – km 52+000

Description: View of the rock quarry at km 52. In good conditions with loose blocks and cobbles on the north wall.

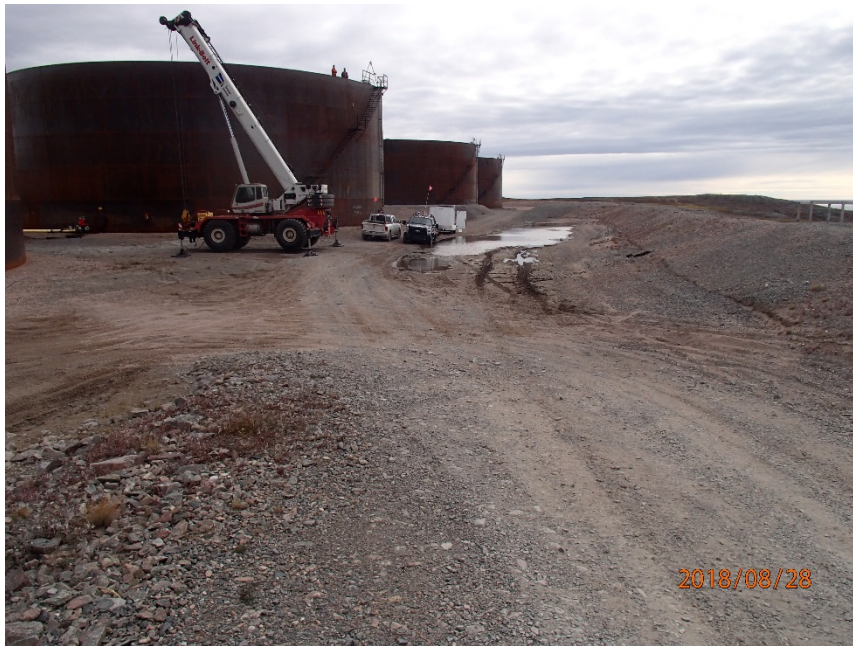
Photograph G1-1 Baker Lake Tank Farm

Description: From the south side of Tank 1, looking southeast at Tanks 1, 2, 3, and 4. Presence of water ponding.

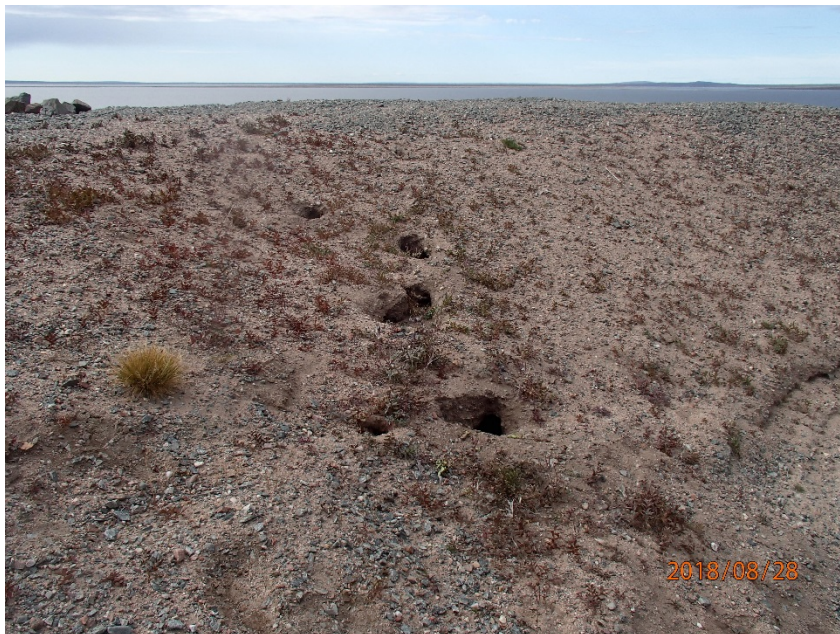
Photograph G1-6 Baker Lake Tank Farm

Description: Looking southwest toward the south wall of the tank farm. Presence of animal burrows.

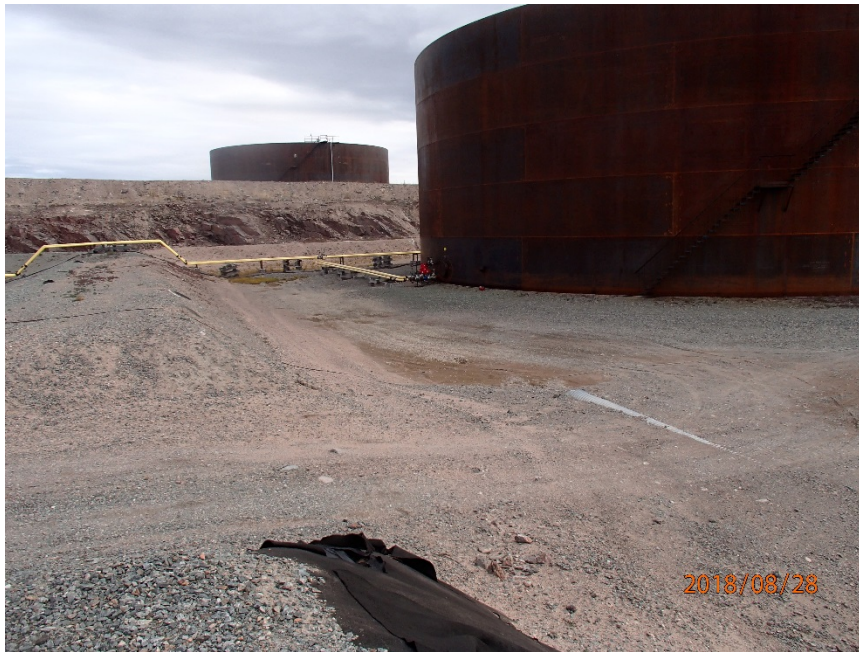
Photograph G1-7 Baker Lake Tank Farm

Description: Looking northeast. The geomembrane between the south side of tank 2 and 3 is damaged.

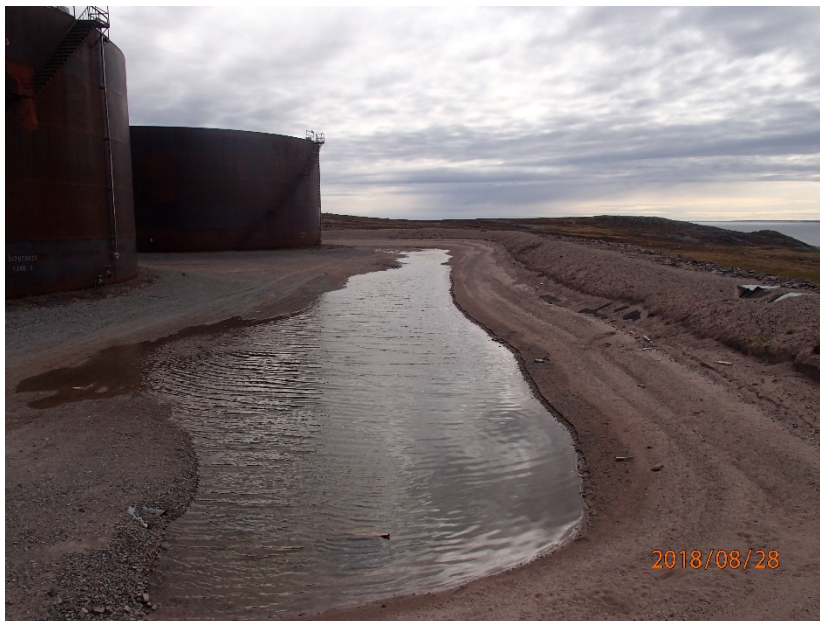
Photograph G1-8 Baker Lake Tank Farm

Description: From the southwestern corner of Tank 3 looking southeast. View of exposed LLDPE.

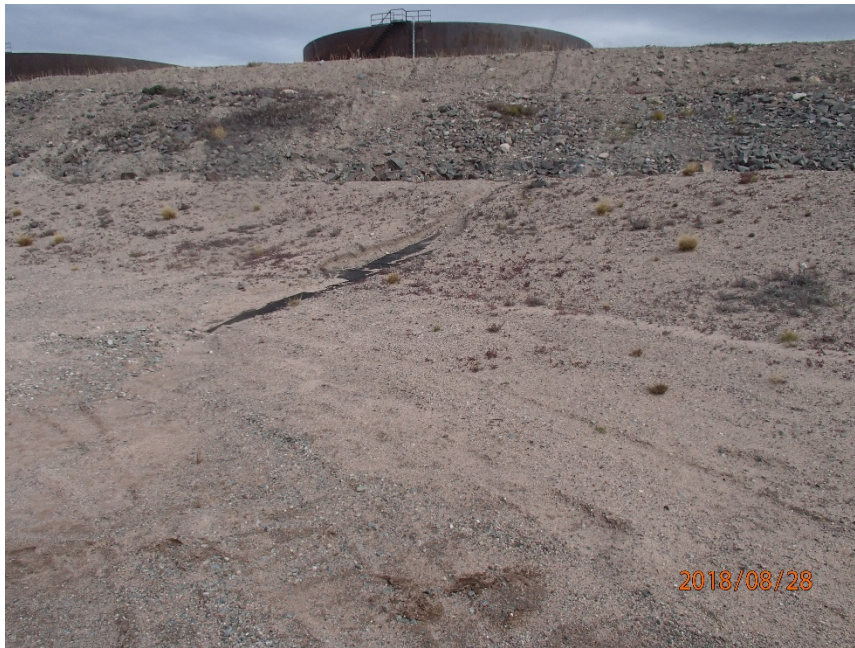
Photograph G1-13 Baker Lake Tank Farm

Description: From the northern side of Tank 4, looking northeast toward Tanks 4, 3, 2, and 1. Presence of exposed liner.

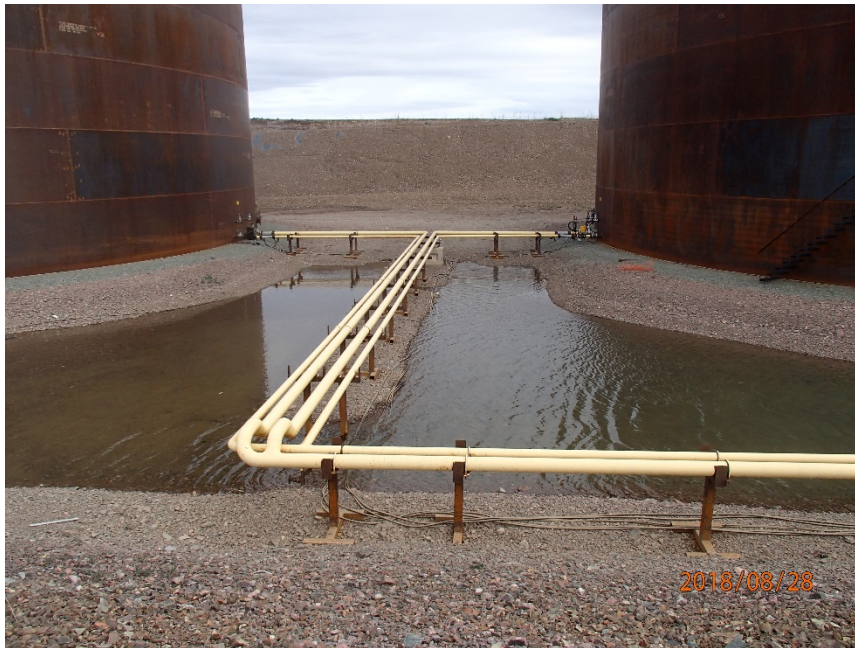
Photograph G1-17 Baker Lake Tank Farm

Description: Looking north between Tanks 5 and 6. Presence of water ponding.

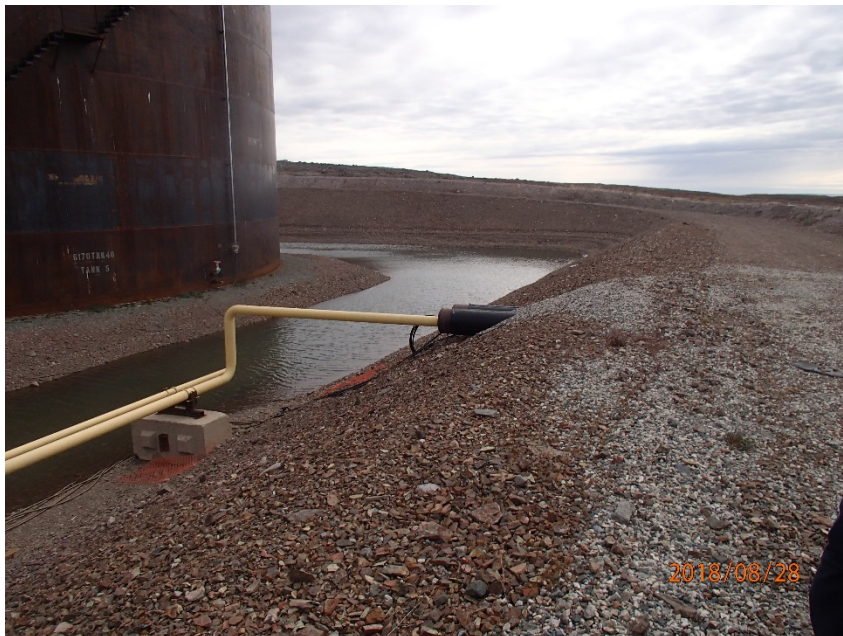
Photograph G1-18 Baker Lake Tank Farm

Description: Looking northeast at the southern side of Tank 6. Presence of water ponding.

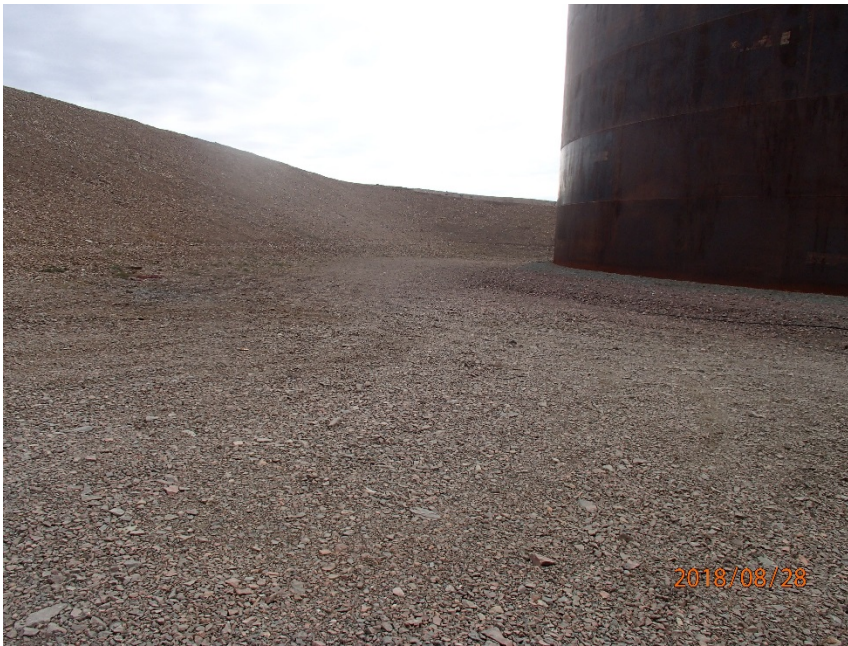
Photograph G1-19 Baker Lake Tank Farm

Description: Looking southeast at the northeastern side of Tank 6. Presence of water ponding.

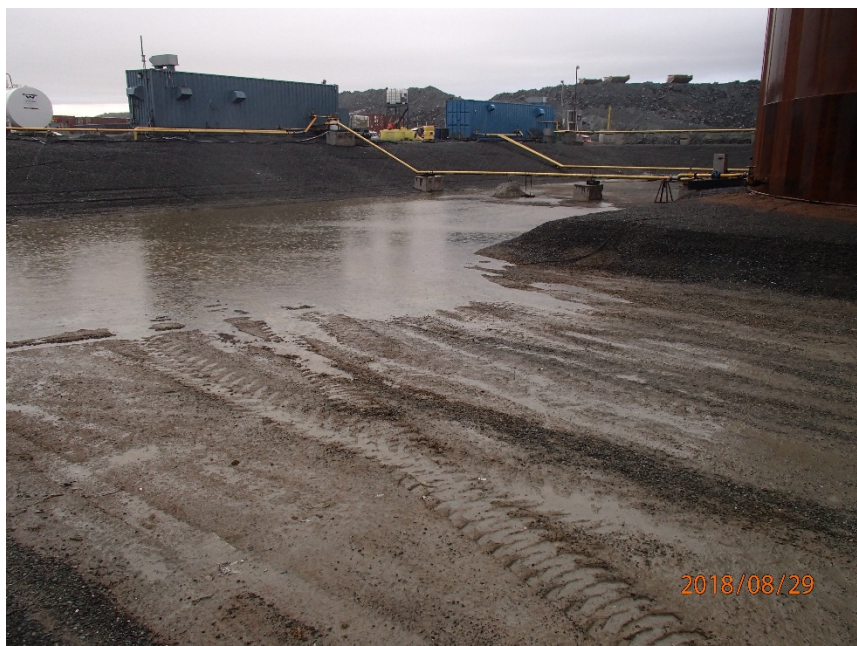
Photograph G2-4 Meadowbank Tank Farm

Description: From the eastern side looking southwest. Presence of water ponding. A pump is installed.

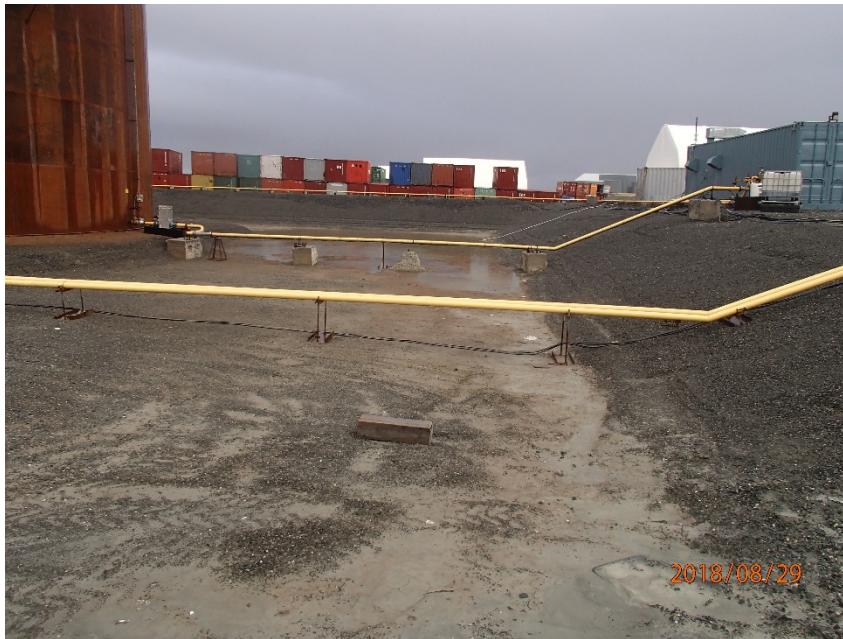
Photograph G2-5 Meadowbank Tank Farm

Description: Looking northeast from the southern corner. Accumulation of water in the eastern corner.

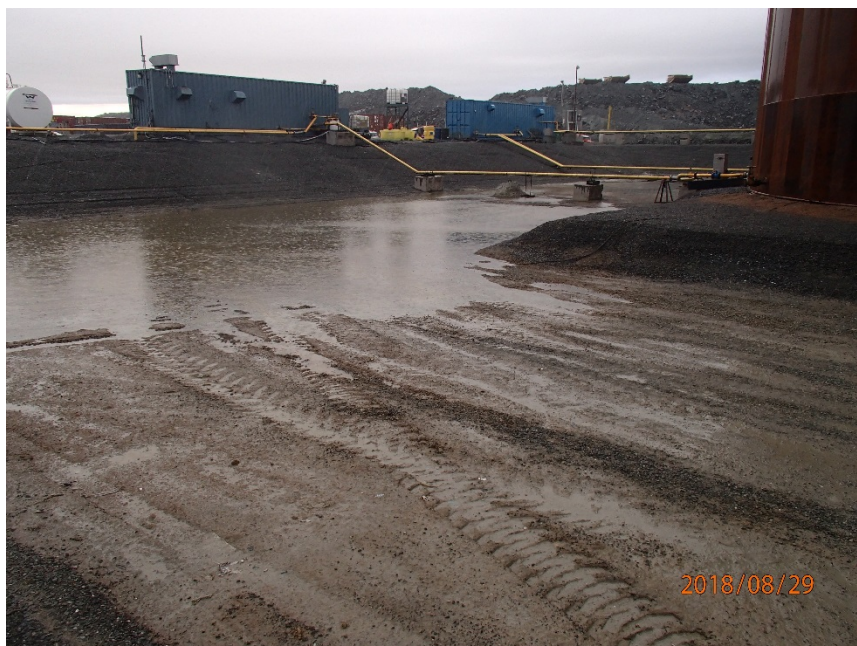
Photograph G2-4 Meadowbank Tank Farm

Description: From the eastern side looking southwest. Presence of water ponding. A pump is installed.

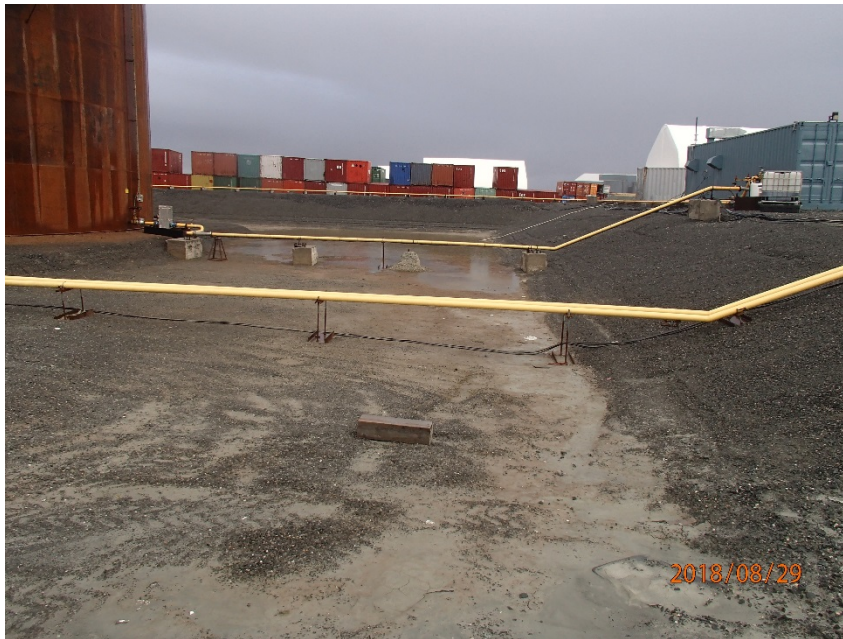
Photograph G2-5 Meadowbank Tank Farm

Description: Looking northeast from the southern corner. Accumulation of water in the eastern corner.
