# **Meadowbank and Whale Tail 2024 Annual Geotechnical Inspection**

# 2024 Annual Geotechnical Inspection

*Meadowbank Complex, NU*

Reference No. CA0038946.6657-1630-R-Rev0

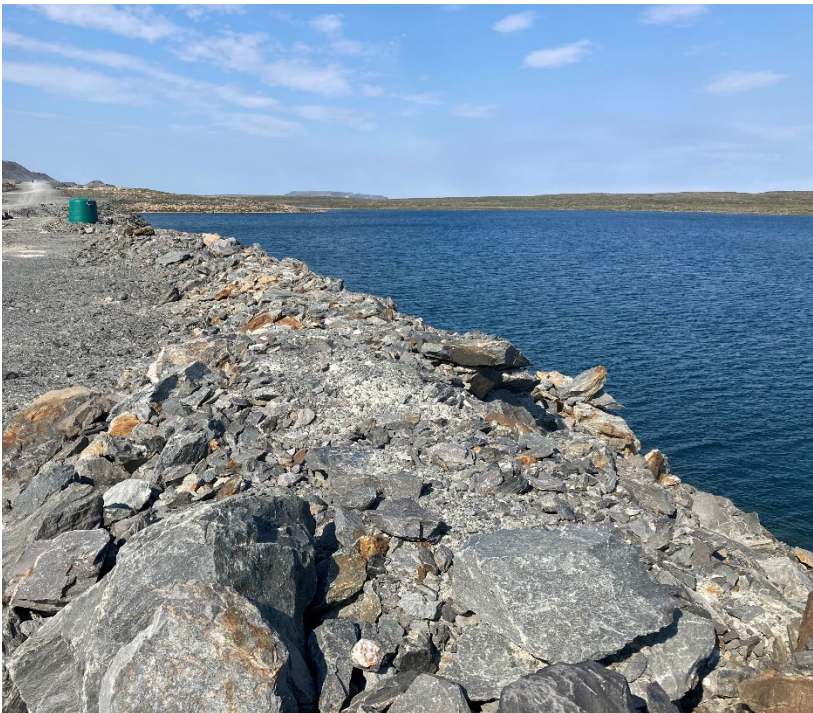
**Photograph A1-04 East Dike**

**Description:** From approximately Sta. 60+500 upstream, looking north at the crest and upstream slope. Irregular upstream crest surface is observed in this area.

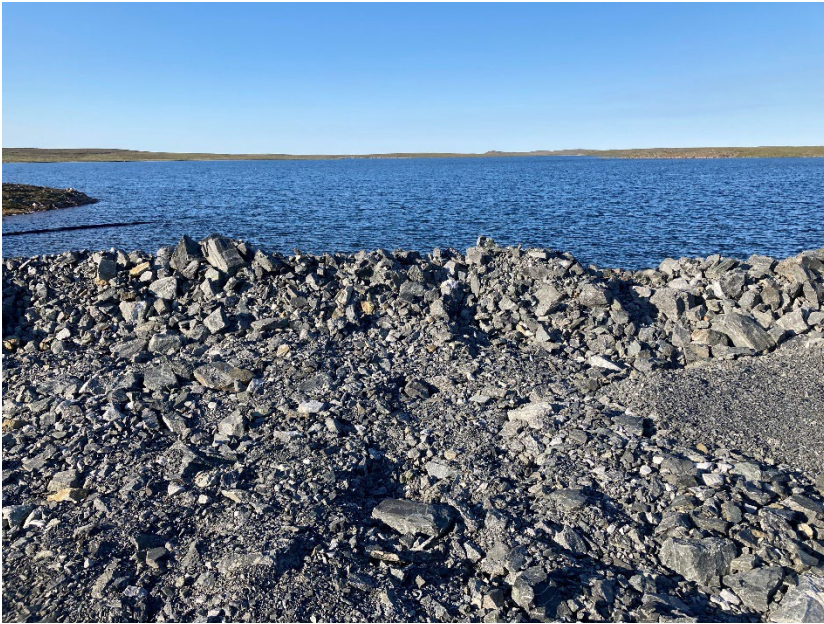
**Photograph A5-17 Whale Tail Dike**

**Description:** From approx. Sta. 0+775 upstream, looking southwest at the capping. Uneven surface is observed, but no visible deformation.

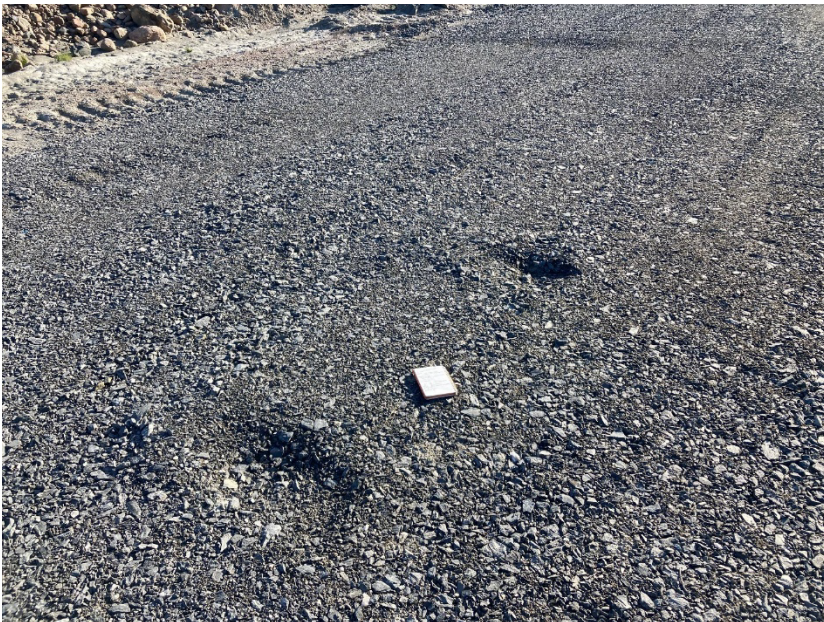
**Photograph A5-22 Whale Tail Dike**

**Description:** From approx. Sta. 0+200 on the downstream platform, looking northeast at the downstream slope and platform. Depressions are observed in downstream platform (~150 mm, seem inactive).

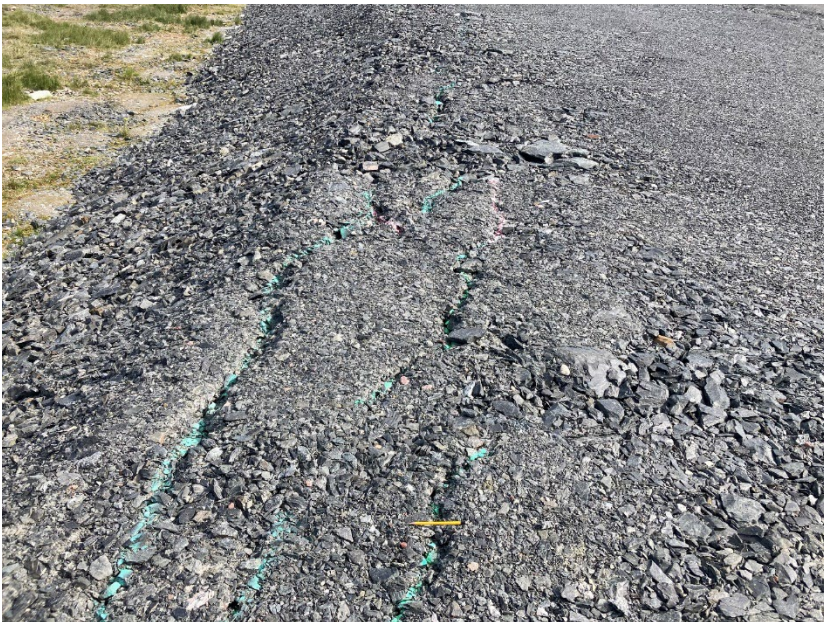
Photograph A6-8 IVR Dike D-1

**Description:** From approx. Sta. 0+300, looking east at the crest and upstream slope. Presence of tension cracks (inactive).

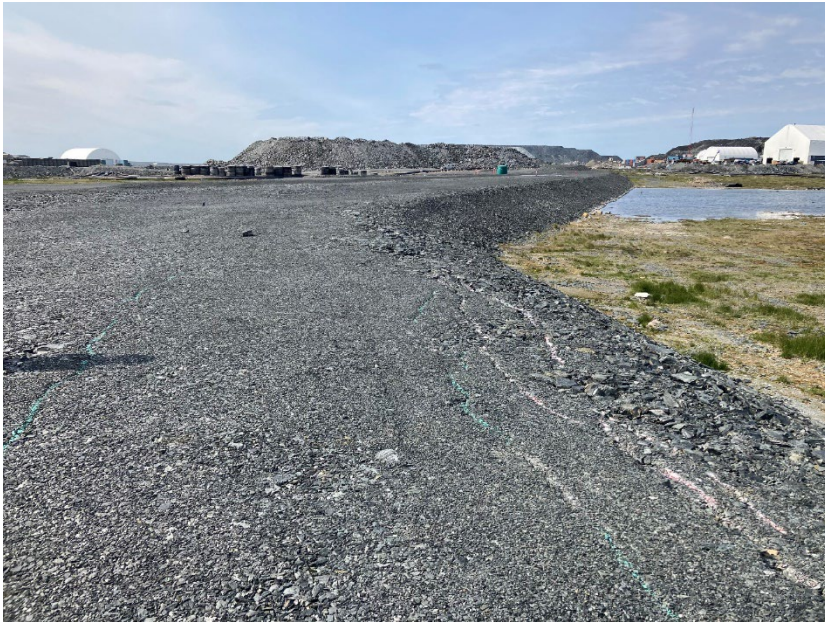
**Photograph A6-9 IVR Dike D-1**

**Description:** From approx. Sta. 0+350, looking west at the crest and upstream slope. Presence of tension cracks (inactive).

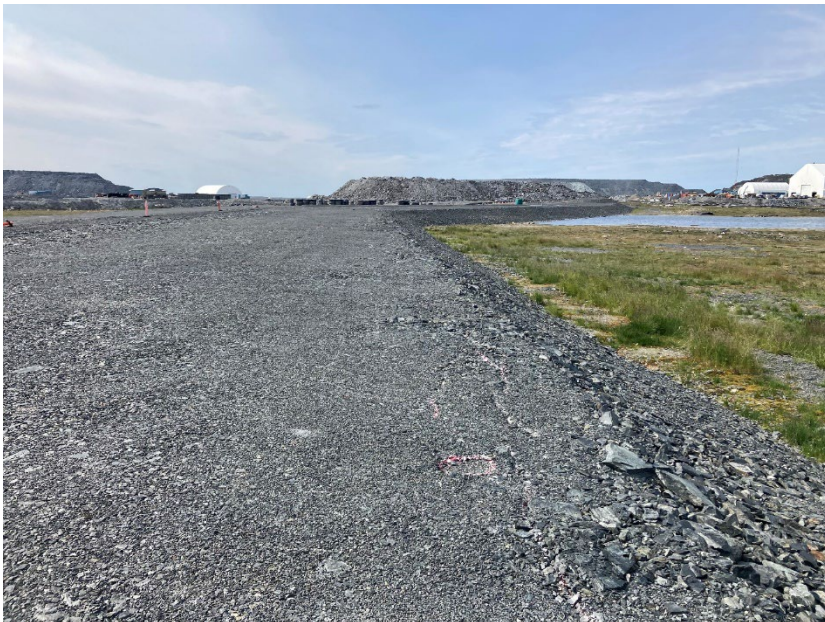
**Photograph A6-10 IVR Dike D-1**

**Description:** From approx. Sta. 0+420 (east abutment), looking west at the crest (thermal cap) and upstream slope. Presence of tension cracks (50 to 100 mm wide, seems inactive) approximately 2 m from the crest.

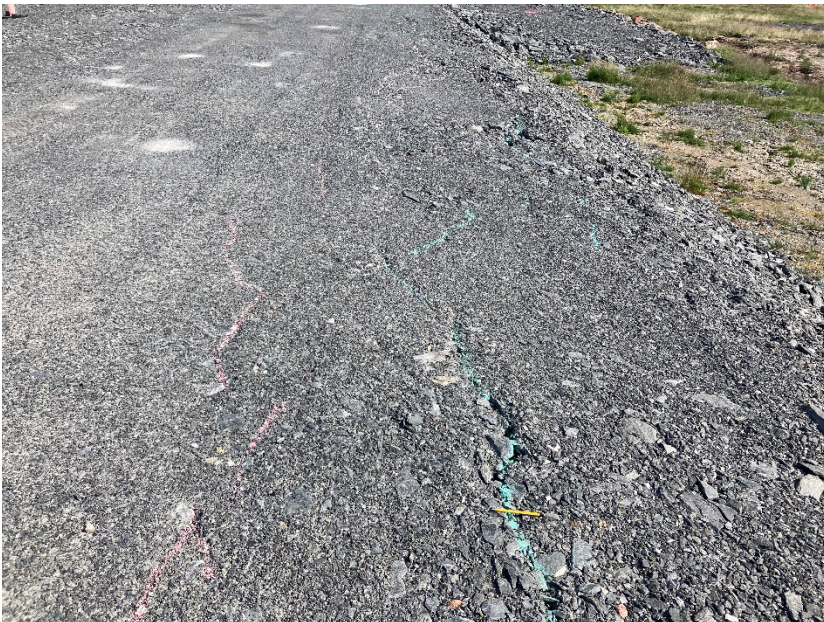
**Photograph A6-14 IVR Dike D-1**

**Description:** From approx. Sta. 0+350, looking east at the crest and downstream slope. Presence of tension cracks (5-6 m long, inactive).

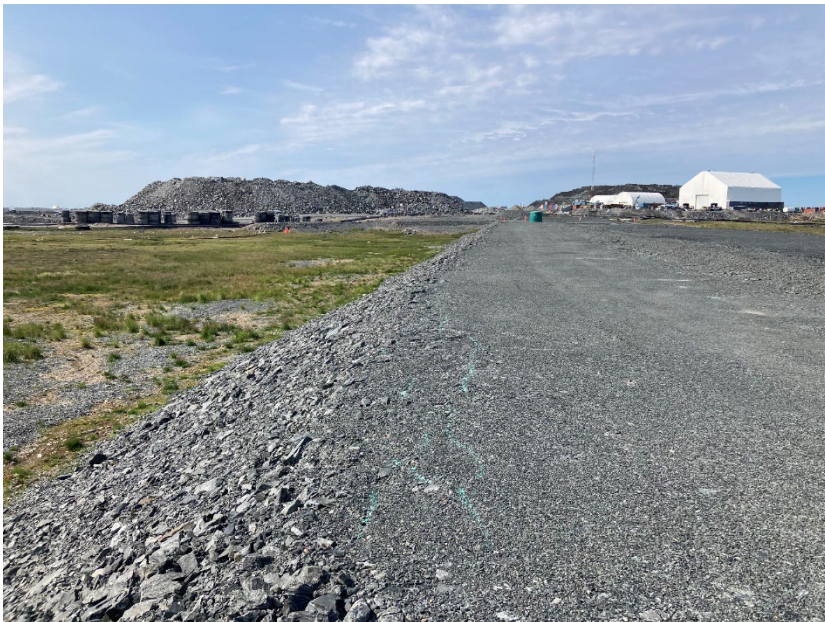
**Photograph A6-18 IVR Dike D-1**

**Description:** From approx. Sta. 0+300, looking northwest at the crest and downstream slope. Presence of tension cracks (up to 30mm wide) approximately 1m from the crest edge.

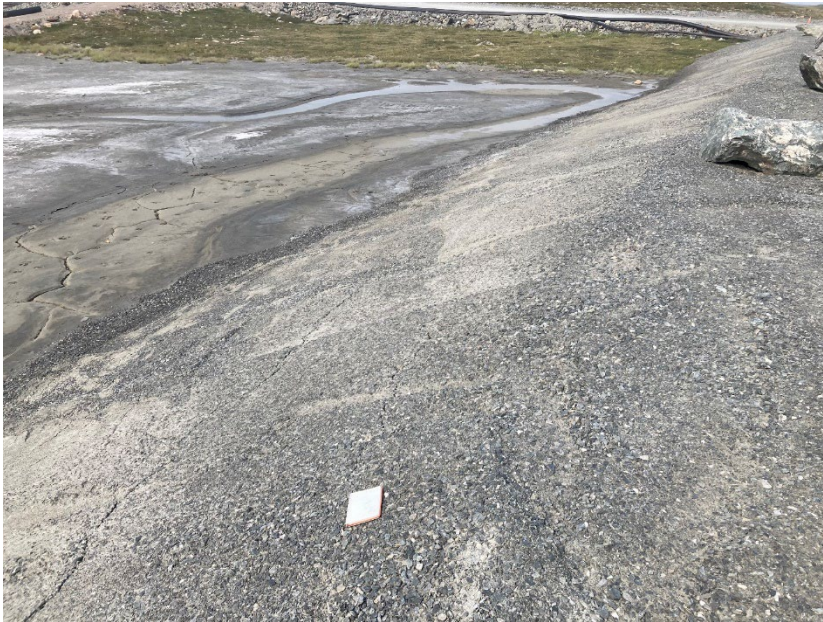
**Photograph B1-01 Tailings Storage Facility**

**Description:** From the North Cell Internal Structure, looking west at upstream slope. Tension cracks in fine filter slope (~ 0- 20 mm wide).

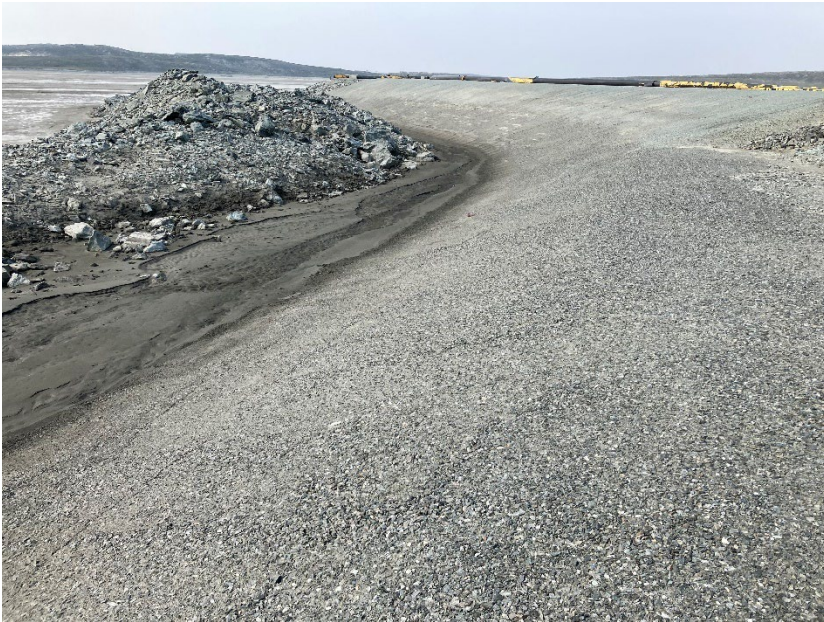
**Photograph B1-11 Tailings Storage Facility**

**Description:** From the North Cell Internal Structure, looking northwest at the upstream slope. Presence of tension crack on upstream slope (approx. 10-20 mm wide).

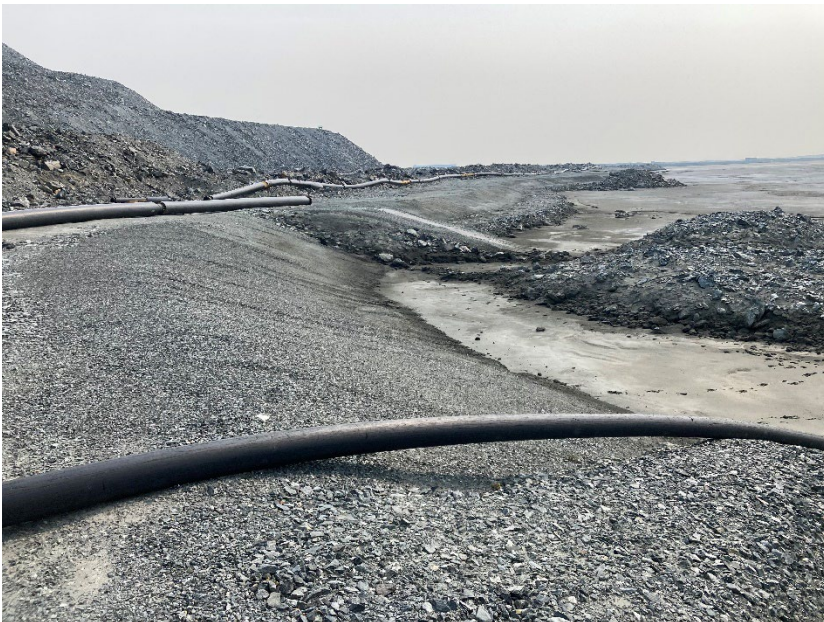
**Photograph B1-12 Tailings Storage Facility**

**Description:** From the North Cell Internal Structure, looking south at the upstream slope. Presence of tension crack on upstream slope (approx. 10-20 mm wide), water channeling at the toe.
