## **Appendix 15**

### **Meadowbank and Whale Tail IRB Report No 33**

January 30<sup>th</sup>, 2026

Report No 33  
Meadowbank Independent Review Board (MBK IRB)  
Site visit August 18<sup>th</sup> to 22<sup>nd</sup>, 2025 and Montréal meeting November 18<sup>th</sup> and 19<sup>th</sup>, 2025.

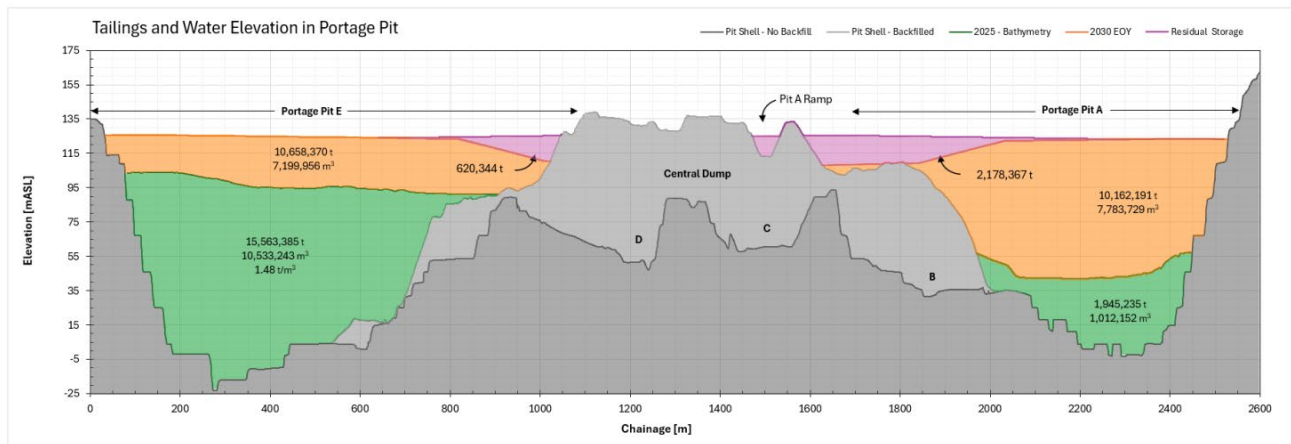
**Figure 4.1 - Pit A and E, Remaining Capacity**

*The Board is encouraged by the advance planning of mine life scenarios with respect to tailings storage capacity, and notes that based on the current assumptions that tailing capacity in Portage Pits will be very close by 2030. It is understood that Newfields are reviewing potential long-term storage options and the board encourages being informed of the progress on this.*

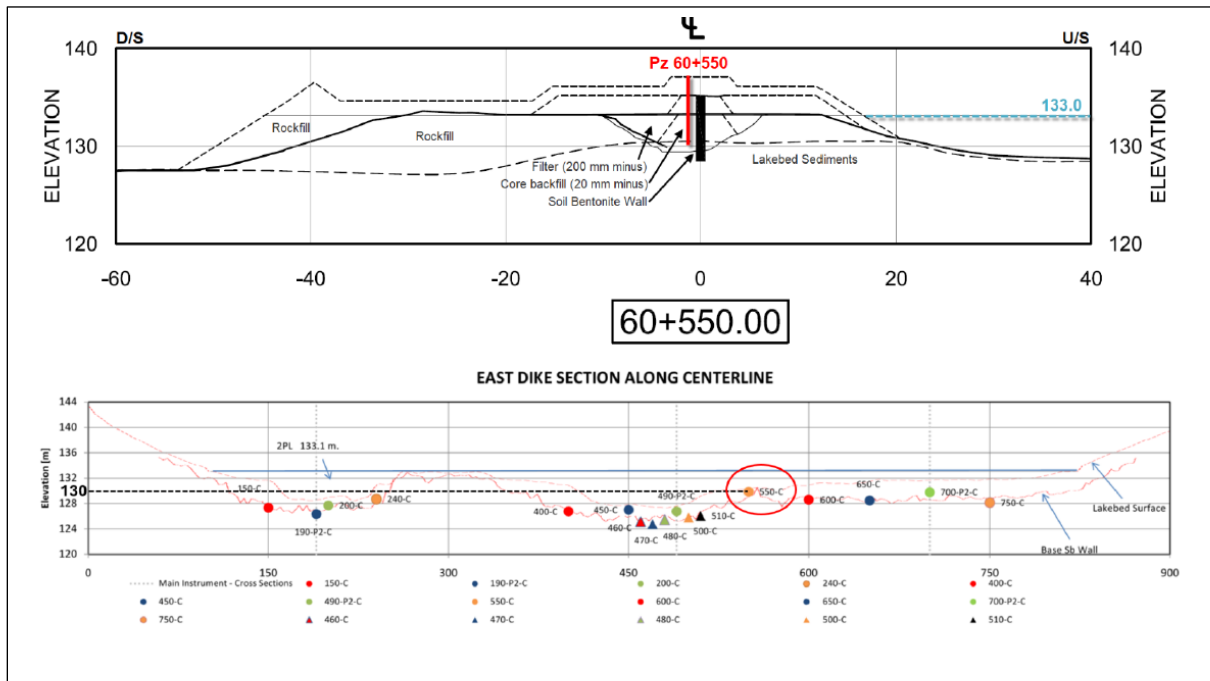
Figure 5.2 Location of Pz550

At the vibrating wire piezometer (VWP) Pz60+550, located downstream of the cut-off, an unexplained pore water pressure rise occurred over the period from March to May 2025. The pressure was noted to remain elevated from May until late July 2025, when a rapid decrease occurred down to the installation elevation (i.e. lower than historic values). The July pressure decrease was noted to correspond to a rapid rise in temperature by approximately 9°C in line with the annual temperature rise in Second Portage Lake. The elevated pressures experienced at Pz60+550 between May and late July exceeded historical highs and even exceeded the water level in Second Portage Lake. Consequently, the functionality of the instrument is suspect, however the reading is currently stable at a value equivalent to the installation elevation and as such, for the moment, an interpretation of a dry condition can be made.

*Nonetheless, the rapid fluctuations in piezometric level accompanying the temperature increase led to the declaration of an increase in TARP level to Yellow, which is justifiable and appropriate. It should be noted that the neighbouring piezometers at Stn. 60+490, also a known seepage area, recorded their highest values in 12 years, although the piezometers have been trending up at a steady rate in recent years.*

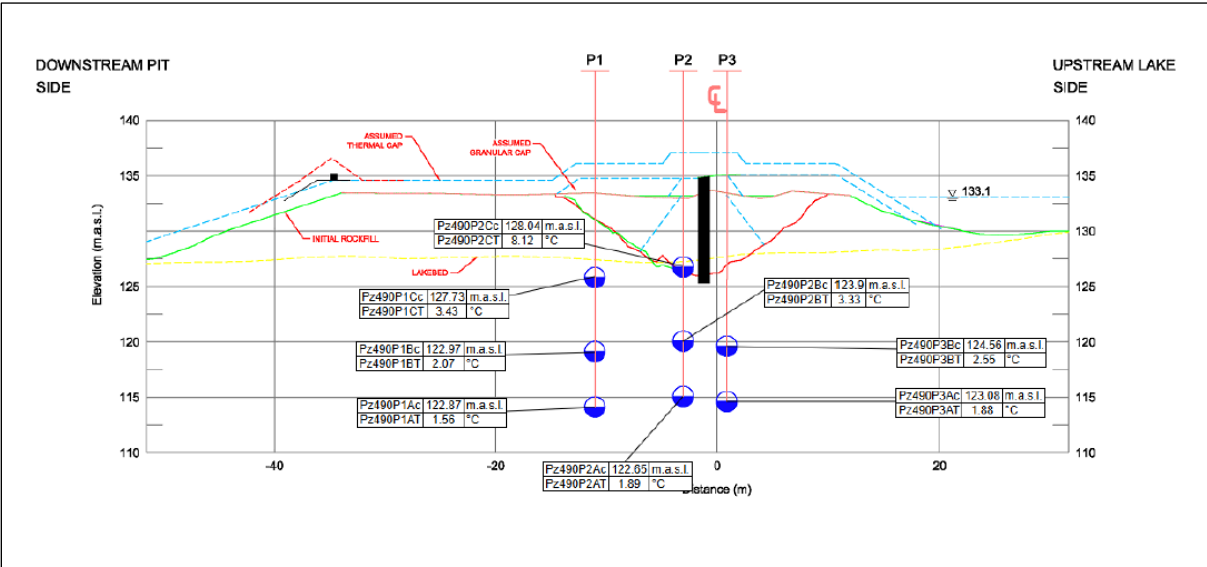
**Figure 5.3 Instruments at 60+490**

The piezometer installed at 60+490 in a similar location (Pz490P2C) in Figure 5.3 also indicates a dry state except for brief periods during freshet. The other seven instruments, installed in the bedrock show downward gradients and a general hydraulic gradient from upstream to downstream. Indeed, pressures recorded by these instruments have been steadily increasing over the past 12 years (see Figure 5.4 below), a phenomenon which is attributed to flow constrictions due to progressive freezing of the terrain downstream of the dike. However, the flow rate is enough to contribute a heat flux and prevent freezing below the dike as can be seen in the temperature readings shown in the lower half of Figure 5.4.

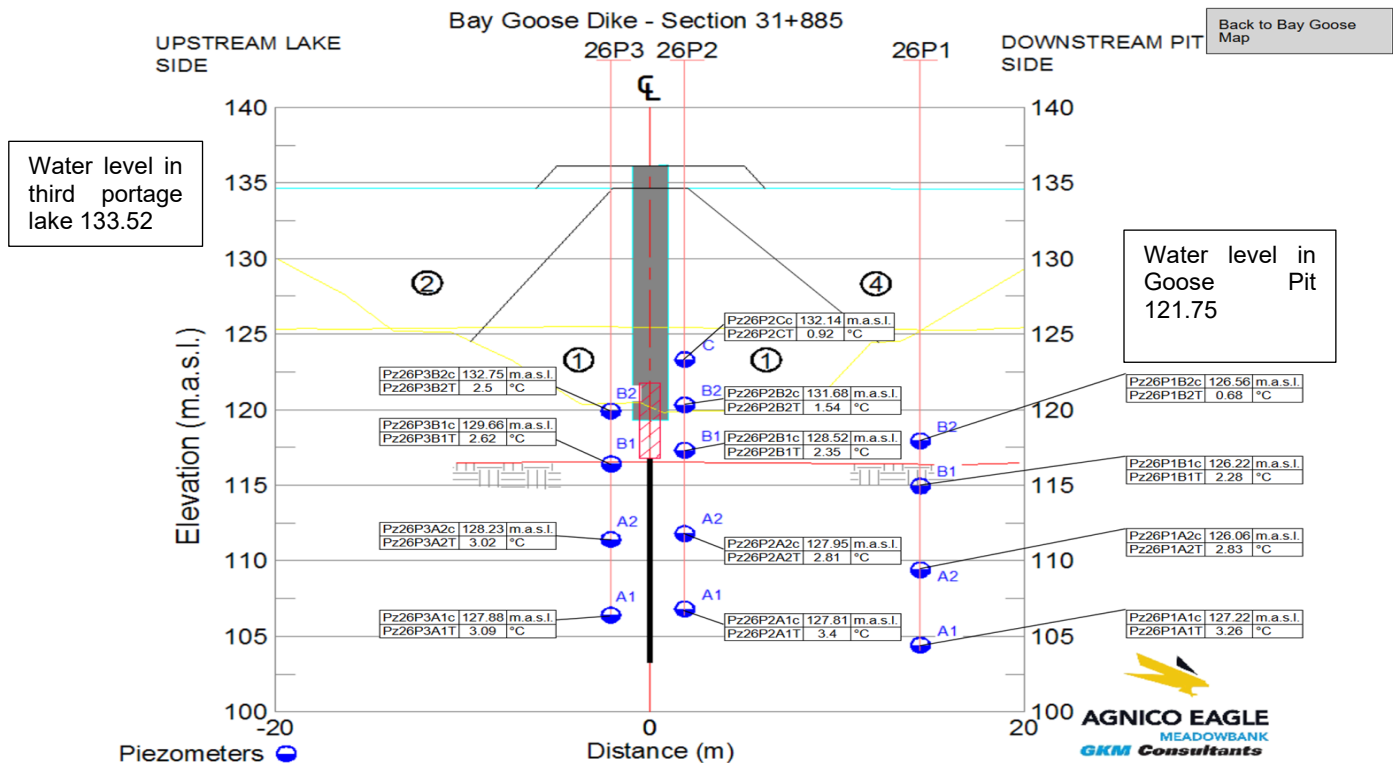
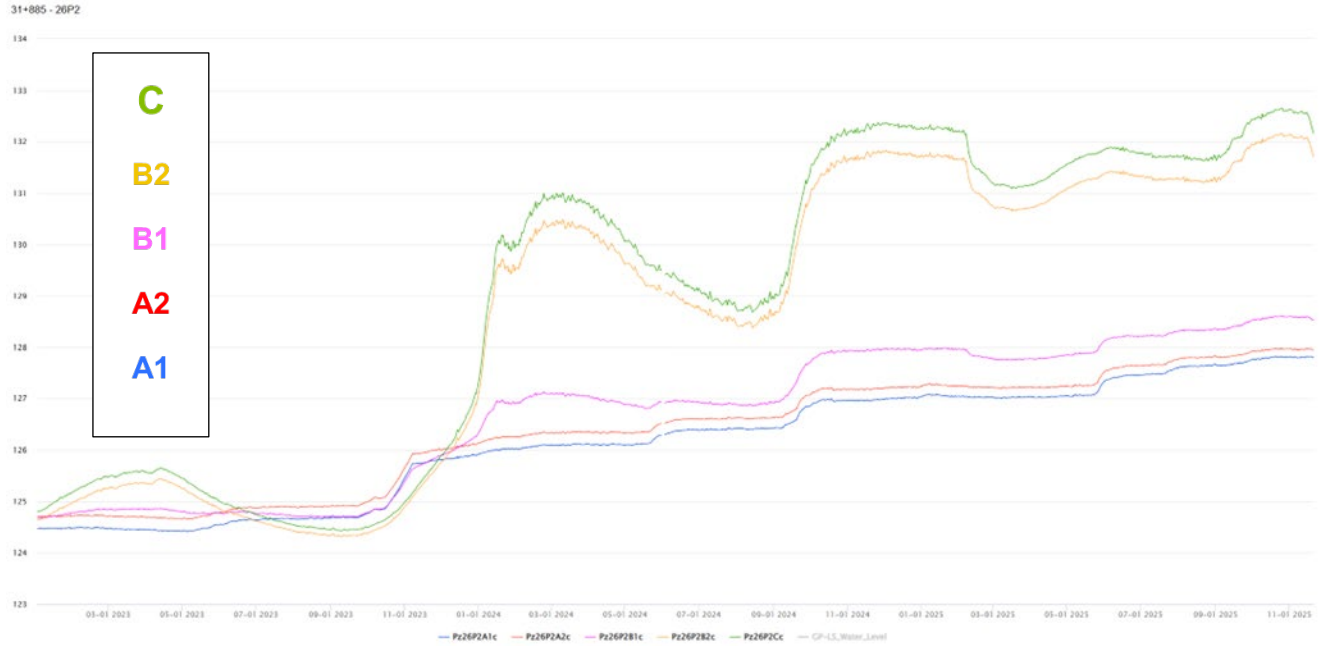
*From the Figures 5.5 and 5.6, certain observations can be made. Note first of all that these instruments are not frozen. The temperatures recorded by the thermistors incorporated in the piezometers have remained above zero since their installation. This is probably due to the fact that the series at Stn. 31+885 are located at lower elevations than the homologous installations elsewhere in Channels 1 and 2. The area constitutes a topographic low for the sector and consequently would attract seepage and infiltration from precipitation.*

Figure 5.5 Piezometer installations at Stn. 31+885

**Figure 5.6** Piezometric levels at select instruments of the P2 column for Stn. 31+885

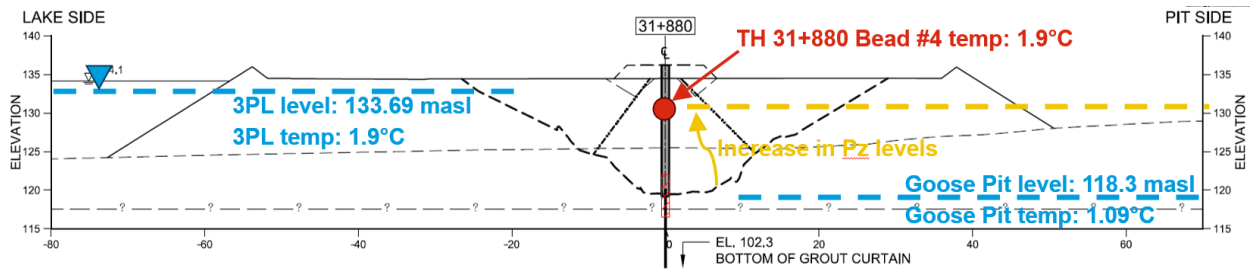
**Figure 5.7** Observations drawn from thermistor T24 data and presented in December 2024.

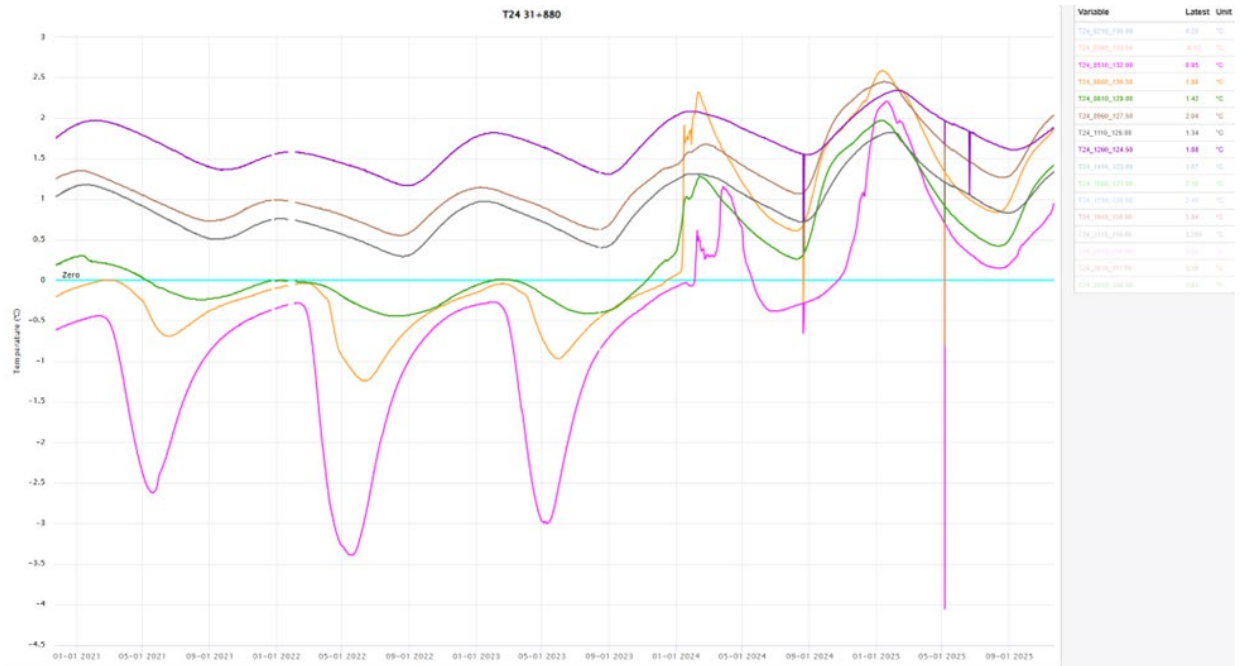
**Figure 5.8 Thermistor string T24 at Stn. 31+880, selected readings from 2021 to 2025**

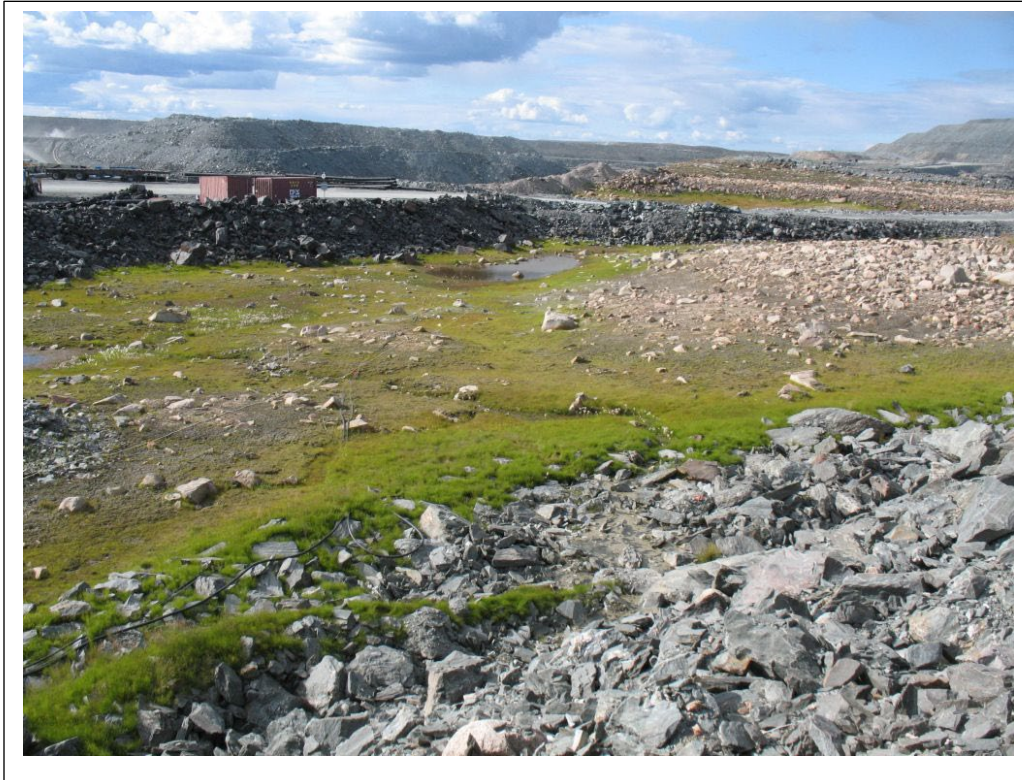
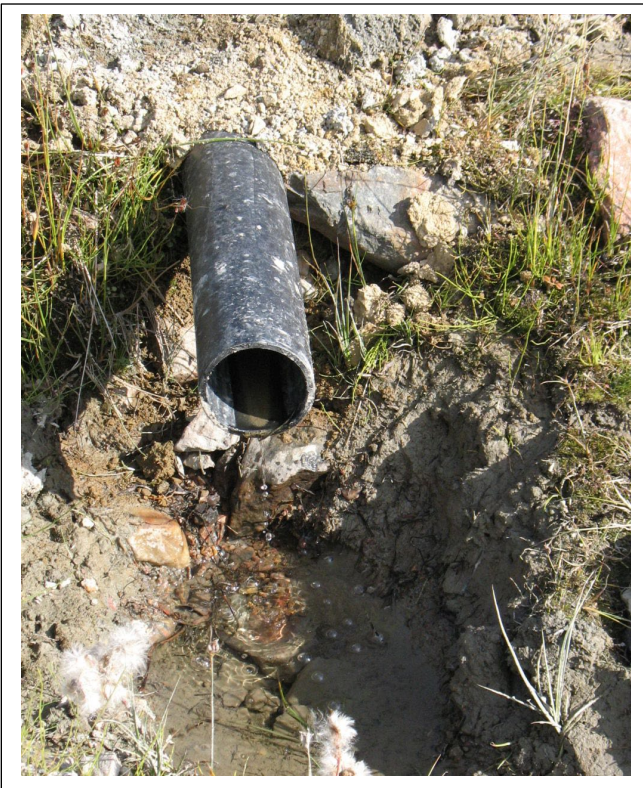
Indeed, seepage flow rates at 60+550 or slightly further to the north that report directly to the dike toe are small as can be seen on Photos 1 and 2 in Appendix B. Examination of the cross-section and longitudinal profile, shown in Figure 5.2 below, indicates that the instrument at 60+550 while situated in the core trench downstream of the cutoff, is at a topographic high and consequently any seepage would drain to neighbouring areas and to downstream. Provided no ice dams are present around the instrument, a piezometer reading indicating a dry state could be expected. Seepage may travel from 60+550 towards 60+490 where it would drain towards the pump station A. Seepage through the rock may be intercepted at the pump station A or may daylight on the pit wall further downstream.

Photo #1 East Dike toe area at 60+550

Photo #2 Surface flow downstream from 60+550

*The Board concurs with the decision to prepare for any remedial works but recommends that AEM make every effort to fully understand the reasons for the observations and to identify the location of any seepage before embarking on a grouting program. To this end, evaluation of the trends should include comparisons with early performance right after initial dewatering, and before any ground freezing and mine pit excavation.*

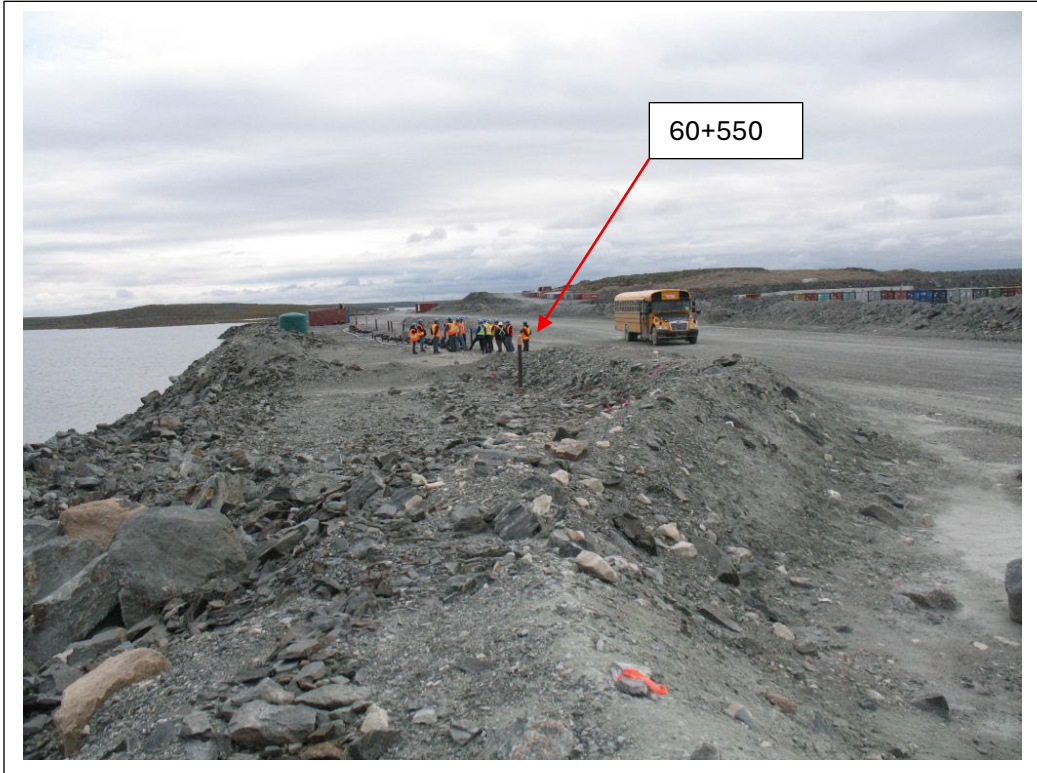
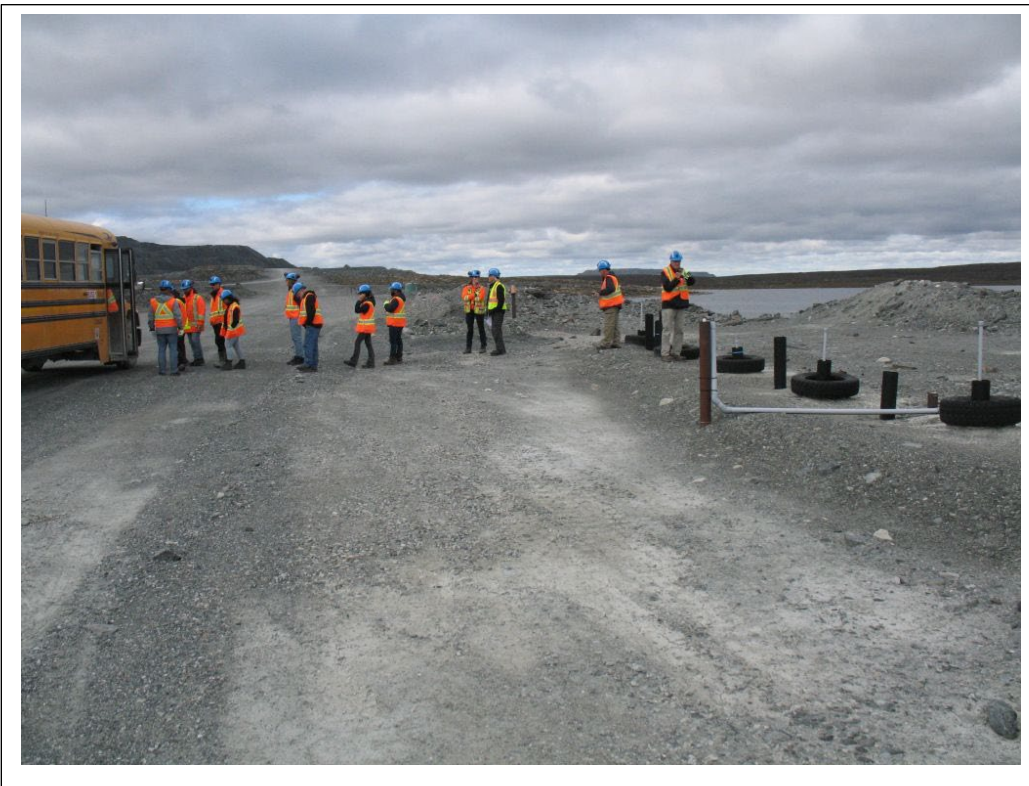
*On Photos 3 and 4 in Appendix B, certain features are noted that could help to explain the changes occurring at 60+550. The windrow would encourage snow accumulation in winter and act as an insulator to limit freezing during winter months. Sediment deposits on the surface show possible periods of surface run-off accumulation that could have led to infiltration of water in July 2025. Since the site visit, AEM has proceeded with the removal of the windrow with a view to enhancing freeze-back. In addition, a small trench has been excavated downstream of Stn. 60+550 to reduce water accumulation at the toe and facilitate inspection.*

Photo #3 Windrow at 60+550

Photo #4 Run-off flow path towards area at 60+550

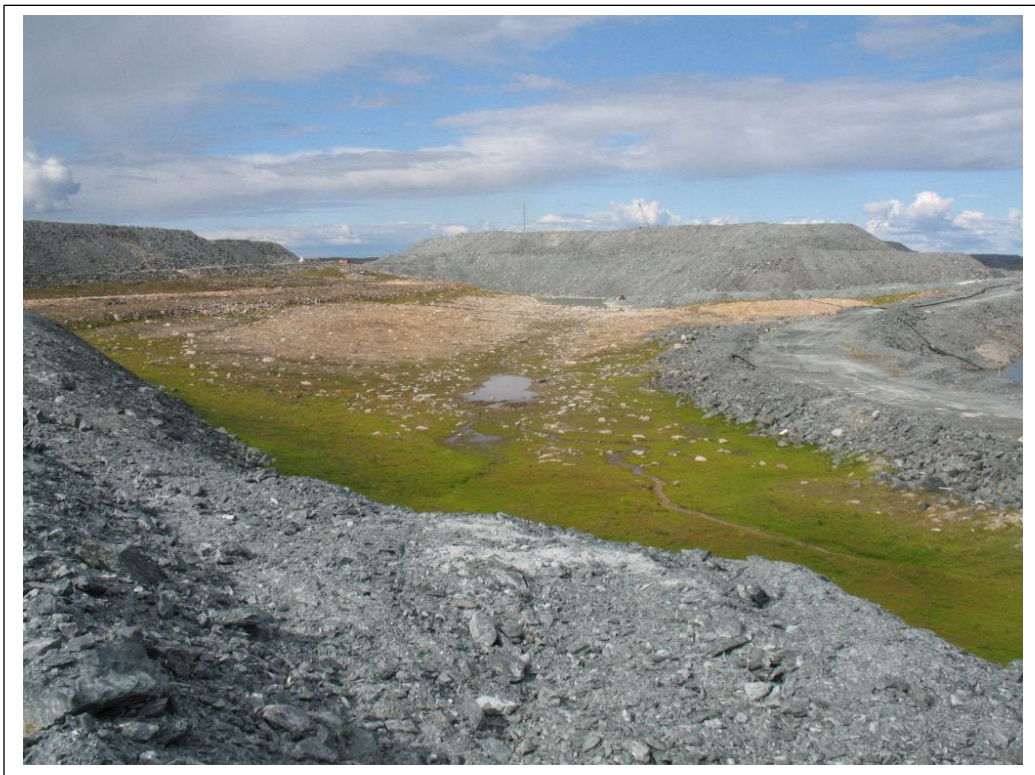
Photo #5 Bay-Goose Dike, downstream of dike in area of channel 1

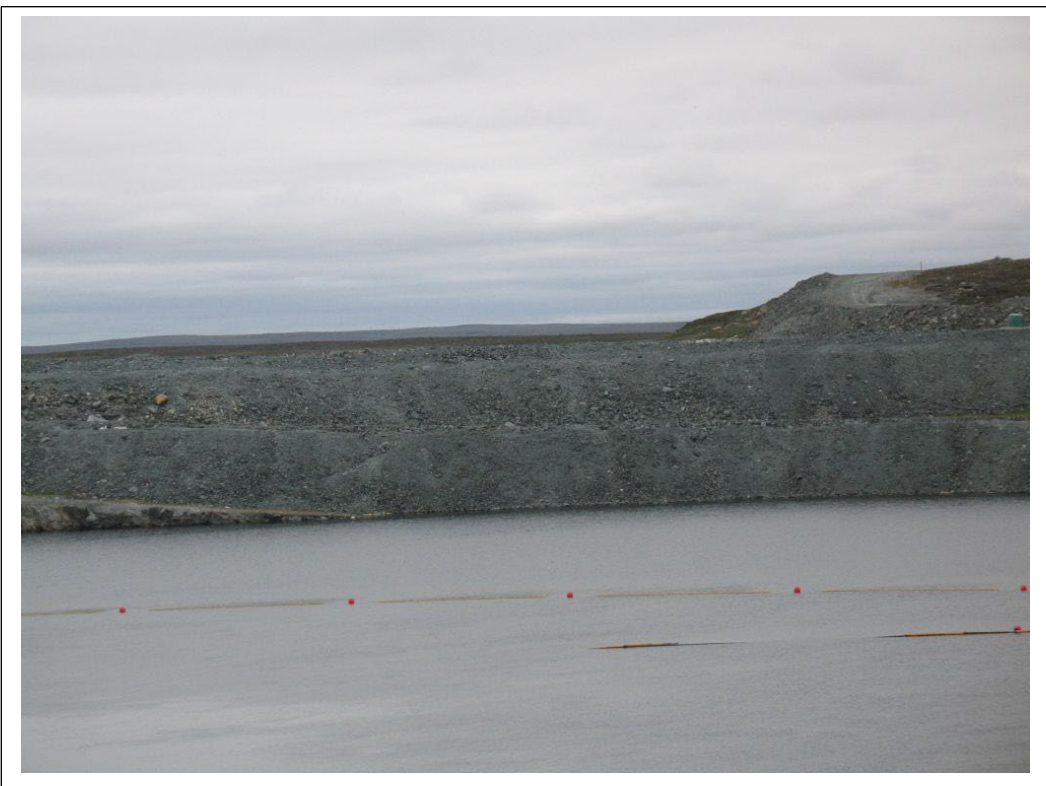
Photo #6 Bay-Goose pit, channels 1 and 2 of Bay-Goose dike.

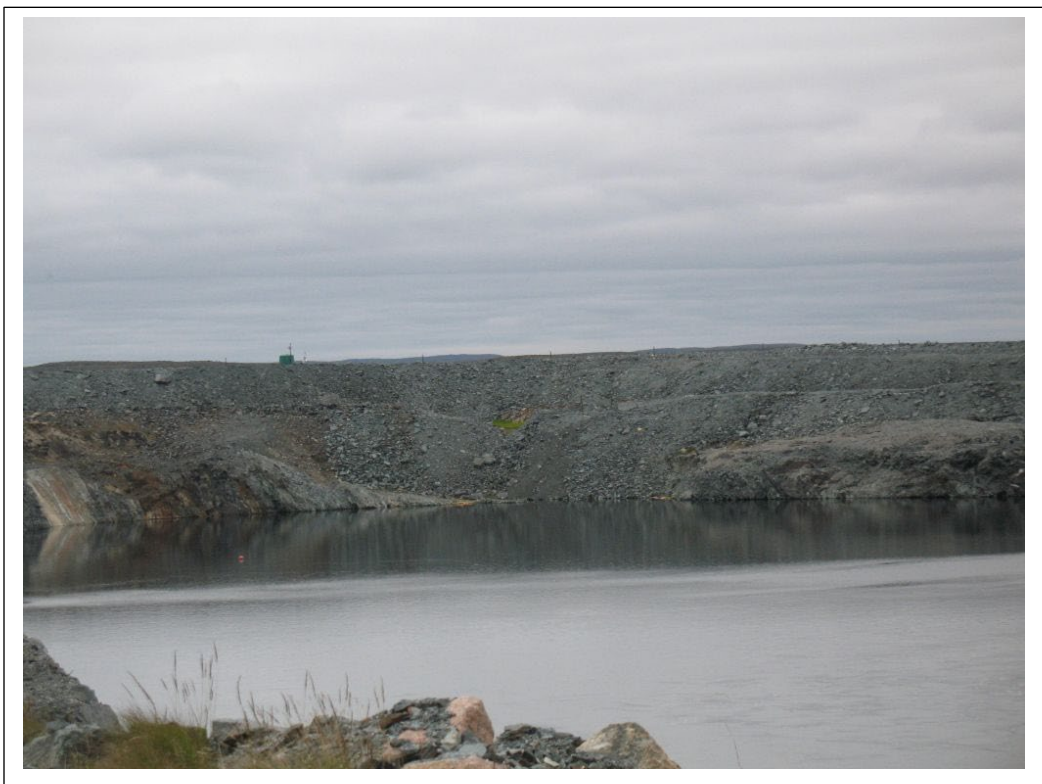
Photo #7 Bay-Goose pit, channel 3 of Bay-Goose dike
