Meadowbank 2025 Annual Open Pit Geomechanical Inspection Report

January 6, 2026

RE: Meadowbank Complex - Meadowbank Site - 2025 Annual Open Pit Geomechanical Inspection

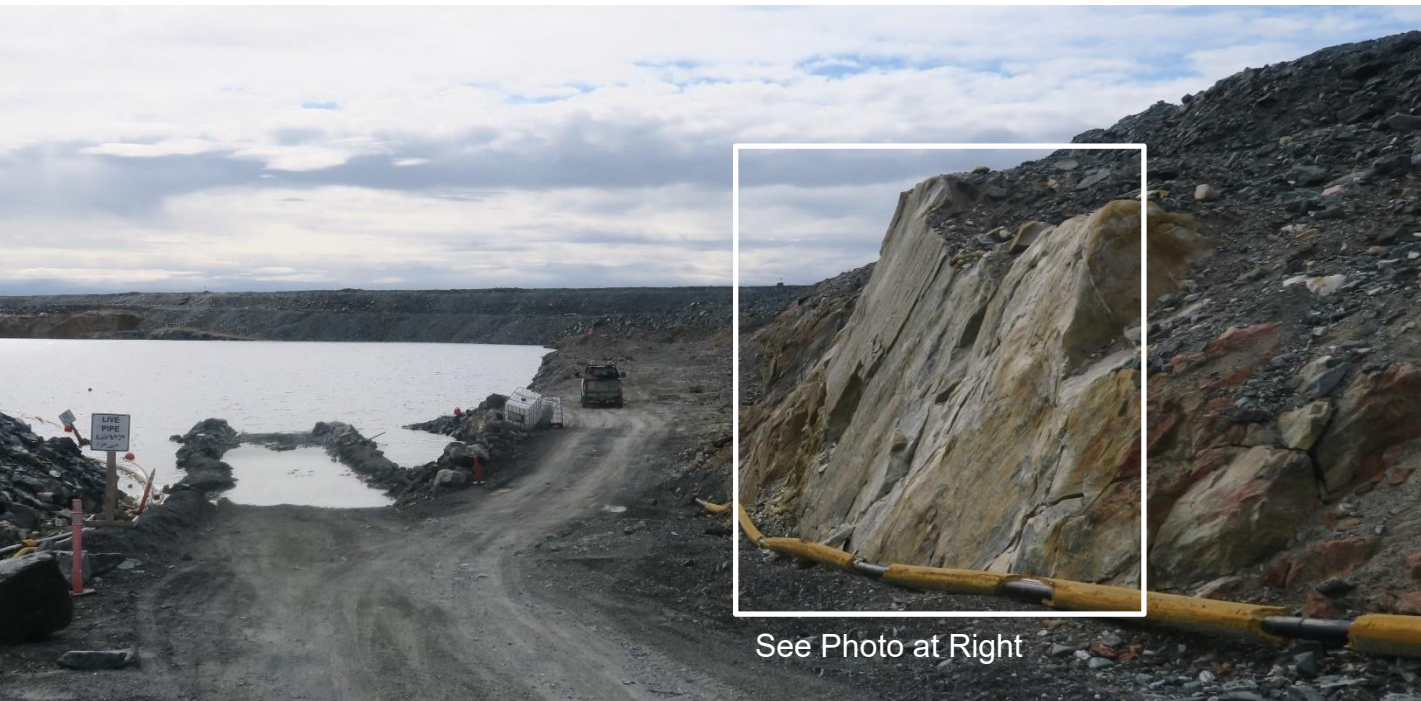
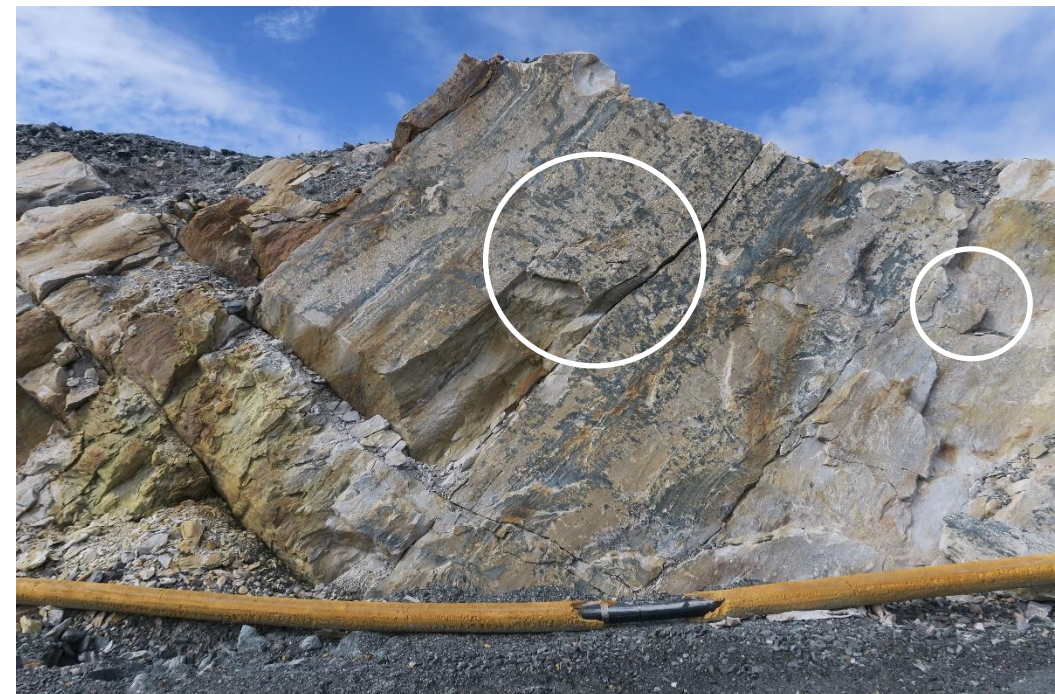
- The access to the pit has been reconfigured and personnel now travel for a short distance along a catch bench to reach a dock on the pit lake. As a result, personnel now travel closer to the uppermost 7 m bench face of the pit. Minor loose was observed on this face, which represents a rockfall hazard. The face should be scaled or a rockfall berm constructed.
- The ramp is clearly sign posted that access is restricted to authorized personnel only.

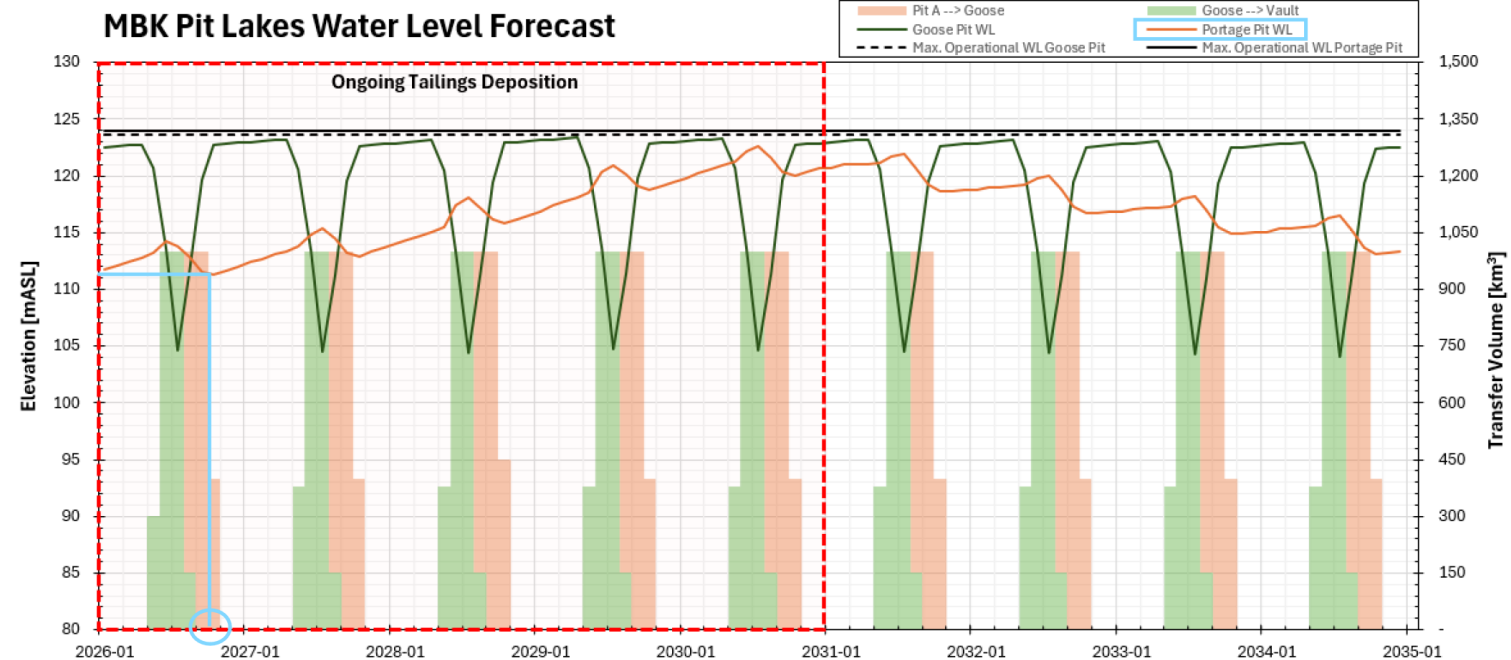
- The rise of the pit lake elevation has progressively reduced the length of the ramp that is exposed and needs to be managed. The open pit water level is planned to be lowered and raised by 17 to 18 m each year starting in 2026 as part of the water treatment strategy for the mine.
- When the water level is lowered, workers will be re-entering previously flooded portions of the ramp. The condition of the open pit walls will need to be re-assessed and the adequacy of any existing control measures (e.g., rockfall berm) reviewed before access is allowed to the re-exposed areas.

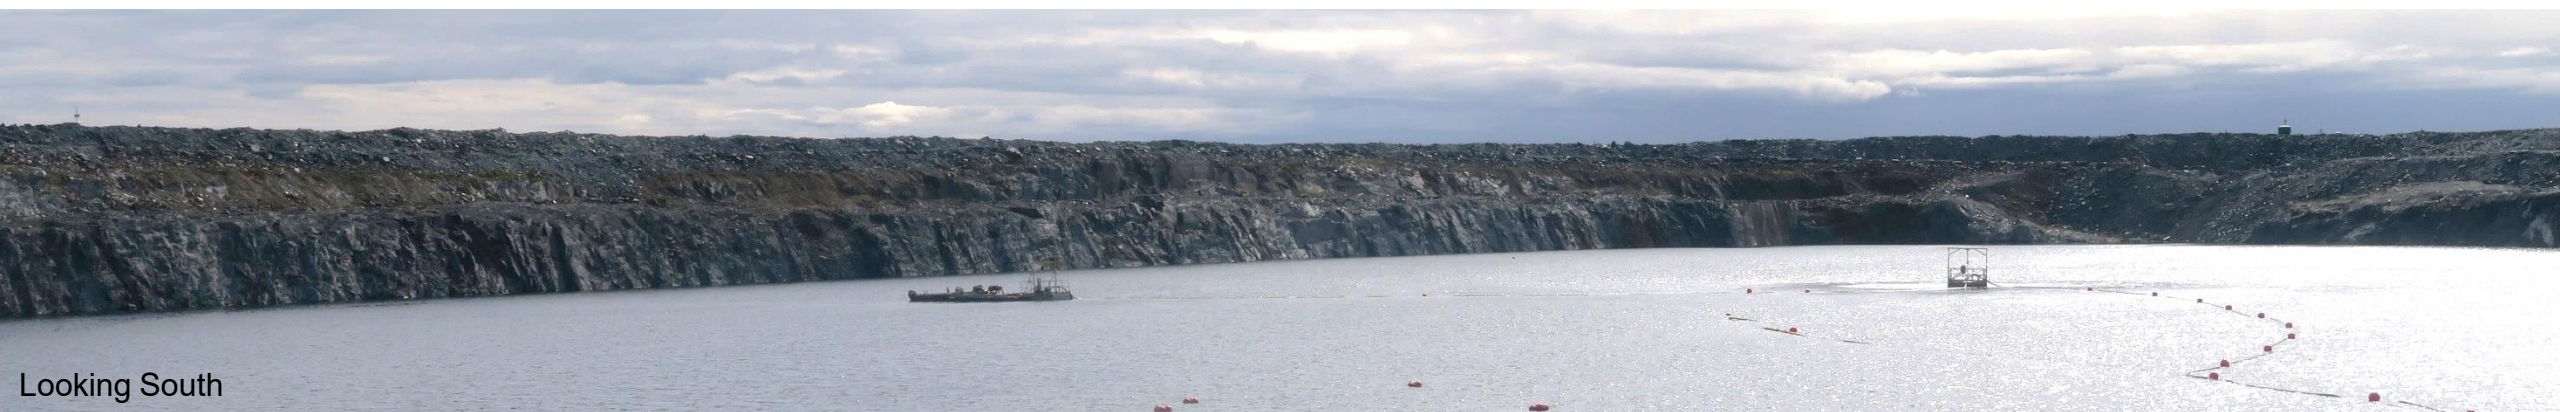
Looking South

- A portion of the upper bench is exposed above the current pit lake.
- The walls are performing well and no particular geomechanical concerns were noted.

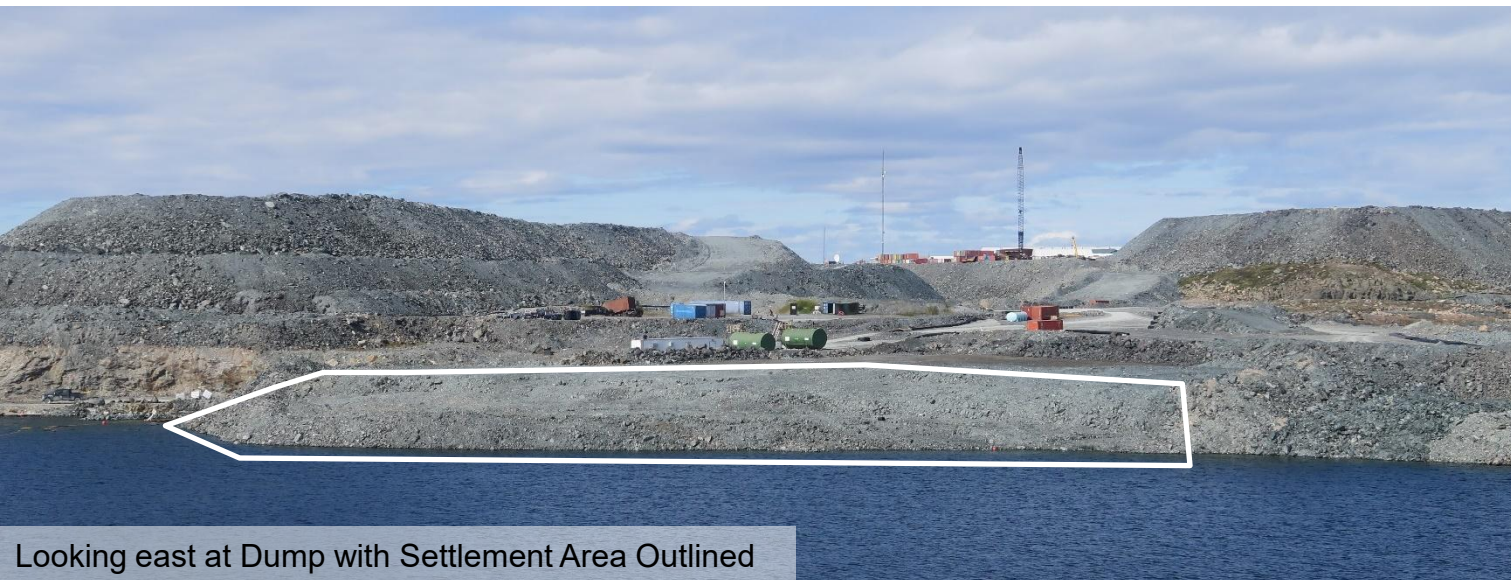
- The dump is inactive, and access is prevented by a rockfill berm and the presence of water pipes at the access point.
- The dump has been subsiding since 2015. The settlement is attributed to the deposition of water in the open pit, through a combination of thawing and increasing porewater pressure.
- The settlement has resulted in a series of scarps along the dump platform, that are now 3 to 4 metres in height (see photo below).
- The settlement is monitored as part of monthly inspections by the Geotechnical Group visually and using four survey pins installed in 2022. The observed deformation is discussed on the following slide.

Looking east at Dump with Settlement Area Outlined

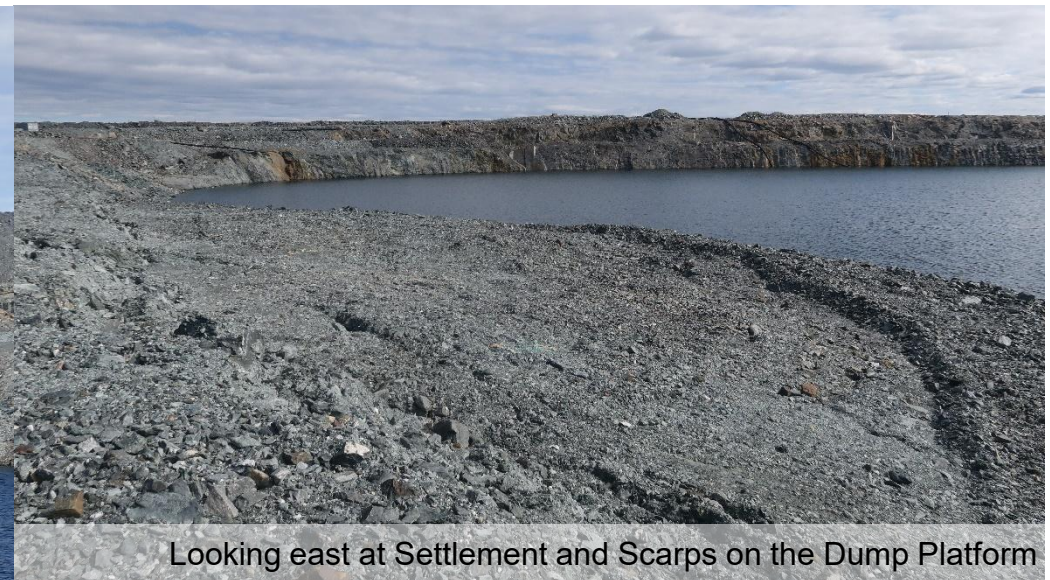
Looking east at Settlement and Scarps on the Dump Platform

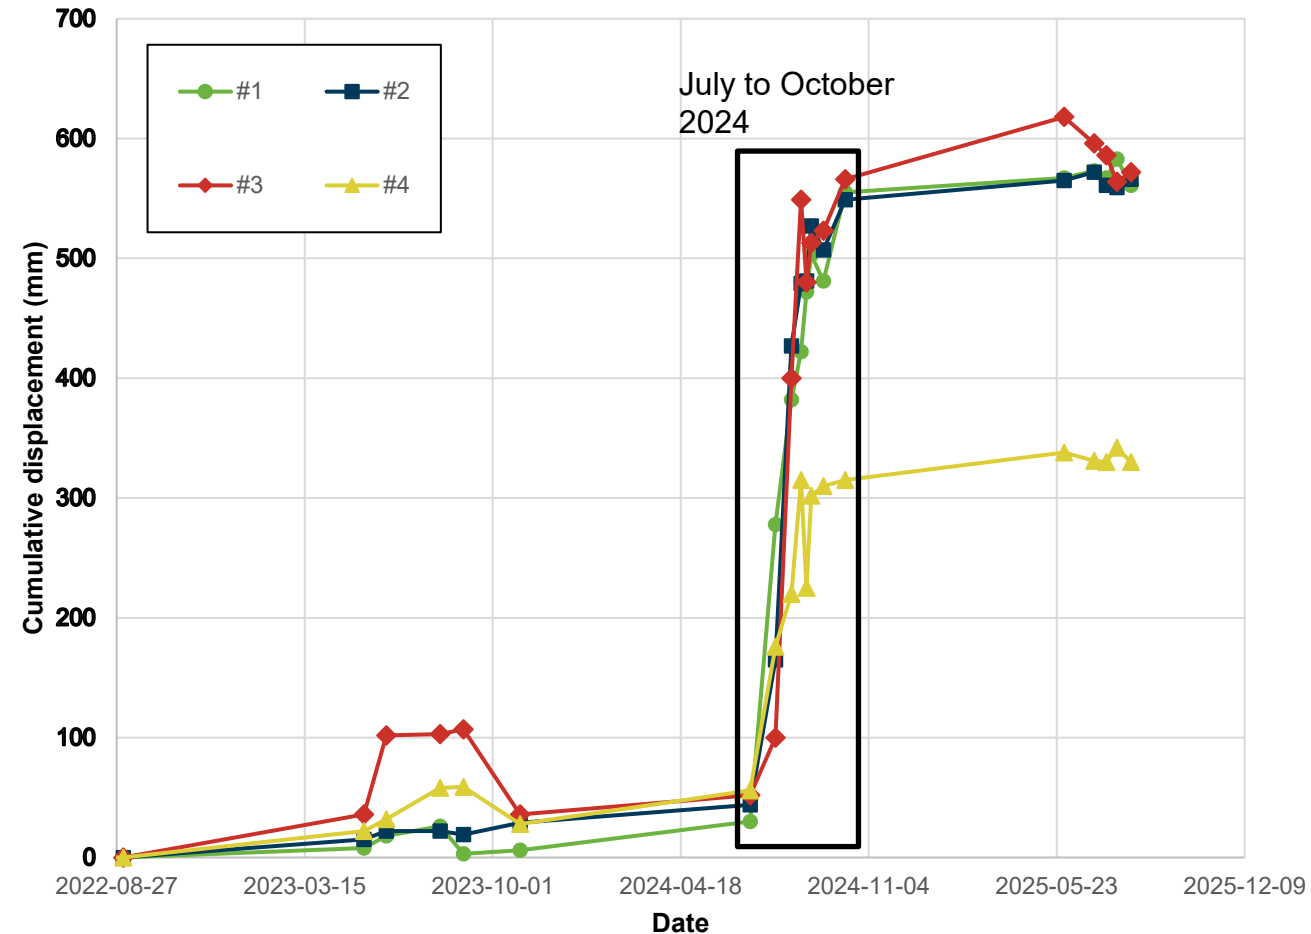
- The four survey pins are monitored on a bi-weekly basis when the open pit is accessed.
- The cumulative displacement increased abruptly by approximately 550 mm between July and October 2024. Until this point, the deformation rate was less than 1 mm/day. The displacement has since stabilized at less than 2 mm/day.
- The cause of the sudden increase in displacement has not been determined but is believed to be due to the increasing water elevation in the pit lake.
- The observed deformation remained within the TARP Blue (Stable) status. However, as discussed during the previous annual inspection, such a sudden change in behaviour should have triggered a review. The TARP should be updated to reflect this.
- There continues to be a need to better quantify the extents and total deformation. Recommend using InSAR or drone photogrammetry to assess this on a semi-annual basis.

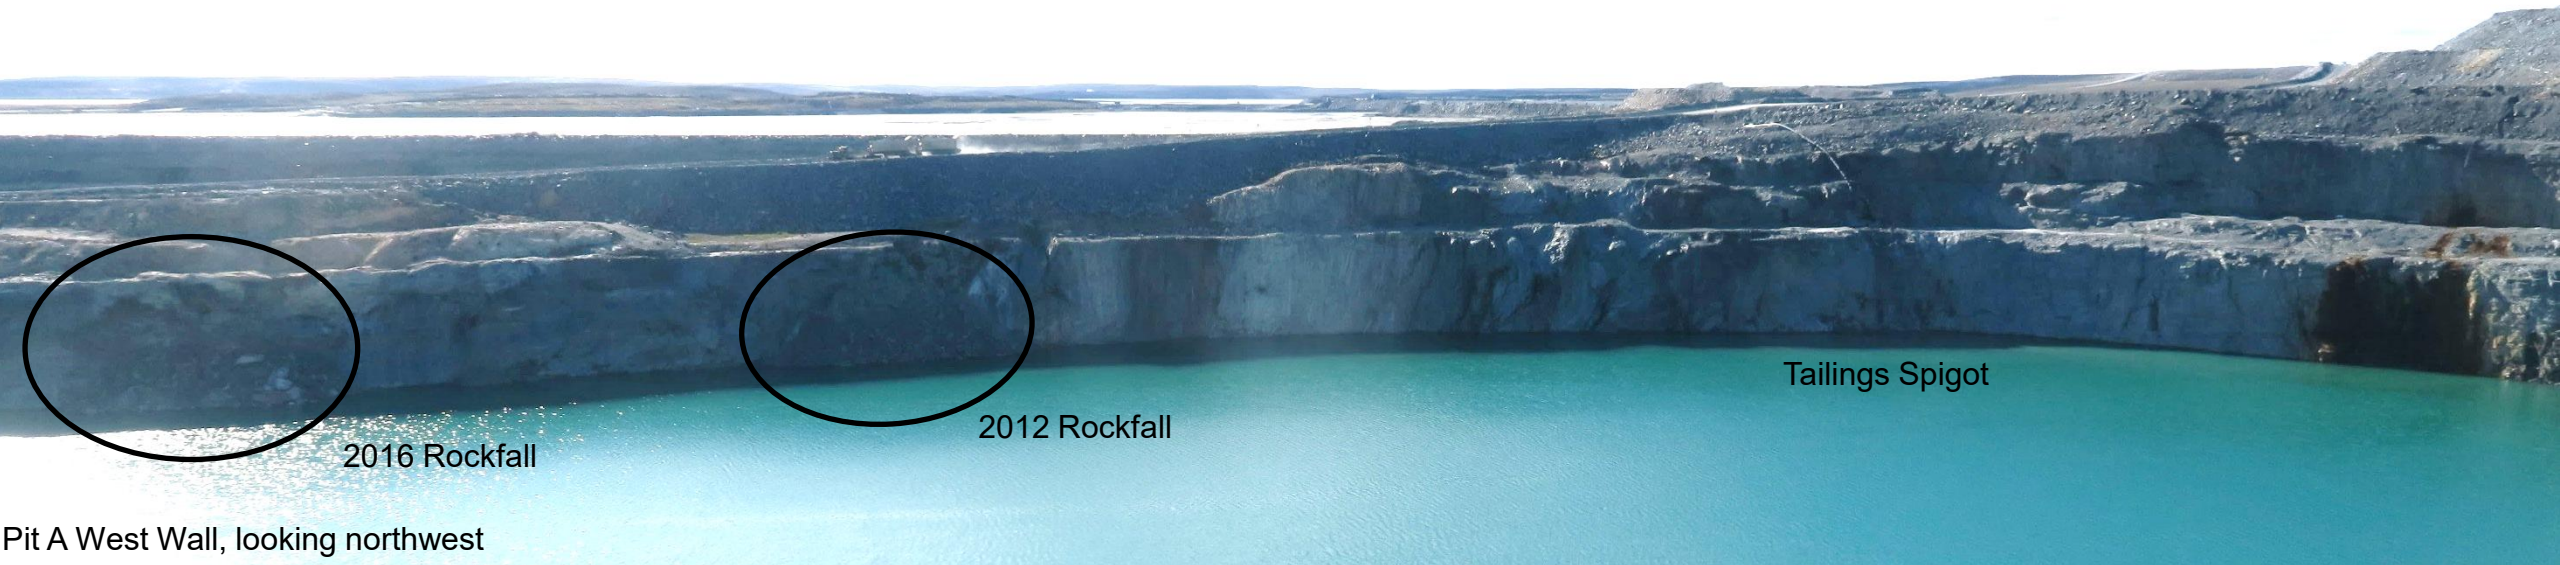
- Approximately one bench is exposed above the pit lake.
- Tailings is being deposited from a spigot in the northwest corner of the open pit. The deposition does not appear to be adversely impacting bench performance.
- No significant change was observed in the pre-existing bench-scale failures remaining above the pit lake since the 2022 inspection, despite the pit lake now reaching the talus piles associated with the failures.
- Access to the East Ramp is restricted by berms at the top and bottom of the ramp (not shown in photo below).
- No particular geomechanical concerns were noted.

Pit A West Wall, looking northwest

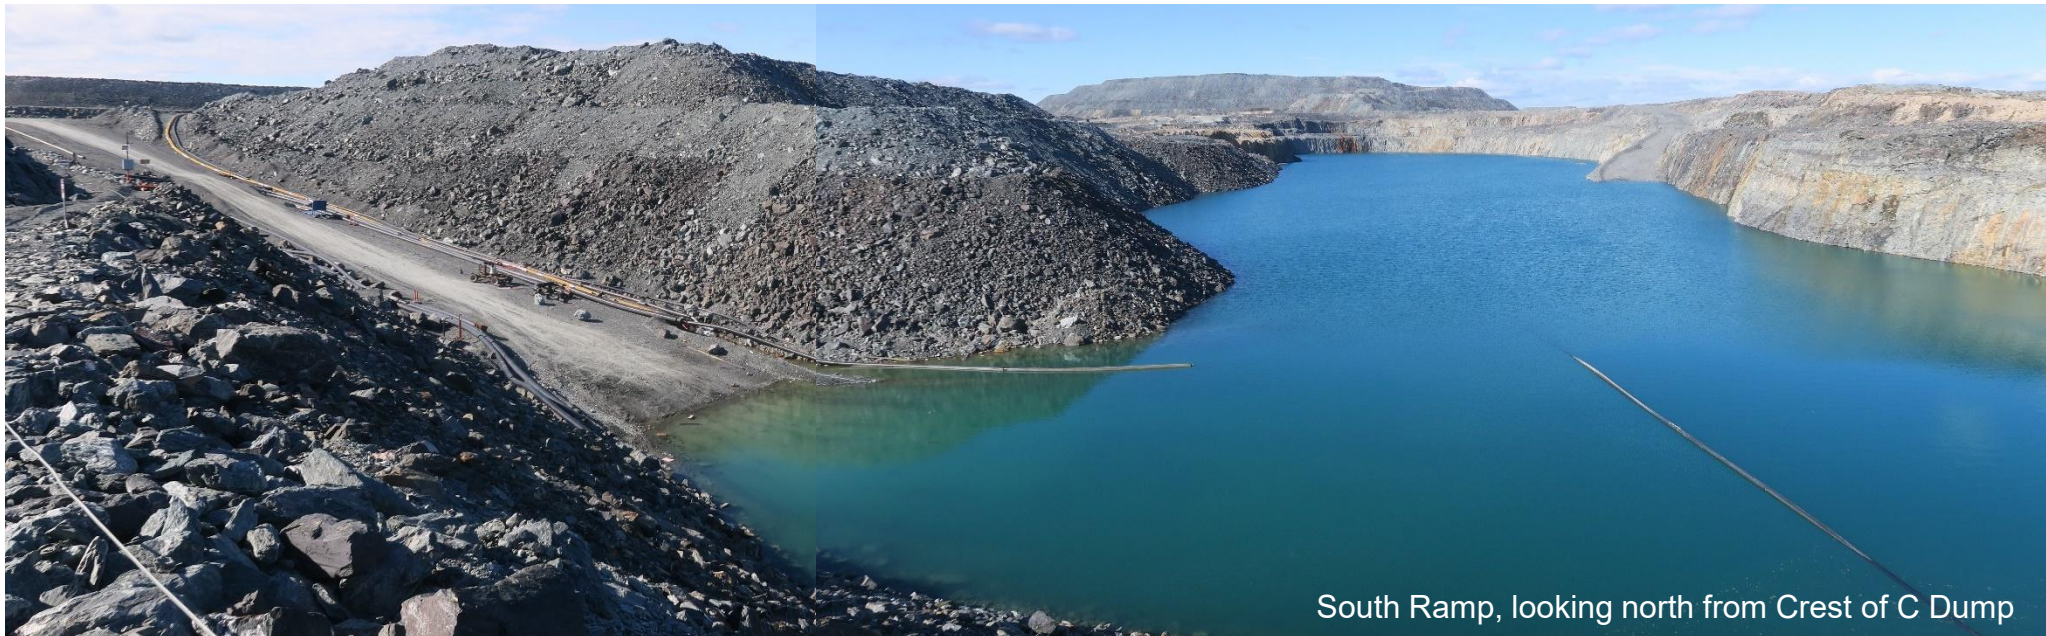
- The South Ramp is used to access the pit lake.
- The ramp is clearly sign posted that access is restricted to authorized personnel only.
- The pump controls have been re-located up the ramp and around the corner from the pit lake, reducing the risk associated with a wave caused by a failure of the open pit slope or the dump.

South Ramp, looking north from Crest of C Dump

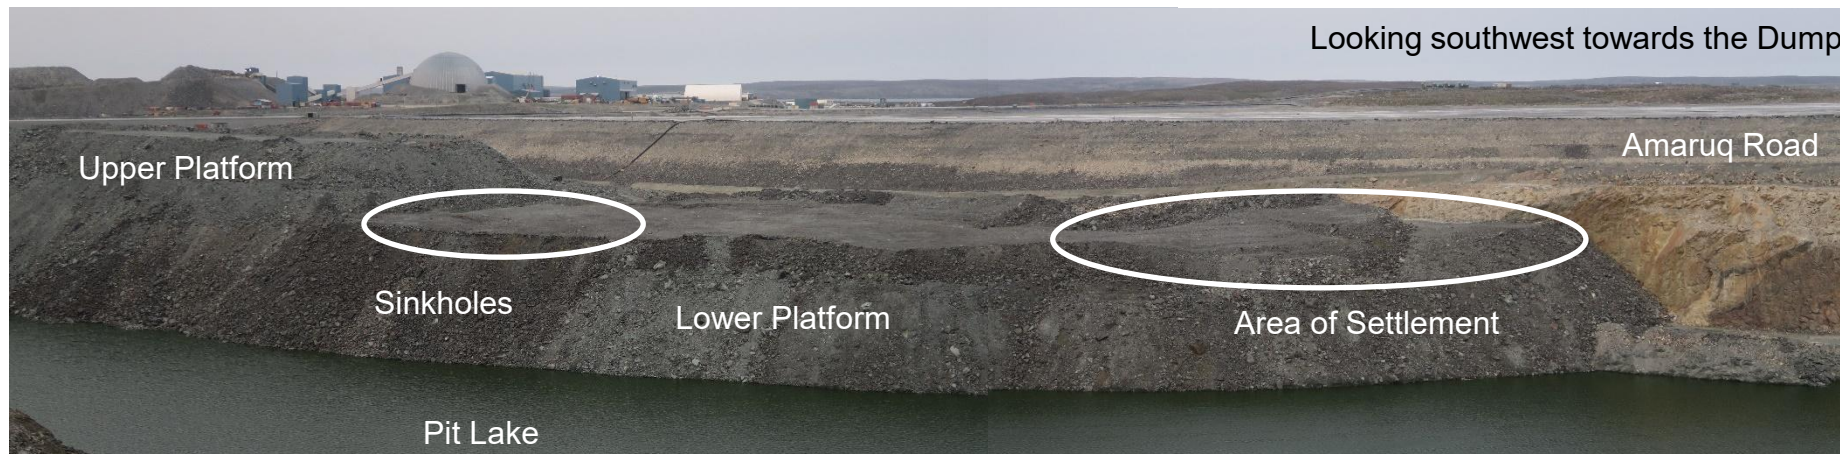
- The B Dump consists of an Upper and Lower Platform, both of which are inactive. Access to both platforms is prevented by berms.
- Failures of the dump slope are possible as the pit lake elevation rises but have not been observed to date. Such a failure could cause a large wave in the pit lake that poses a hazard to personnel conducting water sampling or managing the reclaim water lines.

- Tension cracks and subsidence continue to be observed on both platforms. The northern end of the Lower Platform has experienced the most subsidence. Sinkholes have also formed at the southern end of the Lower Platform. These are discussed on the following slides.

- An extensometer has been installed on the Lower Platform, and this is described further on a following slide.
- The possibility of the settlement progressing back to the Amaruq Road (West Road) was discussed in 2022 and concluded to be unlikely as the settlement and tension cracks appear to be limited to within the footprint of the pit. WSP has completed a detailed assessment of the stability of the road embankment as the water levels increase and the embankment was raised as a result. WSP has recommended that the embankment continue to be monitored as settlement is still possible.

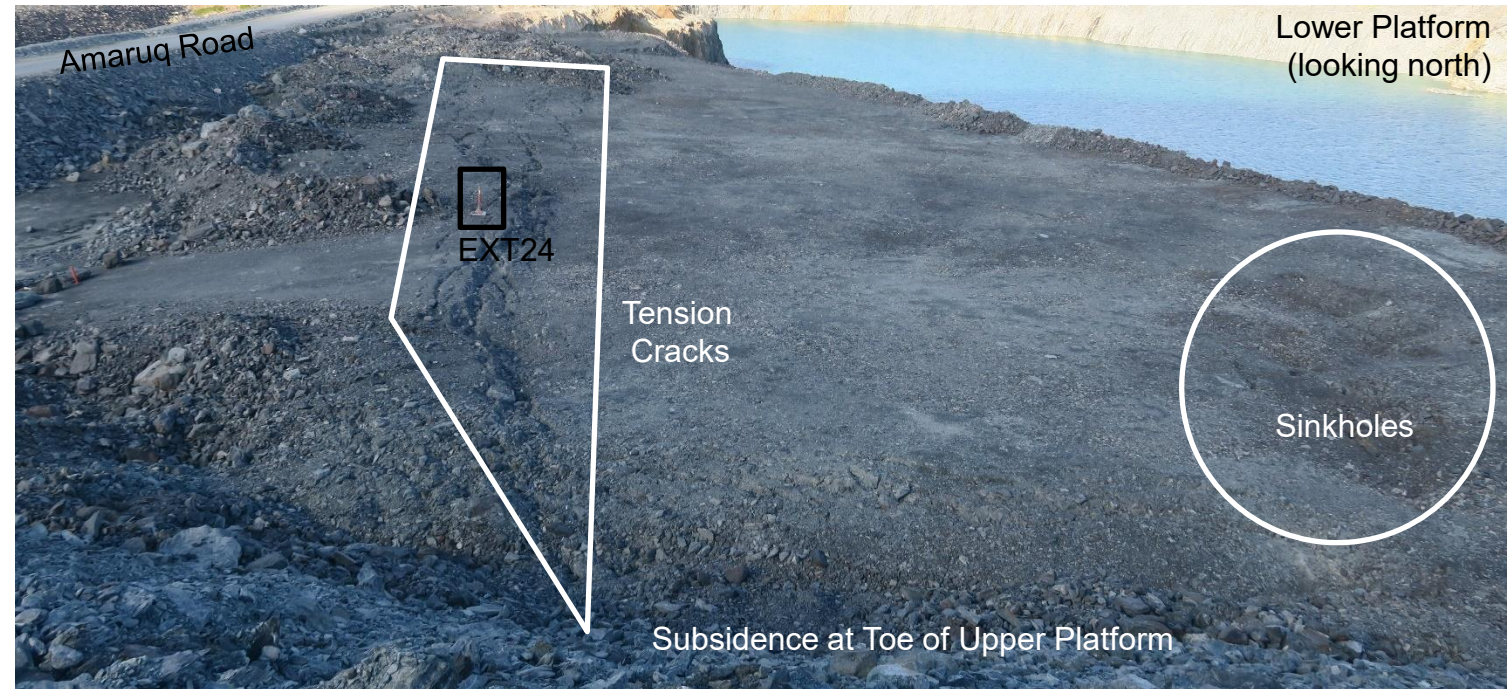
- Tension cracks are present along the western limit of the dump (outlined in white below). The cracks were surveyed a comparison completed in March 2025 suggests that they are located along the crests of the open pit benches. No obvious changes were observed in the tension cracks and associated settlement relative to the 2024 inspection.

- Extensometer EXT 24 was installed in 2022, and readings were taken approximately monthly until September 2024. No readings have been taken in 2025. The displacement rate has typically been less than 1 mm/day since mid-2023. This is TARP Blue status.

- No obvious changes were observed in the sinkholes and subsidence at the toe of the Upper Platform since the 2022 and 2023 inspections.
- As of 2025, the Lower Dump Platform is no longer being monitored. While the risk associated with a dump failure has decreased with the relocation of the pump controls on the Pit A Ramp, there is a need for basic monitoring. Recommend resuming the visual inspections and implementing InSAR or drone-based photogrammetry.

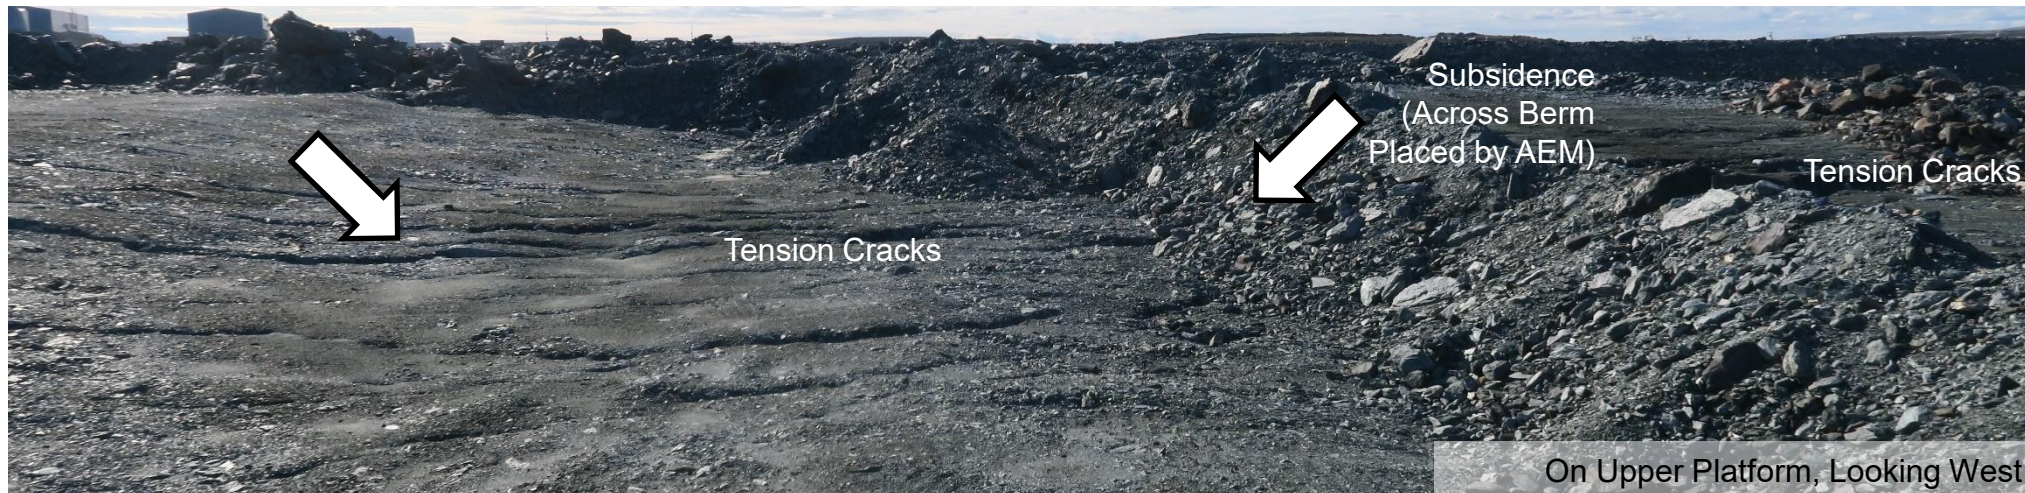
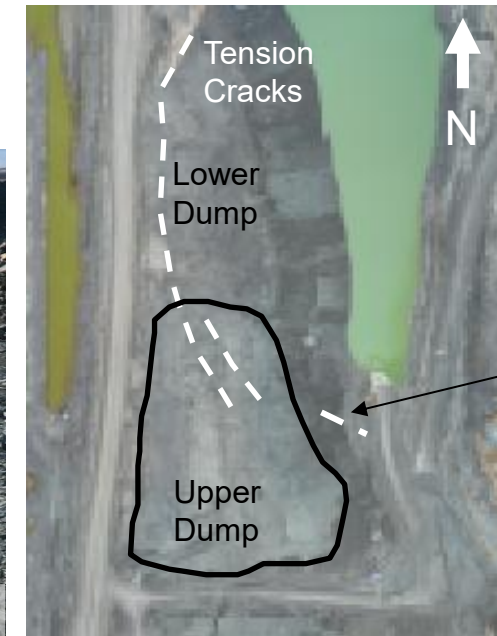
- The NW-SE tension cracks at the northern end of the Upper Platform have continued to increase in number and prominence since the 2024 inspections. Cracks are also now visible on the southeastern corner of the dump. Similar to the lower dump platform, the cracks are thought to be linked to the geometry of the underlying pit slope.

- The northern end of the Upper Platform has experienced settlement since at least 2022. Since 2024, a section of the platform 10-20 m back from the northern crest has subsided further than the platform at the northern crest. The reason for this is unclear. It could be evidence of a rotation of the dump towards the north, but no east-west tension cracks were observed and would be expected to occur under those circumstances.

- Visual inspection are being completed for the Upper Platform. InSAR or drone-based photogrammetry should be used to quantify and better understand the extents of the deformation.

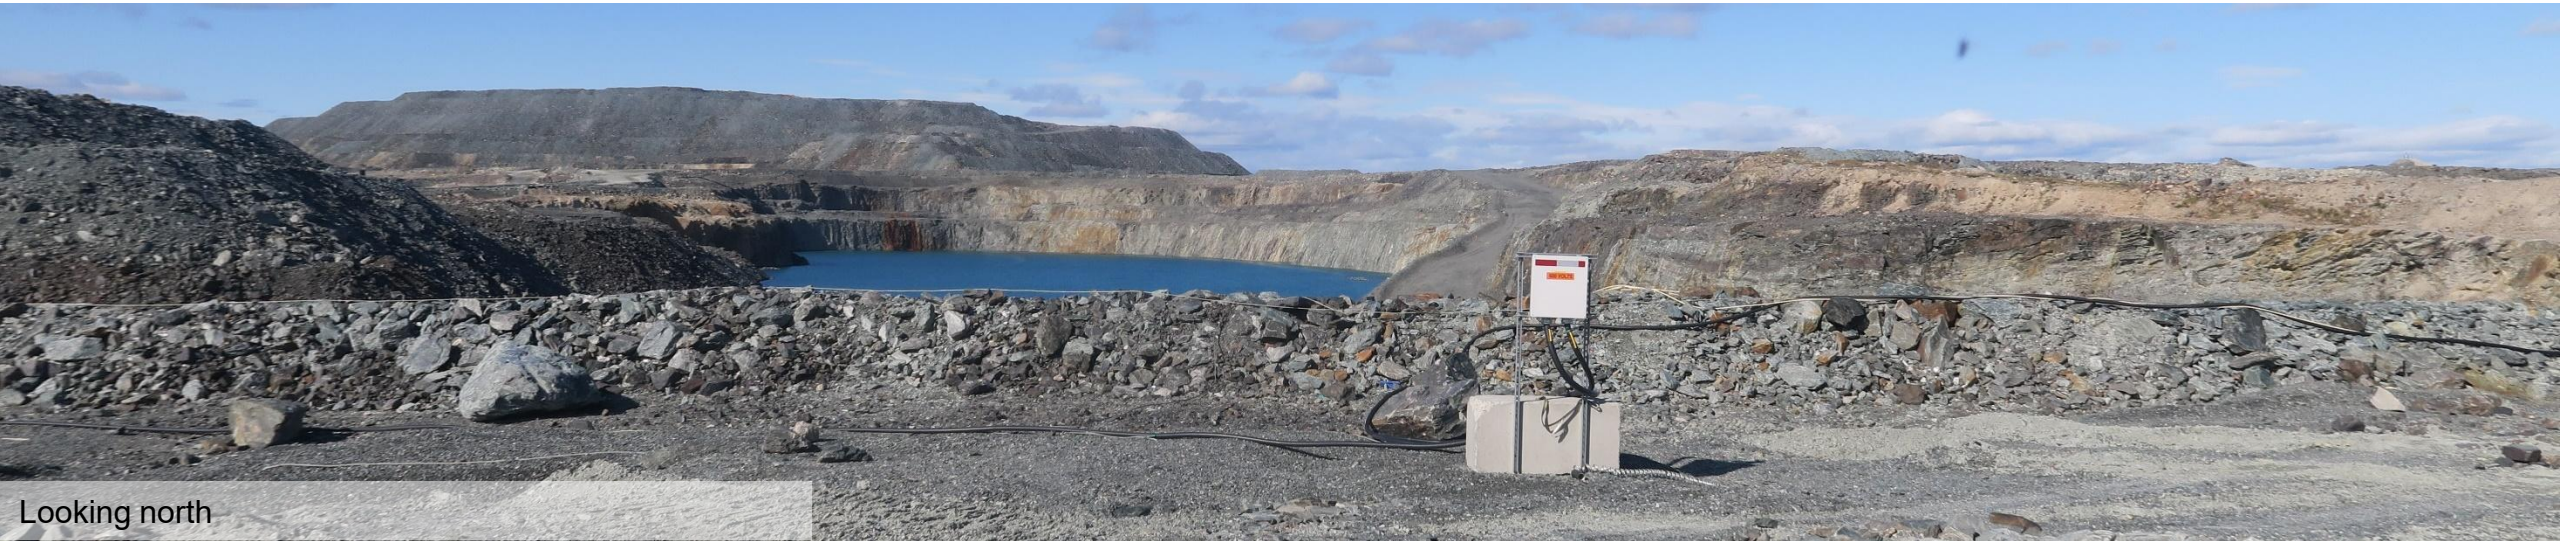
Looking north

- The C Dump, which backfilled Pit C, is located between Pits A and E and is inactive. Access to the dump platform is permitted but a berm has been constructed approximately 25 m back from the crest of the dump above Pit A. A single junction box remains within the berm.
- Settlement of the dump was expected and remains possible as the water elevations in Pit A and Pit E surpass the base of the dump (approximately 5085 mRL). The water elevations in both pits rose above the base of the dump in 2024 and water is now flowing from Pit A to Pit E below the dump. However, no evidence of settlement or instability has been observed to date.
- The ongoing use of the dump as a laydown is considered acceptable as no evidence of instability has been observed and experience at the other dumps suggests that the settlement is likely to be progressive in nature.

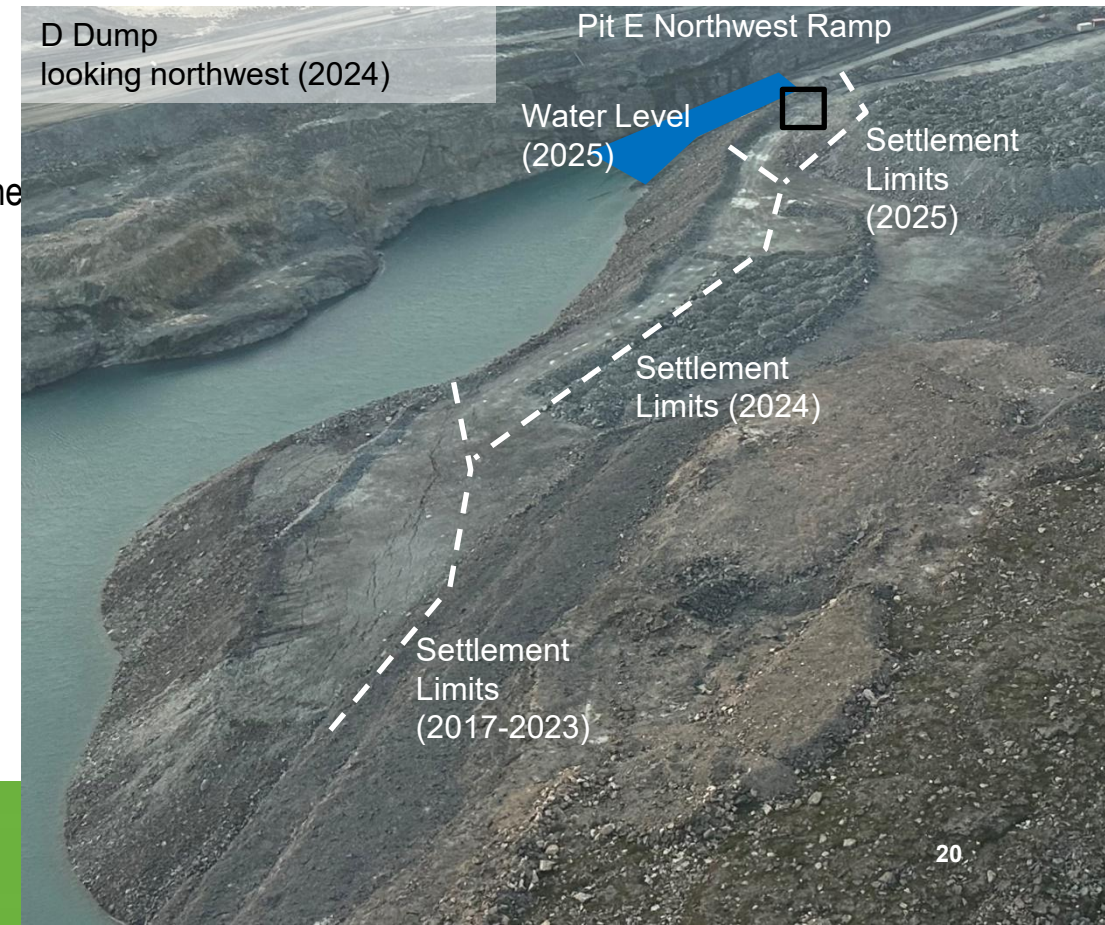
- The southwestern end of the dump started to settle in 2017 and is attributed to the deposition of water in the open pit. Tension cracks are visible in this area.

- The settlement and tension cracks have migrated progressively to the north as the elevation of the pit lake rises, and water migrates beneath the dump (see image).

- The dewatering pumps for Pit E are located at the toe of the dump. The pumps have been moved progressively up the ramp as the pit lake has risen. This has reduced the personnel to rockfall hazards along the ramp as well as any instability of the dump.

- Four wireline extensometers were installed at the crest of the dump and have been periodically relocated as the settlement has migrated north. At the time of the 2025 inspection, only one (EXT02, in the area outlined in black at right) was still being used and monitored, directly above the pumps.

- The extents of the settlement exceed what can be practically monitored with extensometers. Recommend using InSAR or drone photogrammetry to better understand the spatial distribution of the deformation. The extensometers could be limited to areas with increased exposure (e.g., above the pumps).

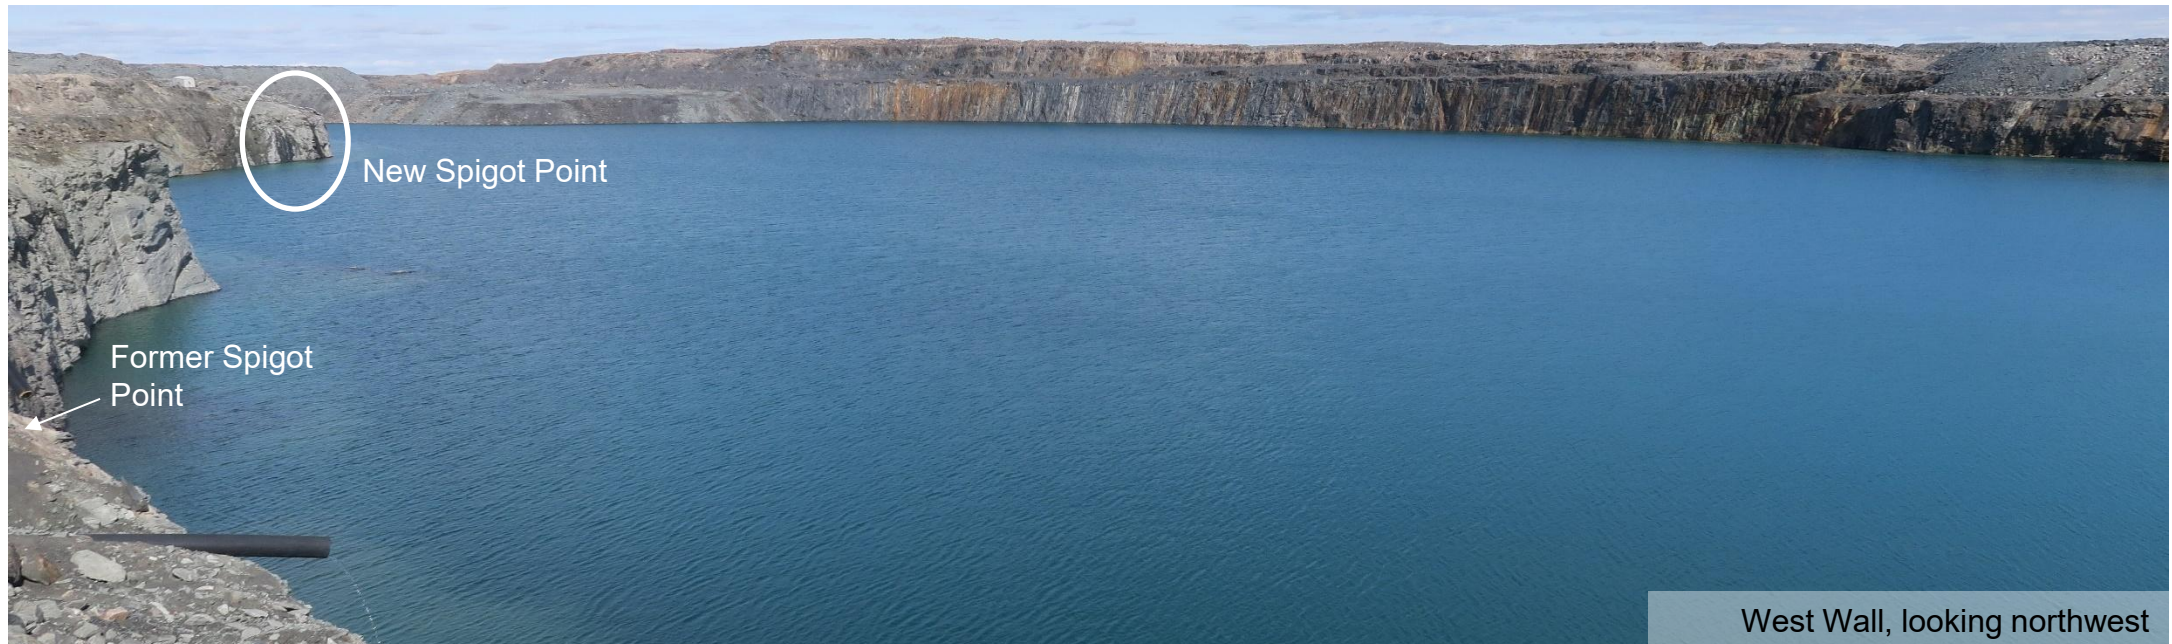
- The pit lake has continued to rise and approximately one bench is now exposed above the pit lake.
- The walls are generally performing well. No new instabilities were noted, and no significant change in the historical bench-scale instabilities along the south wall were observed.
- The deposition of tailings from the Southwest Wall has been discontinued. A new spigot point has been established along the West Wall. No particular geomechanical concerns were noted.

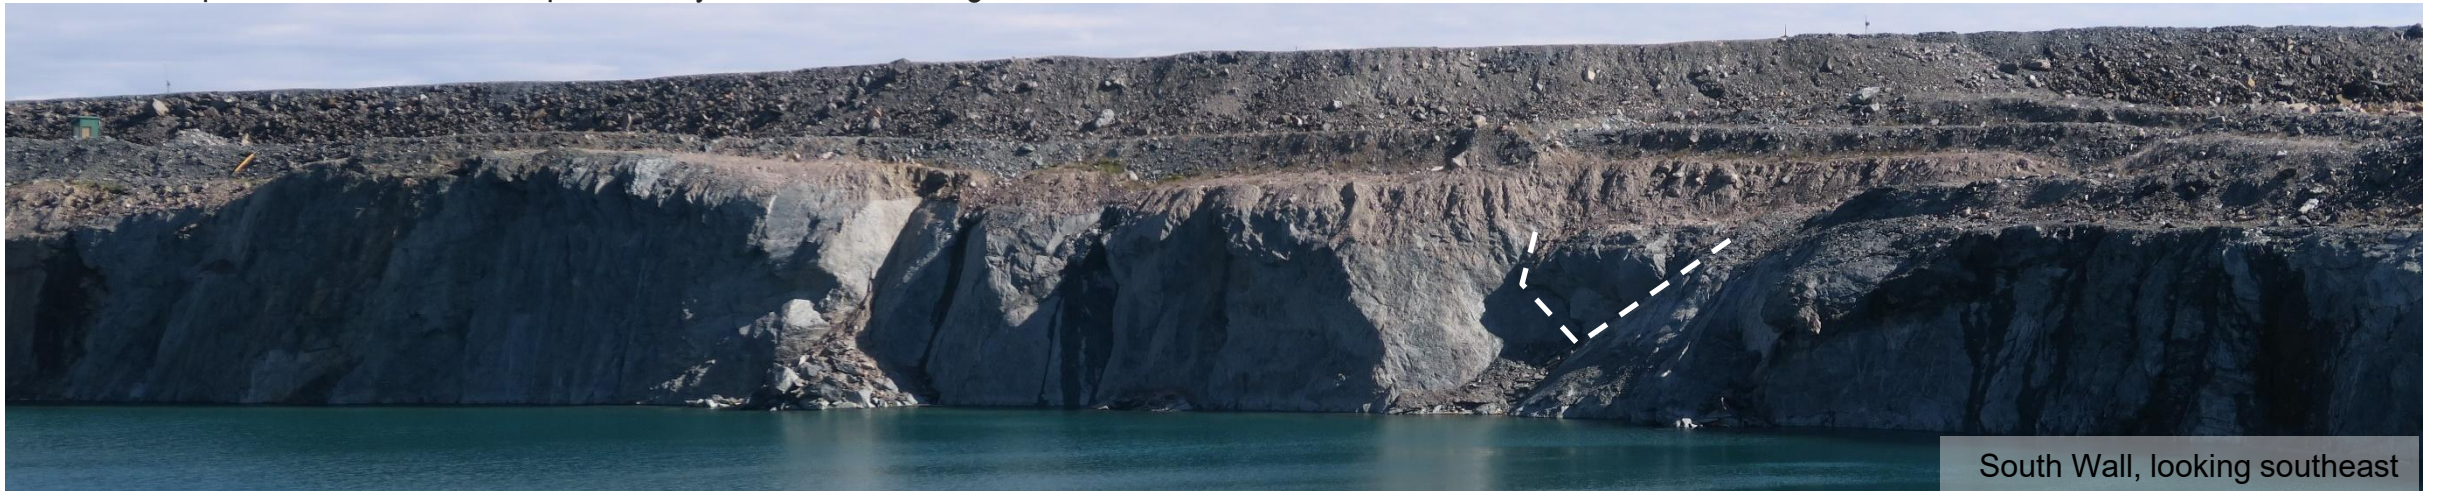
- The berm preventing access to the ramp along the south wall has been re-established and the vibrating wire piezometer cable that was run along the ramp close to the pit wall has been removed. This is a positive development as rockfall continues to be observed on the ramp in this area.

- The pit lake water level has reached the toe of the historical bench-scale instabilities that occurred within the Ultramafics in the south wall. There is the potential for the instabilities to re-mobilize as the water level continues to rise. In particular, there is a possible wedge remaining in the westernmost of the two instabilities (outlined in white below).

South Wall, looking southeast

- There is currently no access above these instabilities as the road along the pit crest has been bermed off. However, it is understood that AEM wishes to route a water pipeline along the road as part of closure activities. The potential failure limits of the historical instabilities should be estimated and the pipeline located outside of these limits. A monitoring plan should be developed and implemented for this area prior to any work commencing.

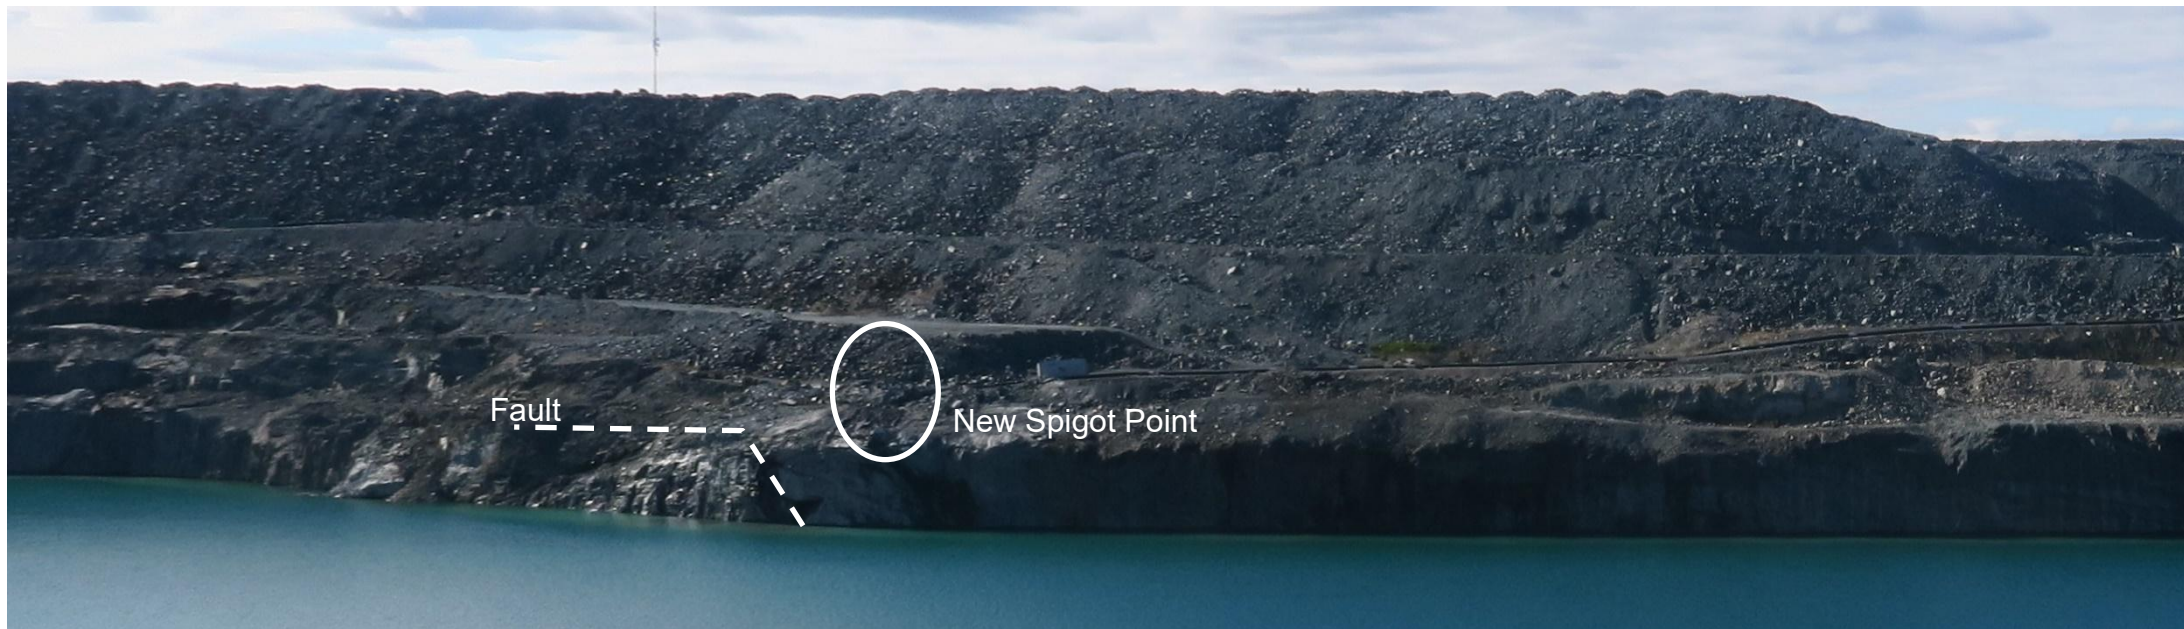
- A new tailings spigot has been established halfway along the west wall. Tailings are discharged from a line at the crest of this wall.
- The Bay Fault Zone dips into this wall in the area of the spigot point. The infiltration of water from the tailings into the fault could adversely impact slope performance. No evidence of instability was observed during the inspection.
- Recommend continuing the monthly visual inspections to monitor the area for bench degradation, tension cracks, seeps, etc.
