Meadowbank 2025 Annual Open Pit Geomechanical Inspection Report

January 6, 2026

RE: Meadowbank Complex - Meadowbank Site - 2025 Annual Open Pit Geomechanical Inspection

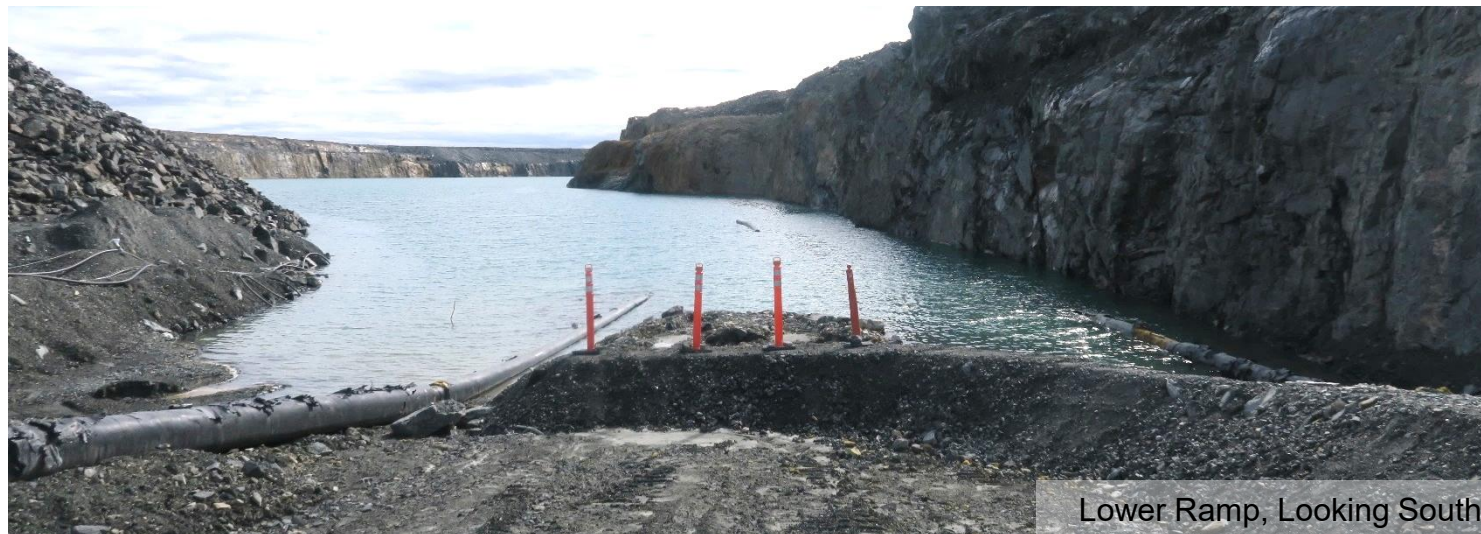
- The Northwest Ramp is used to access the pit lake and water management infrastructure is present along the ramp.
- Multiple rockfall hazards have been previously identified along this wall. With the continued rise of the pit lake, almost all of these hazards have been flooded and no longer pose a risk to personnel. If the water level is lowered, some of these hazards may be re-exposed. The condition of the open pit walls will need to be re-assessed and the adequacy of the current control measures (e.g., rockfall berm) reviewed before access is allowed to these areas.

- The rockfall berm at the toe of the pit slope has been effective at managing rockfall. In 2023-2024, the berm was locally repositioned closer to the slope to create room for the pumps. The reconstructed berm is relatively short and may not be an effective rockfall barrier. It was recommended that the height of the berm in this area be increased to match the remainder of the berm. This work was not completed before this portion of the ramp was flooded. It should be completed before this portion of the ramp is re-accessed.

Lower Ramp, Looking South

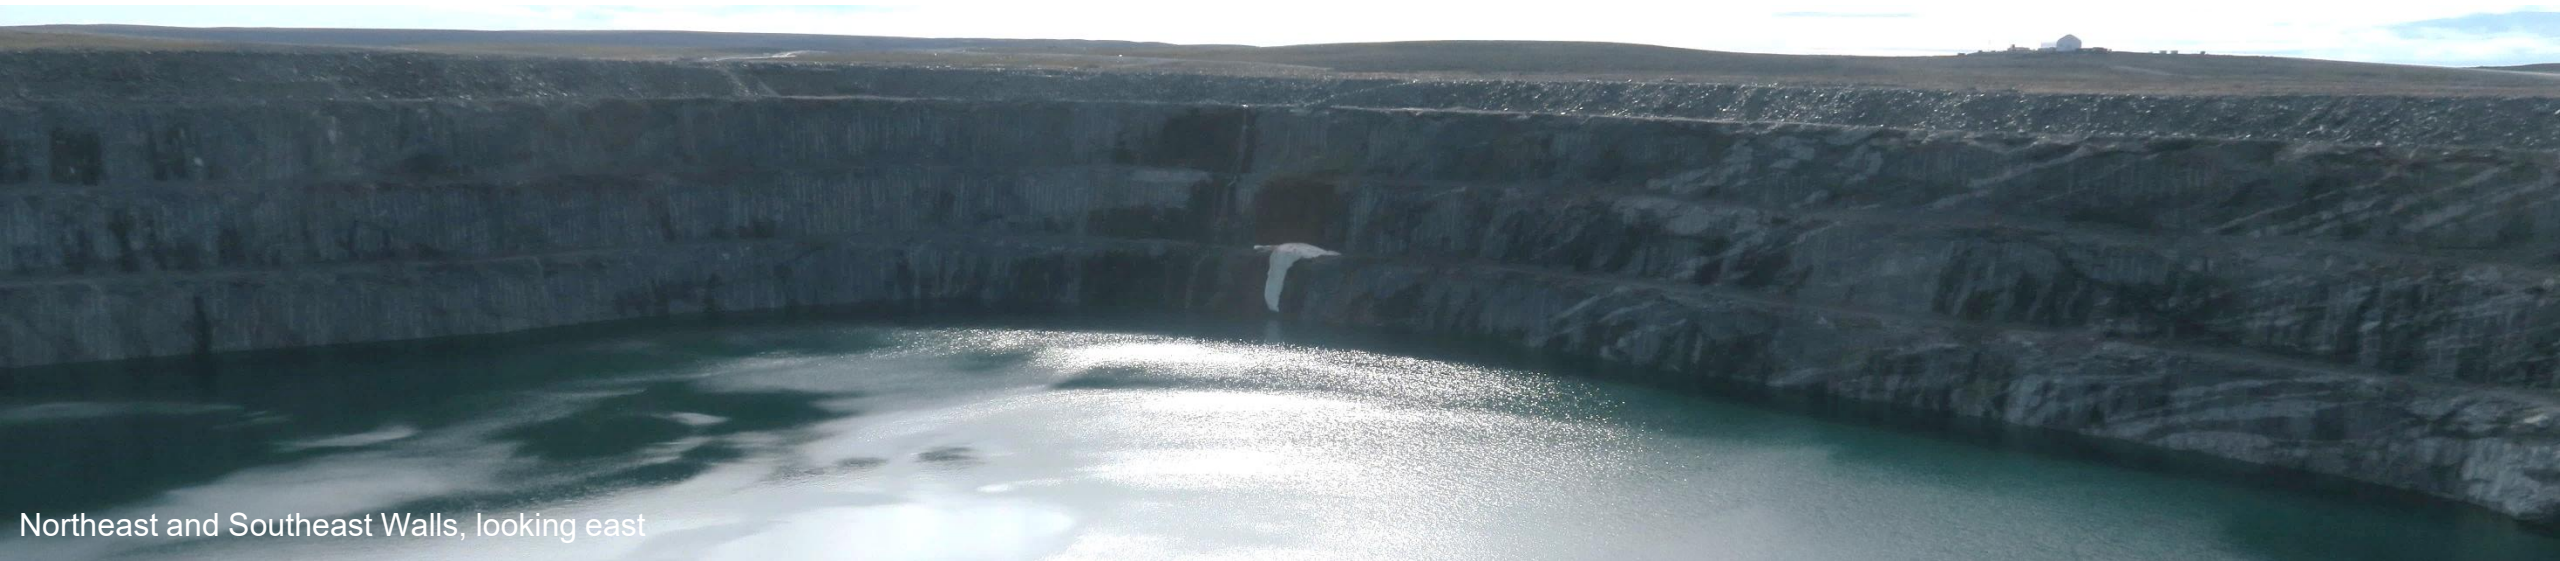
- The walls are performing well. No particular geomechanical concerns were noted.
- The ice wall continues to form each winter on and below the talik zone in this wall. Limited seepage through the rock was observed at the time of the inspection.
- Treated water from the Goose Pit is planned to be discharged into the Vault Pit. The discharge pipe will be laid along the ramp and then submerged in the pit lake. The rockfall hazard to personnel working in the pit will need to be assessed prior to the start of work. A drone could be used to assist with this.

Northeast and Southeast Walls, looking east

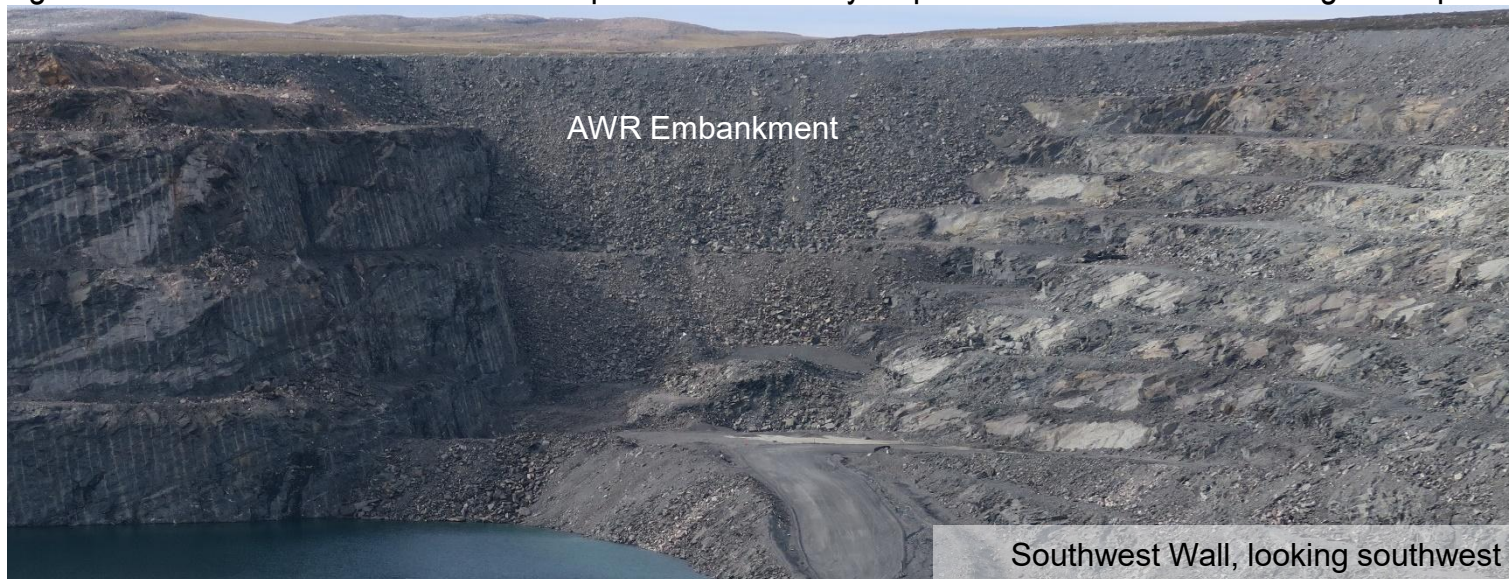
- The Amaruq AWR crosses a saddle between the Vault and Phaser Pits on a rockfill embankment.
- During the winter of 2023, tension cracks were observed on the surface of the road, perpendicular to the axis of the road. The cracks have not been observed since and may have been due to frost heave within the upper road surface.

- No evidence of instability in the AWR embankment was observed during the inspection (e.g., no tension cracks on the road surface or bulging of the embankment toe).

- The stability of the Amaruq AWR embankment could be impacted if the water level in the Phaser Pit on the other side of the embankment increases and water ponds behind the embankment. This has not occurred. Possible minor seepage at the toe of the embankment was observed at the time of the inspection. The presence of seepage should continue to be evaluated as part of the monthly inspections. Recommend noting the importance of this in the GCMP.

Southwest Wall, looking southwest

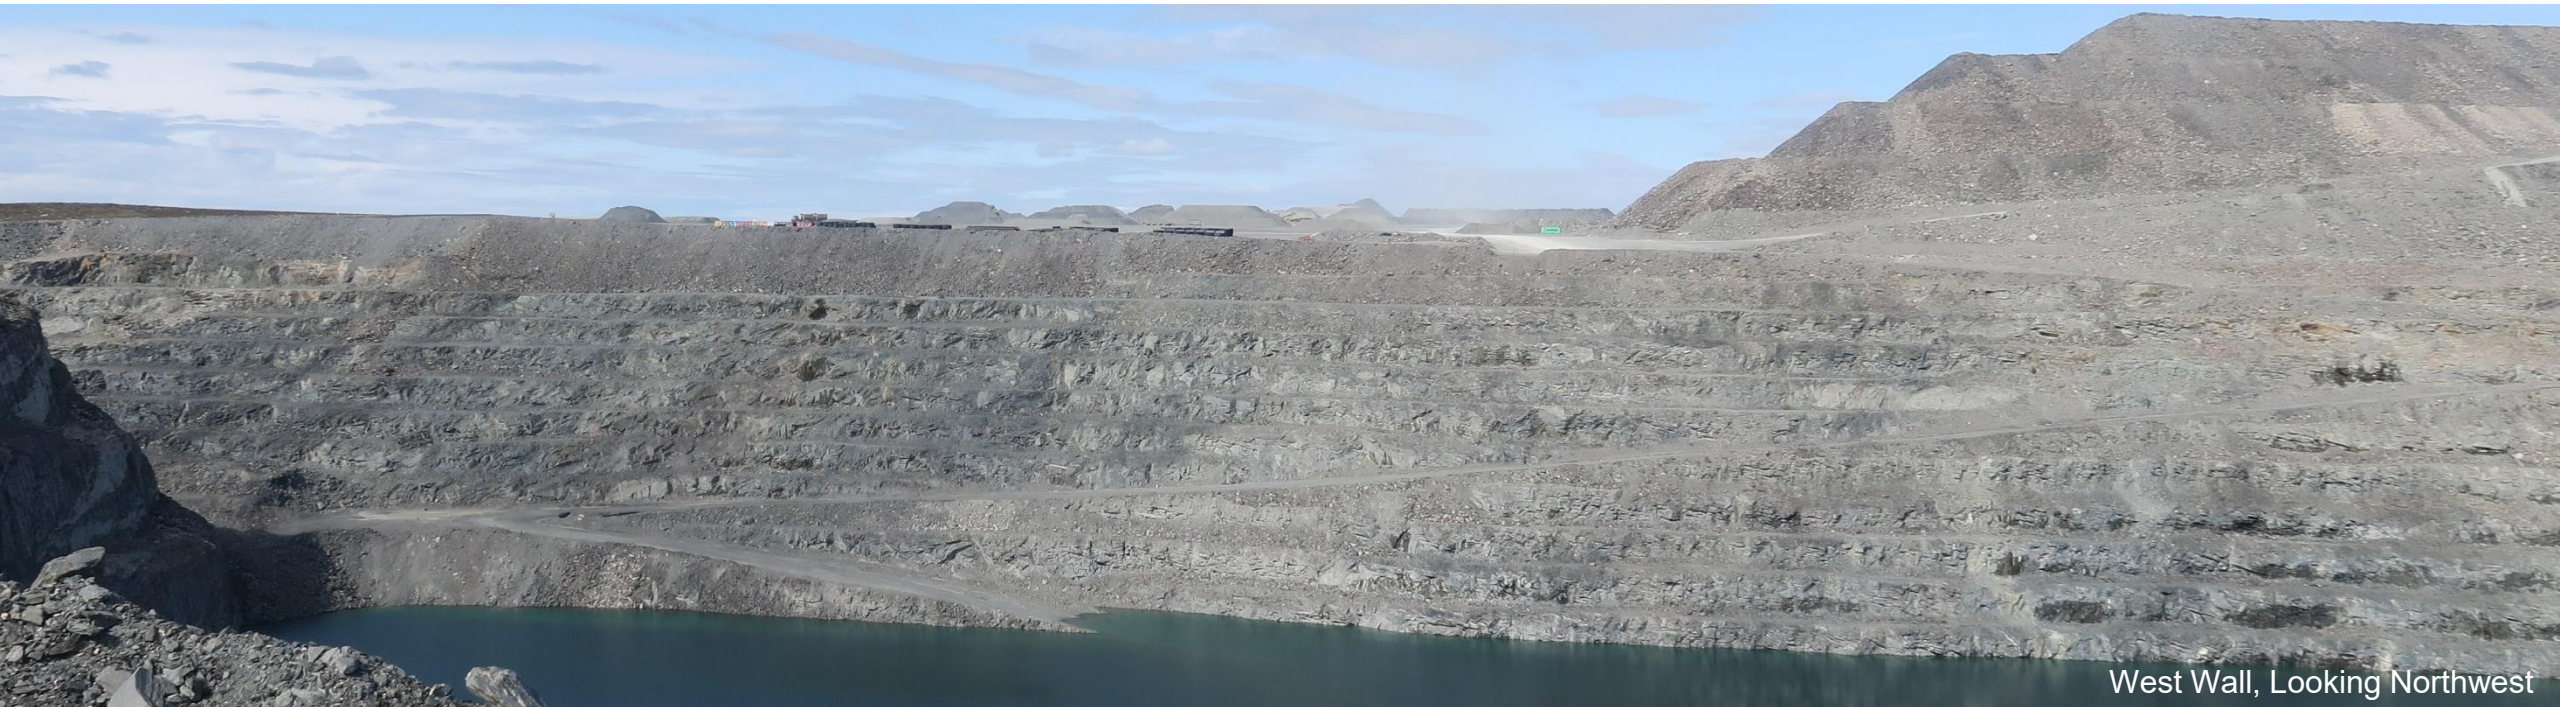
- The West Wall is located along the footwall of the deposit. The wall was established with 7 m high single benches without pre-shear and commonly failed or were scaled back to the foliation. The ramp is located along this wall.
- At the time of the inspection, access to the ramp was restricted by a barricade.

West Wall, Looking Northwest

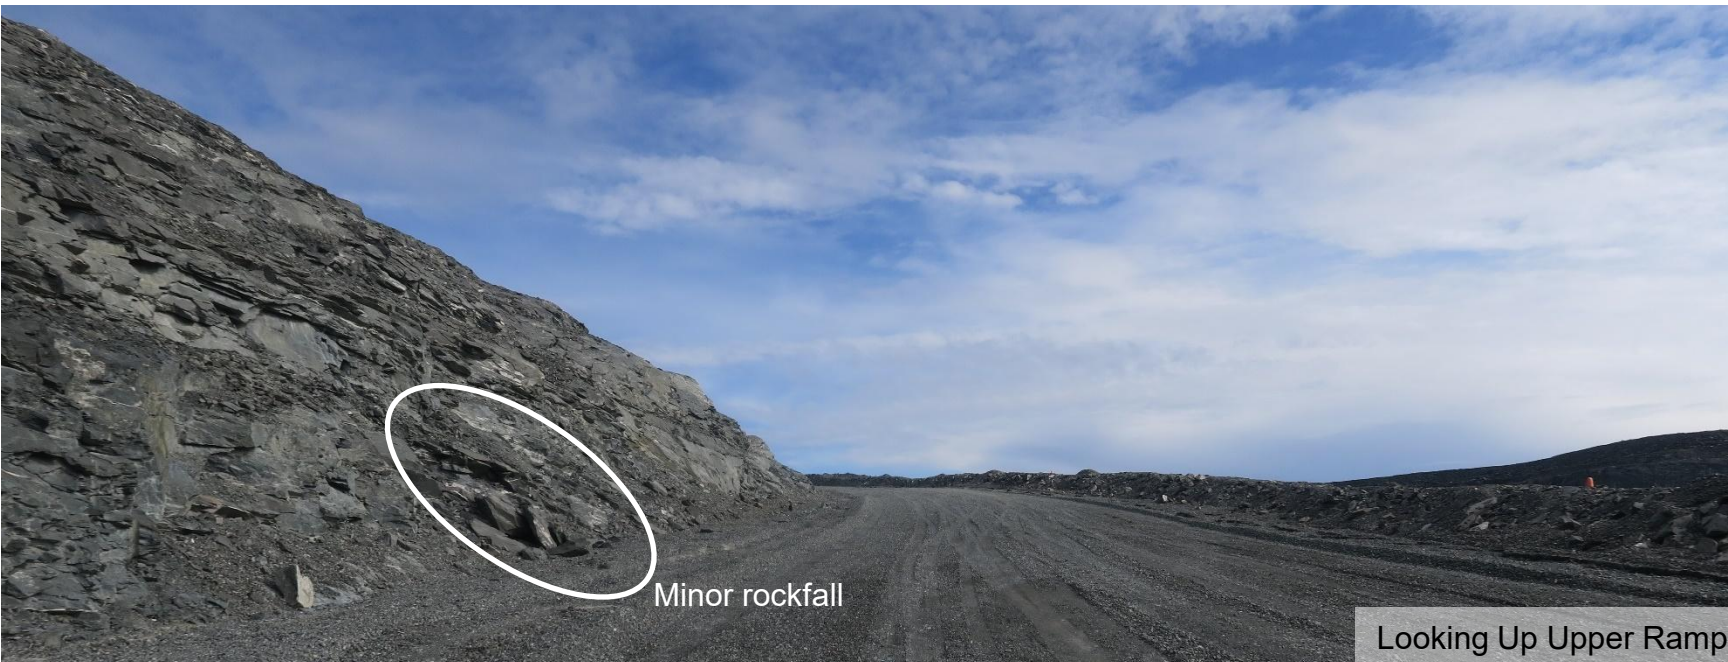
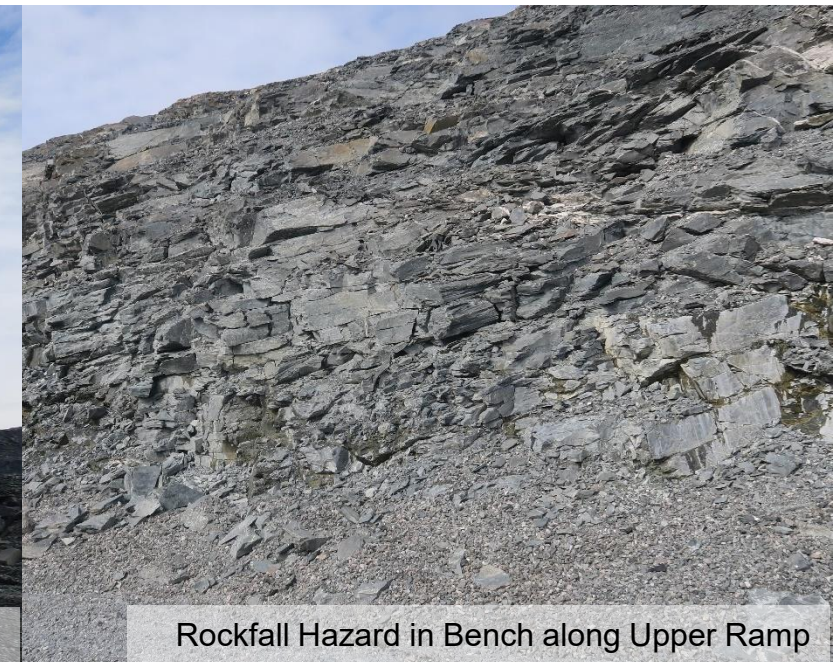
- Rockfall hazards are present along the ramp and evidence of periodic rockfall was observed at the toe of the benches during the inspection.
- The ramp is sufficiently wide that personnel accessing the pit for water quality sampling are able to stay well away from the benches.
- However, it is understood that personnel may need to work in proximity to the benches during the installation of the planned water line. If personnel cannot remain a sufficient distance from the walls (e.g., at least equal the to 7 m height of the bench) then a rockfall assessment should be completed. It is expected that a rockfall berm will need to be constructed in at least some areas along the inside of the ramp in this scenario.

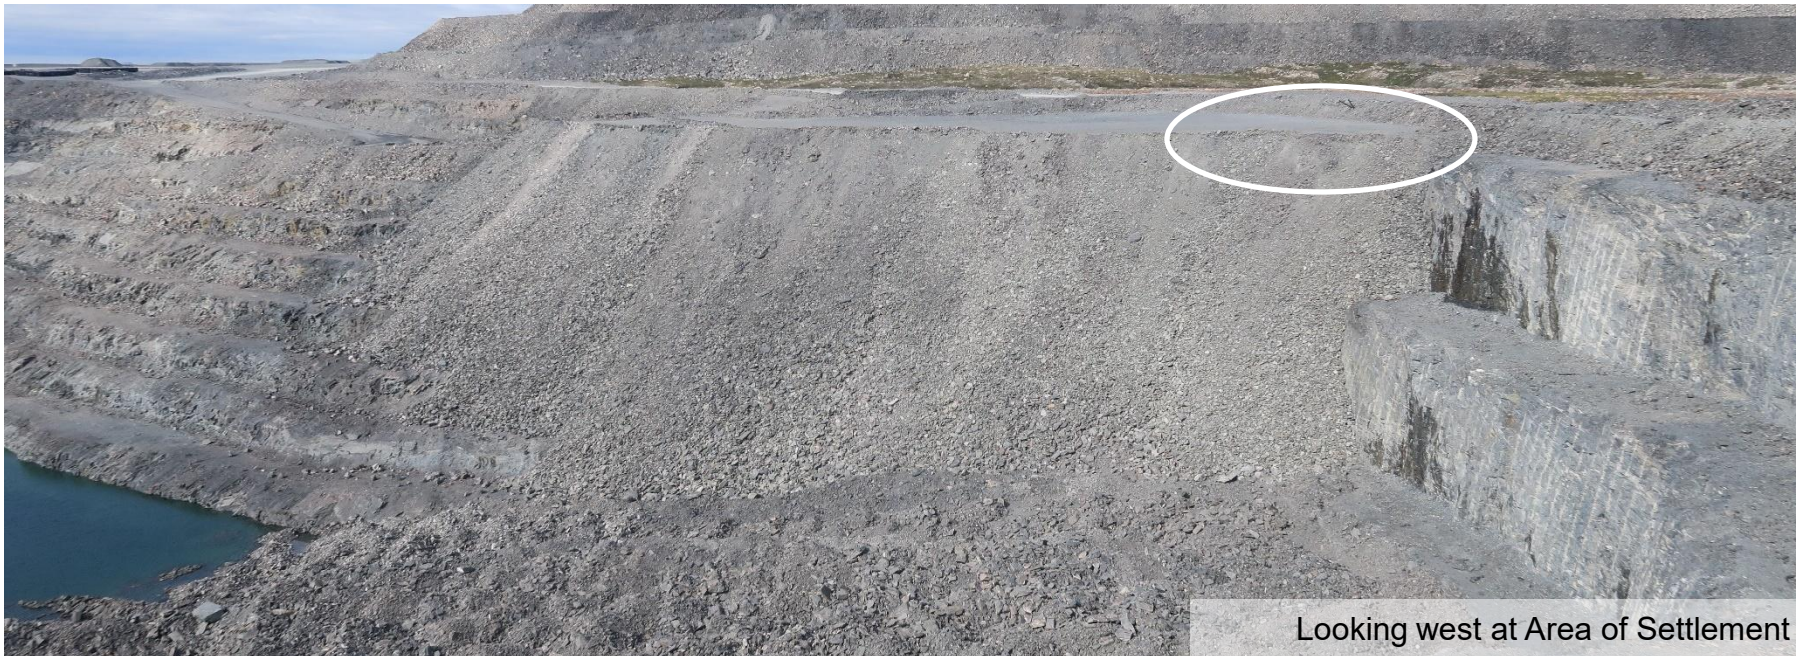
- A waste rock dump was constructed at the north end of the Vault Pit. The dump is inactive and consists of two platforms with elevations at approximately 5133 mRL and 5082 mRL.
- Settlement and tension cracks were observed at the crest of the upper platform at the north end of dump during the 2019 inspection. There appears to have been little change since that time. The affected area is relatively small and is not above the ramp.
- No other evidence of instability was observed during the inspection.
- Access to the dump is prevented with a berm.

Looking west at Area of Settlement

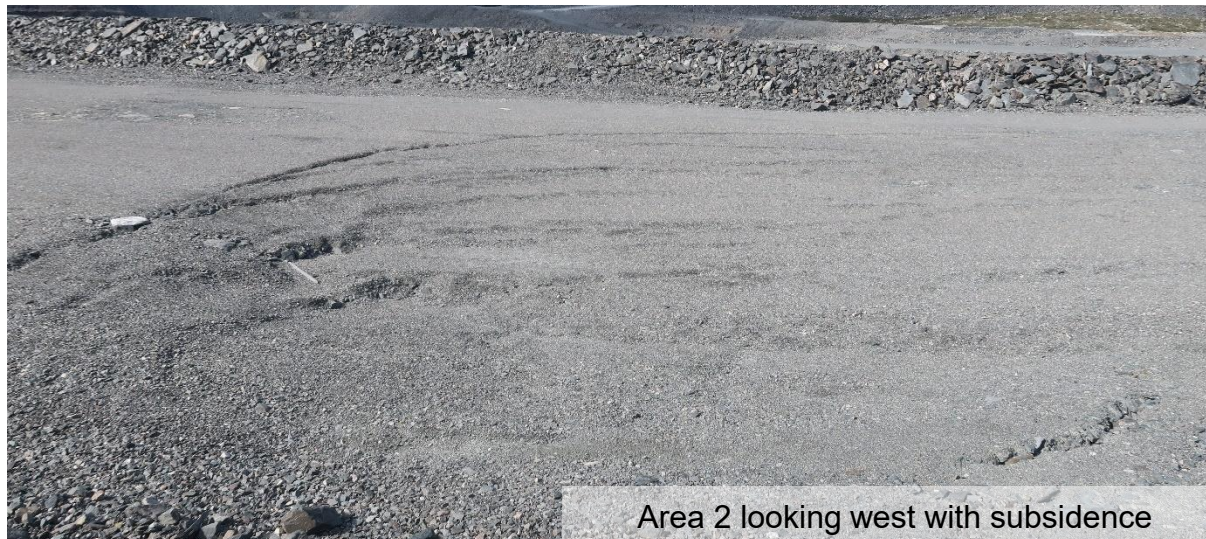
1. Seepage from Pond D has flowed under the road and down the pit wall in 2019, 2021, and 2023. Seepage was also observed during this year's inspection.

2. Subsidence of the road has occurred adjacent Vault Lake. The subsidence appears to have only marginally increased since the 2024 inspection. No seepage was observed below the road. The potential for a sudden inrush of water from Vault Lake into the open pit was previously identified as a hazard in the event of a breach or erosion of the Ring Road in this area. As a result, the area should continue be inspected prior to accessing the open pit. Alternatively, the road could be purposely breached in this area to eliminate the hazard.

Area 2 looking west with subsidence

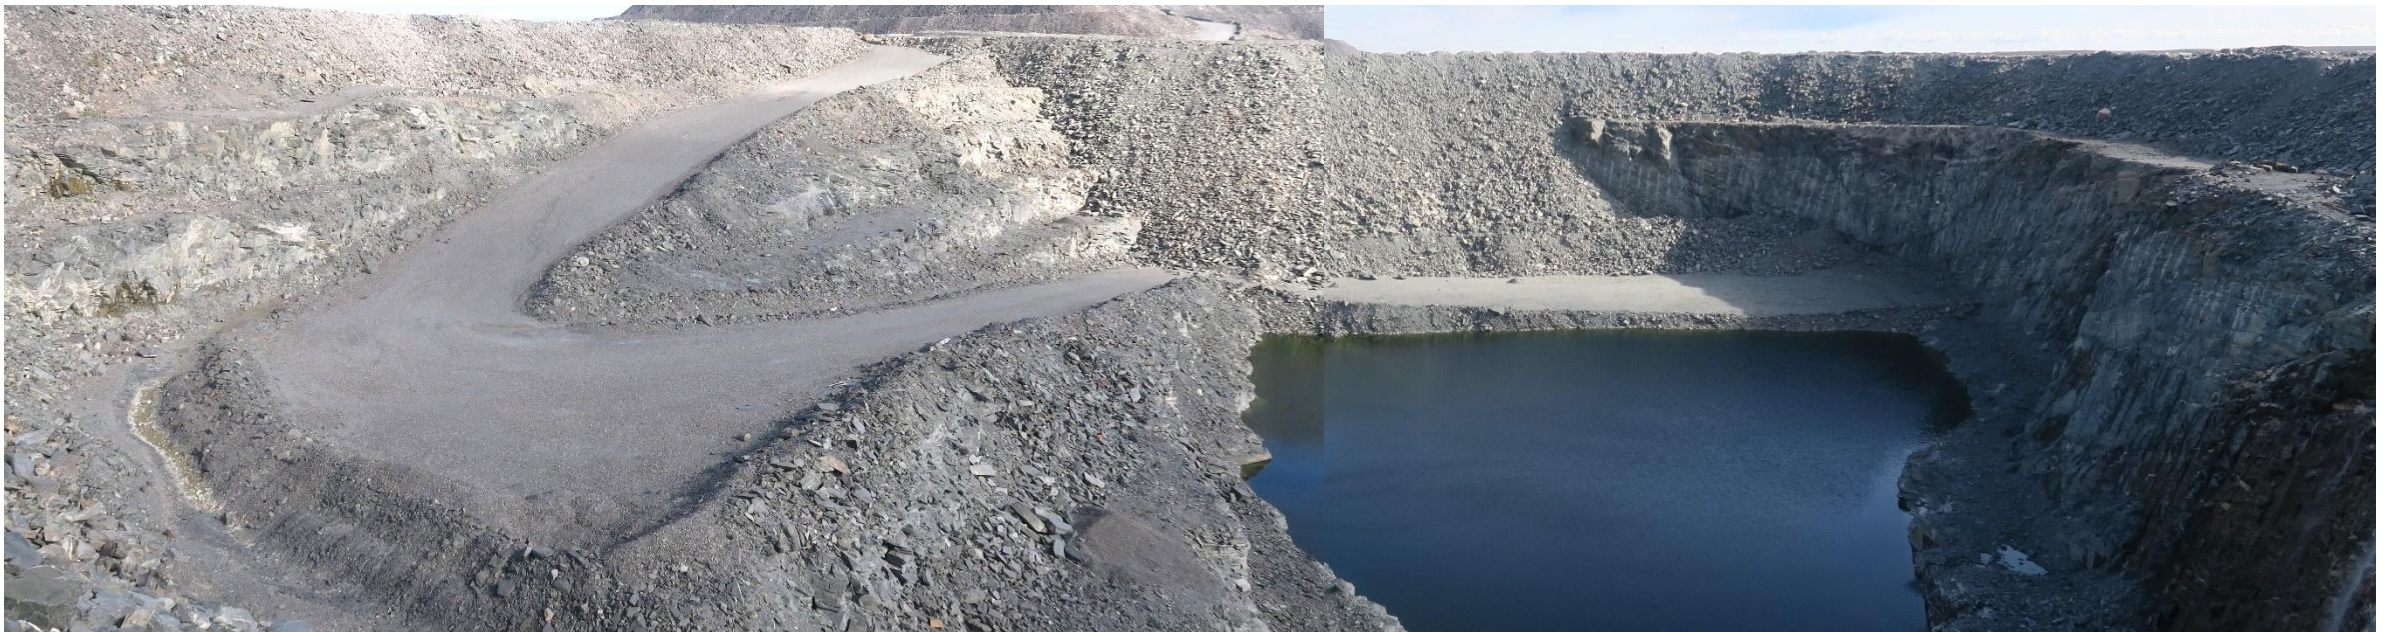
- The open pit is partially flooded and access to the open pit is prevented by a berm. The pit is accessed for water quality sampling.
- Rockfall hazards are present along the upper ramp and the toe of the AWR embankment. The ramp is sufficiently wide that personnel accessing the pit are able to stay well away from the benches. If pumps and/or pipelines are installed in the pit, the rockfall risk should be assessed. It is expected that rockfall berms will need to be established.
- No evidence of instability was observed in the Amaruq AWR embankment. The stability of the embankment could be adversely impacted if the water level in the Phaser Pit increases and water ponds behind the embankment. A visual assessment of the water level in the open pit is included in the monthly inspections. The pit lake elevation has not significantly changed since the 2021 inspection.

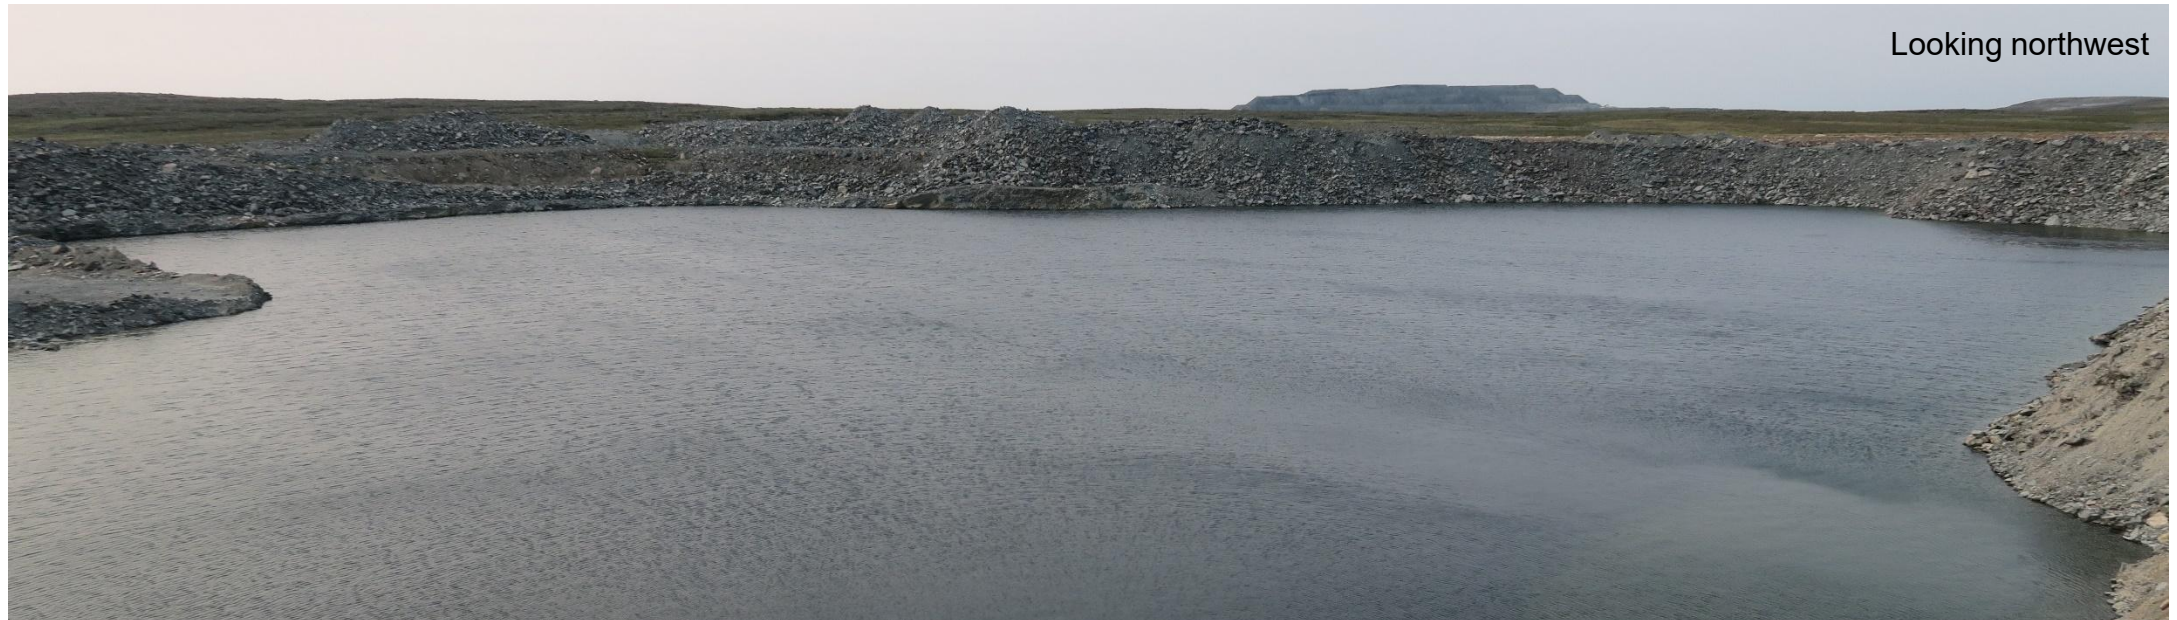
- The open pit is flooded, with no rock slopes visible.
- Access to the open pit is prevented by a berm. The berm is traversed when water quality sampling is required to be completed.
- No particular geomechanical concerns were noted.

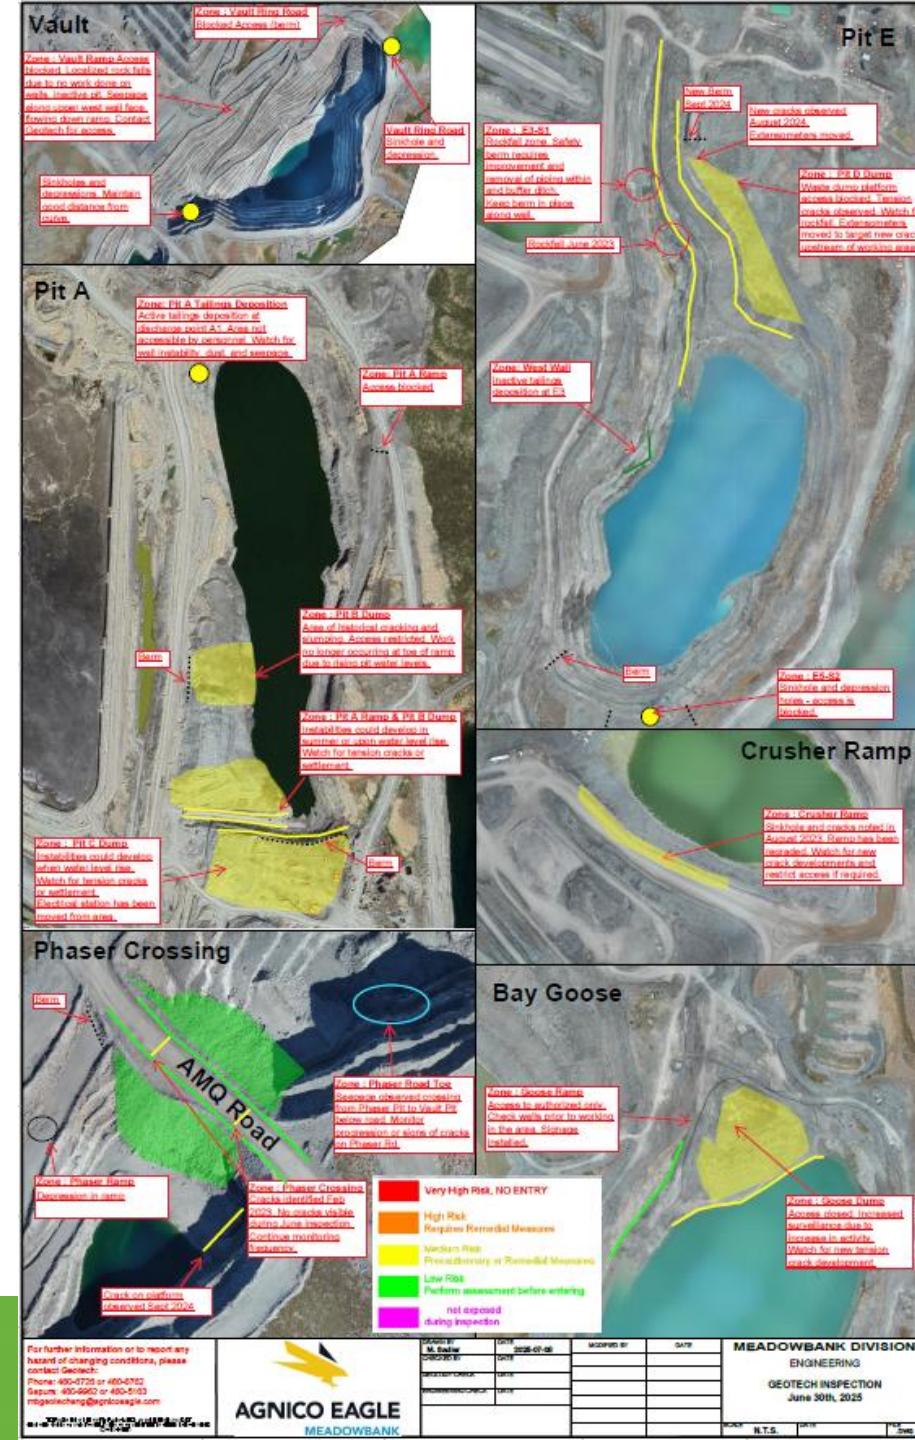
- The most recent hazard assessment map (June 30, 2025) was reviewed. A summary is shown at right and comments are provided below.
- Most of the hazards identified during the annual inspection have been captured by the hazard assessment. However, the rockfall hazards along the ramps in the Goose Pit and Phaser Pit were not noted. The map should be updated to reflect these hazards.
- The risk ratings assigned to the identified hazards are thought to be generally reasonable.
- With the exception of Pit A, the drone photos used for the hazard map are out of date and do not reflect the reduction in slope hazards / accessible areas as the pit lake elevations rise (e.g., at Pit E). The drone photos should be updated to reflect the current conditions.
