### **CONSTRUCTION SUMMARY REPORT**

Agnico Eagle Mines Ltd

653281-0004-40ER-0002\_0 January 29, 2019

SNC-Lavalin Stavibel Inc. was retained by Agnico Eagle Mines Limited to prepare a construction summary (as built) report for the fresh water intake for the Whale Tail Project, Nunavut. SNC Lavalin Stavibel Inc. previously prepared the construction drawings and specifications for the fresh water intake.

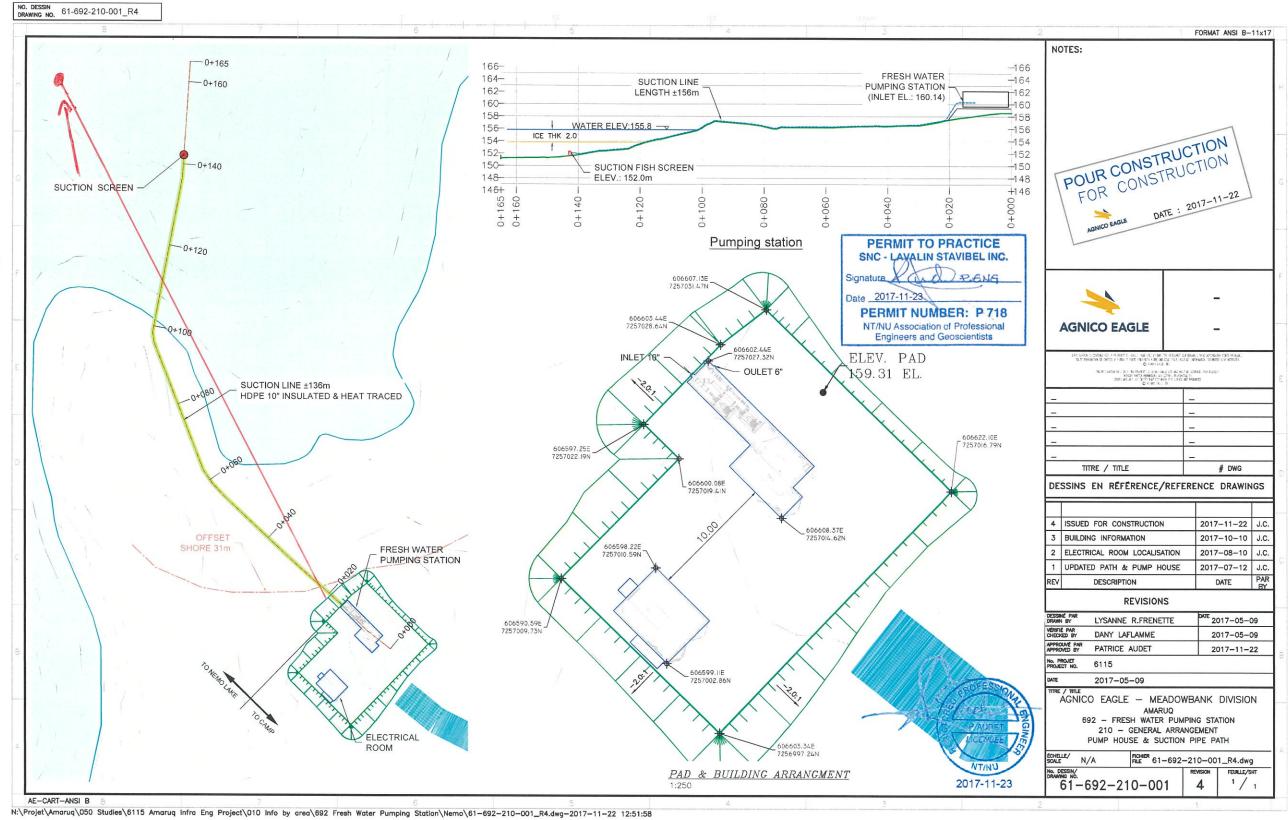
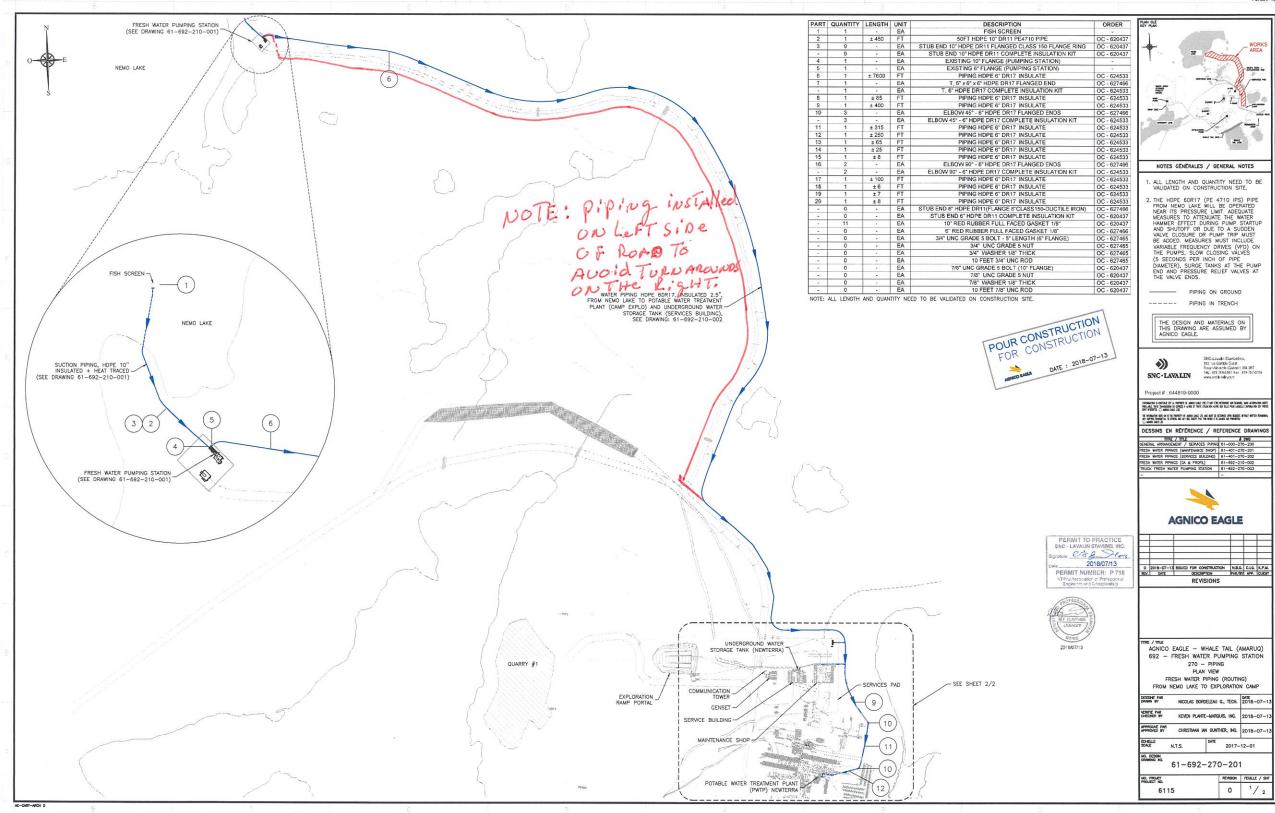
NOTE: SUCTION LINE ± 200m TO BE ABLE TO REACH NEEDED DEAPH

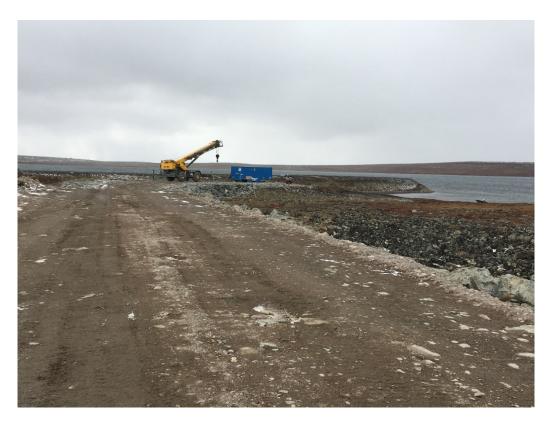
Picture 1 Pumping station installation

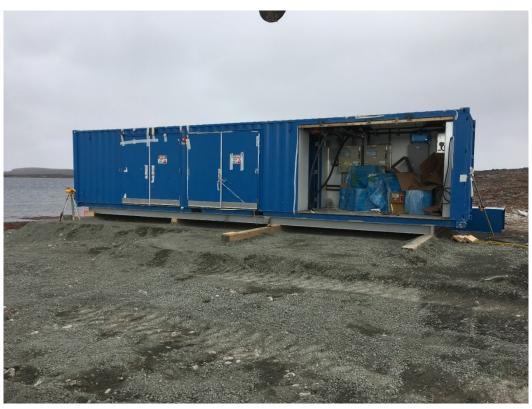
Picture 2 Pump section of pumping station

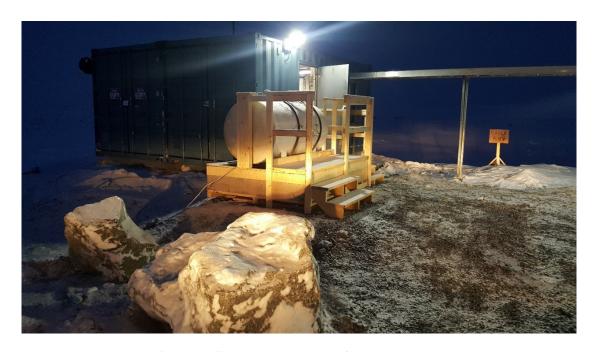
Picture 3 Electrical substation after construction

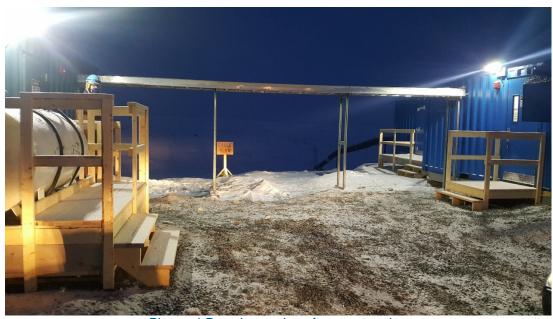
Picture 4 Pumping station after construction

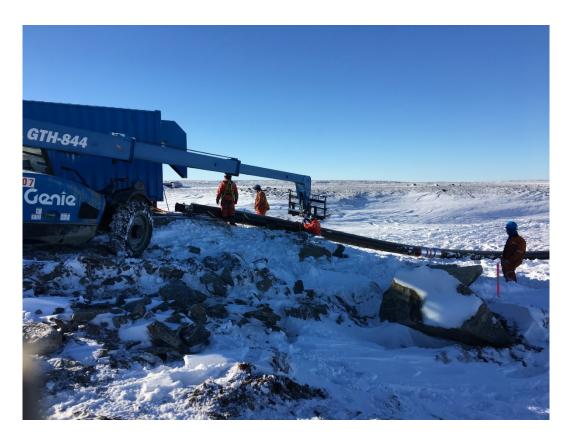
To protect the lake and limit machinery circulation within 31 meters from the shore, Agnico Eagle Mine elected to install the intake pipe line on ice with a telehandler, instead of with a boat and a helicopter. Using that telehandler on the pump station gravel pad, the telescoping boom was used to push the pipeline on it pipe supports and on the ice. Once the fish screen was over the prescribe water depth, ice was cut from underneath the pipe line so that the line could sink, helped with ballast. Picture of this operation can be found in appendix C.

Picture 5 Telehandler pushing pipe with boom

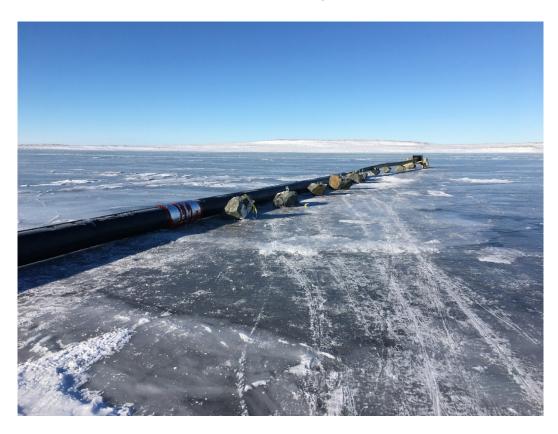
The suction line sections were assembled on the shore, with the fish strainer and ballasts. The fish strainer was redesigned to respect DFO's Freshwater Intake End-of-Pipe Fish Screen Guideline. Screen opening was changed from 13 mm to a screen with a mesh size opening of 2,54 mm. It was deployed on the lake ice. Once the suction line was located correctly, the suction was flooded by cutting ice underneath, to sink into its place.

Picture 6 suction line with ballast on lake ice

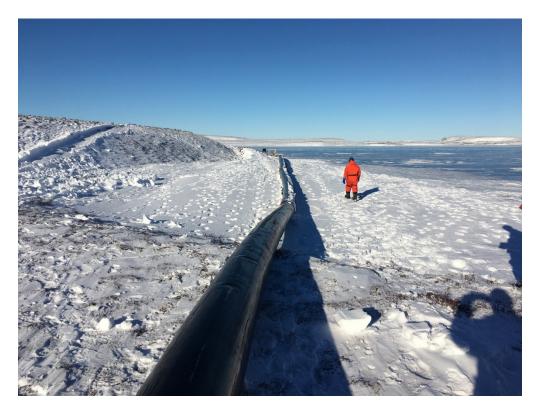
The water suction location has been moved 100 meters north-west to have it in appropriate water depth. To do so, the construction team reviewed the pipe line layout from the pumping station to the lake bed. The new layout can be reviewed in appendix B.

Picture 7 Suction line localization

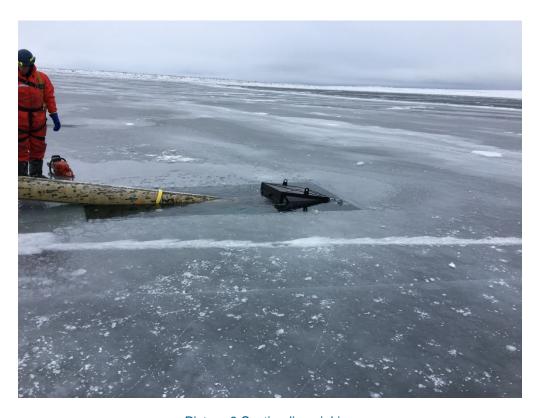
Picture 8 Suction line sinking

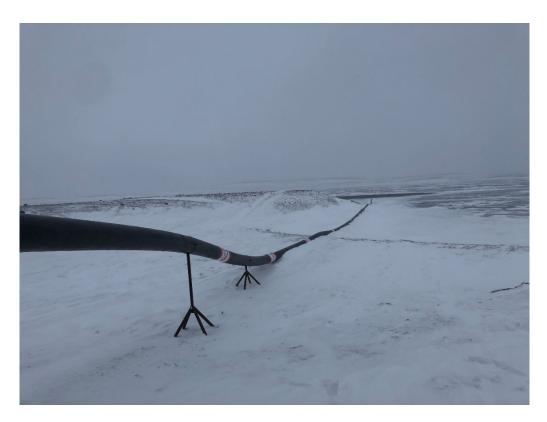
Picture 9 Final suction line installation

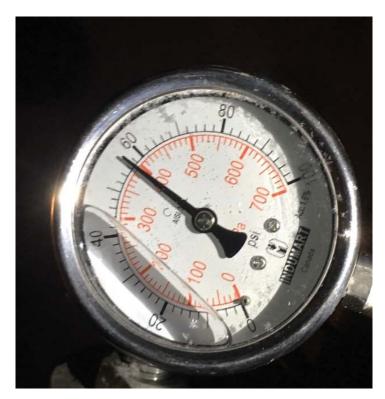
During the commissioning phase, the pipeline from the pumping station to the construction camp has been tested for leaks. The line was filed with water then capped and put under pressure for 5 hours. Results are shown in Table 1: Pipeline leak test pressure record.

Picture 10 Pipeline pressurization

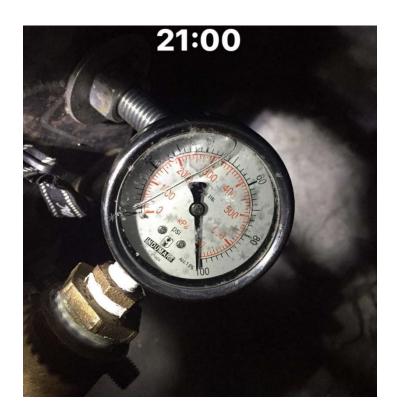
Picture 11 Pressure readout at 21:00

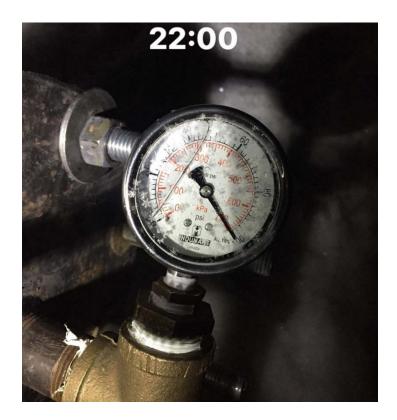
Picture 12 Pressure readout at 22:00

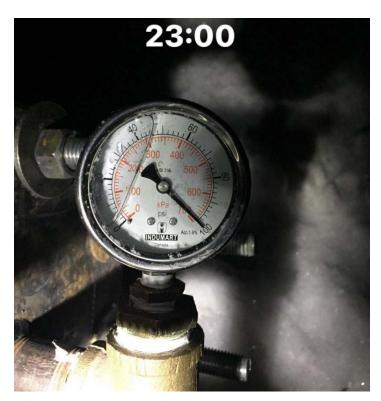
Picture 13 Pressure readout at 23:00

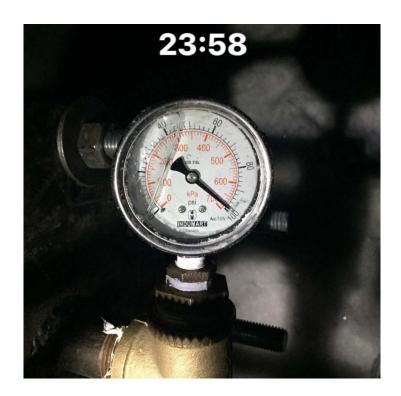
The results shown in table1 are within the acceptance limits for the pipeline. The pressure drop recorded on the 5 hours is less than 3% and confirms that no leaks are present on the line. This variation can be attributed in part to HDPE pipe expansion, in part to ambient temperature change during the test period and in part to the fact that closing the pipe line at the camp end was a butterfly valve, which are known to leak in such use.

Picture 14 Pressure readout at 23:58
