CONSTRUCTION SUMMARY REPORT CULVERT ROAD 11

Agnico	Eagle	Mines	Ltd
J	- 0 -

653281-0004-40ER-0006_0 November 29, 2019

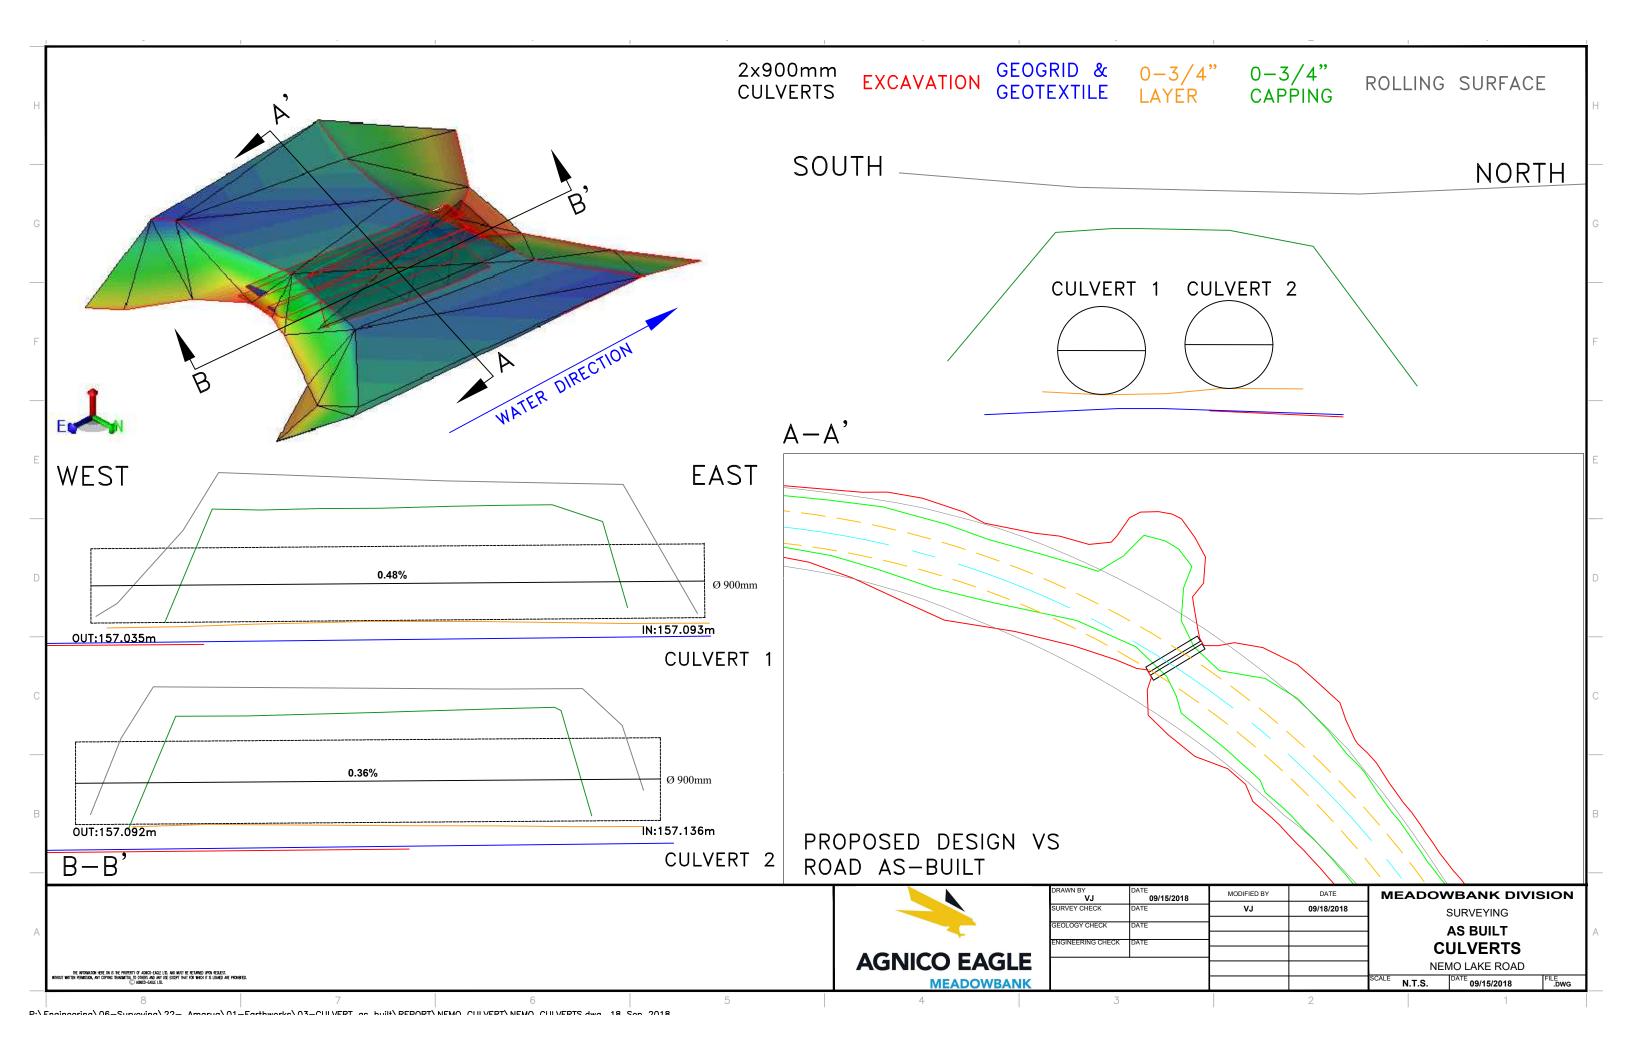
Appendix B Culvert 11-4 As built drawing

For culvert 11-4, Agnico Eagle Mine elected to install only the two 900 mm culverts even though the construction drawing asked for 4 culverts, two 1200 mm and two 900 mm. This decision was taken because off minimal water level at that creek on road 11 construction.

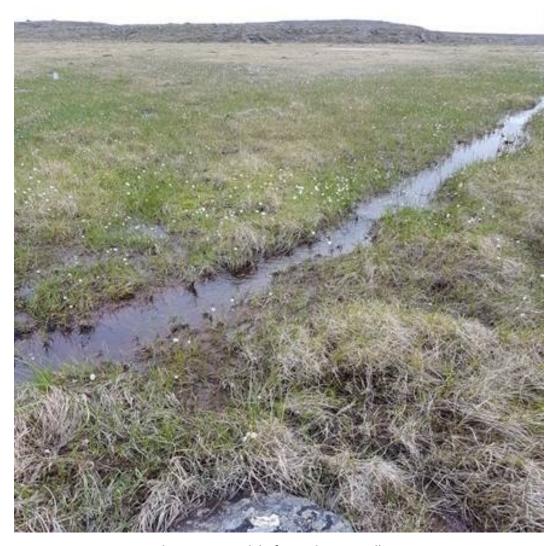
Culvert 11-4 creek before culvert installation

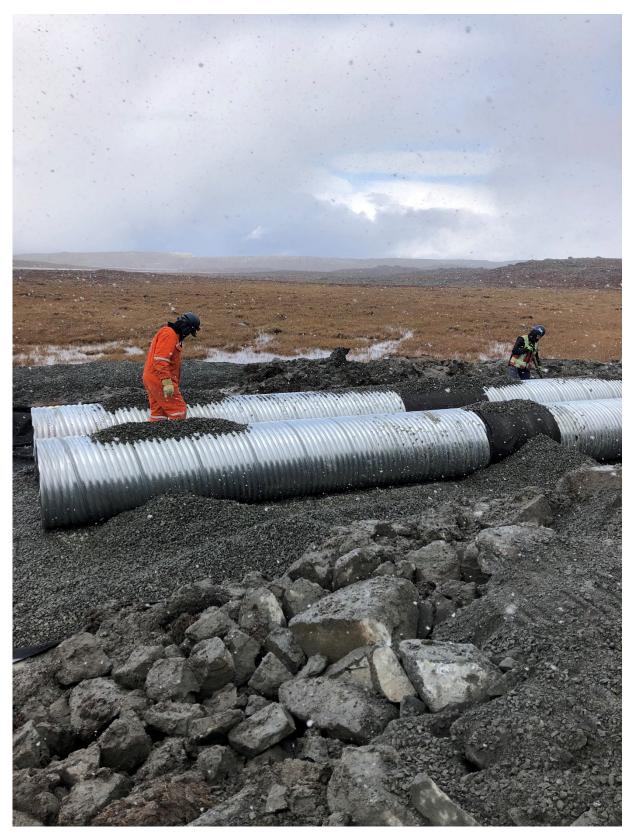
Culvert 11-4 installation

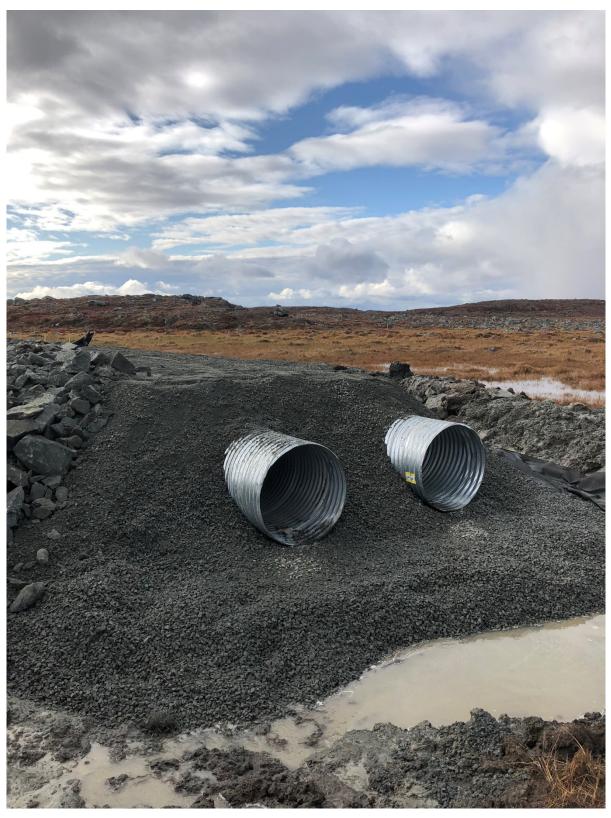
Culvert 11-4 installation

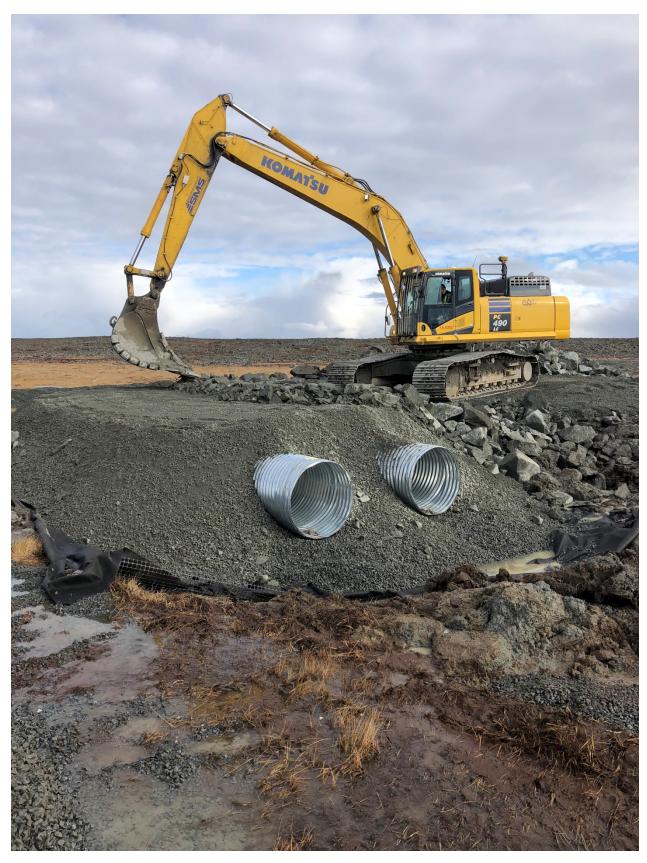
Culvert 11-4 installation
