E-3 TECHNICAL MEMORANDUM – BRIDGE INSPECTIONS

Agnico Eagle Mines Ltd.

Meadowbank to Amaruq Road Bridge Inspections

August 2017

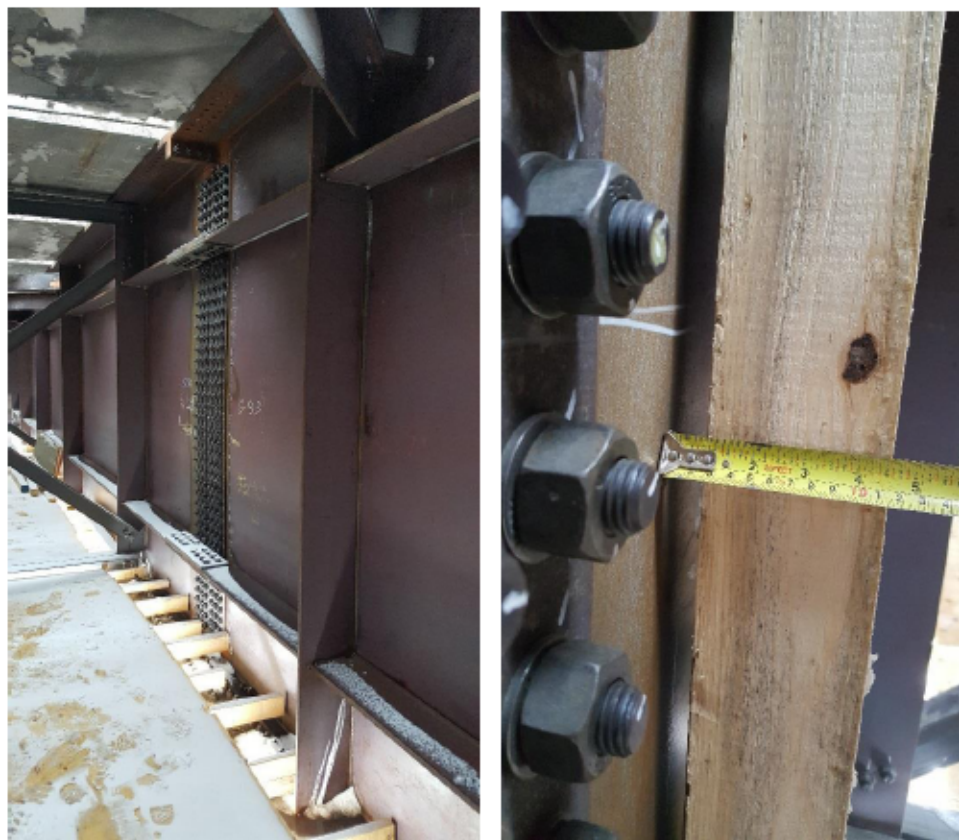
Following launching and installation of the 44.88 m and 66 m span bridges, web-panel out-of-straightness was noticed by on-site crews at some girder splice locations (see Figure 3-1). As these were documented following completion of the bridges, it is not possible to confirm whether they occurred during fabrication, transportation, erection, or traffic loading.

Figure 3-1
Web Panel Out-of-Straightness at Splice Locations (Bridge at km 23.9)

Measurements were taken by Groupe Gilbert construction staff, varying from zero up to 25 mm and were monitored a few weeks in a row in June and July 2017. Some variation was observed within these values, although these variations could be within the tolerance of the measurement tools. During AE's visual inspections, web out-of-straightness was observed to be in the range of zero to 18 mm. Some web out-of-straightness was also observed between vertical stiffeners (not at splice locations) on the km 23.9 bridge.

We believe that the web-panel out-of-straightness is the result of unbalanced welding shrinkage that occurred during girder fabrication. The girder design includes two longitudinal stiffeners installed on one side of the girder. The heat applied to one side of the web plate by the longitudinal-stiffener welds likely caused asymmetrical shrinkage in the web plate during cooling. Heating and cooling effects during the fabrication process can be mitigated by careful welding practices, but cannot be avoided completely with this type of web design. It is also possible that the out-of-straightness measurement will vary after installation due to asymmetric heating which can occur under solar radiation.

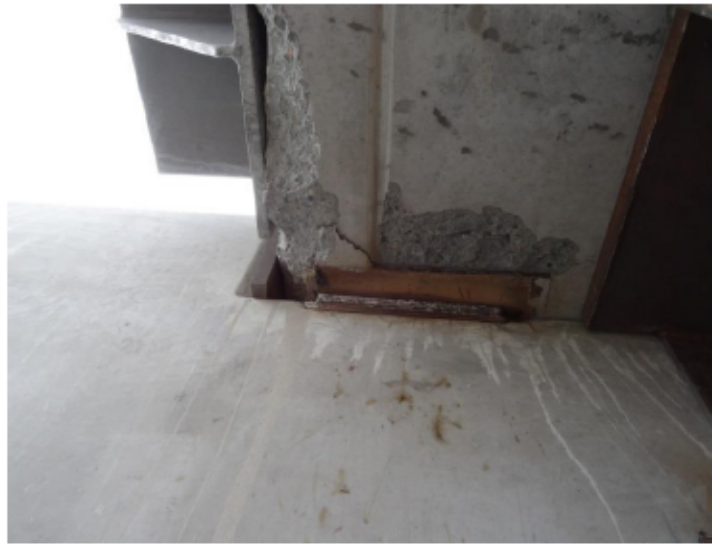
Precast components for the bridges include deck panels (with cast-in-place concrete joints and pockets), ballast walls (two pieces per abutment) and footings (one supporting each girder end and bearing). Various degrees of concrete cover spalling and cracking was observed (See Figure 3-2) at corners and particularly near embedded plates that required welding during installation. Corner areas and edges of precast concrete components were likely chipped and damaged during transportation, installation by heavy equipment or rough handling. A small number of locations were observed with reinforcing bars visible at damaged corners. Most spalls were less than 25 mm deep with no exposed reinforcing steel.

Figure 3-2
Spall in Deck Soffit at km 44.8 Bridge, Southeast Corner

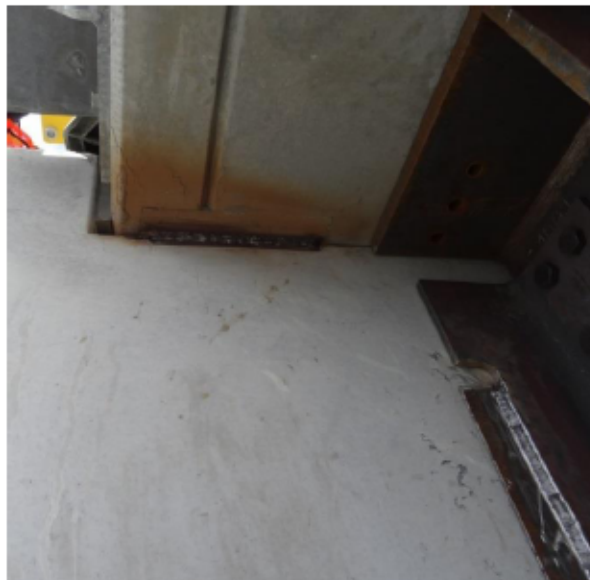
Scorching of the concrete was evident at welding locations, showing that a significant degree of heat was applied to the areas. We observed that some of the welds were significantly larger than the size specified on the drawings. This would have increased the amount of heat applied to the area which would have caused the embedded plate to expand. Some of the bridges were installed in winter conditions, where the precast concrete mass would have been particularly cold. If the heat was not carefully controlled, welding would have caused the observed scorching, cracking and subsequent spalling around the embedded plates (See Figure 3-3).

Figure 3-3
Minor Spalling in Ballast Wall Next to Embedded Plate (km 32.3 Bridge, Southeast Corner)

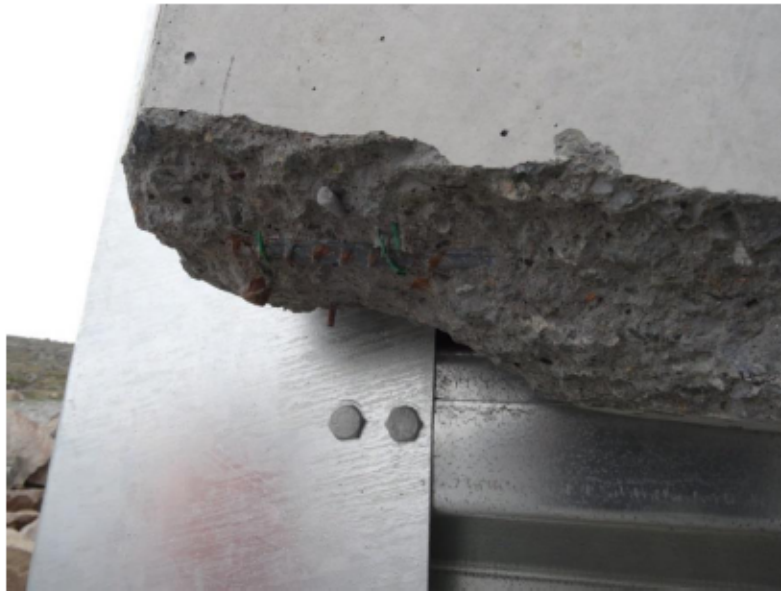
The observed spalled concrete is mostly cosmetic, however, in areas where reinforcing steel is visible (see Figure 3-4), repairs are recommended to prevent corrosion. Agnico Eagle may decide whether repair is required for the smaller spalls and cracks that do not affect the durability of the structure.

Figure 3-4
Bridge at km 23.9 – Northwest ballast wall bottom corner – exposed rebar in spall

We recommend repairing all concrete spalls where reinforcing is exposed. Other areas of minor spalling may be repaired as determined by Agnico Eagle. We suggest the following general repair procedure for these concrete repairs:

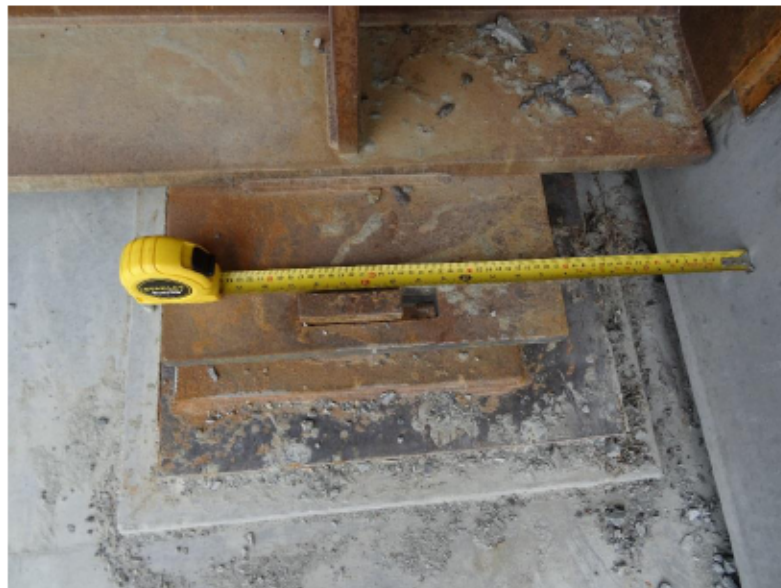
Figure 3-5
Bearing guide plate engaging shear key – bridge at km 3.5, northeast bearing

To limit the possibility of thermal restraint forces being applied to the abutments we recommend Agnico Eagle lengthen the slots in the top bearing plates. Further, we recommend resetting of the bearings on the bridge at km 43.5 and 32.3 km.

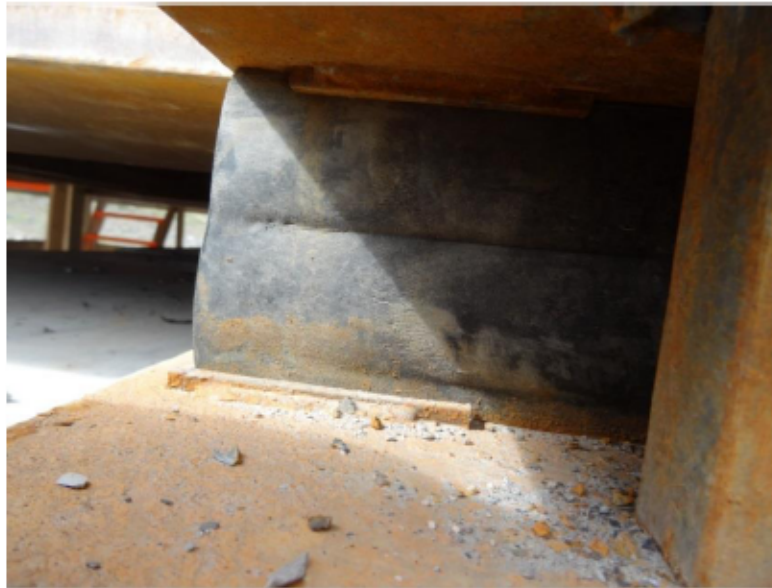
Figure 3-6
Bridge at km 32.3 Southwest bearing – front top keepers have been removed

We recommend that the bearings be reset on the bridges at km 43.5 and 32.3. A detailed procedure and loads can be provided by AE for this work. In general, this will involve the following:

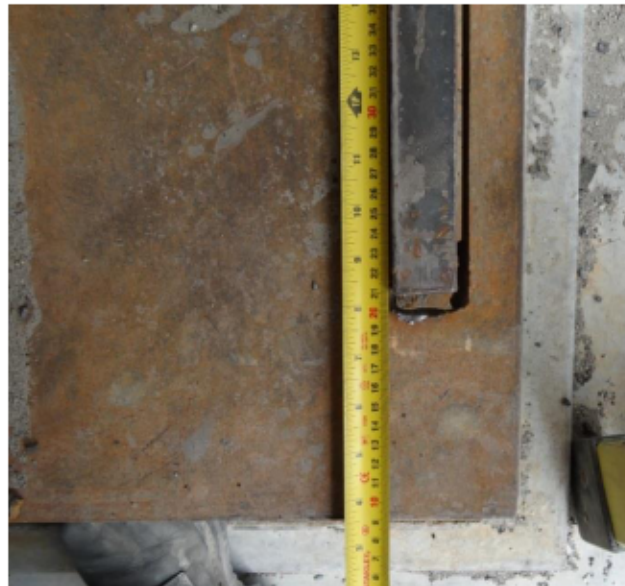
Figure 3-7
Bridge at km 32.3 Southwest bearing – Enlarged bearing guide plate slot by the Contractor during installation

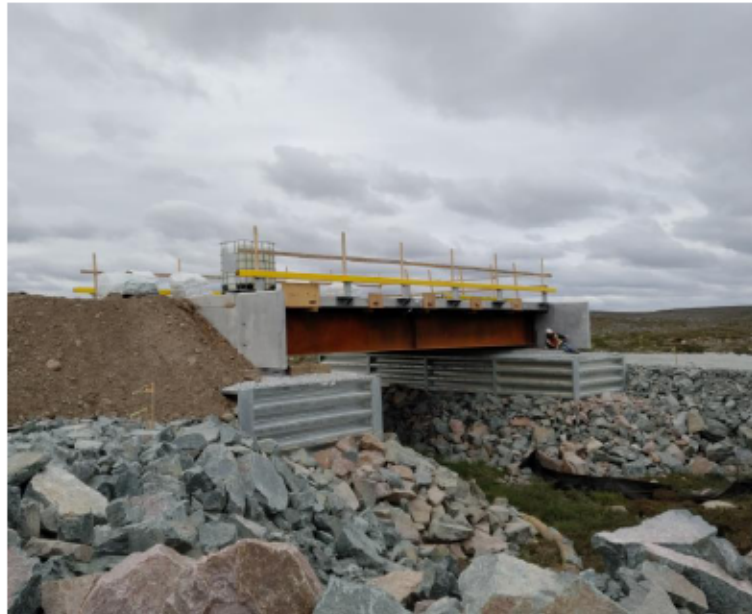
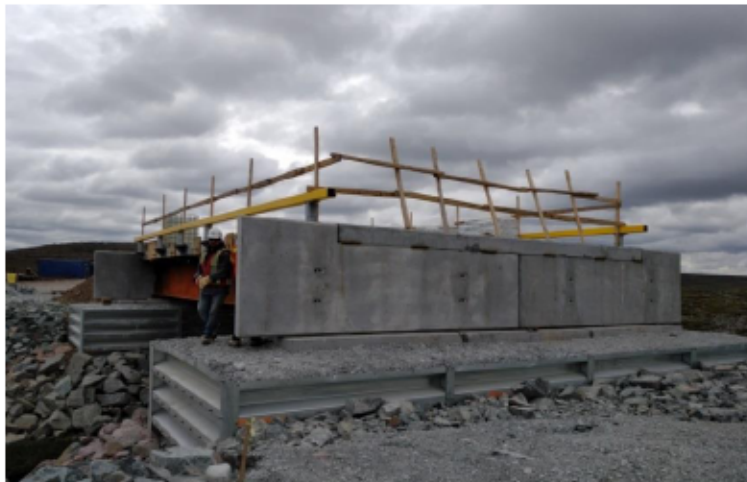
**Figure 3-8
Bridge at km 43.5 – Approach Fills Complete Only on South End**

For all bridges that have not been backfilled, we recommend placing the backfill in equal lifts at each end to maintain a balanced loading condition. If this is not possible, the bearings can be "locked" by installing temporary shims between the vertical guide plate and the ends of the slot. Once backfilling is complete the shims can be removed.

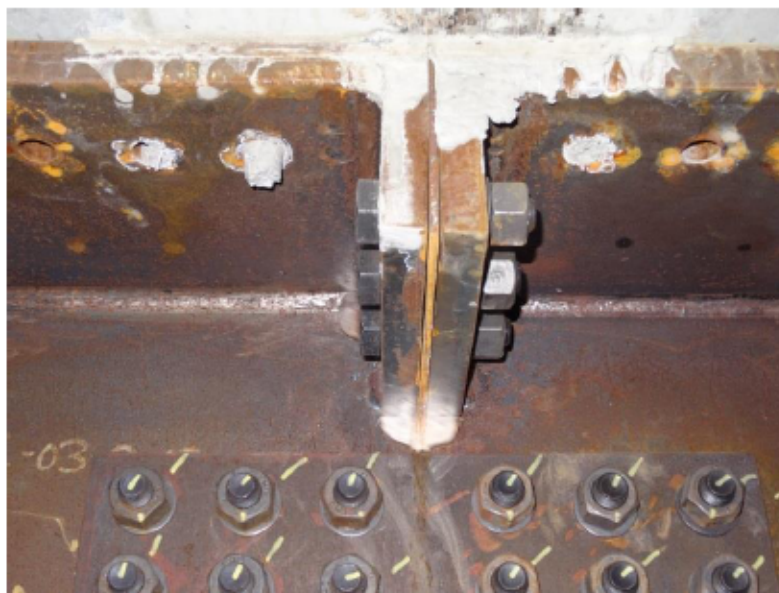
We noted that shims were installed in the top-flange compression splice at girder splice locations on the 44.88 m and 66 m span bridges (see Figure 4-1). These shims vary in thickness from 6 to 10 mm and were not detailed in the shop drawings reviewed by AE. We believe that the splices were not fabricated correctly and the shims were added as an attempt to address the “fit to bear” design requirement. This requirement ensures that the steel girders are able to transfer compression loads across the bolted splice.

Figure 4-1
Bridge at km 32.3 – compression splice with shim

We recommend that while access to the splice locations is available, the top-flange compression splices be checked for gaps using a feeler gauge. Where the feeler gauge can be inserted more than 10 mm the bolts should be re-tightened and any remaining gaps sealed using a suitable pressure injected epoxy.

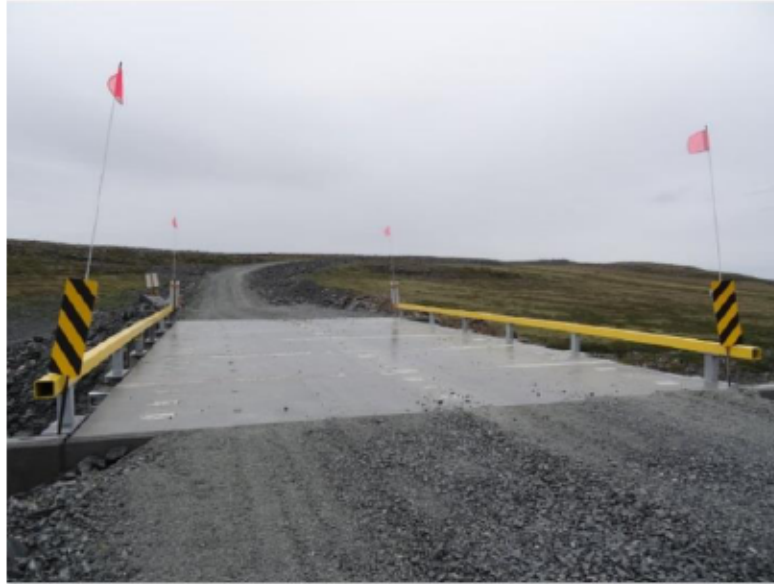
It was observed during our site visit that the roadway embankments at the bridge interfaces do not extend for the full width of the bridge deck at some locations (See Figure 4-2). This poses a safety concern to traversing traffic that crosses near the bridge railings and may result in premature deterioration of the deck panels at these locations. In addition, road maintenance crews should grade the roadway to ensure a smooth transition onto the bridge deck to minimise impact damage from heavy vehicular traffic.

Figure 4-2
Bridge at km 3.6 approach from north

To minimize impact damage to the bridge deck we recommend Agnico Eagle maintain smooth approach transitions on the bridge through regular road maintenance.

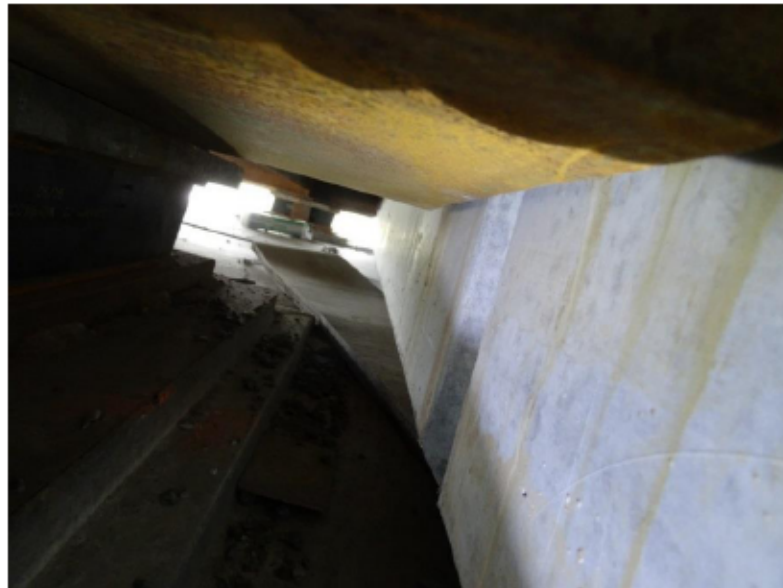
We observed loose or displaced Evazote joint filler at numerous locations. We understand that the contractor had difficulty installing the Evazote due to misaligned precast concrete components (see Figure 4-3). This can result in debris accumulating around bearings and other components (see Figure 4-4).

Figure 4-3
Bridge at km 43.5 Evazote loose in front of ballast wall

We recommend that Evazote joints at the ballast walls be monitored during maintenance inspections for missing portions or fill spilling through joint gaps. A UV-resistant and weather-appropriate polyethylene foam approved by the Engineer may be used to replace Evazote where required to minimize soil and rock spill through the joints and permit joint displacement.

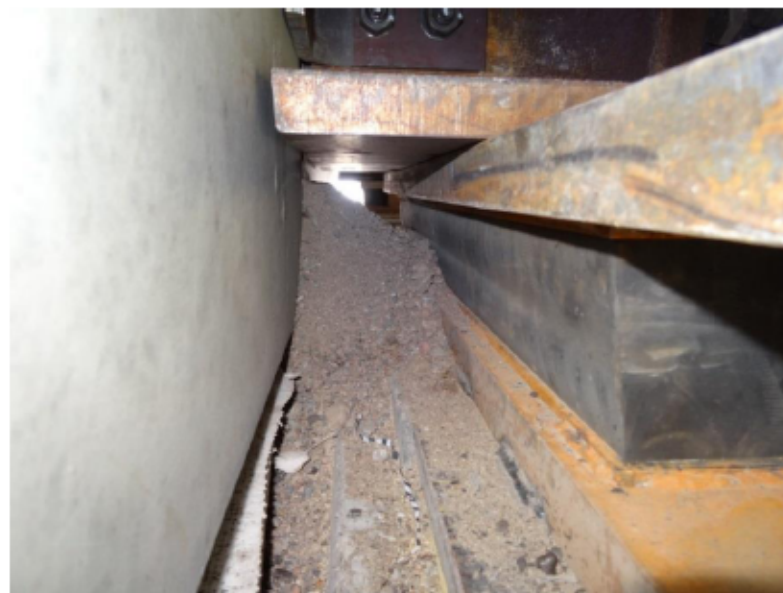
Figure 4-4
Bridge at km 44.5 – north centre bearing – debris spill through ballast wall Evazote joint

The bridge at km 44.8 shows fill spilling through the centre gap between precast ballast walls, indicating that the Evazote has not been installed or has been breached at that joint. As part of regular maintenance, fill and debris should be cleared of the area around bearings to prevent premature deterioration of the bearings.

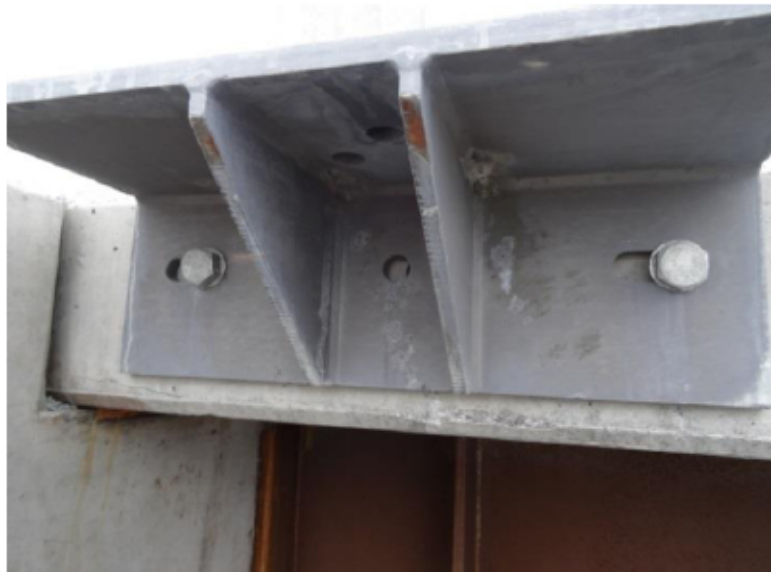
We noted that the bridge railing brackets at a number of locations on the exterior of the precast deck panels had only two of the intended three connecting bolts installed (see Figure 4-5) due to fit-up. This results in the anchorage capacity of the railing system being reduced.

Figure 4-5
Bridge at km 10.5 railing bracket (Note: This bracket could be shifted to capture the centre bolt)

We recommend slotting the centre hole on the railing brackets to allow all three anchor bolts to be installed.

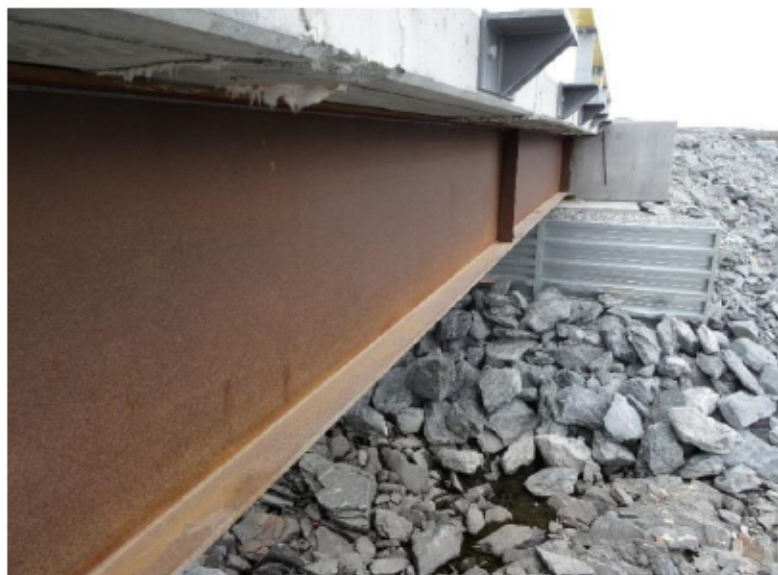
Bridges installed earlier in the construction period have rough cast-in-place deck joints and are missing drip grooves comparable to the adjacent precast panels (see Figure 4-6). The drip groove prevents water migrating along the underside of the deck panel to the girder where it could promote premature deterioration.

Figure 4-6
Bridge at km 3.6 – Underside of deck joint (southeast)

When completing concrete repairs, consideration can be given "grinding: drip grooves in the cast-in-place concrete joints to minimize the possibility of deck runoff draining onto the outside face of the exterior girders.
