Bridge Inspection Report Agnico Eagle

Bridge No.	2017-2318-3.6	Road Name	Meadowbank to Amaruq	Inspection Date	2017-07-15
------------	---------------	-----------	----------------------	-----------------	------------

Bridge No.	2017-2318-10.7	Road Name	Meadowbank to Amaruq					Inspection Date	2017-07-15						
STA.	Forest District					Access Notes									
10.7 km															
Bridge Length	Stream Crossing					Inspected By

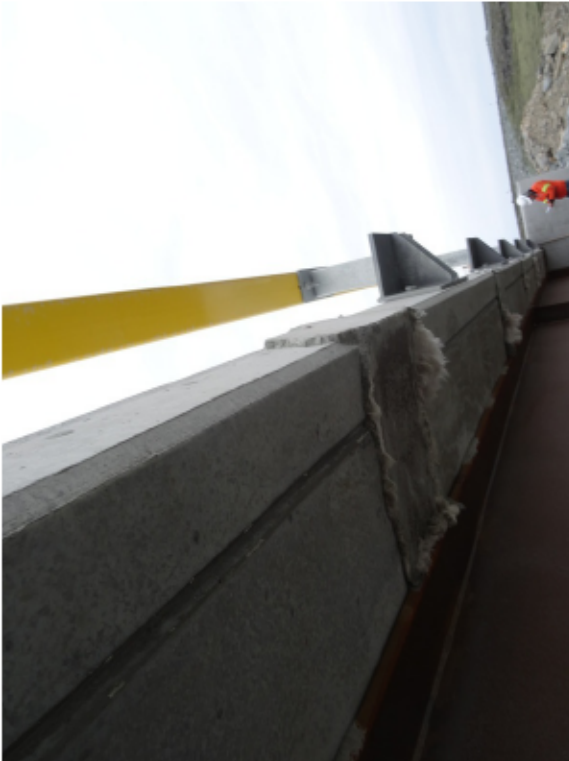
Figure 2: Deck joint (at northwest)

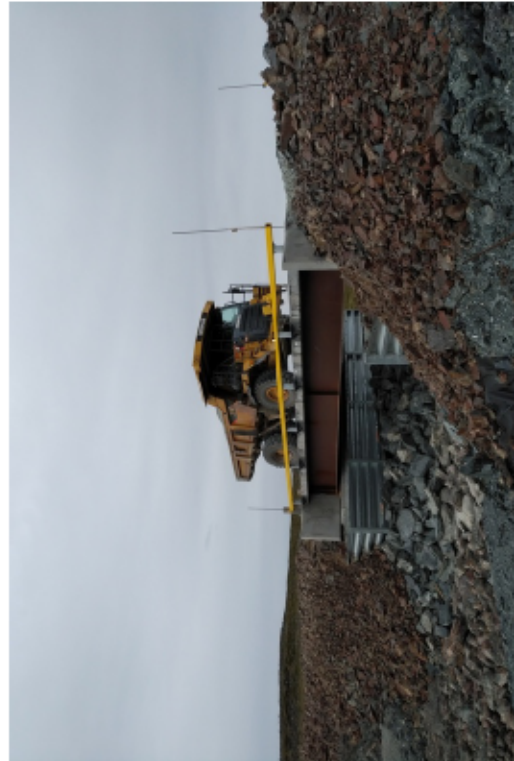
Figure 4: Load Test (View from NE of bridge)

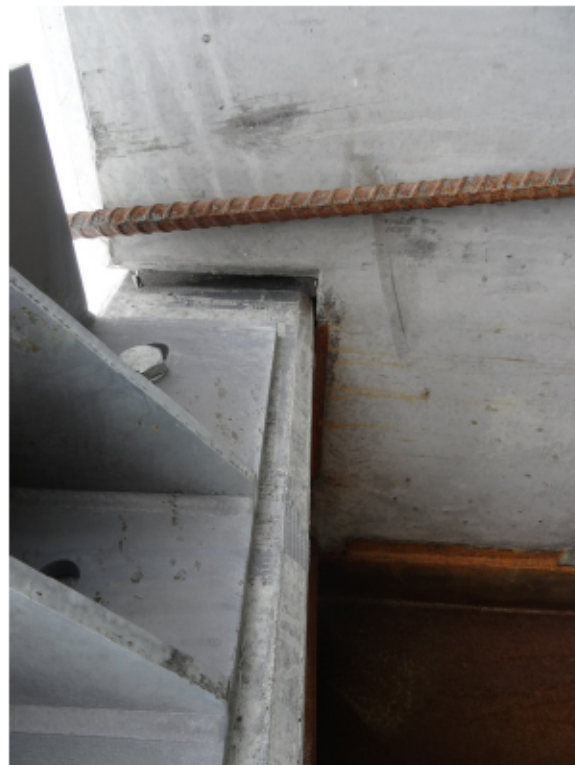
Figure 3: Deck to ballast wall joint (NE)

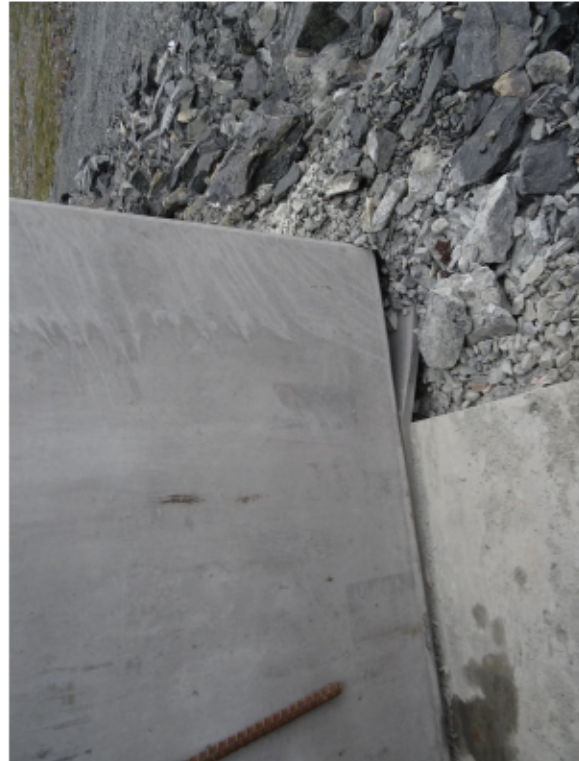
Figure 8: Northeast ballast wall and evazote

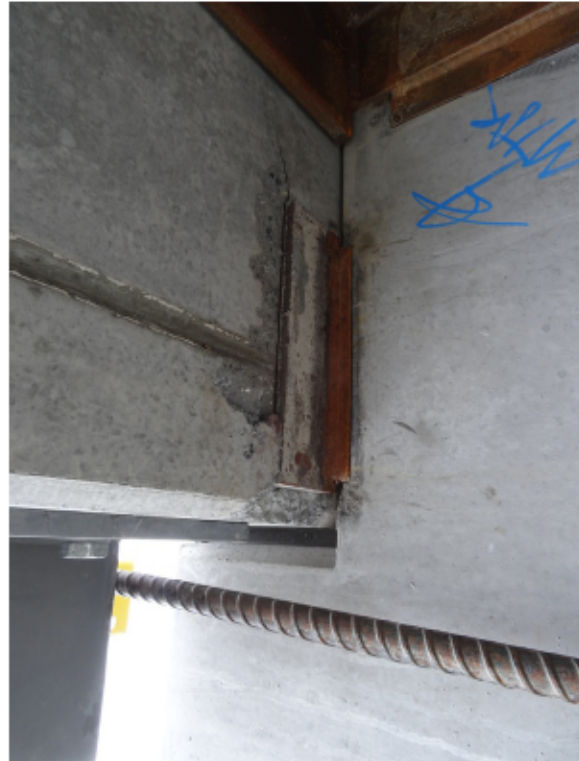
Figure 12: Minor concrete spall, underside of deck (NW corner)

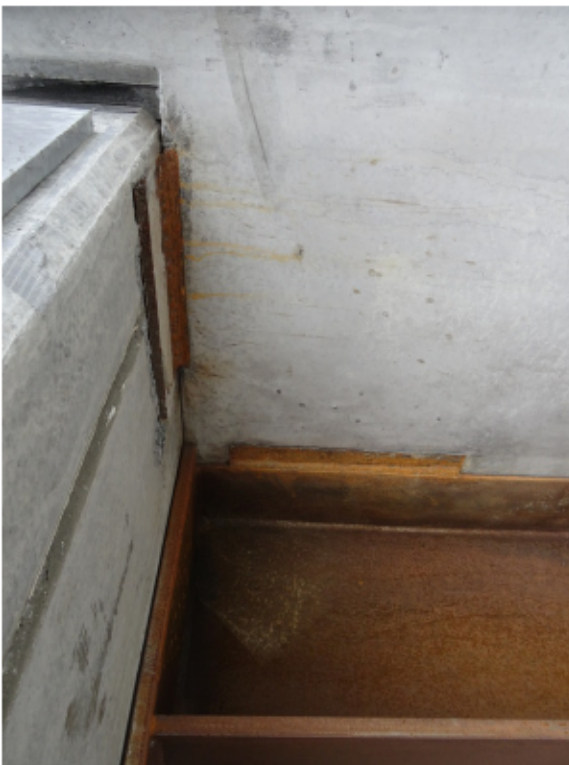
Figure 9: Minor concrete spall at NE abutment

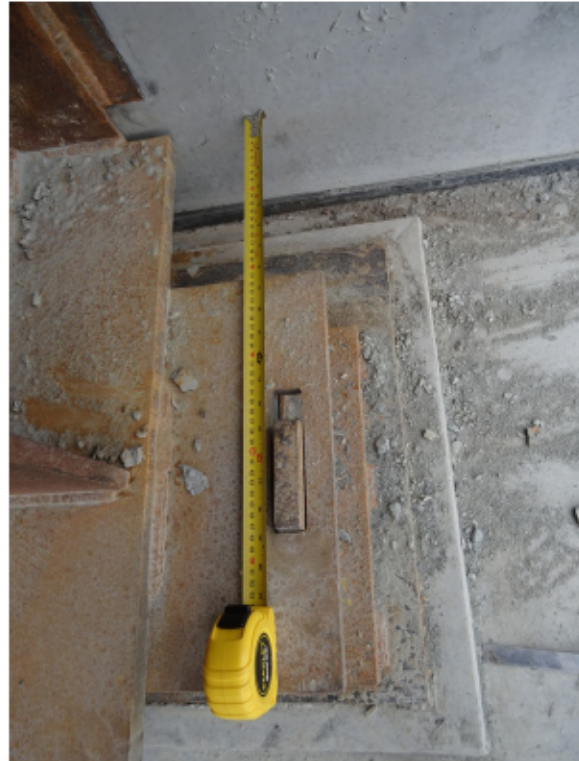
Figure 16: Typical bearing guide plate at the end of its slot

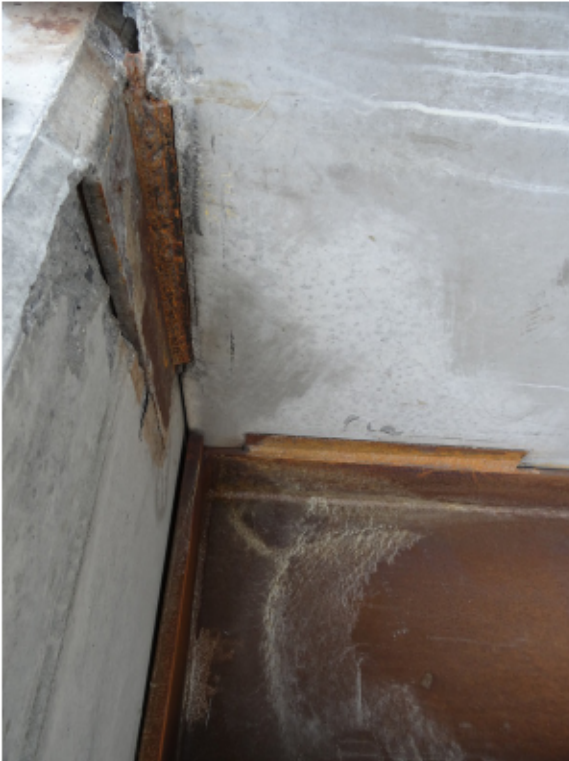
Figure 2: Minor deck soffit spill (SW corner)

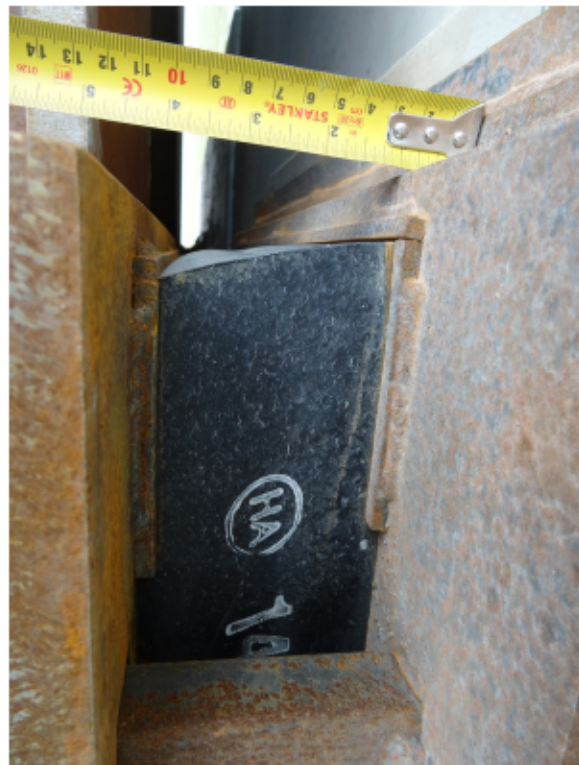
Bridge No.	2017-2318-10.7	Road Name	Meadowbank to Amaruq	Inspection Date	2017-07-15
Abutment - North					
Bearings	Poor	Some guide plates have reached or are near the limit of allowed movement. Some pillowing effects in neoprene pads is evident.			
Bracing	Good				
Ballast Wall	Good	Evazote under ballast wall appears loose and varies in thickness. Thicker pad to east of wall. Some minor spalling evident at welded embedded plate locations.			
Corrosion Protection	N/A	weathering steel			
Caps or Sills	Good	Footings appear level			
Fill	Good	Approach grading has some gaps near the ends of the deck			
Hardware	Excellent	weathering steel			
Riprap	Excellent				
Wingwall	Good				
Overall	Good				
Abutment - South					
Bearings		Bearing guide plates are near the limit of allowed movement. Some pillowing effects in neoprene pads is evident.			
Bracing	Good				
Ballast Wall	Good	Ballast wall has minor rotation, toe kicking in towards bridge. Some minor spalling evident at welded embedded plate locations.

Figure 3: Typical bearing (SE)

Bridge No.	2017-2318-10.7	Road Name	Meadowbank to Amaruq	Inspection Date	2017-07-15
Repair Description and Cost Estimate					
No.	Description	Priority	Cost Estimate		
1	Confirm that all bracing and bolted connections are tightened according to project specifications	Medium	\$0.00		
2	Cut bearing slots for guide plates to allow further movement - see report for recommended amount	Medium	\$0.00		
3	Install permanent signage at bridge approaches	Low	\$0.00		
4	Grout lifting lug pockets in deck to prevent damage from gravel and traffic	Low	\$0.00		
5	Install railings meeting facility requirements - ensure all anchor bolts are installed	Low	\$0.00		
<p>High: Immediate, non-recurring repair to assure public safety</p> <p>Medium: Ongoing, regular maintenance items to protect capital investment</p> <p>Low: Minor maintenance items or improvements to extend service life</p> <p>The cost estimate for individual maintenance items reflects the cost of materials and labour for completing a task; it does not include any costs associated with mobilization, demobilization, delivery of materials, engineering or contract administration.</p>

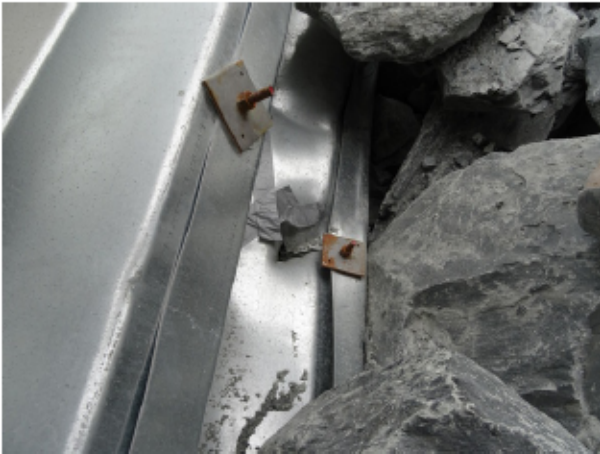
Figure 6: Damaged NE bin wall

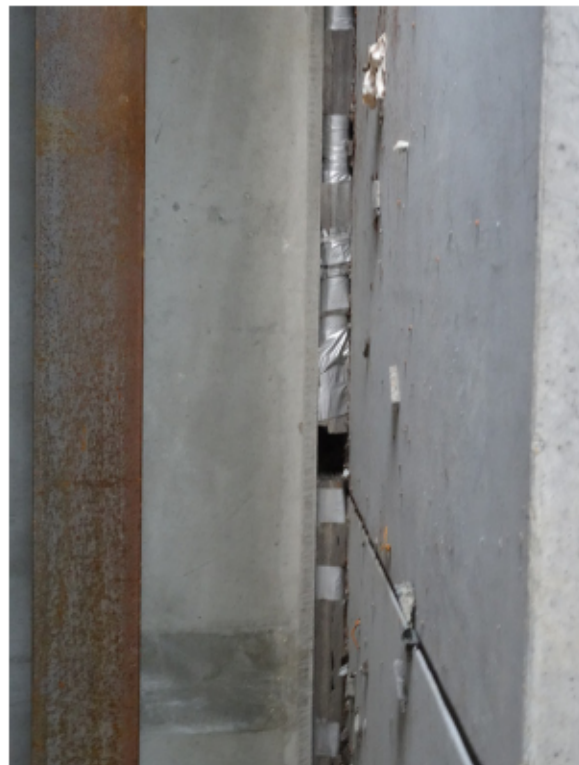
Figure 7: Evazote under NE ballast wall

Monitoring Items					
No.	Description				
1	Widen road embankments to match bridge deck width or provide delineation at gap				
2	Monitor leakage due to lack of drip grooves at cast-in-place concrete deck soffit				
3	Monitor for loose or missing evazote at underside of ballast wall or joints and replace/repair as required				
4	Monitor approach fills regularly to avoid traffic damaging the precast deck panel edges				
Comments				Seal	
Partial Inspection 1:21 pm, 16 degrees C ambient temperature Overcast / Partly Cloudy Load test conducted earlier on July 15th

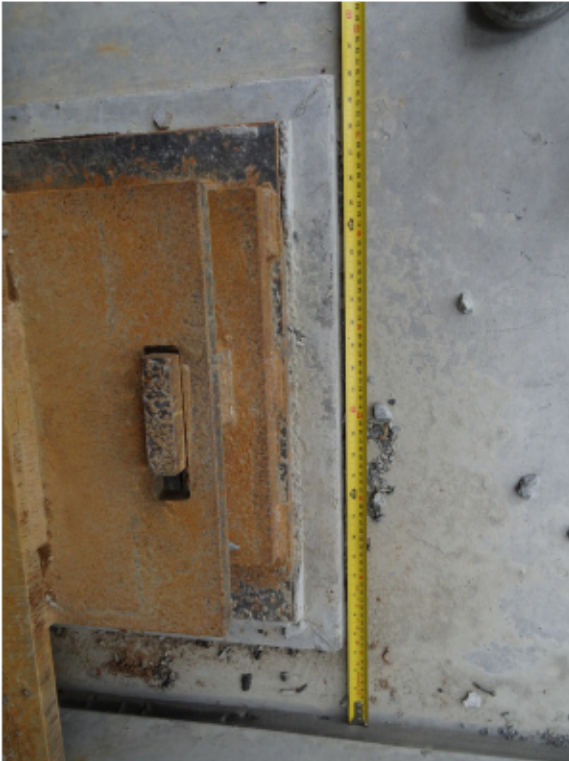
Figure 10: NW bearing - some slot length remaining

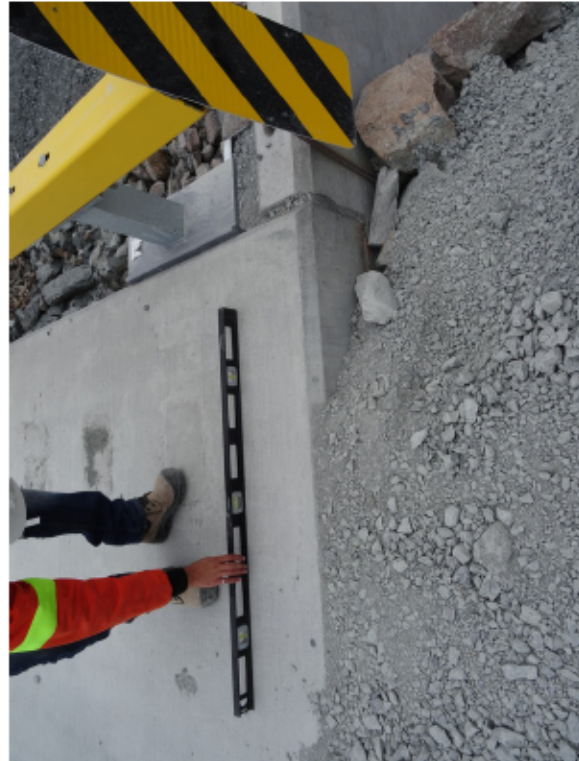
14.7 o/o m						R. Smertina									
UTM Zone	Easting					Northing									
No. Spans		Installation Date		Current Load Rating		Deck Width		Project No.		Anticipated Replacement					
1		2016				7900 mm									
Span / Length (m)	1	13.88	2		3		4		5		6		7		
Comments	single span, steel girders, precast concrete deck, integral abutments														
Excellent: New or almost new condition and properly installed Good: Structurally sound, in good repair and have minimal wear Fair: Structurally sound, but show moderate wear or preliminary indications of rot or corrosion Poor: Structurally unsound, major items in need of repair or replacement, or bridge load rating should be reduced															
Abutment, spans, piers numbered from left bank, facing downstream / girders numbered from upstream to downstream.															
Approaches															
Approach Road	Good		Some gaps in road embankment approaching deck edge

Figure 12: SE end of deck and road embankment

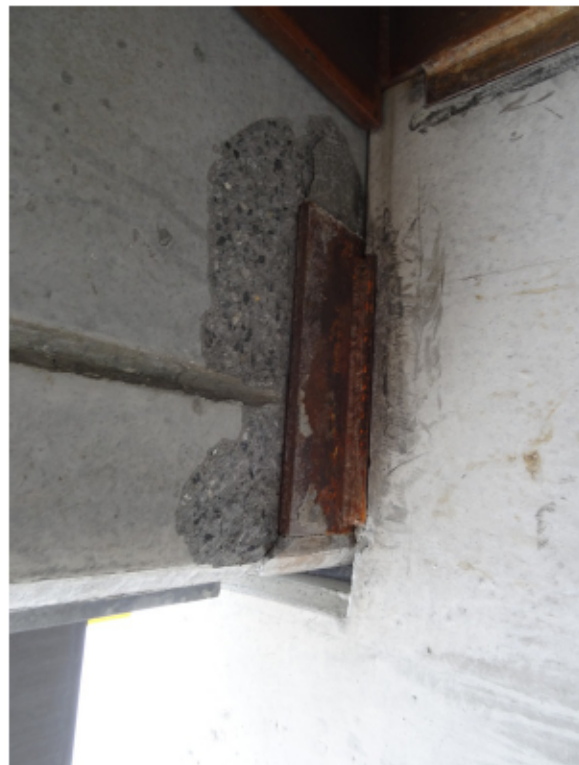
Figure 11: Minor spall at NW deck soffit

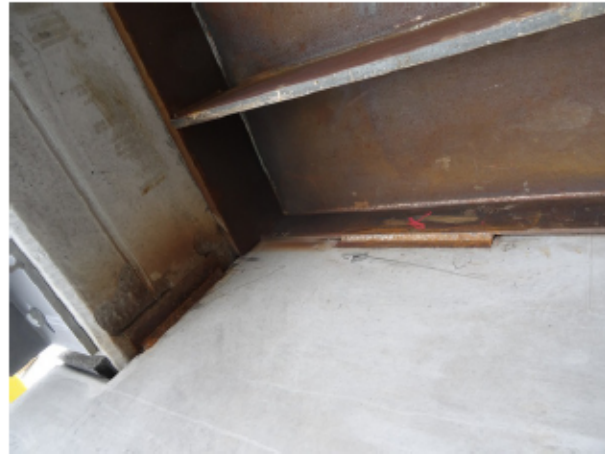
Figure 4: Minor spalling and scorching at ballast wall and deck soffit (SE)

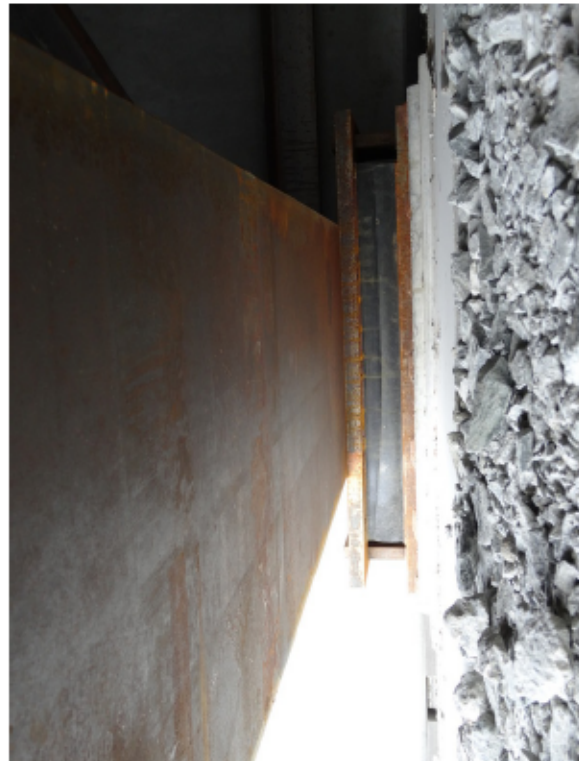
Figure 8: NW bearing front (fabrication imperfection)

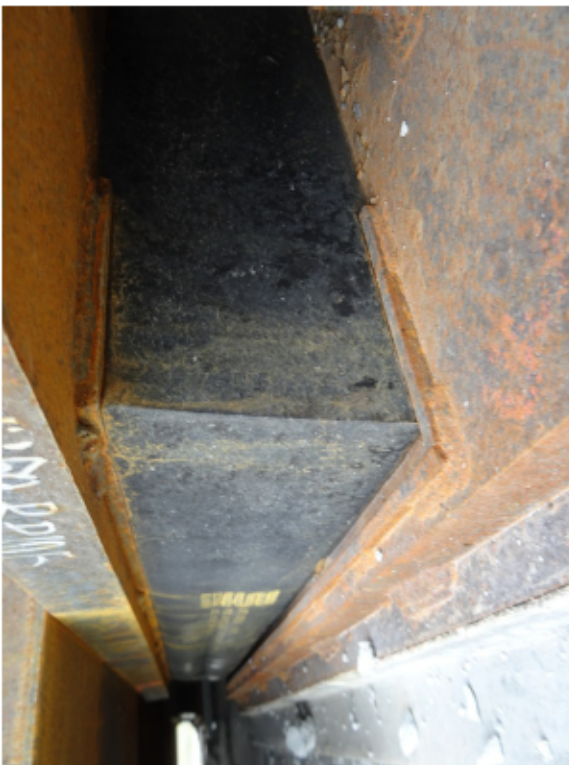
Bridge No.	2017-2318-16.0	Road Name	Meadowbank to Amaruq	Inspection Date	2017-07-15
Abutment - North					
Bearings	Fair	Guide plates are at or near the limit of allowed movement			
Bracing	Good				
Ballast Wall	Good	some loose evazote under ballast wall and at joint with deck. Some minor spalling evident at welded embedded plate locations			
Corrosion Protection	N/A	weathering steel			
Caps or Sills	Good	Some minimal slope observed in top of footings. 7mm movement of longitudinal movement at NW corner.			
Fill	Good				
Hardware	Excellent				
Riprap	Excellent				
Wingwall	Good				
Overall	Good				
Abutment - South					
Bearings	Fair	Guide plates are at or near the limit of allowed movement			
Bracing	Good				
Ballast Wall	Good	some loose evazote under ballast wall and at joint with deck. Some minor spalling evident at welded embedded plate locations			
Corrosion Protection	N/A	weathering steel			
Caps or Sills	Good	some minimal slope observed in footings.

Figure 5: NE bearing front (some protrusion of neoprene over top keeper)

Bridge No.	2017-2318-16.0	Road Name	Meadowbank to Amaruq	Inspection Date	2017-07-15
Repair Description and Cost Estimate					
No.	Description	Priority	Cost Estimate		
1	Cut bearing slots for guide plates to allow further movement	Medium	\$0.00		
2	Confirm that all bracing and bolted connections are tightened according to project specifications.	Low	\$0.00		
3	Install permanent signage at bridge approaches	Low	\$0.00		
4	Grout lifting lug pockets in deck to prevent damage from gravel and traffic	Low	\$0.00		
5	Install railings meeting facility requirements - ensure all anchor bolts are installed	Low	\$0.00		
<p>High: Immediate, non-recurring repair to assure public safety</p> <p>Medium: Ongoing, regular maintenance items to protect capital investment</p> <p>Low: Minor maintenance items or improvements to extend service life</p> <p>The cost estimate for individual maintenance items reflects the cost of materials and labour for completing a task; it does not include any costs associated with mobilization, demobilization, delivery of materials, engineering or contract administration.</p>
