Bridge Inspection Report Agnico Eagle

| Bridge No. | 2017-2318-20.0 | Road Name | Meadowbank to Amaruq | | | | | Inspection Date | 2017-07-13 | | | | |
| Comments | single span. steel girders with precast concrete deck, integral abutments | | | | | | | | | | | | |

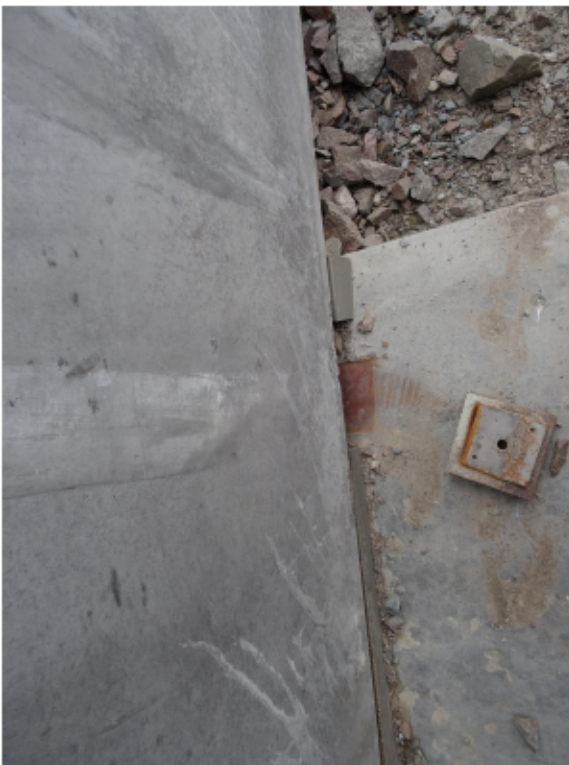
Figure 17: Base of ballast wall - evazote gaps observed (NE)

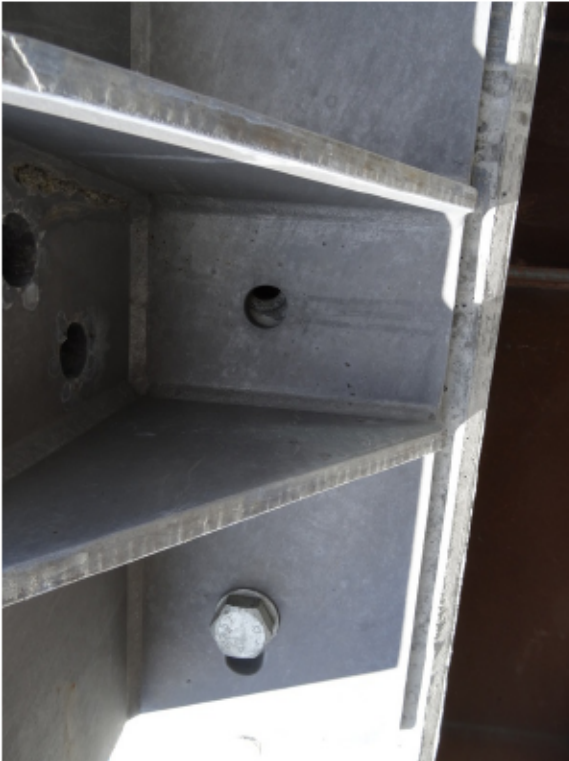
| Curb Rails and Risers | Fair | | Only 2 of 3 anchor bolts currently installed at each connection - fit-up problems during construction at some locations | | | | | | | | | | |

Figure 2: Bridge railing connection into deck (SW)

| Bridge No. | 2017-2318-20.0 | Road Name | Meadowbank to Amaruq | Inspection Date | 2017-07-13 |
|---|--|---|---|---|---|
| 5 | Install railings meeting facility requirements - ensure all anchor bolts are installed | Low | \$0.00 | | |

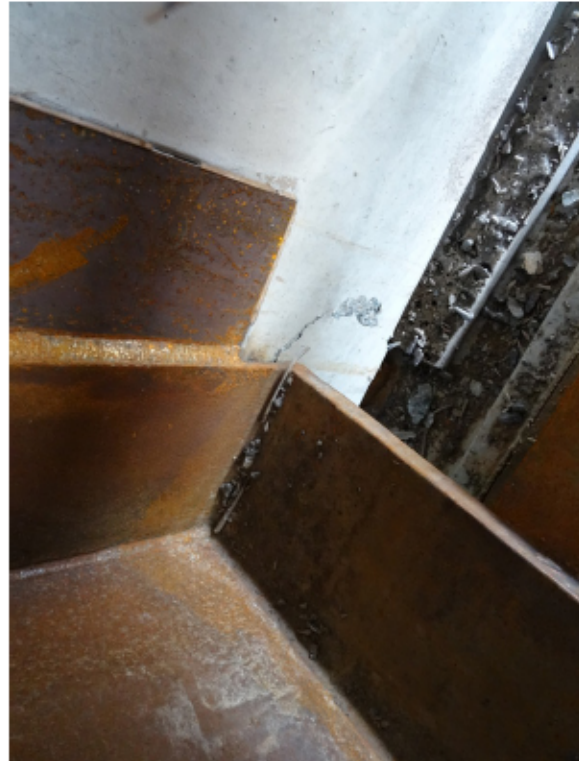
| Ballast Wall | Good | Some loose evazote under ballast wall and at joint with the deck | | | |

Figure 4: Evazote under south centre girder and ballast wall

| Bridge No. | 2017-2318-20.0 | Road Name | Meadowbank to Amaruq | Inspection Date | 2017-07-13 |
|---|--|---|---|---|---|
| 4 | Monitor for loose or missing evazote at underside of ballast wall or joints and replace/repair as required | | | | |

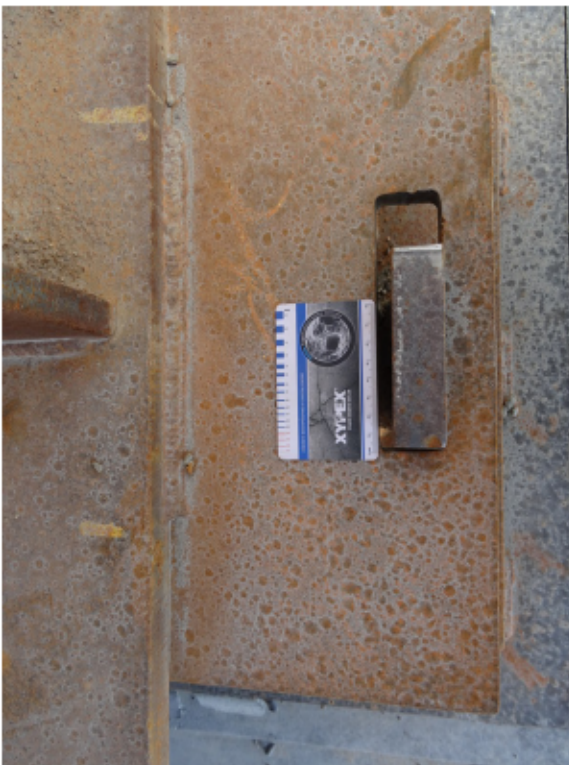
| Bearings | Fair | Guide plates are nearing the limit of allowed movement on the day of inspection | | | |

Figure 1: Bearing guide plate nearing end of slot (SW outside of bearing)

| Bridge No. | 2017-2318-20.0 | Road Name | Meadowbank to Amaruq | Inspection Date | 2017-07-13 |
|---|--|---|---|---|---|
| 1 | Cut bearing slots for guide plates to allow further movement - see report for recommended amount | Medium | \$0.00 | | |

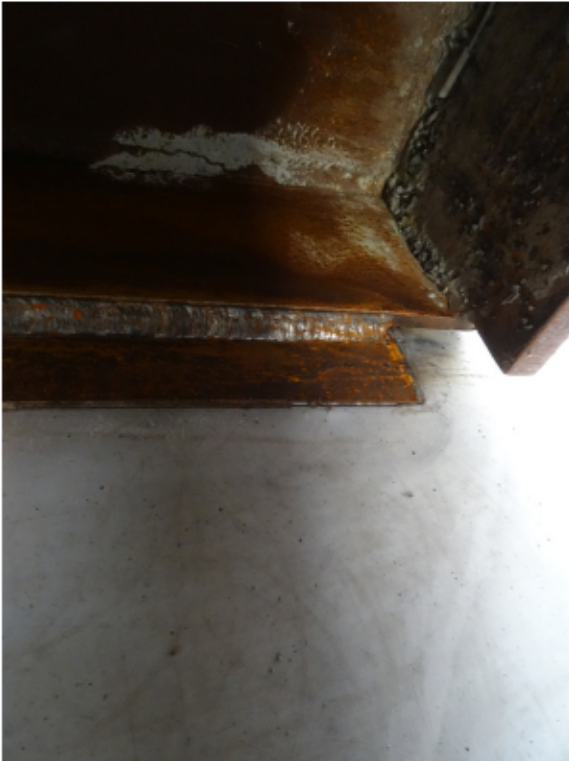
Figure 6: Large weld at ballast wall connection (SW girder, inside face)

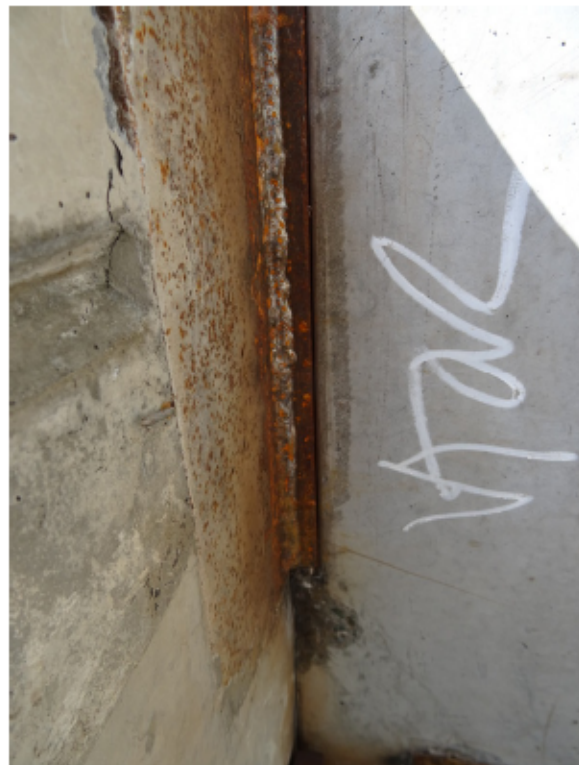
| Ballast Wall | Good | Some loose evazote under ballast wall and at joint with the deck. Some minor spalling evident at welded embedded plate locations. | | | |

Figure 7: Minor spall at soffit of deck to ballast wall connection (SW)

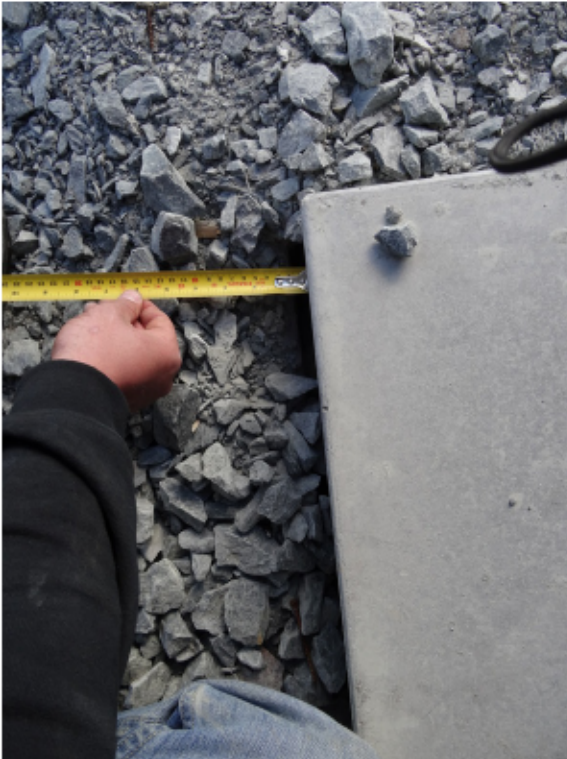
| Caps or Sills | Good | footings appear level. evidence of footing movement (particularly at NW corner) - either fill has moved forward towards the creek or footing has moved backwards to ballast wall. | | | |

Figure 10: NW footing movement

| Bridge No. | 2017-2318-20.0 | Road Name | Meadowbank to Amaruq | Inspection Date | 2017-07-13 |
|---|--|---|---|---|---|
| 1 | Monitor footings and bin walls for any future movement | | | | |

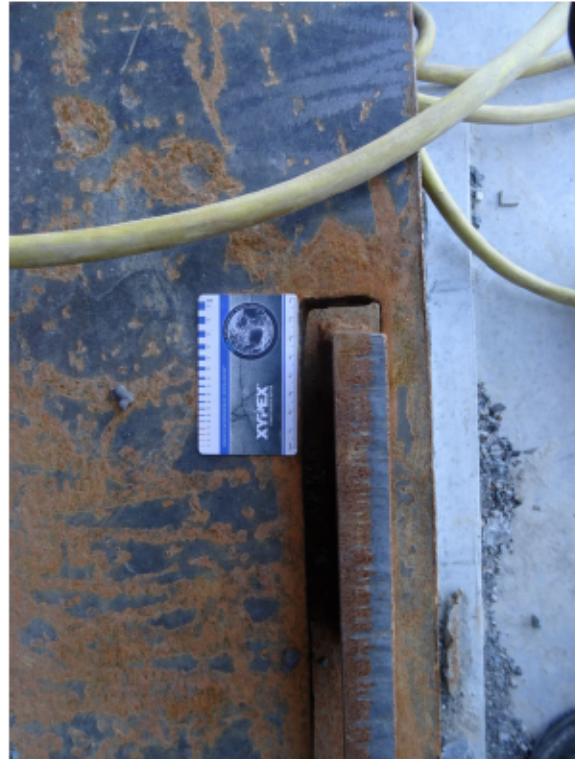
| Bridge No. | 2017-2318-23.9 | Road Name | Meadowbank to Amaruq | Inspection Date | 2017-07-13 |
|---|---|---|---|---|---|
| Bearings | Fair | Some slot length (amount varies) remaining for guide plate movement. No top keepers were installed during bearing installation. | | | |

Figure 4: Remaining slot length (SE bearing outside)

| Bridge No. | 2017-2318-23.9 | Road Name | Meadowbank to Amaruq | Inspection Date | 2017-07-13 |
|---|--|---|---|---|---|
| 3 | May cut bearing slots for guide plates to allow further movement (optional) | Low | \$0.00 | | |

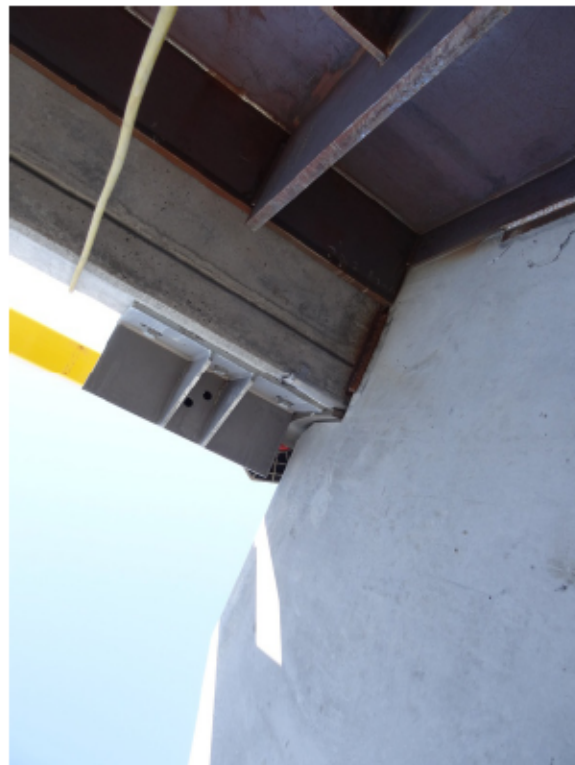
Figure 3: Railing connection and deck soffit (SE corner)
