Bridge No.	2017-2318-23.9	Road Name	Meadowbank to Amaruq	Inspection Date	2017-07-13
------------	----------------	-----------	----------------------	-----------------	------------

Bridge Inspection Report Agnico Eagle

Bridge No.	2017-2318-26.1	Road Name	Meadowbank to Amaruq					Inspection Date	2017-07-15						
STA.	Forest District					Access Notes									
26.1 km															
Bridge Length	Stream Crossing					Inspected By

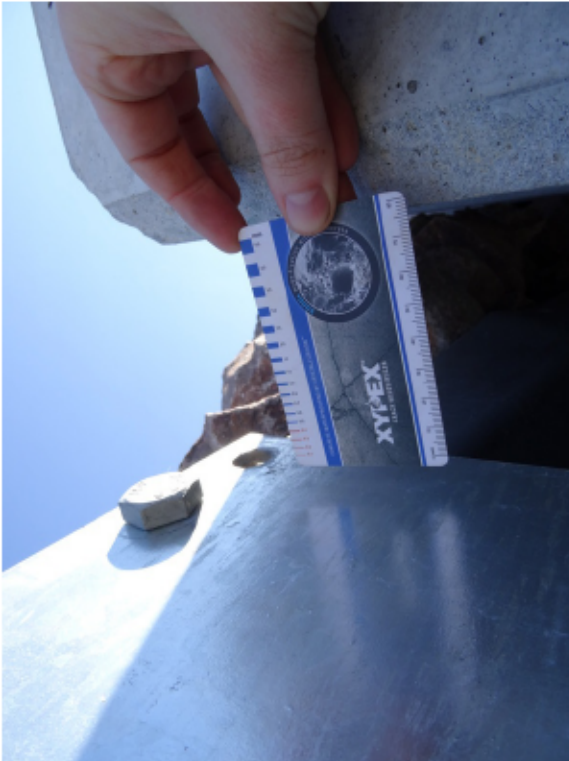
Figure 6: SE binwall and ballast wall gap (top)

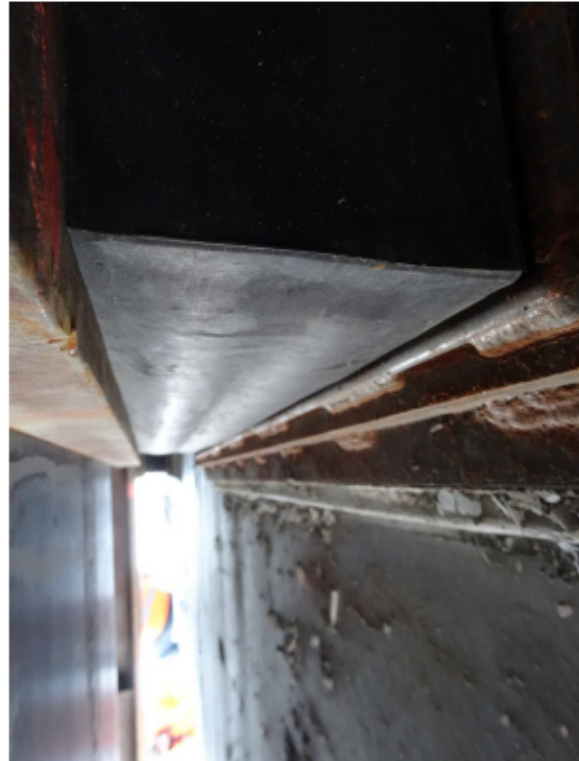
Figure 8: South centre bearing, front face

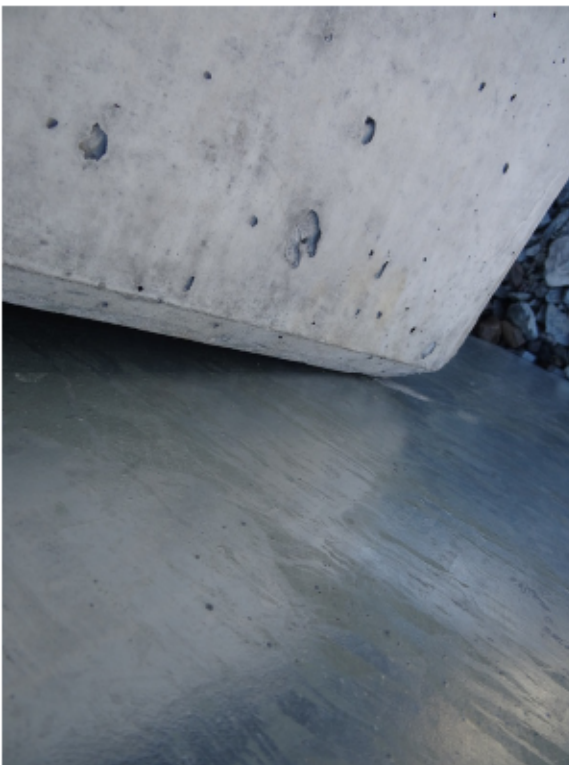
Figure 5: SE binwall and ballast wall (base)

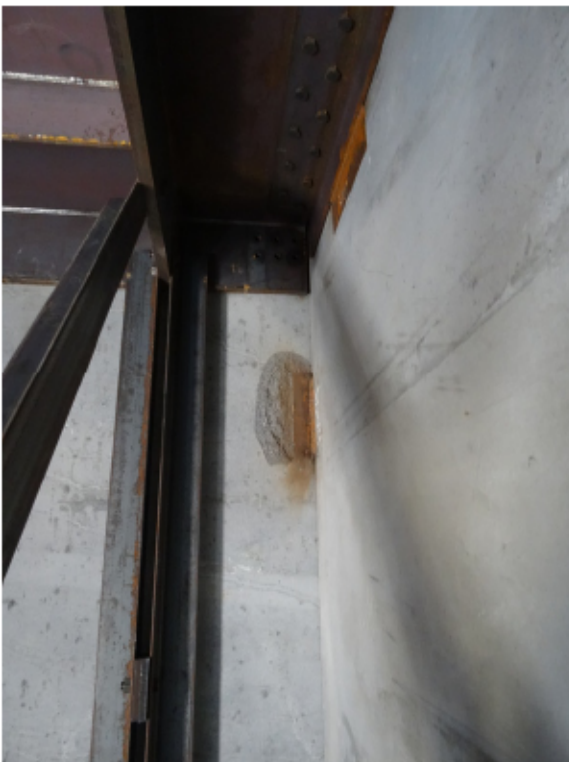
Figure 9: Spall in deck soffit, north centre girder (west side)

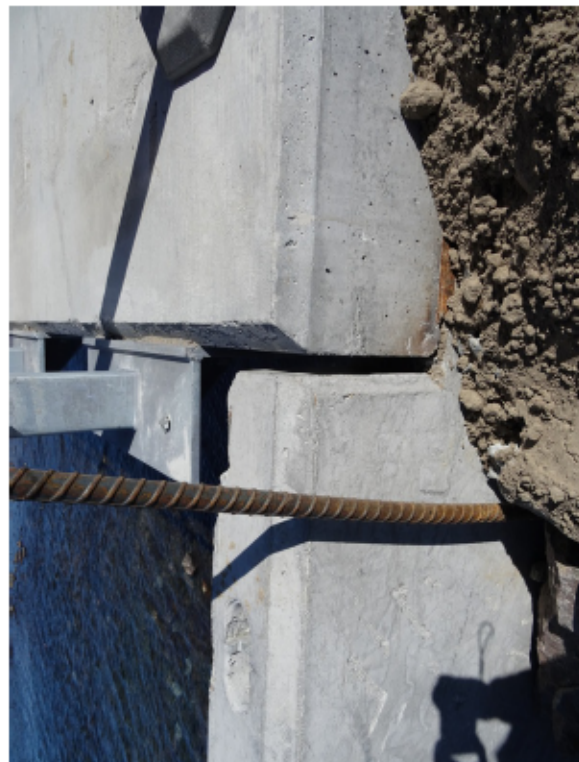
Figure 23: NE ballast wall and deck edge (note evazote missing in joint)

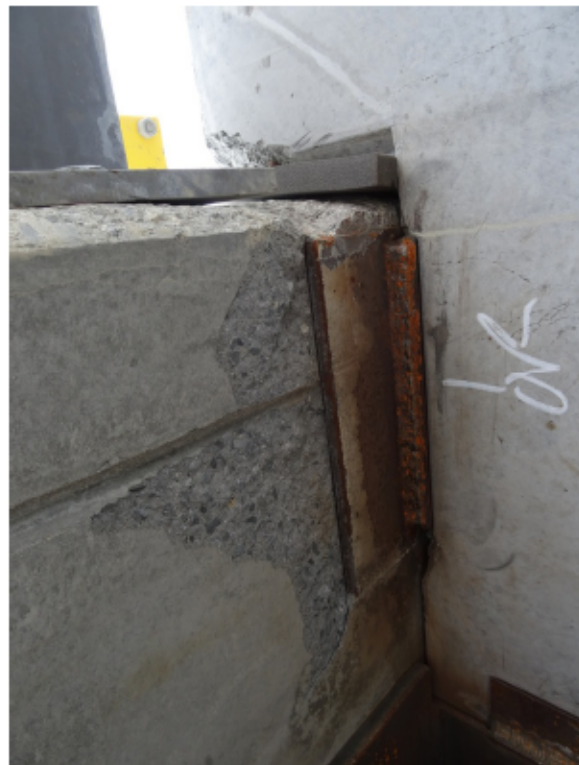
Figure 3: Minor spall in deck soffit (SW corner)

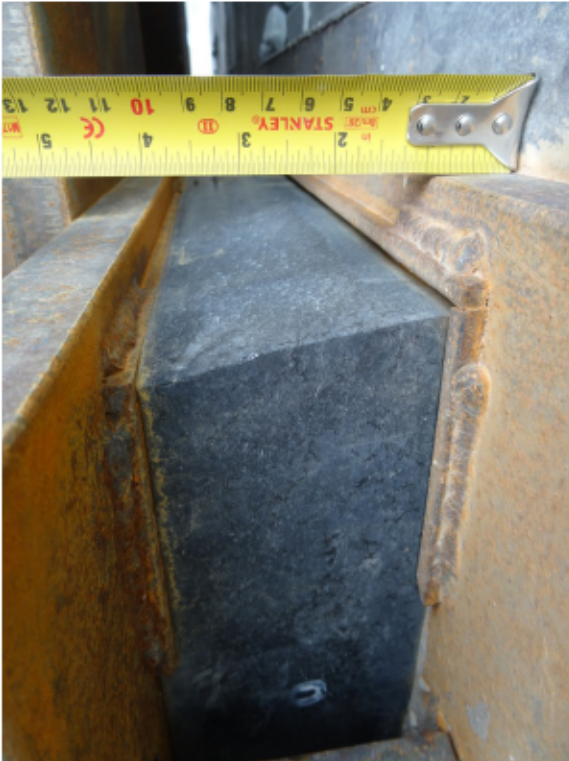
Bridge No.	2017-2318-26.1	Road Name	Meadowbank to Amaruq	Inspection Date	2017-07-15
Abutment - North					
Bearings	Poor	Guide plates are at the limit of allowed movement			
Bracing	Good				
Ballast Wall	Good	Some loose evazote under ballast wall and at joint with deck Some minor spalling evident at welded embedded plate locations Minor rotation out of plumb (bottom of ballast wall kicks in, opposite of other abutment)			
Corrosion Protection	N/A	weathering steel			
Caps or Sills	Good	footings installed level			
Fill	Good	Some minor gaps in approach grading at the ends of the deck			
Hardware	Excellent				
Riprap	Excellent				
Wingwall	Good				
Overall	Good				
Abutment - South					
Bearings	Poor	Guide plates are at the limit of allowed movement			
Bracing	Good				
Ballast Wall	Good	Some loose evazote under ballast wall and at joint with deck Some minor spalling evident at welded embedded plate locations Minor rotation out of plumb (top of ballast wall tips inwards)

Figure 6: NW bearing - front west corner

Bridge No.	2017-2318-26.1	Road Name	Meadowbank to Amaruq	Inspection Date	2017-07-15
Repair Description and Cost Estimate					
No.	Description	Priority	Cost Estimate		
1	Cut bearing slots for guide plates to allow further movement - see report for recommended amount	Medium	\$0.00		
2	Confirm that all bracing and bolted connections are tightened according to project specifications	Low	\$0.00		
3	Install permanent signage at bridge approaches	Low	\$0.00		
4	Clean out and grout lifting lug pockets in deck to prevent damage from gravel and traffic	Low	\$0.00		
5	Install railings meeting facility requirements - ensure all anchor bolts are installed	Low	\$0.00		
6	Maintain road embankments to match bridge deck width or provide delineation at gap locations	Low	\$0.00		
7	Repair concrete spall areas where steel reinforcing is exposed	Low	\$0.00		
<p>High: Immediate, non-recurring repair to assure public safety</p> <p>Medium: Ongoing, regular maintenance items to protect capital investment</p> <p>Low: Minor maintenance items or improvements to extend service life</p> <p>The cost estimate for individual maintenance items reflects the cost of materials and labour for completing a task; it does not include any costs associated with mobilization, demobilization, delivery of materials, engineering or contract administration.</p>

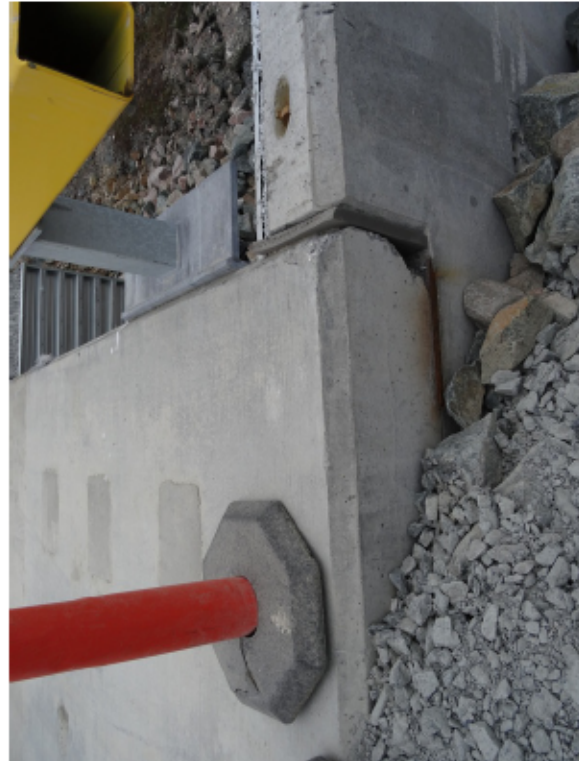
Figure 8: SE deck and ballast wall end

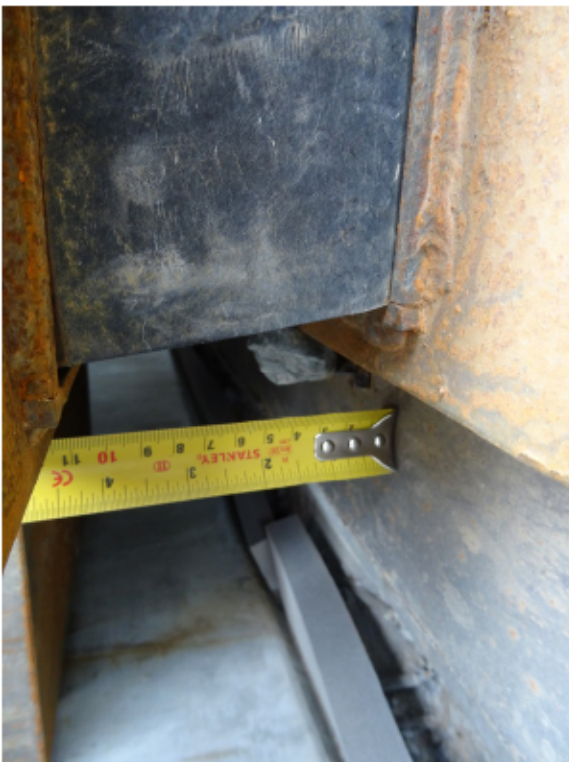
Figure 5: NW bearing - back west corner

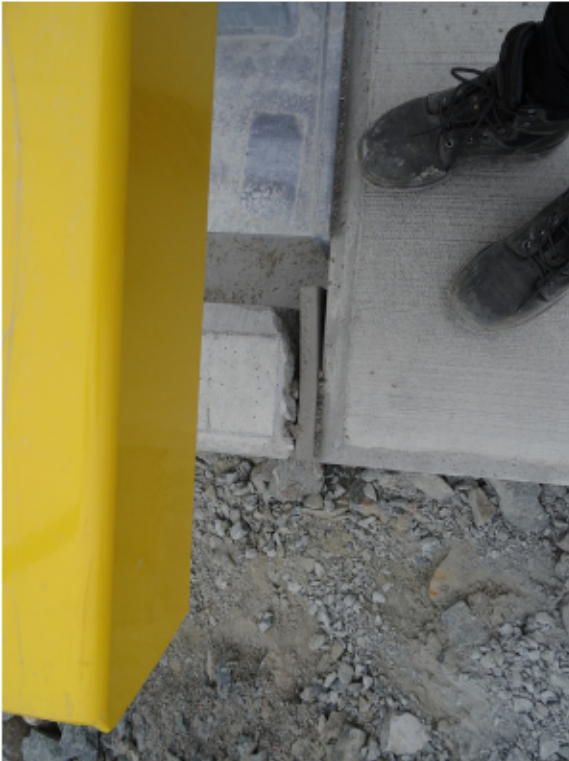
Figure 10: SW ballast wall and deck joint from above

Monitoring Items					
No.	Description				
1	Monitor approach grading regularly to avoid traffic damaging the precast deck panel edges				
2	Monitor for loose or missing evazote at underside of ballast wall or joints and replace/repair as required				
3	Monitor ballast walls for further movement				
Comments				Seal	
Partial Inspection 12:00 pm Girder exterior face skin temperature varies from 8.9 to 12 degrees Celcius Load test conducted on July 15th - minor noise observed

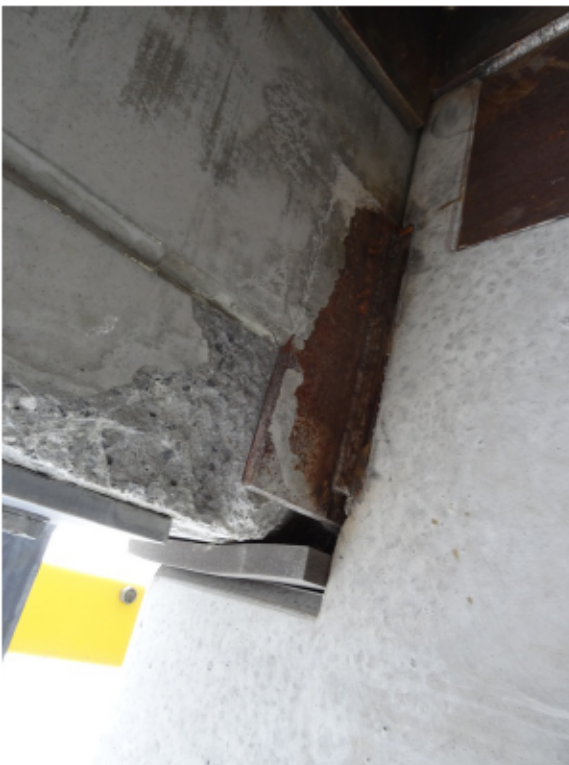
Figure 9: Spall in dek panel corner (SE)
