Bridge Inspection Report

Agnico Eagle

Bridge No.	2017-2318-32.3	Road Name	Meadowbank to Amaruq					Inspection Date	2017-07-14						
STA.	Forest District					Access Notes									
32.3 km															
Bridge Length	Stream Crossing					Inspected By

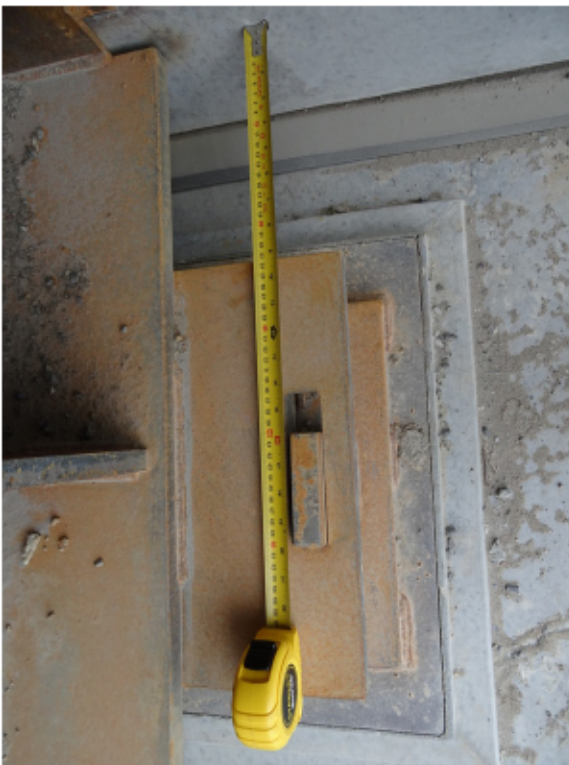
Figure 13: SW bearing (at end of slotted hole)

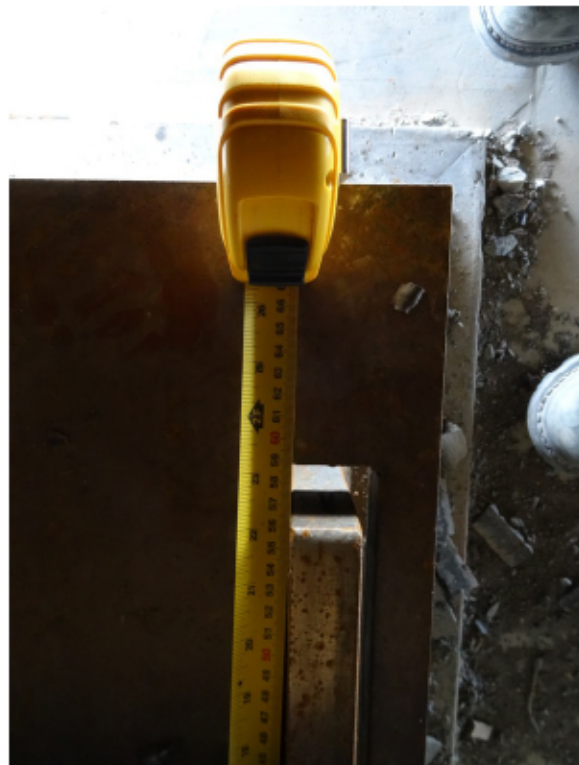
Bridge No.	2017-2318-32.3	Road Name	Meadowbank to Amaruq	Inspection Date	2017-07-14
Abutment - North					
Bearings	Poor	bearings not aligned within keeper bars. pillowing effects observed at front of bearings guide plates nearing limit of travel in slot.			
Bracing	Good				
Ballast Wall	Good	some loose evazote under ballast wall and at joint with deck. some minor spalling evident at welded embedded plate locations			
Corrosion Protection	N/A	weathering steel			
Caps or Sills	Good	minimal settlement. appear level.			
Fill	Good	approach grading has some gaps/dips near the ends of the deck			
Hardware	Excellent				
Riprap	Excellent				
Wingwall	Good				
Overall	Good				
Abutment - South					
Bearings	Poor	bearings not aligned within keeper bars. top front keepers were removed by the contractor during installation. pillowing effects observed at front of bearings guide plates nearing limit of travel in slot.

Figure 7: NE bearing remaining slot length

Bridge No.	2017-2318-32.3	Road Name	Meadowbank to Amaruq	Inspection Date	2017-07-14
Repair Description and Cost Estimate					
No.	Description	Priority	Cost Estimate		
1	Jack up girders and reset bearings to proper alignment.	High	\$0.00		
2	Confirm that all bracing and bolted connections are tightened according to project specifications	Low	\$0.00		
3	Grout lifting lug pockets in deck to prevent damage from gravel and traffic	Low	\$0.00		
4	Grade road embankments to match bridge deck width	Low	\$0.00		
5	Install railings meeting facility requirements - ensure all anchor bolts are installed	Low	\$0.00		
6	Install permanent signage at bridge approaches	Low	\$0.00		
<p>High: Immediate, non-recurring repair to assure public safety</p> <p>Medium: Ongoing, regular maintenance items to protect capital investment</p> <p>Low: Minor maintenance items or improvements to extend service life</p> <p>The cost estimate for individual maintenance items reflects the cost of materials and labour for completing a task; it does not include any costs associated with mobilization, demobilization, delivery of materials, engineering or contract administration.</p>

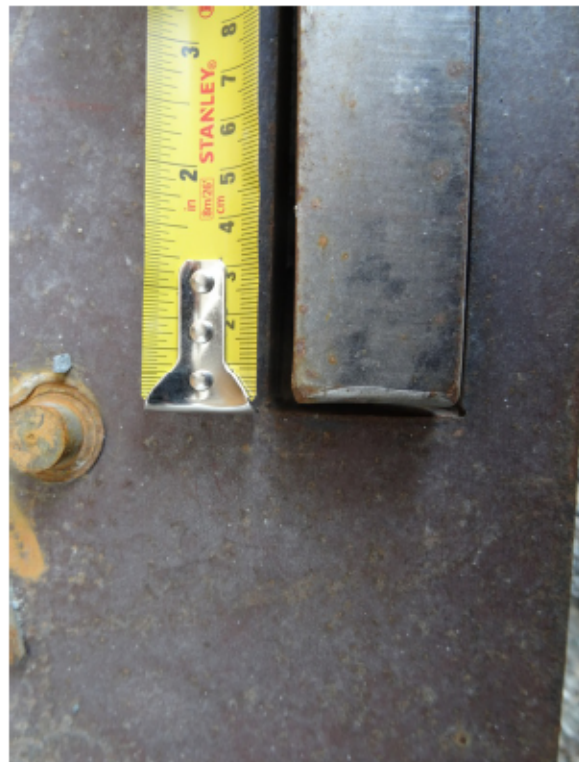
Figure 11: NW bearing remaining slot length

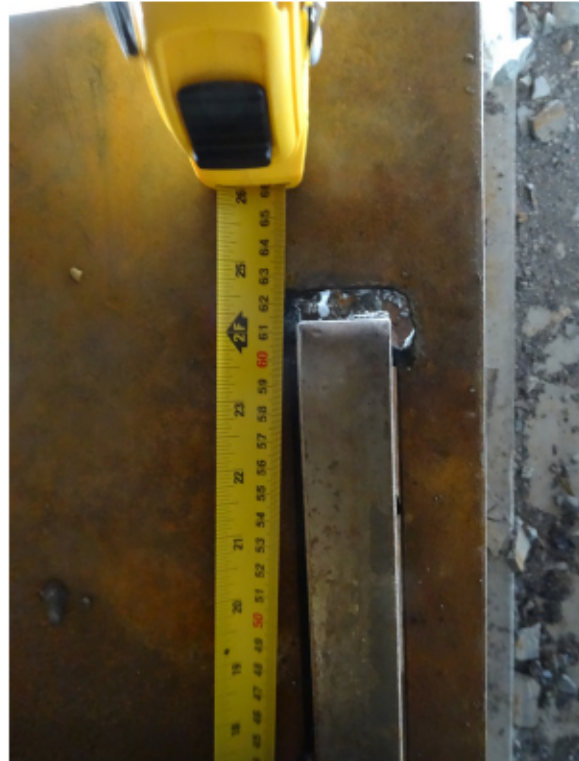
Figure 16: SW bearing front of slot cut by contractor (interior)

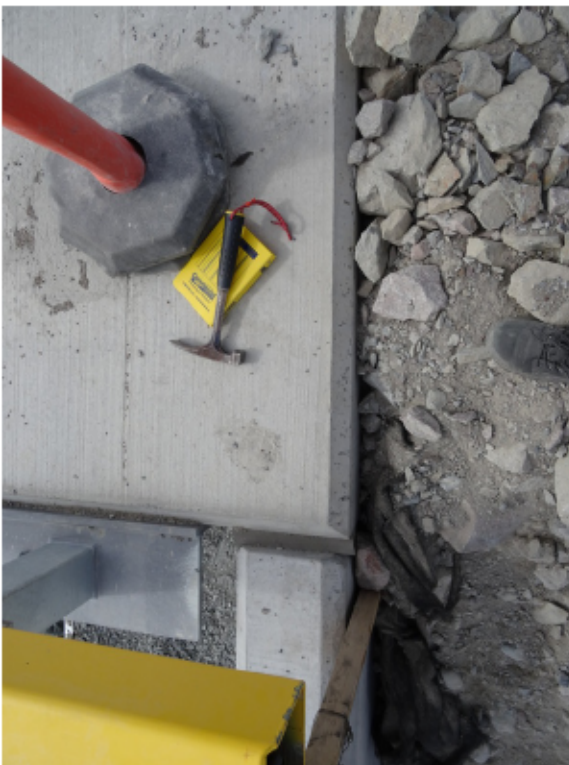
Bracing	Good				
Ballast Wall	Good	some loose evazote under ballast wall and at joint with deck. some minor spalling evident at welded embedded plate locations			
Corrosion Protection	N/A	weathering steel			
Caps or Sills	Good	minimal settlement. appear level.			
Fill	Good	approach grading has some gaps/dips near the ends of the deck			
Hardware	Excellent				
Riprap	Excellent				
Wingwall	Good				
Overall	Good				
Hazards					
High Water					
Scour					
Ice					
Debris					
Aggradation					
Channel					
Estimated Present Water Level Depth					
Estimated Present Water Level Width					
Estimated High Water Level Clearance

Figure 13: Road embankment (SE corner)

Monitoring Items					
No.	Description				
1	Monitor approach grading regularly to avoid traffic damaging the precast deck panel edges				
2	Monitor for loose or missing evazote at underside of ballast wall or joints and replace/repair as required				
Comments				Seal	
<p>Partial Inspection</p> <p>Skin temperature on girders varies between 9 and 12 degrees Celcius</p> <p>Load test conducted on July 15th - minor noise observed</p>

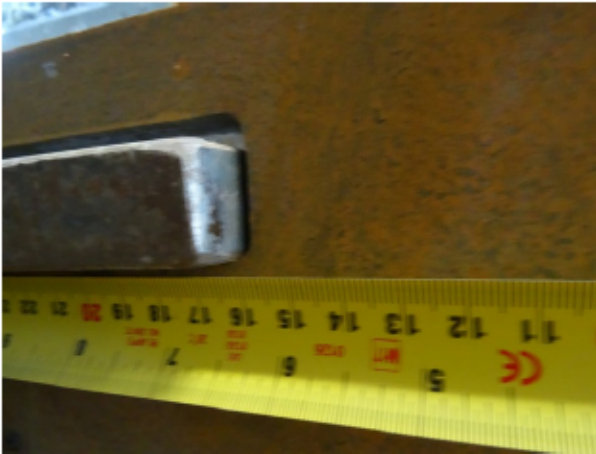
Bridge No.	2017-2318-43.5	Road Name	Meadowbank to Amaruq	Inspection Date	2017-07-14
Abutment - North					
Bearings	Poor	Guide plates installed at inconsistent locations within slot. One has reached it's limit within the slot, no longer allowing bearing shear deformation.			
Bracing	Good				
Ballast Wall	Fair	Some loose and missing evazote under ballast wall and at joint with the precast deck panels. Large spall in NW corner, reinforcement visible Some minor spalls at welded steel plate locations. Ballast wall appears to be set on skew to supestructure			
Corrosion Protection	N/A	weathering steel			
Caps or Sills	Good	footings appear level. minimal settlement.			
Fill	N/A	Roadway embankment not constructed			
Hardware	Good				
Riprap	Excellent				
Wingwall	Good				
Overall	Fair				
Abutment - South					
Bearings	Poor	Guide plates installed at inconsistent locations within slot. One has reached it's limit within the slot, no longer allowing bearing shear deformation.

Figure 2: North centre bearing - remaining slot length

Bridge No.	2017-2318-43.5	Road Name	Meadowbank to Amaruq	Inspection Date	2017-07-14
Repair Description and Cost Estimate					
No.	Description	Priority	Cost Estimate		
1	Unload south road embankment temporarily. Reinstall through equal lifts at each end of the bridge to minimize asymmetrical longitudinal loads after resetting the bearings	High	\$0.00		
2	Jack structure and reset bearings to accurate and symmetrical alignment prior to installation of roadway embankment fill	High	\$0.00		
3	Repair spalled concrete areas in precast components, particularly where reinforcement is visible.	Medium	\$0.00		
4	Ensure drip grooves are installed in cast-in-place deck formwork prior to pouring concrete	Medium	\$0.00		
5	Install railings meeting facility requirements - ensure all anchor bolts are installed	Low	\$0.00		
6	Confirm that all bracing and bolted connections are tightened according to project specifications	Low	\$0.00

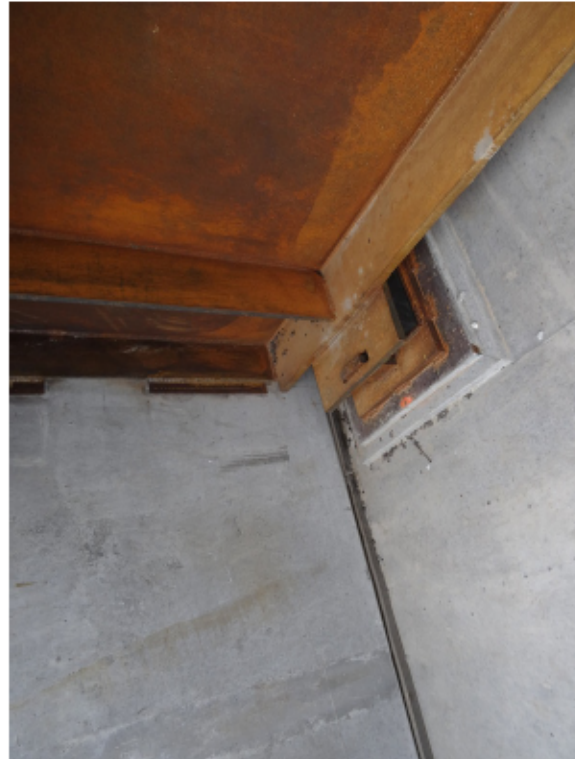
Figure 4: SE bearing slotted hole
