WHALE TAIL ATTENUATION POND RAMP

Construction Summary Report

September 9, 2020

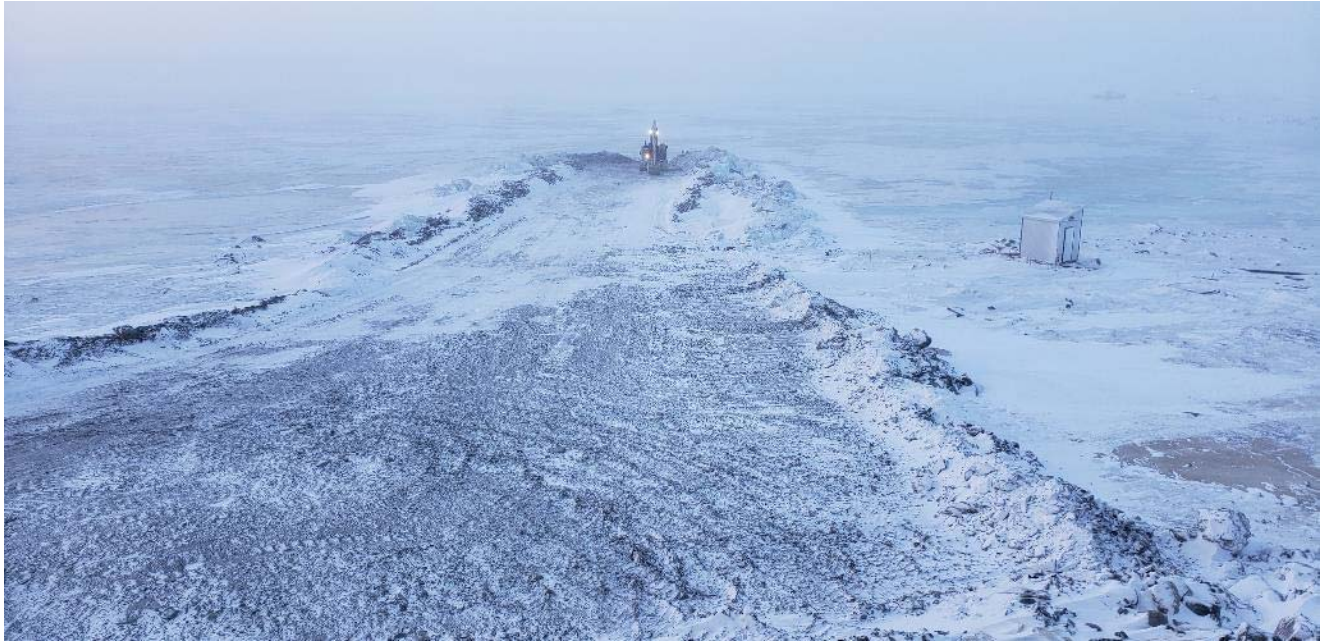
Picture 3 – Construction of the Dewatering Ramp access. Ice blocks are excavated and placed on the side of the ramp (January 14, 2019)

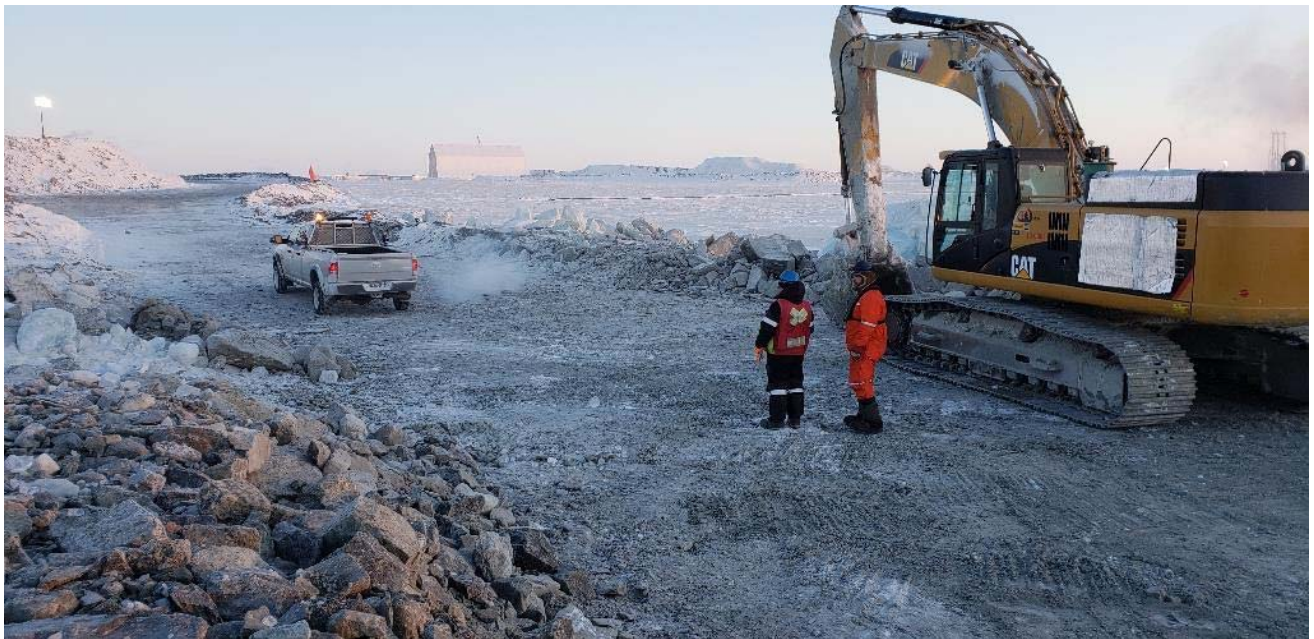
Picture 4 – Construction of the Dewatering Ramp access. Ice blocks are excavated and placed on the side of the ramp (January 17, 2019)

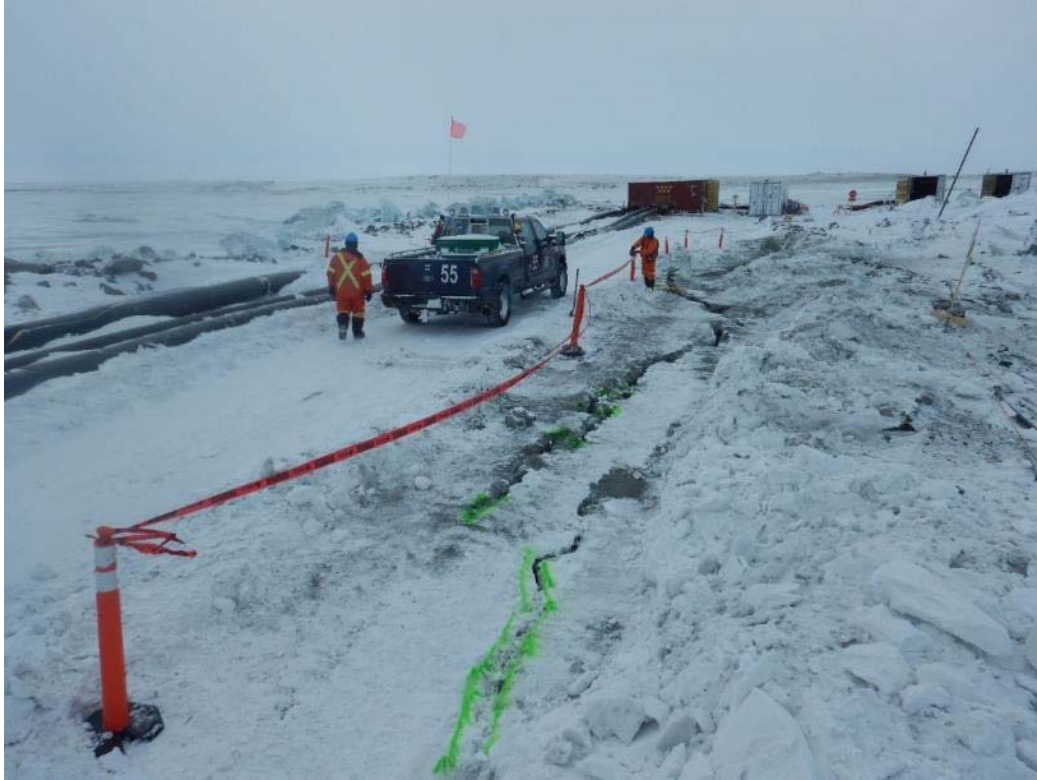
During the dewatering activities, tension cracks and instabilities appeared in the vicinity of the ramp. These were first observed in March-April 2019 and were mainly located in the bumpers area where the ice blocks

Picture 7 – Observation of tension crack in the bumper area of the access to the Dewatering Ramp (March 25, 2019)

were placed during construction. Remediation works were performed to create a new Phase 1 access ramp parallel to the original one.

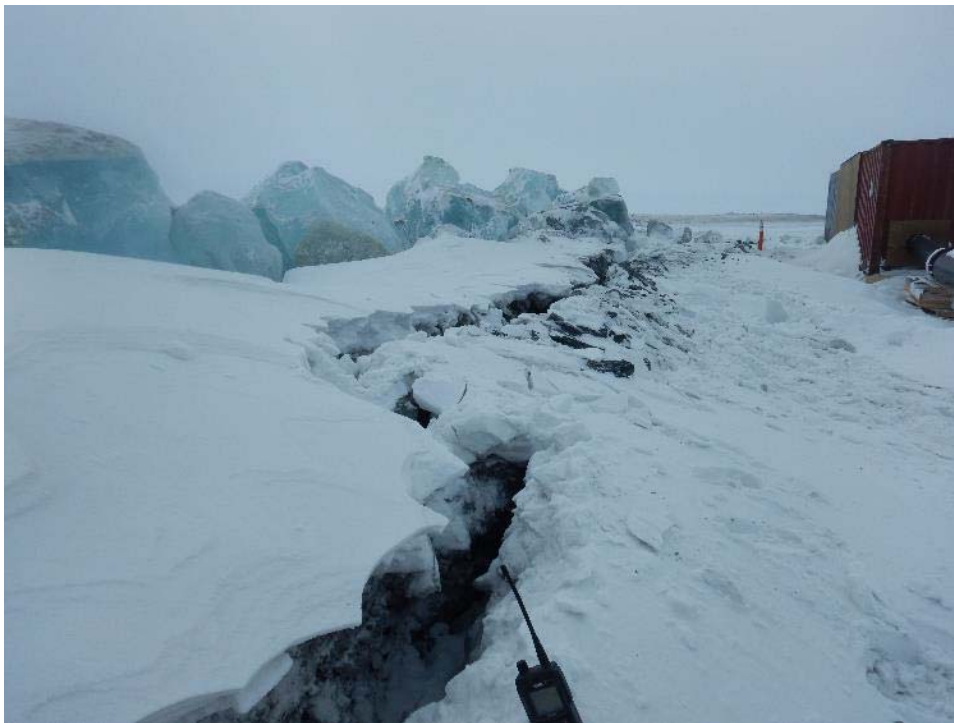
Picture 8 – Observation of tension crack in the bumper area of the pump pad of the Dewatering Ramp (March 25, 2019)

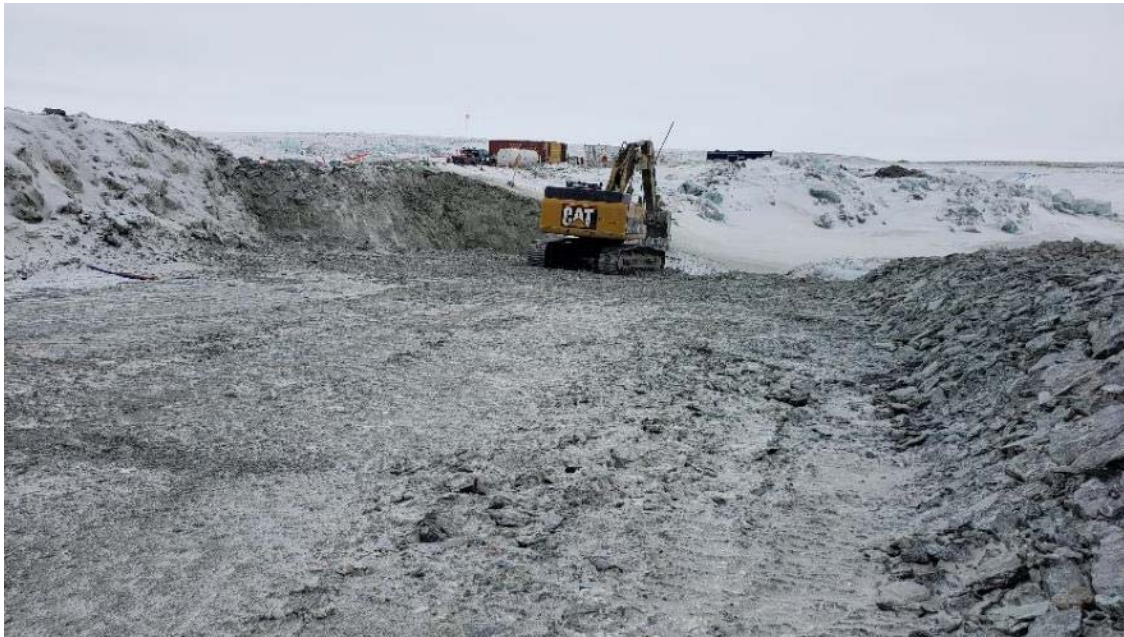
Picture 10 – Widening of the Dewatering Ramp access (construction of a parallel access) to mitigate instability (April 10, 2019)

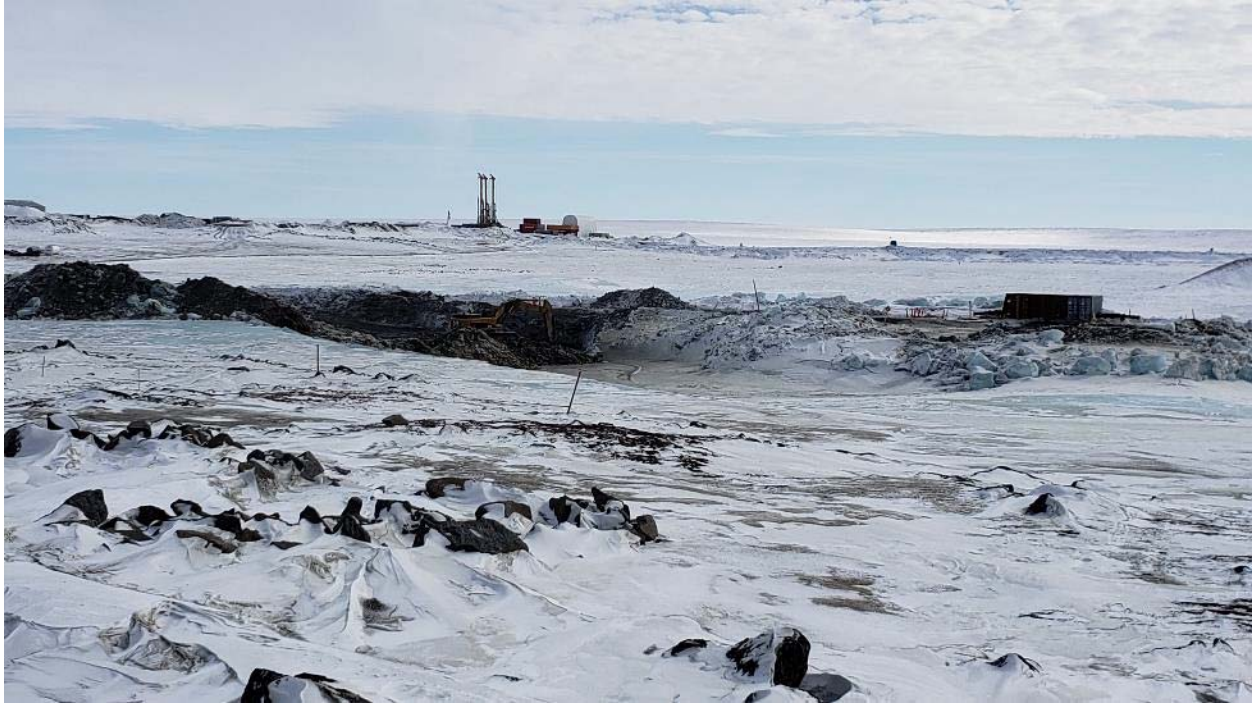
Picture 11 – Widening of the Dewatering Ramp access (construction of a parallel access) to mitigate instability (April 10, 2019)

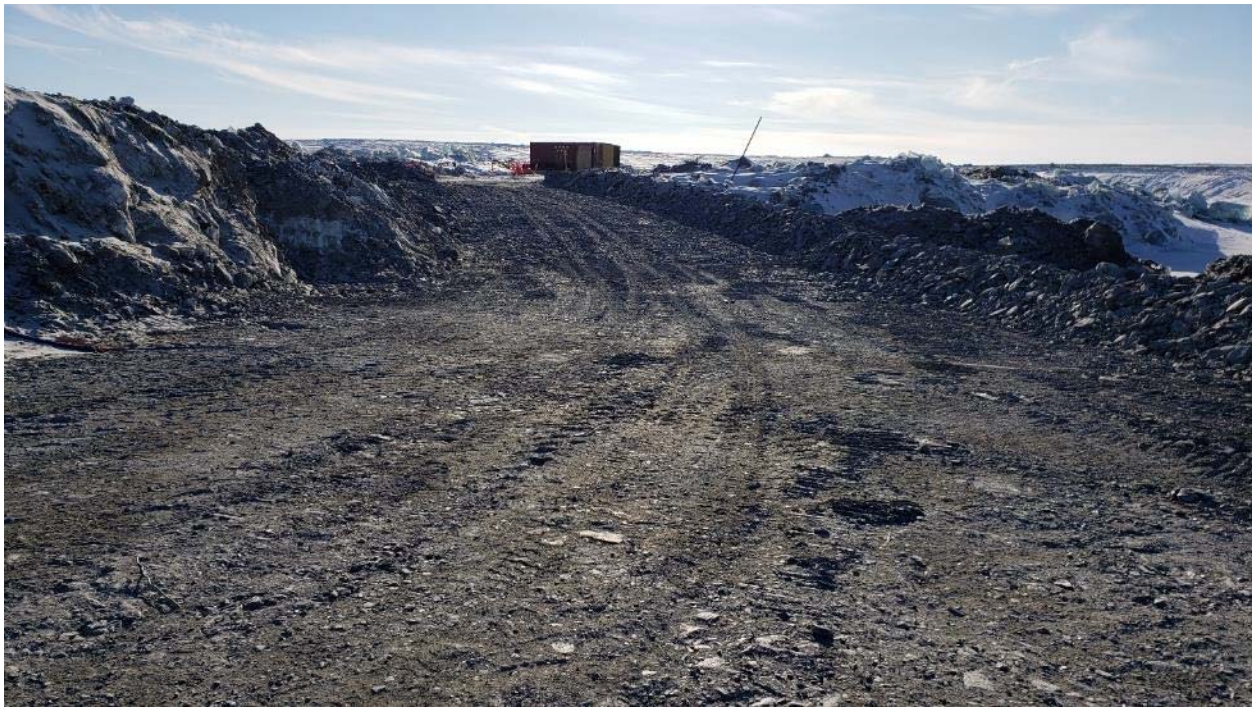
Picture 12 – View of the new Dewatering Ramp access built to mitigate instability (April 12, 2019)

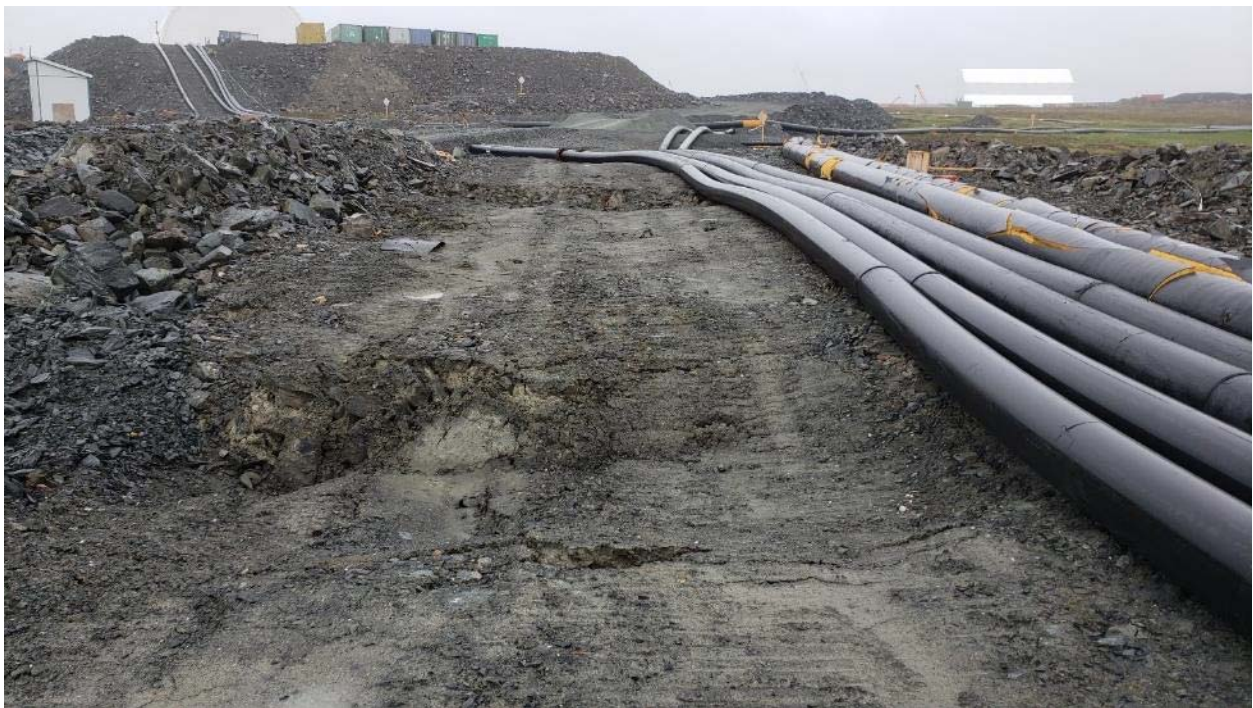
In July 2019 other signs of instability such as settlement were observed in the original instability area and extended towards the new access. It was discovered that the original access and some parts of the new one had been built over snow and ice. Further remediation work was performed by widening the access further and re sloping the side of the ramp. Ice, snow, and soft sediment were removed from the foundation during this process.

Picture 16 – Instability observed in the old access to the Phase 1 Dewatering Ramp (July 8 2019)

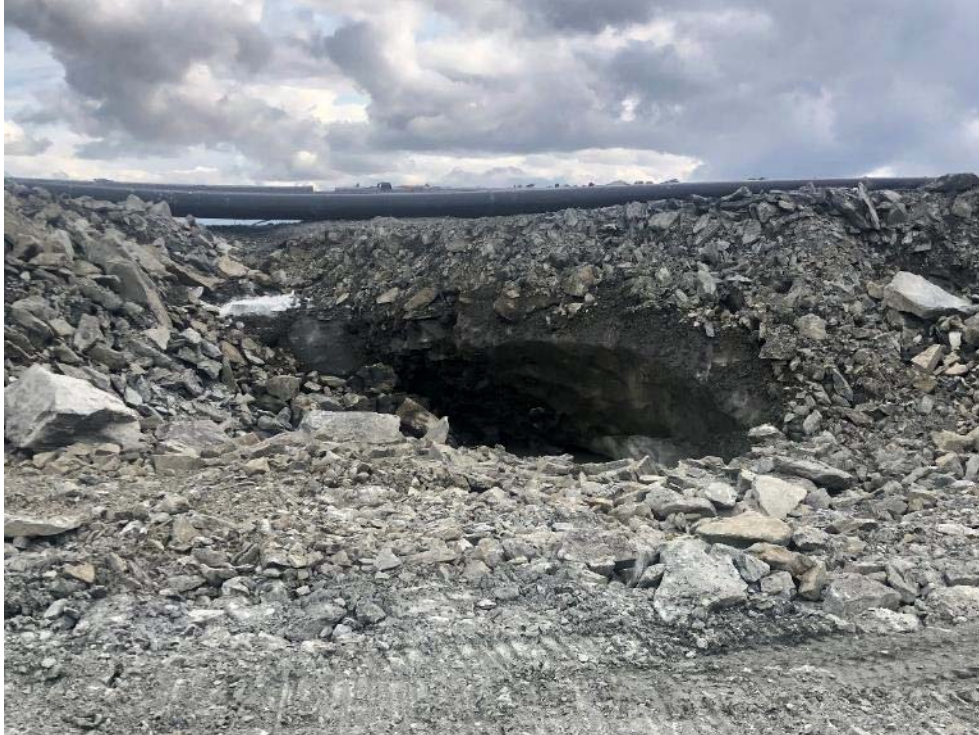
As described in Section 2, the access ramp to the Phase 1 dewatering pad had to be reworked twice during the dewatering activity due to the observation of instability. These instabilities were due to placement of rockfill material over an unsuitable foundation (ice blocks and snow). Inspection frequencies were increased during construction as a result of the instability events.

Picture 17 – Observation of ice and snow in the foundation of the old access to the Phase 1 Dewatering Ramp (July 8 2019)

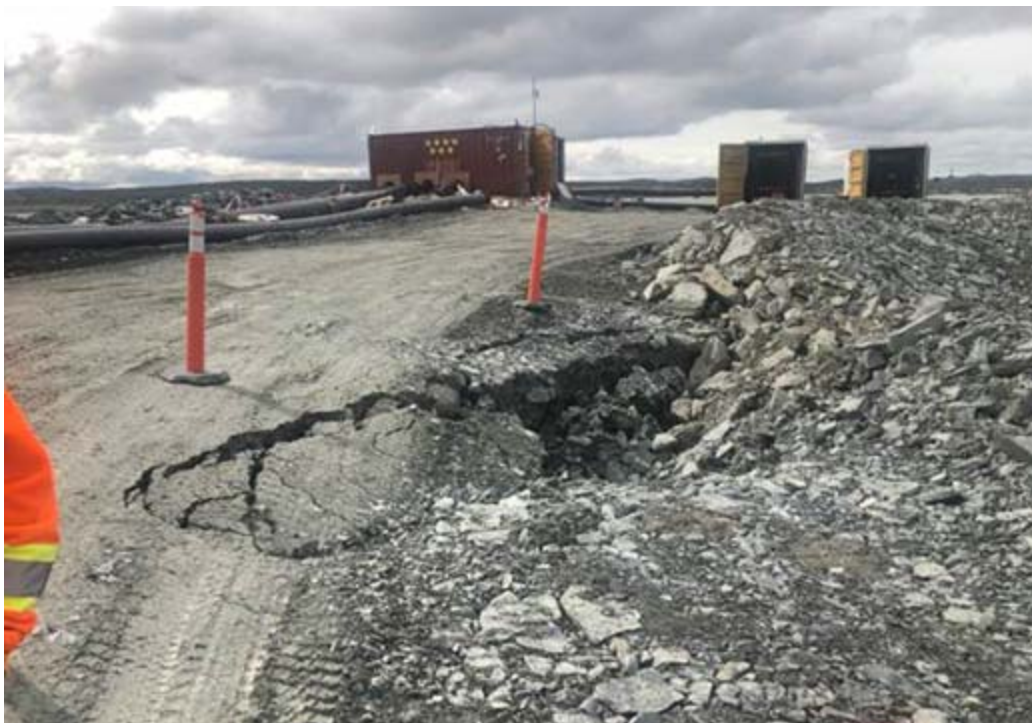
Picture 18 – Observation of instability in the widened portion of the Phase 1 Dewatering Ramp (July 10 2019)

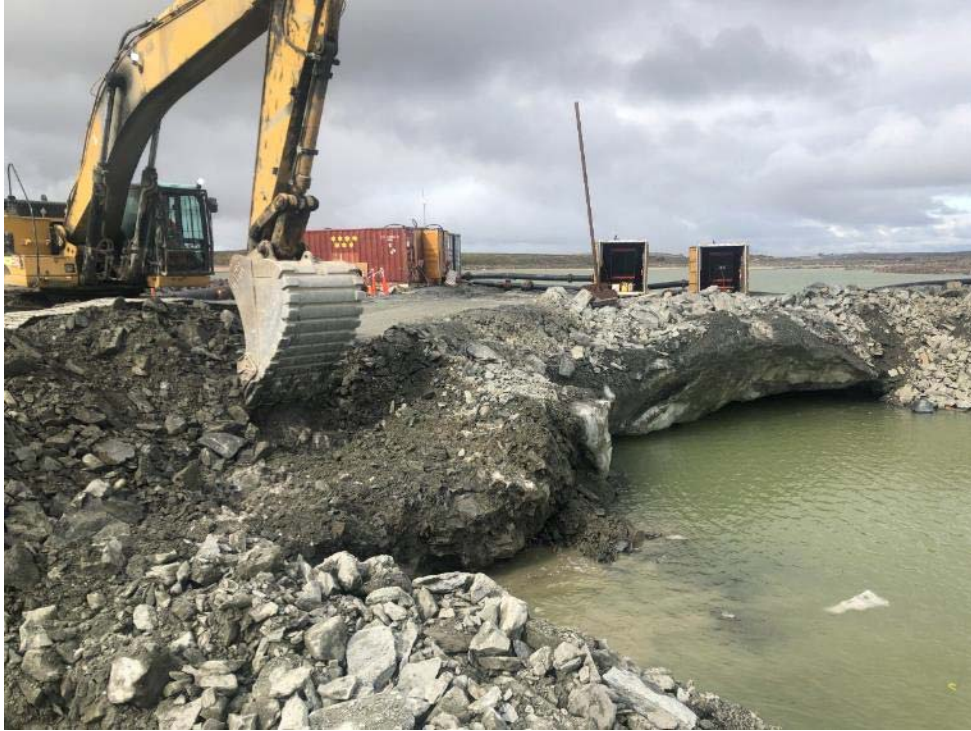
Picture 19 – Removal of snow to mitigate instability in the widened access road to the Phase 1 Dewatering Ramp (July 11 2019)

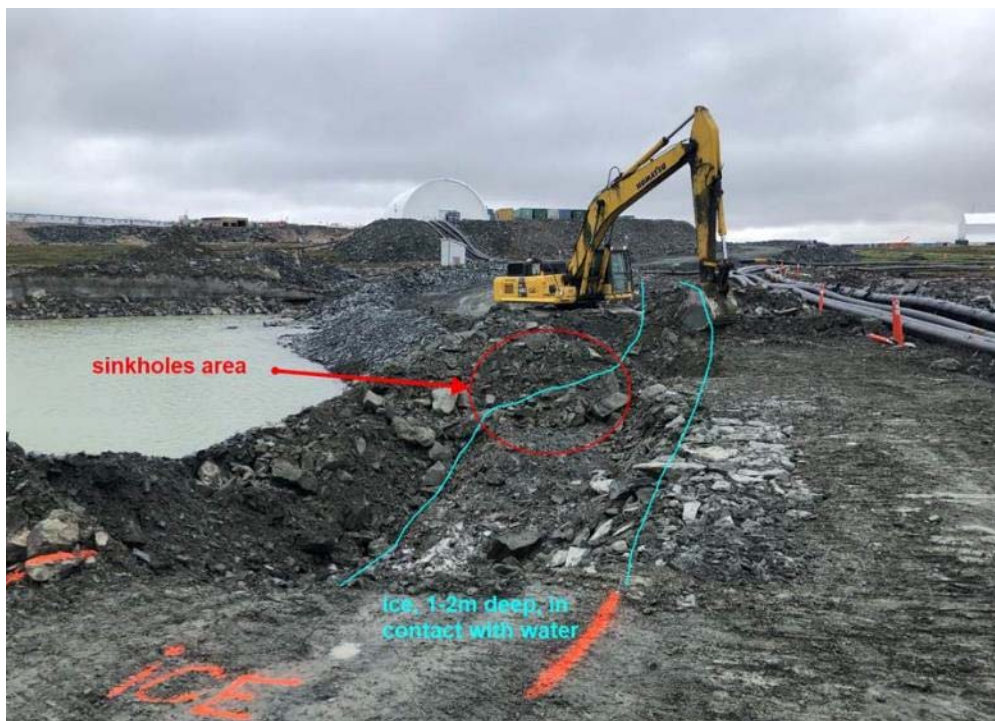
Picture 20 – Removal of snow and ice in the widened access road to the Phase 1 Dewatering Ramp (July 11 2019)

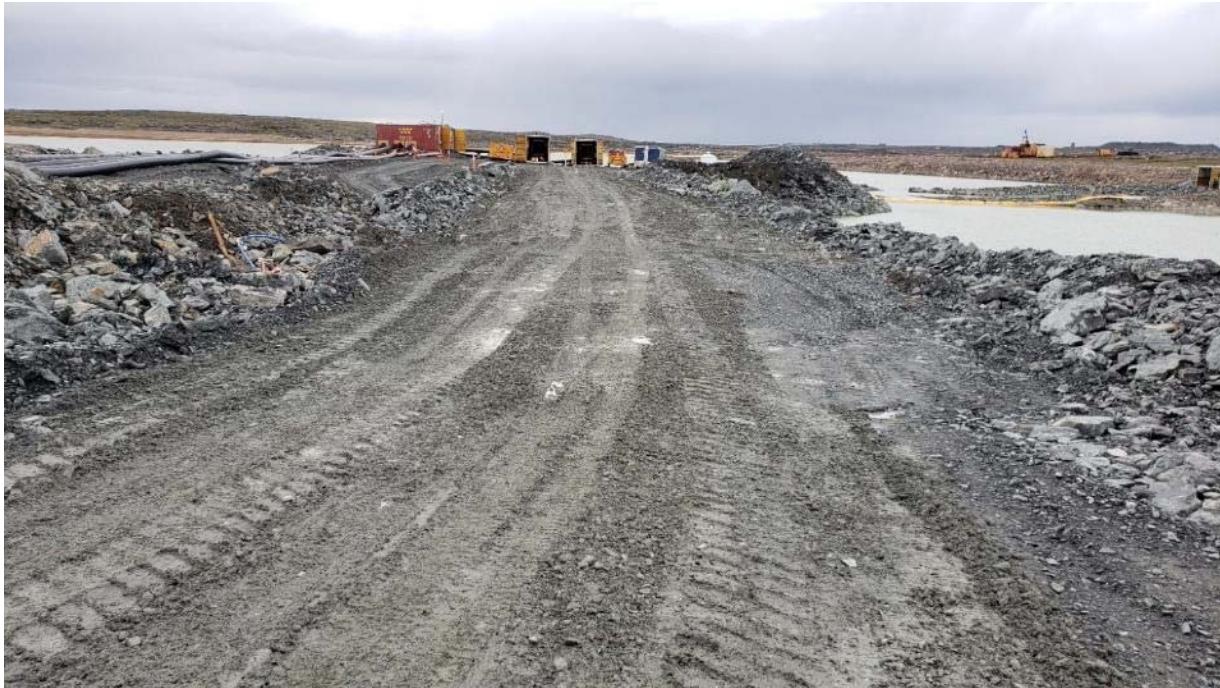
Picture 21 – View of the access road to the Phase 1 Dewatering Ramp after the mitigation (July 28 2019)
