# CONSTRUCTION SUMMARY REPORT

## Whale Tail Dewatering Phase 2

Agnico Eagle Mines Ltd

6127-648-132-REP-002\_R2

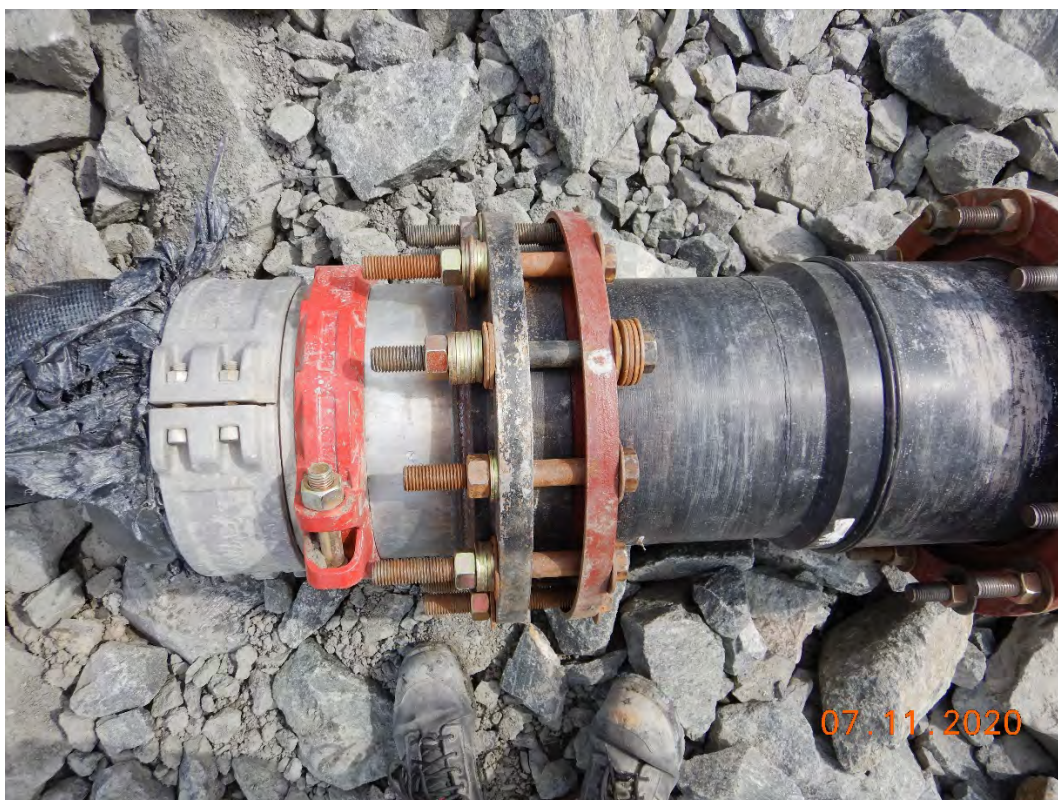
| Activities | Approximate location | Visual observation during field visit |
|---|---|---|
| Pipe inspection | Line 648-200-WFR-PC11-0214 | <ul style="list-style-type: none"> <li>• Connection between a Mineflex hose and an HDPE with incorrect bolt length. Extra washer to compensate to a lack of thread. (Photo 1)</li> <li>• The line is crossing two existing lines at AP-5 on an uneven ground. To prevent any damage to the existent pipe elevate the new pipe. (Photo 2)</li> <li>• Pipe insulation damaged with the culvert during installation. Hard to tell if there is any damage to the pipe inside the culvert. (Photo 3)</li> <li>• Half of the bolts was installed on the Mineflex connection. (Photo 4)</li> </ul> |

*Photo 1. Mineflex hose connection with multiple washer, North of the culvert of AP-5*

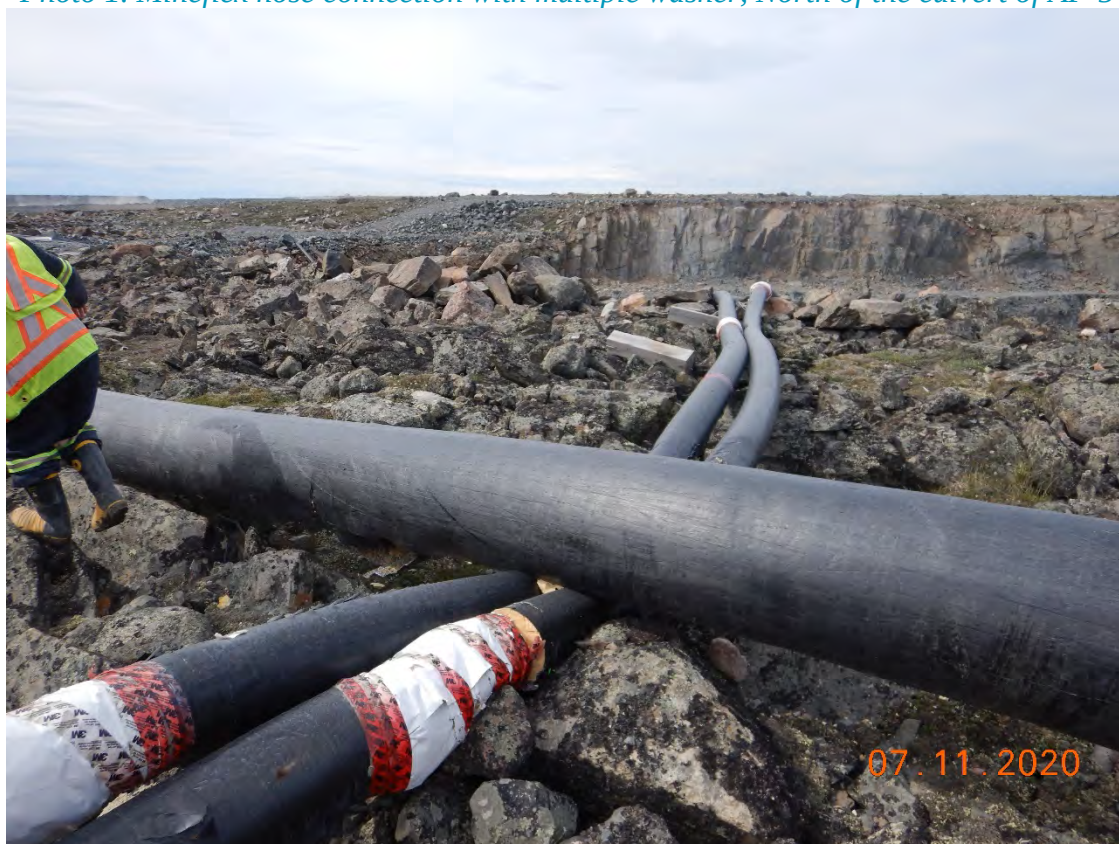
*Photo 2. Pipe crossing two smaller pipes, AP-5*

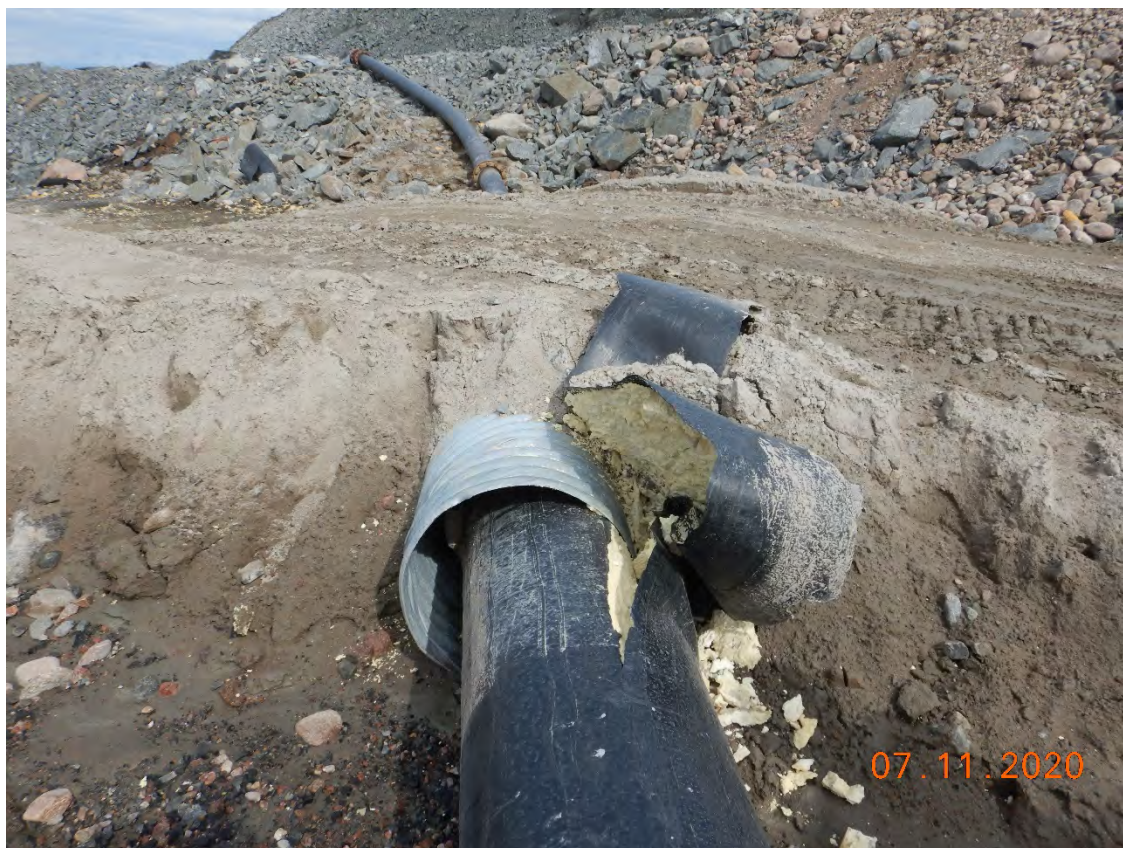
*Photo 3. Pipe insulation damaged with the culvert, AP-5*

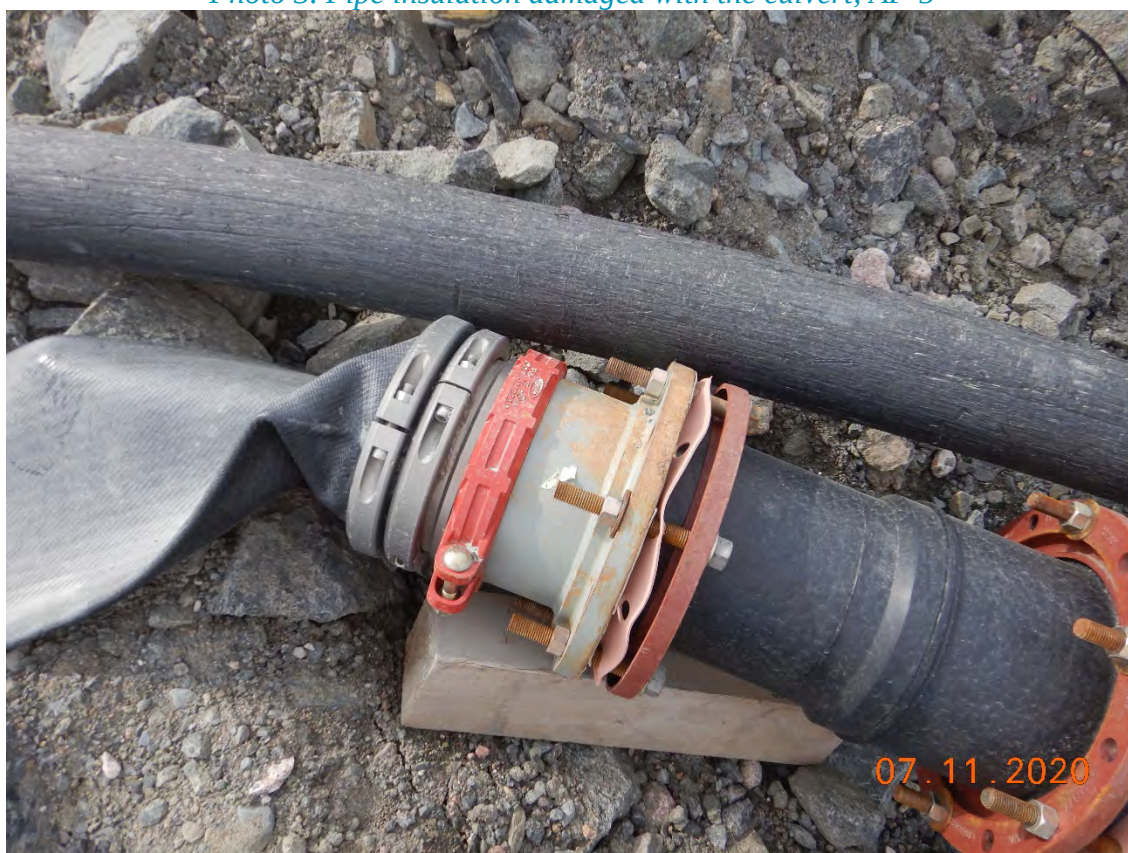
*Photo 4. Missing bolts at a Mineflex connection, beside the pit ramp culvert*

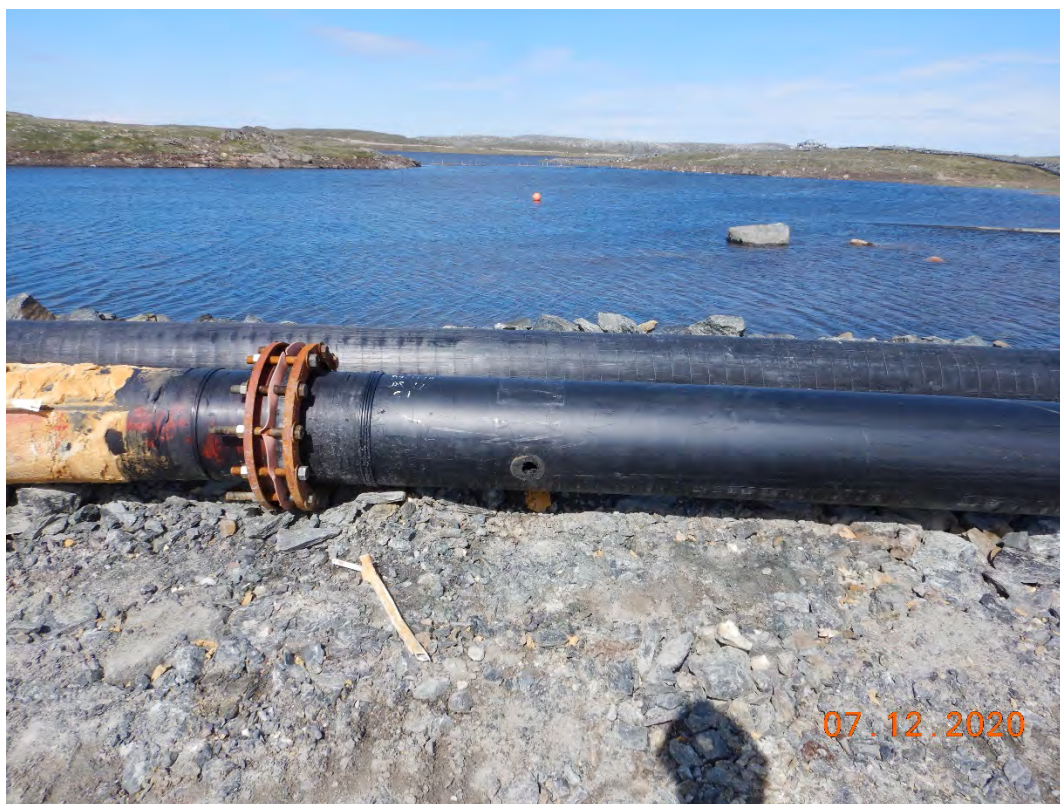
*Photo 1. Instrument hole in the line 648-200-WFR-PC11-0214, NE Dike*

- Replace or repair the section with the hole.

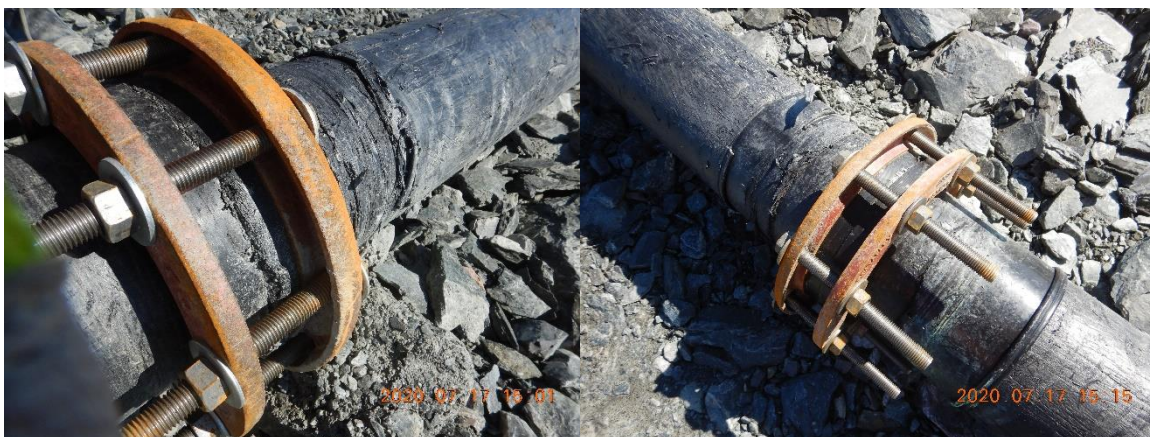
*Photo 4. Flanged assembly without gasket*

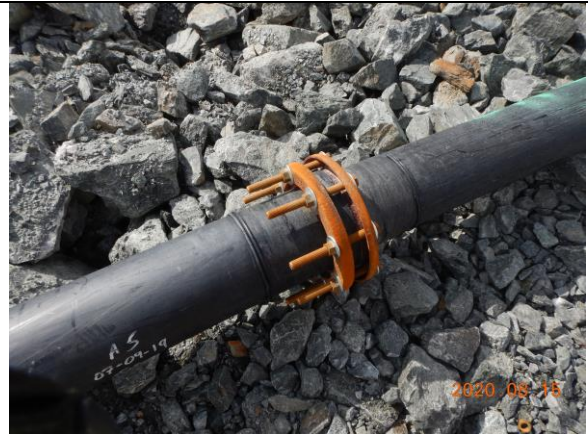
3.2 Flange properly bolted, without gasket  
Pipe showing damage

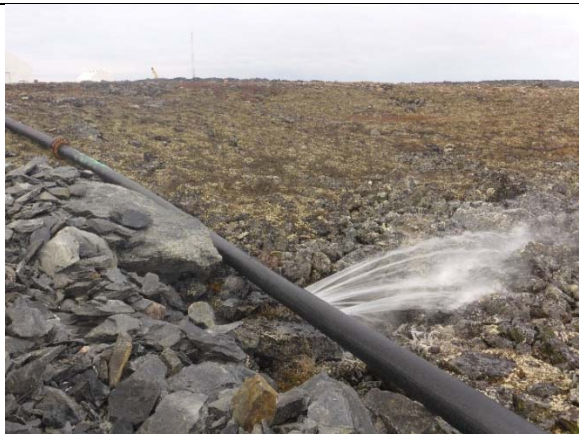
| Activities | Approximate location | Visual observation during field visit |
|---|---|---|
| Dewatering pipe inspection | Lake A-50 and A-51 | <ul style="list-style-type: none"> <li>• The dewatering of the lake A-50 and A-51 is ongoing.</li> <li>• Gaskets missing on multiple flanges.</li> <li>• The pipe used for the dewatering of lake A-50 is cracked and leaking.</li> <li>• The pipe used for the dewatering of lake A-51 is cracked and leaking.</li> <li>• Both pumps are activated and pumping the two lakes in lake A-53.</li> <li>• One flange is leaking on the pipe used for the dewatering of lake A-50</li> </ul> |

1.1 Pipe cracked between lake A-50 and lake A-53

The cracked pipes were replaced and the pumping is now continuing free of leaks

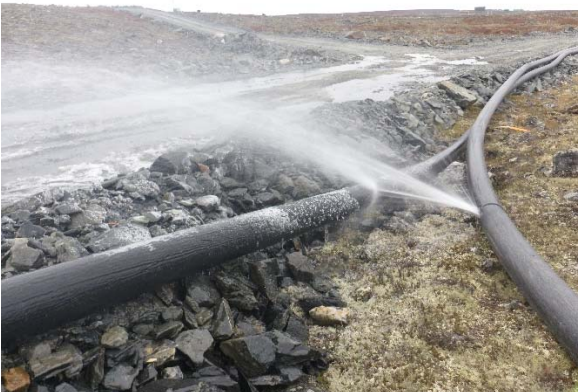
1.2 Pipe cracked between lake A-51 and lake A-53

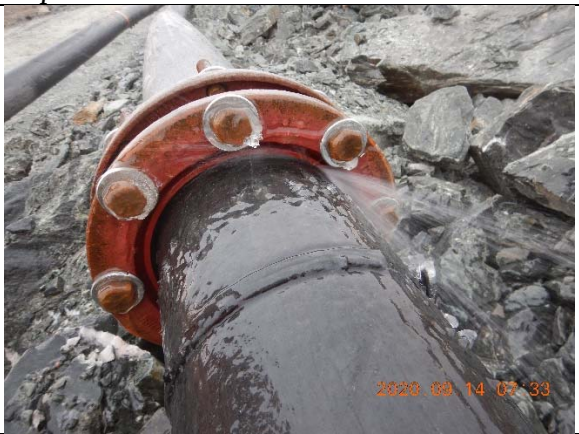
1.4 Flange leaking near lake A-50
