WHALE TAIL WATER MANAGEMENT PROJECT

ROAD 22 CULVERT #22-2

CONSTRUCTION SUMMARY REPORT WHALE TAIL PROJECT

December 16, 2021

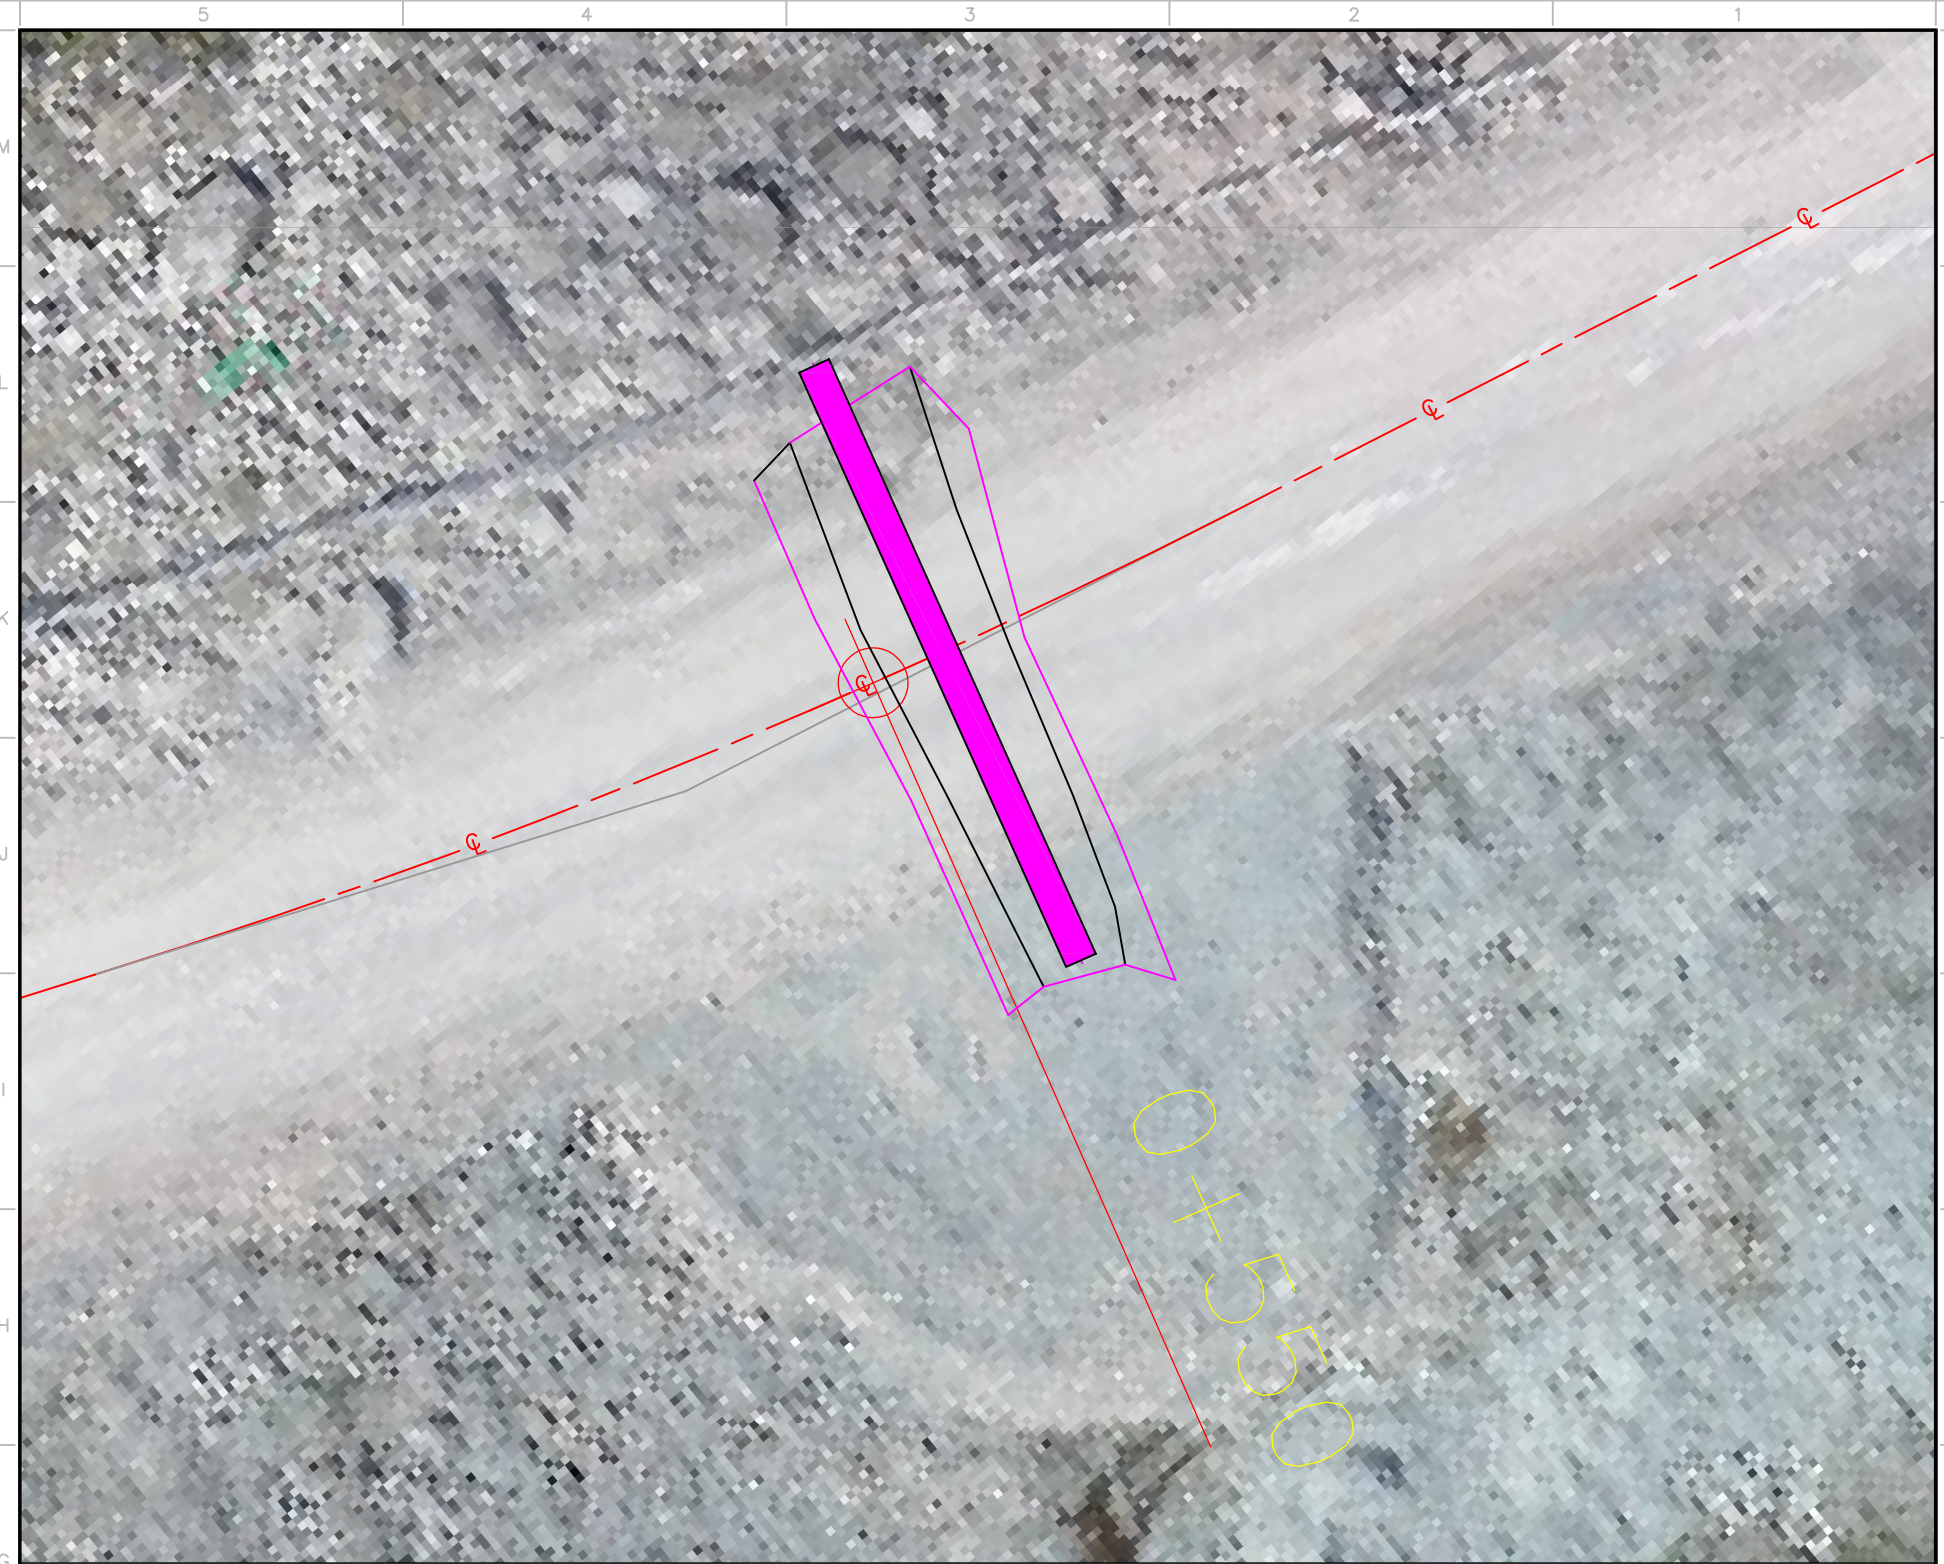
CULVERT LENGTH: 18m
EXCAVATION: 100m³
0-¾ BACKFILL: 90m³

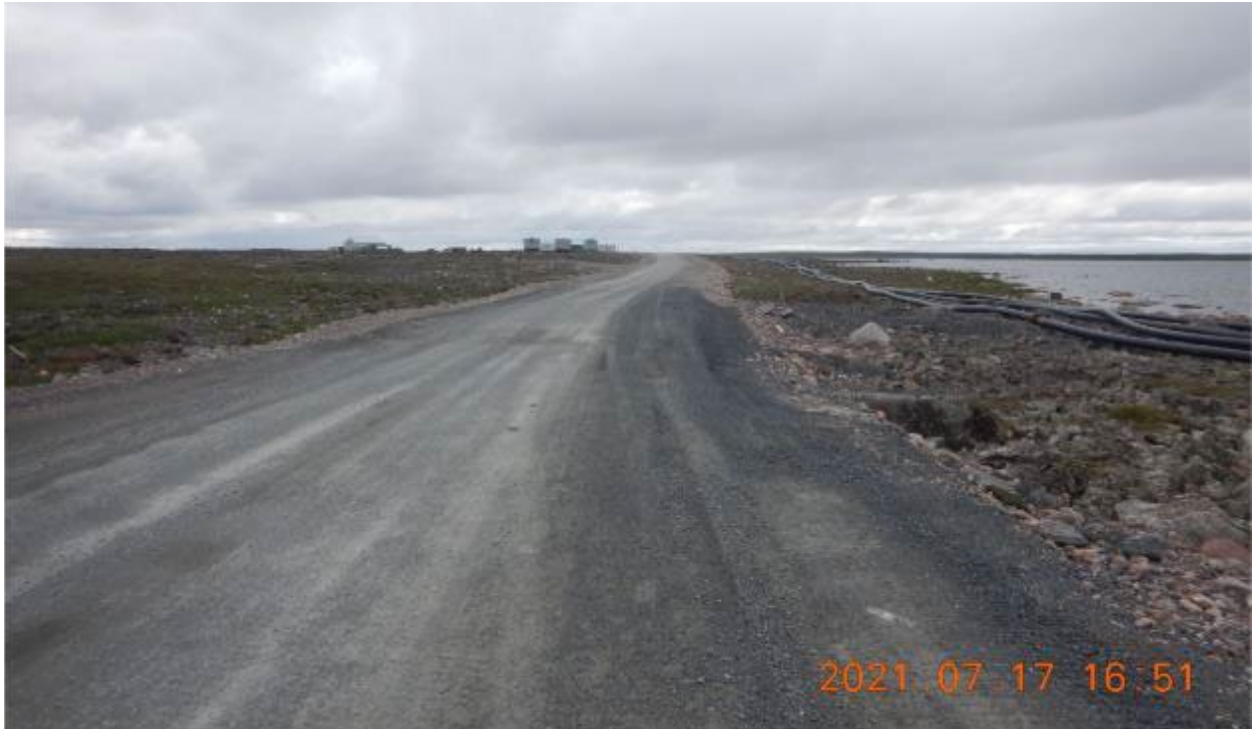
Photo 1. Initial site view along Road 22 of culvert 22-2 location, looking West.

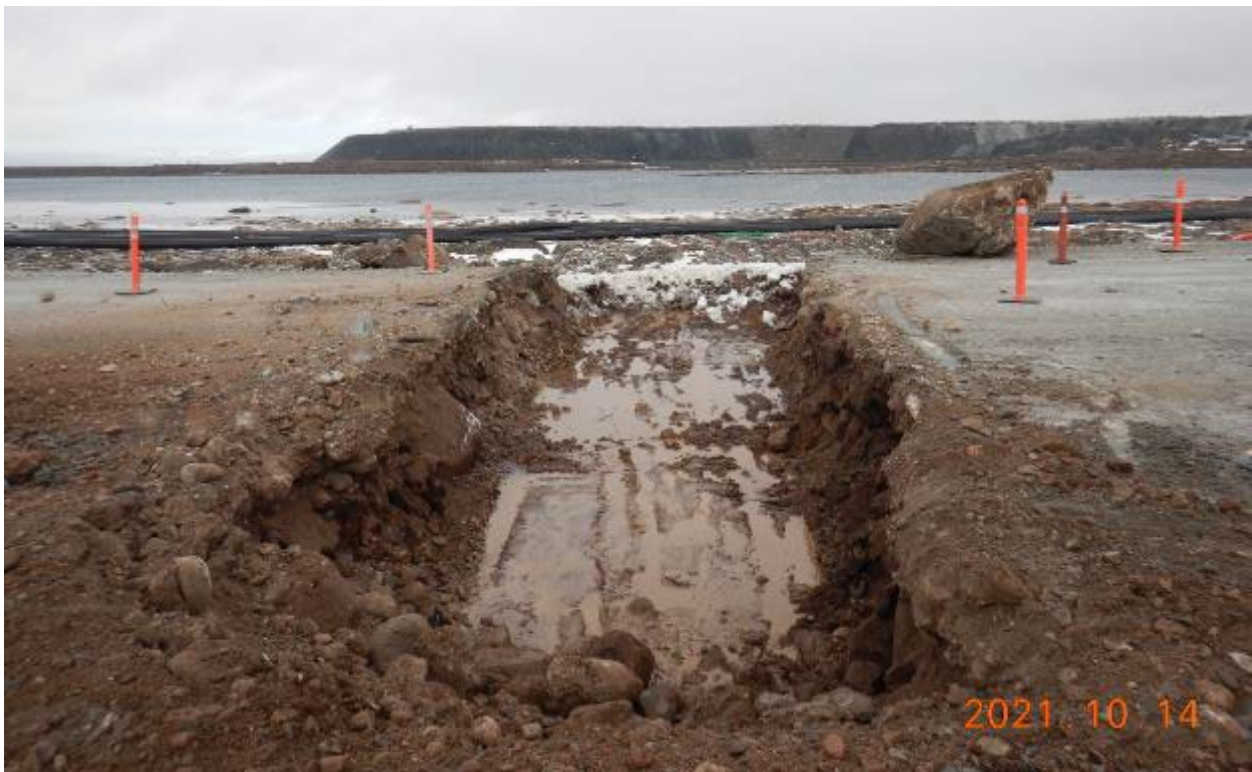
Photo 2: Excavation of the road material to install the culvert 22-2, looking North.

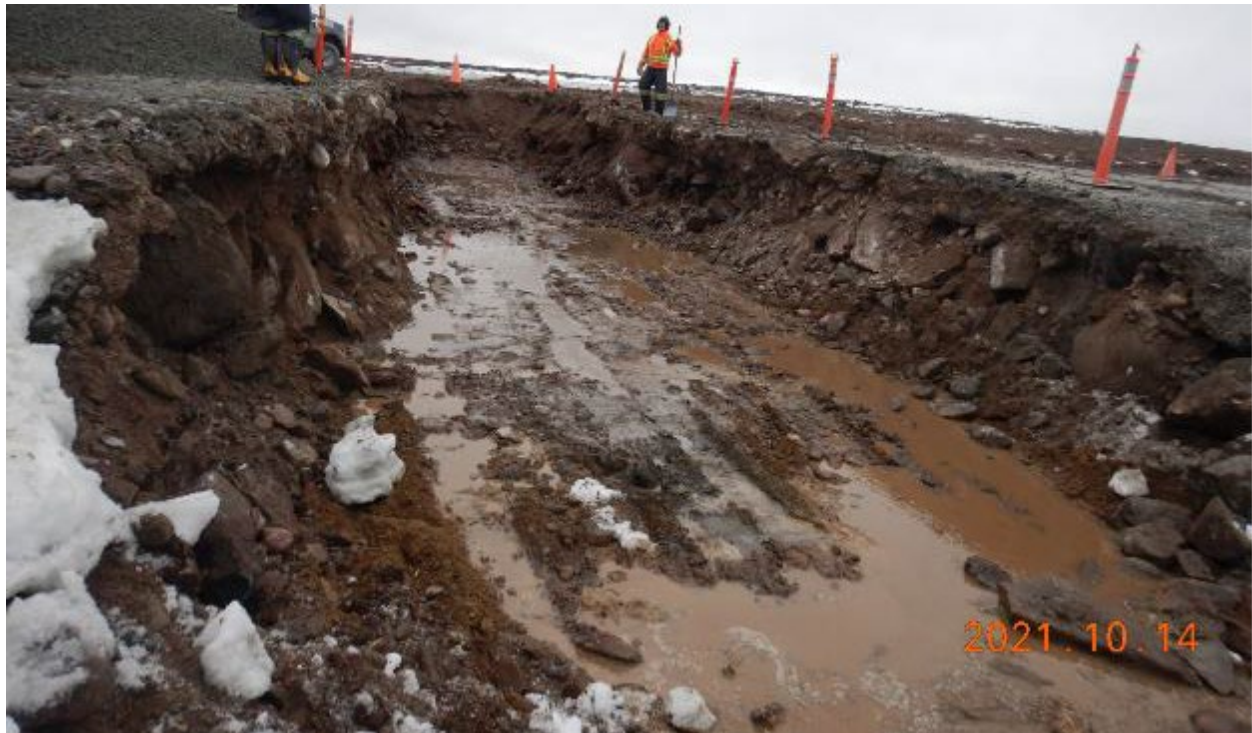
Photo 3. Excavation of the road material to install the culvert 22-2, looking South.

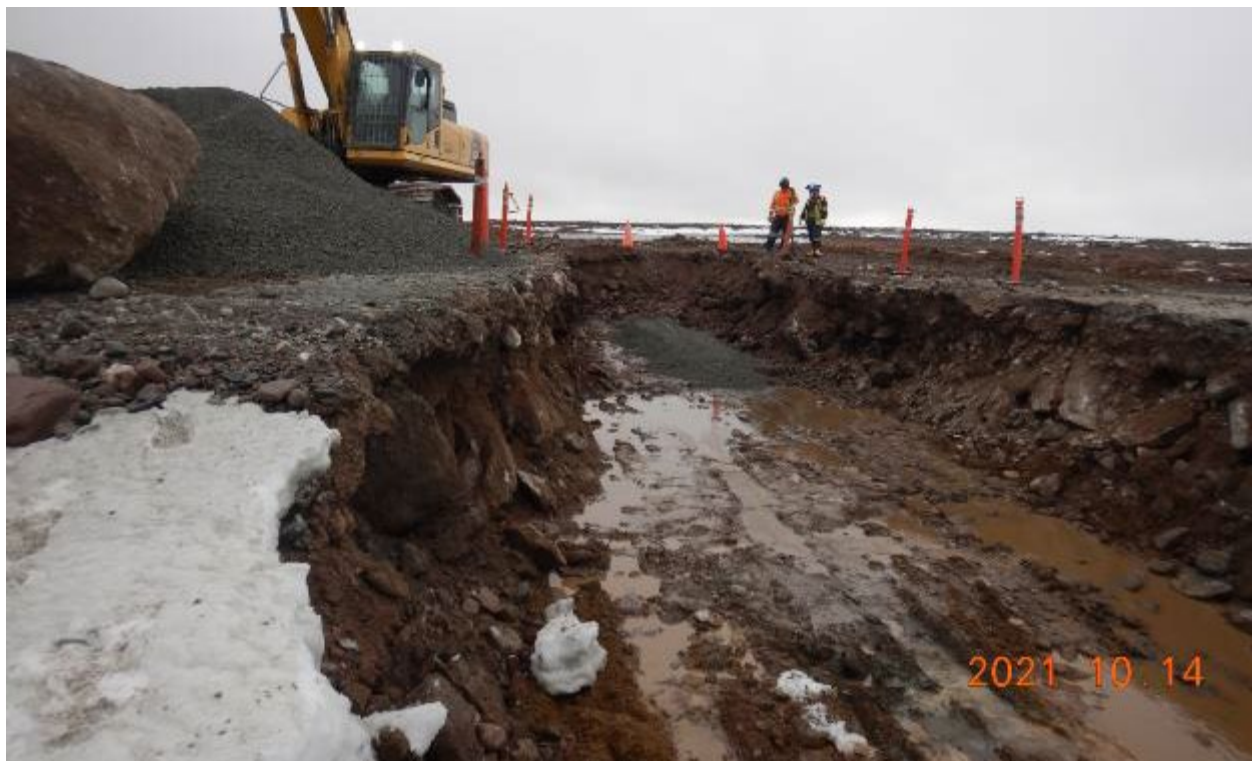
Photo 4. Placement of fine filter layer (0-3/4\"), culvert 22-2, looking South.

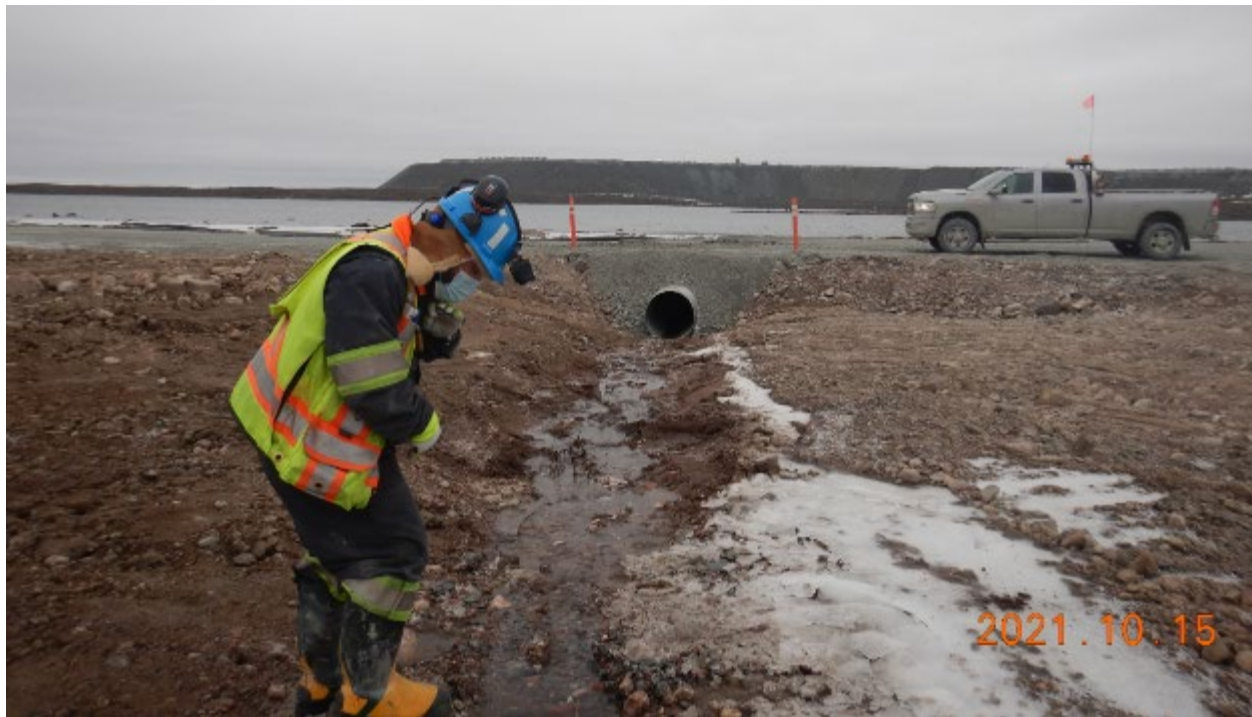
Photo 5. Installed culvert 22-2 with overlaying protective layer with excavated inlet, looking North.

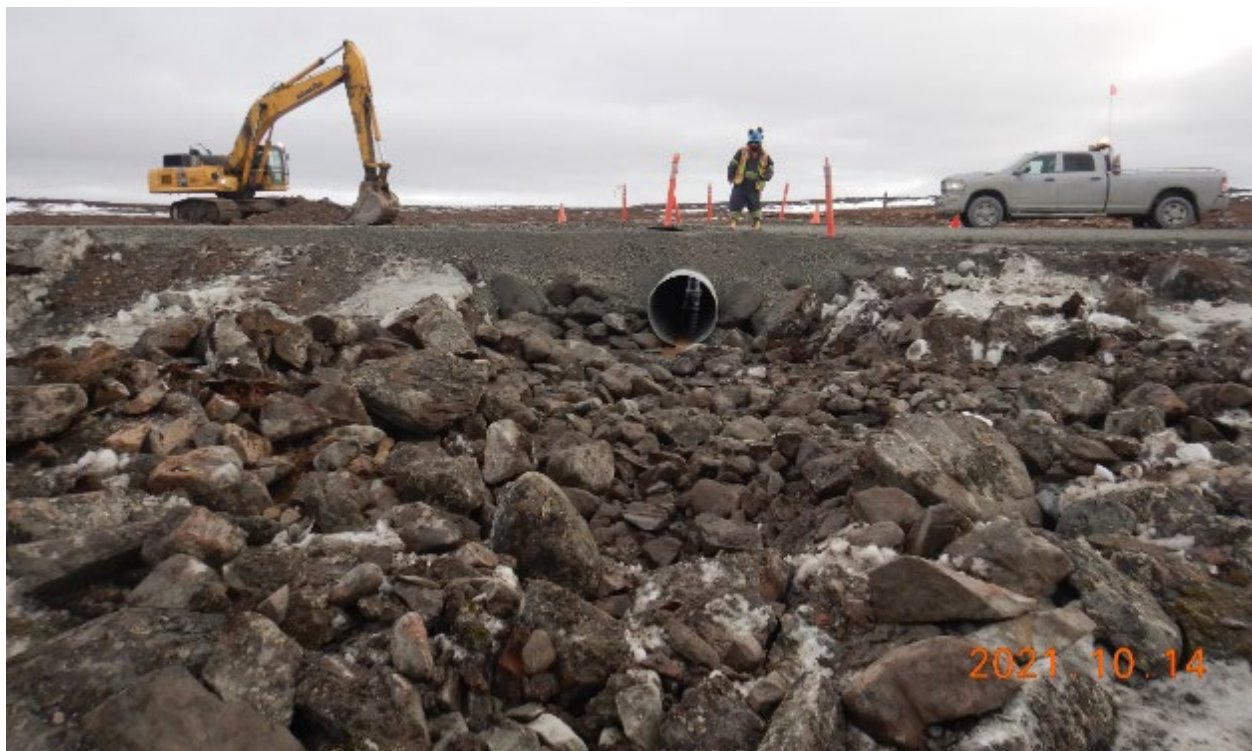
Photo 6. Installed culvert 22-2 with overlaying protective layer, looking South.
