WHALE TAIL A47-N SUMP

CONSTRUCTION SUMMARY REPORT

WHALE TAIL SITE

November 19, 2025

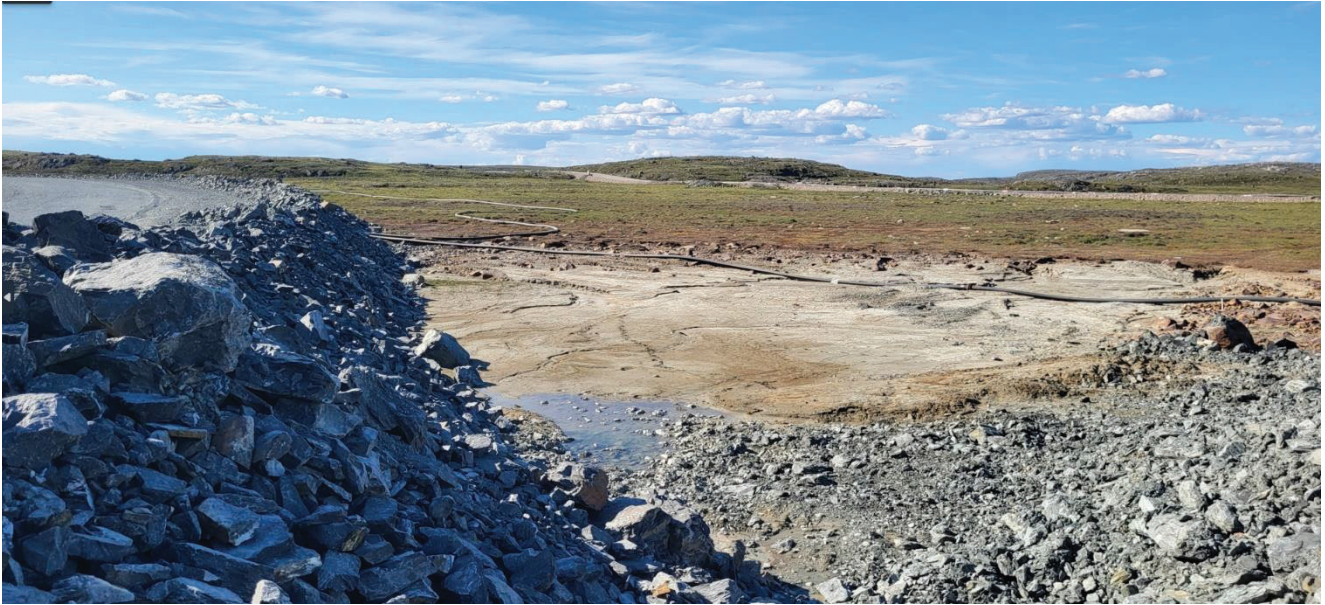
Photo 1. Initial view of the site before any earthworks performed.

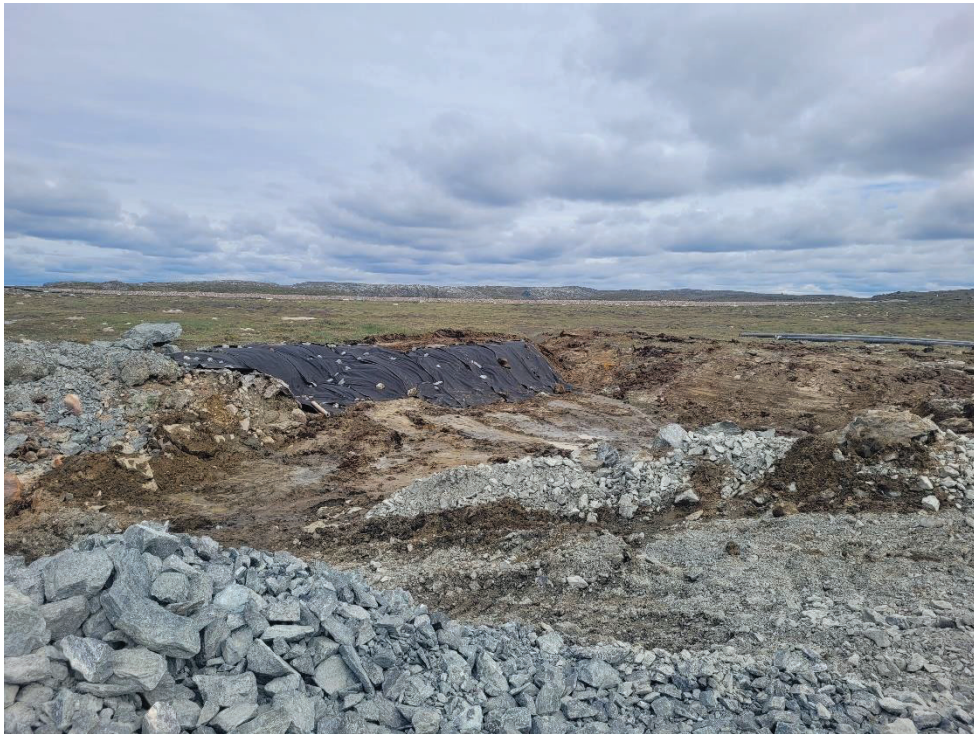
Photo 2. Excavated lakebed sediments and geotextile placed on slope, looking North.

Geotextile was placed on the north side of the slopes, after the excavation of the sediments was completed. The length placed was about 16 m long and sloped from the natural topography (~155 masl) to the floor of the excavated channel (~153.5 masl). The geotextile was placed to secure the sump walls and prevent ingress of soft sediments.

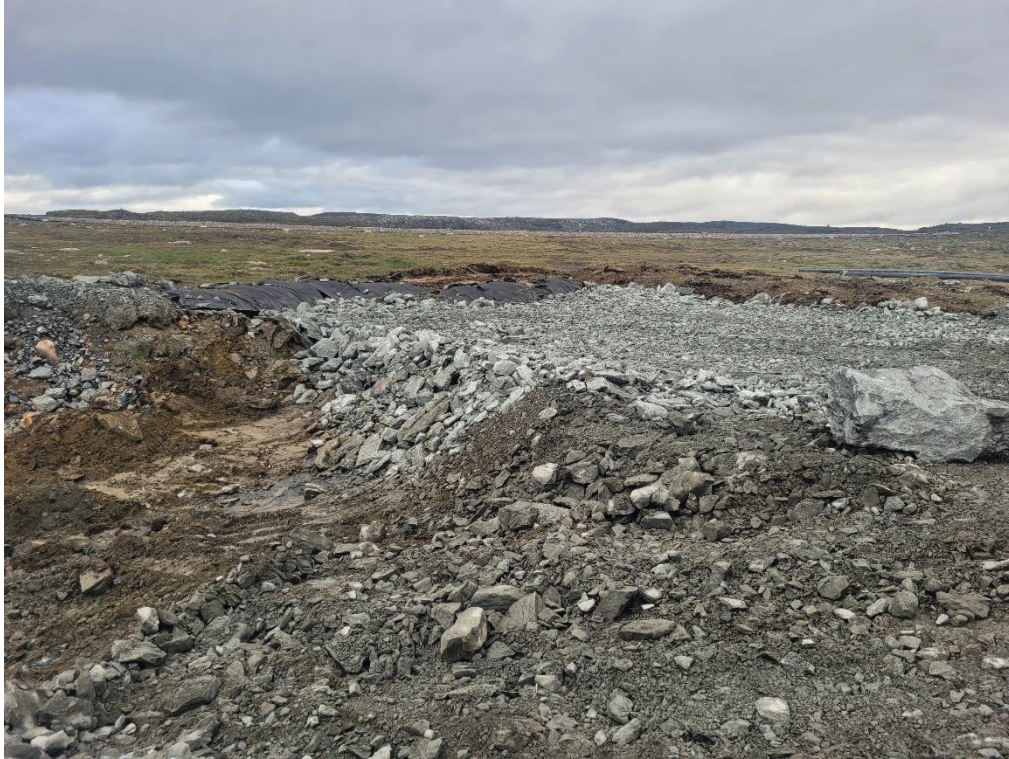
Photo 3. Placement of rockfill material around sump to access sedimented area, looking North.

The NAG rockfill was placed in the slopes at a height of about 1.5m to protect them and minimize sloughing of the natural slopes in the channel. The material was brought with a CAT 777 haul truck, and placed in the channel and slope with the excavator. Additionally, rockfill was placed to consolidate the existing pad and sump access between the pad and the IVR Ring road.

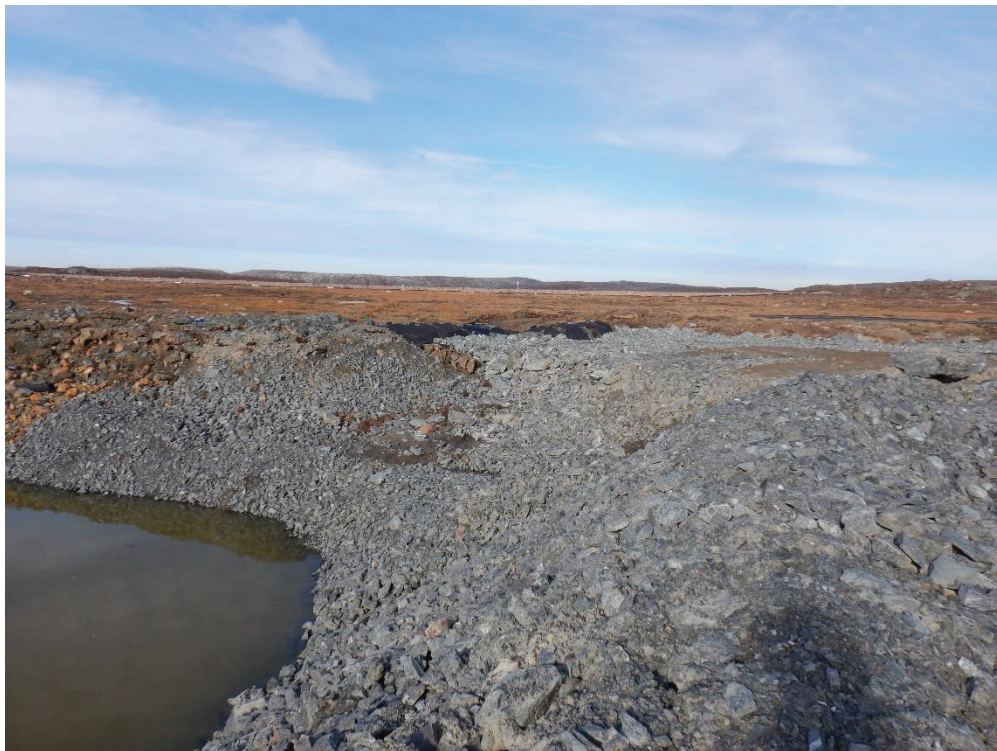
During early operation of this sump, fluctuating water level within caused the side slopes to slough, leading to this displaced material accumulating in the sump, gradually reducing its capacity. To improve the operations of the sump, a remediation plan was developed by Agnico Eagle to stabilize the slopes and remove the lakebed sediments from the bottom of the sump.

Photo 4. A47-N sump with improved northeast slope for stabilization after construction completion.

In order to minimize wave action erosion, the slopes of the sump were secured with a layer 0.5 to 1m thick of non-potentially acid generating (NAG) rockfill. The material was placed in the slopes and at the bottom of the sump for a total quantity of 1,500m³. During remediation construction, NAG rockfill (0-500mm) was placed over geotextile to contain the erosion and to improve stability of the slopes at the north-east corner of the sump.
