CONSTRUCTION SUMMARY REPORT IVR WRSF water management system

Agnico Eagle Mines Ltd

Report 6127-648-132-REP-005_R1 March 2, 2022

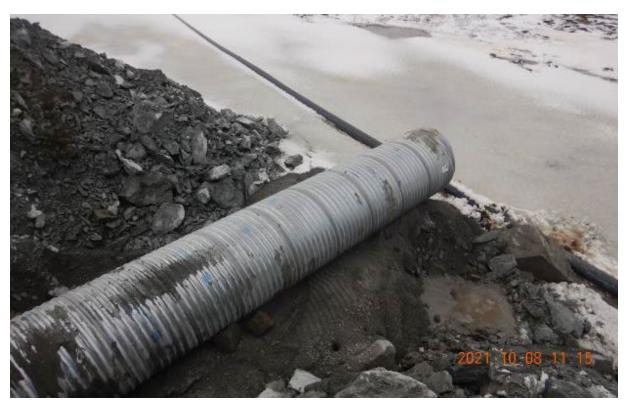
Photo 1. Installed culvert 35-1 on top of an underlaying layer of compacted fine filter, looking at outlet (South-West).

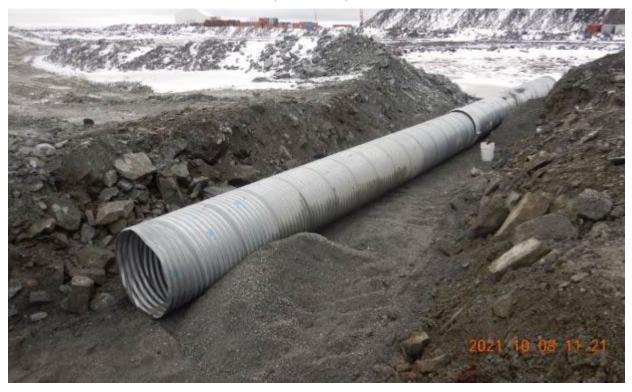
Photo 2. Installed culvert 35-1 on top of a layer of compacted fine filter, looking South-West.

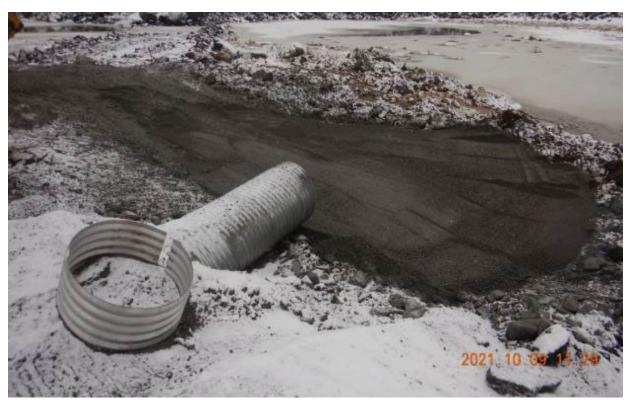
Photo 3. Compacted pad of fine filter material extended to IWB sump for culvert 35-1, looking North-East.

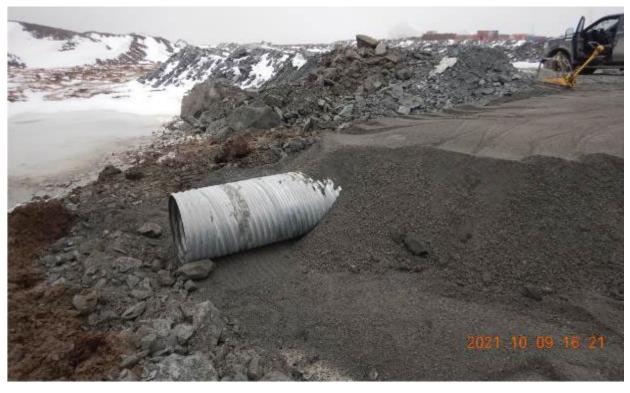
Photo 4. Installed culvert 35-1 with compacted overlying protective layer, looking South at inlet.

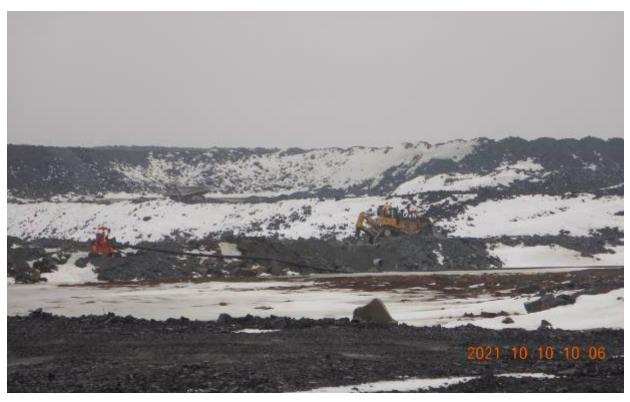
Photo 5. View of the pipe crossing culvert 35-1 backfilled with fine filter material, and in the process of being backfilled with NAG by a bulldozer, looking North-East.

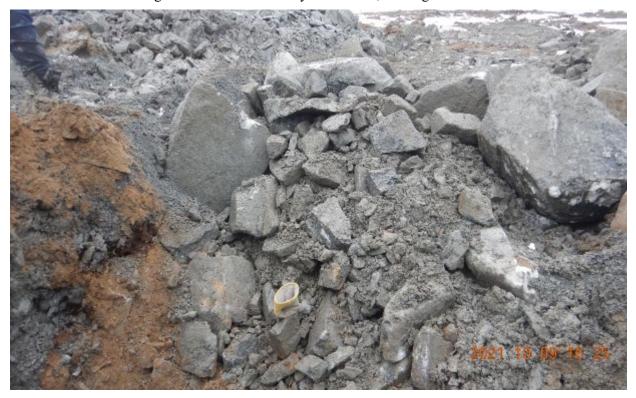
Photo 6. Excavation of rockfill and till material for culvert 35-2, looking South-West.

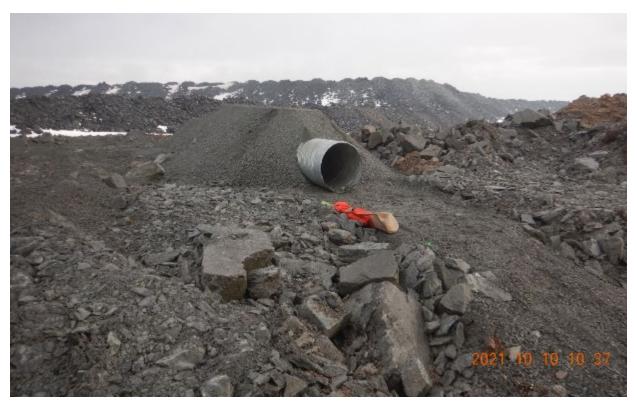
Photo 7. Installed culvert 35-2 with overlying protective layer compacted using a Wacker-Packer, looking North-East at outlet.

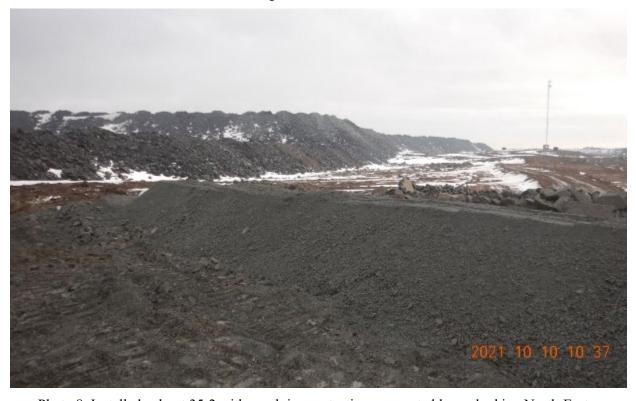
Photo 8. Installed culvert 35-2 with overlying protective compacted layer, looking North-East.

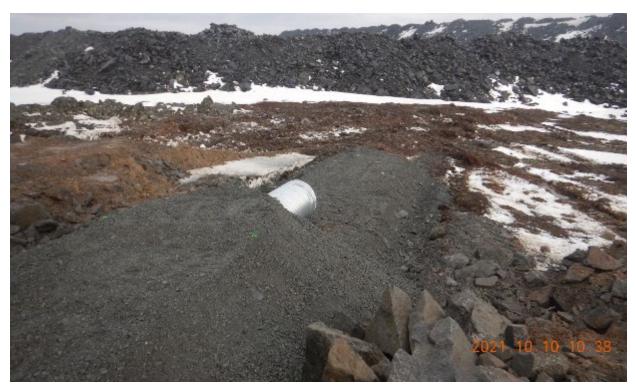
Photo 9. Installed culvert 35-2 with overlying compacted layer, looking North-East at inlet.

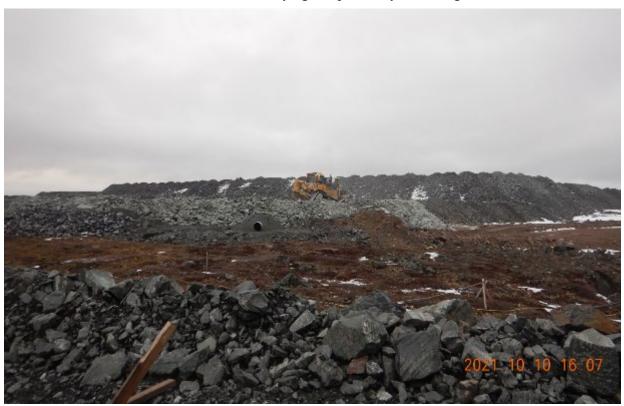
Photo 10. View of the pipe crossing 35-2 backfilled with fine filter material, and in the process of being backfilled with NAG by bulldozer, looking North-East.

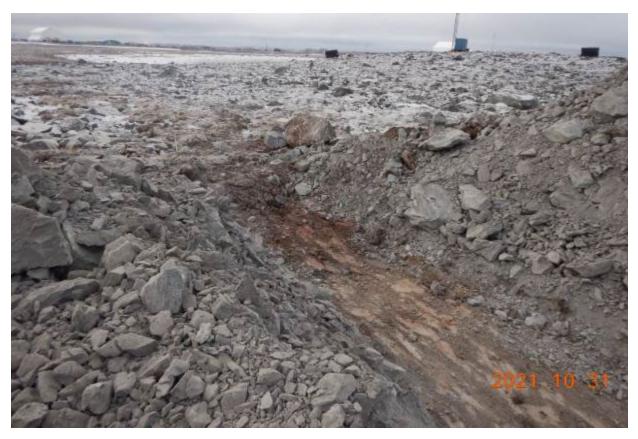
Photo 11. Excavation of road material for installation of the culvert 35-3, looking North-East.

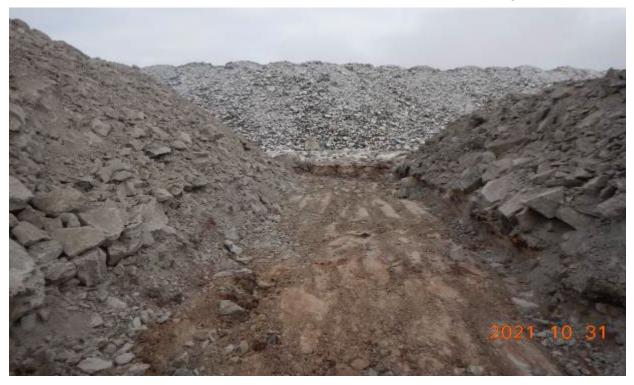
Photo 12. Excavation of road material for installation of culvert 35-3, looking South-West.

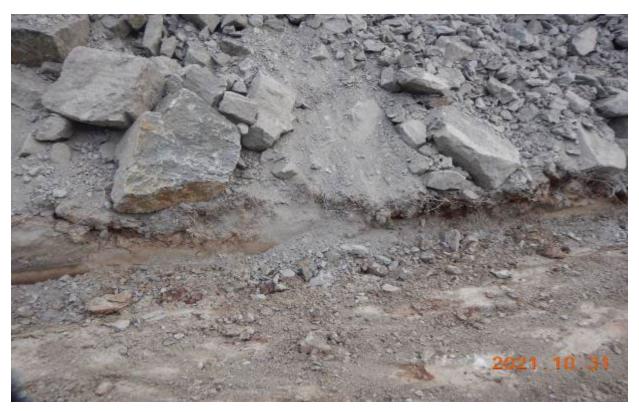
Photo 13. Exposed trench wall of culvert 35-3 showing till foundation underlying tundra.

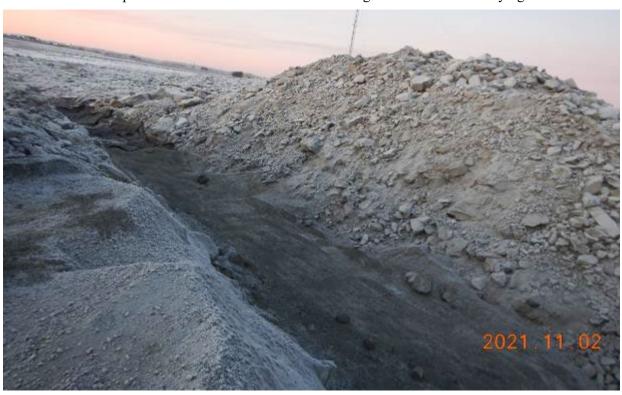
Photo 14. Fine filter layer for culvert 35-3 the width of the road and installed geotextile strips at the South-West end of the trench.

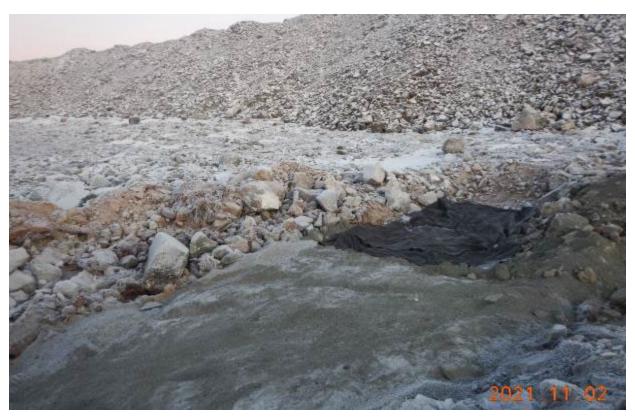
Photo 15. Installed geotextile strips at the North-East end of the trench, culvert 35-3.

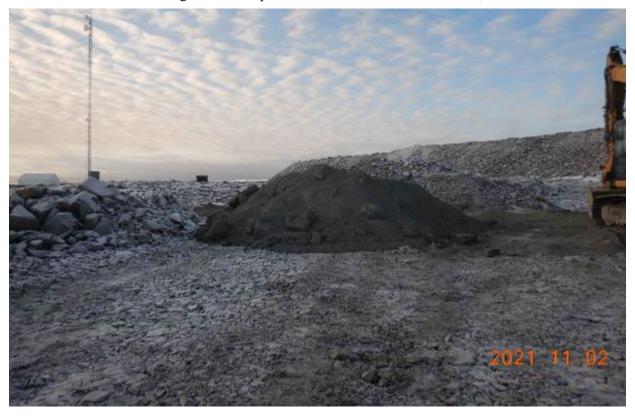
Photo 16. Fine filter subgrade material used as backfill, culvert 35-3.

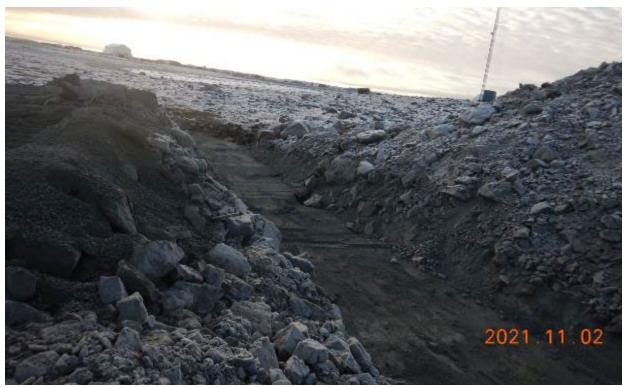
Photo 17. Fine filter subgrade material covering geotextile strips at the South end of the trench for culvert 35-3.

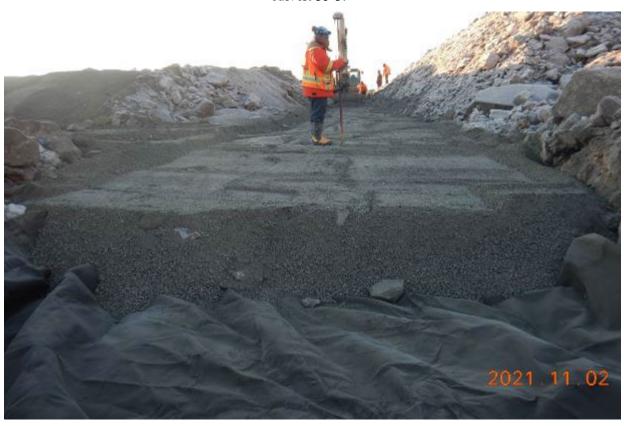
Photo 18. Fine filter subgrade material final thickness, looking South-West, culvert 35-3.

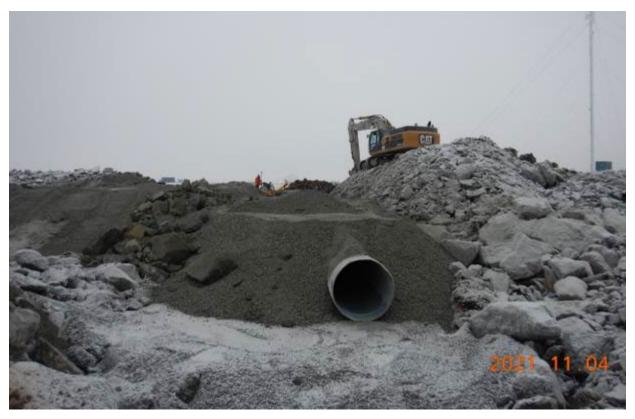
Photo 19. Installed culvert 35-3 with overlaying compacted protective layer, looking South-West.

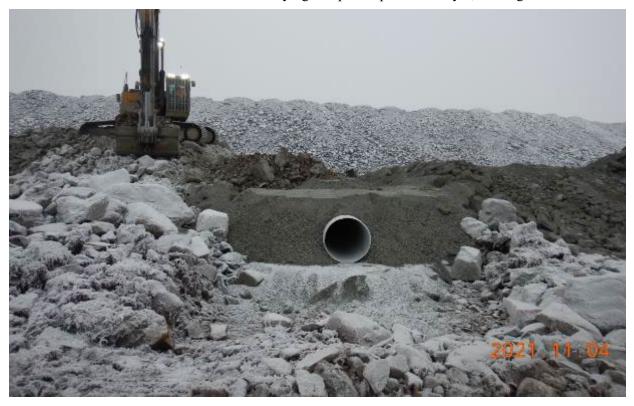
Photo 20. Installed culvert 35-3 with compacted overlying protective layer, looking North-East.

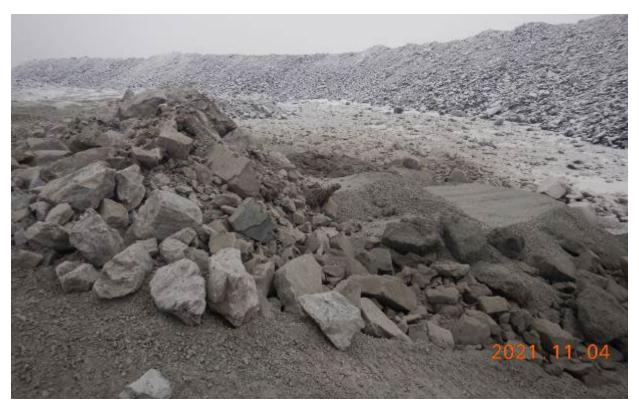
Photo 21. Culvert 35-3 North-East end with road berm.

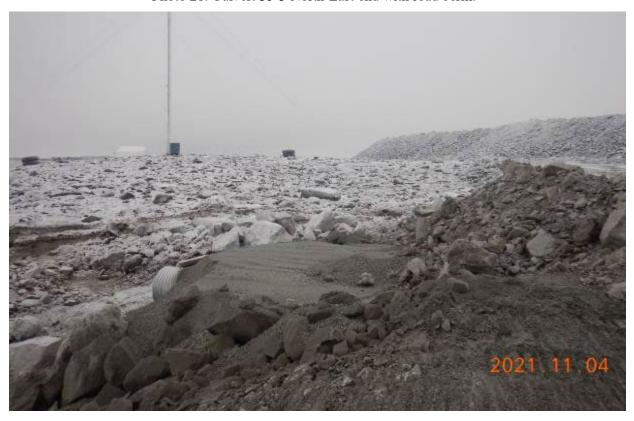
Photo 22. Culvert 35-3 South-West with road berm.

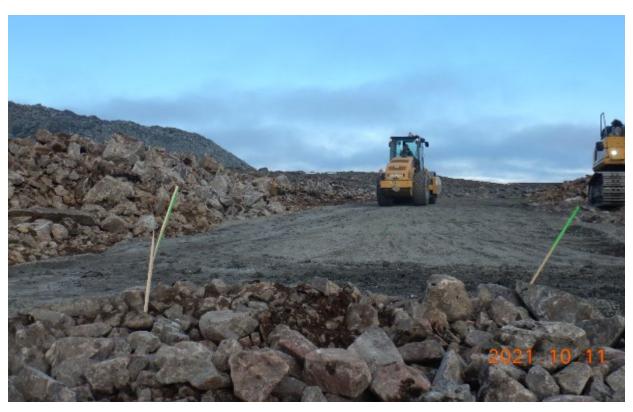
Photo 23. Fine filter subgrade material covering geotextile strips and being compacted by roller-compactor, looking East, towards culvert 35-4 (A, B, C) inlet.

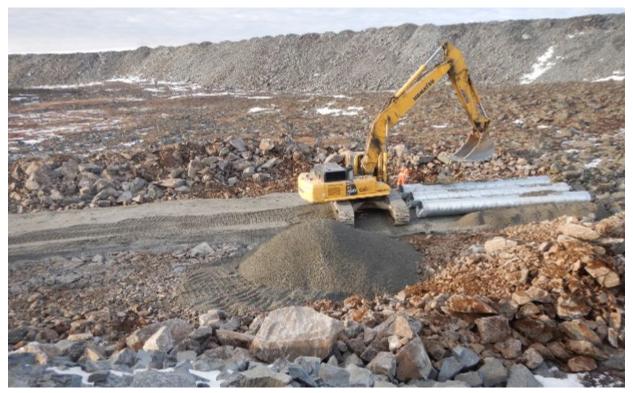
Photo 24. Culvert 35-4 (A, B, C) installation on top of compacted fine filter, looking North at inlet.

Construction of the culvert 35-4 (A, B, C) was slightly modified as it was moved from its original proposed location, an area that was not a topographical low point. This move was necessary as the culverts would not have been as useful channeling contact water from IWE lake/sump to the IVR Attenuation Pond, because the water pathway was situated in the topographical low point.

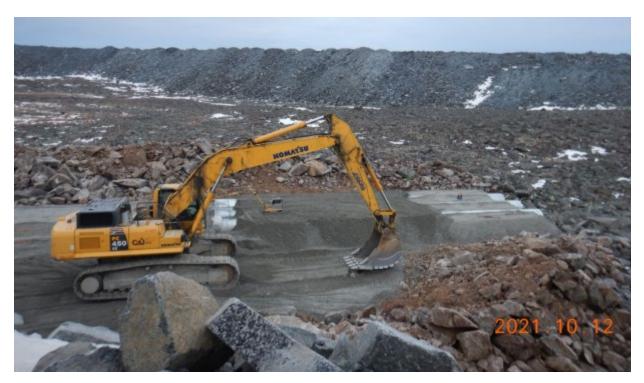
Photo 25. Installed portion of culvert 35-4 (A, B, C) being covered with compacted fine filter protection layer, looking North at inlet.

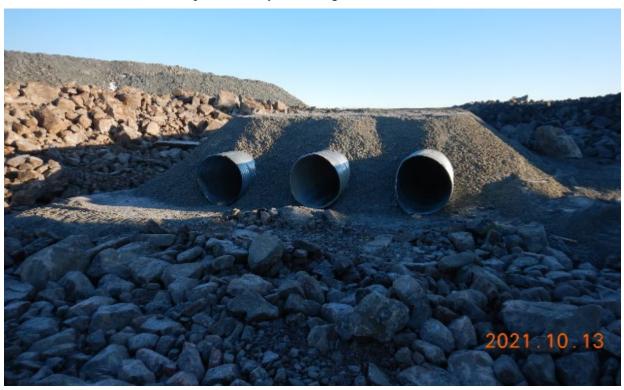
Photo 26. Installed culvert 35-4 (A, B, C), covered with a compacted fine filter layer, looking East at outlet.

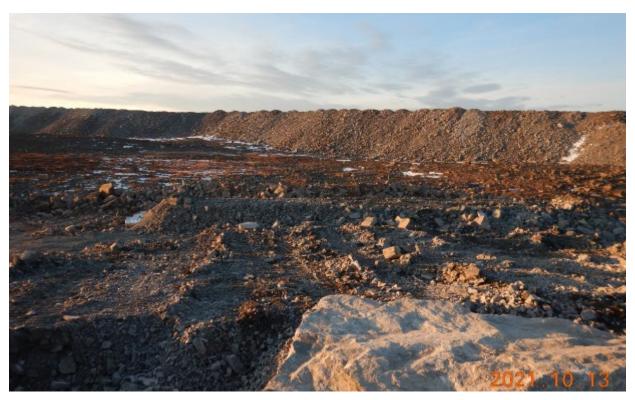
Photo 27: Installed culvert 35-4 (A, B, C) covered with run-of-mine NAG, looking North.

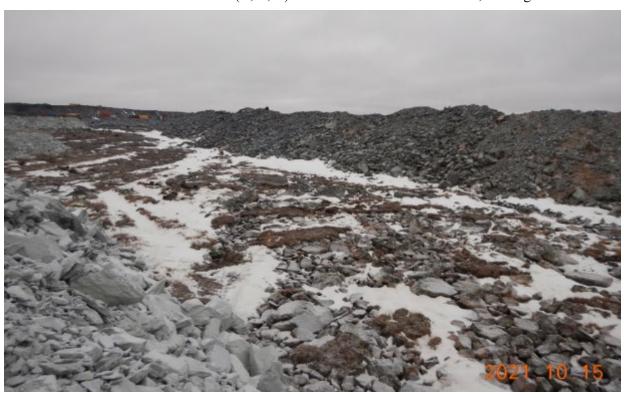
Photo 28. North-East View of IWD Sump location prior to excavation.

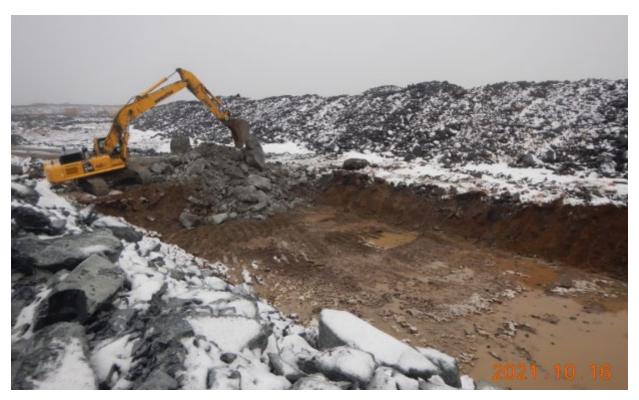
Photo 29: IWD sump being excavated with Komatsu P450, looking North.

The IWD sump volume was increased to hold approximatively 568 m3, by lengthening the sump by 10 m parallel to the road. The volume increase was necessary to conform with design specifications. The IWD sump was also moved slightly South-West to a topographical low point.

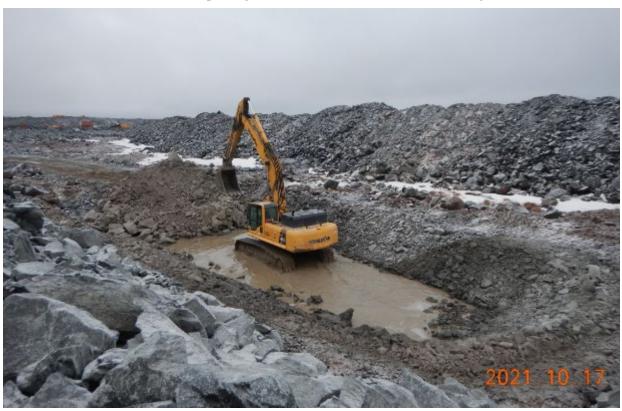
Photo 30. IWD sump being layered with rockfill, looking North.

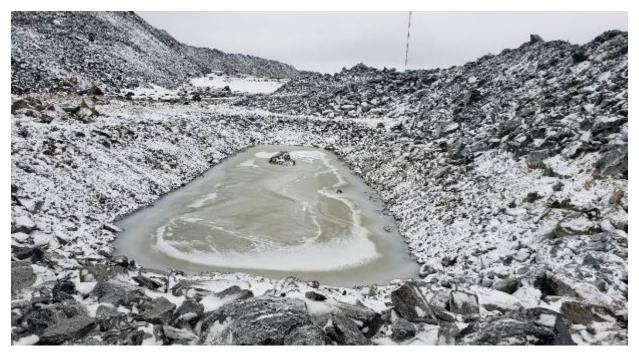
Photo 31. IWD sump once completed with rockfill and slopes in place looking East.

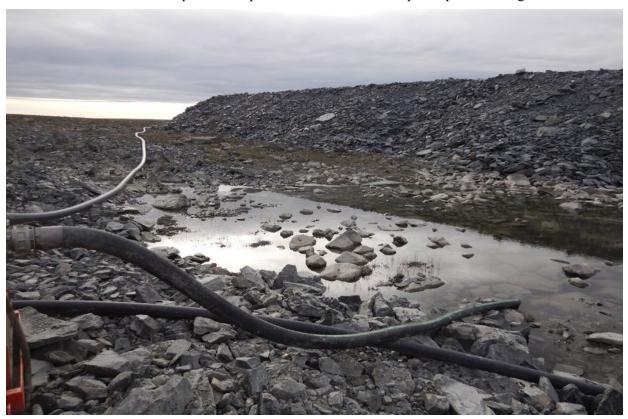
Photo 32. View of the IWC sump and water line 122 looking East.

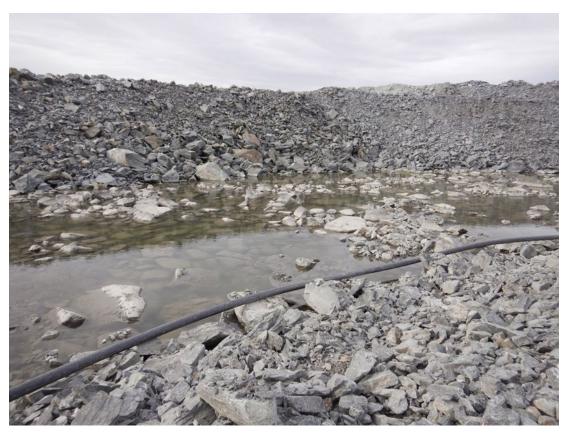
Photo 33. View of the IWA sump and water line 117, looking South.

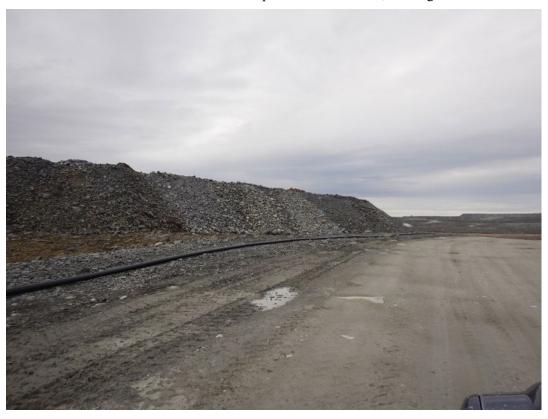
Photo 34. View of line 117, looking southwest.

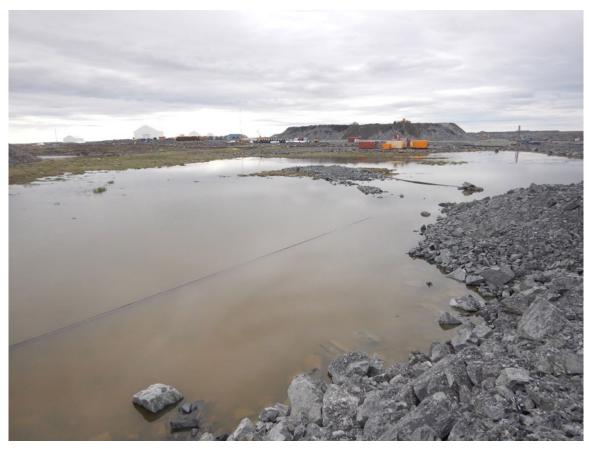
Photo 35. IWB sump with end of pipe 117 underwater to the left and beginning of pipe 118, looking south.
