**APPENDIX C**

# Construction Photographs

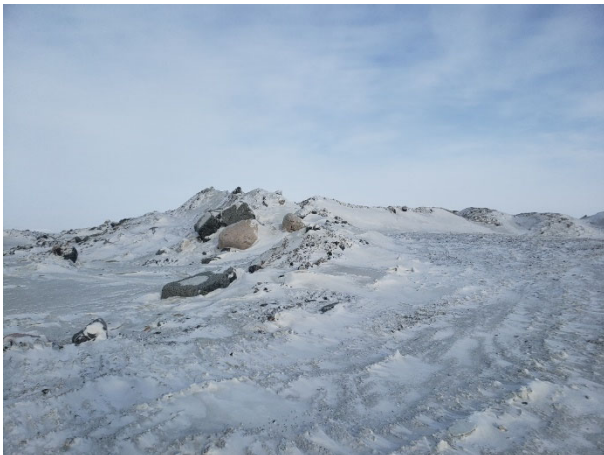
**2004: (2021-02-21), looking E from Sta. 0+160. Additional snow and ice removed within footprint of downstream shell for road access.**

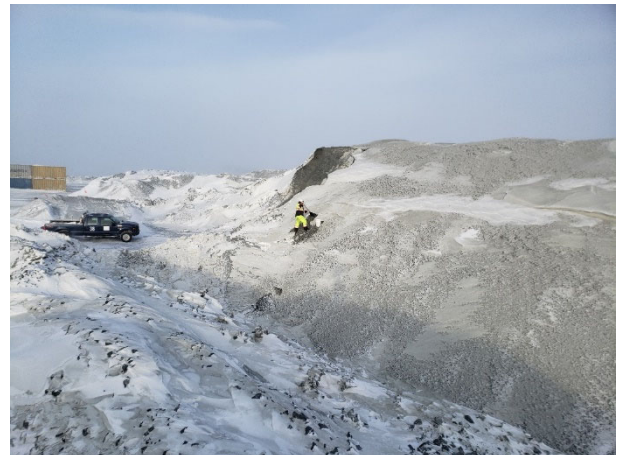
**2005: (2021-02-21), North Esker stockpile located within the WSRF, view looking S. Large amounts of snow and ice were observed over Zone 4 material.**

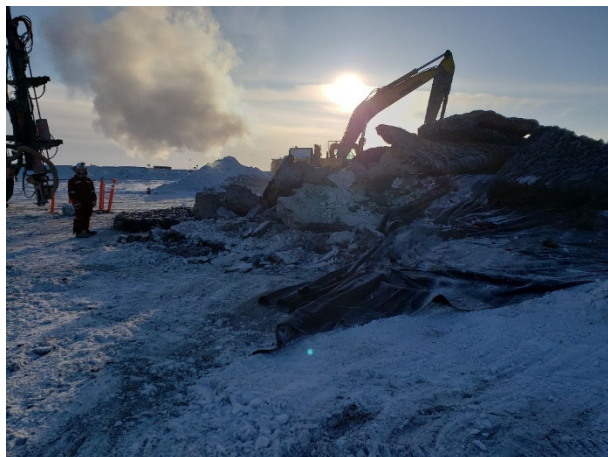
2011: (2021-02-24), looking W from Sta. 0+130. Overburden exposed from this afternoon's blast, no visible ice lenses observed.

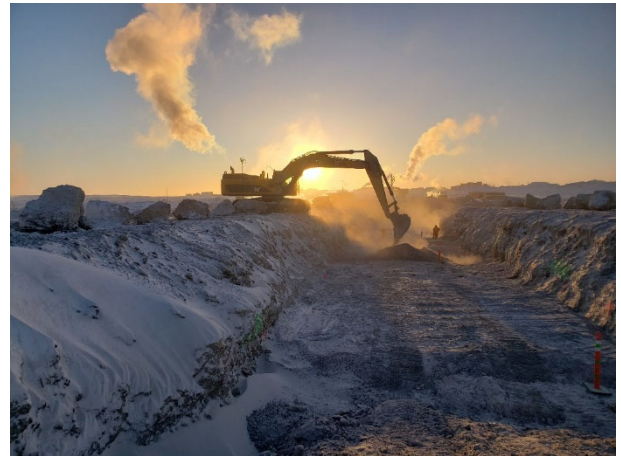
**2035: (2021-03-04), looking E from Sta. 0+155. Downstream side wall of key trench excavation small ice lenses (1-2 mm) observed throughout till overburden.**

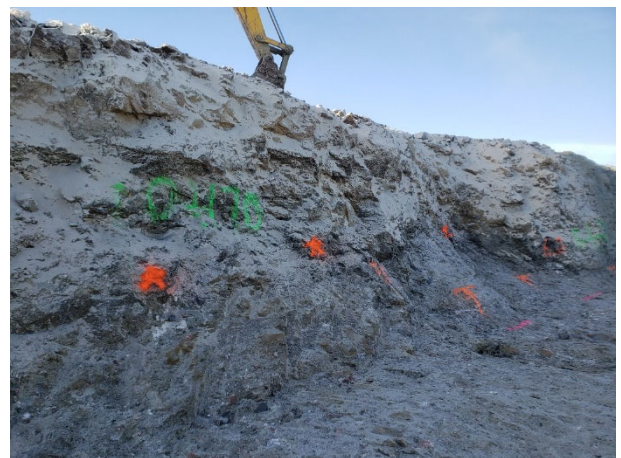
**2038: (2021-03-05), looking SW from Sta. 0+170. Orange stars highlight a 100-150 mm thick lens of fine-grained ice rich material along downstream sidewall of excavation.**

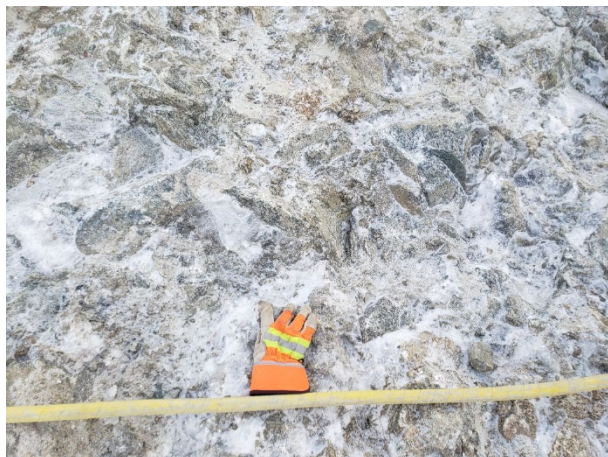
**2051: (2021-03-08), looking E from Sta. 0+206. Additional ice and loose bedrock to be removed during key trench foundation preparation.**

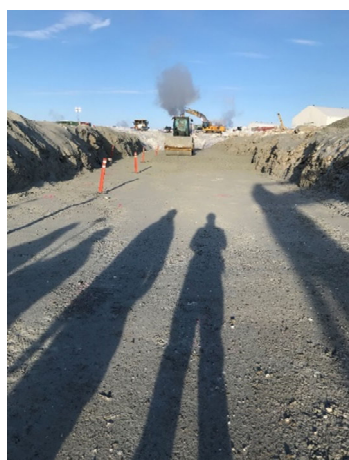
**2054: (2021-03-10), looking E from Sta. 0+225. High spot of subgrade foundation (50 mm too high).**

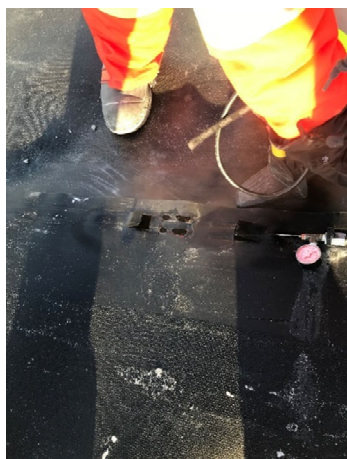
2099: (2021-03-19), looking W from Sta. 0+310. Damage to seam P16/17 due to stuck welder

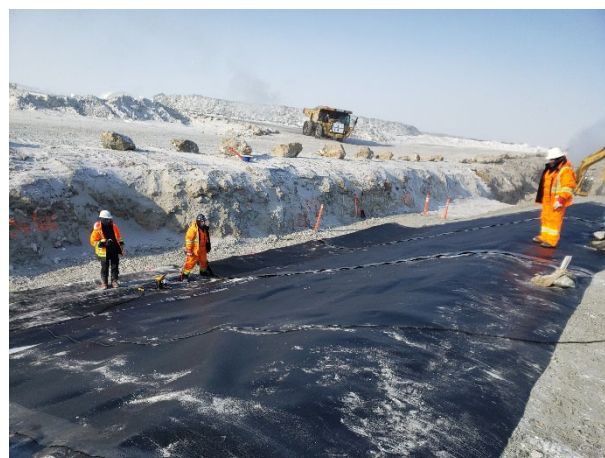
**2117: (2021-03-24), looking S from Sta. 0+170. FC liner removing 'smooth' portion of panel P01 at approx. Sta. 0+170 due to damage along seam caused by excavator during snow removal.**

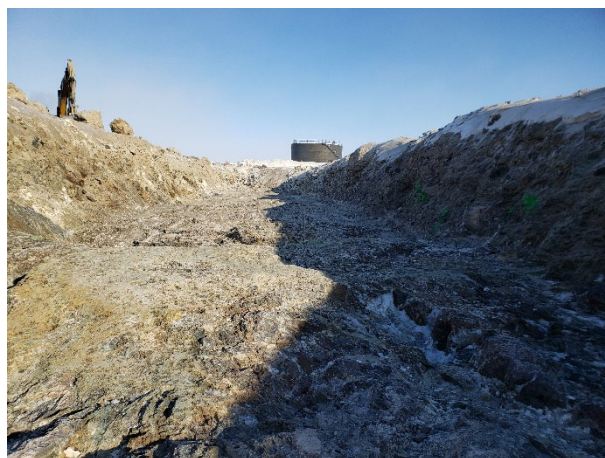
2153: (2021-03-30), looking S from Sta. 0+438. Ice pocket observed in bedrock along base of key trench.

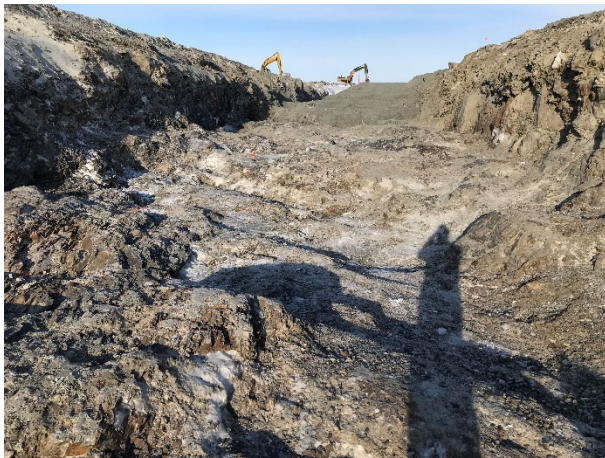
**2192: (2021-04-10), looking N from Sta. 0+500.** Ice-filled joint at Sta. 0+500 (joint #4 on bedrock map).

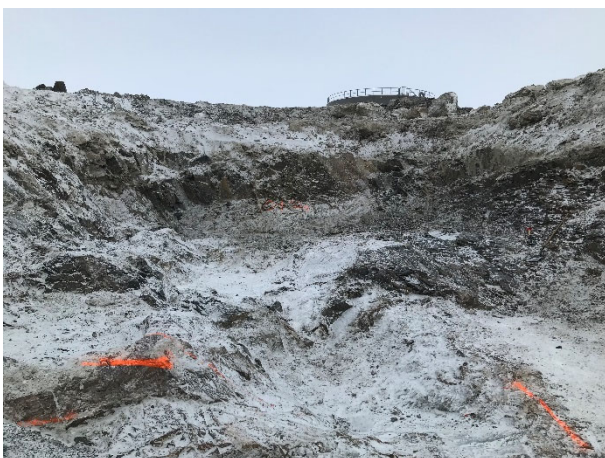
**2194: (2021-04-10), looking W from Sta. 0+526.**  
Approved key trench bedrock foundation from Sta. 0+515 to Sta. 0+526. Ice pockets visible on left and right sides of photograph.

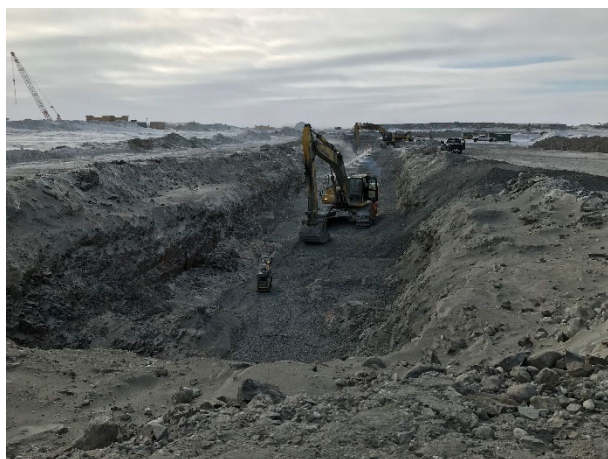
**2196: (2021-04-10), looking E from Sta. 0+520.** Closely spaced joint set/fracture zone on downstream side of key trench foundation.

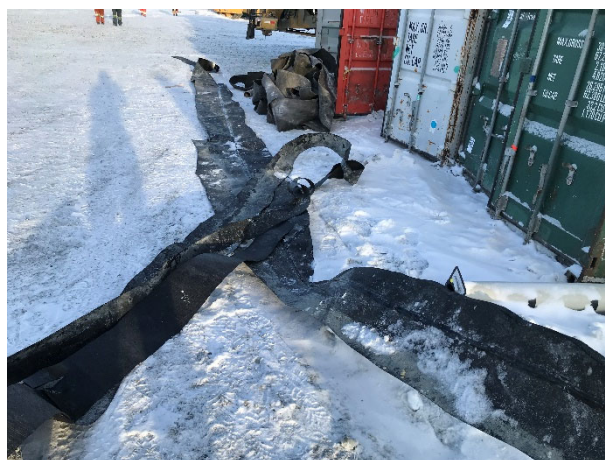
**2211: (2021-04-17), Liner trimmings showing damaged hinge weld.**

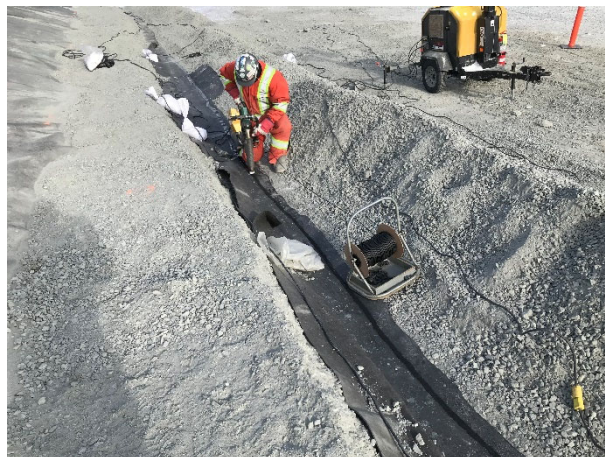
**2212:** (2021-04-17), looking E from Sta. 0+200. Exposed hinge weld damage.
