Construction Summary Report IVR Diversion Channel

Agnico Eagle Mines Ltd

6127-695-132-REP-012_R2

February 16, 2021

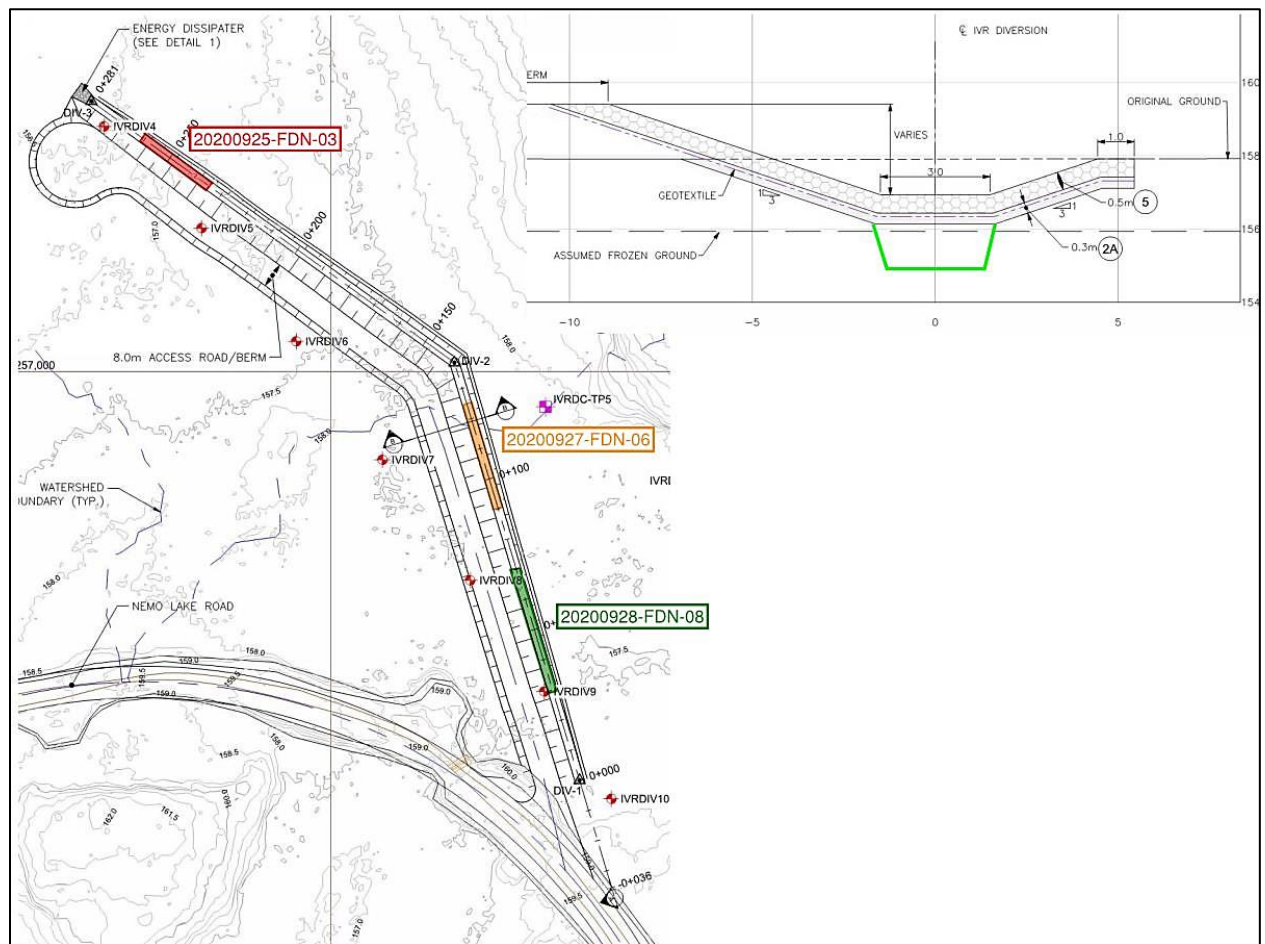
Figure 1. Plan view of the over-excavation resulting of ice & ice-rich material removal

Ice-rich frozen till was encountered in between Stations 0+235 and 0+260. The till was tested at surface (sample IVR-EX-04) and returned more than 92% of total moisture content, therefore classified as ice-rich. A field decision was therefore made to continue the excavation to remove the first 600mm of ice-rich till below the channel planned excavation then reassess the situation after the clean-up. Visually there was little to no changes, so QA asked that another 600mm was removed from the bottom of the excavation. Another visual assessment of the foundation revealed a slight improvement in the material. A sample was taken for analysis and turned out to be ice-rich also. In the meantime, it was decided to stop the excavation and backfill it for the following reasons:

Ice lenses were removed from the foundation in those areas during the excavation of the bottom of the channel. The largest was found at 0+247 and was removed up to the toe of the key trench downstream slope and replaced with esker material. Other lenses were left in place under the toe of the existing slope but were removed during the 3in1 sloping of the downstream of the key trench, as described in the next section.

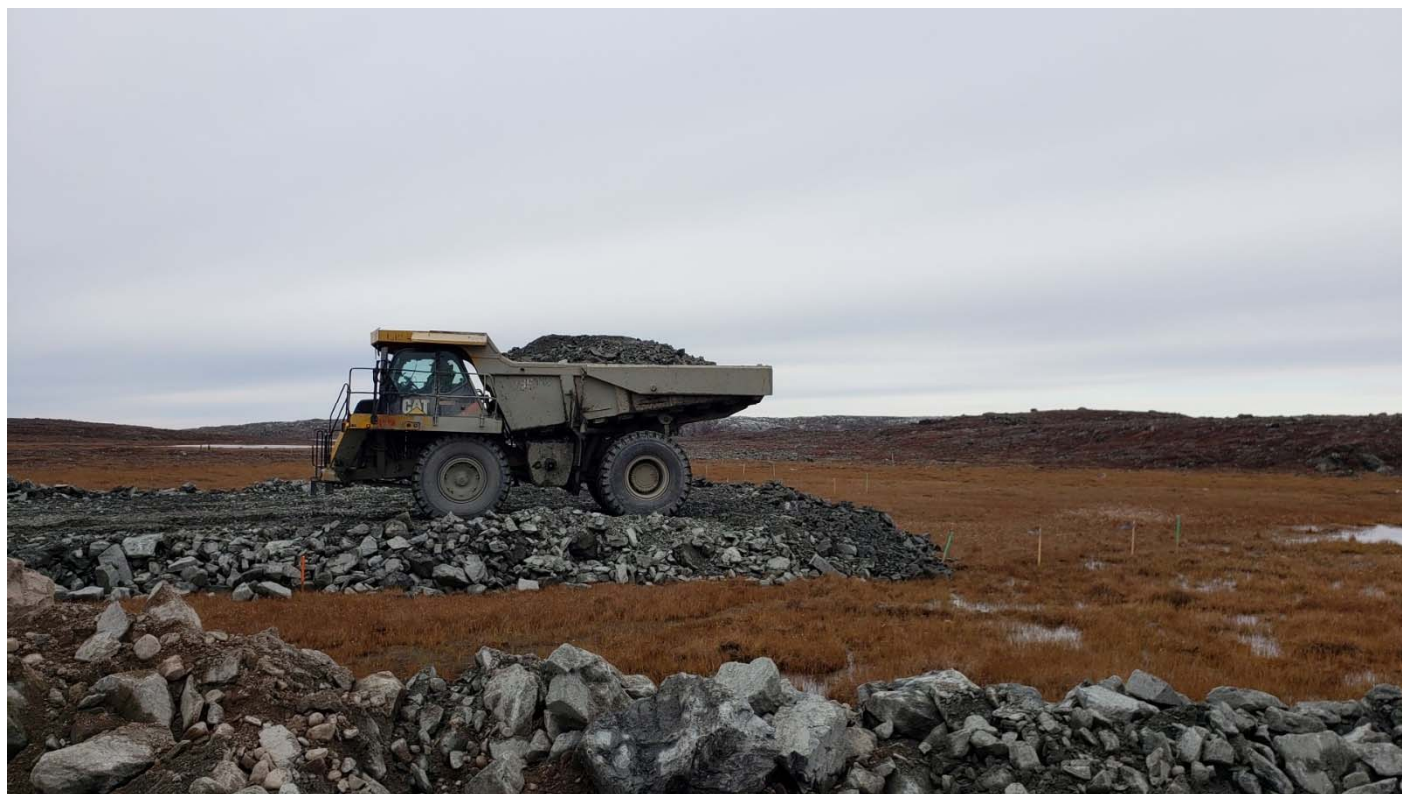
Photo 2: Construction of the d/s berm with rockfill, station 0+026. First lift slightly over the specified thickness as soft foundation encountered in the wet flat area between 0+000 and 0+125.

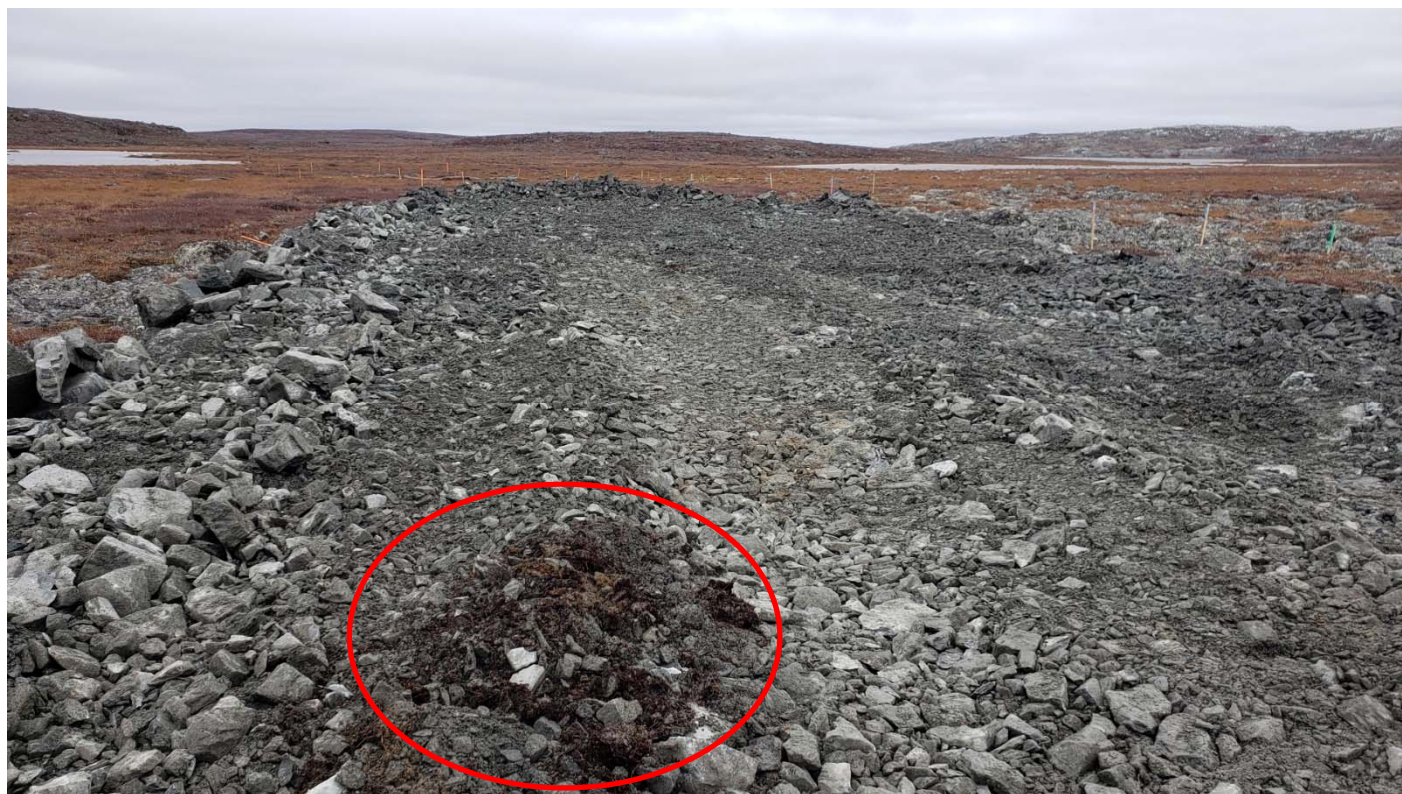
Photo 2: Station 0+200 looking North. Softer material from foundation protruding through the rockfill layer that was too thin. Before it got out of control, QA asked to retreat 50m from there and restarted with another lift 500mm over the existing one. Material shown was on the downstream end of the platform and it was left in place and covered.

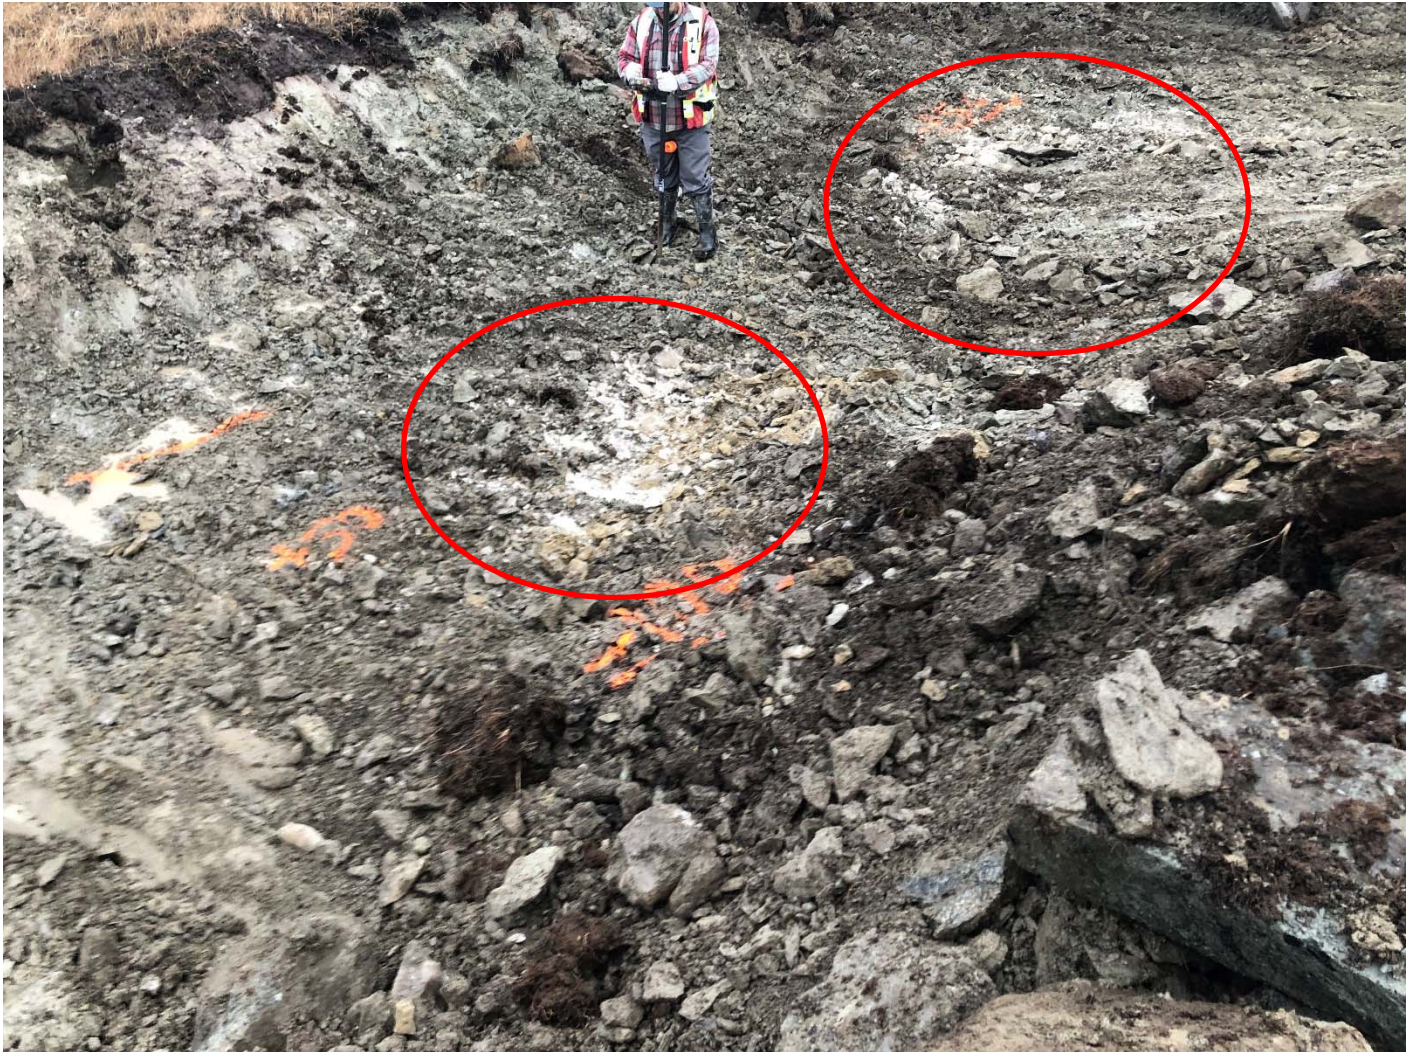
Photo 4: ice rich till in the foundation of the channel St. 0+245 looking North. Summary removal was completed without the presence of QA or QC. Ice situation will be reassessed tomorrow morning and complete removal will be performed if required, as per Specifications.

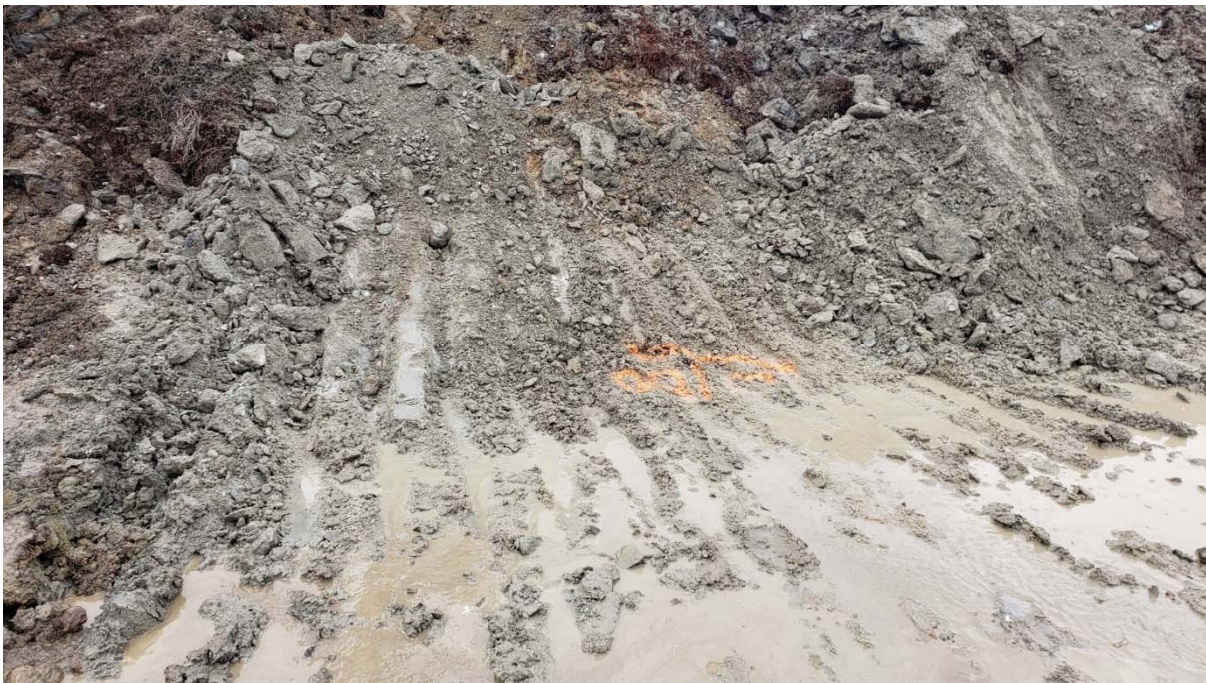
Photo 3: ice rich frozen till in the foundation of the channel between St. 0+235 and 0+260. Ice content sample revealed 93% water. Material to be excavated and replaced by esker in the next days.

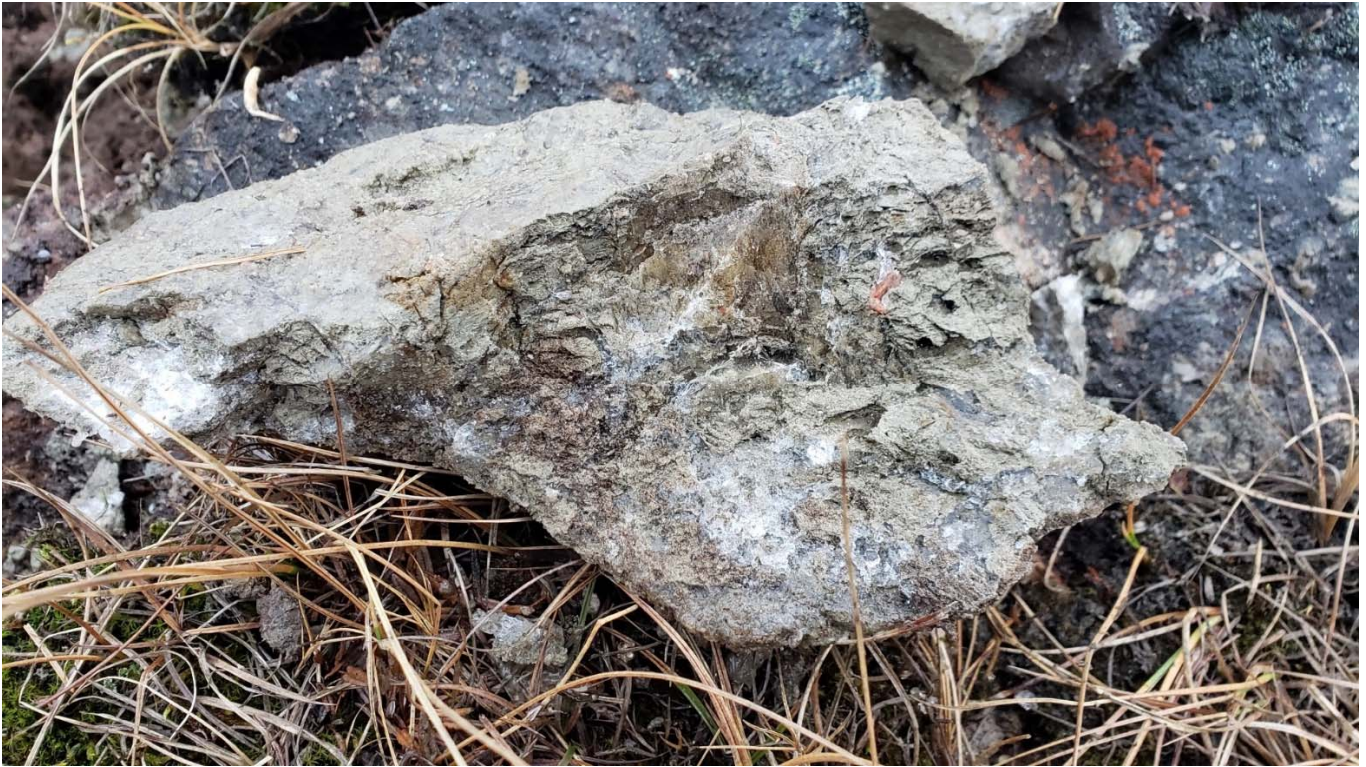
Photo 4: ice crystals and inclusion in till, from foundation at St. 0+243.

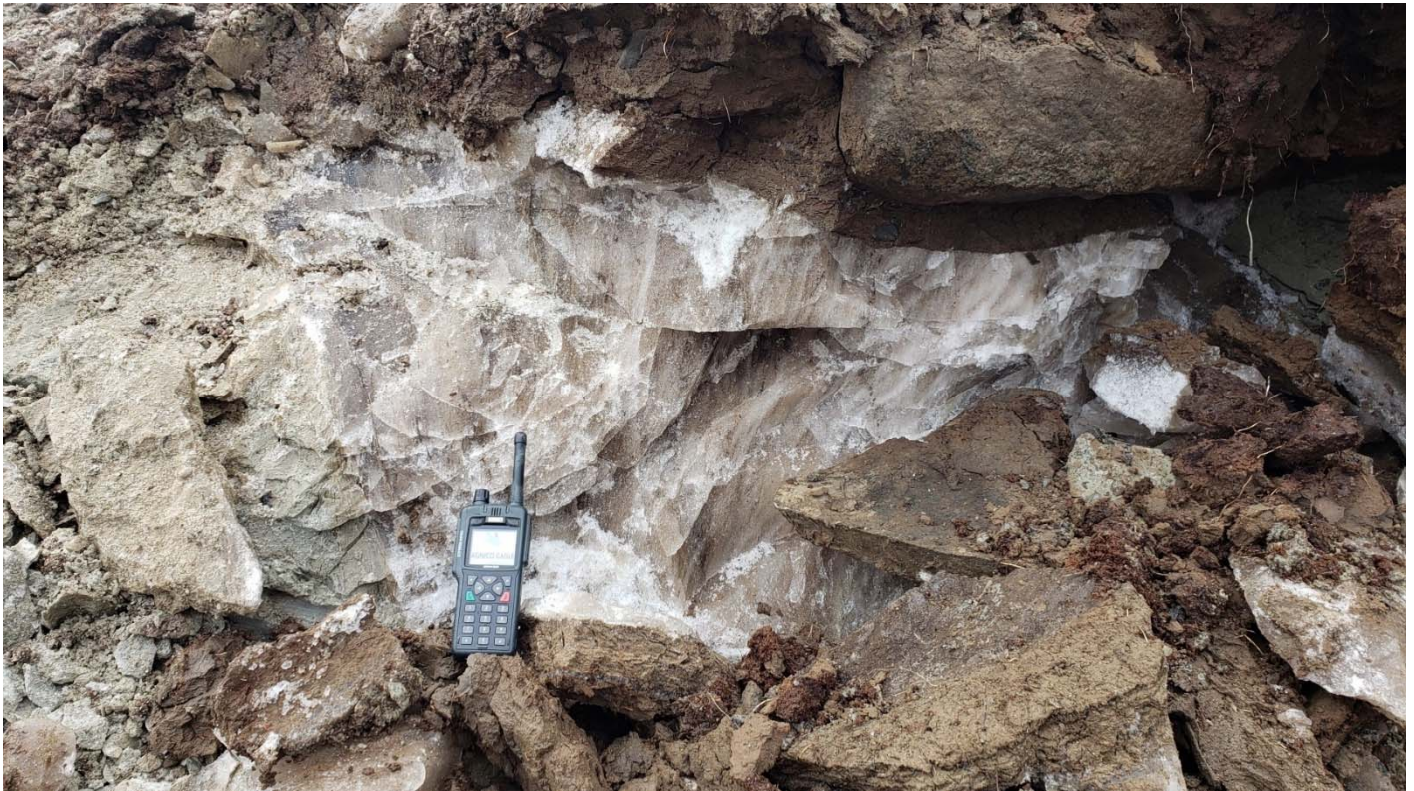
Photo 5: partial view of the ice lens found under the rockfill at the base of the slope St. 0+243, original size 1.2m long x 0.9m deep x 0.6 m wide. Lens was entirely removed and replaced with rockfill.

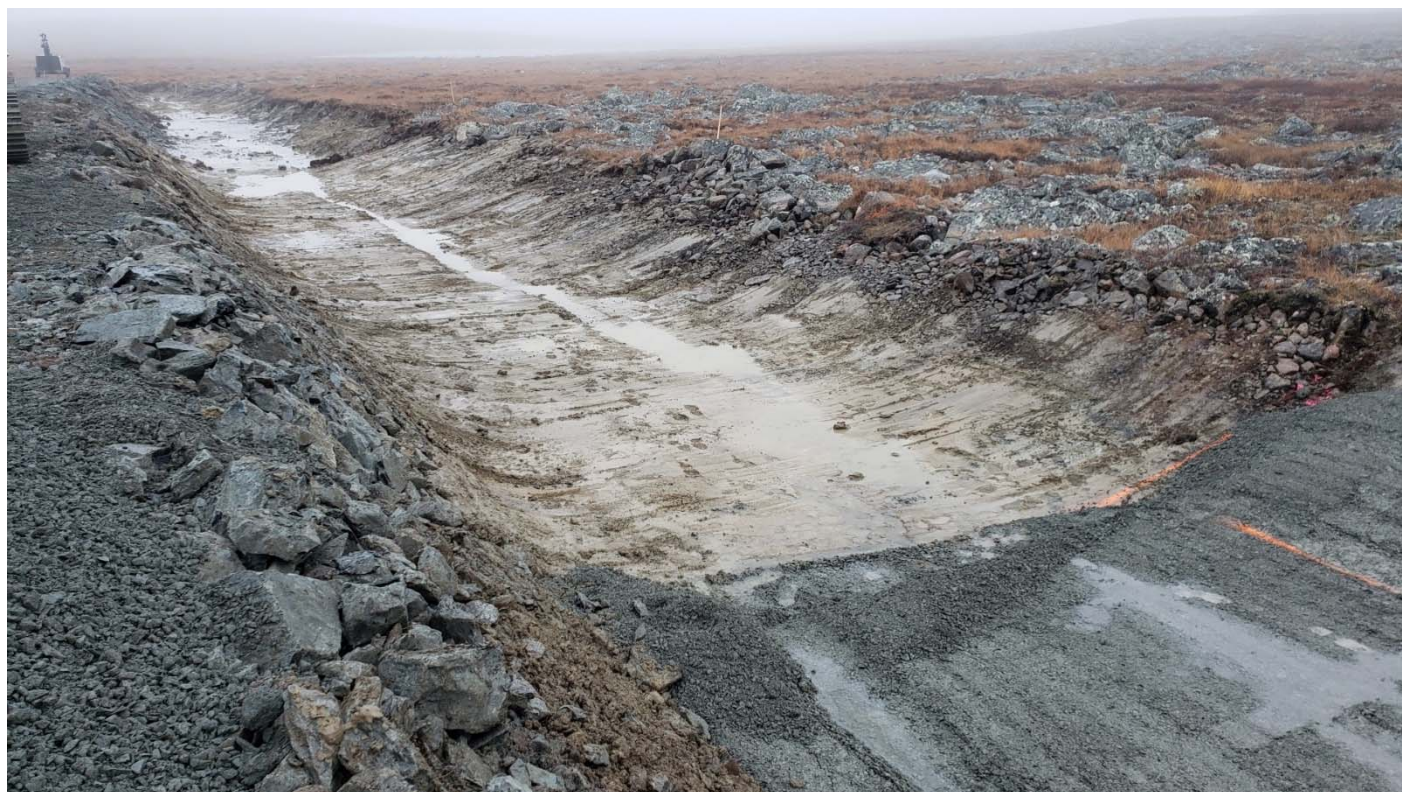
Photo 1: Ice rich till section between 0+235 and 0+260, after clean up and before hammering. Unsuitable foundation material visible ice greater than 10% of the surface, presence of ice lenses.

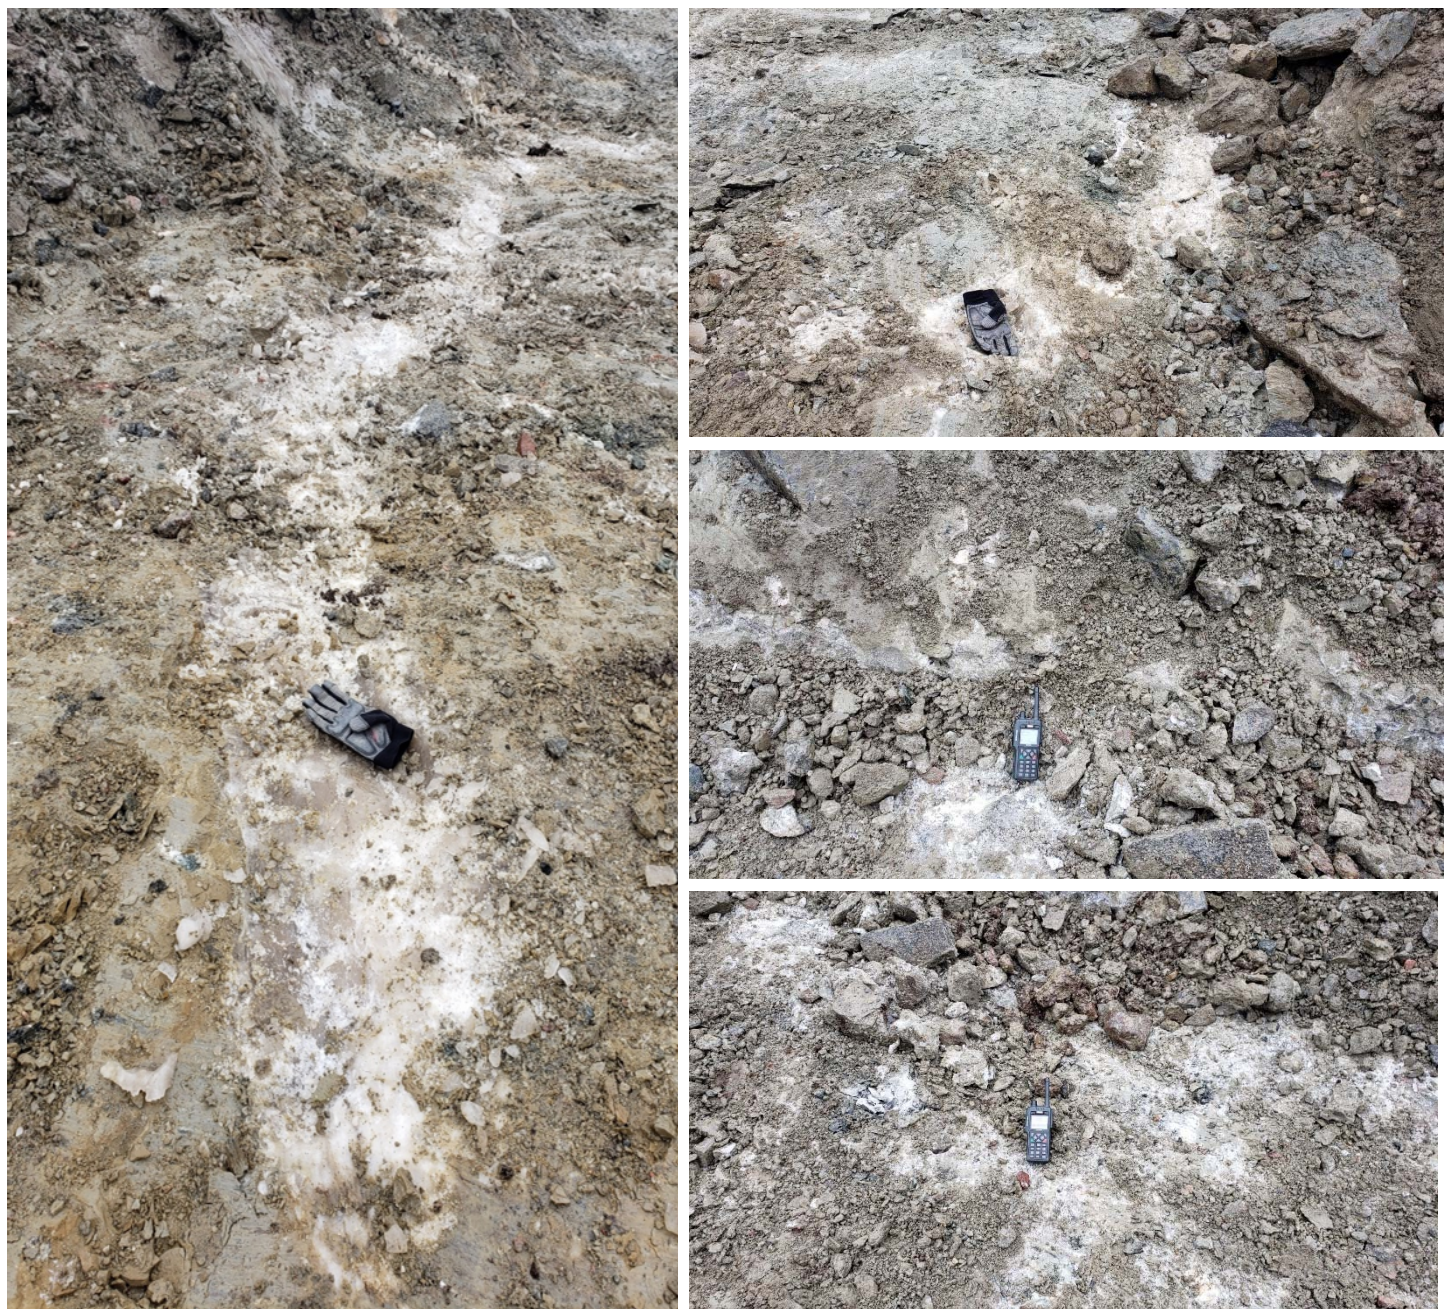
Photo 2: Ice lenses present after the first hammer pass at Station, Sta. 0+240 to 0+260.

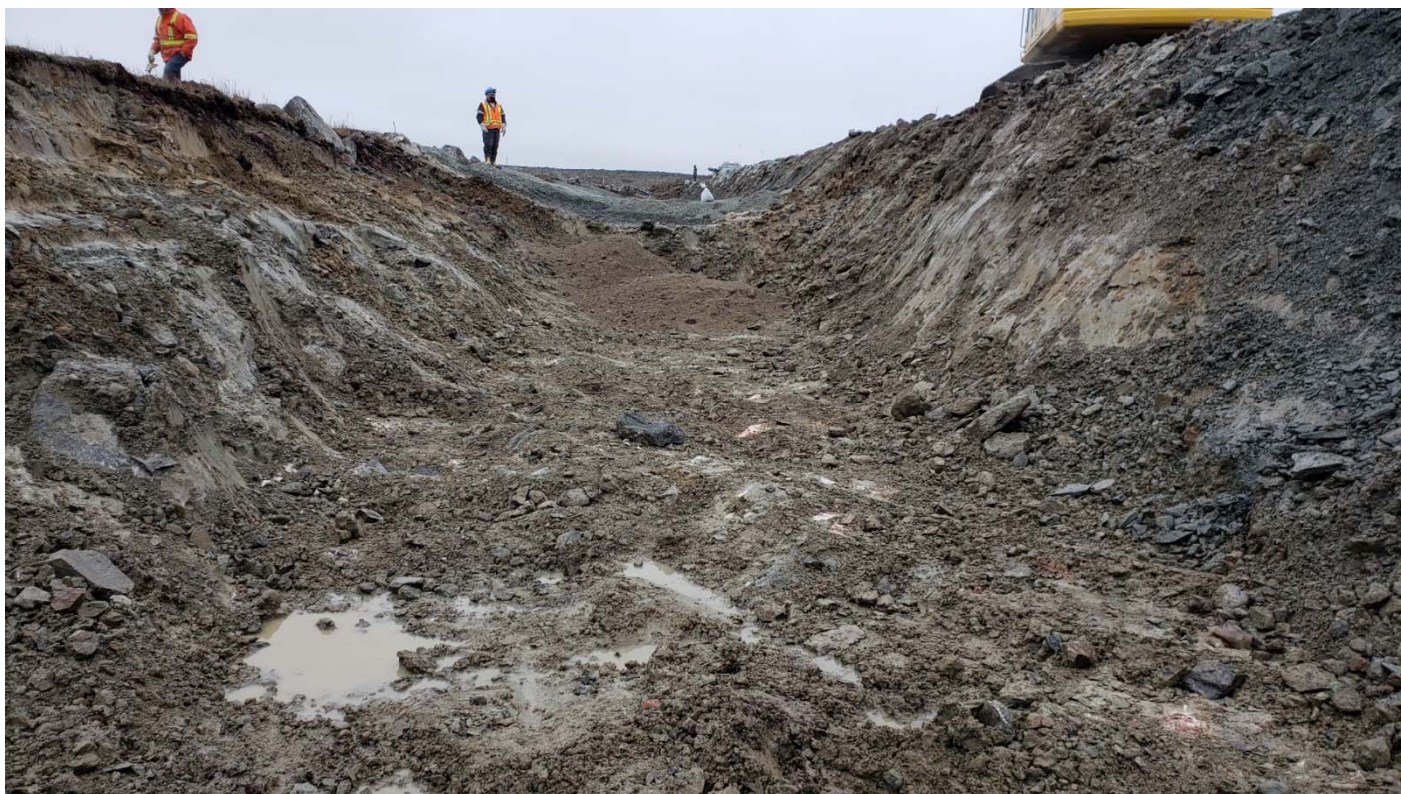
Photo 5: bottom of the ice rich section once all accessible till removed, St 0+255 looking S-E towards 0+235. Esker placement started by dropping loads of esker material with excavator and compacting it.

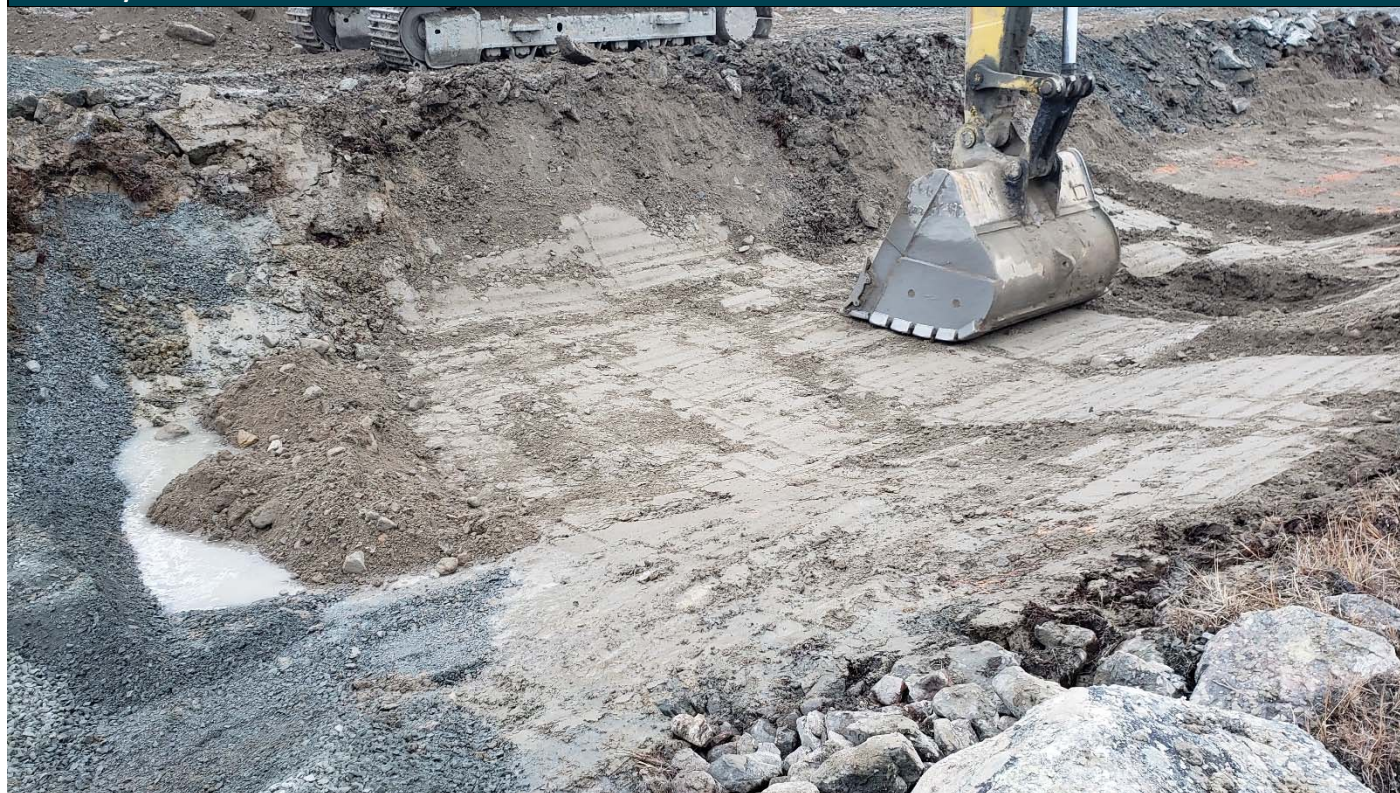
Photo 1: 2nd lift of esker fine material in replacement of ice-rich till St. 0+235 looking North. Material placed in 600mm lifts compacted with the bucket of the excavator.

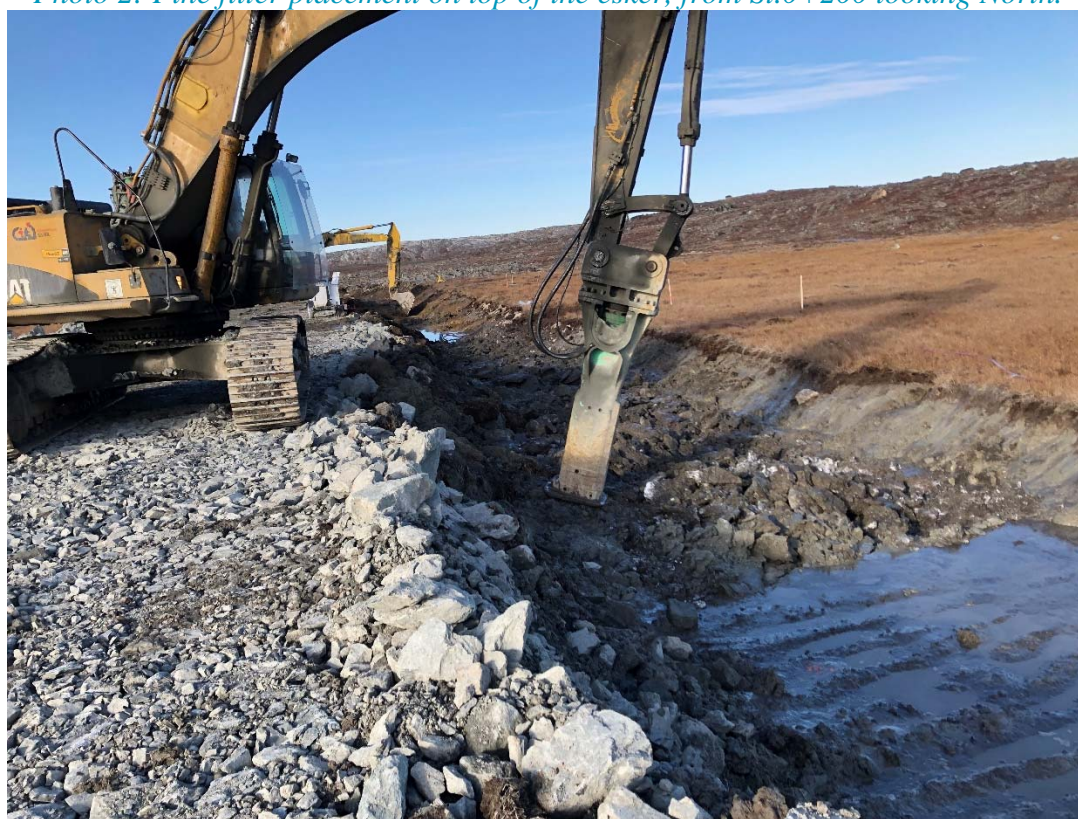
Photo 3: hammering of the frozen till to reach proper foundation grade in ice rich sector 0+125 to 0+090, taken from St.0+100 looking North.

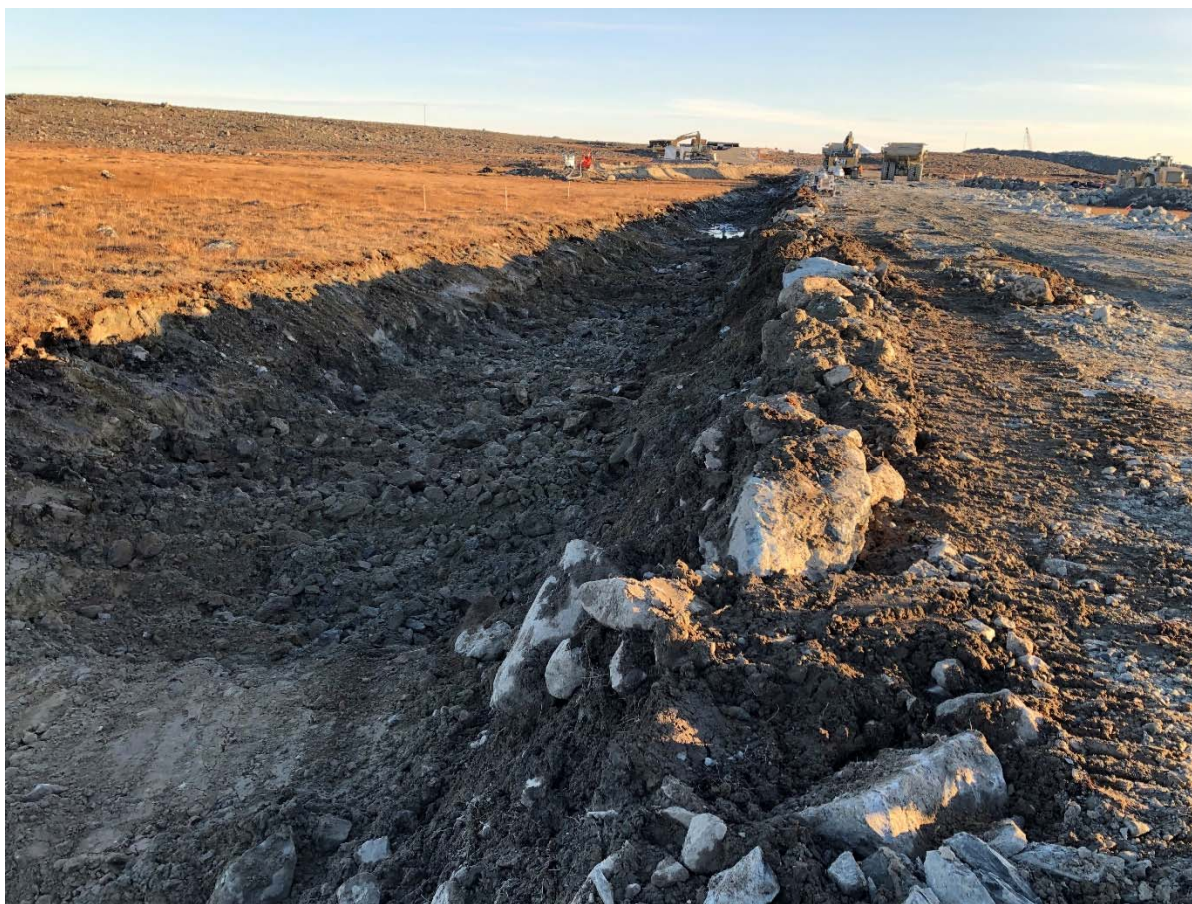
Photo 4: hammering of the first 400mm of frozen till, St.0+125 looking South. Clean up and assessment needs to be done.

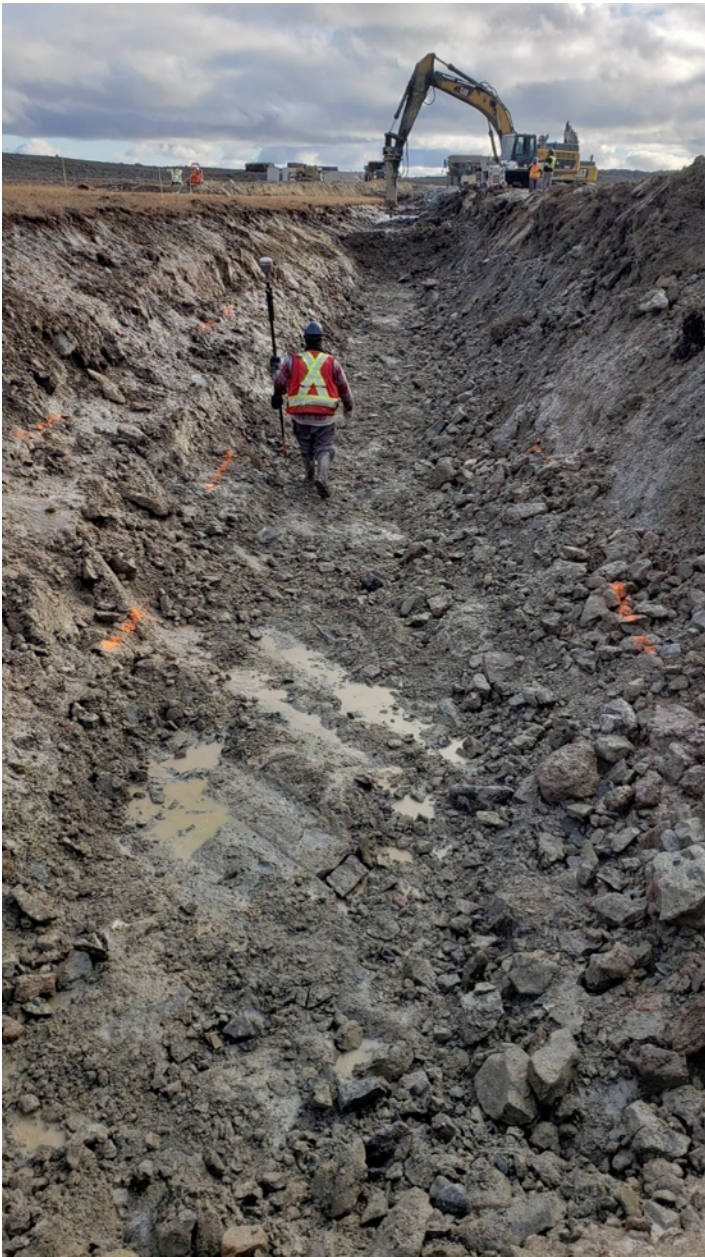
Photo 3: hammering of the frozen till to reach proper material in ice-rich sector 0+125 to 0+090, taken from St.0+125 looking South. With depth the till had gotten more ice-rich than at surface, ice lenses appeared in foundation (right). Excavation was stopped as it had reached maximum depth allowed for safety and was covered by fine esker material. Results of the water content of 3 till samples taken from that section, 20 (planned elevation), 24 and 25% (bottom of excavation), gradation on materials ongoing.

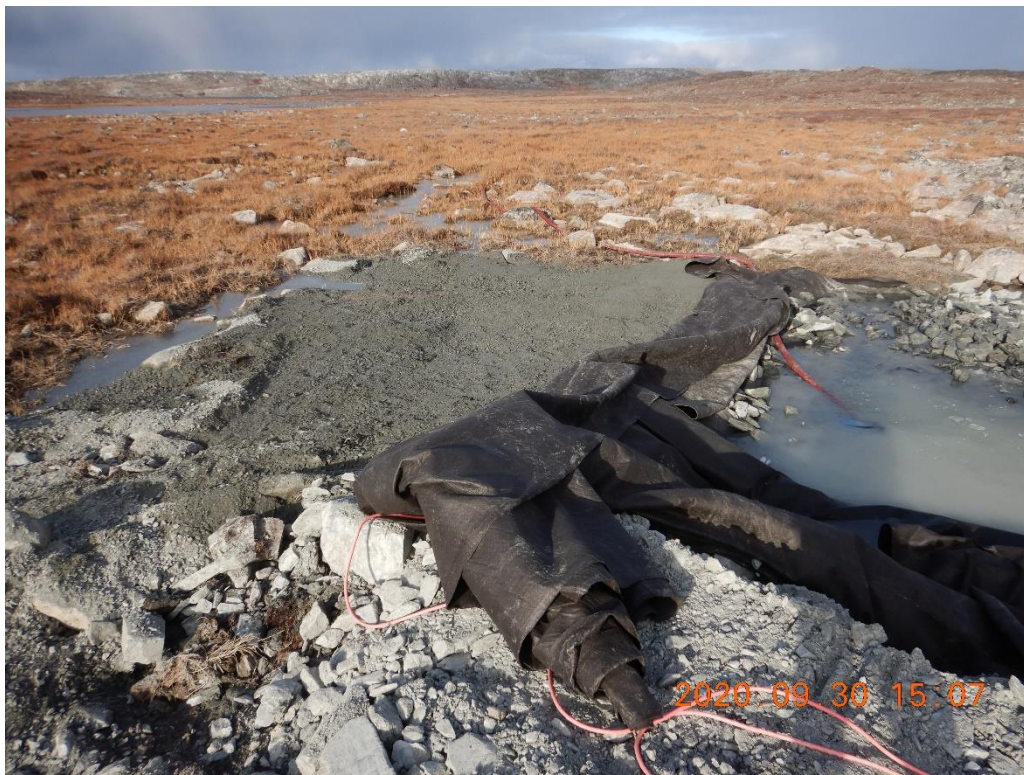
Photo 10. Non-compliant rip rap material containing fines and gravel <100mm. Excavator were told not to place any material of that kind. Manual cleaning will be required at some location along the channel where finer material was observed within the rip rap. Refer to comment section above.

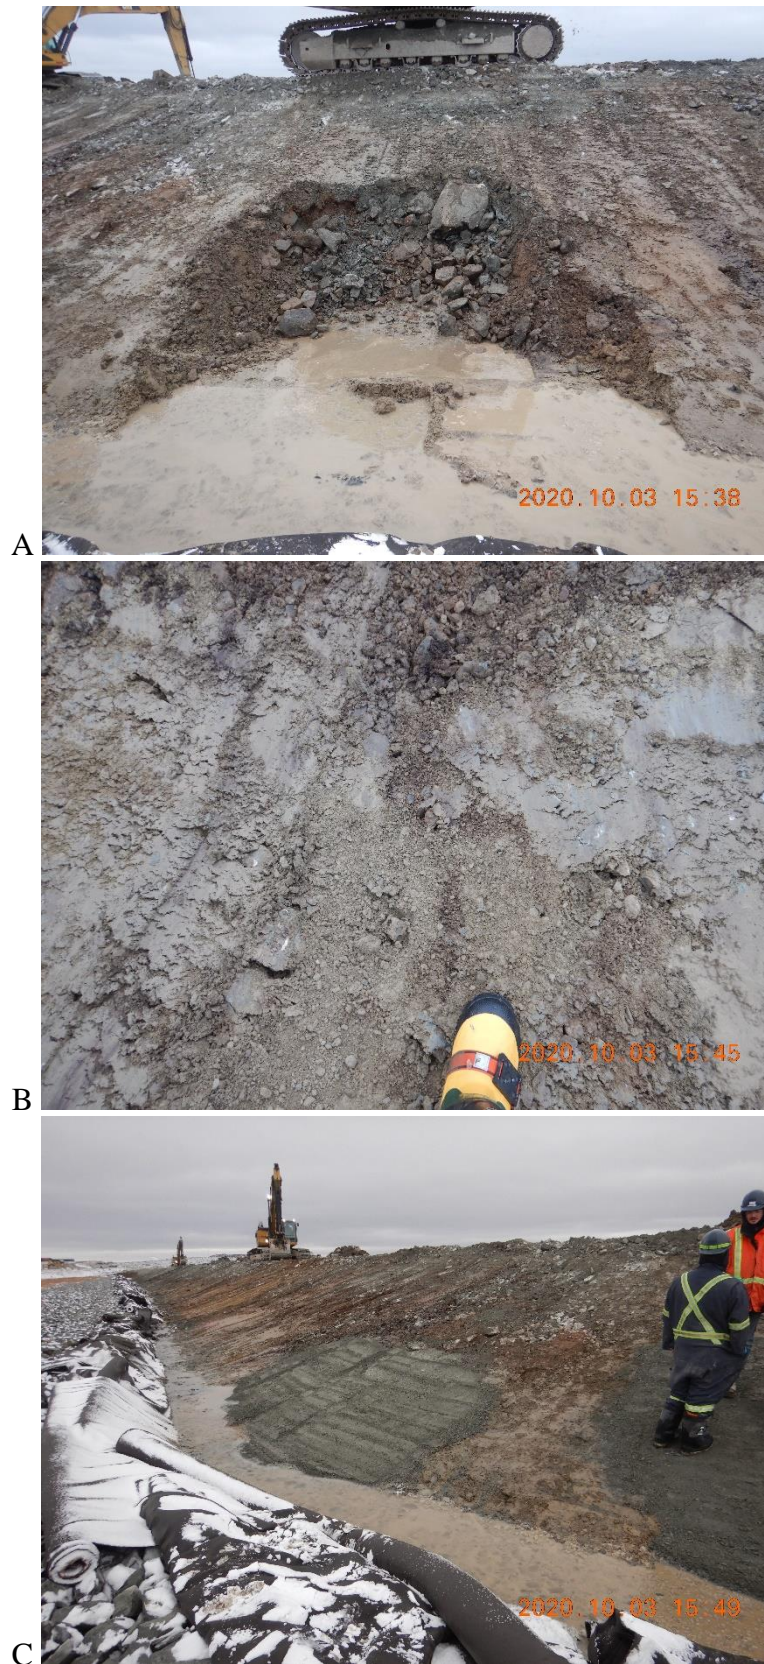
Photo 8. A) patch installed on the slope to cover the damaged geotextile. B) Close up on the damaged geotextile found the day before.

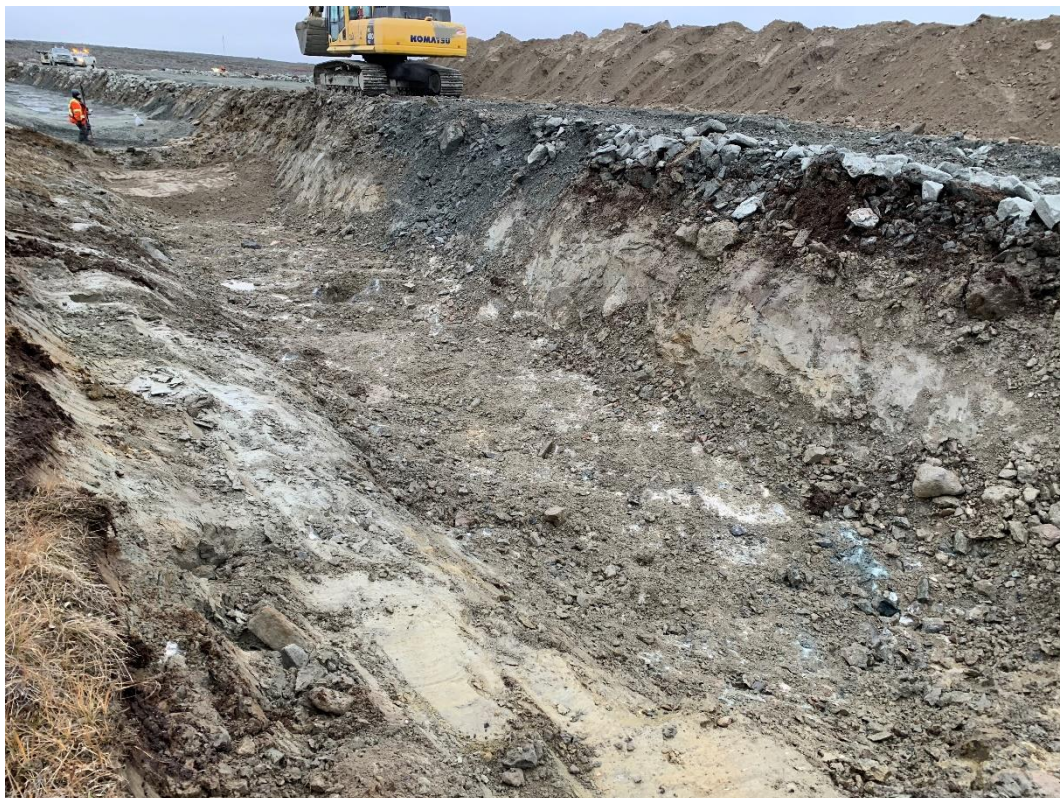
Figure 2: Ice removed between 0+235 and 0+261

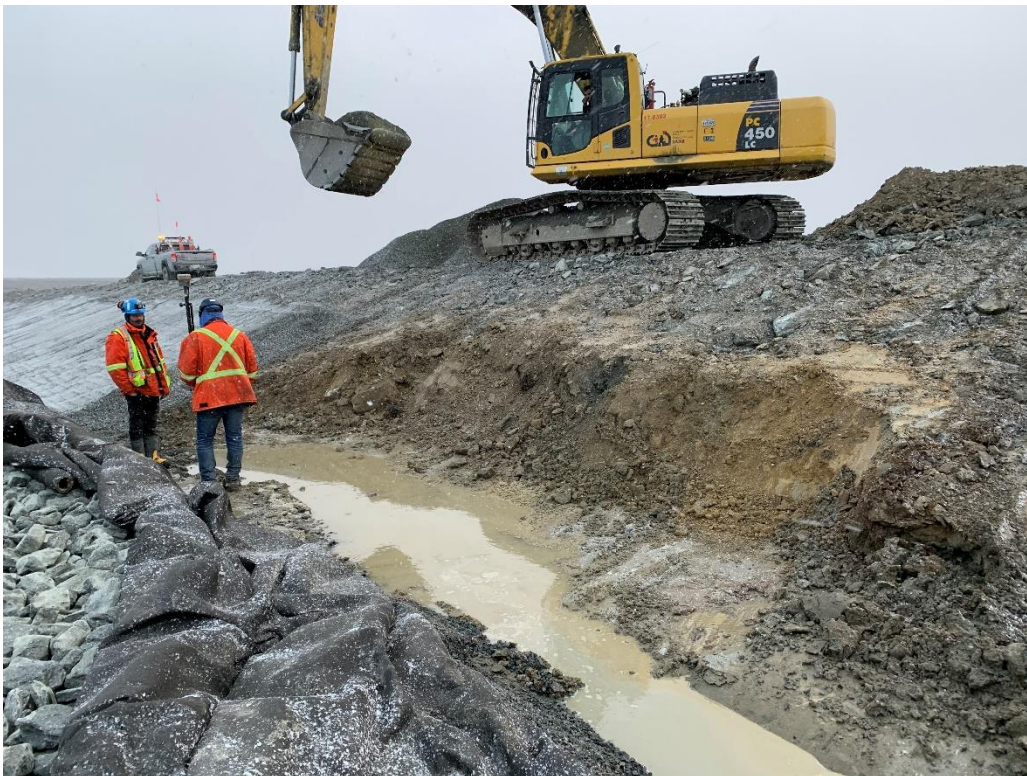
Figure 6: Ice excavated out of the foundation at 0+230

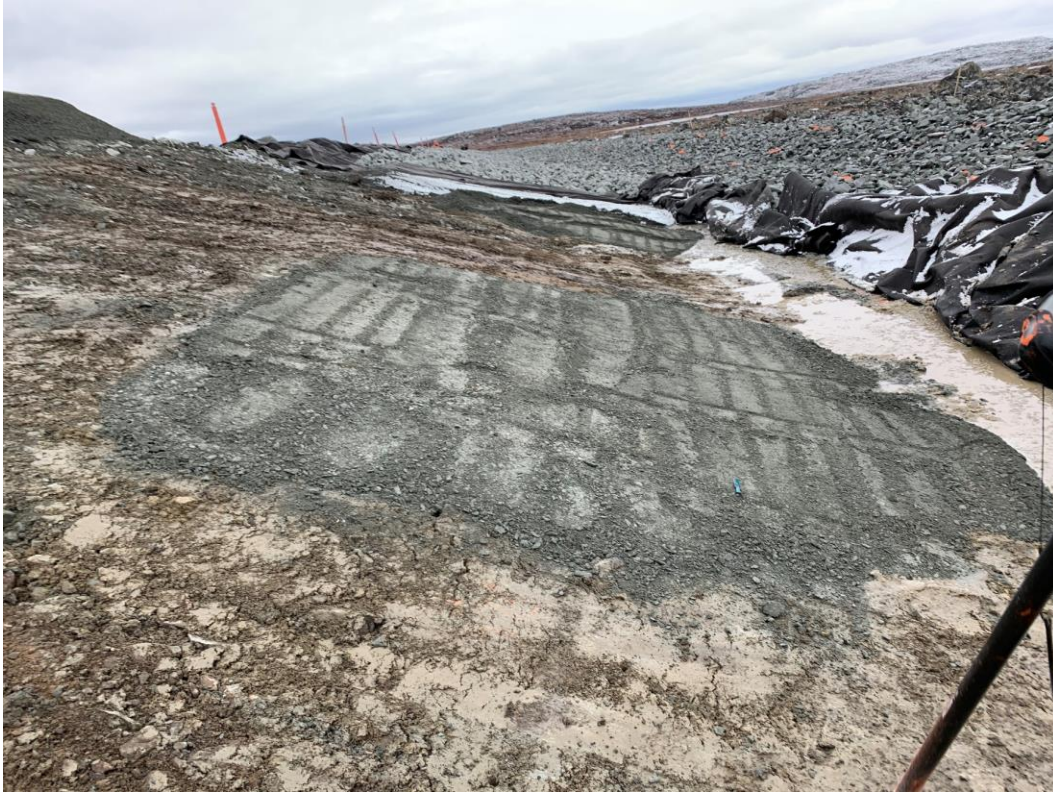
Figure 3: Excavated material replaced by well-compacted fine filter
