20181128-NS-SR

2018-11-28 6PM-6AM 658 309 J. Leblanc  
Visit date Time (Start/End) Project No. Prepared by  
WTD CONSTRUCTION Agnico Eagle  
Project Client  
SNC-Lavalin KCG (SP by HD)  
Consultant Contractor

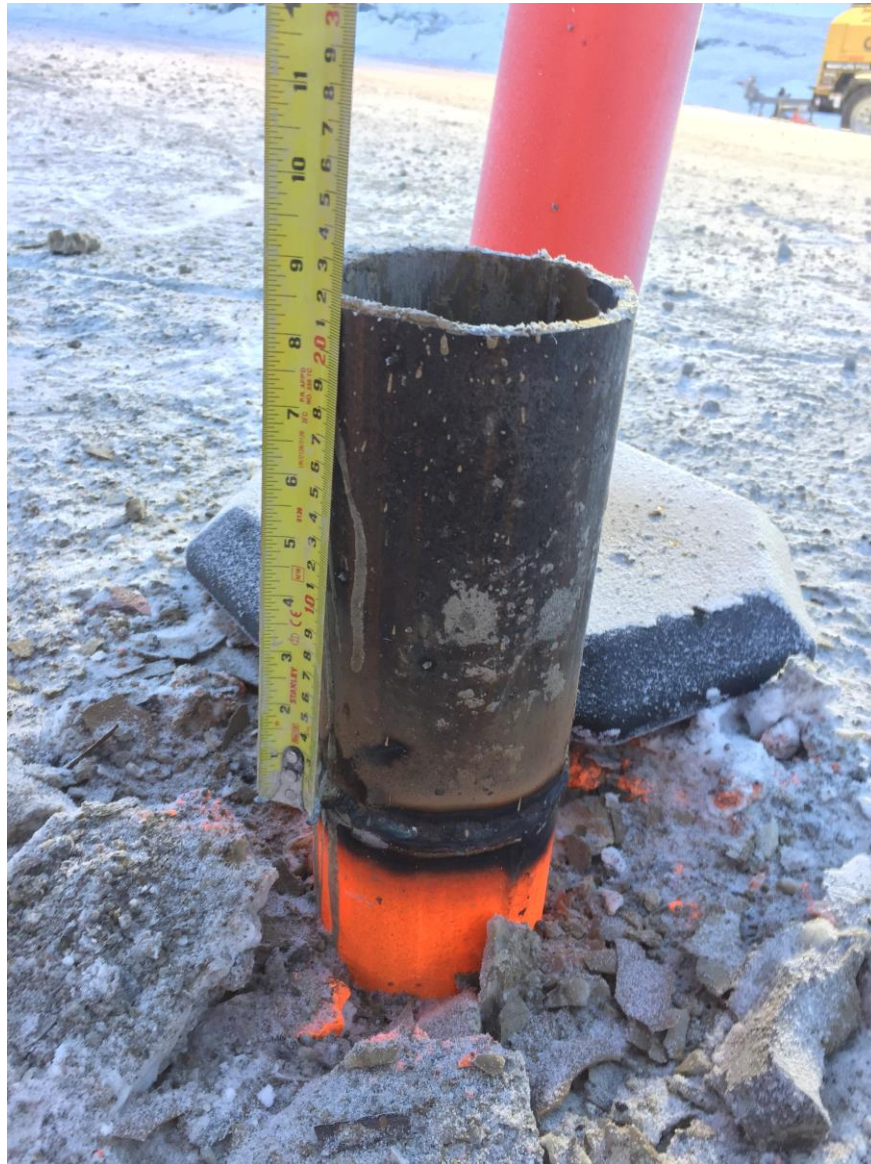
\* THOSE CASINGS WERE DRILLED ON NOVEMBER 28 BUT SOME MISTAKES WERE FOUND IN KCG REPORT. AEM ASKED KCG TO DRILL AN ADDITIONAL 900mm AS SHOWN IN THE PHOTO IN APPENDIX.

Figure 1: A photograph of the casing of primary hole #180 showing the ~200 mm welded tube on top of the casing

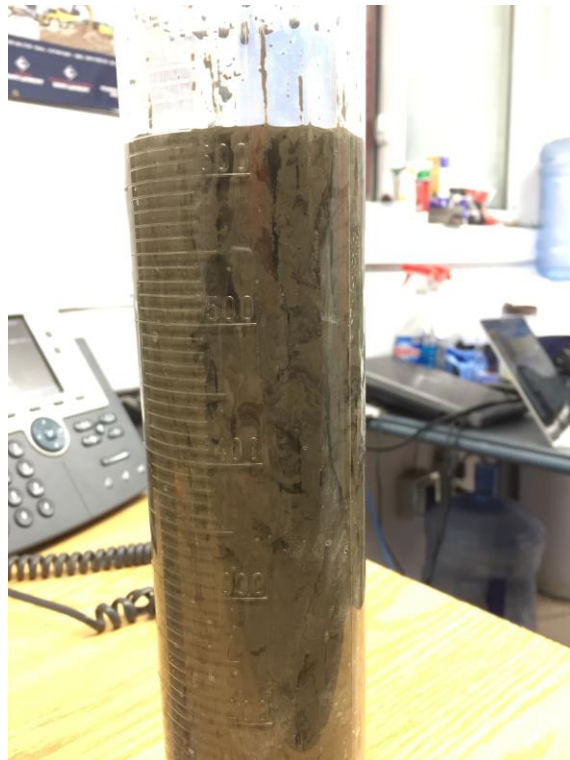
Subject: QC NOTED THAT MIXES "A" AND "A + COLD WEATHER ADMIXTURE" WERE NOT HOMOGENEOUS: THIS IS PROBABLY DUE TO THE FACT THAT GLENIUM 3030NS ADMIXTURE WAS PREVIOUSLY STORED IN A COLD ENVIRONMENT. IT LOOKS LIKE THE SUPERPLASTICIZER SPLIT INTO TWO PHASES. THE PRODUCT WILL BE PUT IN A WARM ENVIRONMENT (~20°C) AND MIXED UNTIL IT BECOMES HOMOGENEOUS, AND TRIAL TESTS WILL RESUME TOMORROW. SEE ATTACHED PICTURES FOR GROUT MIXES.

**Figure 1: Mix A after ~ 2 hours**

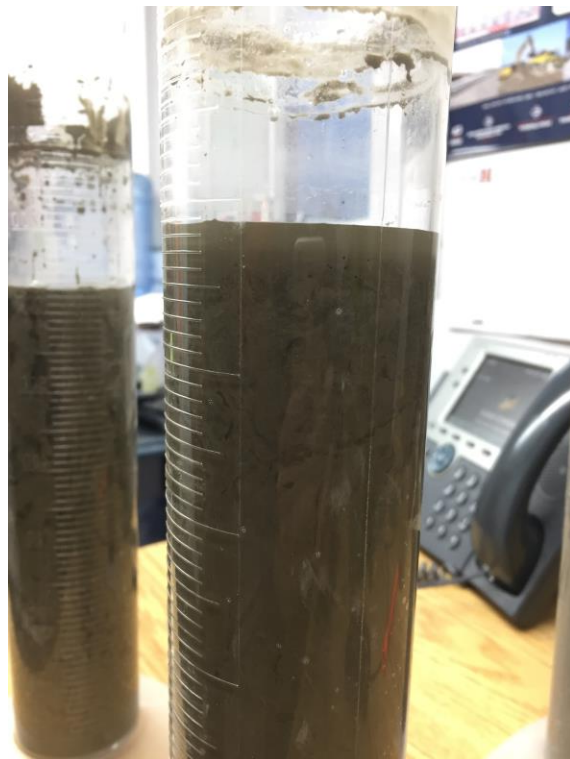
**Figure 2: Mix A + cold weather admixture after ~ 2 hours**

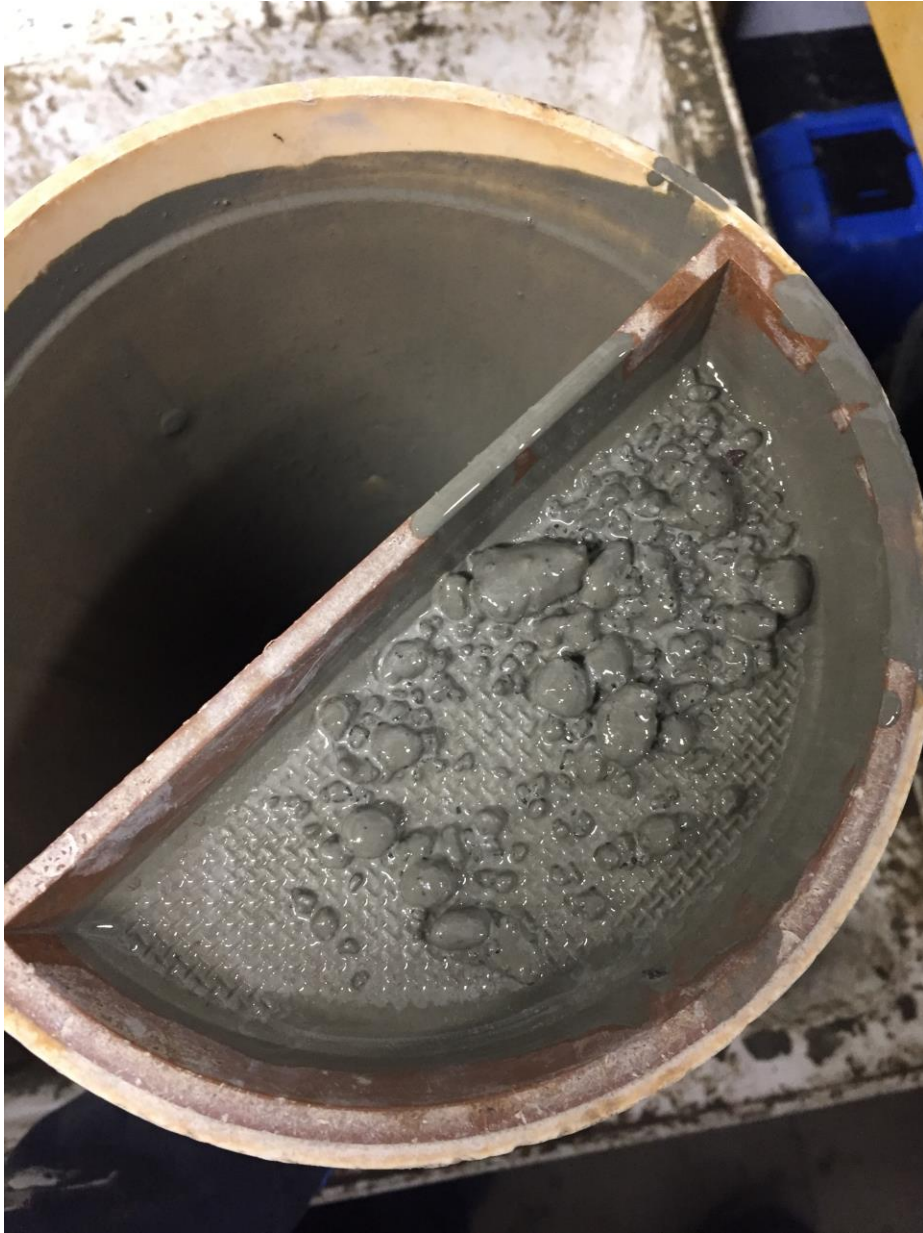
\* VISCOSITY OF MIX A WAS HIGH; THAT MAY BE DUE TO IMPROPER MIXING OF THE SUPERPLASTICIZER (CHUNKS OF GLENIUM WERE FOUND ON THE SIEVE OF MARSH FUNNEL AS SHOWN IN THE ATTACHED PHOTO).

**Figure 1: Chunks of Glenium 3030 NS observed on Marsh Funnel sieve (Mix A)**
