**SNC-LAVALIN**

**SITE REPORT**  
(Detailed)

20180813-DS-SR

Visit date 13/08/2018	Time (Start/End) 6AM-6PM	Project No. 658309	Prepared by A. Arbuzov
Project WTD construction		Client Agnico Eagle	
Consultant SNC-Lavalin		Contractor KCG

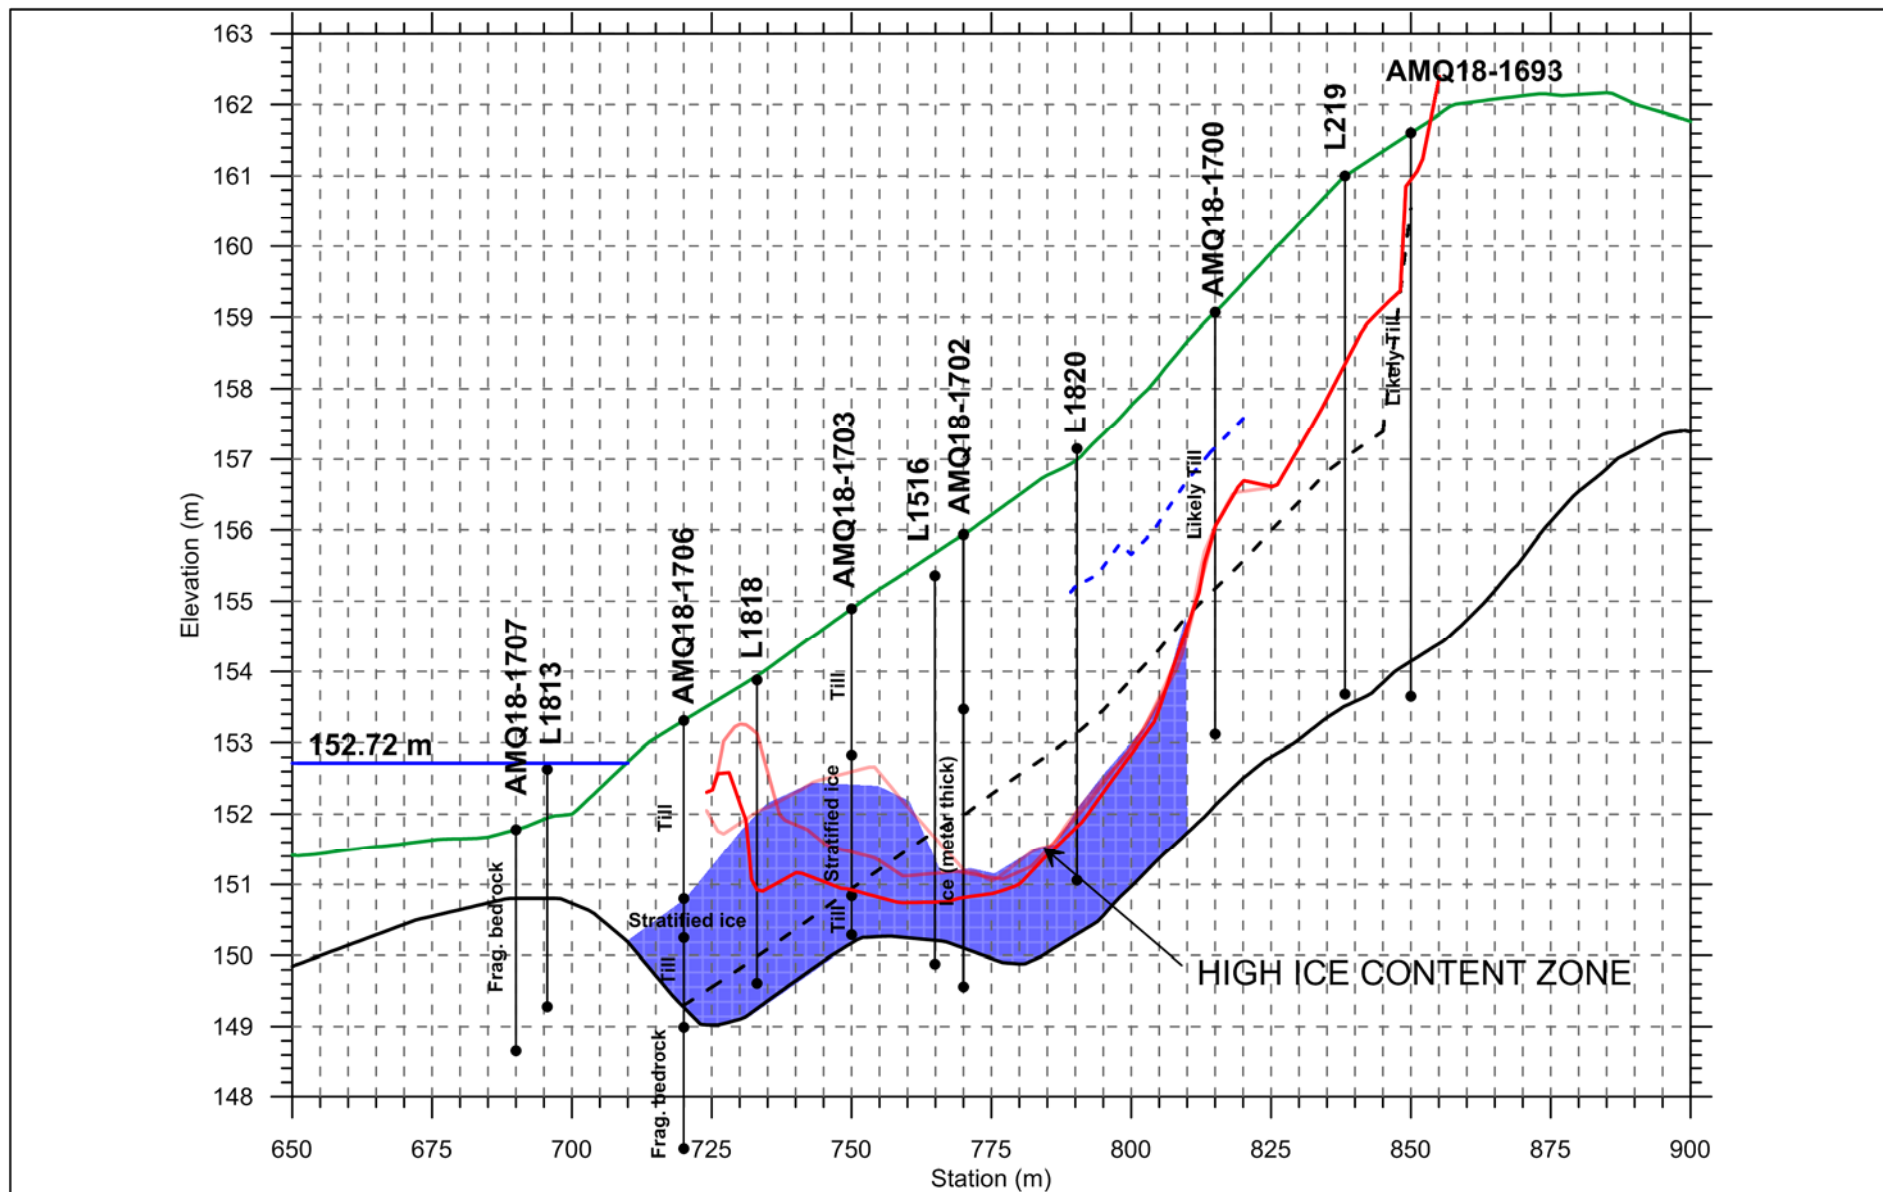
| → | Excavation at the east abutment. Bedrock is observed from station ~ 0+725 to ~ 0+770. | |

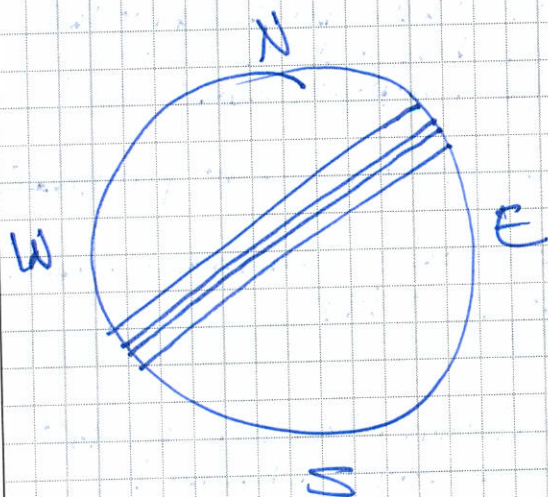
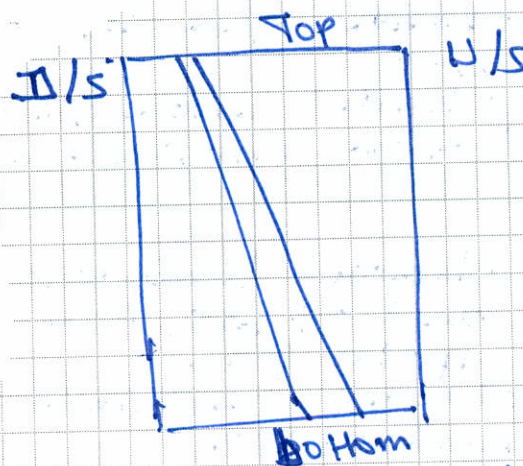
Crack orientation (approximate and general) in the bedrock at the east abutment area.

- Inspection of excavation in the east abutment area. Checked if bedrock has been reached at stations between station 0+39 to 0+72, did spot checks and approved that bedrock has been reached. The bedrock is highly fractured with <sup>many</sup> vertical fractures from north-east to southwest. (See approval form)
- observed fine filter placement from station 0+395 progressing east
- Observed coarse filter placement in west abutment area between approximate stations 0+139 to 0+170

(a) Orientation of cracks in plan view

(b) orientation of cracks in profile (vertical) direction

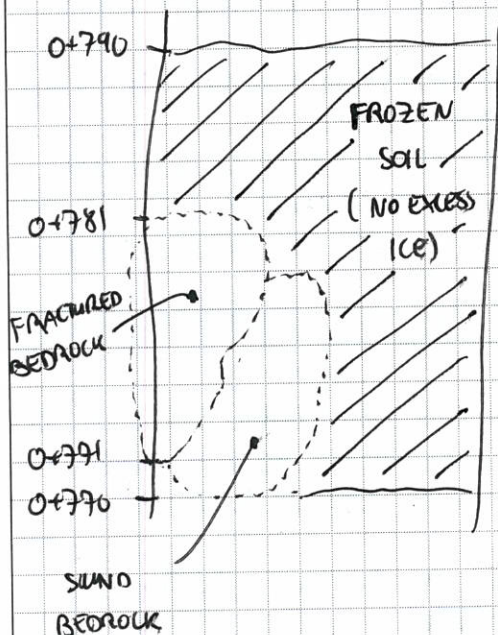
FOUNDATION APPROVAL - EAST ABUTMENT

- FOUNDATION (FOOTPRINT) WAS APPROVED AT THE EAST ABUTMENT BETWEEN ST 0+773 TO 0+790.
  - ZONE OF FRACTURED BEDROCK BETWEEN 0+771 TO 0+781 (REFER TO SKETCH)
  - BOTTOM OF THE FOUNDATION IS ON BEDROCK (FRACTURED AND SOUND) AND ON FROZEN SOIL.
  - WELL CLEANED AND NO ICE-RICH MATERIAL LEFT ON FOUNDATION FLOOR.
- QA INSPECTOR NOTICED THAT FINE FILTER + COARSE FILTER HAVE BEEN PLACED BETWEEN ST 0+740 TO 0+770 DURING A PREVIOUS SHIFT AND HAVE NOT BEEN APPROVED BY QA OR QC
  - COARSE FILTER ON THE UPSTREAM SLOPE (AGAINST ROCKFILL) IS TOO THIN. A WIDTH OF 1.0m WAS MEASURED AND THE REQUIREMENT FROM THE DRAWINGS IS 1.5m: NON-CONFORMITY. (SEE THE SKETCH).
- WIDTH OF COARSE FILTER AGAINST NATURAL GROUND ON THE DOWNSTREAM SLOPE WAS REDUCED FROM 3.0m AT ST. 0+790 AND BELOW TO 1.5m BETWEEN 0+770 TO 0+790.

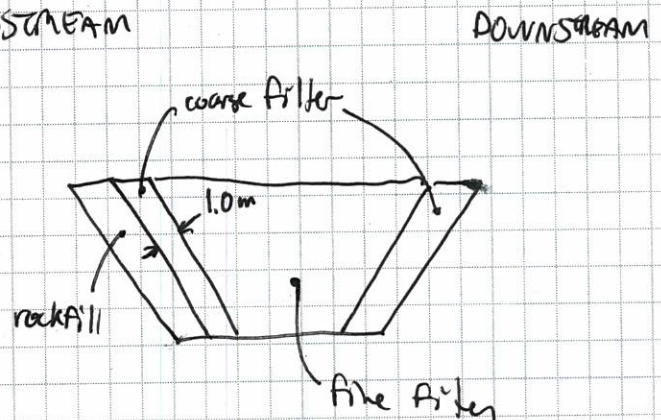
COARSE FILTER - EAST ABUTMENT

Elements	Location	Scope and comments
FOUNDATION (FOOTPRINT) APPROVAL	0+772 TO 0+790	APPROVED
COARSE FILTER PLACEMENT	0+740 TO 0+770	NON-CONFORMITY (THICKNESS)
"	0+495 TO 0+515	APPROVED
FINE FILTER PLACEMENT	0+471 TO 0+480	APPROVED
ROCKFILL PLACEMENT	0+770 TO 0+785, SOUTH SIDE	APPROVED
"	0+140 TO 0+240, NORTH SIDE	APPROVED

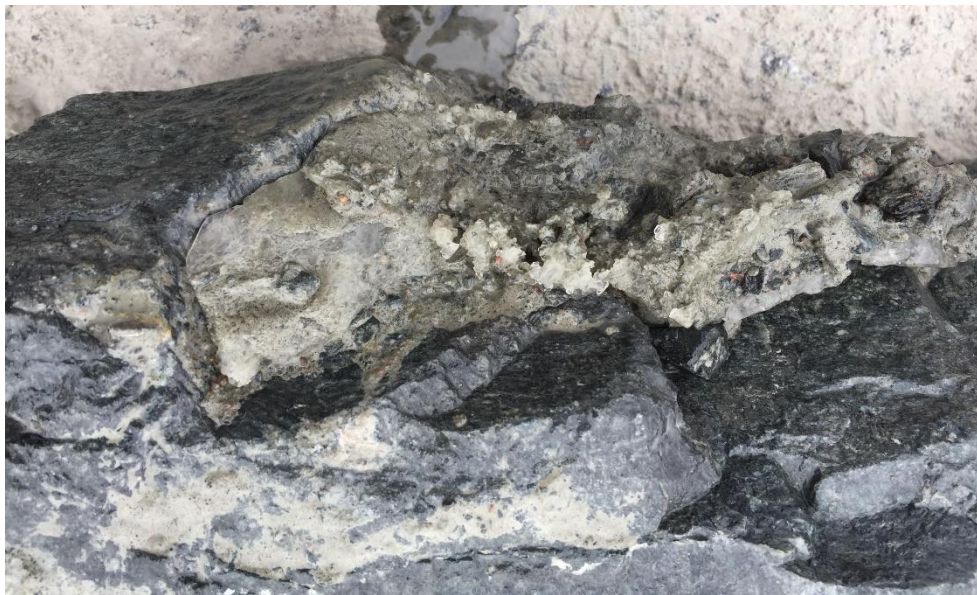
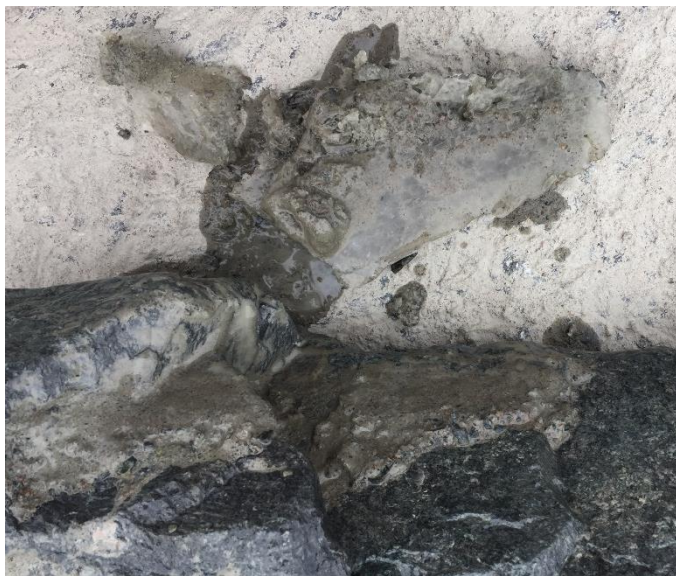
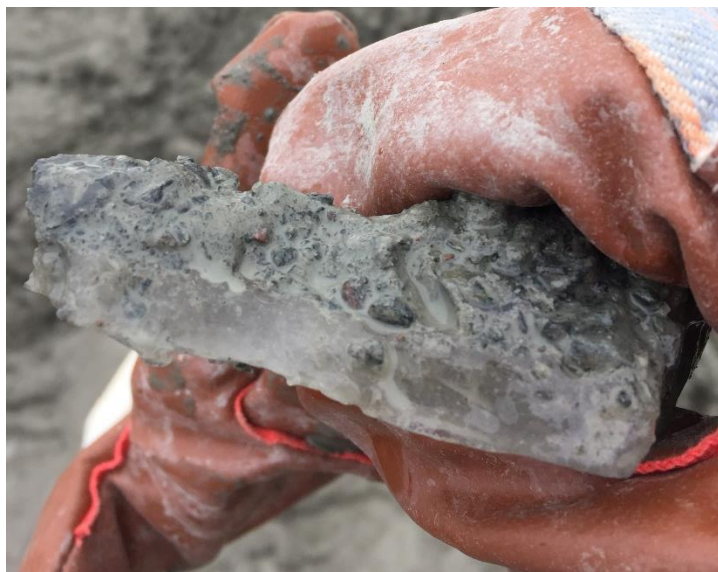
**Indicators of Presence of Frozen Material above bedrock in the station between 0 + 555 and 0 + 595**

→ observed foundation clean-up between stations 0+555 and 0+595. Part of this section has been observed by QA/QC in the night shift. The QA and QC during day shift made spot checks to make approvals and the checks indicated that the foundation was not clean since indications of frozen foundation condition (i.e. ice) was observed. The day shift QA/QC recommended re-cleaning. The foundation ~~was~~ condition after re-cleaning seem to have reached the bedrock (past the frozen zone). Hence, it was considered acceptable. Refer to photo for ice.

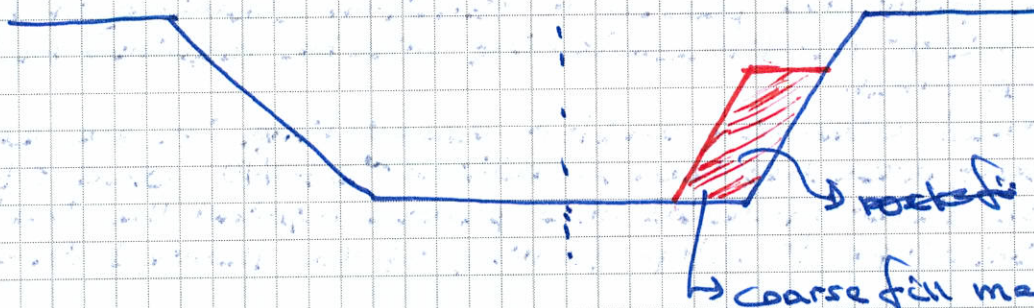
Between stations ~ 0+710 and 0+739

→ observed cleaning and/or excavation in the east abutment area between stations 0+710 and 0+739. Coarse filter material was placed against the in-situ frozen material slope to stop flowing of the thawed in-situ

→ coarse fill material placed here to support the thawing slope and protect it from spilling into the excavation. The extent of the coarse fill material and also its foundation condition need to be verified after final clean-up before approval.

No	Subject	Given to
1	material towards the pit bottom making the excavation difficult. Extent of this coarse material placed needs to be checked to see if it is as per design, and correction may be required (before placement of fine filter and approval of foundation). Refer to the sketch at the back	
2	Observed placement of fine filter to El. 153.5 between stations 0+545 and 0+575	
3	Observed rock fill placement to El. 15m at about st. 0+140

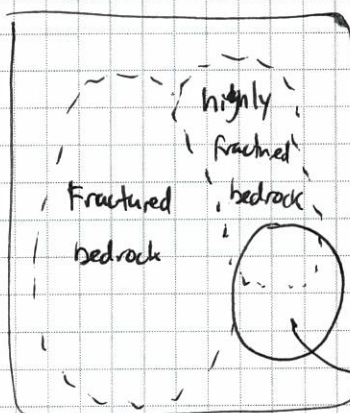
EAST ABUTMENT FOUNDATION

- KEY TRENCH CLEANING BETWEEN 0+595 TO 0+615 TO THE SATISFACTION OF QA/QC REPRESENTATIVES
  - QA INSPECTOR ASKED EXCAVATOR OPERATOR TO SURVEY THE ELEVATION AT ST. 0+609, 1m UPSTREAM WHICH CORRESPONDS TO BOREHOLE AMG17-1201
    - ELEVATION FROM BOREHOLE: 148.70m / FROM SHOVEL: 147.18m
  - BATHYMETRY COMPLETED BY SHOVEL EQUIPPED WITH GPS + MANUAL READINGS WITH MEASURING TAPE ON A BOAT
  - HOWEVER, QA INSPECTOR RECOMMENDS DOING A COUPLE OF SPOT CHECKS BEFORE THE PLACEMENT OF COARSE FILTER MATERIAL DUE TO POTENTIALLY FROZEN LAKEBED MATERIAL REMAINING.
- EAST ABUTMENT: FOUNDATION APPROVAL BETWEEN 0+727 TO 0+739
  - FOUNDATION SITS ON FRACTURED BEDROCK ON THE WHOLE FOOTPRINT
  - ICE LENSES OBSERVED BETWEEN BEDROCK FRACTURES

presence of ice lenses  
between fractures of bedrock

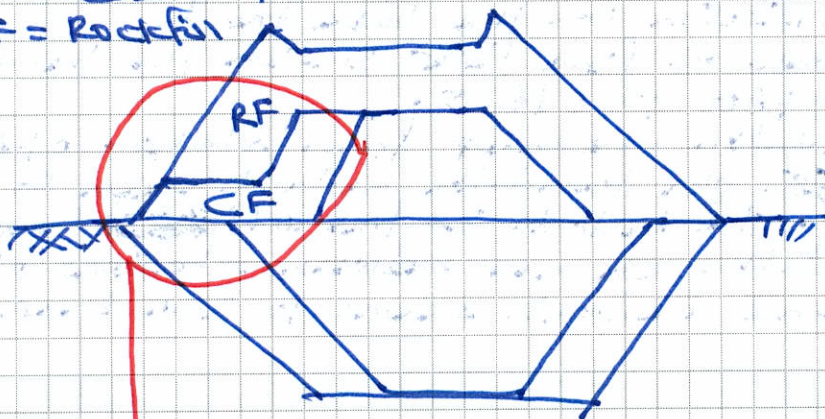
CF = coarse filter  
RF = Rockfill

- observed rock fill placement to El. 157m. Extent of bedrock rock fill compared to the coarse filter material on the downstream side needs to be checked after getting the cross-section drawings. ~~From the~~ It was mentioned in the daily meetings, by the drafts person, that at some sections of rock fill placement on the downstream side, the rock fill could be on top of sitting on top of the coarse filter, as shown in the sketch in the next page. This was later found out to be true after receiving the cross-section drawings for stations between 0+355 to 0+385. Refer to attachment.

→ compare this with cross-section F-F  
at station 0+350 in construction  
drawings.

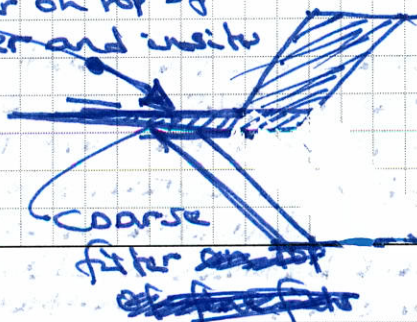
Coarse filter on top of fine filter and inside soil

Coarse filter on top of fine filter
