SITE REPORT (Detailed)

20180909-DS-SR

WTD Construction Agnico Eagle

Project Client

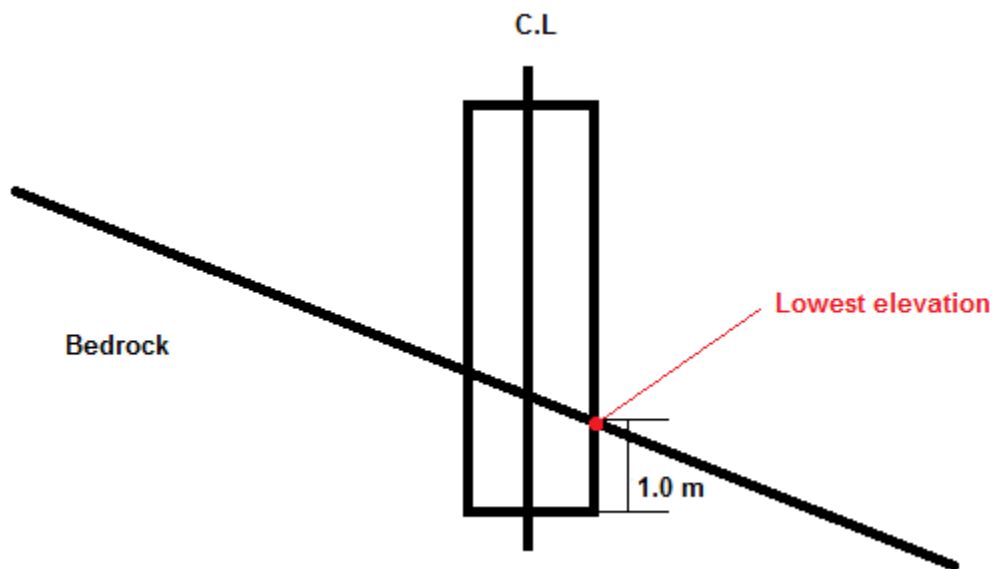
- 1- **Approved Foundation** | The bathymetry of the bedrock done by the surveyor was not treated (there are some noise with high and low peaks). KCG is aware of this and is cleaning their bedrock surface survey. *Result: KCG will send an excel file with clean approved bedrock profile.*
- 2- **Review of pile depth** | The lowest elevation of bedrock where a one meter pile will be located is being taking into consideration as implementation point for the piles instead of taking the center line point, which was giving higher elevations and the 1.0 m bedrock socket was not being respected. *Result: KCG should send an excel file with the new depth of bedrock to attain by pile (excel file: WT_SCEACANT PILES LISTING WITH QUANTITIES.xlsx).* The following sketch demonstrates the change.

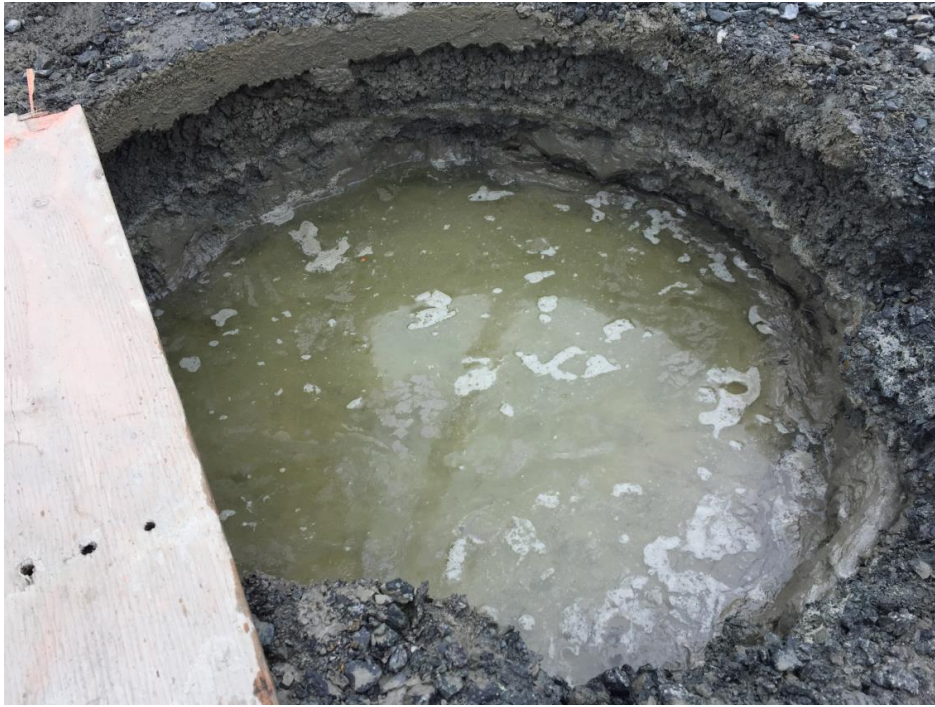
Figure 1 - Drop in Pile Height After Placement in Primary Pile 065: The pile was filled to the full elevation later on

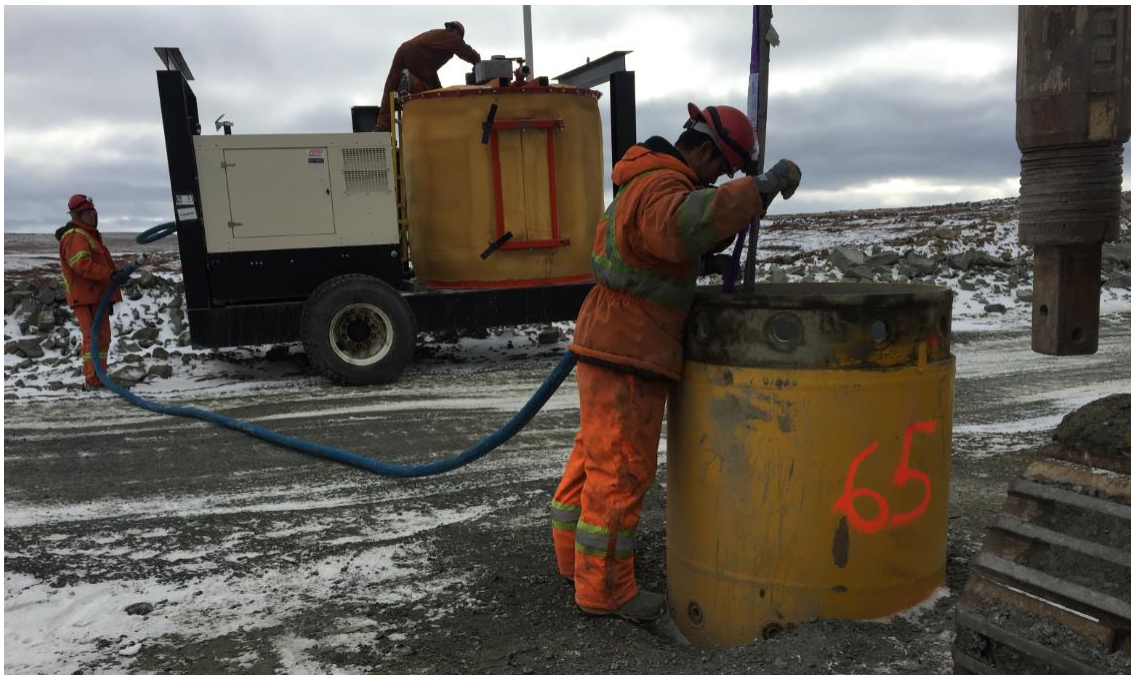
Figure 2 – CB Mix being Pumped to Primary Pile 065

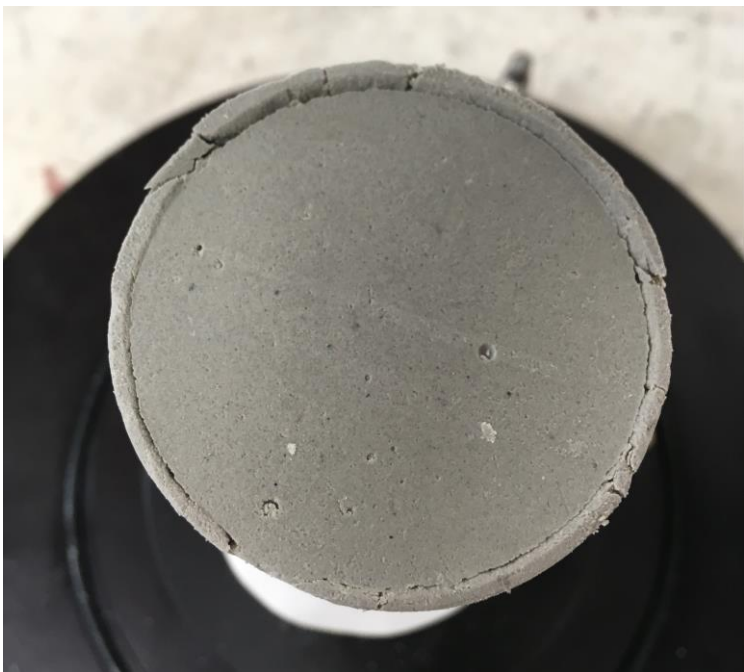
- QA INSPECTOR SPENT MOST OF THE SHIFT IN THE LABORATORY OBSERVING UNCONFINED COMPRESSION TESTS ON 12-DAYS OLD CB SAMPLES. THE FOLLOWING OBSERVATIONS WERE MADE:
 - ALL SAMPLES MEET UCS REQUIREMENTS AFTER 28 DAYS OF CURING (200 KPa MINIMUM ACCORDING TO TECHNICAL SPECIFICATIONS).
 - TOP PLATEN IS 50 mm WIDE AND THE SAMPLES HAVE A 52 mm DIAMETER. AS A RESULT, QA OBSERVED THAT PUNCHING OCCURED IN CB SAMPLES CAUSED BY A SMALLER PLATEN (IT PENETRATED IN THE SAMPLE). SEE FIGURE ATTACHED.
 - SOME AIR VOIDS HAVE BEEN OBSERVED INSIDE BROKEN SAMPLES. SEE FIGURE ATTACHED.
 - "SHEAR CONES" HAVE BEEN OBSERVED WHEN BROKEN SAMPLES WERE TAKEN APART, WHICH IS A TYPICAL FAILURE MODE FOR REGULAR CONCRETE (SEE FIGURE ATTACHED).

Figure 1: Punching on top of the CB sample

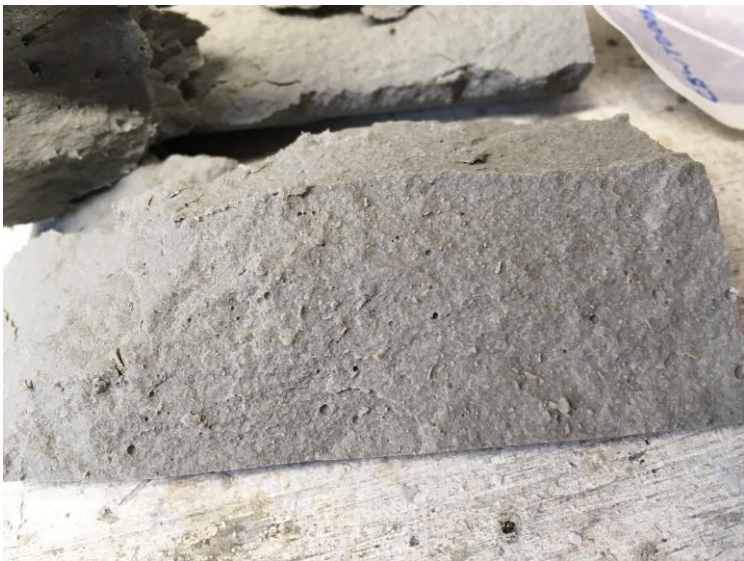
Figure 2: Air voids inside broken CB sample

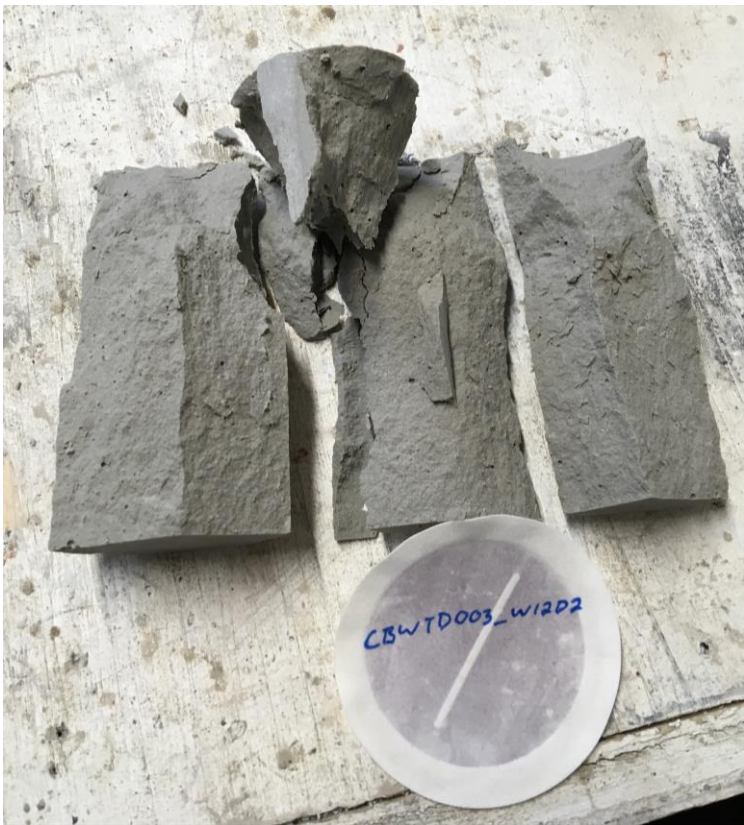
Figure 3: "Shear cone" observed on broken CB sample after unconfined compression test

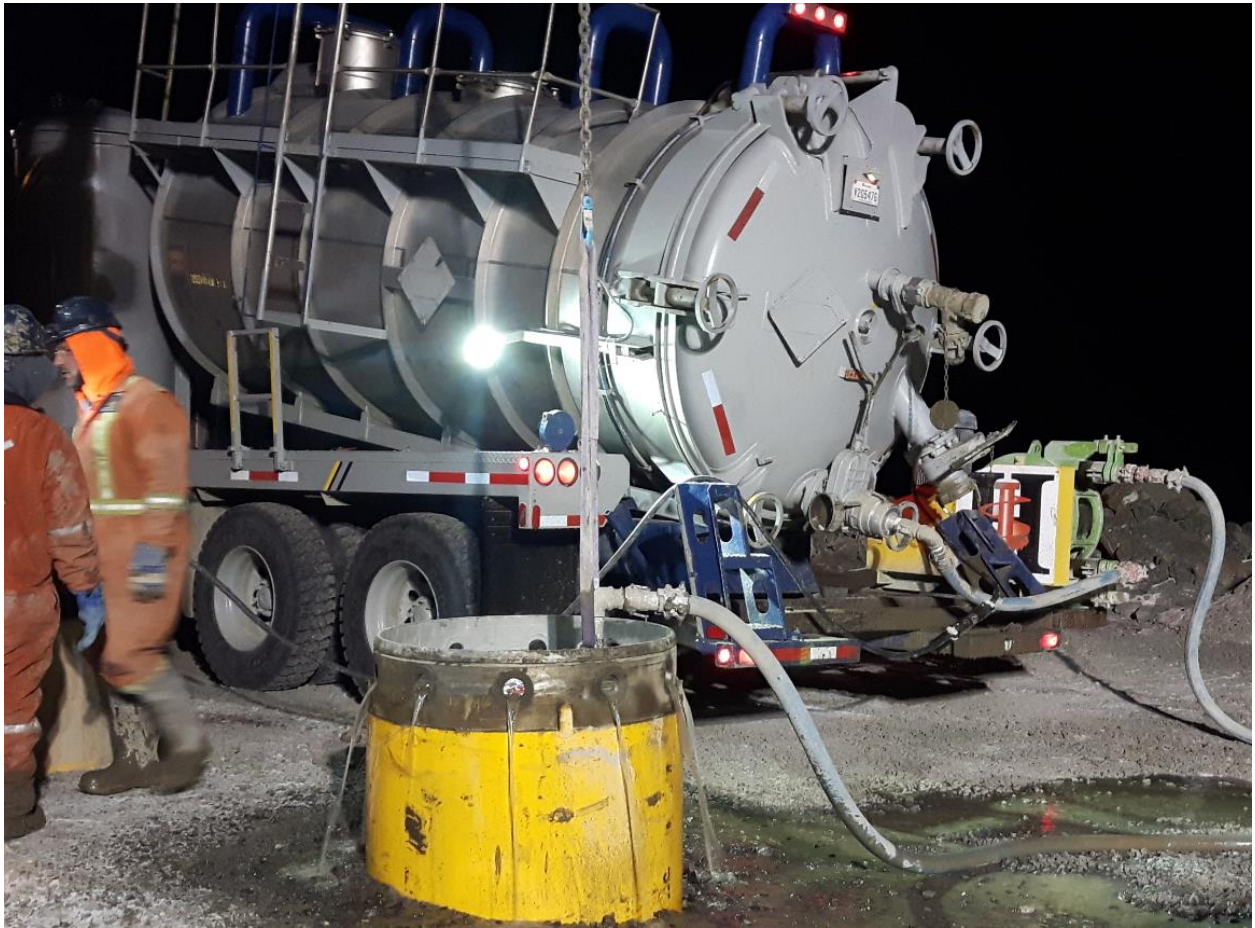
Picture showing slurry being pumped from truck to the piles
