2019-03-05 WTP 400 HYDRAULIC OIL SPILL

GN reference #: 2019-088

Please find the following information as a follow up to the spill report submitted March 5th, 2019 by Agnico Eagle. This detailed report is submitted to the Inspector in compliance with the conditions under the Nunavut Water Board License NWB-2AM-WTP1826, Part H, Item 8c.

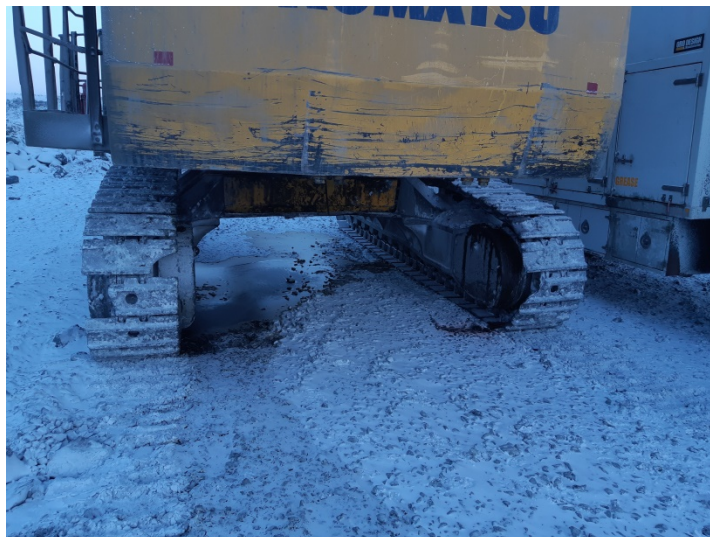
After have been fixed, the excavator was traveling for another work place. After only 100 feet the traction hose let go and spilled about 400 L of hydraulic oil on the ground. The operator stopped immediately the equipment and he called the maintenance to fix it.

There were no off site impact or discharge to any receiving watercourses. Distance to the closest lake is estimated at 150 meters.

The leak was caused by a faulty coupling on the hydraulic hose.

The operator stopped immediately his excavator and he made a request to fixe que equipment. All contaminated soil has been removed and place on the proper place. It was brought at the landfarm at Meadowbank.

The hydraulic system including hoses and fittings are inspected as part of the preventive maintenance program done on site. Routine visual inspection of the hydraulic system is also performed during pre-operations checks.
